Performance of RC Cast-in-Place Buildings During The November 26, 2019 Albania Earthquake

Abstract

5. Structural Damage Of Cast-in-place Rc Buildings In The 2019 Albania Earthquakes

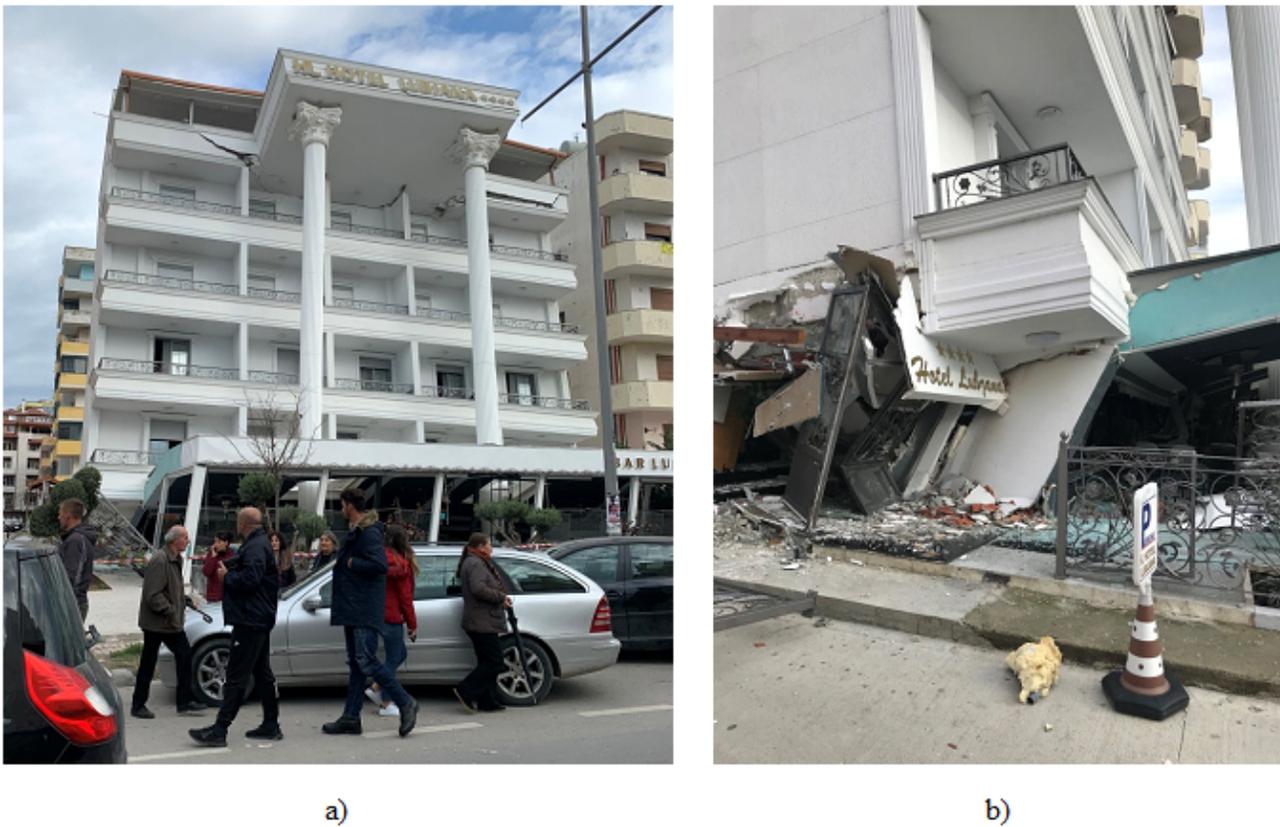
Figure 6

“Soft storey” collapse mechanism was observed in several buildings within the epicentral area, particularly in the Durrës area, as reported in reconnaissance studies (Freddi et al. 2021; EERI 2021). This mechanism was caused by an irregularity in elevation, where stiffness of one floor is significantly less than adjacent floors. Buildings characterized by this irregularity had unevenly distributed masonry infills in these buildings. The buildings had an open space at the ground floor level, which was used for various purposes (e.g., as a garage, office space, shops, restaurants, etc.), while masonry infills were constructed at upper floors, which were typically used for residential purposes (as apartments). Due to the presence of masonry infills at upper floors and the resulting increase in stiffness, deformation demands on RC columns at open lower floors were significant. Significant damage and collapse of several RC buildings located in the epicentral area of the November 2019 earthquake can be attributed to this failure mechanism. For example, Hotel Ljubljana, located in the severely affected area of Durrës (Fig. 6), experienced this type of collapse. Note that the hotel also had a vertical extension (three floors were added after the original construction was completed), which could have also contributed to collapse

Collapse of Hotel Ljubljana in Durrës due to “soft storey” failure mechanism

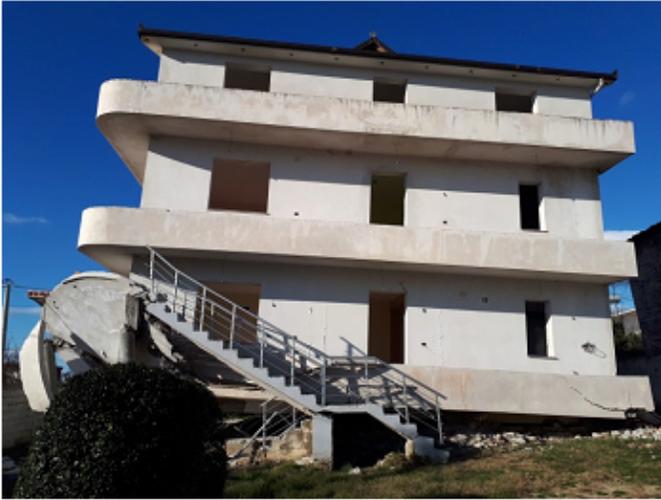
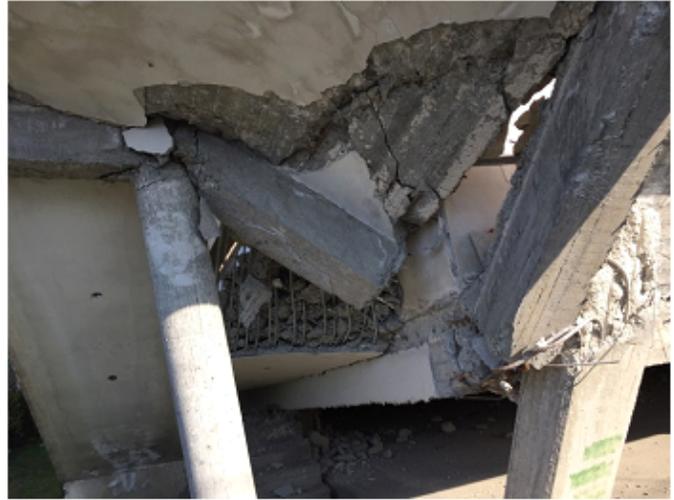
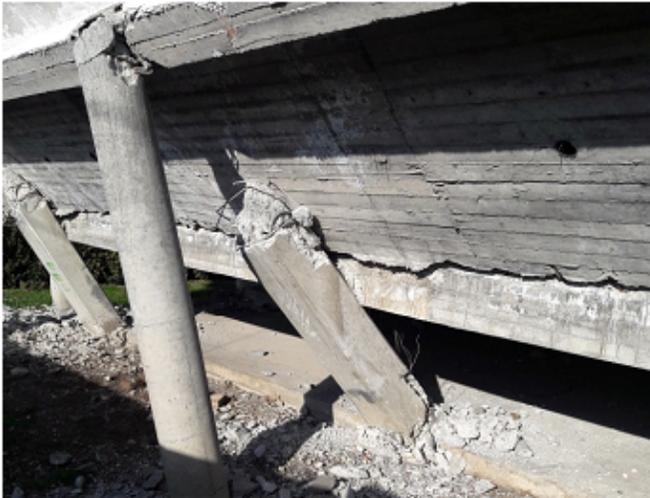
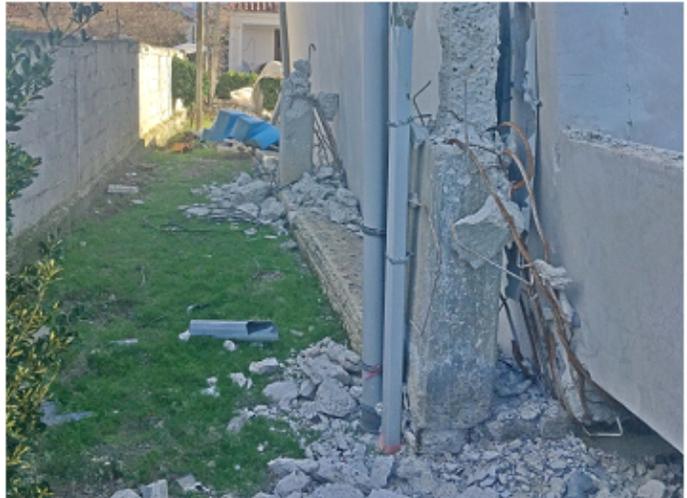
Figure 7

“Soft storey” collapse of a 4-storey house in Thumanë: a) east façade; b) south-west corner; c) south façade; d) north façade

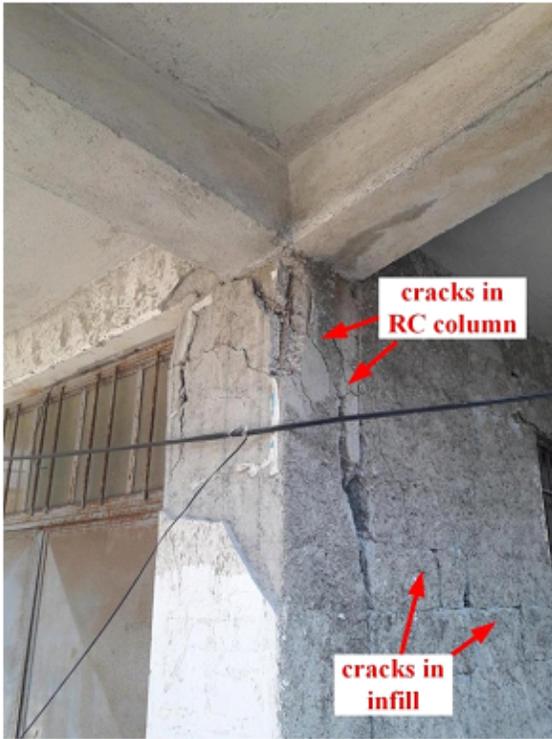
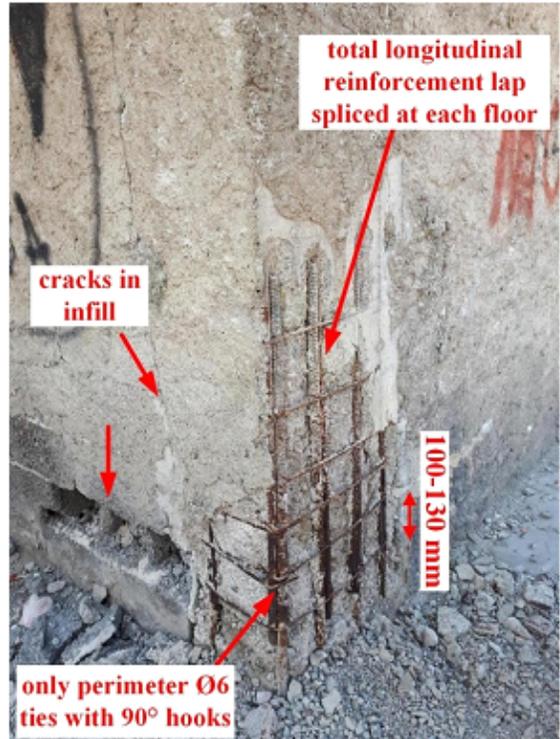
Figure 8

It was observed that some columns in RC buildings experienced damage due to frame-infill interaction and due to “short column” effects. In some cases, cracks in RC columns with rather small cross-sectional dimensions appeared due to interaction with masonry infill walls, characterized by significantly higher stiffness than the adjacent frame elements. Fig. 8 shows damaged RC columns in a building located in Durrës. It was observed that these columns have 6 mm ties with 90° hooks were observed, at 10-13 cm spacing (Fig. 8a). It can be noticed that cracks propagated from infill walls into adjacent RC columns.

RC columns damaged due to stiff infills and frame-infill interaction

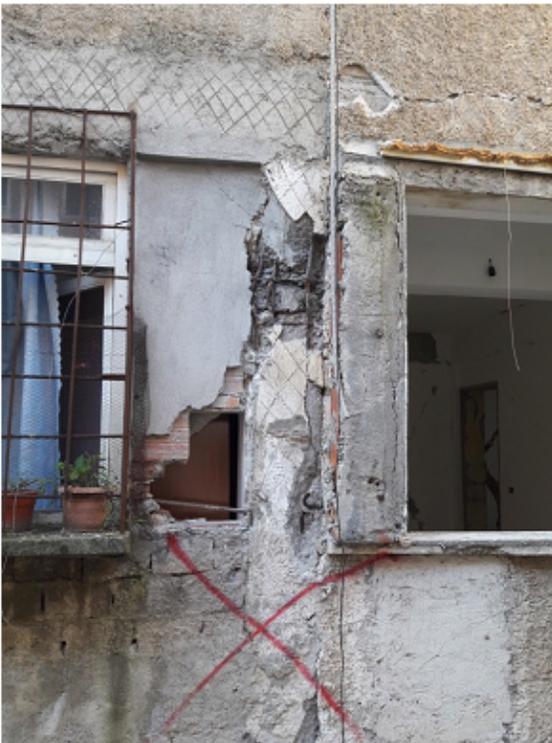
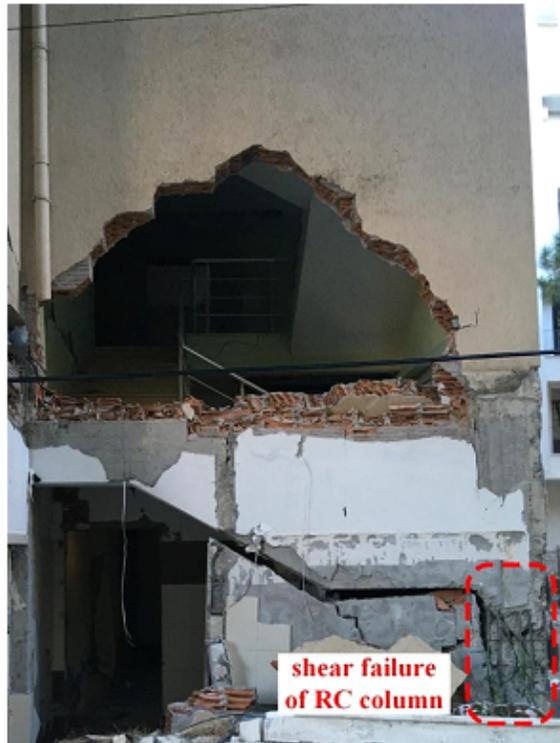
Figure 9

The “short-column” effect was observed in buildings with masonry infills placed up to a limited height due to presence of openings, e.g., windows, that is, partial infills (Fig. 9a). The resulting concentrated infill stiffness reduces the effective column height and increases shear forces which act on the part of a column which is not in direct contact with the infill. Failure of short columns may occur at sufficiently high seismic demands. The “short column” effect may also occur when a part of the staircase (usually intermediate landing) is supported by the RC columns (Fig. 9b).

Examples of damaged RC columns due to „short-column” effect: a) the effect of a partial infill, and b) the effect of a stiff staircase on RC column

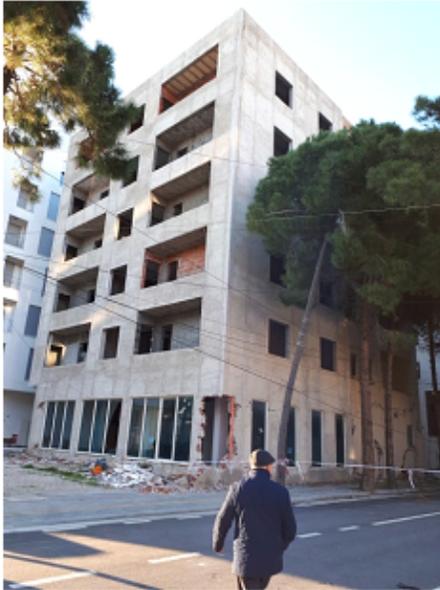
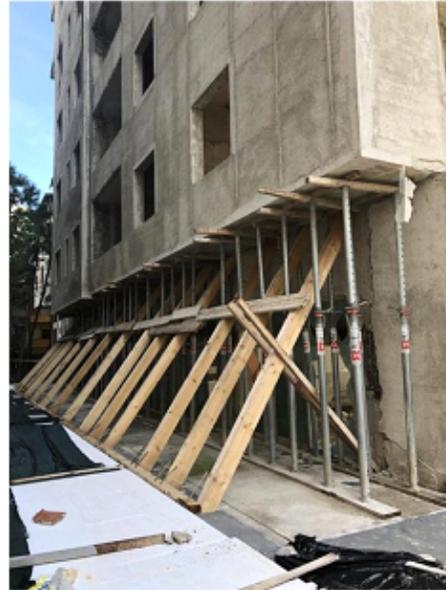
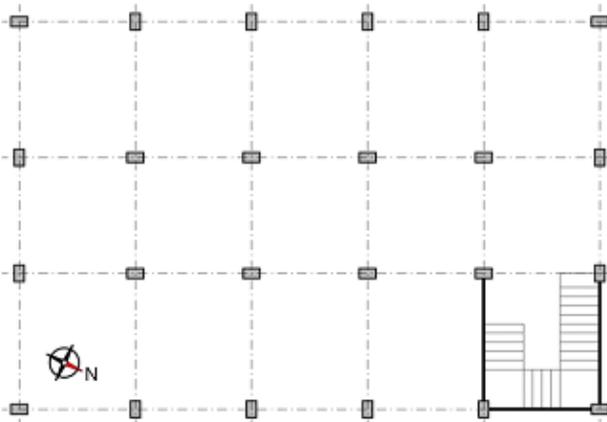
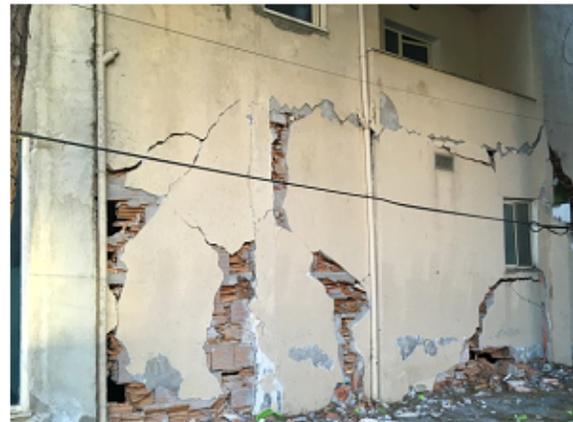
Figure 10

One of the most common types of irregularity observed in the affected RC buildings was a plan irregularity which is due to asymmetrical stiffness distribution in plan, and caused significant torsional effects. Plan irregularity in RC buildings affected by the 2019 Albania earthquakes was caused by asymmetrical distribution of masonry infills and stairs, and caused significant damage and even collapse due to torsional effects. Fig. 10 shows a 7-storey RC frame building located at the seaside area of Durrës. According to Google Earth images, the building was built between 2000 and 2005. The last floor was under restoration and had a setback located on N-W side of the building. Floors and roof were supported by a grid of 4×6 rectangular columns arranged in a regular pattern, with spans ranging from 3.5 - 4.2 m (Fig. 10c). Columns were approximately 30 cm wide and 50 cm deep. It was noticed that most columns in longitudinal perimeter frames were aligned such that their depth was perpendicular to the frame direction, which reduced torsional stiffness of the building. The floor system was in the form of a two-way ribbed RC slab with polystyrene filling and shallow RC beams (explained earlier in this section). The beams were approximately 70 cm wide and 30 cm deep. The perimeter frame at S-E façade had 30×50 cm beam at the first floor level, but the authors were not able to confirm whether similar beams were present at upper storeys.

The stairs were located at the north corner of the building and were supported by the beams and adjacent perimeter columns (see Fig. 10c). The building had an open ground floor and large openings in the exterior infill walls at the N-E and N-W façade, near the stairs (see Fig. 10a and Fig. 10b). It is believed that both stairs and infills, concentrated at the north corner of the building, had adverse local and global effects on the seismic performance of the flexible RC frame structure. Fig. 10d) shows damage of masonry infills on the north side, whereas Fig. 9b) shows shear and axial load damage of a “captive” RC column supporting the stairs. Globally, stairs and adjacent infill walls caused higher displacement demands on perimeter frames due to torsional effects. As a result, perimeter columns at the S-E façade experienced shear and flexural damage and had to be propped, as shown in Fig. 10b).

Damage of a 7-storey RC building at seaside Durrës: a) east corner, b) S-W façade of the building with severely damaged RC columns, c) floor plan at ground floor level, d) infill damage at N-E façade

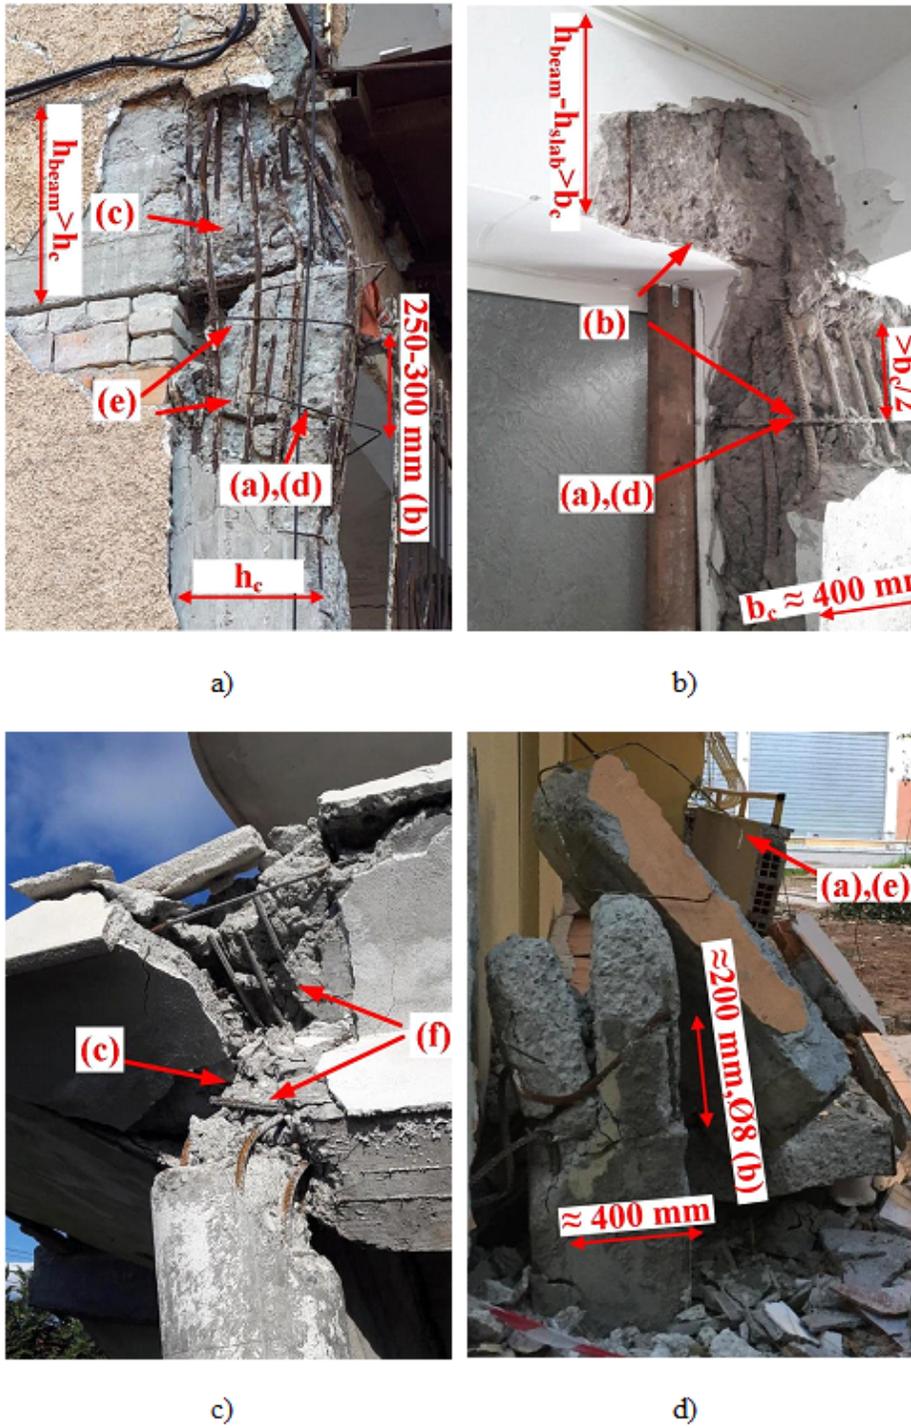
Figure 11

Several reinforcement detailing flaws were observed in majority of damaged and collapsed buildings surveyed during the reconnaissance study. Examples of these flaws are shown in Fig. 11 and summarized next (Milićević et al. 2021):

Examples of inadequate reinforcement detailing of RC columns and beams: a), b) buildings in downtown Durrës, c) a 4-storey house in Thumanë, d) a building at seaside Durrës

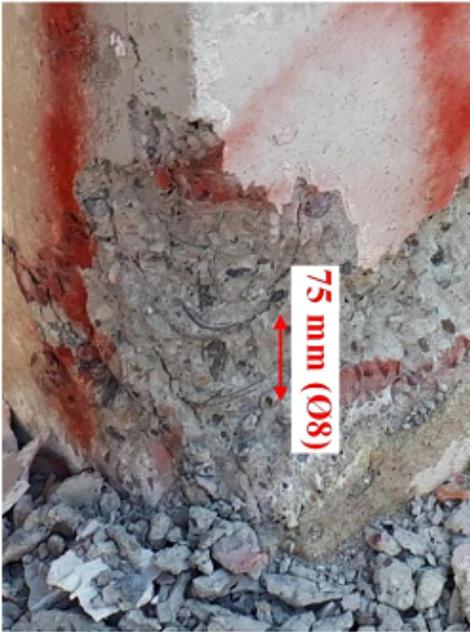
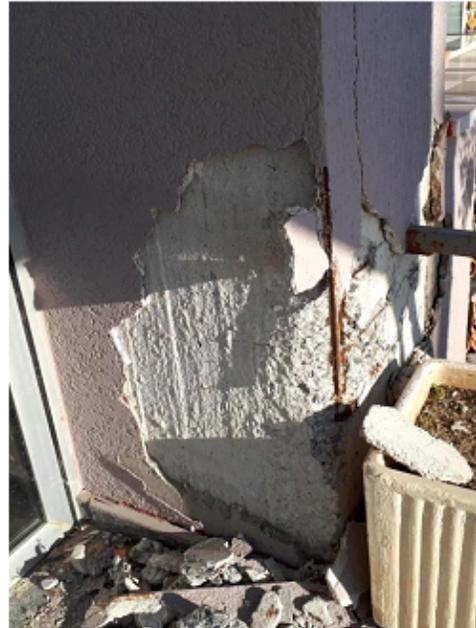
Figure 12

Beside inadequate reinforcement detailing, the authors also observed examples of good practice. Fig. 12a) and Fig. 12b) show minor damage in RC columns with small tie spacing of ties. In the case of the columns shown in Fig. 12a, the ties had 8 mm diameter and were placed at 7.5 cm spacing, which is less than required by KTP-N.2-89 (1989).

Examples of good reinforcement detailing practice in multi-storey RC buildings constructed after 2010: a) a 12-storey building in downtown Durrës; b) a 6-storey building at seaside Durrës

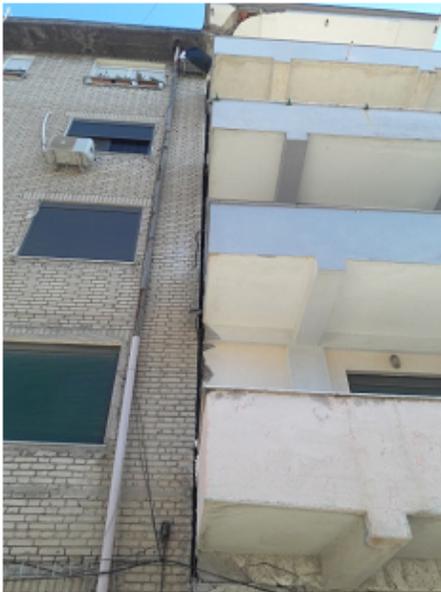
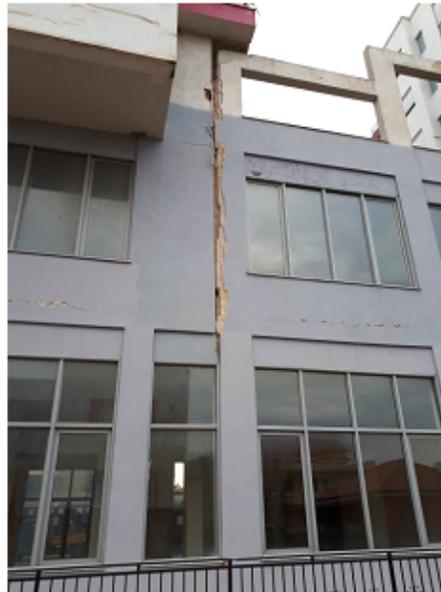
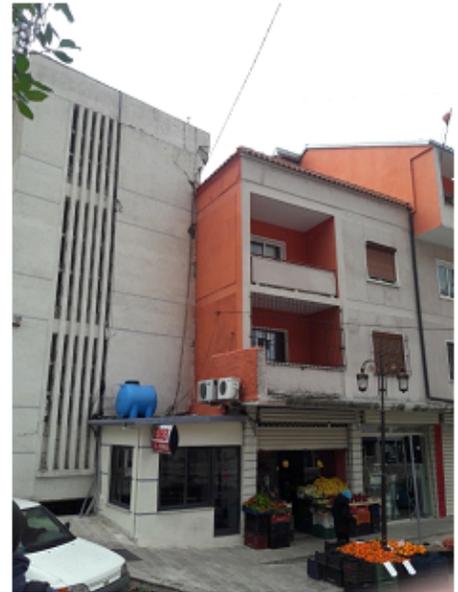
Figure 13

Several buildings suffered minor damage in the earthquake due to pounding, which was caused by insufficient size, or absence of seismic gaps, as well as differences in storey heights. Fig. 13a) shows a 5-storey RC frame building located near the fire station in downtown Durrës. The building had 3×2 rectangular columns arranged in a regular grid and infill walls constructed using concrete blocks on all sides at the ground floor level. The building experienced pounding damage due to proximity to a neighbouring masonry building and insufficient seismic gap. The pounding caused permanent (residual) deformations of RC building after the earthquake. Minor damage was also observed on buildings in other cities, e.g. Fushë-Krujë and Krujë (Figs. 13b and 13c, respectively).

Damage in RC buildings due to pounding: a) pounding of a 5-storey masonry and a RC buildings in downtown Durrës, b) pounding of 8-storey and 2-storey RC building blocks in Fushë-Krujë, c) pounding of 3-storey RC buildings in Krujë

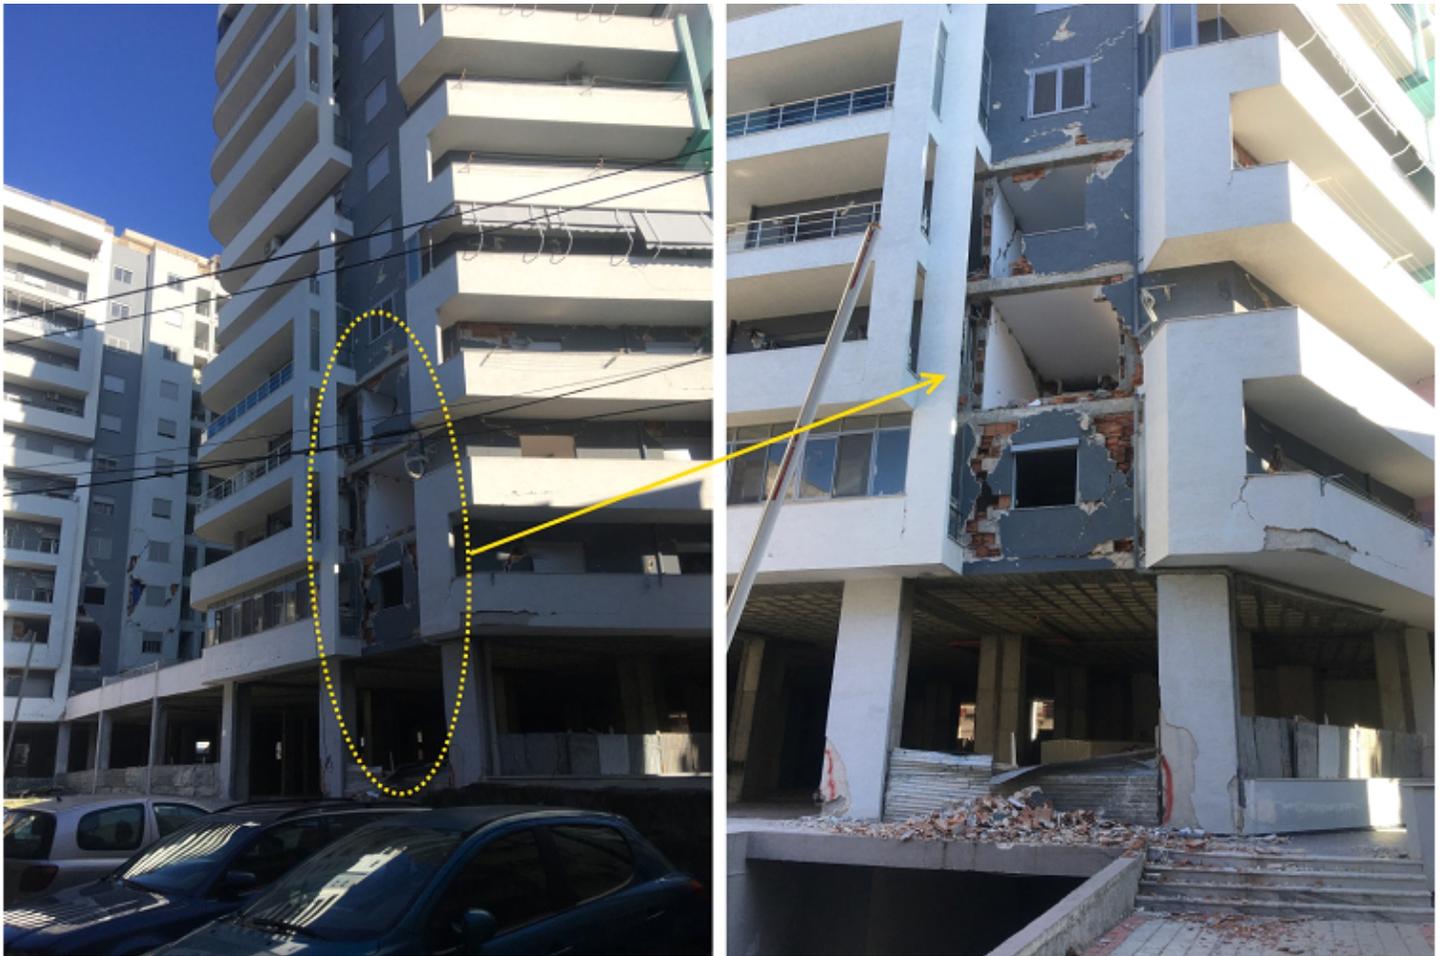
Figure 14

The authors observed during the reconnaissance visit that many RC buildings did not experience significant structural damage but had to be vacated due to extensive damage of masonry infills and partition walls. Fig. 14 illustrates typical damage in masonry infills, characterized by extensive cracking, while the RC structure remained undamaged. Damage of masonry infills in mid- to high-rise RC structures was widely spread in the Durrës municipality, but similar damage was also observed in other urban areas, including Fushë-Krujë, Krujë (Fig. 13c), and the Bubq village.

Damage and collapse of infill walls in a recently constructed 12-storey RC building in Durrës

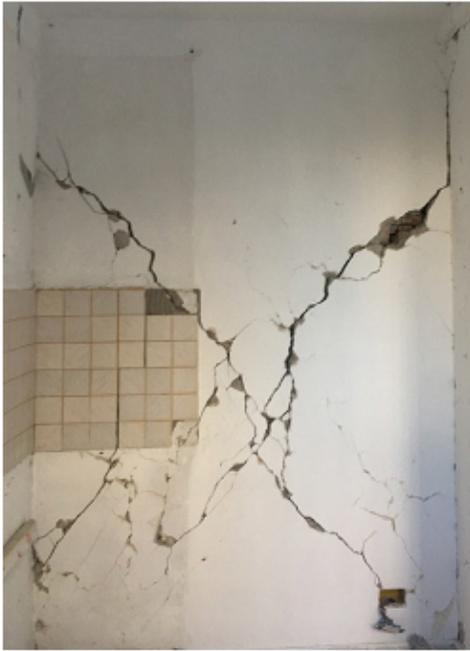
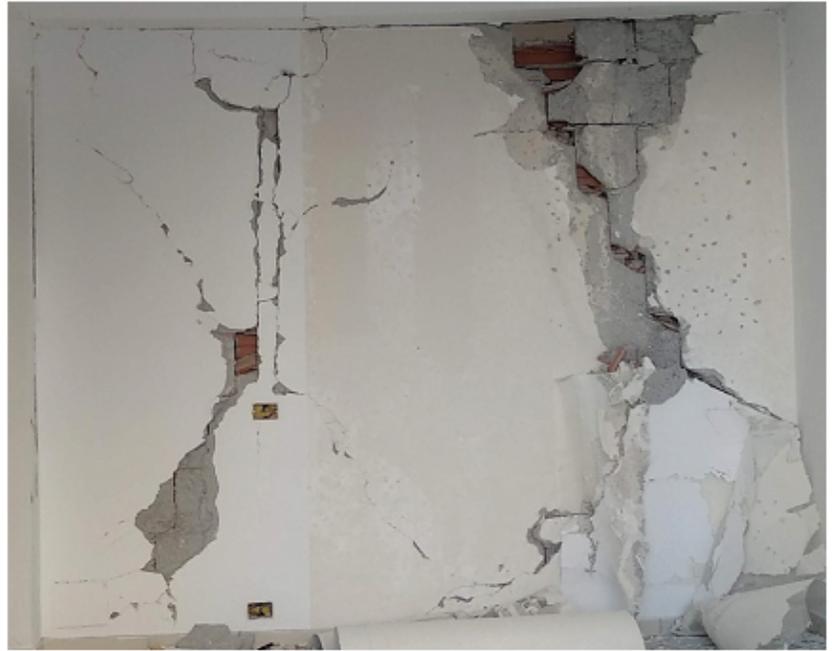
Figure 15

Diagonal (X-shaped) cracks in masonry infills inside an RC building in Durrës

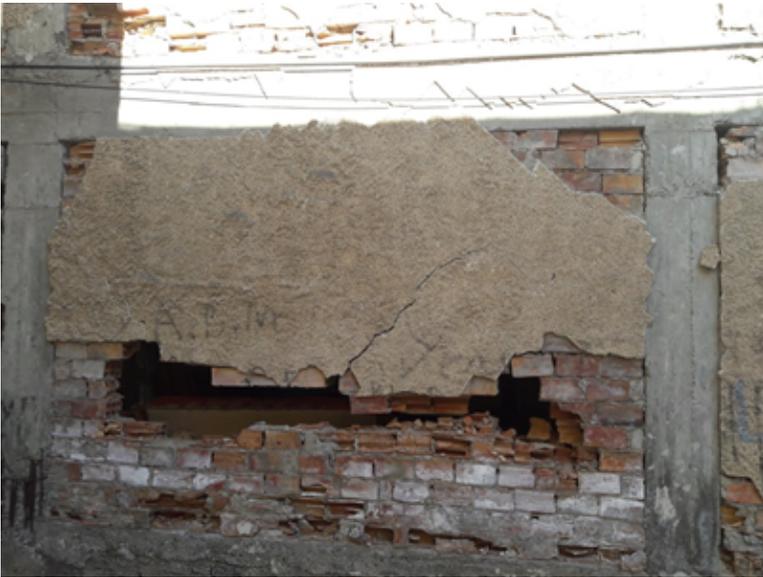
Figure 16

Extensive damage of masonry infills in the November 2019 earthquake can be attributed to excessive flexibility of RC frame structures and significant lateral drift demand (see Section 5.2), which caused in-plane damage of the infills. A typical damage pattern was in the form of diagonal (X-shaped) cracks (Fig. 15). Another characteristic in-plane damage pattern observed after the earthquake is bed-joint sliding shear failure along the mortar bed joints, which in some cases caused falling of the central portion of the wall (Fig. 16).

Damage of a masonry infill wall in the form of bed-joint sliding mechanism and failure of central portion of the wall

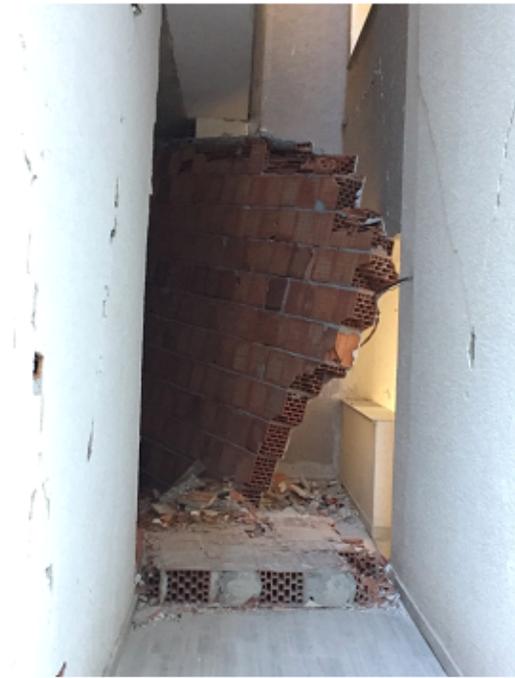
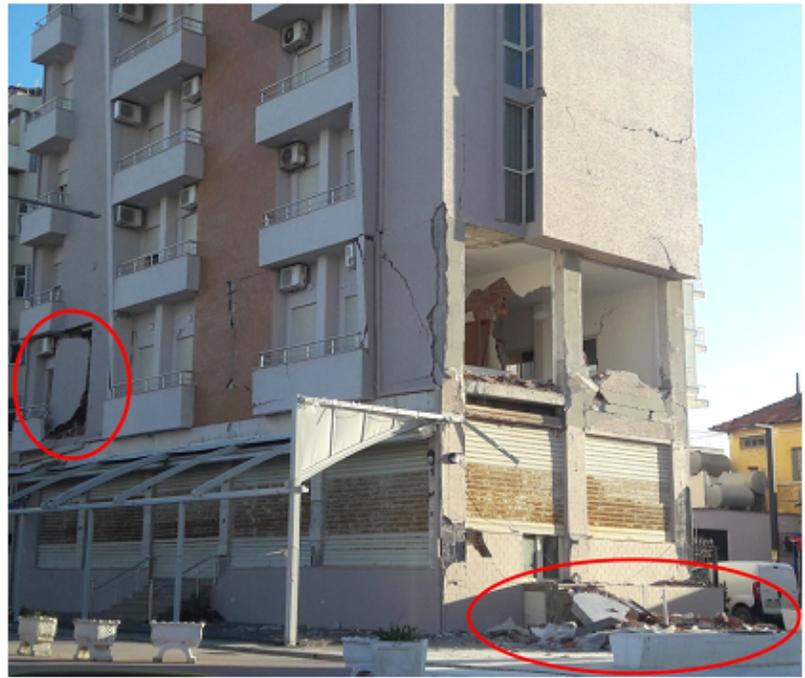
Figure 17

In many cases, masonry infills experienced out-of-plane damage due to distributed inertial forces perpendicular to the infill surface which are induced by spectral accelerations. The out-of-plane damage or failure of masonry infills was also observed after the November 2019 earthquake (Fig. 17). It is expected that in some cases the failure of infills in the building entrance area prevented or disrupted the evacuation from these buildings during and immediately after the earthquake (Lu et al. 2020). Out-of-plane infill failure is usually characterized by tilting of an infill like a rigid body (Fig. 17 and 18). This occurs due to a loss of contact between the frame and the wall.

Out-of-plane failure of infill walls in RC buildings in Durrës: a) infill failure at ground floor of a 10-storey building (note horizontally aligned perforations in the blocks), and b) various stages of damage and collapse of infills at the second storey level of a 6-storey building

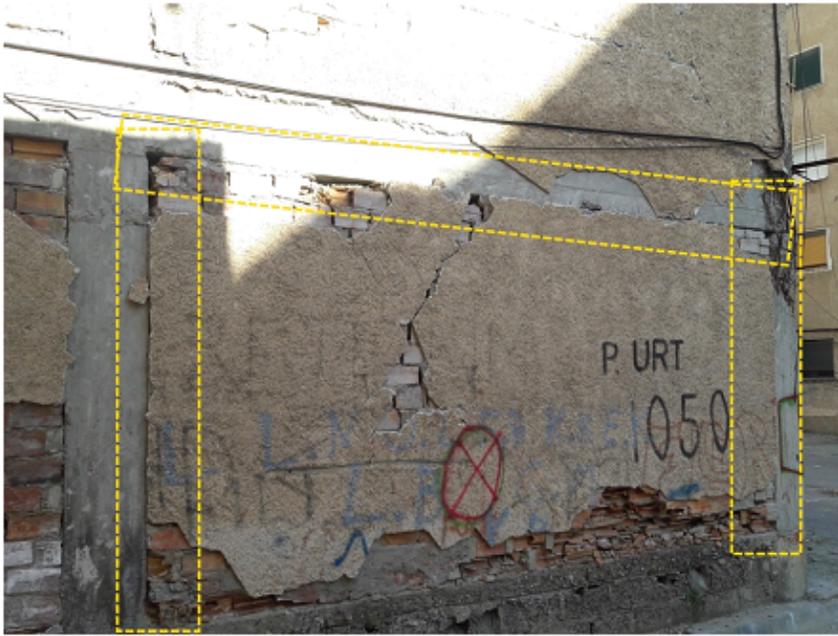
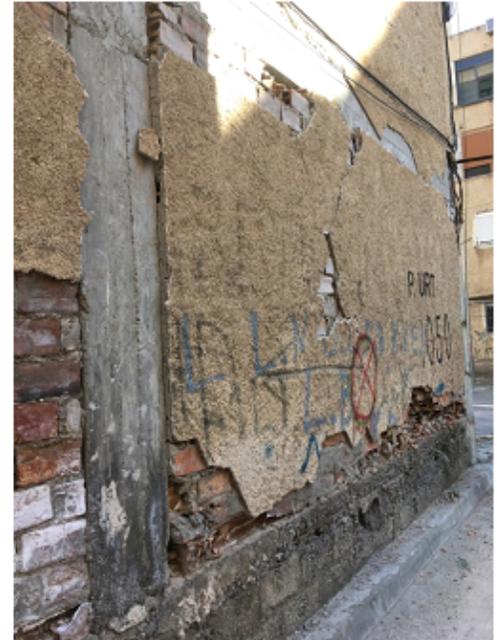
Figure 18

filling a gap between the infill and the frame with mortar; however, mortar filling gets crushed and falls out due to in-plane movement, as shown in Fig. 18; this makes infill walls vulnerable to damage or failure due to the out-of-plane earthquake shaking (Butenweg et al. 2019). Therefore, it is necessary to take into account the interaction of the in-plane and out-of-plane load. It should be also noted that out-of-plane failure of infills can occur without previous in-plane damage. This happens under simultaneous in-plane and out-of-plane action, when in-plane frame deformation causes loss of contact between frame and infill resulting in infill collapse when even small out-of-plane load acts at the same time. Unfortunately, only a few studies have been conducted on the topic of combined loading action (Butenweg et al. 2019; Kadysiewski and Mosalam 2009; Yuen et al. 2016; Marinković 2018).

Damage of masonry infills at a ground floor level of an RC building: a) a loss of connection between RC frame and infills (Nikolić-Brzev et al. 2020), and b) out-of-plane movement (onset of tilting) of an infill wall

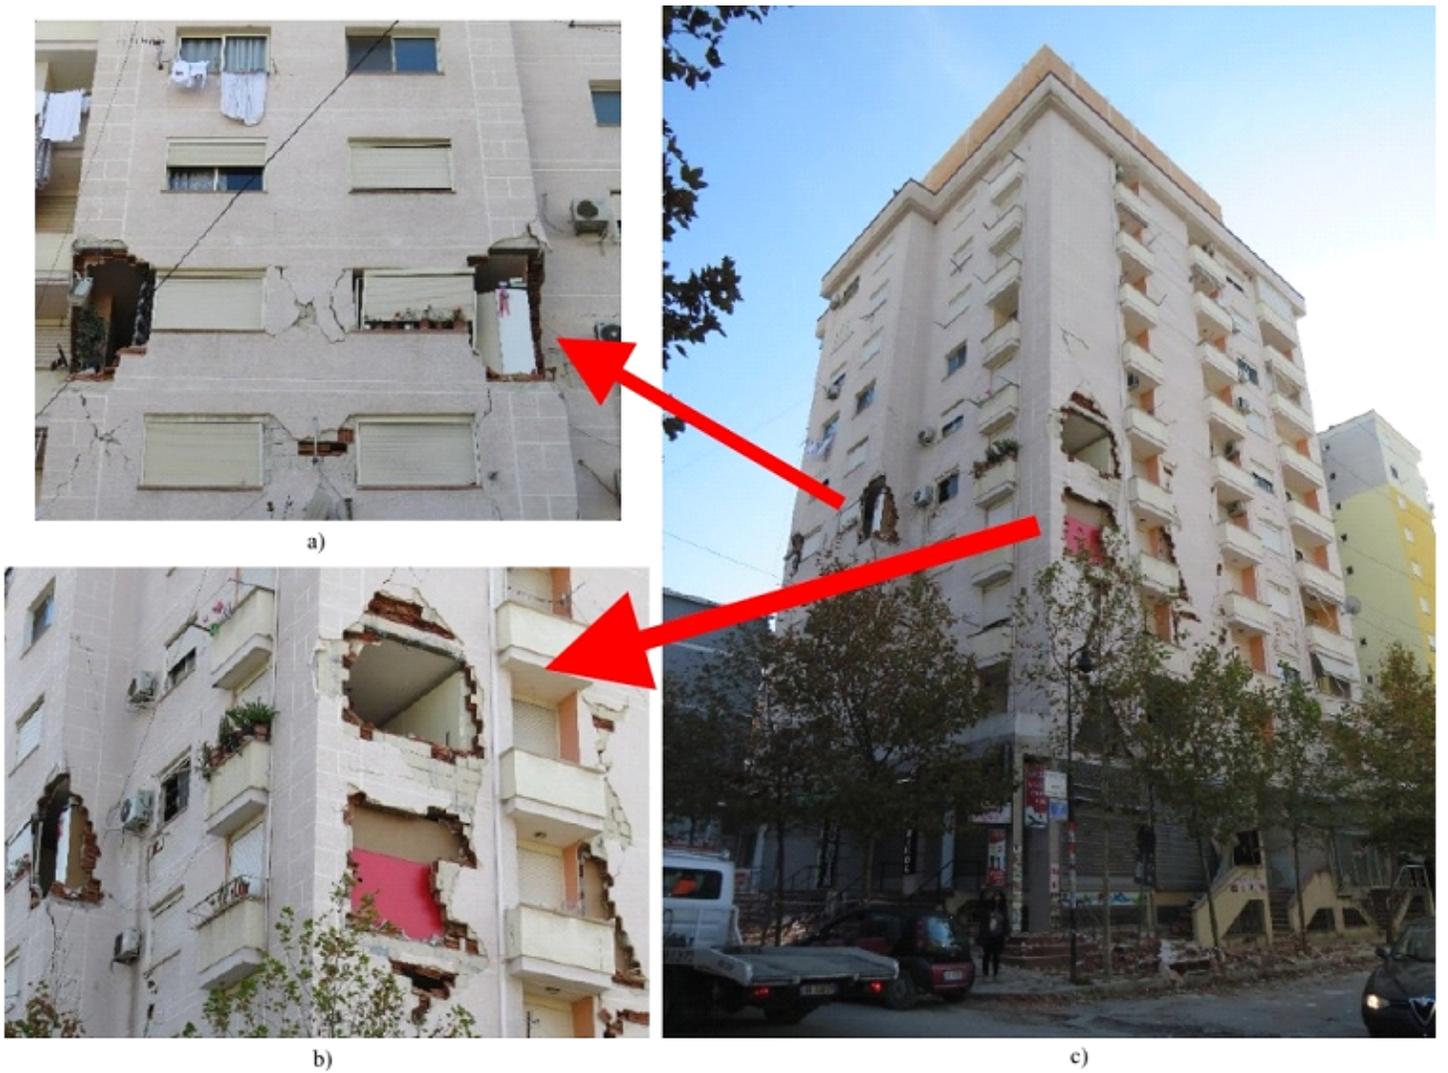
Figure 19

Damage and collapse of a) exterior (façade) walls and b) masonry infills due to out-of-plane earthquake shaking in c) 12-storey RC building in Durrës (Lekkas et al. 2019)

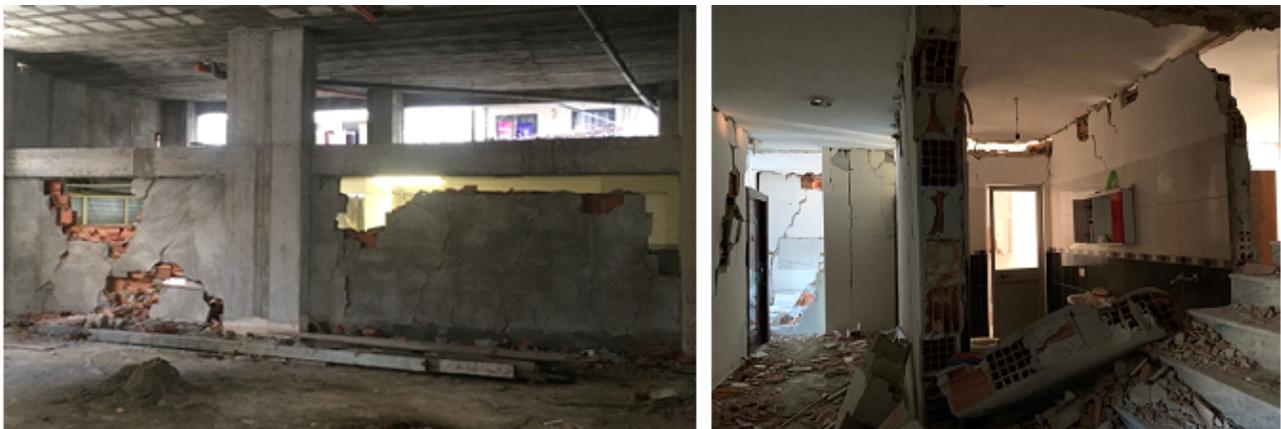
Figure 20

Damage of interior masonry infills inside a 12-storey RC building in Durrës: a) damage and partial collapse of infills at the ground floor level (Nikolić-Brzev et al. 2020) and b) heavy damage and collapse of infill walls at the second floor level

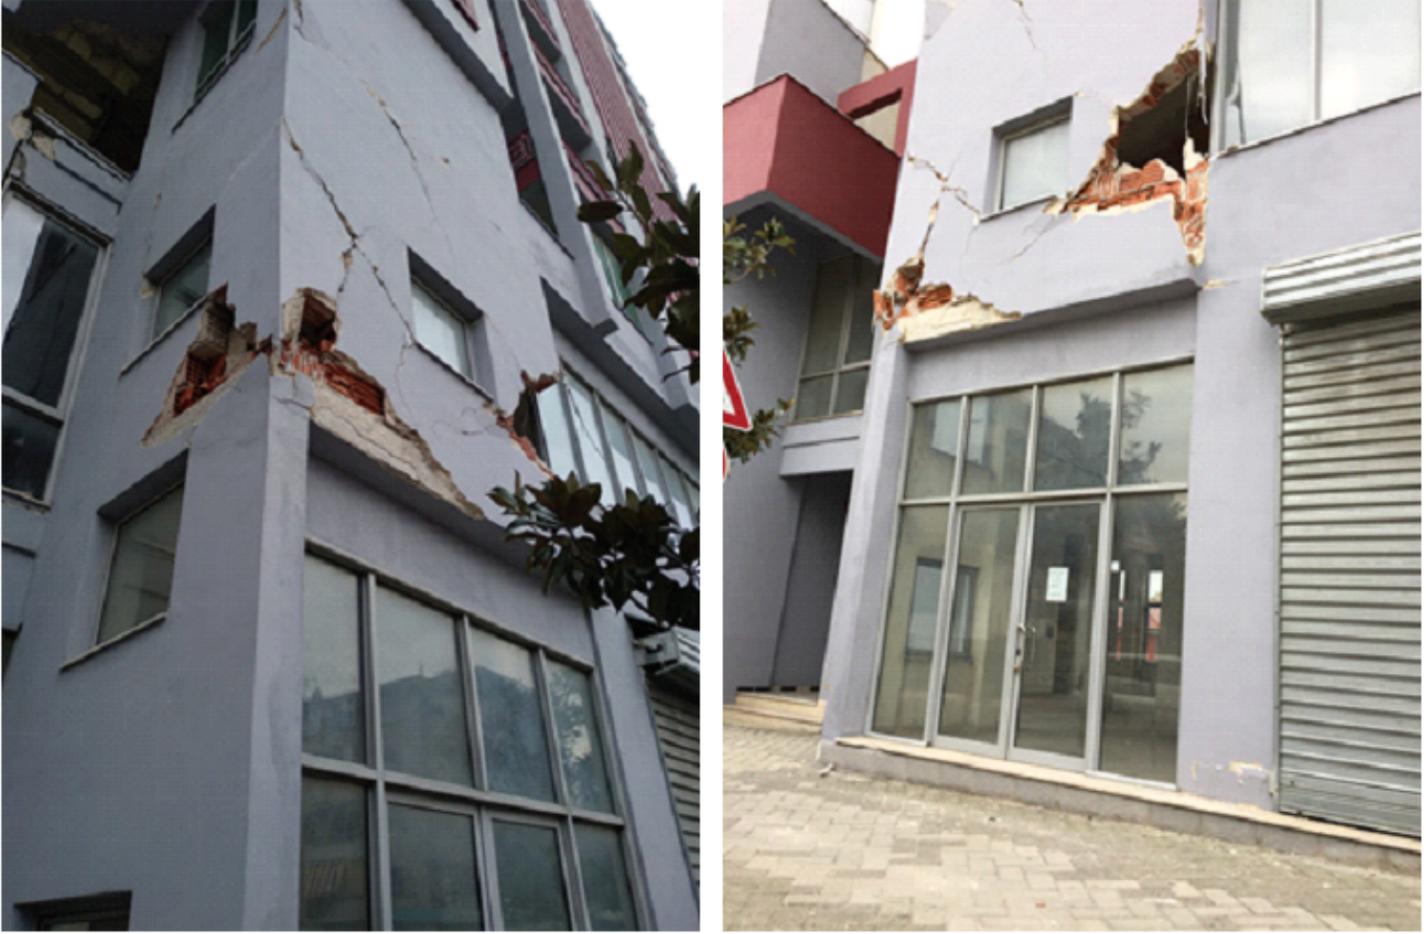
Figure 21

Beside masonry infill walls, exterior (façade) unreinforced masonry walls were also extensively damaged (Fig. 21, 22 and 29). These walls were constructed using hollow clay blocks with horizontally aligned holes, and located in cantilevered portions of buildings at the perimeter (Fig. 19a). These walls were supported on the cantilevered portions of floors. These walls are commonly used in RC buildings in Albania. The extensive damage of similar walls was also observed in the 2015 Gorkha, Nepal earthquake (CAEE 2017). Seismic behaviour of these walls can be improved by providing RC vertical elements at the wall end and intersections. The extensive damage of these cantilever walls was due to horizontally aligned holes in clay blocks, permanent floor slab deflections due to gravity loads and lack of connection of these walls with the structural system.

Damage of exterior (façade) masonry walls in a 6-storey RC building in Fushë-Krujë

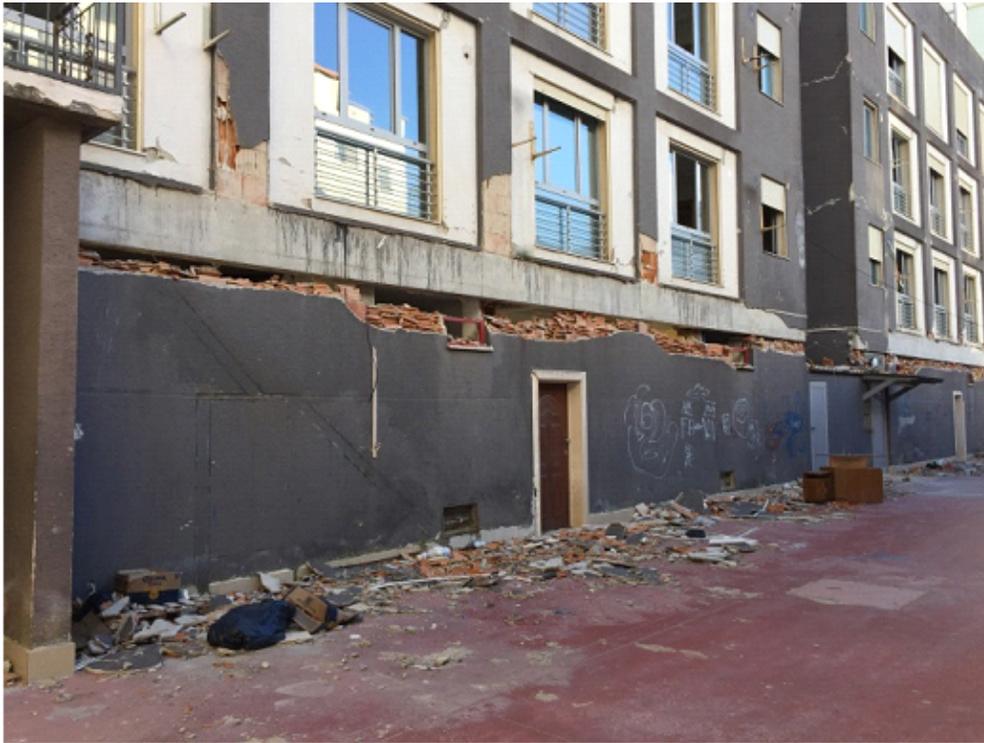
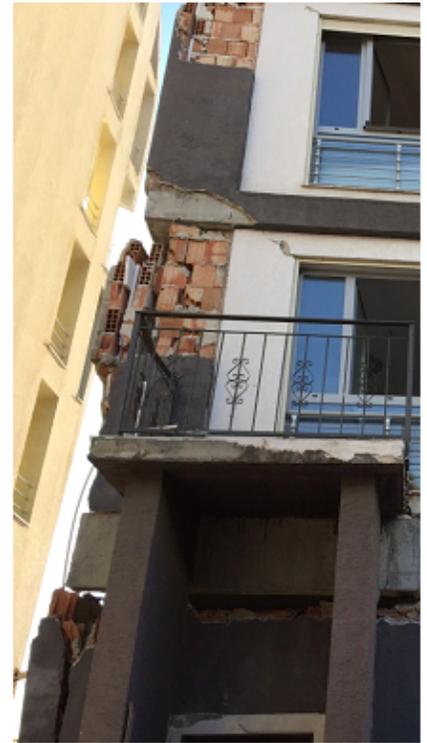
Figure 22

Damage of exterior (façade) masonry walls in a 6-storey RC building in Durrës

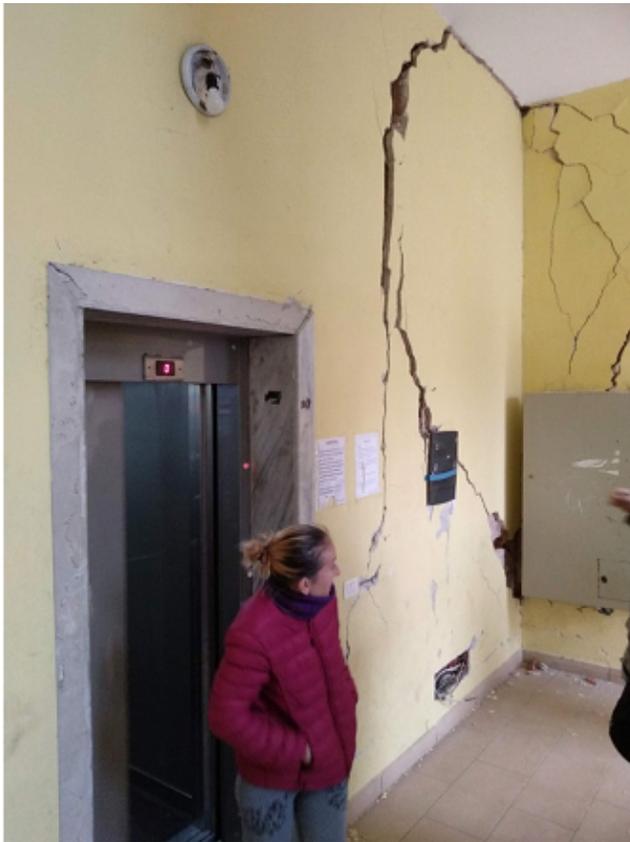
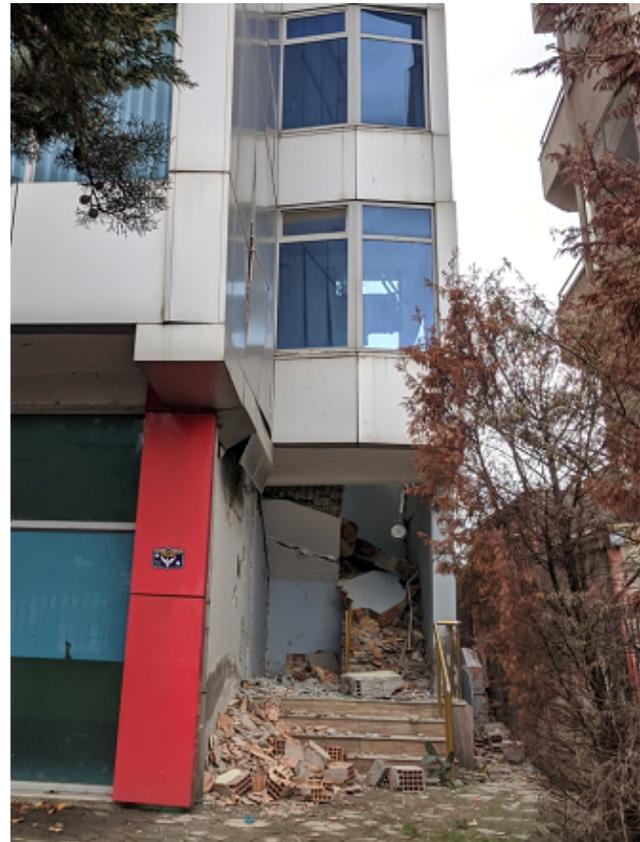
Figure 23

experienced out-of-plane failure blocked the stairs in several RC buildings (Fig. 23b and Fig. 24b). This type of damage was observed in multi-storey RC buildings, where large RC frame deformation or insufficient connections between the RC frame and the infill walls caused the masonry infills to separate from the RC frames and fall out, thereby blocking the stairway. Similar damage and failure patterns were also observed after the 2008 Wenchuan earthquake (Li and Mosalam 2013).

a) Damaged masonry infill around a functional elevator in an 8-storey RC building in Fushë-Krujë (Nikolić-Brzev et al. 2020) and b) an example of a 5-storey RC building in which out-of-plane failure of masonry infill blocked the stairs (McKenney 2019)

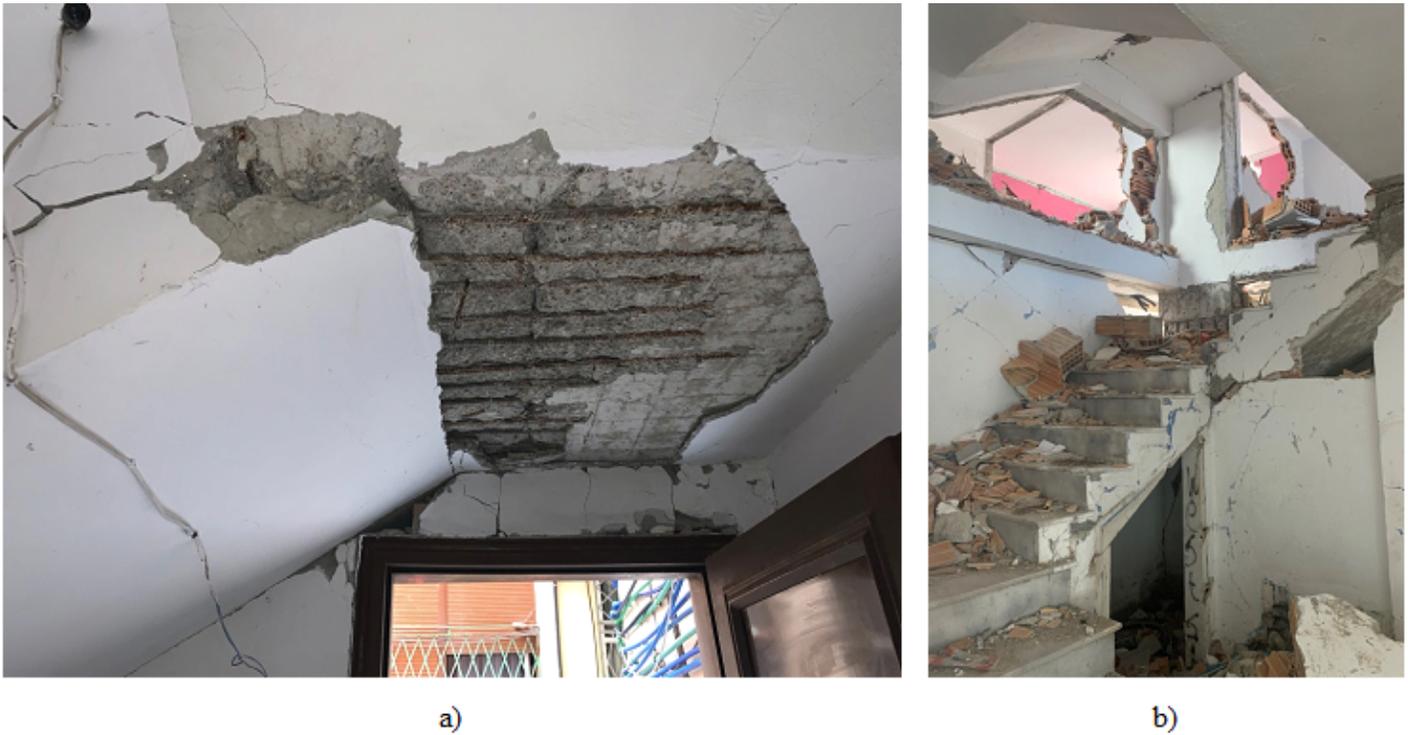
Figure 24

Examples of stair damage in the November 2019 earthquake: a) damage stair landing (spalling of concrete), and b) damaged stairway enclosure (collapsed masonry infill walls)
