Performance of RC Cast-in-Place Buildings During The November 26, 2019 Albania Earthquake

Abstract

5. Structural Damage Of Cast-in-place Rc Buildings In The 2019 Albania Earthquakes

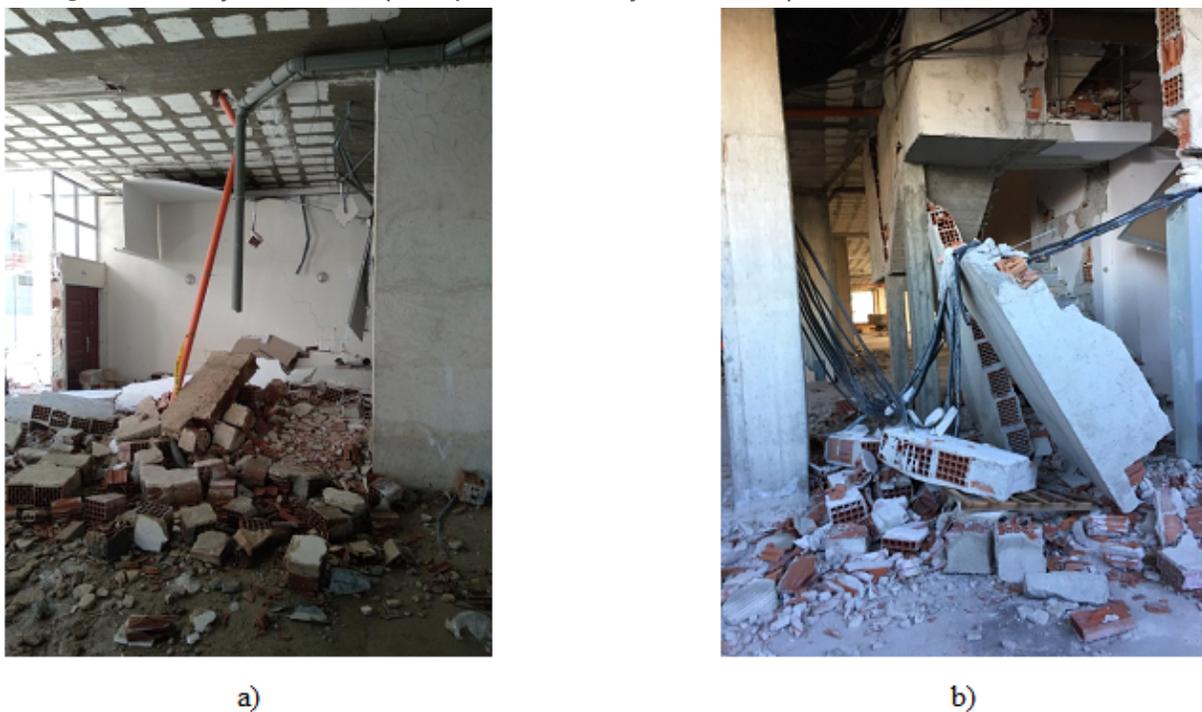
Figure 25

Falling out of severely damaged masonry infill walls in 12-storey RC frame building in Durrës (Fig. 14) caused damage to the building piping and installations (Fig. 25). As non-structural damage was concentrated on the lower floors of the buildings, tenants at the upper floors could continue to occupy their apartments for shelter purposes. However, due to the damage of building installations at the lower floors, some of the apartments at the upper floor levels did not have access to the necessary infrastructure (e.g., electric power, potable water), hence these apartments were not fully functional after the earthquake (Blagojevic et al. 2022).

Damaged utilities: a) damaged piping and b) electrical installations in a 12-storey RC building in Durrës

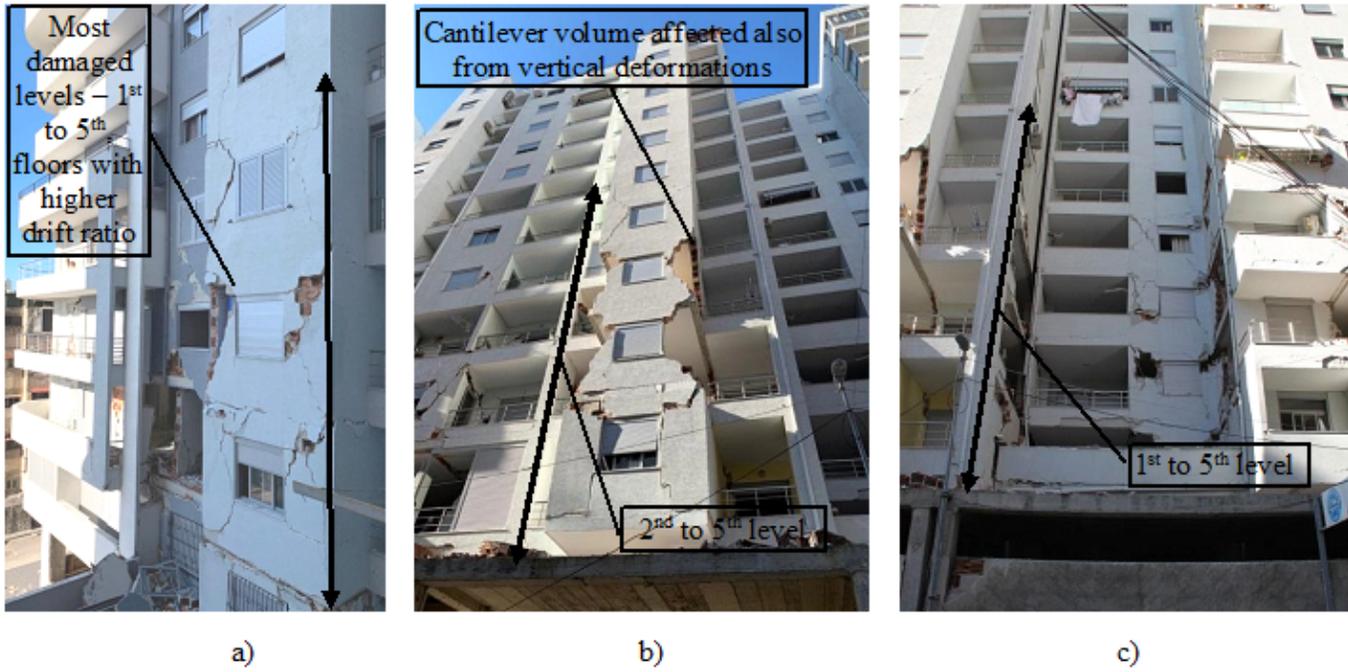
Figure 29

Extensive damage of a), b) exterior (façade) masonry walls and c) infill masonry walls in the 12-storey case study building was limited to the lower 5 storeys

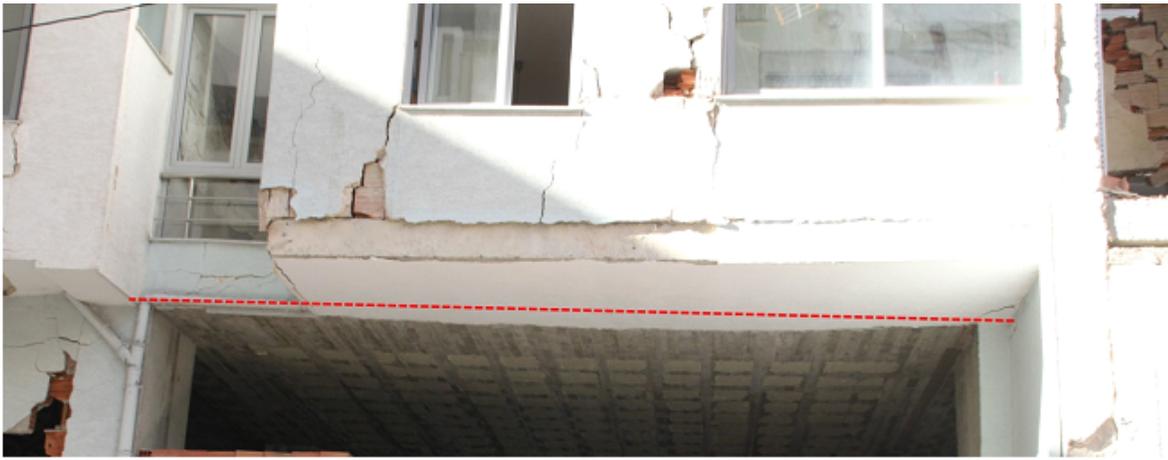
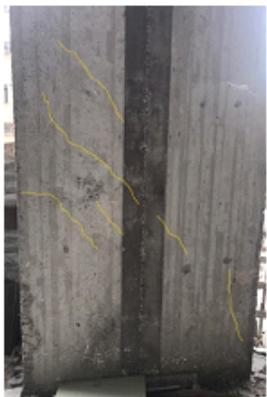
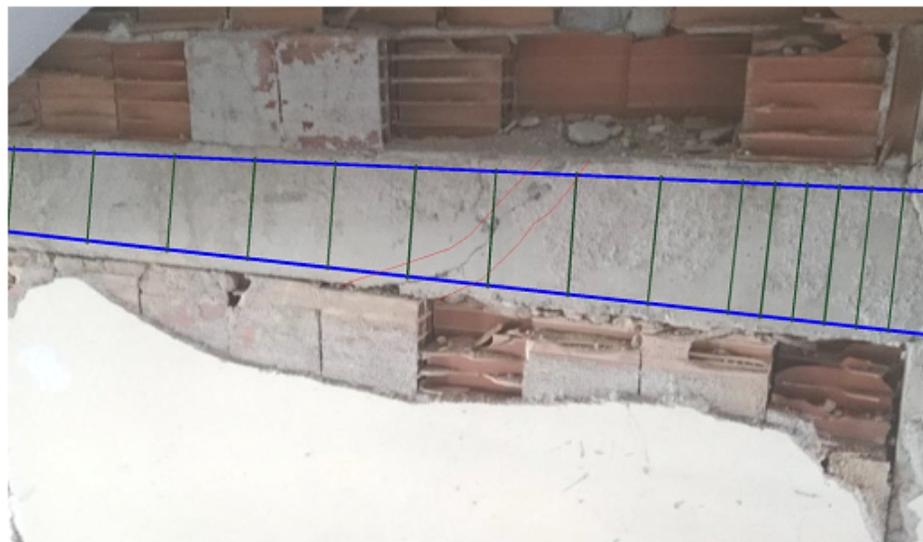
Figure 30

Other damage patterns observed in the 12-storey building: a) excessive beam deflections; b) damage of RC columns, and c) inclined cracking on shallow beam around 80cm from the column face

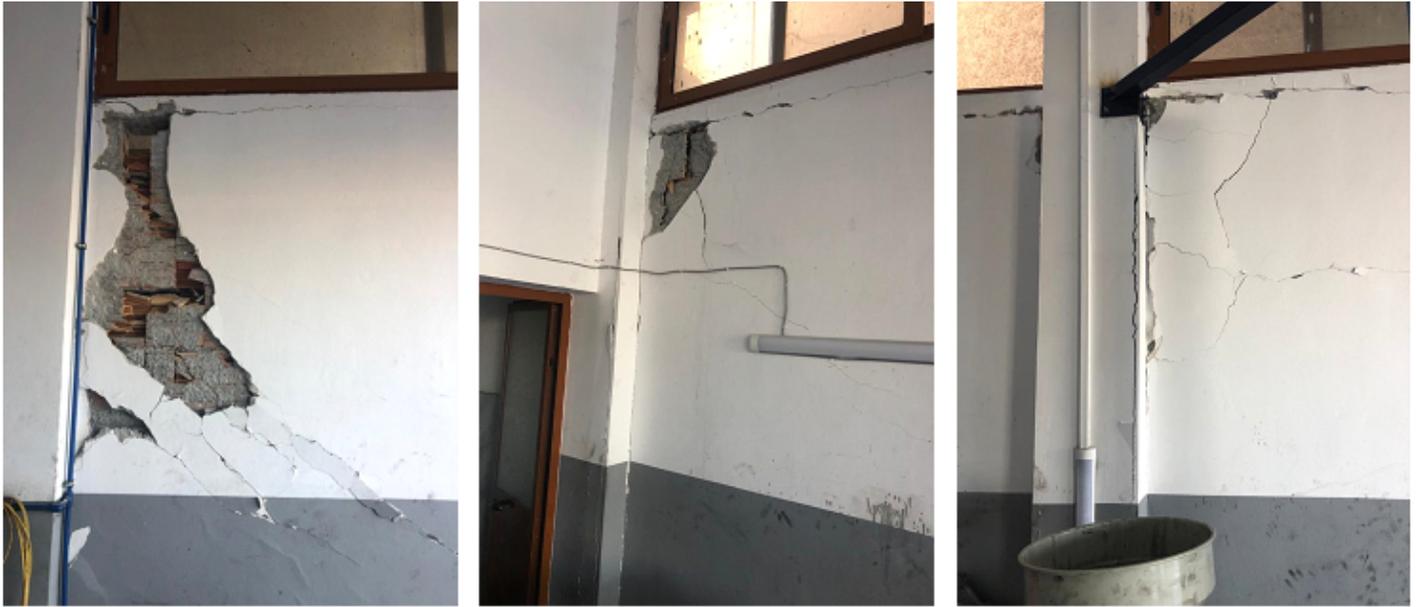
Figure 31

Examples of damaged masonry infills in 4-storey case study building due to the September 2019 earthquake (ground floor level)

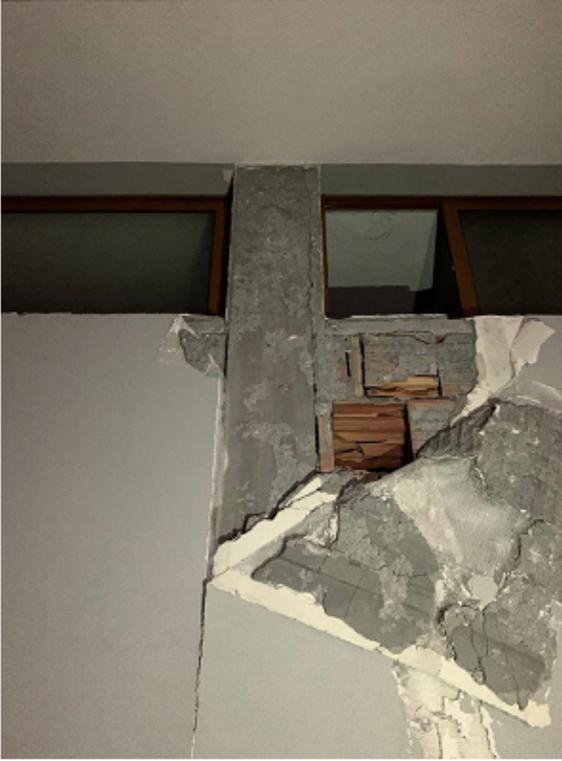
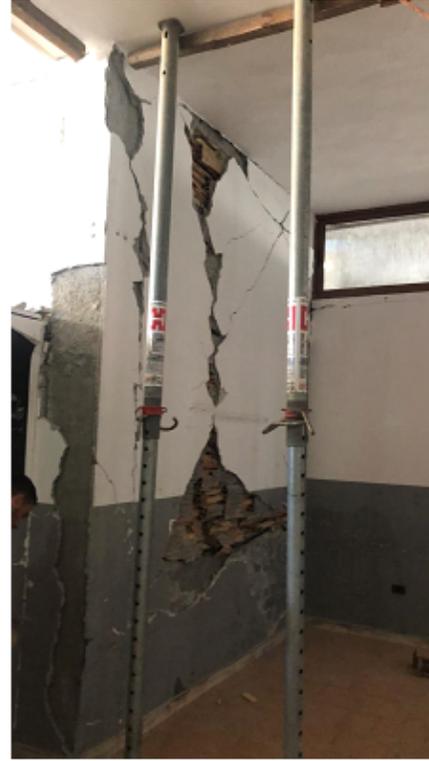
Figure 34

Damage of infill walls in the 4-storey case study building in Durrës
