Analysis of the Characteristics of the Land Creeping (Slow-Moving) at Seomyeon, Suncheon-Si Area

Jae hyeon park (✉ pjh@gntech.ac.kr)

Research Article

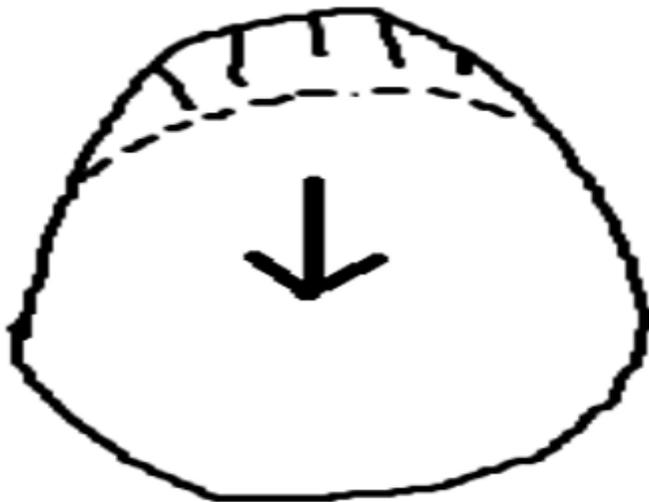
Figure 5

Land crept area landslide scarp horseshoe type

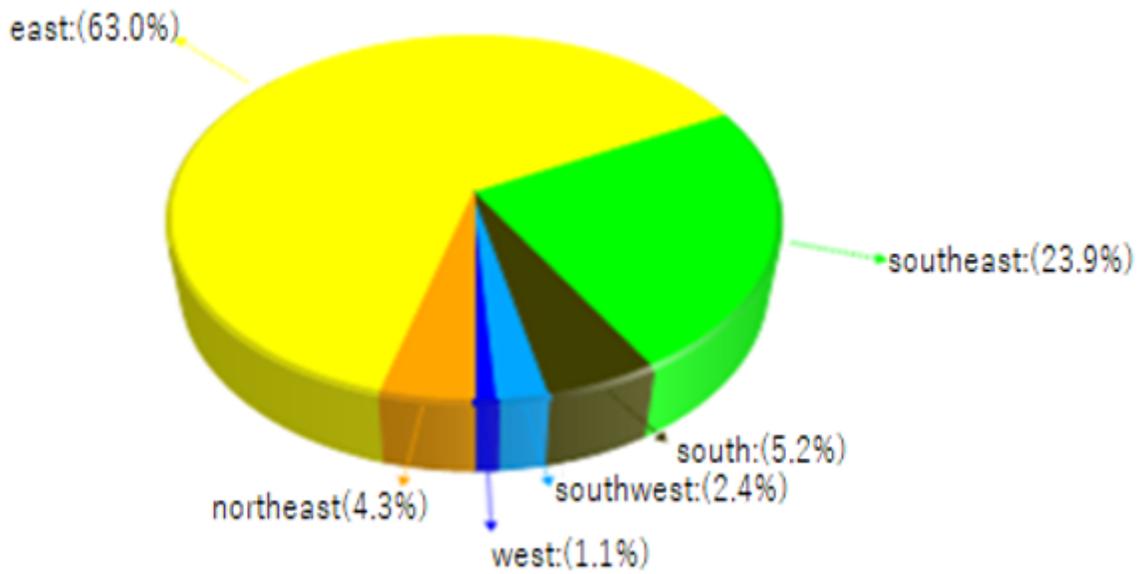
Figure 13

As a result of analyzing the direction distribution of the target area, 63.0% has been identified to be in the east direction, 23.9% in the southeast direction, 5.2% in the south direction, 4.3% in the northeast direction, 2.4% in the southwest direction, and 1.1% in the west direction. In other words, when compared with the results of analyzing the direction of growing in distortion of trees in the past due to the land creeping, the land creeping direction is found to be growing toward the east and southeast. Most of the results are consistent with the direction of the outflow of groundwater that has the most significant effect on the land creeping. These findings are consistent with the conclusion that microtopography during long-term terrain changes considerably affects land creeping (Takaya. 2017, Park et al., 2019).

Dangerous land creep area Direction distribution chart using GIS (Arc map Ver. 10.8)
