A Case Study of Two Failures of a High Cut-slope in the Northeastern Area of Sichuan, China

Abstract

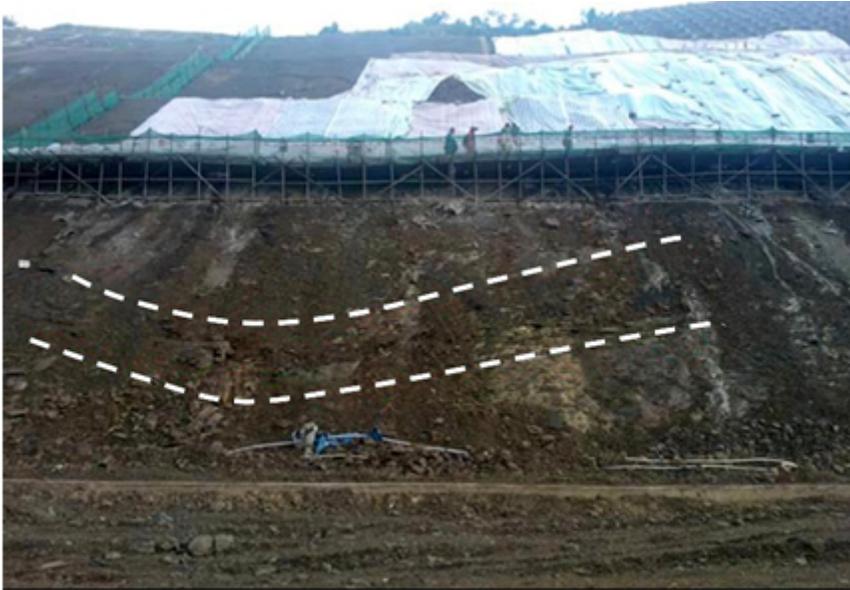
(a)

Photos of: **a** the core of the syncline at the slope toe; **b** the ground water flowing out of the core of the syncline after rainfall

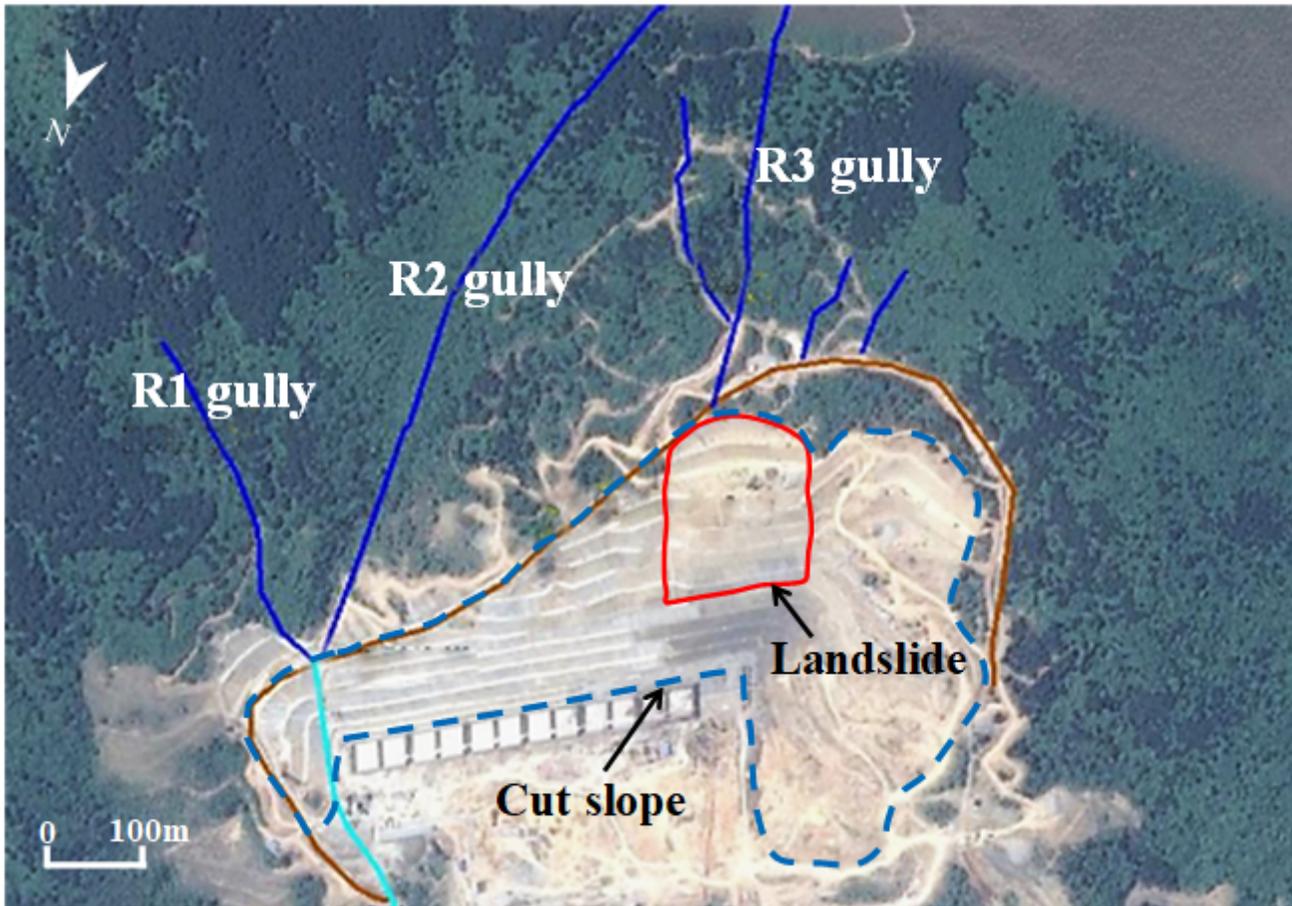
Figure 3

Gullies located above the corners of the cut-slope

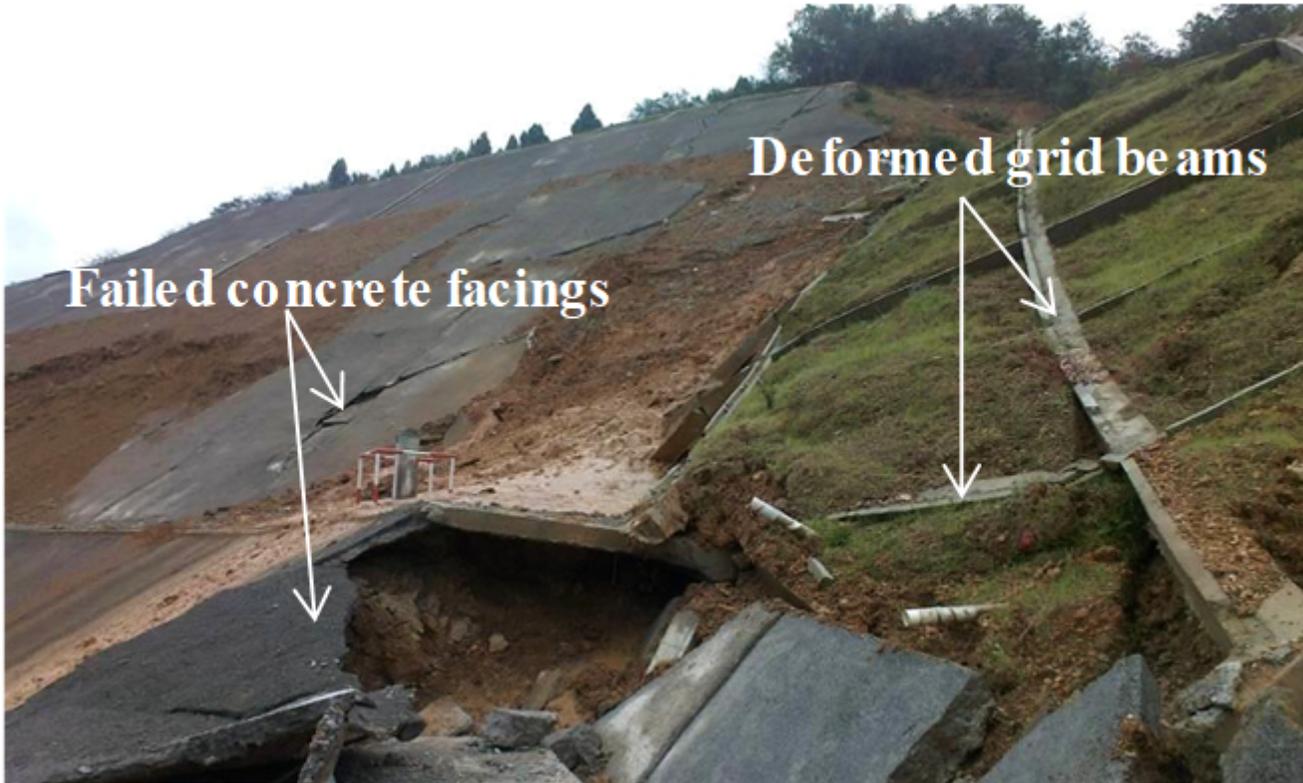
Figure 5

About three months after the excavation was finished, the study area was subject to several heavy rainfalls since the 27th of May, 2013. A landslide occurred on the 25th of June, 2013, resulting in the deformation of the grid beams and failures of the shotcrete facings (see Fig. 5). This failure is called the first slope failure in the following context. The main sliding body was approximately 170 m in length, 130 m in width, 0.02 km² in area, and 4.78×10^5 m³ in volume, with the direction of 347° from North (Fig. 6a). The average elevations of the leading and trailing edges of the landslide were 656 m and 739 m, respectively. Moreover, there were numerous tension cracks in the upper part of the slope.

Photo of grid beams and concrete facings after first slope failure

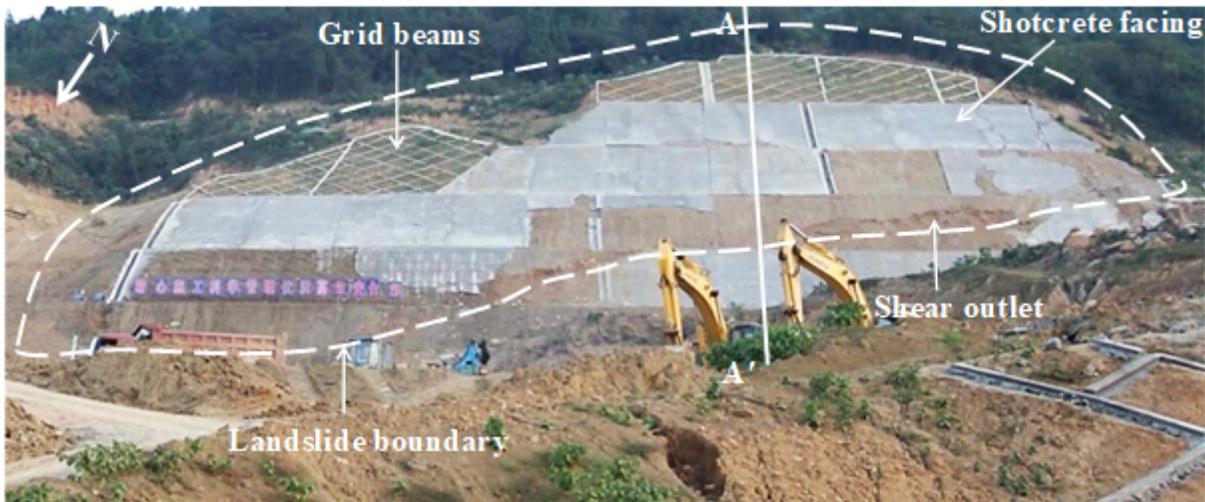
(a)

The first failure of the excavated slope: **a** Site photo; **b** Cross section AA'

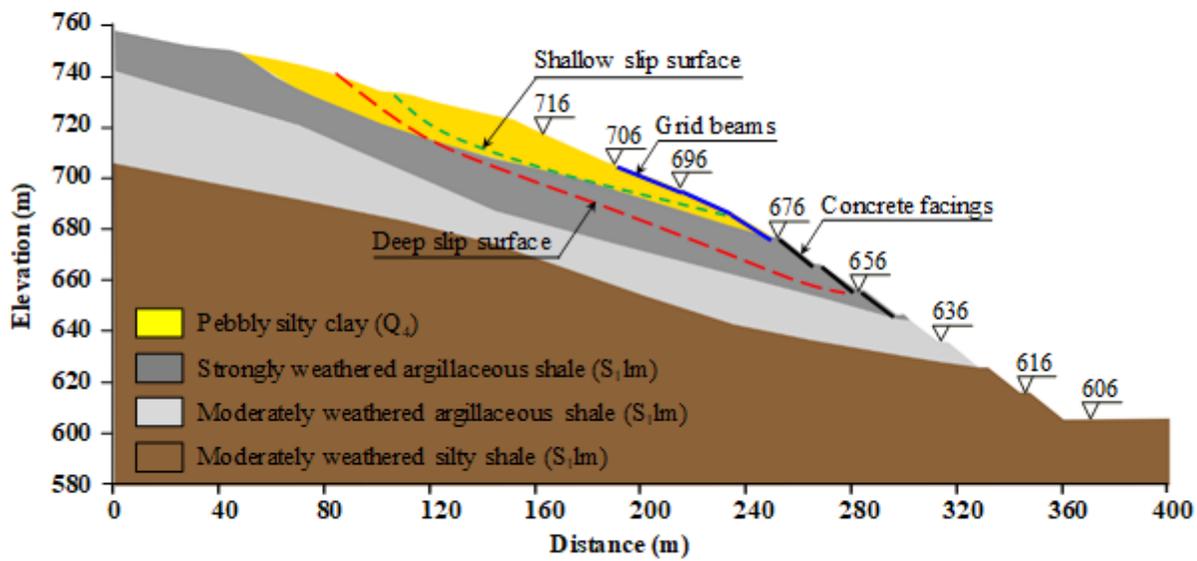
(b)

Field observation and borehole investigation after landslide revealed that there were two sliding surfaces and the thickness of the sliding mass ranged from 9 m to 22 m (see Fig. 6b). The shallow sliding surface was mainly within the pebbly silty clay layer, with part of the surface along the surface of the strongly weathered argillaceous shale layer. The deeper slip surface initiated in the top layer and extended into the second layer. The material of slip zone in the deep failure surface mainly was the strongly weathered argillaceous shale. The weak layers (i.e., mudstone interlayers which will be discussed later) developed in the strongly weathered shale layer could contribute to the formation of the deep slip surface due to the softening of the mudstone under rainfall. However, this condition was not appropriately recognized after the slope failure. The field investigation also found that groundwater flowed out of the slope along the fissures of shotcrete facings. This indicates that high water pressure had been built up in the slope due to the blockage of natural seepage by the shotcrete and the absence of subdrainage system, e.g., horizontal drain hole and drain tunnel, as recommended in the Chinese Standard (GB50330-2013) and Sun et al. (2010b). The movement of the sliding mass gradually stabilized in October 2013.

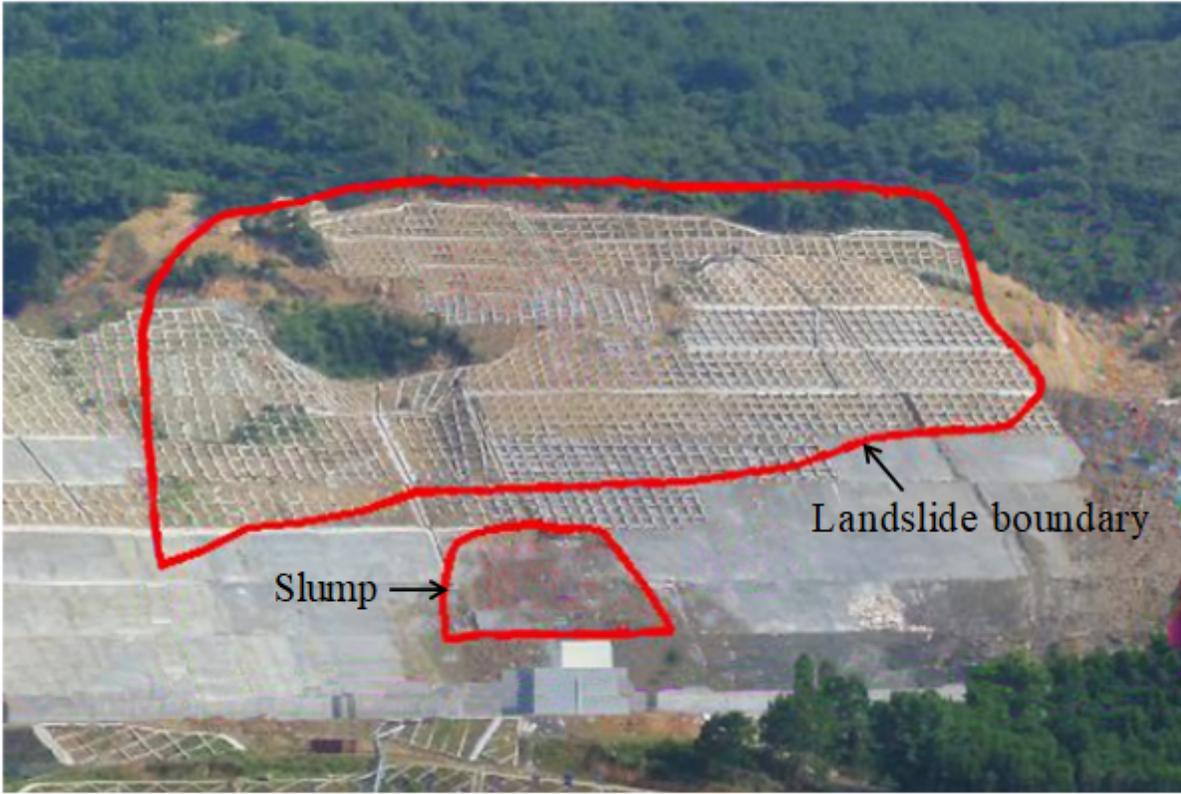
Figure 8

About two weeks after the completion of the remediation works, a second slope failure occurred on the 18th of July, 2014, under continuous heavy rainfall. The maximum daily precipitation recorded by a nearby weather station was 123.6 mm during that period. On the 21st of July, 2014, large deformation was observed at the lower part of the reinforced slope (see Fig. 8). The slump was about 60 m long, 40 m wide and 5 m thick, with a total volume of approximately 9,000 m³. Further distress of the slope led to the failure of the reinforcement system, including the failure of anchor cables and grid beams (Fig. 9), the cracking of shotcrete facings, and the distortion of the channels.

Site photo of the reinforced slope after the second failure

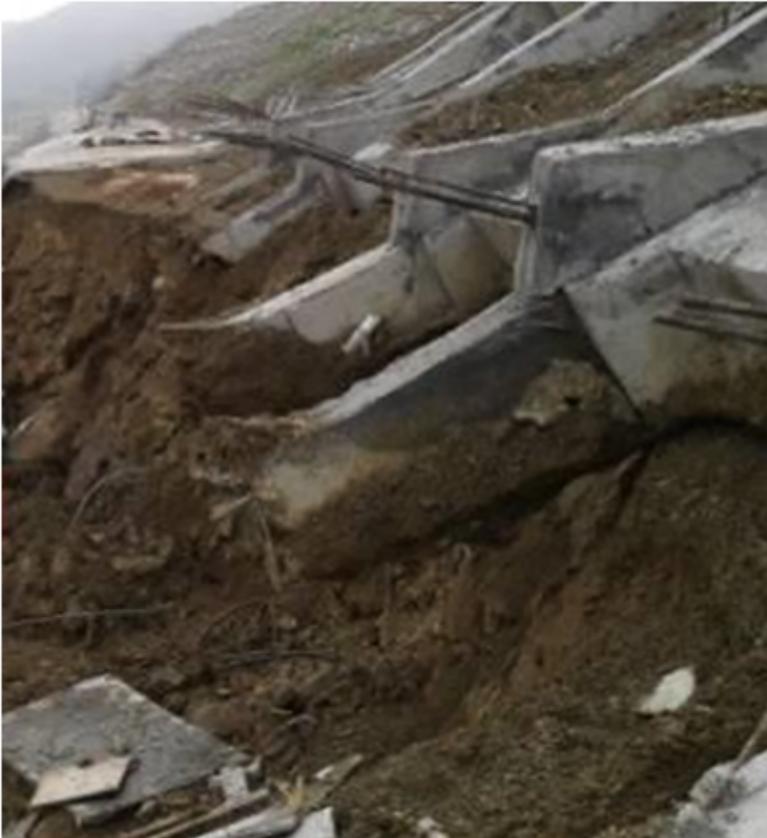
Figure 9

Photo of the failed anchor cables and grid beams

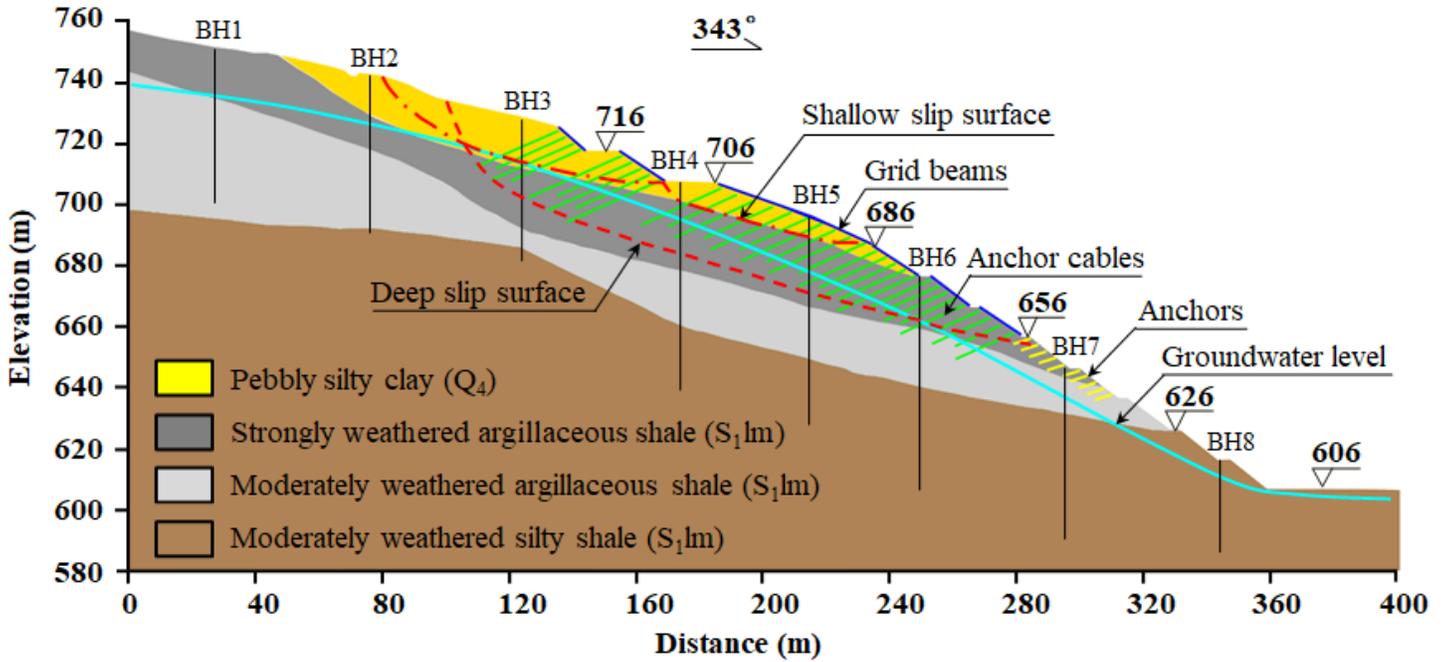
Figure 10

Field investigation was conducted shortly after the second slope failure. The boreholes, i.e. BH3–BH6 shown in Fig. 10, revealed that two of the shallow slip surfaces were in the pebbly silty clay layer, with the slip surfaces along the contact with the strongly weathered argillaceous shale. The deeper slip surface passed through the edge of most of the anchor cables. The lower part of the deep slip surface was mainly along the interface between strongly weathered argillaceous shale layer and moderately weathered argillaceous shale layer. The boreholes, i.e. BH1 and BH2, indicated that the thickness of the weathered, well-permeable rocks ranged from 40 to 60 m, which was favorable for the surface water to flow into the sliding mass and the accumulation of the groundwater. At the toe of the slope, several small sinkholes were observed around the axis of the syncline with water flowing out of the holes. This suggests that high pore water pressure had been built up in the lower part of the slope, possibly due to the blockage of natural seepage by the shotcrete on the slope surface and the insufficiency of drain holes. According to the water levels measured from the boreholes, the groundwater table after the heavy rainfall rose by 2 - 10 m (Fu et al., 2017).

Cross section BB' (shown in Fig. 7) of the slope after second failure

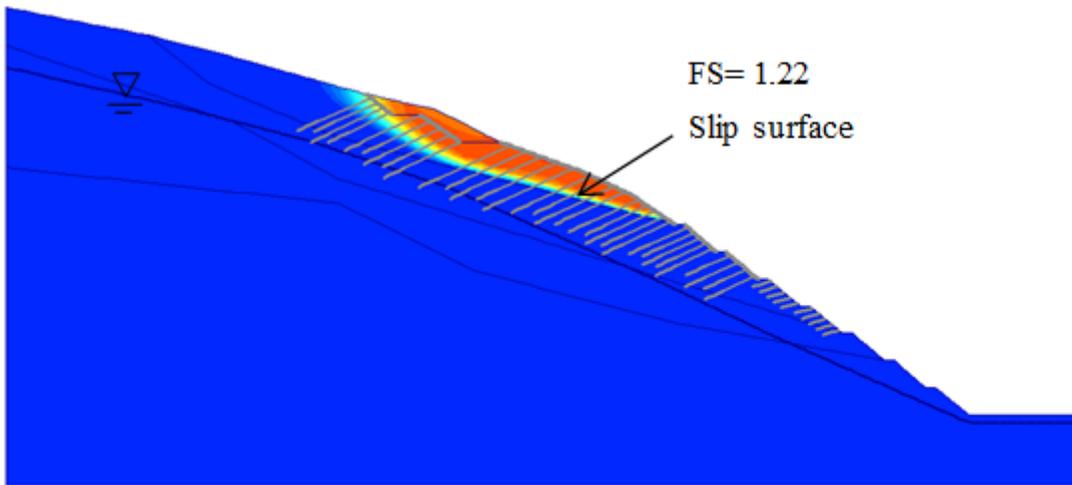
(a)

As shown in Fig. 12a, under natural water table condition, the slope after excavation has a FS value of 1.22, and the potential slip surface lies in the limited zone of upper part of the slope. However, under extreme rainfall condition (see Fig. 12b), the critical slip surface enlarges and propagates upwards because of the rising of ground water, and the FS value of the slope reduced to 1.01, which is at limit state. This means that the cut-slope was certainly stable under natural condition, but it failed under heavy rainfall. In Fig. 12b, the predicted failure surface develops along the contact of top layer and second layer and lies in between the investigated ones. It can be inferred that the failure might have been induced by the rapid increase of pore water pressure within the slope after long-lasting rainfall, even though the numerical model only predicted one slip surface. It is worth noting that, the lower part of the slope surface was covered with shotcrete but the drain holes were not installed in this part, which have blocked the drainage of the slope and resulted in the high pore water pressures in the local part of the slope. This situation may mainly cause the occurrence of deep slip surface observed in the field. However, the pore pressure distribution in the field is not simulated accurately in the numerical modeling (Liu et al., 2012). Therefore, the assumed water table in the model may be unrealistic and is only for simplicity. Also, the recharge of water from the gully (R3), could make the water regime in the slope more complicated than the one assumed in the numerical model.

Total displacement increment contour of the unreinforced cut-slope: **a** under natural conditions; **b** under extreme rainfall conditions

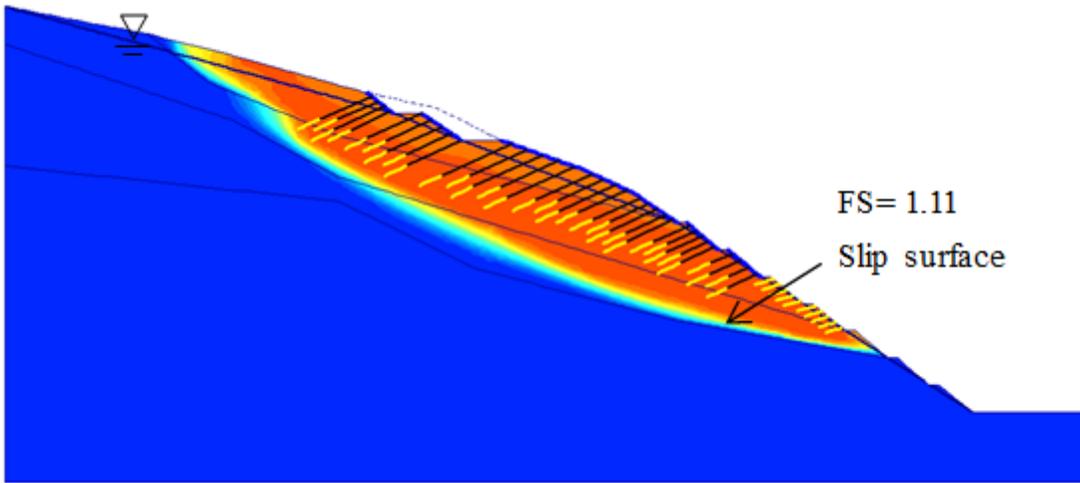
Figure 13

Firstly, stability of the reinforced slope under extreme rainfall conditions was analyzed using the parameters listed in Table 1, which were used in the original remediation design. The result from Fig. 13 shows that the potential slip surface of the reinforced slope mainly develops within the third rock layer (i.e., moderately weathered argillaceous shale layer). The slope is stable, with the FS value of 1.11. This suggests that provided the strength of slope materials was not decreased owing to the rainfall and excavation, the reinforced slope could be stable even under extreme rainfall conditions.

Total displacement increment contour of the reinforced slope under extreme rainfall conditions using soil parameters listed in Table 1

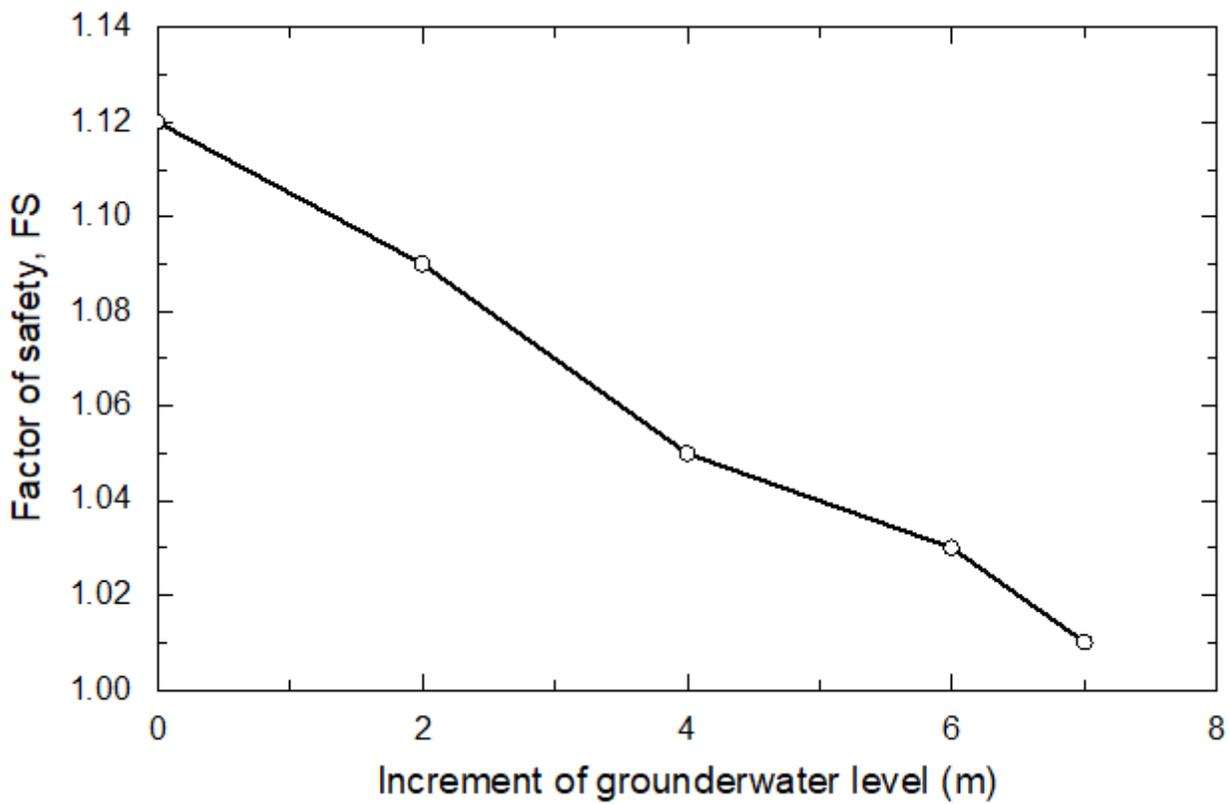
Figure 14

In the analysis, different heights of groundwater table were considered to obtain the relationship between the safety factor of the slope and the groundwater level. The results in Fig. 14 show that the slope stability decreases with rising of groundwater level. Under natural water table condition, considering the reduction of soil strength, the FS of the reinforced slope is about 1.12. But the slope would have failed when water table increases by 7 m. This value is very close to the mean increment of water level revealed from the site investigation as described in Section 4.3. As shown in Fig. 15, the critical slip surface of the slope with an elevated water level passes through the ends of anchor cables, indicating a global failure. The computed slip surface is very close to the deep failure surface revealed from the site investigation as described earlier. This indicates that the second slope failure was partly due to the heavy rainfall, and partly due to improper design of the anchor cables.

Variation of safety factor with the different increments of groundwater level

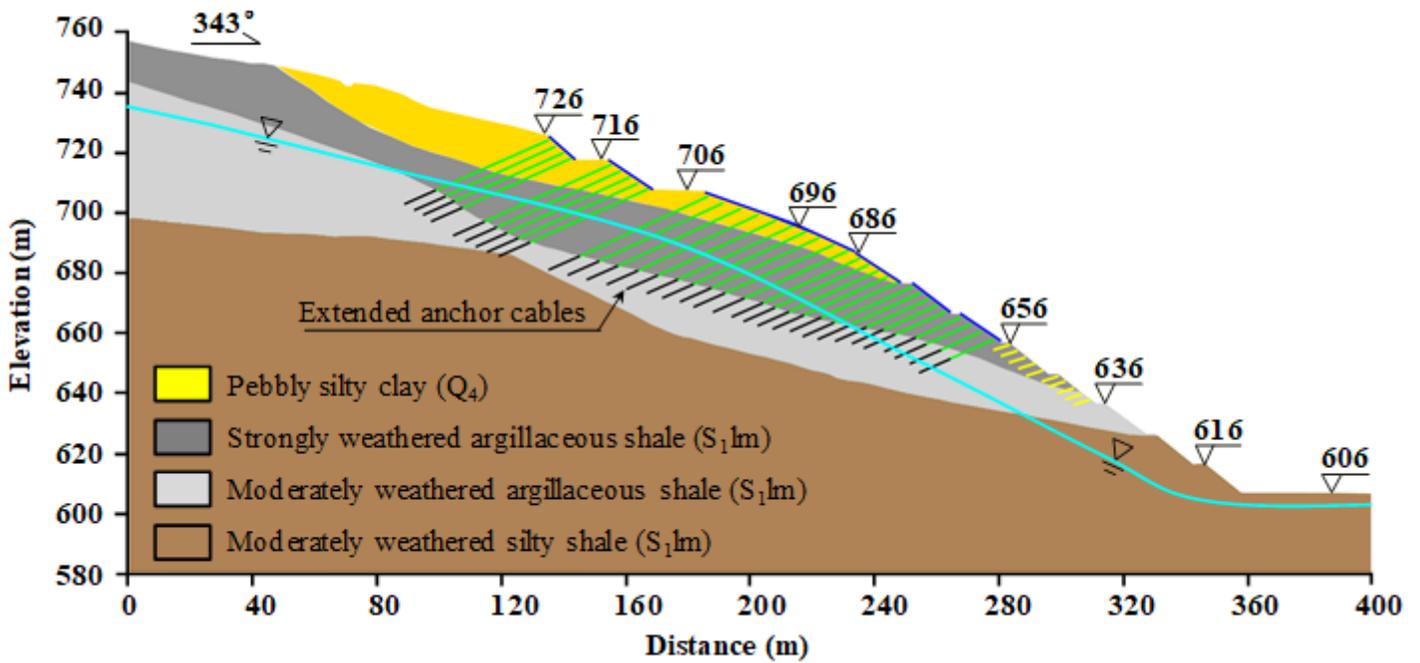
Figure 16

Geological profile of the slope reinforced with extended anchor cables

Based on above analysis, it was recommended to install additional longer anchor cables to the third soil layer, i.e., the moderately weathered argillaceous shale, as the deep slip surface passed through the ends of the anchor cables. Fig. 16 presents the geological profile of the slope with extended anchor cables. The bonded length of the extended anchor cables was also 8.5 m. The strength parameters of top two layers listed in Table 2 were used in the analysis to consider the reduction of soil strength.

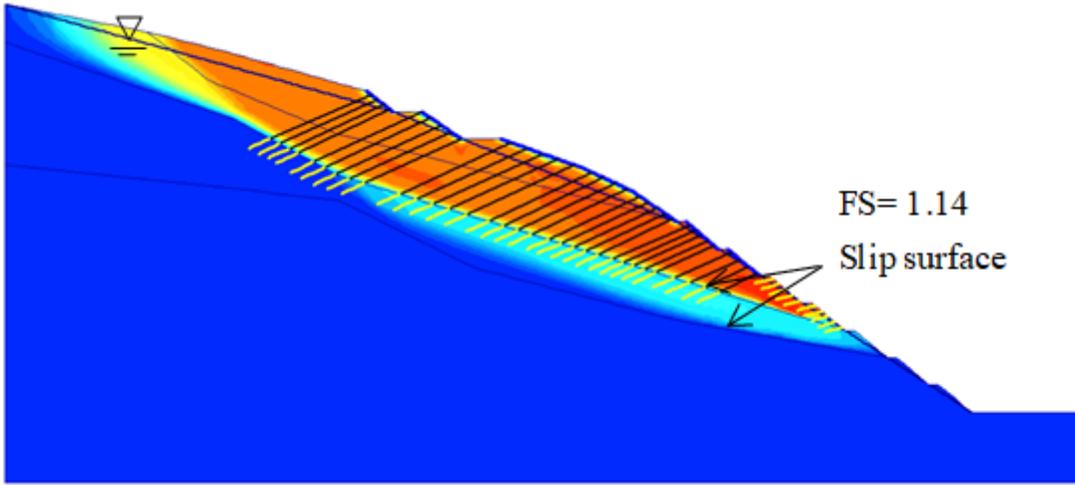
Figure 17

Total displacement increment contour of the slope reinforced with extended anchor cables under extreme rainfall conditions

The results from FEM show that, the FS value of the slope with extended anchor cables is 1.55 under natural conditions, and 1.14 under extreme rainfall conditions with water table close to the slope surface. According to the Chinese specification (DZ/T 0219-2006), the required safety factors of the reinforced slope are 1.20 to 1.30 under natural conditions and 1.10 to 1.15 under rainfall conditions. Therefore, it can be considered that the extended anchor cables can significantly stabilize the sliding mass and improve the slope stability even under extreme rainfalls. The potential slip surface of the slope under this condition is presented in Fig. 17. The result shows that there are two potential slip surfaces within the slope. One develops along the contact between the strongly weathered argillaceous shale layer and moderately weathered argillaceous shale layer and the other mainly along the ends of the anchor cables. The extended anchor cables expand the slip surface and pass through shallow slip surface, and thus improve the stability of the slope.
