Study on Collapse Mechanism and Treatment Measures of Portal Slope of a High-speed Railway Tunnel

Research Article

Keywords: Open cut tunnel, Slope deformation, Rainfall, Finite element method, Stabilization treatment, Field monitoring

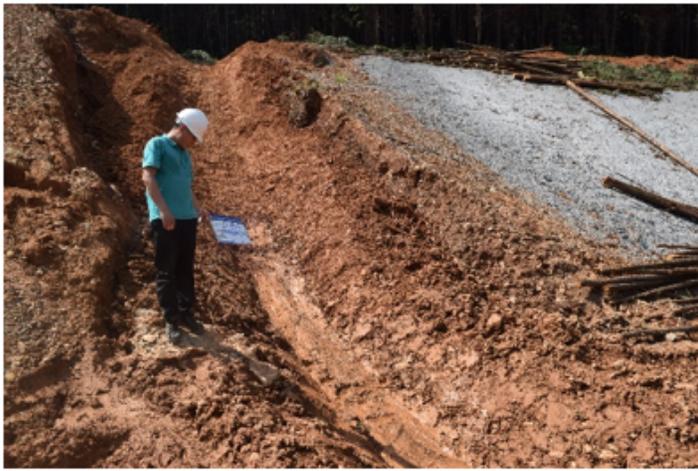
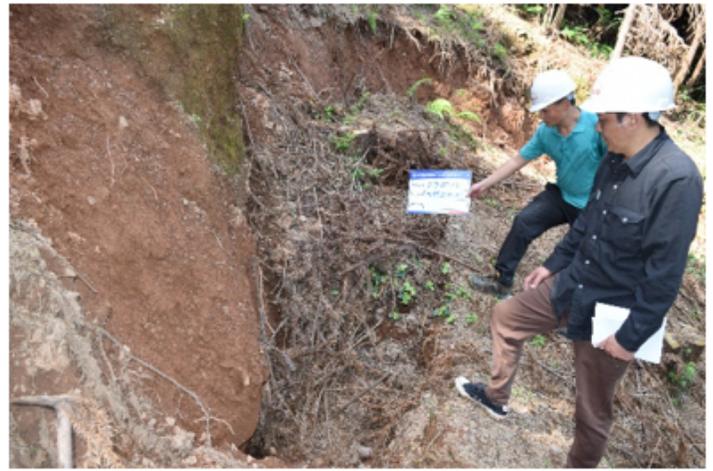
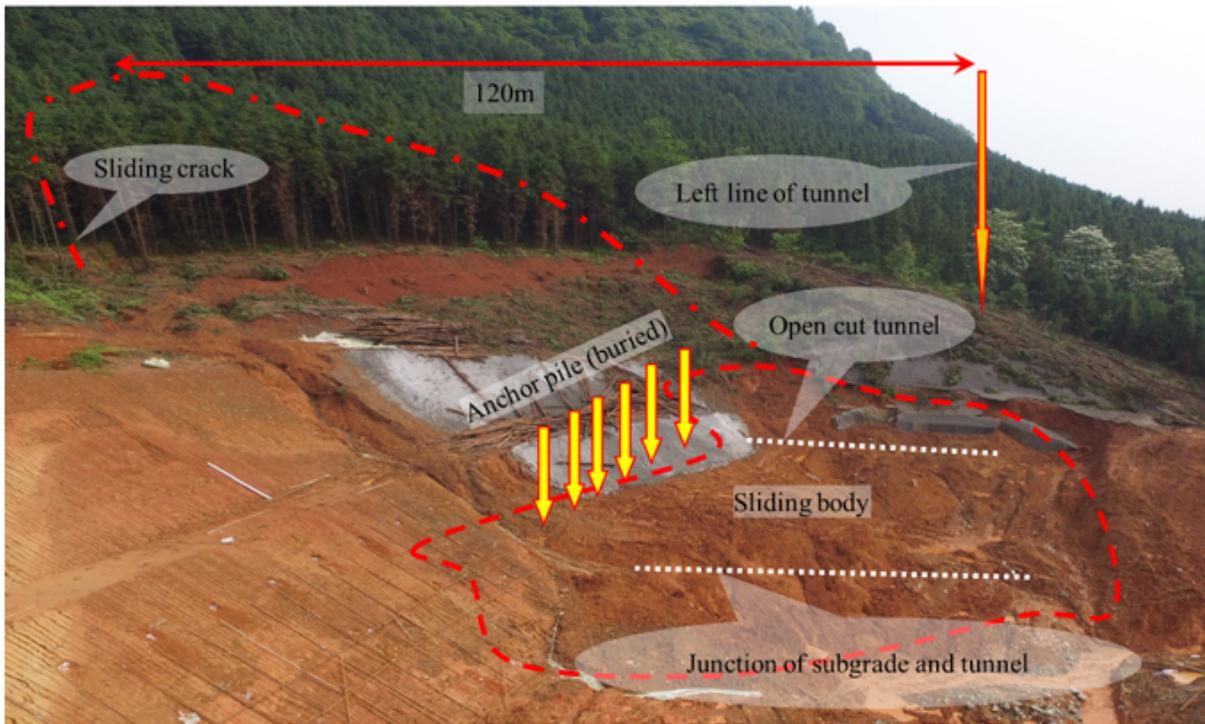
Figure 3

The slope project at the exit of Leijia tunnel has been under construction since February 2016. During construction, the surrounding rock at the exit slope of the tunnel was extremely broken and was mainly composed of silty clay, a locally fine sand layer, and rich groundwater, and the left slope was wet from the excavation. To ensure the stability of the slope, temporary support works of the slope and front slope were carried out, and the anti-sliding pile hole was excavated at the position of the primary platform. In April 2016, heavy rainfall occurred in the area where the tunnel was located, and the originally wet slope began to seep. In particular, the area 5 m above the secondary platform on the right slope of section DK36 + 005 became a water inflow area after rain (Fig. 3a). The whole front slope collapsed and fluid gushed out, and a tensile fracture with a width of approximately 80 cm appeared at the rear edge of the landslide. The constructed anti-sliding pile hole on the right side of the open cut tunnel was buried by a landslide (Fig. 3b). The landslide mass is tongue shaped on the plane, approximately 120 m in length and 25 m in width; the area of the landslide body is approximately 9100 m²(Fig. 3c).

April 2016, **a** water inflow area, **b** tensile cracks at the trailing edge of the slope, **c** picture of the slope collapse

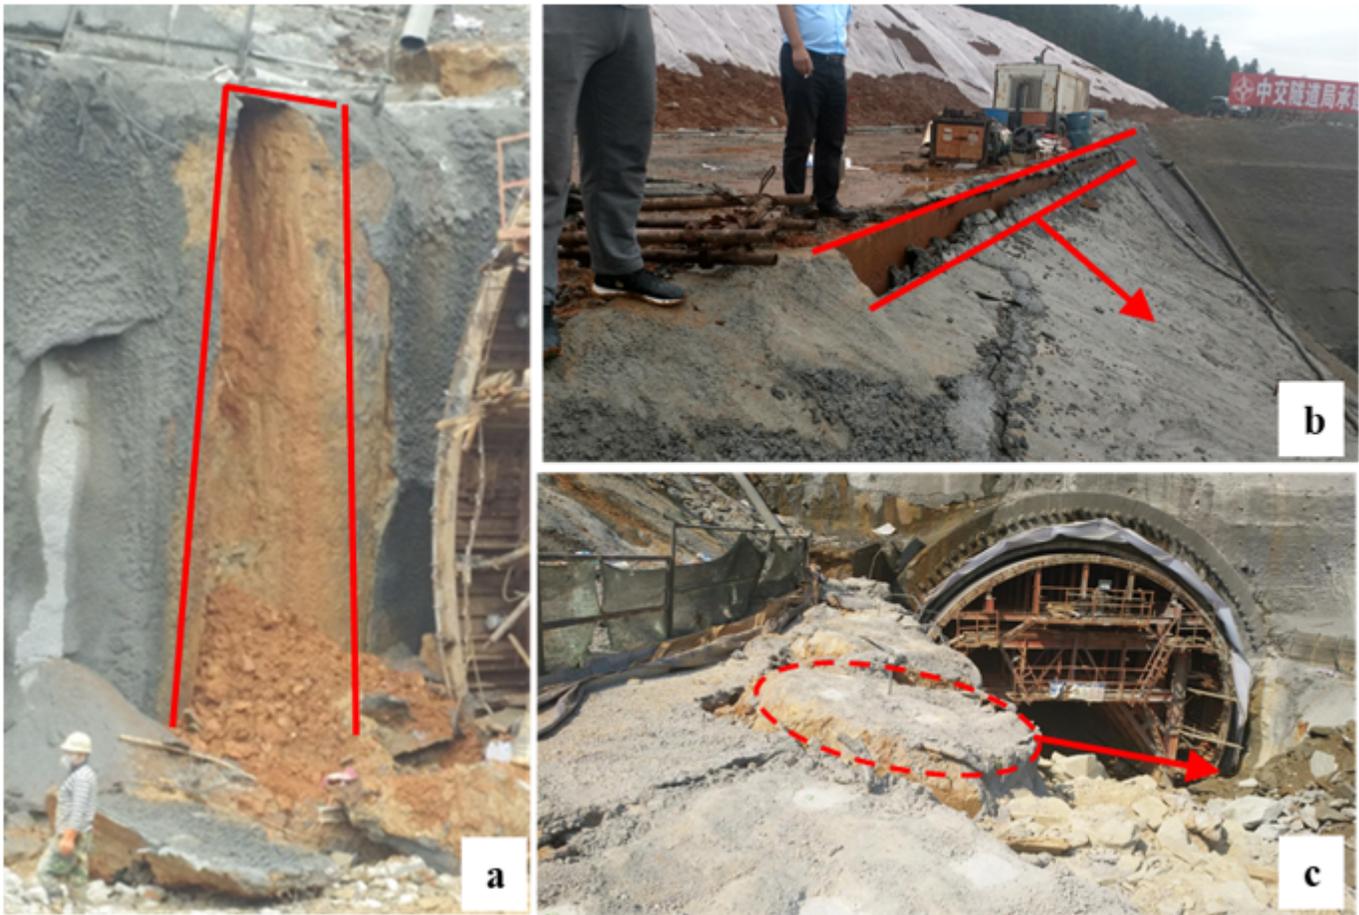
Figure 4

From April 2016 to March 2017, slope reinforcement was carried out at the site, and no tunnel excavation was carried out. On March 1, 2017, the construction of the anti-slide piles on the upper part of the slope and the adjacent tunnel was completed. On March 3, 2017, the dark part of the tunnel was excavated for the first time, and the first slab lining was constructed on April 18, 2017. From approximately 4:00 p.m. on April 19, 2017 to 6:15 a.m. on April 20, 2017, there was heavy rainfall (heavy rain). At 6:40 a.m., it was discovered that the soil collapsed between the bored cast-in-place piles on the right side of the exit open cut tunnel (Fig. 4a). Then, large cracks on the slope (Fig. 4b) and obvious displacement of the bored cast-in-place pile on the right side of the open cut tunnel were found (Fig. 4c).

April 2017, **a** collapse of the soil between piles, **b** slope cracking, **c** lateral displacement of the pile

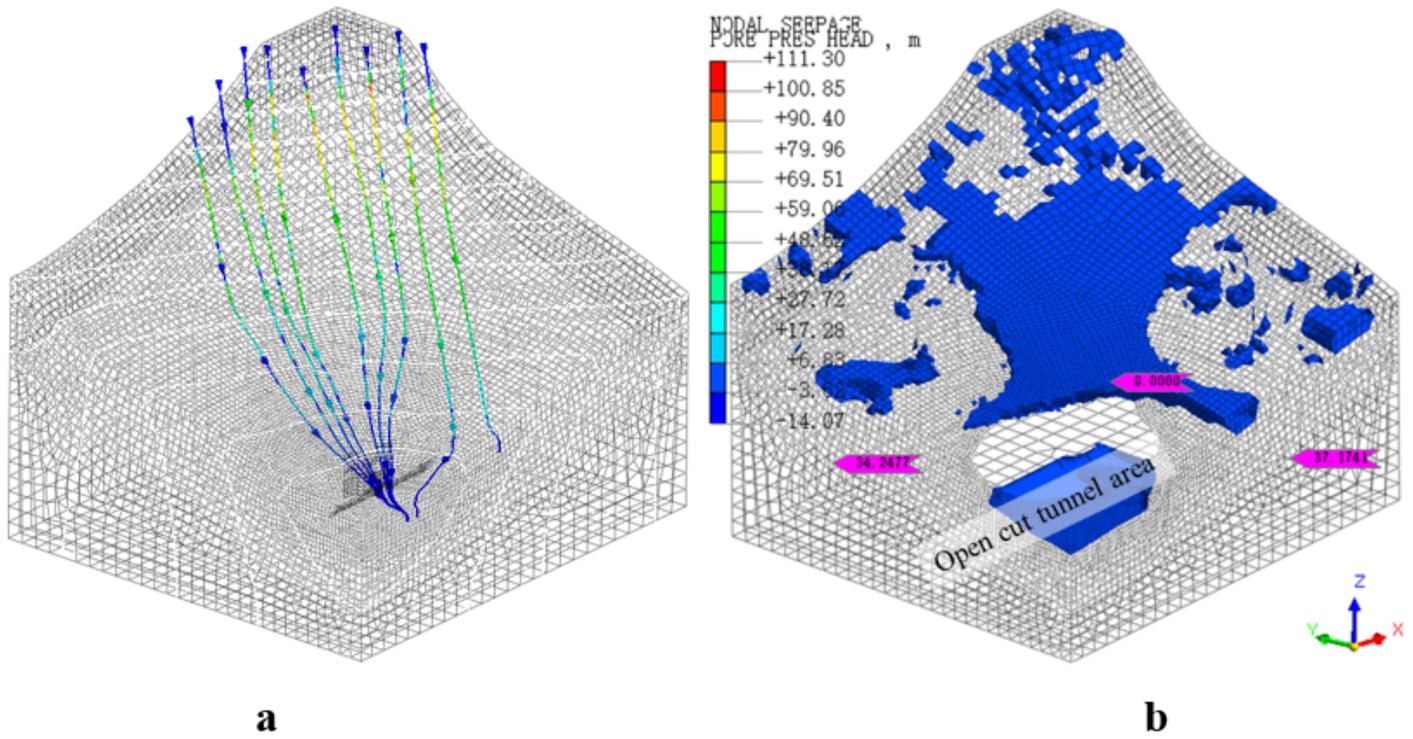
Figure 6

Figure 6(a) shows that on mountains, when rainfall occurs, the water on the slope converges along the slope to the area where the tunnel is located while seeping downward. The field survey shows that there are several water outlets at the lower part of the slope when continuous rainfall occurs, which indicates that the calculated results are basically consistent with the actual results. Figure 6(b) shows the distribution of the transient saturation zone of the slope on April 10 and 26. The figure shows that after three consecutive days of rainfall, several saturation zones appear on the slope, and the saturation areas are mainly concentrated in the open cut tunnel area and its upper area, which is basically consistent with the sliding area found on site.

The studied region has a subtropical monsoon climate and abundant rainfall. The mean annual precipitation in Xingan County is 1678.9 mm. In April 2016 and 2017, heavy rainfall occurred continuously in the survey area, and the total rainfall in April 2016 and 2017 reached 354.4 mm and 151.4 mm, respectively (Fig. 9a). Because the permeability coefficient of each layer of soil in the site is different, and the permeability coefficient of surface soil is less than that of underlying bedrock, the rainfall infiltrated water will be stored in the upper weathered soil layer, saturating the weathered soil layer and increasing the unit weight, as shown in Fig. 6(b) and Fig. 9(b).

a Flow path diagram of water and **b** distribution of the transient saturation zone (2016/04/10)

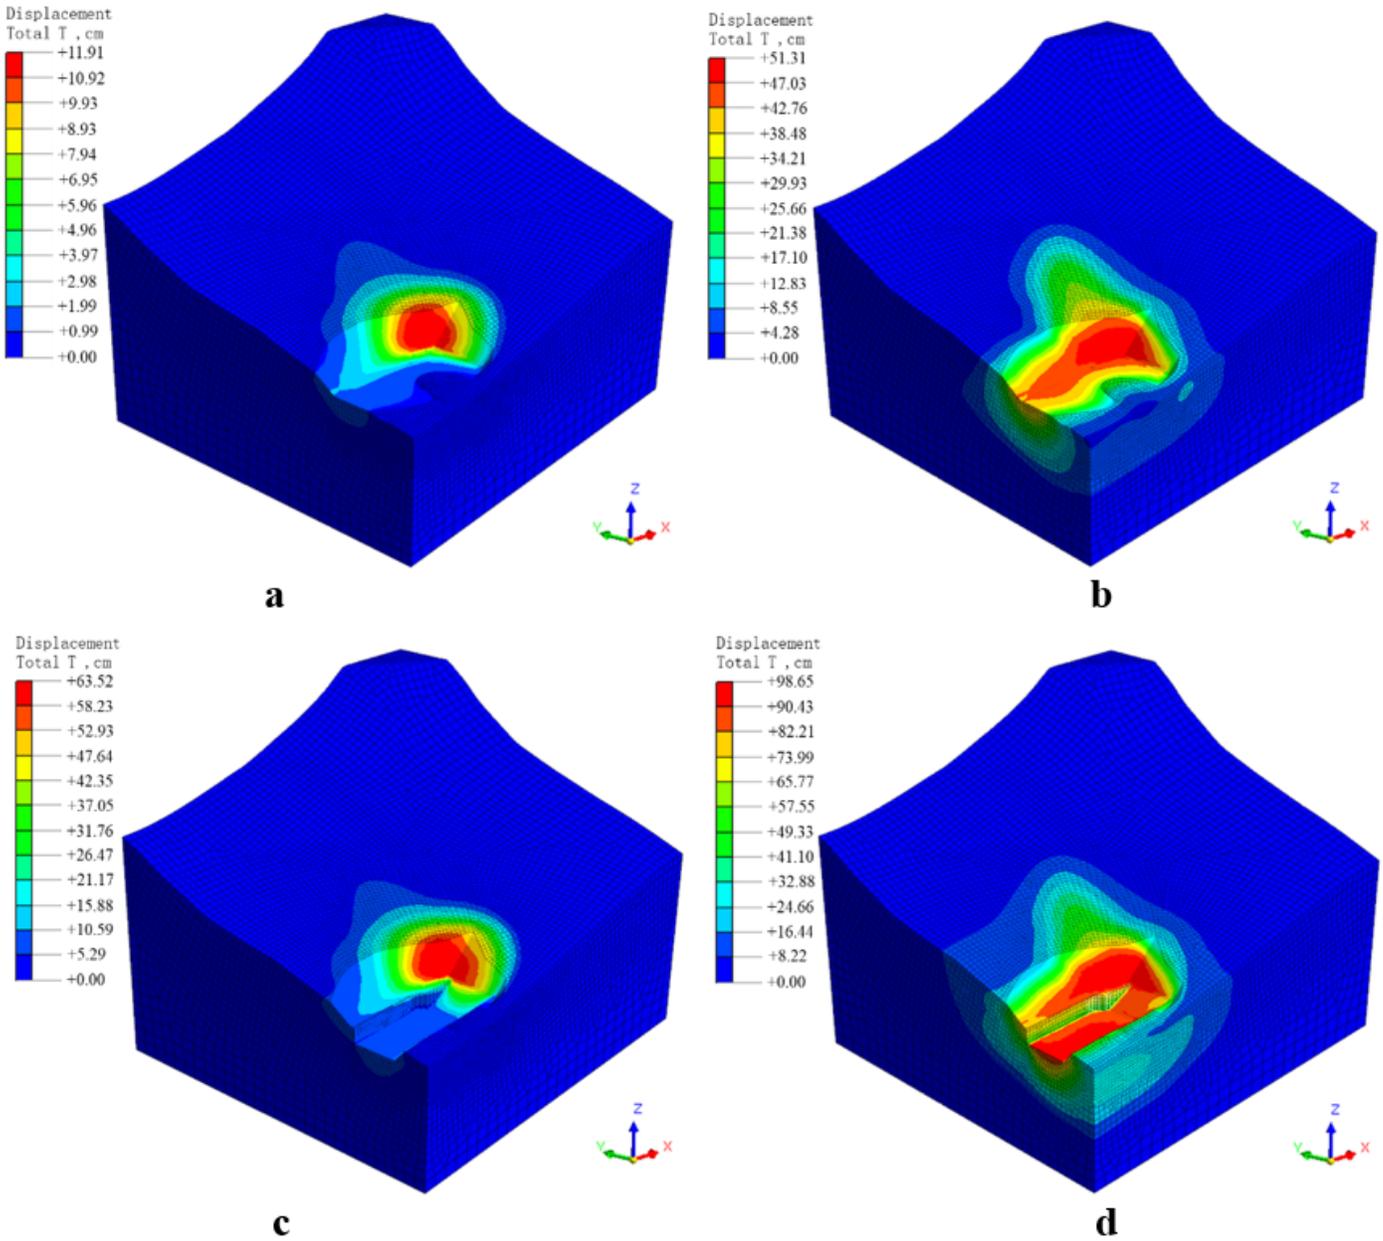
Figure 7 shows the overall displacement contour distribution of the slope after being affected by excavation and rainfall. Figure 7(a) shows the deformation of the slope when the topsoil in the location of the open cut tunnel is excavated. At this time, the area of slope deformation is mainly near the open cut tunnel, the maximum displacement is 11.91 cm, and the deformation in other areas is small. Figure 7(b) adds the rainfall calculation based on the first excavation calculation, and the maximum displacement value of the slope is 51.31 cm, which is significantly larger than that without rainfall, and the deformed area is also enlarged; its shape is basically the same as that of the site survey in Fig. 4.

Figure 7(c) shows the deformation of the slope after the anchor pile is constructed and the second excavation is carried out. The maximum displacement of the slope is 63.52 cm, which is slightly larger than that in Figure 7(b). Figure 7(d) shows the deformation of the slope after rainfall again, and the maximum displacement of the slope is 98.65 cm.

Compared with the calculation results of the above four steps, both the soil excavation and rainfall have a great impact on the slope deformation. The increases in the extreme values of slope deformation caused by the two soil excavations are 11.91 cm and 12.21 cm, respectively, and the increases in the extreme values of slope deformation caused by the two rainfall events are 39.4 cm and 35.13 cm, respectively. The impact of rainfall on the slope deformation is more significant after the topsoil is excavated.

a Deformation of the slope after the first excavation, **b** deformation of the slope caused by rainfall after the first excavation, **c** deformation of the slope after the second excavation, **d** deformation of the slope caused by rainfall after the second excavation

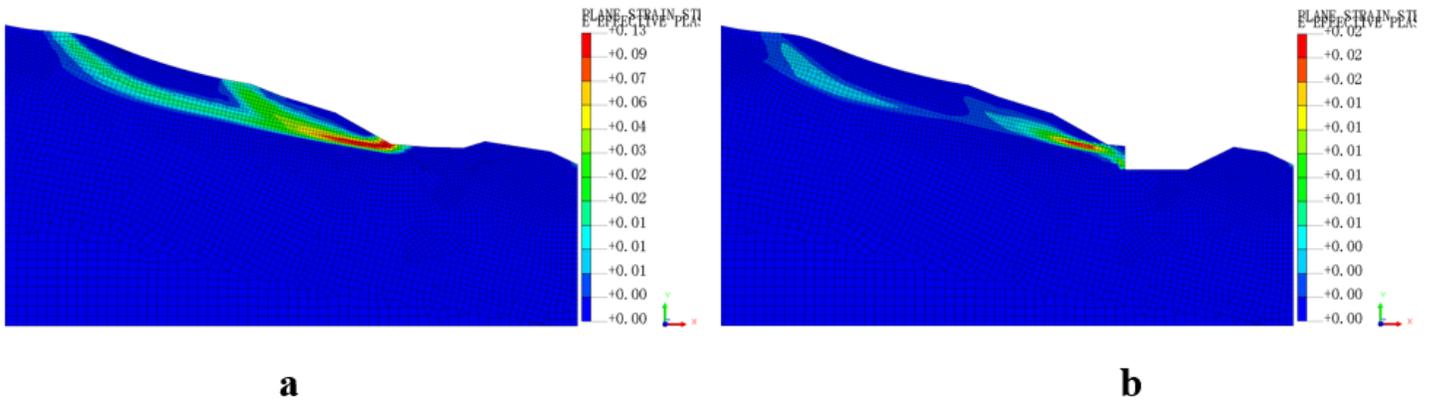
Figure 8

To assess the instability of the slope under different working conditions, the main sliding section is selected to analyze the distribution of the soil plastic zone (Sheng et al. 2002). Fig. 8(a) shows that within the first excavation, due to rainfall infiltration and soil excavation, an obvious plastic zone appeared on the upper layer of the slope, and two potential sliding surfaces appeared, which basically matched the field monitoring results in Fig. 4. Fig. 8(b) shows the distribution of the plastic zone of the slope after the secondary excavation of the soil. The figure shows that the position of the plastic zone of the slope is mainly concentrated in the toe area, which is deeper than the position of the plastic zone calculated by the first excavation.

Variation in the plastic zone of the slope. **a** First excavation. **b** Second excavation

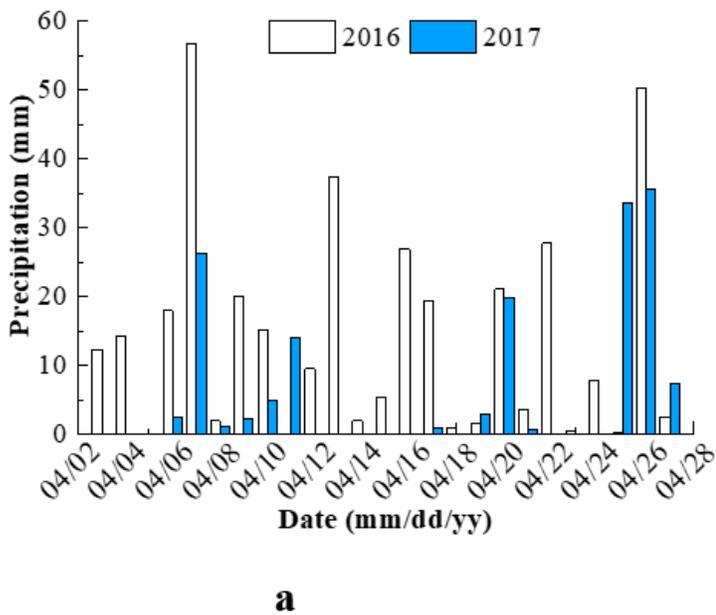
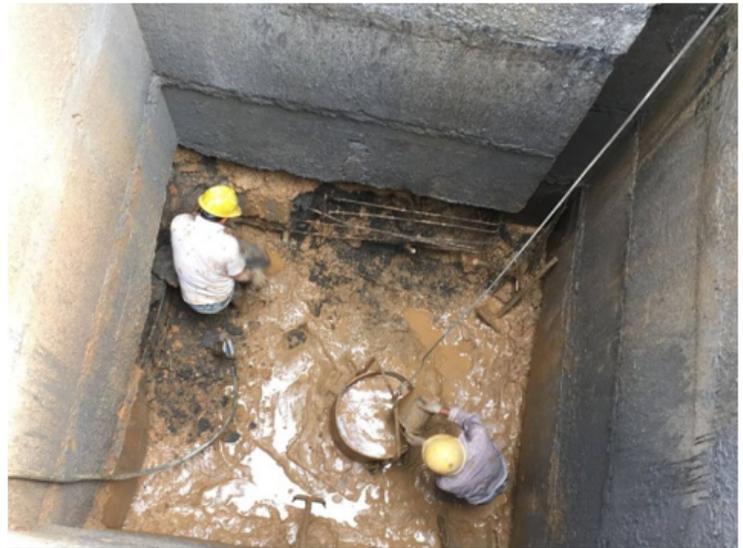
Figure 9

In the first stage, the soil mass of the slope above the top of the anchor pile was excavated, and several anchor piles were excavated, as shown in Fig. 9(b). During this period, no effective protection or drainage measures were formed on the slope surface, and the excavation of large-scale anchor piles further damaged the anti-sliding capacity of the slope toe. At the same time, slope excavation destroyed the vegetation, increased the infiltration of rainwater, and accelerated the formation of a soft layer in the soil, resulting in a collapse of the slope in April 2016, as shown in Fig. 3. The second stage of excavation was executed after some reinforcement measures were completed, and the excavated area was mainly the soil of the open cut tunnel. This stage was affected by the accumulation of excavation deformation generated in the previous stage, and the anti-sliding ability of the original anchor pile was insufficient, which led to the stability of the soil in the lower part of the slope again.

a Daily precipitation in the study area (2016 and 2017), **b** excavation of anchor piles

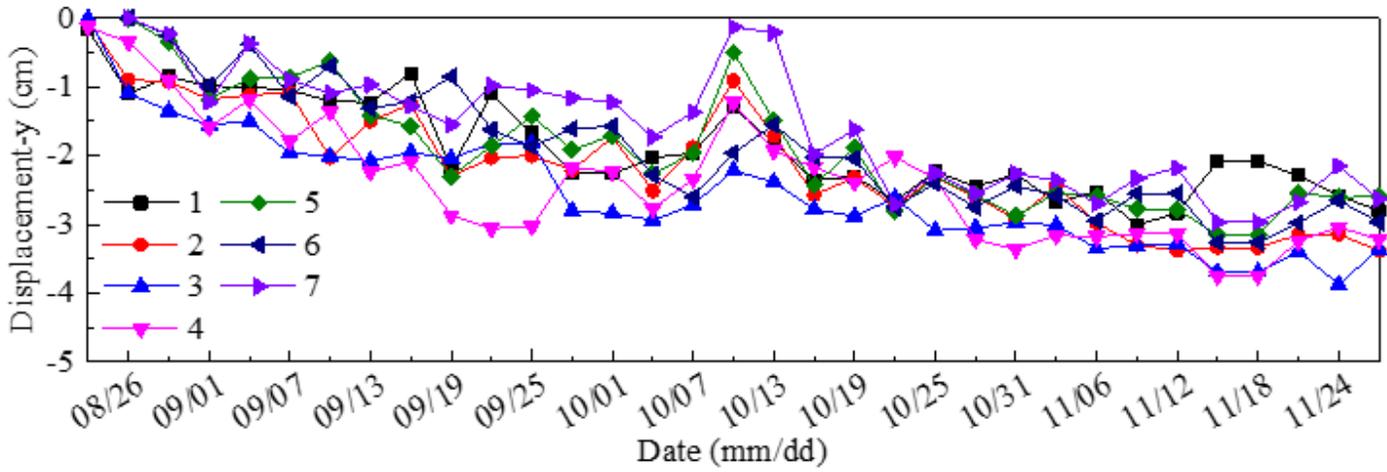
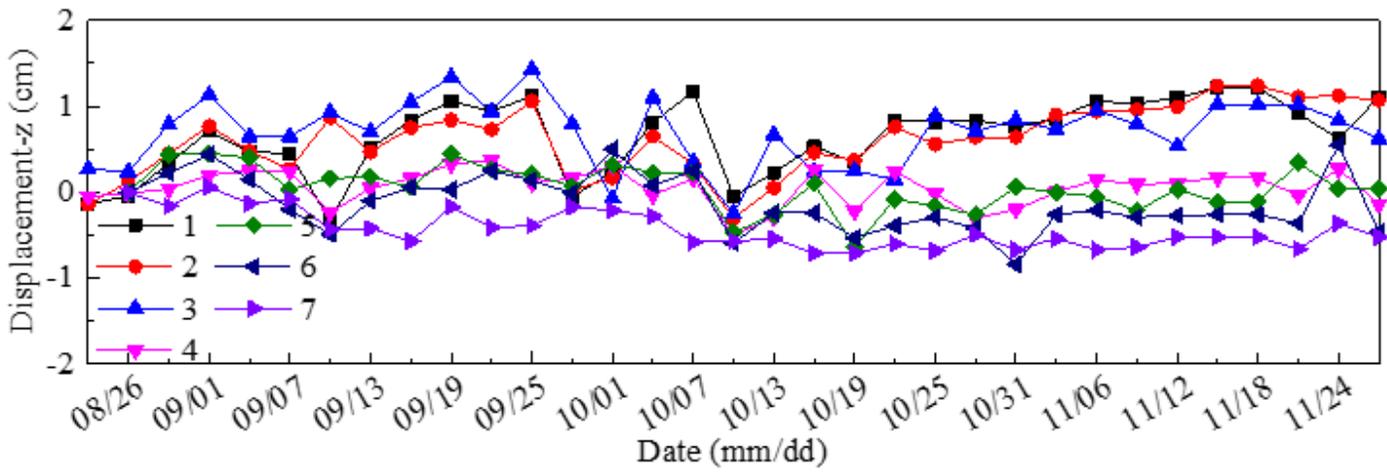
Figure 13 shows the displacement of the anti-slide pile top beam in both the vertical railway strike direction and settlement. During the whole monitoring process, the deformation of the anti-slide pile itself was relatively small, the maximum horizontal displacement value of its top was 3.36 cm, and the maximum settlement value was only 0.52 cm.

Monitoring results of the displacement of the top beam: **a** displacement vertical railway strike direction (y), **b** settlement deformation (z)

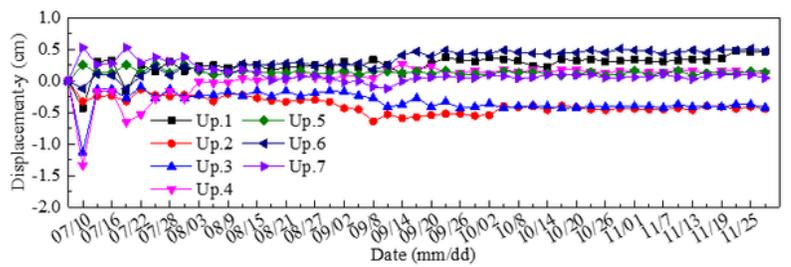
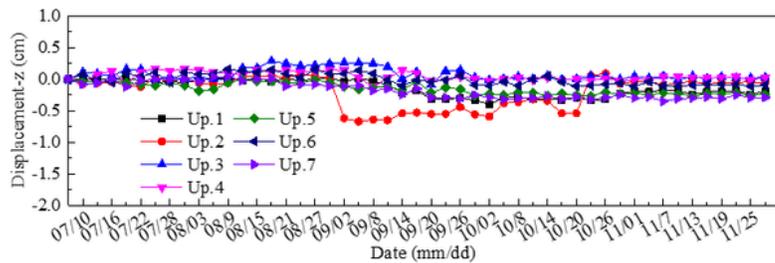
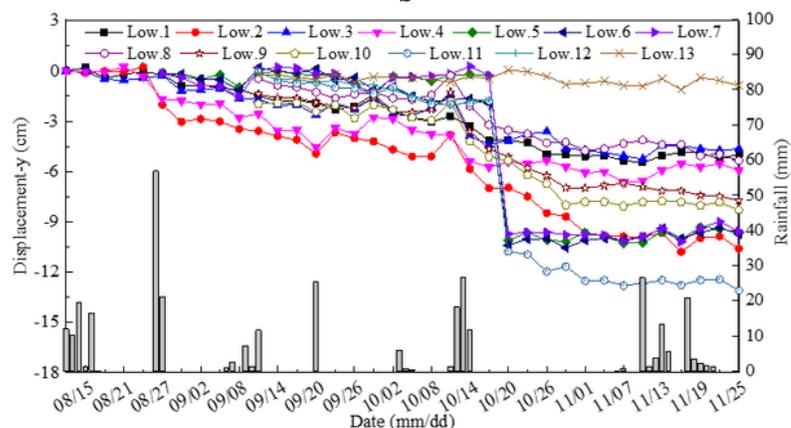
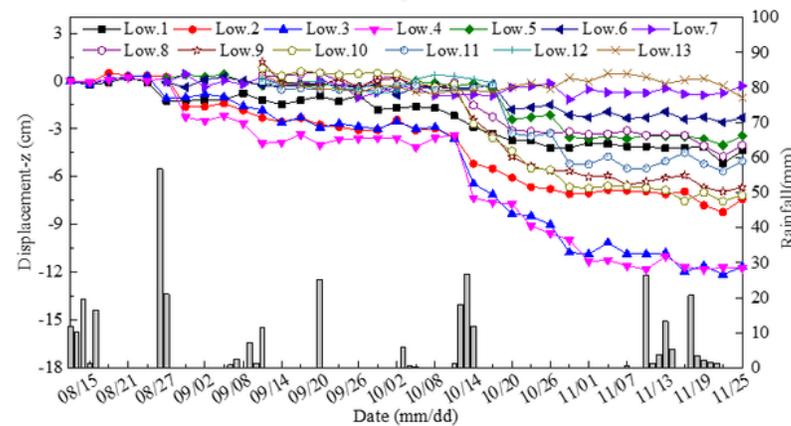
Figure 14 shows that the deformation of the upper part of the slope is obviously smaller than that of the lower part. The lower slope has a large deformation, the maximum horizontal displacement value is 13.11 cm, and the maximum settlement value is 11.76 cm. During the monitoring process, there were two obvious increases in the data, which occurred from August 23 ~ August 25 and from October 11 ~ October 13. According to the meteorological monitoring records of the site, the daily rainfall on August 24

reached 56.8 mm, and the cumulative rainfall from October 11 to 13 reached 56.6 mm. Clearly, rainfall has a great influence on the deformation of the tunnel portal slope.

Compared with the sudden increase in the two displacements, the sudden increase in October is much larger than that in August. Further analysis combined with the field construction records shows that the back-pressure soil was not excavated in August, but the back-pressure soil was excavated in October; the anchor cable construction of the anchor pile was not completed, and the anti-slide force was still insufficient. Based on the analysis of the above two factors, the main cause of slope deformation is rainfall, but the reinforcement conditions determine the magnitude of the deformation. After anchor cable construction is completed, the slope tends to stabilize.

Figure 14 shows that the slope was basically stable on November 1, and the on-site slope has not been deformed thus far, indicating that the abovementioned treatment measures are basically effective.

Monitoring results of the surface displacement points: **a** upper slope displacement vertical railway strike direction (y), **b** upper slope settlement deformation (z); **c** lower slope displacement vertical railway strike direction (y), **d** lower slope settlement deformation (z)
