The Corrosion Degradation Characters of the Secondary Loop Piping in Nuclear Power Plant

Keywords: nuclear power, secondary loop pipe, flow accelerated corrosion, erosion corrosion

The corrosion damage characters of the secondary loop piping in nuclear power plant

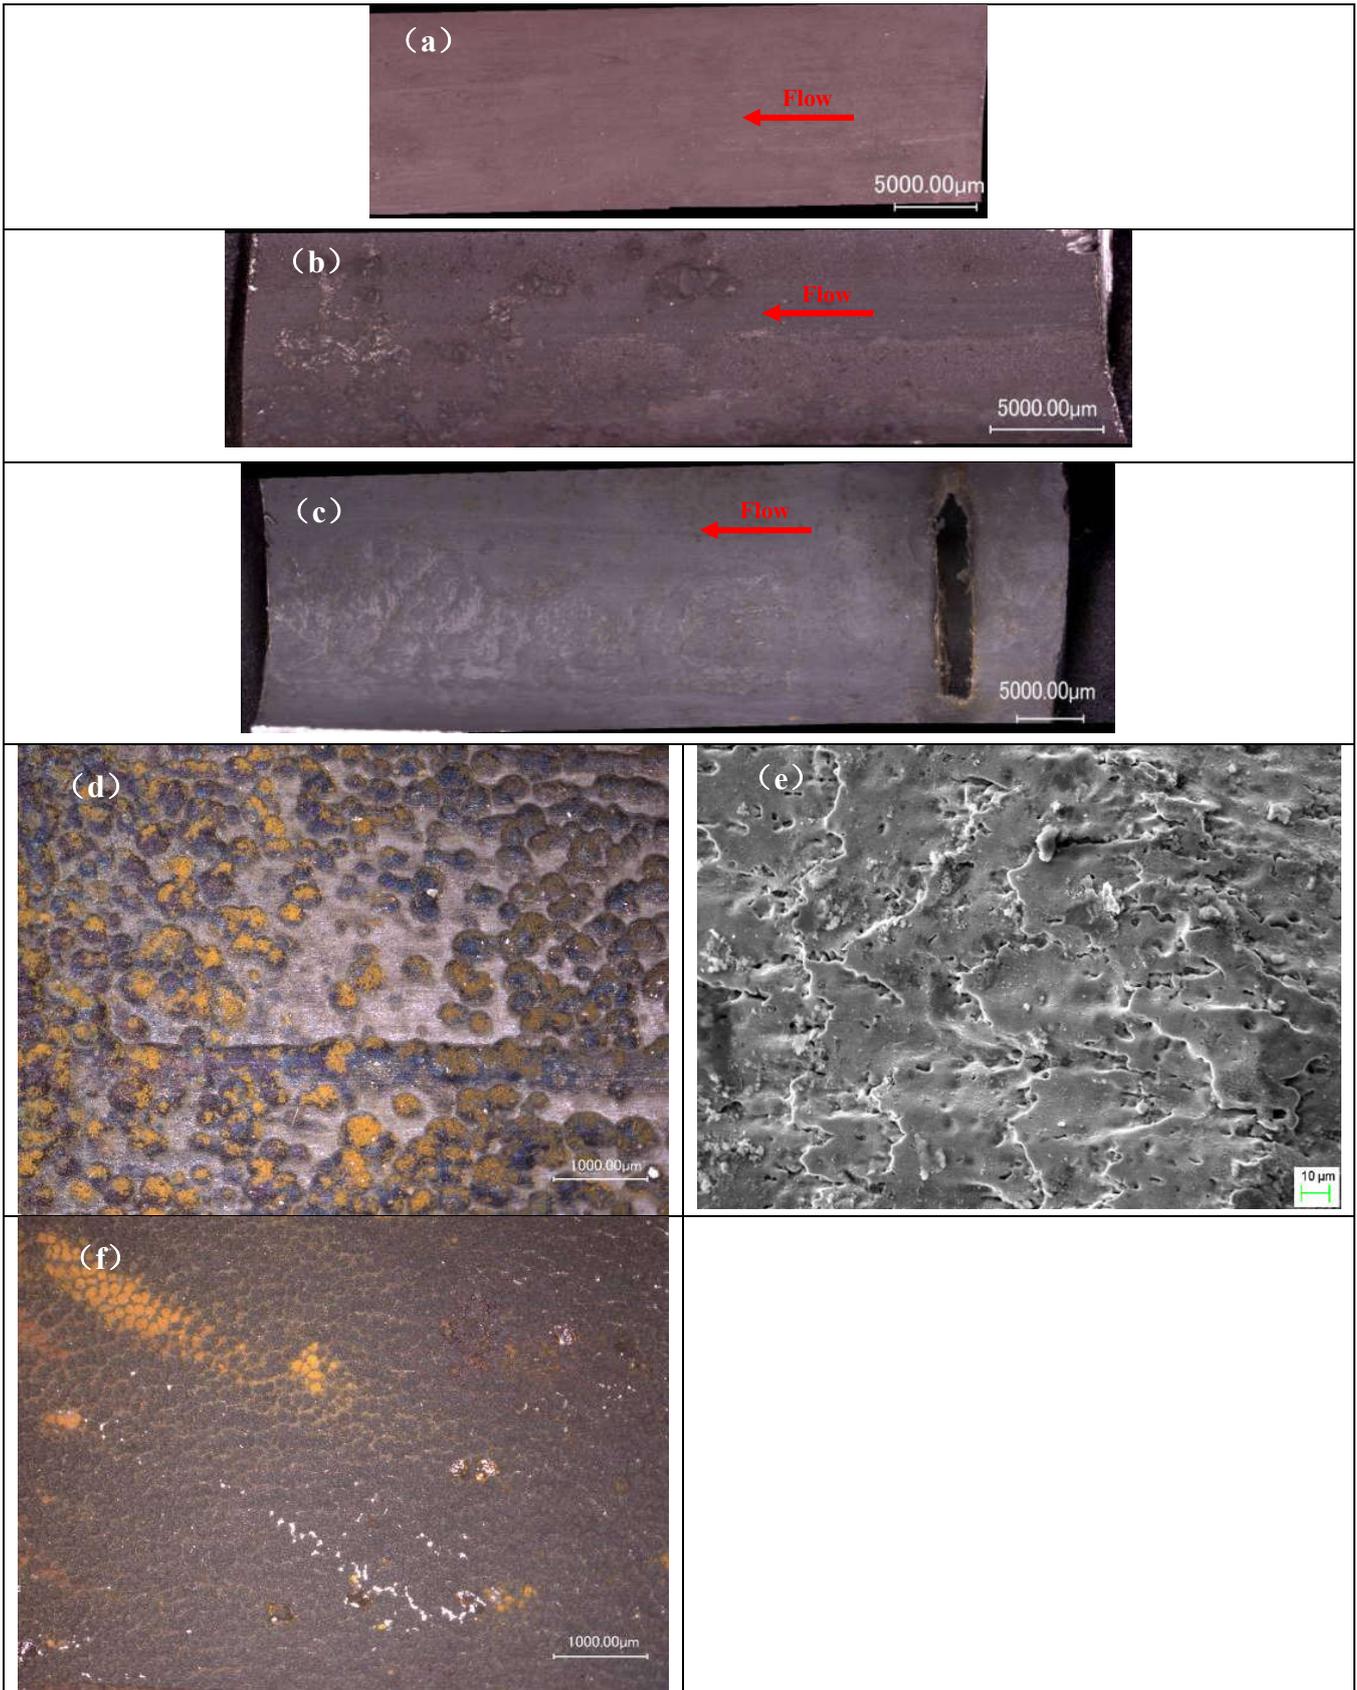
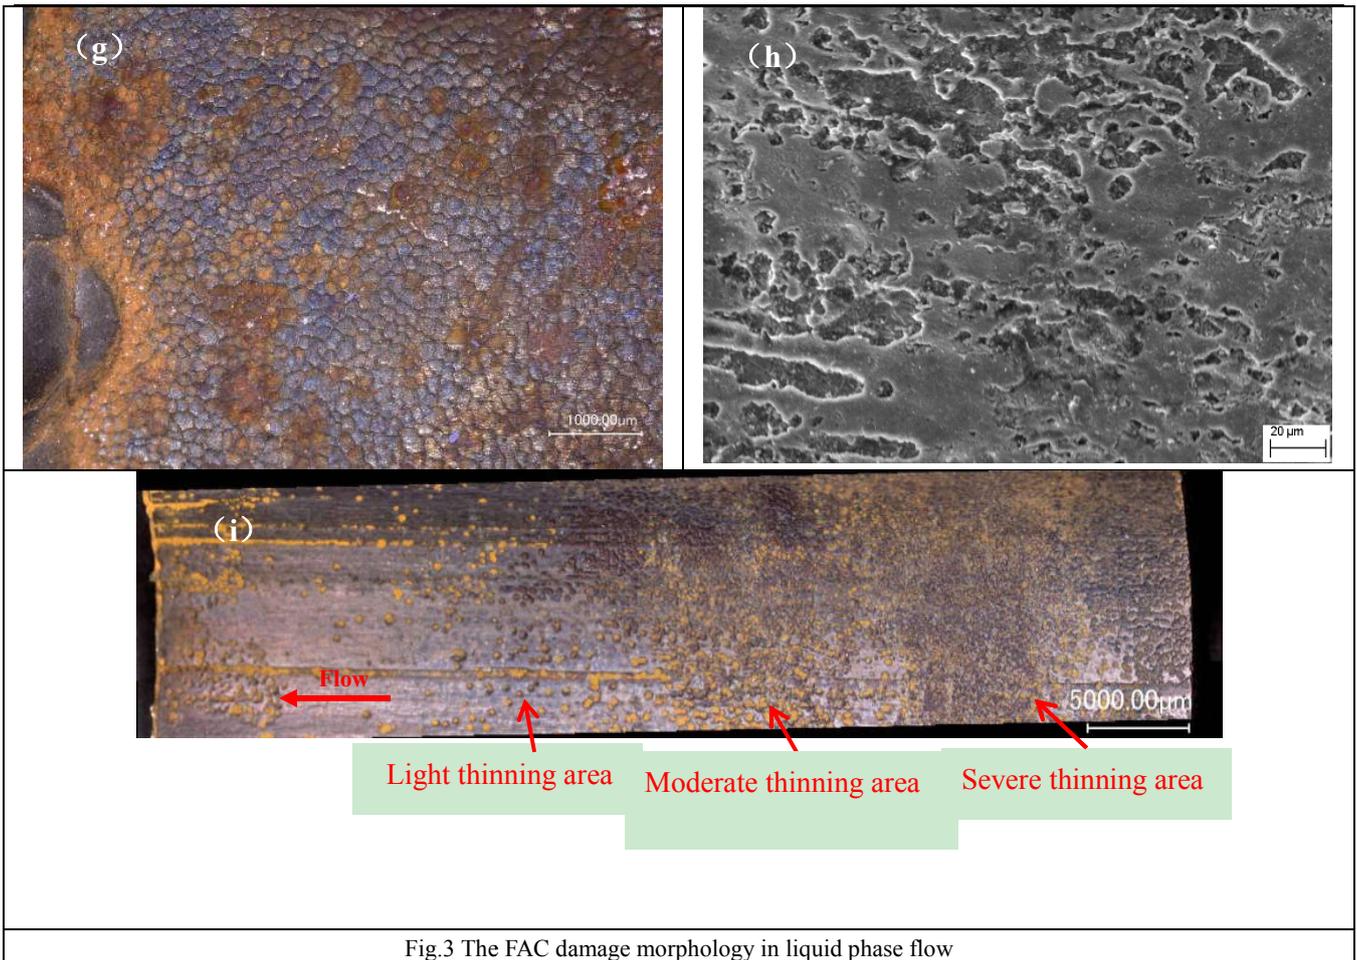
Fig.3 The FAC damage morphology in liquid phase flow

In the initial stage of the pipeline operation, a relatively uniform and smooth Fe_3O_4 oxide film was formed on the inner wall at high temperature, as shown in Fig. 3 (a). The energy spectrum showed that the oxide film is composed of O and Fe, the atomic percentage of Fe is 43.32%, which is consistent with the content of Fe in Fe_3O_4 . After the pipeline was put into normal operation, the flow rate increases, and the oxide film at the sensitive position of FAC dissolved locally, causing local corrosion damage. As shown in Fig. 3 (b), there are shallow corrosion pits on the inner wall of the pipeline. 18 months after the pipeline was put into operation, a strip thinning area with large width but shallow depth appeared on the inner wall of the pipeline, as shown in Fig. 3 (c). The thinning area at the sensitive position of FAC was narrow and deep, and then became wide and shallow along the flow direction. There are large pits with irregular shape on the thinning area. The width of the large pits at the sensitive position of FAC is about 300 μm , and then gradually increases to 500 μm along the flow direction. The energy spectrum showed that the atomic percentage of Fe is 60.19% at the bottom of the pit, which is significantly higher than that of Fe_3O_4 , indicating that the surface oxide film has been damaged. After the pipeline has been put into operation for 37 months, small round pits formed at the sensitive position of FAC, as shown in Fig. 3 (d). The diameter of the pits was about 300~400 μm , and then these pits gradually become large and sparse along the flow direction. As shown in Fig. 3 (e), traces of local dissolution of oxide film under the action of fluid can be found at the bottom of the pit. The maximum thinning rate was 0.19mm/a, and the wall thickness of the thinning area and the non thinning area transits smoothly. 56 months after the pipeline was put into operation, the pits at the sensitive position of FAC densely distributed in orange peel shape [8], as shown in Fig. 3 (f), the diameter of the pits is about 100~150 μm , and the energy spectrum showed that the percentage of iron atoms in the inner wall of the pipeline is 62.28%. The maximum thinning rate is 0.22mm/a. The thickness of the thinning

zone and the non thinning zone transits smoothly. 74 months after the pipeline has been put into operation, the pits on the inner wall of the pipeline got smaller and denser, as shown in Fig. 3 (g). The pits at the sensitive position of FAC densely distributed in orange peel shape, and the diameter of the pits is about 100-150 μm . The oxide film dissolution traces at the bottom of the pits is obviously shown in Fig. 3 (h), no complete oxide film could be found. The percentage of Fe atom reached 66.2%. The maximum thinning rate is 0.3mm/a. It can be seen that FAC rate increases with the dissolution of oxide film. As shown in Figure 3 (i), the pits formed by FAC at the severe thinning area are small and dense, and then gradually become large and sparse along the flow direction. The wall thickness of the pipeline from the thinning area to the non thinning area has a smooth transition, and there were no obvious mutation, which is related to the relatively stable local flow pattern and flow field of the liquid single-phase flow.

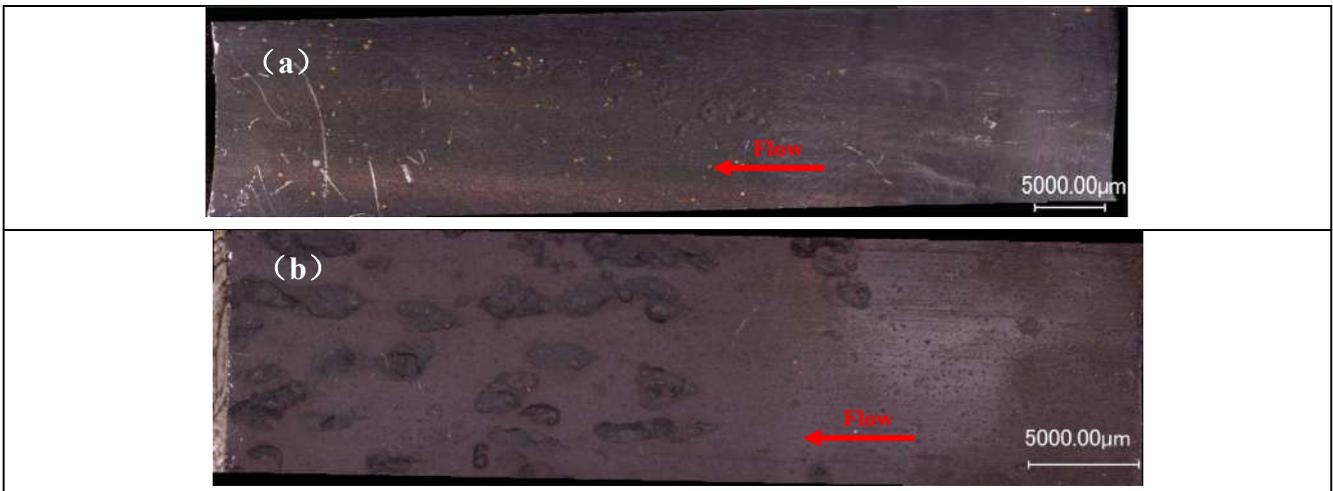
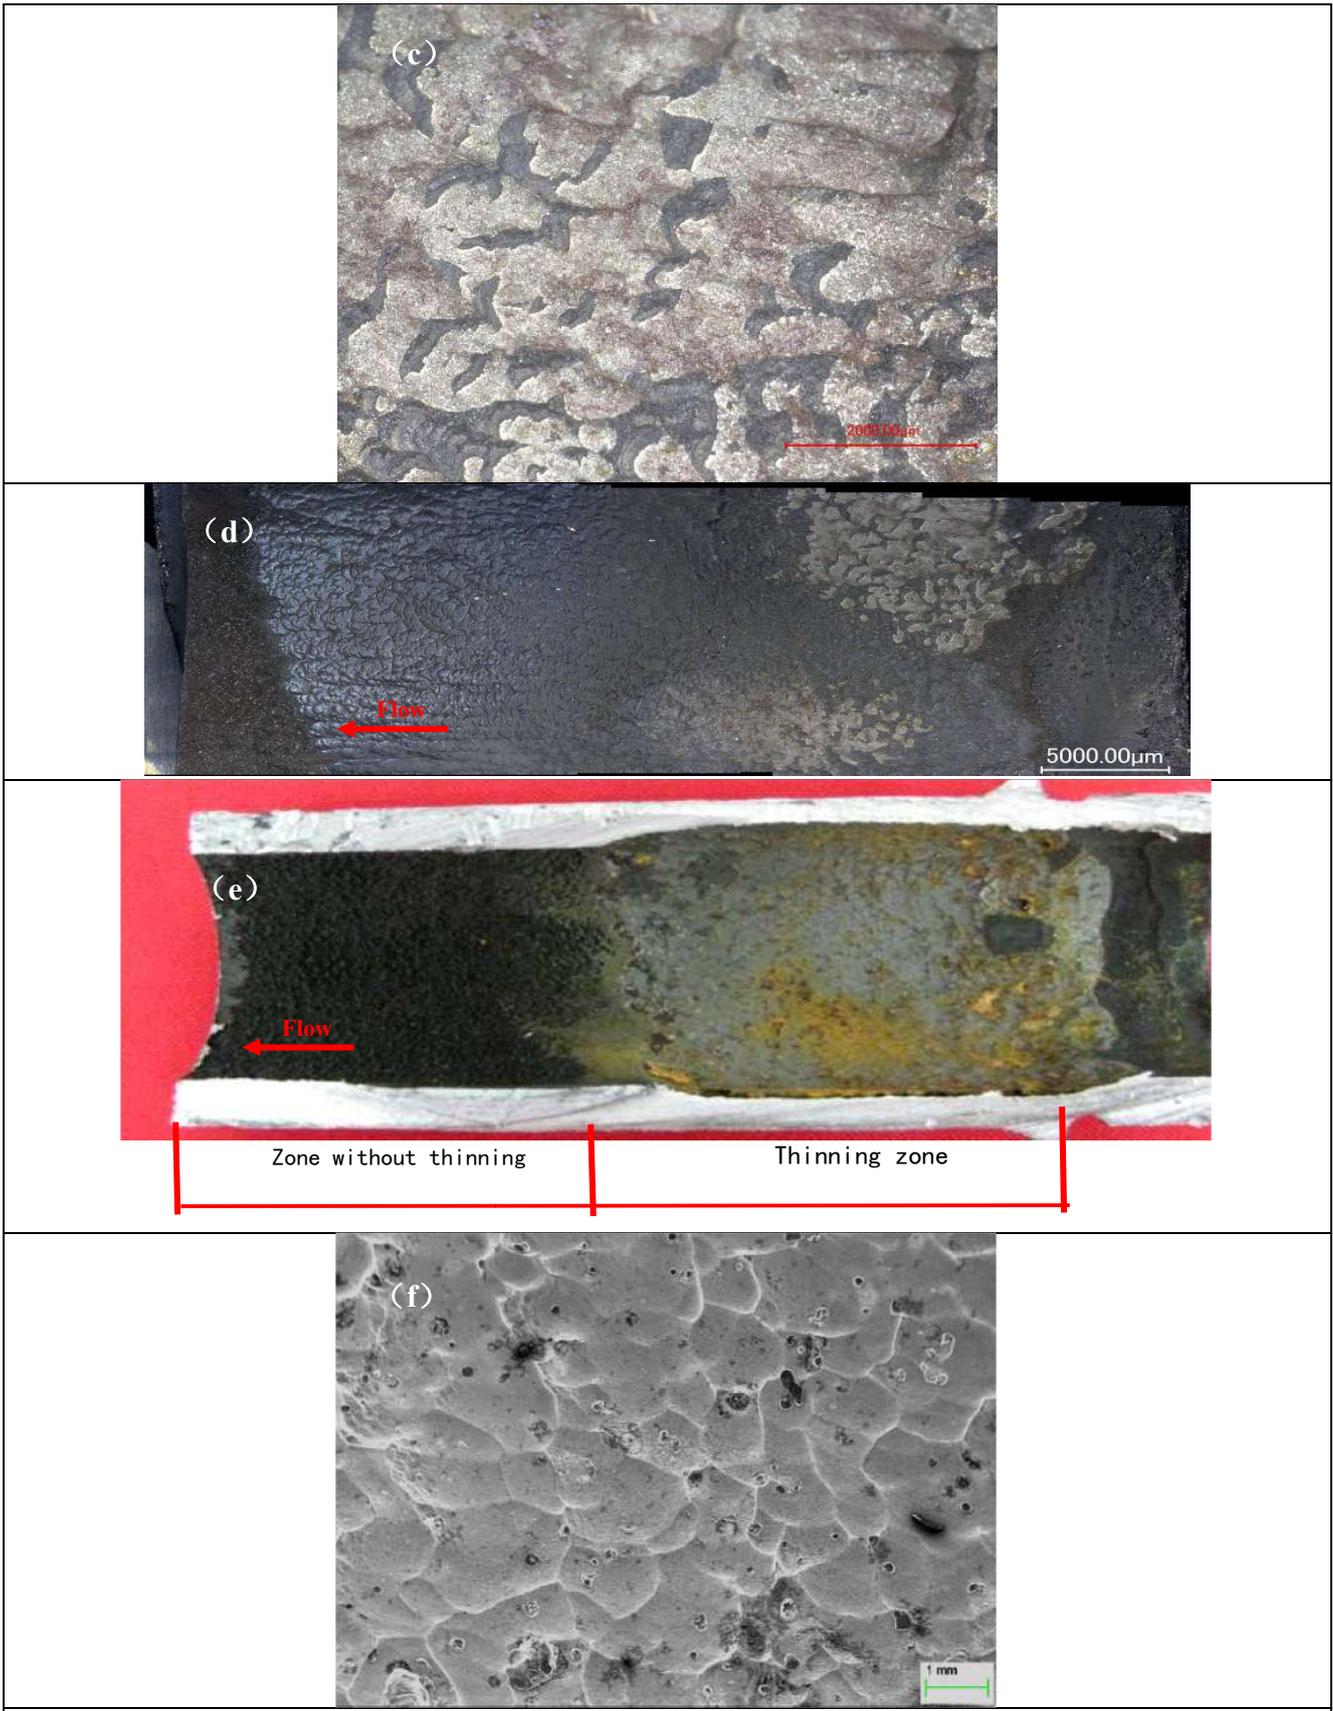
Fig.4 The FAC damage morphology in vapor-liquid dual-phase flow

The downstream pipe section of single-stage single orifice of main steam valve drainage pipeline was selected for tracking analysis. The medium in the pipe is vapor-liquid two-phase flow. The operating temperature is about 170 °C, and the pipe material is ASME SA106B with 0.10%Cr. The nominal pipe size is DN25, and the nominal wall thickness is 4.51mm, the orifice diameter is 5mm. The flow velocity reached the maximum value of 40m/s at 2 times inner diameter from the orifice according to calculation, which is the FAC sensitive position. In the process of temperature and pressure rise at the initial stage of pipeline operation, a relatively uniform and smooth Fe_3O_4 oxide film was formed on the inner wall of the pipeline at high temperature, as shown in Fig. 4 (a). After the pipeline was put into normal operation, the flow rate increases, and the oxide film at the FAC sensitive position on the inner wall dissolves locally. As shown in Fig. 4 (b), local corrosion damage occurred, and there are irregular corrosion pits distributed along the flow direction. The flow pattern of vapor-liquid two-phase flow is more complex than that of liquid single-phase flow. The mass transfer rate of ions in two-phase flow is also higher, and the dissolution rate of oxide film is faster. Compared with the local corrosion damage of liquid single-phase flow, more corrosion pits were formed, and the corrosion damage is relatively serious. 37 months after the pipeline was put into operation, the thickness of FAC sensitive position decreased obviously, the maximum thinning rate is 0.2mm/a, and the wall thickness of thinning area and non thinning area transits smoothly. The local inner wall of

FAC sensitive position presents black and white tiger pattern as shown in Fig. 4 (c), and the tiger pattern gradually disappears along the flow direction and turns into black horseshoe pit as shown in Fig. 4 (d). 74 months after the pipeline was put into operation, the whole circle thinning occurred in the range of 1-3 times of the inner diameter from the orifice, as shown in Fig. 4 (e), and the maximum thinning rate is 0.3 mm / a, the tiger spot pattern can no longer be found in the thinning area, but is covered with horseshoe pits as shown in Fig. 4 (f). The diameter of horseshoe pits is about 0.5 mm to 1 mm. There are tiger spots at the transition location between the thinning area and non thinning area, and the wall thickness changes suddenly. It shows that the dissolution rate of Fe_3O_4 oxide film is faster in the vapor-liquid two-phase environment, and the corresponding FAC thinning rate is higher. With the damage and disappearance of oxide film, FAC rate also increases significantly.

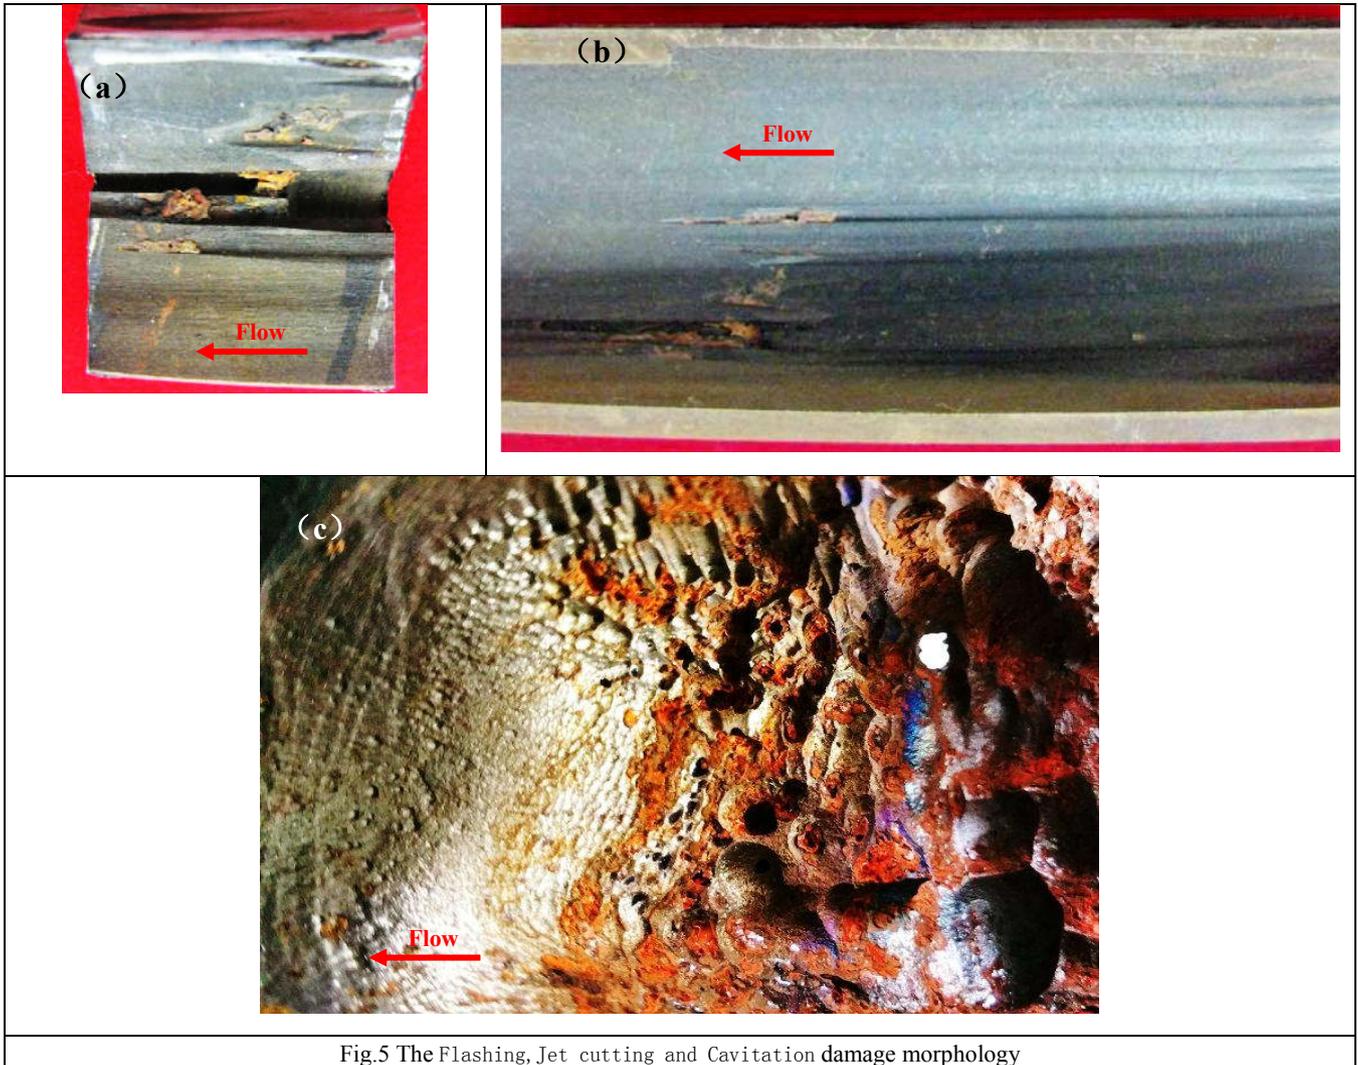
Fig.5 The Flashing, Jet cutting and Cavitation damage morphology

Figure 5 shows the EC damage morphology of the pipeline downstream of the steam trap of the high pressure heater in a nuclear power plant. The upstream of the steam trap is liquid single-phase flow. The operating temperature is 170 °C, and the pressure head of the steam trap is 1.2MPa. The material of the downstream pipeline is ASME SA106B. The nominal pipe size is DN50, and the nominal wall thickness is 5.54mm. The small opening action of the steam trap produces high pressure jet flow, and the calculated flow rate can reach 177m / s. The metal on the pipe wall is directly jet cut to form the groove with neat boundary in Fig. 5 (a). The thickness at the groove has been reduced from 5.54mm to 1.5mm. At the same time of jet cutting, the high temperature and high pressure water flash, which aggravates the fluid erosion on the pipe wall, resulting in the overall thinning of the pipeline. As shown in Fig. 5 (b), except for the location of the jet cutting groove, other thinning positions are smooth and flat, which are flash erosion morphology. High speed fluid not only caused jet cutting and flash erosion damage to the downstream pipeline of the trap, but also formed serious cavitation corrosion on a pipe socket about 500mm downstream of the trap. As shown in Figure 5 (c), the cavitation corrosion area is densely covered with rough round slag holes. In the most serious damage area, the slag holes are large and deep, with the maximum diameter of about 10 mm. Then, the slag holes gradually become smaller along the flow direction, with the minimum diameter of about 2 mm. As the cavitation corrosion damage gradually weakens, the small slag holes change to

small pits with a diameter of less than 2 mm.

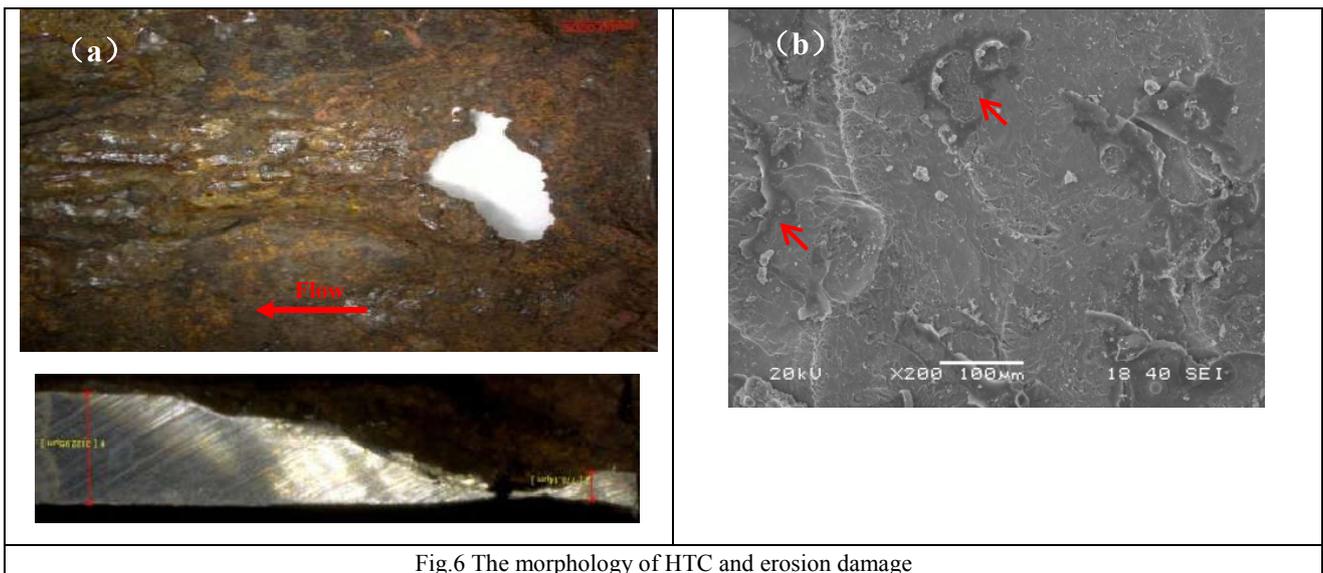
Fig.6 The morphology of HTC and erosion damage

Figure 6 shows the appearance of HTC erosion damage on the inner surface of a pipe section. The pipe is the high-pressure cylinder drain pipe of a nuclear power plant. There is a single-stage single hole orifice upstream of the pipe. The material of the pipeline is ASME SA106B. The nominal pipe size is DN25, and the nominal wall thickness is 4.51mm. The diameter of the orifice is 3mm. The operating temperature is 216 °C. The pressure head of the orifice is 1.95MPa, and the maximum flow velocity at the downstream thinning of the orifice is about 90m/s. The erosion thinning part presents the riverbed shape and smooth groove shape along the flow direction as shown in Figure 6 (a). In Figure 6 (b), the cracked oxide layer can be discovered at the thinning location. The maximum thinning rate of the pipe section is about 0.5mm/y.

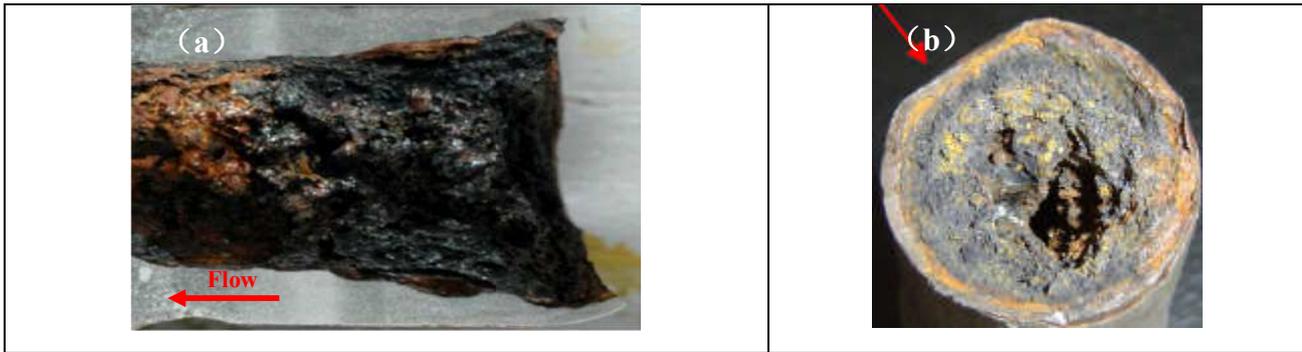
Fig.7 The morphology of HTC

Figure 7 [9] shows the corrosion thinning and blockage of the gland seal steam drainage pipeline of the reheat main steam valve in a nuclear power plant. The pipe material is JIS g3454 (stp410) low carbon steel. The nominal pipe size is DN15, the nominal wall thickness is 3.73 mm. The operating temperature of the reheat main steam valve is 200°C. There is serious thinning near the reheat main steam valve (see Figure 7 (a)), the thinning rate reaches 0.4mm/a. The thinning pipe section is filled with corrosion products (see Fig. 7 (b)). The drain water vaporized rapidly in the air drainage pipeline due to the sudden drop of pressure. Under high temperature and saturated oxygen condition in the pipeline, the water vapor, oxygen and metal reacted rapidly to form a loose oxide film. At the same time, the pipeline vibration caused large alternating stress in the pipe section. Thus, the continuous rupture of the film and the further corrosion of the metal are promoted. The accumulation of corrosion products hindered the flow and kept the temperature and humidity in the pipe at a high level, thus further aggravating the HTC.

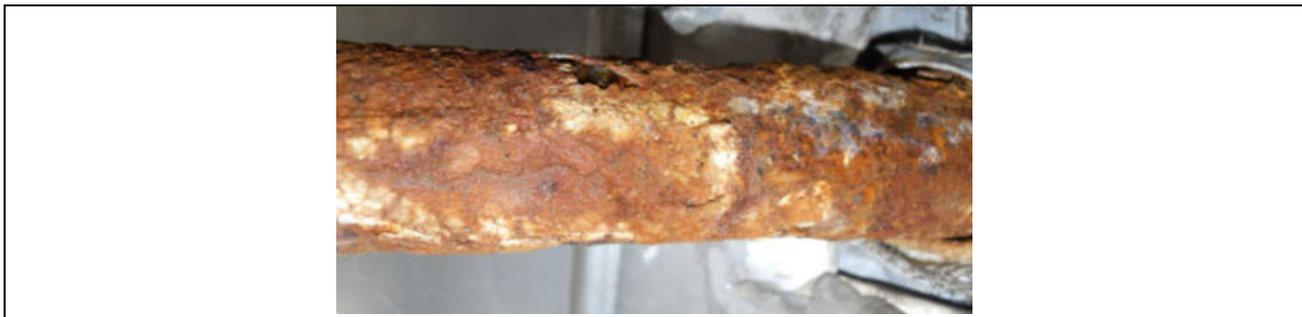
Fig.8 The morphology of HTC damage

Figure 8 shows the macroscopic appearance of serious corrosion on the outer surface of the main steam flow pressure pipeline of a nuclear power plant. The pipeline is an outdoor insulation pipeline directly connected with the main steam pipe. During the operation, the interior of the insulation layer had kept warm and humid for a long time, resulting in the rapid corrosion and thinning of the low-carbon steel pipeline.

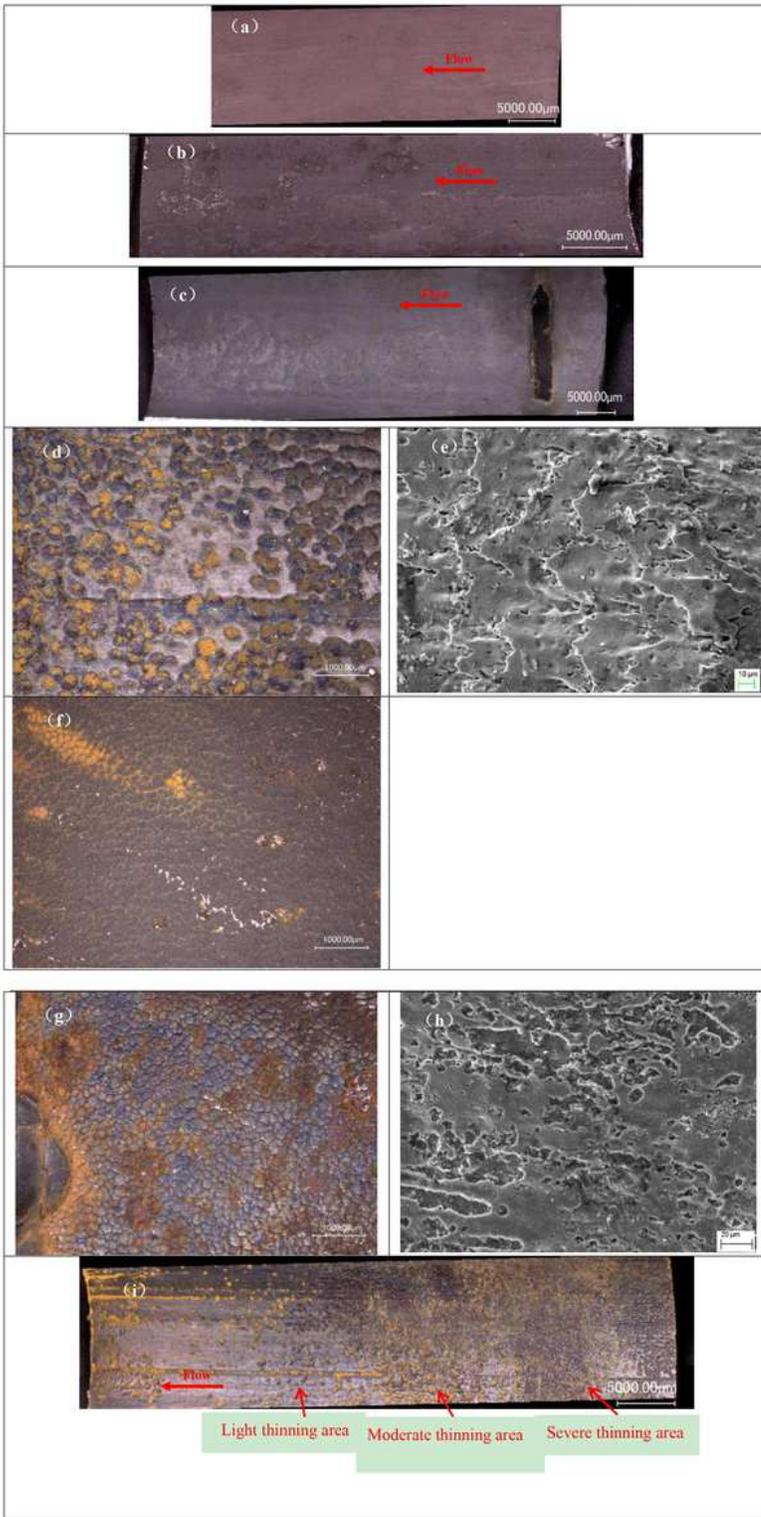
Figure 3

The FAC damage morphology in liquid phase flow

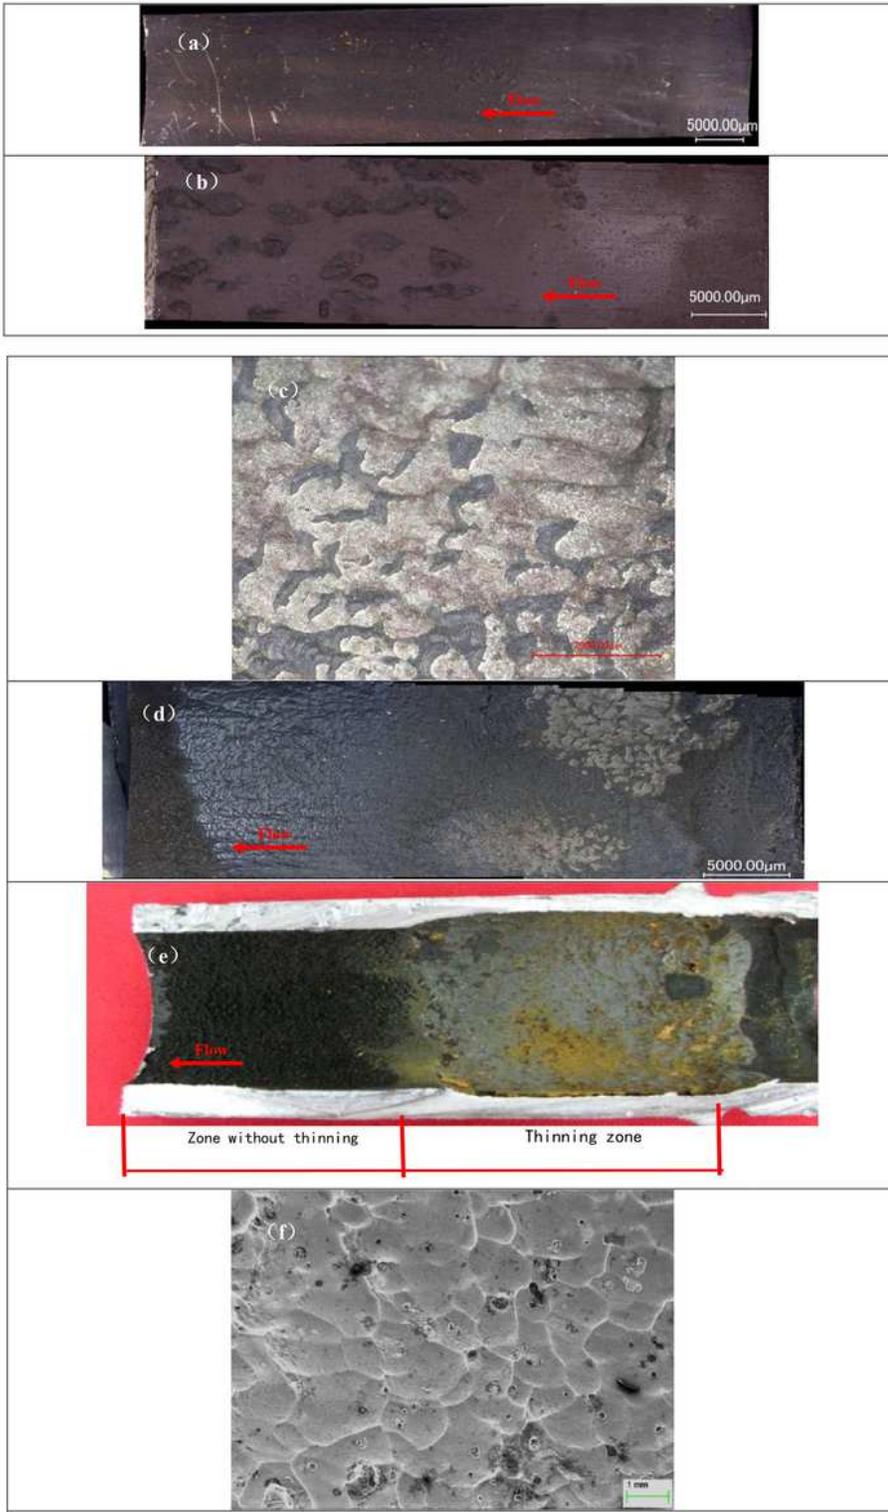
Figure 4

The FAC damage morphology in vapor-liquid dual-phase flow

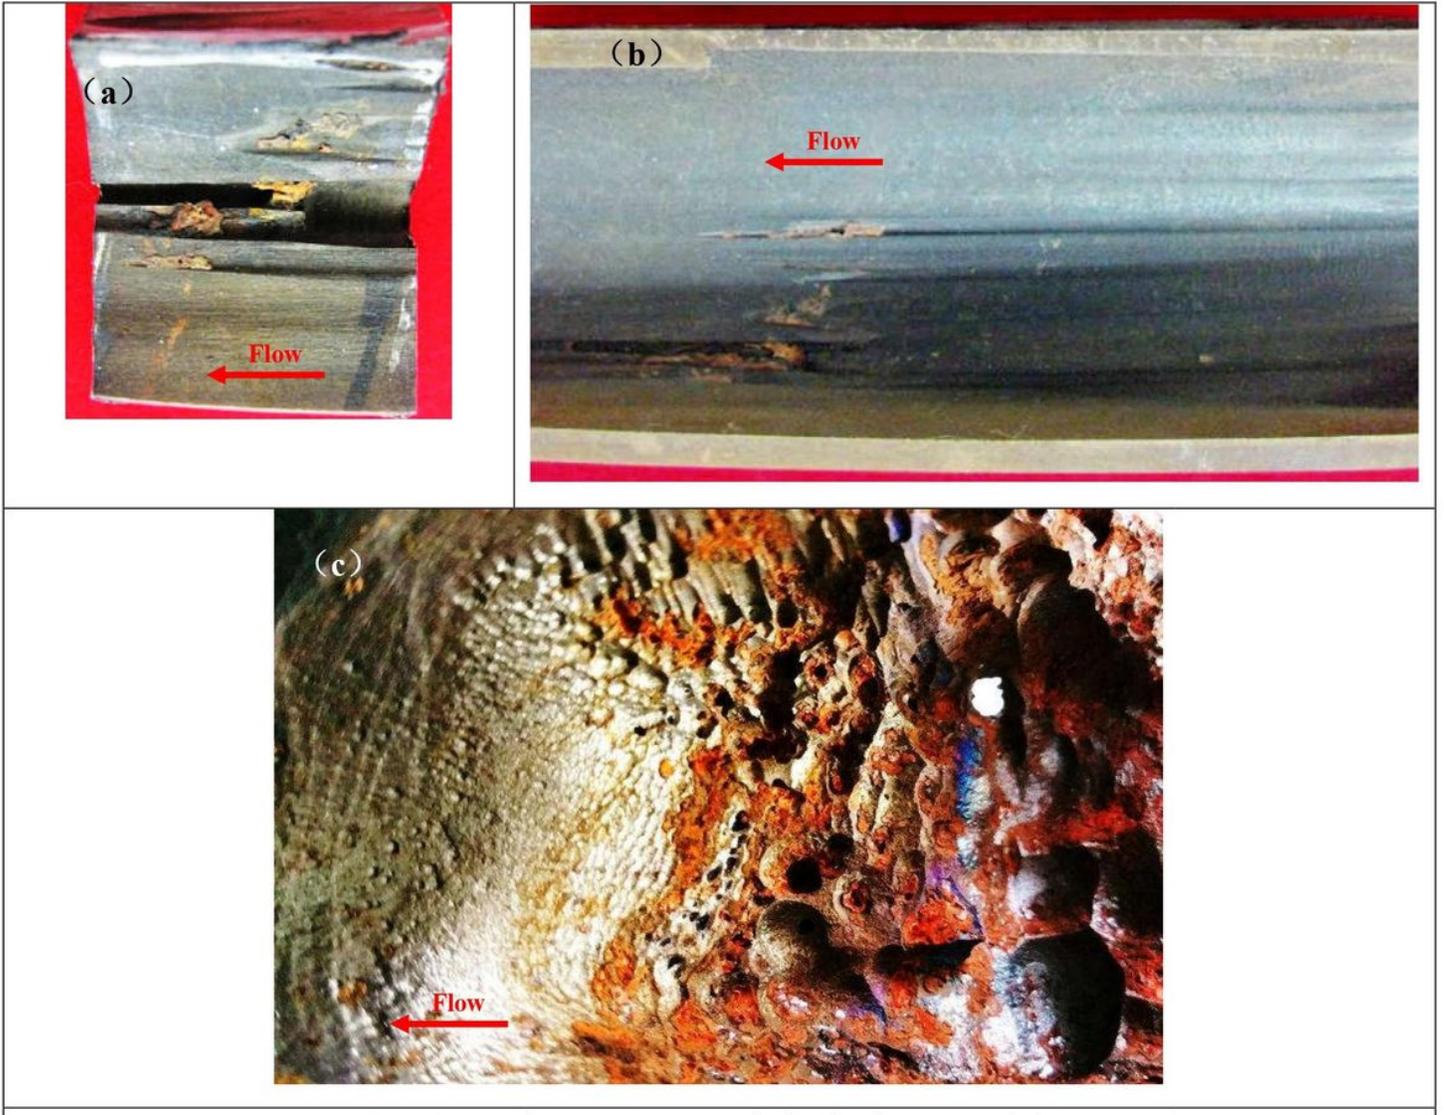
Figure 5

The Flashing, Jet cutting and Cavitation damage morphology

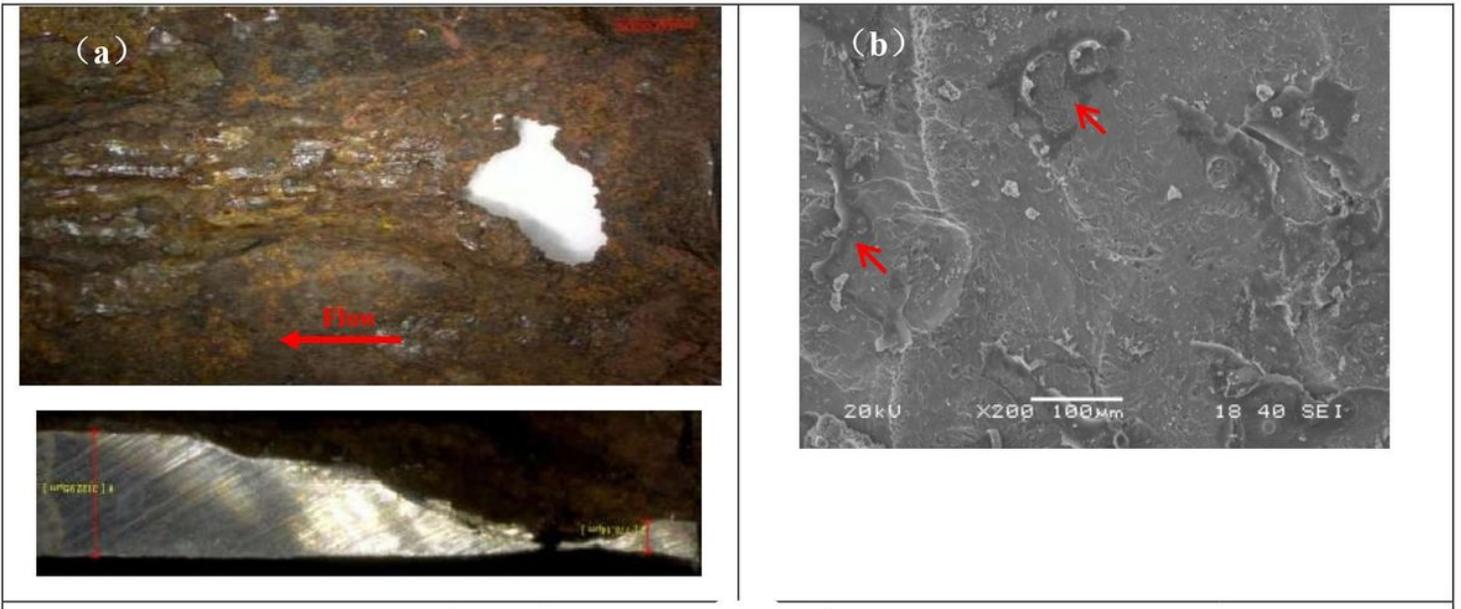
Figure 6

The morphology of HTC and erosion damage

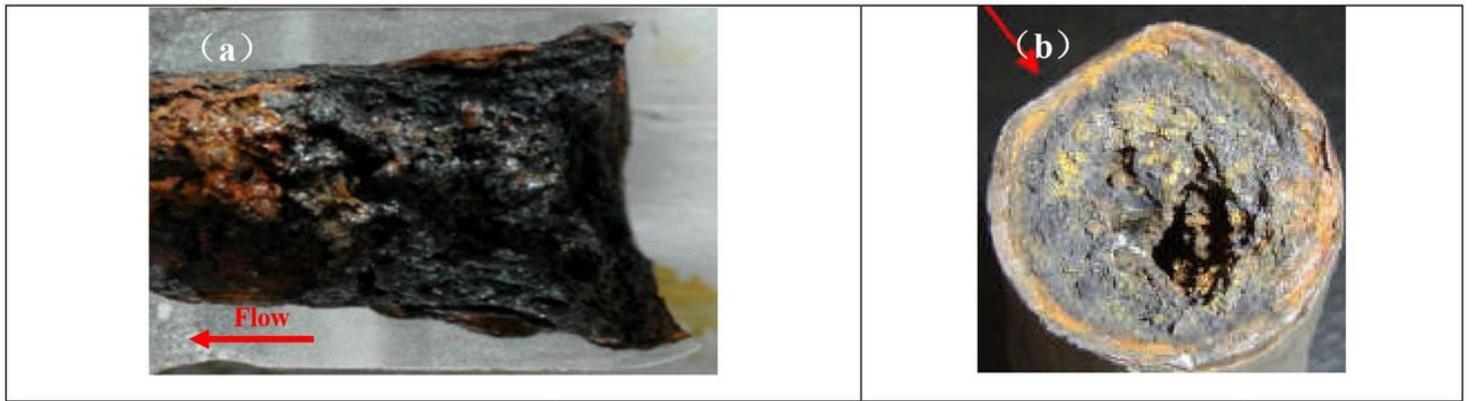
Figure 7

The morphology of HTC

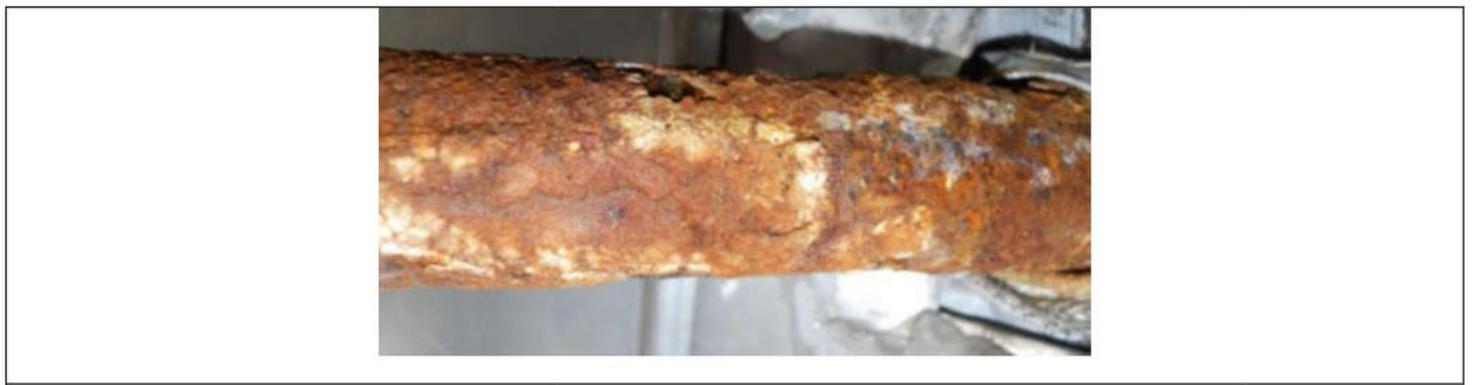
Figure 8

The morphology of HTC damage
