The Impact of the September 7th 2017 Earthquake on the Businesses of the Municipal Market of Juchitán De Zaragoza Due to Property Damage

Research Article

Keywords: Chiapas 2017 earthquake, business interruption, loss due to earthquake, damages and rehabilitation in the Juchitán Market

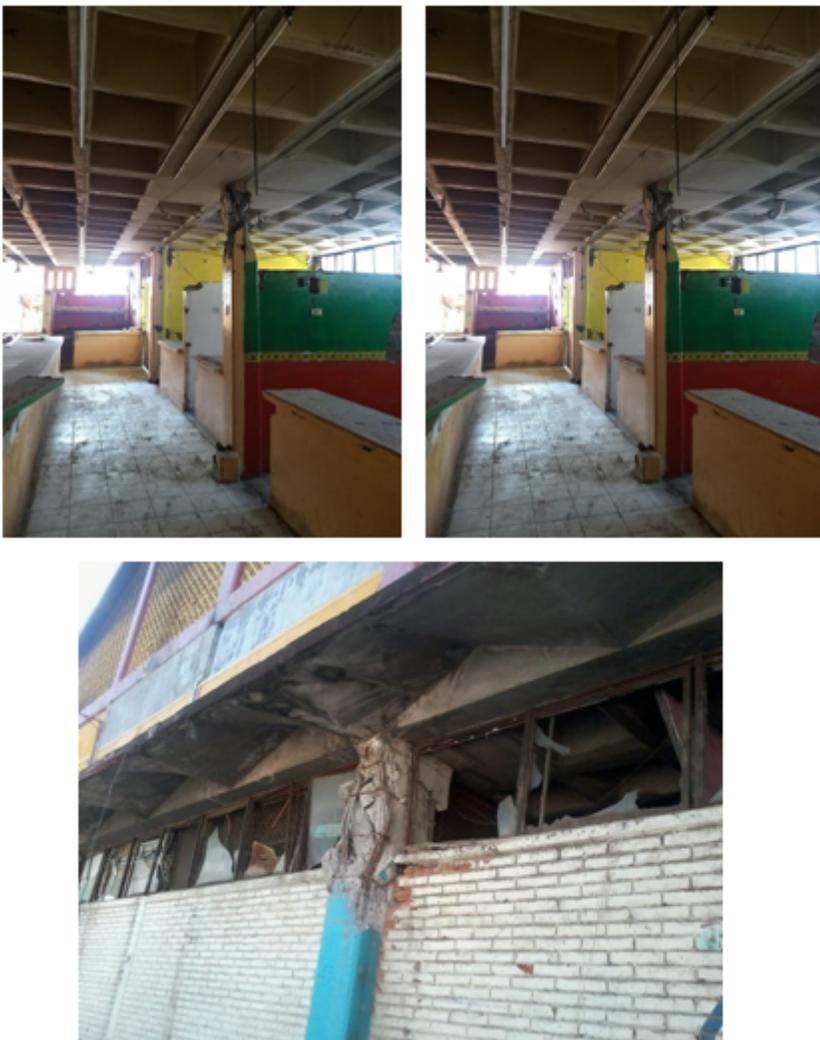
Figure 3

As shown in Fig. 3, the columns were severely damaged due to the short column effect, which consists of a partial restriction of the lateral displacement of the structural element, which forces all the stress and deformation demand to be concentrated in its free portion, which are substantially greater than those that would appear in the same column if it were free throughout its height. It was observed that this problem occurred because the non-structural masonry walls did not span the full height of the respective columns, but there were voids, in some cases for the windows. Among the local effects produced by the short column problem were the increase in lateral stiffness and shear stress, as well as the decrease in ductility. The global effects were derived from the incompatibility of deformations between the short columns and the rest of the structural members resistant to lateral actions, since the former failed prematurely and a chain reaction was generated (Beauperthuy and Urich 2011).

Short column effect on columns of the Juchitán market building

1. To rehabilitate the columns of the ground floor and the first floor, the cladding technique was used, which according to Ayala and Giraldo (2018) consists of a way to reinforce a structural element that has undergone changes in its resistant capacity, increasing its section wrapping it with an additional section of suitably reinforced concrete, in order to increase its load capacity against compression, bending, shear and torsion, guaranteeing simultaneous work between different elements. The foregoing in order to comply with the provisions of current regulations (resistance, safety factors, quality of materials, functionality and useful life). The construction process is shown in Fig. 6 and consisted of the following:

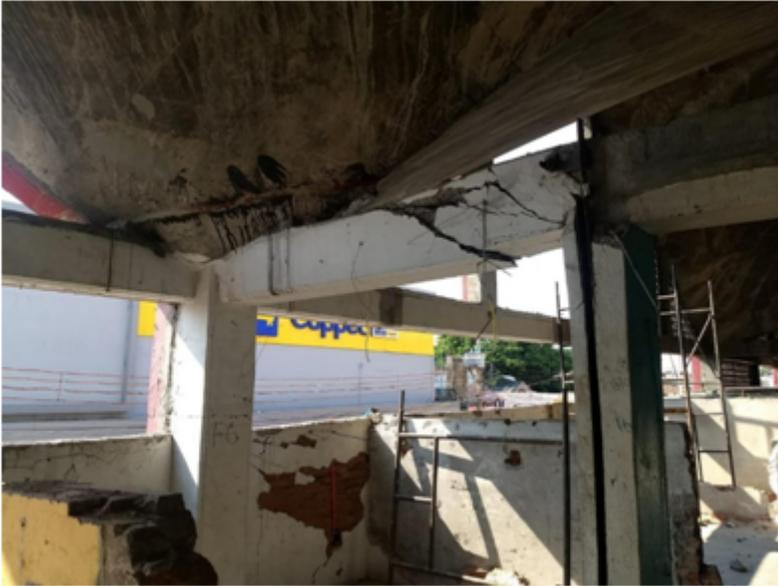
Figure 4

Likewise, in the northeast corner, there was a subsidence of the footing, which caused the prestressed girder of the second level to fail, so that there was an approximate difference in level in the corner area of 10 to 15 cm with respect to the horizontal. In Fig. 4, a beam shear failure is shown, which is characterized by the presence of diagonal cracks. On the other hand, Fig. 5 shows some non-structural damage, such as broken windows, detachment of finishes and shear cracking in non-structural walls.

Settlement in the Juchitán market property, which caused damage to the mezzanine

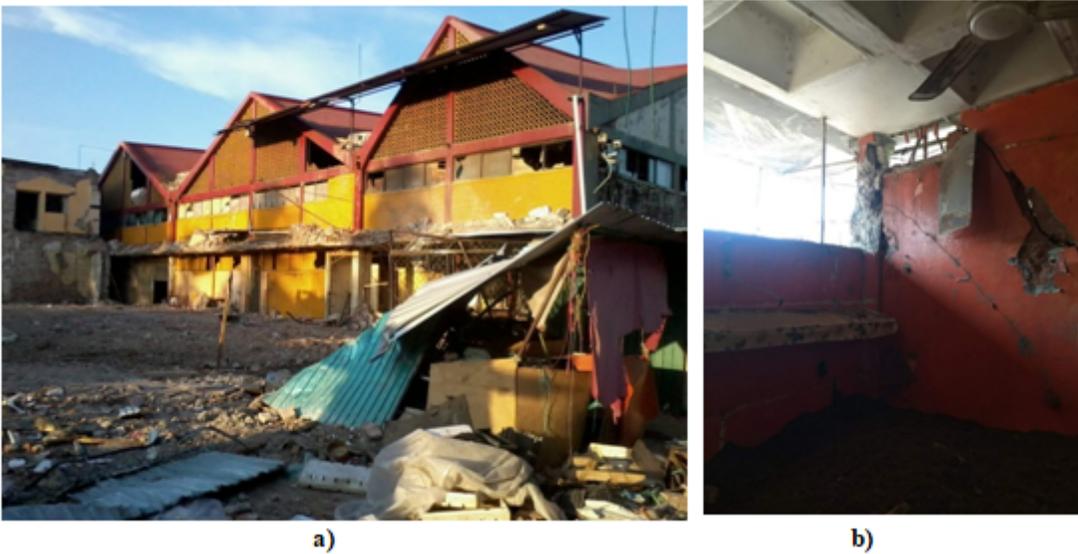
Figure 5

Damage nonstructural to market Juchitán a) release finishes and broken windows; b) shear cracking in non-structural wall
