Slope stability assessment along Indian Himalayan National Highway NH-154A

Research Article

Keywords: Slope stability, Factor of safety, Transport corridor, Chamba Himalaya

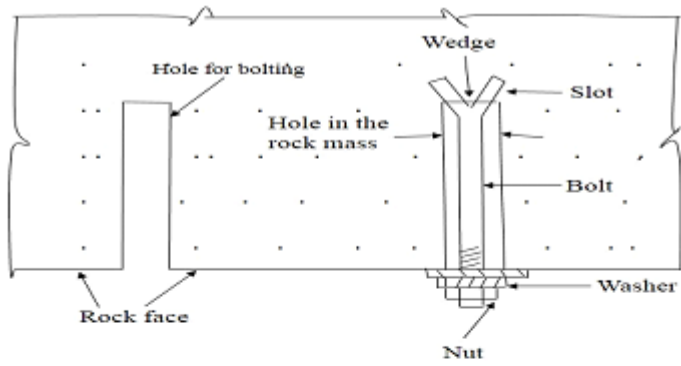
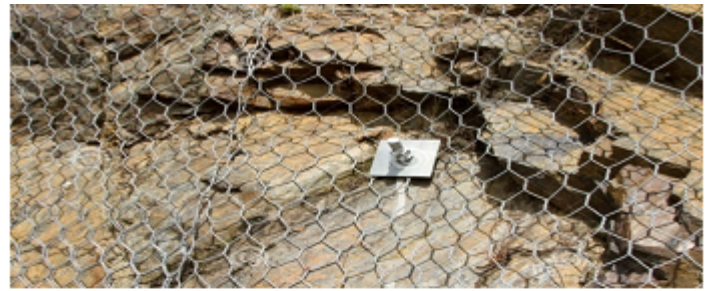
Mitigation measures to prevent slope surface a) Details of rock bolting (Verma BP 1985), b) Wire mesh and anchor bolt, c) Dry-mix shotcrete process using bagged mix feeding a pump and pre-moisturizer (Wyllie and Mah 2004), d) Shotcrete-stabilized cliff (<https://en.wikipedia.org>)

planar slides, major toppling and general slope instabilities. For anchoring, along block size 1.5 to 2m, anchor of length 5m should be applied at the spacing of 2 to 2.5m as shown in Figure 7 (a, b).

The steel bars of diameter 25 to 40mm can be used. The anchor plates of size 30×30cm should be fixed on top of the rock bolt. After rock bolting, a polymer wire mesh or net should be anchored on the slope surface with nails before shotcreting to prevent falling of loose rock and shotcrete pieces (Figure 7c). Then, the systematic shotcreting in the form of cement water slurry should be injected into it under high pressure of 0.5 to 1.0 kg/cm² to protect the slope surface from erosion and weathering. Shotcrete consist of water cement mortar and it can be applied to the slope surface by an air jet Figure 7(c, d). Thickness of the shotcreted layer varies from 50mm to 70mm. The shotcreting is mainly for highly jointed rocks and is profitable, which can be done very quickly.
