Geotechnical Assessment Using Kinematic Analysis for an Unstable Road Cut, Along Haibat Sultan Mountain, Iraqi Kurdistan Region

Research Article

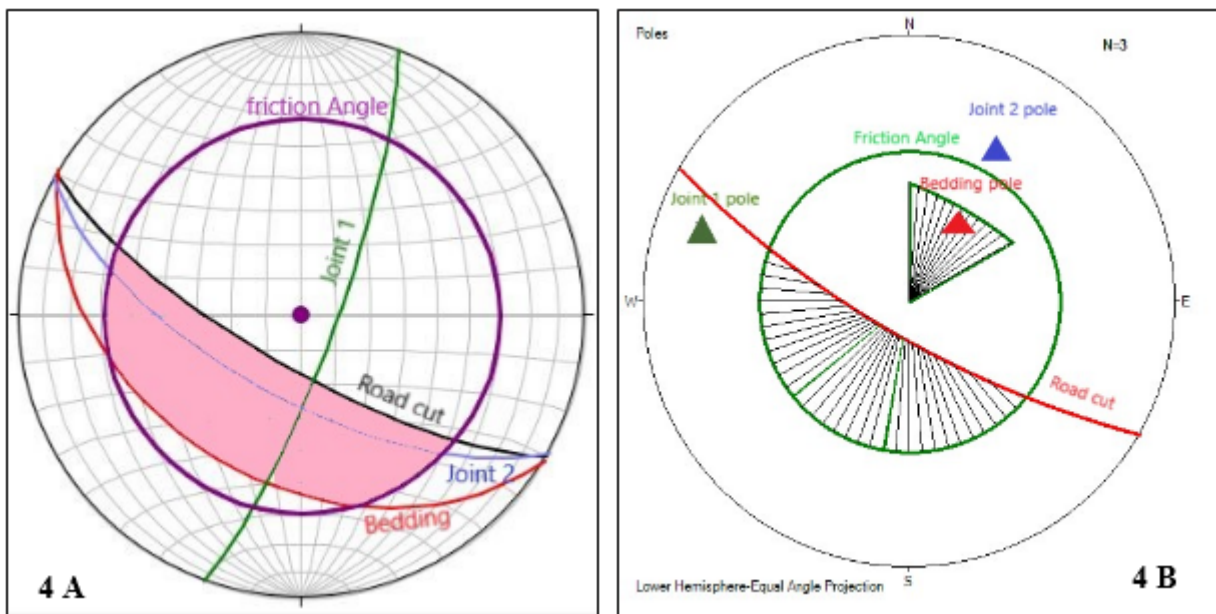
Figure 3

The kinematic analysis for this station shows: The amount of the slope angle is 75° and that of the dip of the bedding plane is 41° , since ($\psi_A < \psi_f$) (a Daylight slope); therefore, the possibility of the failure is high (marked by pink colour in Fig. 3). The analysis was performed using DipAnalyst 2.0 software. The sliding could be prevented by only cutting the slope at an angle less than 41° . The dip amount and direction of the discontinuity sets (joints 1 and 2) may also influence the stability. Plane sliding is less likely; if the dip direction of the discontinuity (α_A) differs from the dip direction of the face (α_f) by more than about 20° ; $|\alpha_A - \alpha_f| > 20^\circ$, i.e. $\alpha_A - \alpha_f$ must be more than 20° . Accordingly, for the joint 1: $|209^\circ - 120^\circ| = 89^\circ$, and because $89^\circ > 20^\circ$, therefore joint 1 has no effect on the sliding. For joint 2 $|121^\circ - 120^\circ| = 1^\circ$, and because $1^\circ < 20^\circ$, therefore, there is a main effect of joint 2 on the sliding. This assumption is according to [1 and 2]. The data in this station show that the friction angle is greater than slope angle and the discontinuities are within the shaded area (Fig. 3). Therefore, a potentiality for a planar failure exists. The calculated factor of safety for this station is 0.67 (Fig. 3 and Table 3).

Stereographic projections of stations No. 4. For 4 A, the bedding plane is in red color, joint planes are in green and blue colors, road cut is in black color and the internal friction angle is in violet color. The pink area represents the critical area indicating potentiality for sliding. For 4 B, the road cut is in red color as great circle. The bedding planes (in red), joint planes (in green and blue), all are represented as poles, whereas the internal friction angle is in green. On **4 A**, the critical area is highlighted, whereas in **4 B** the critical area is determined by DipAnalyst 2.0 software. Note the similarity between the critical areas in both cases.

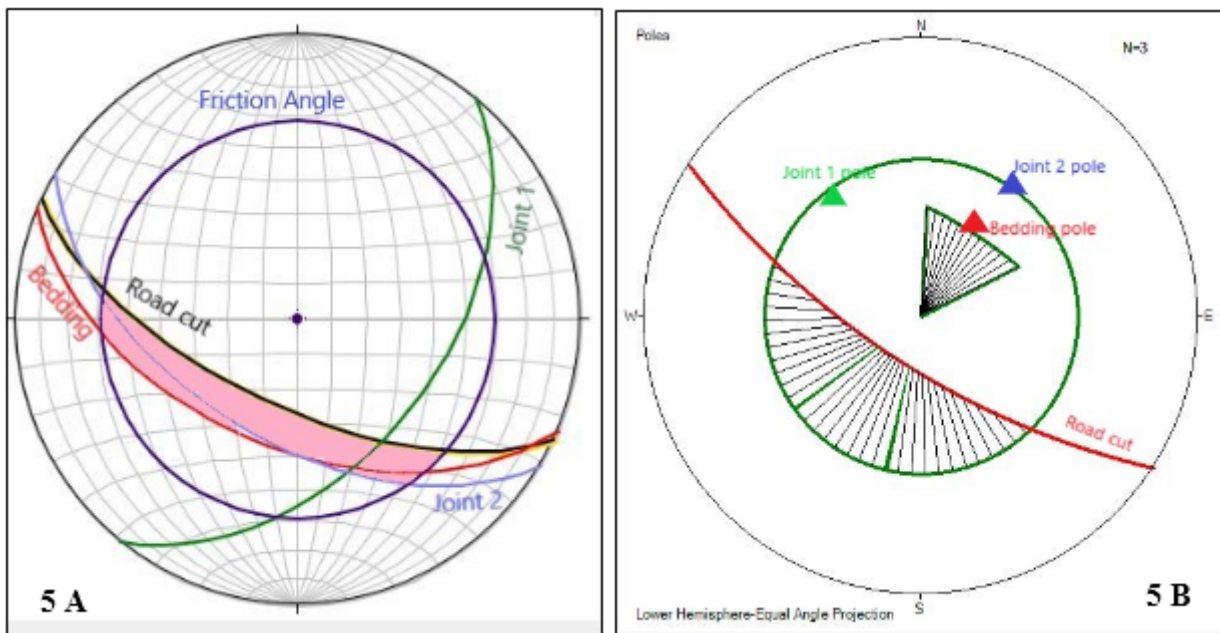
Figure 4

The kinematic analysis shows that the dip of the bedding plane has moderate effect on sliding as Ψ_A (51°) $< \psi_f$ (65°) and increasing the angle of the slope will lead to high possibility of sliding. The direction of the bedding plane has a major effect on sliding as $|112 - 115|$ must be $> 20^\circ$, and because $3^\circ < 20^\circ$. The joint 2 also has a main effect on sliding as $|121 - 115|$ must be $> 20^\circ$, and because $6^\circ < 20^\circ$. While joint 1 has no significant role in the failure, because $|219 - 115|$ must be $> 20^\circ$ and because $104^\circ > 20^\circ$. The analysis by DipAnalyst 2.0 software shows that there is a high possibility for sliding by the bedding plane and joint 2 as both are within the shaded area (Fig. 4). The factor of safety is 0.75 (Table 3), which indicates that sliding possibility is high (Fig. 4). At this station, toppling is not possible since the pole of the bedding plane is out of the toppling zone criteria (Goodman, 1989) (Fig. 4).

Stereographic projections of station No. 5. For 5 A, the bedding plane is in red color, joint planes are in green and blue colors, road cut is in black color and the internal friction angle is in violet color. The pink area represents the critical area indicating potentiality for sliding. For 5 B, the road cut is in red color as great circle. The bedding plane (in red), joint planes (in green and blue), all are represented as poles, whereas the internal friction angle is in green. On **5 A**, the critical area is highlighted, whereas in **5 B** the critical area is determined by DipAnalyst 2.0 software. Note the similarity between the critical areas in both cases.

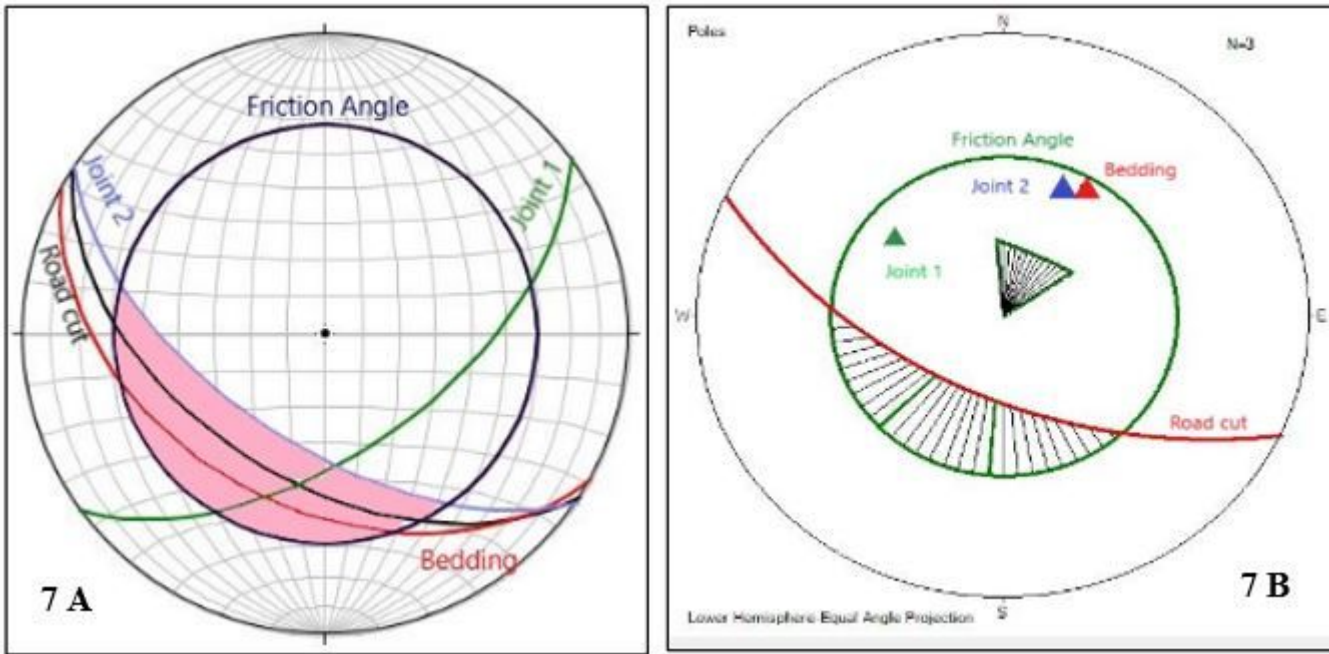
Figure 5

The kinematic analysis shows that the slope angle is almost equal to the dip of the bedding plane; thus, it has minor to moderate effect on the sliding along layers of rocks in this station. Increasing of the angle of the slope in the same direction of the bedding plane will trigger failure. The direction of the bedding plane and Joint 2 has a significant role in sliding as the difference in their direction to the direction of the Road cut (slope face) is less than 20° . Joint 1 has almost no effect on sliding (Fig. 5) because joint 1 is dipping to southeast while the bedding plane and road cut (slope face) are dipping southwest ward. The numerical analysis by DipAnalyst 2.0 software shows that the value of the factor of safety is 0.66 (Table 3). At this station, toppling is less possible since the pole of the bedding plane is almost on the limits of the toppling zone criteria (Goodman, 1989) (Fig. 5).

Stereographic projections of station No. 7. For 7 A, the bedding plane is in red color, joint planes are in green and blue colors, road cut is in black color and the internal friction angle is in violet color. The pink area represents the critical area indicating potentiality for sliding. For 7 B, the road cut is in red color as great circle. The bedding plane (in red), joint planes (in green and blue), all are represented as poles, whereas the internal friction angle is in green. On 7 A, the critical area is highlighted, whereas in 7 B the critical area is determined by DipAnalyst 2.0 software. Note the similarity between the critical areas in both cases.

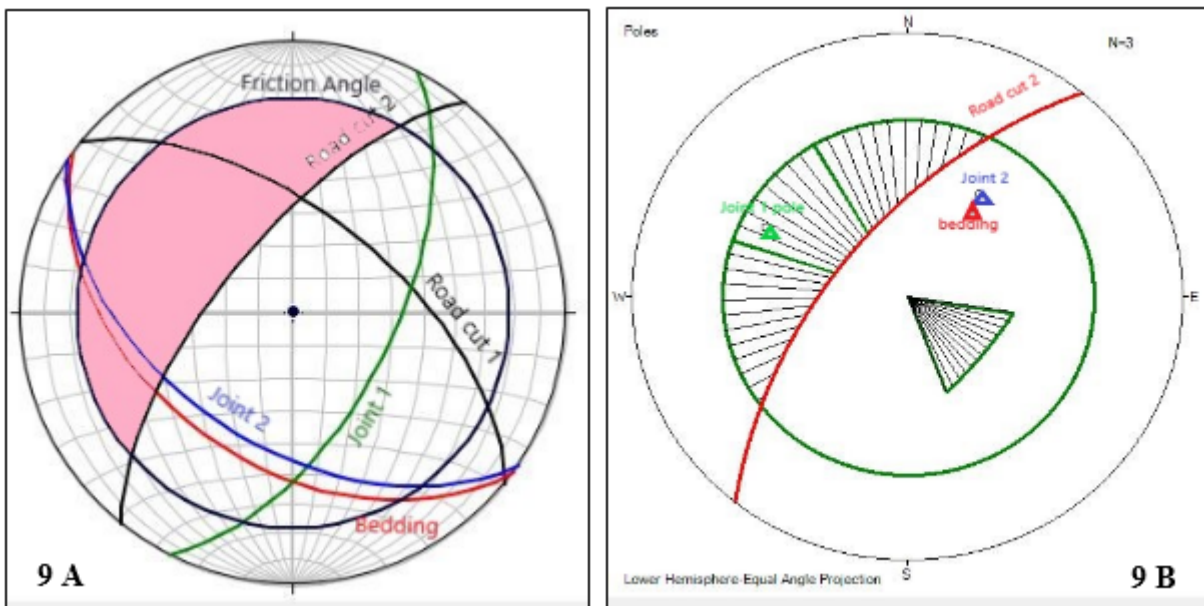
Figure 6

The kinematic analysis shows that the slope face (Road cut 1), which is 129/60° NE has no effect on the sliding. However, the slope face (Road cut 2), which is 219/68° NW has significant effect on the sliding. Moreover, Joint 2, which is 124/50° SW plays a big role in the sliding (Fig. 6). The factor of safety is 0.85 (Table 3). This indicates that sliding is likely to occur in Joint 2 and Road cut 2. At this station, toppling is not possible since the pole of the bedding plane is out of the toppling zone criteria (Goodman, 1989) (Fig. 6).

Stereographic projections of station No. 9. For 9 A, the bedding plane is in red color, joint

planes are in green and blue colors; road cuts are in black color and the internal friction angle is in violet color. The pink area represents the critical area indicating potentiality for sliding. For 9 B, the road cut is in red color as great circle. The bedding planes (in red), joint planes (in green and blue), all are represented as poles, whereas the internal friction angle is in green. On **9 A**, the critical area is highlighted in pink color, whereas in **9 B** the critical area is determined by DipAnalyst 2.0 software. Note the similarity between the critical areas in both cases.

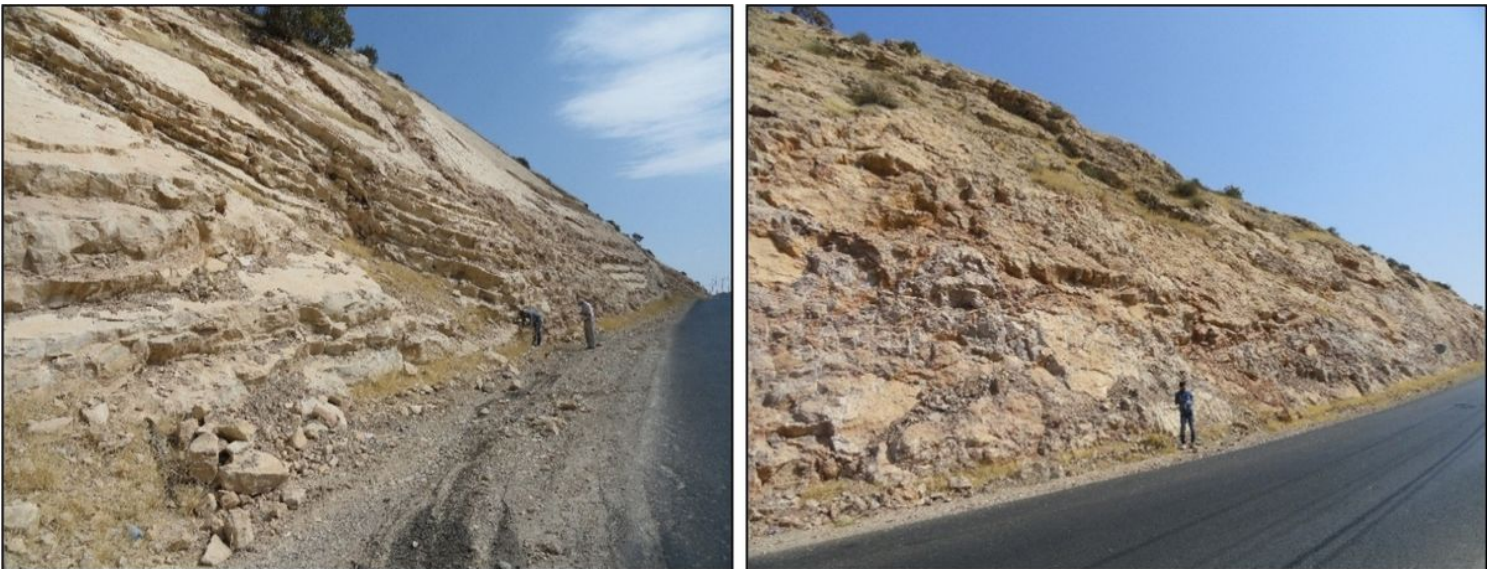
Figure 7

Daylighting slopes of the well bedded rocks of the Pila Spi Formation. Note the unstable slopes due to road cuts, which are almost parallel to the dip of the beds (Station No. 7).

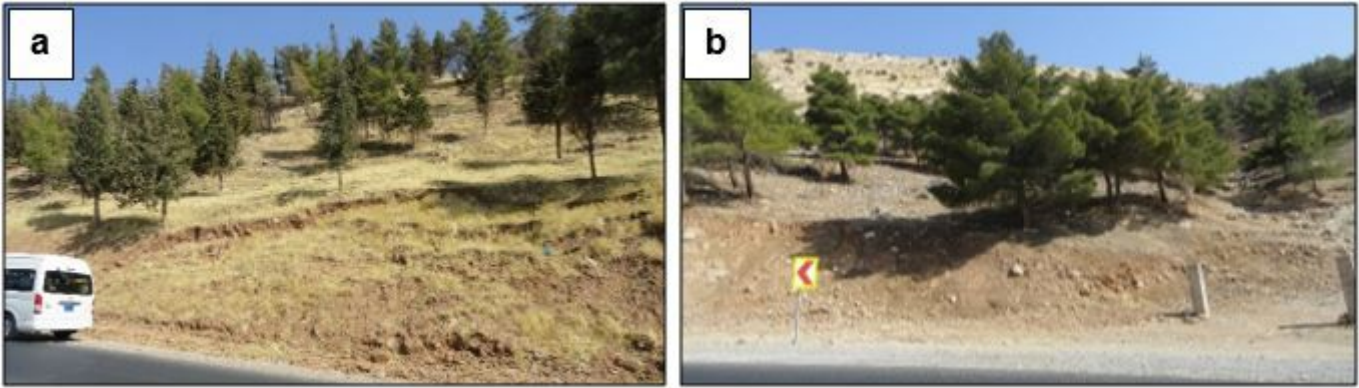
Figure 8

Two unstable slopes in residual soils. 8a Station No. 1, note the recent failure with the developed cliff in the crown area. 8b Station No. 2, note the inclined trees.

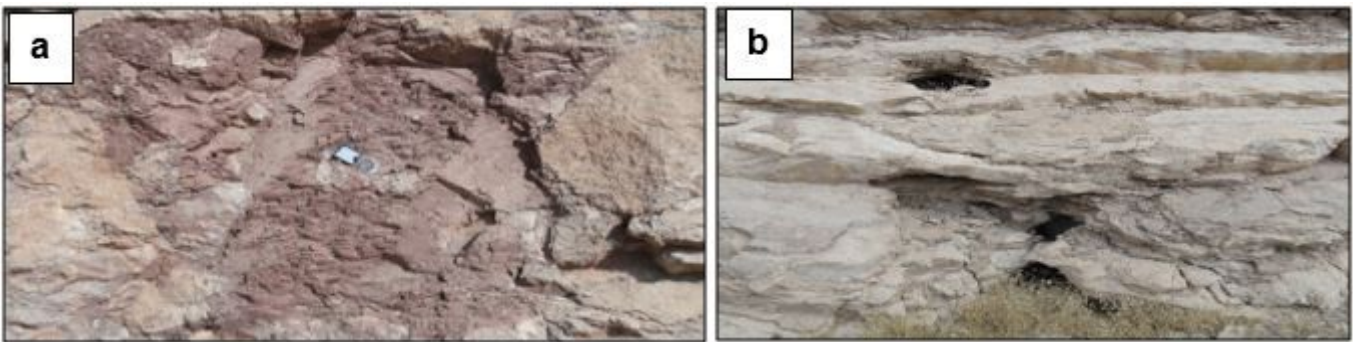
Figure 9

These include stations Nos. 1–7 (Fig. 1). The main reasons for the presence of landslides and potential areas for sliding are: **1)** The majority of the road cuts are almost parallel to the bedding planes of the Pila Spi Formation, which forms daylighting slopes (Fig. 7), **2)** Locally, claystone and/ or residual clayey soil form potential areas for sliding (Stations No. 1 and 2) (Fig. 8), especially when oversaturated by rain water, which will increase the pore water pressure. This will decrease the internal friction and cause sliding (Terzaghi, 1943 and Terzaghi et al., 1996), **3)** The carbonates of the Pila Spi formation, locally includes karst cavities (Fig. 7b), which accelerates water penetration in the slope causing the failure. Also, some claystone layers can produce lubricated sliding surfaces (Fig. 9a).

The Pila Spi Formation, 9a Reddish brown claystone, it acts as a lubricant surface for sliding after being oversaturated, 9b Karst cavities, which accelerate water penetration (Near Station No. 7).

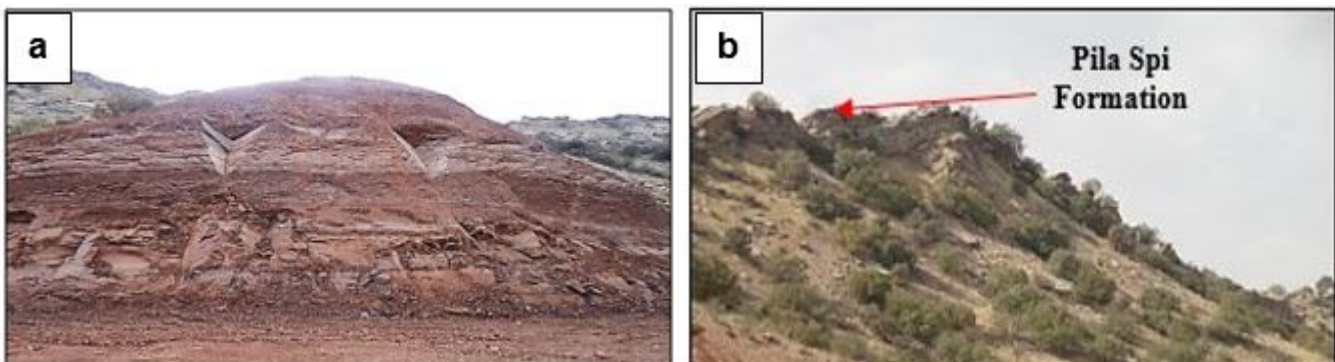
Figure 10

This is attributed to: **1)** The claystone beds within the Gercus Formation are thinly bedded and intensely jointed (Fig. 10a); therefore, these areas are prone to disintegrate; even though the road runs along slopes, which are opposite to the dip direction, **2)** The directions of the road cuts and their slope angles intersect with the attitudes of the bedding and joint planes and form unstable slopes, and/ or prone areas for wedge failure (Fig. 10a), and **3)** The anti-dip slope is capped by the carbonates of the Pila Spi Formation forming hanging cliffs (Fig. 10b) because of the weathering of the soft rocks of the Gercus Formation, thus forming unstable slopes, which may exhibit toppling, sliding and occasionally rock fall.

a. The Gercus Formation well bedded and intensely jointed claystone beds and the two-wedge sliding (Station No. 10), 10b Hanging cliffs formed by the carbonates of the Pila Spi Formation, overlying soft rocks of the Gercus Formation; forming prone areas for sliding, toppling and rock fall.

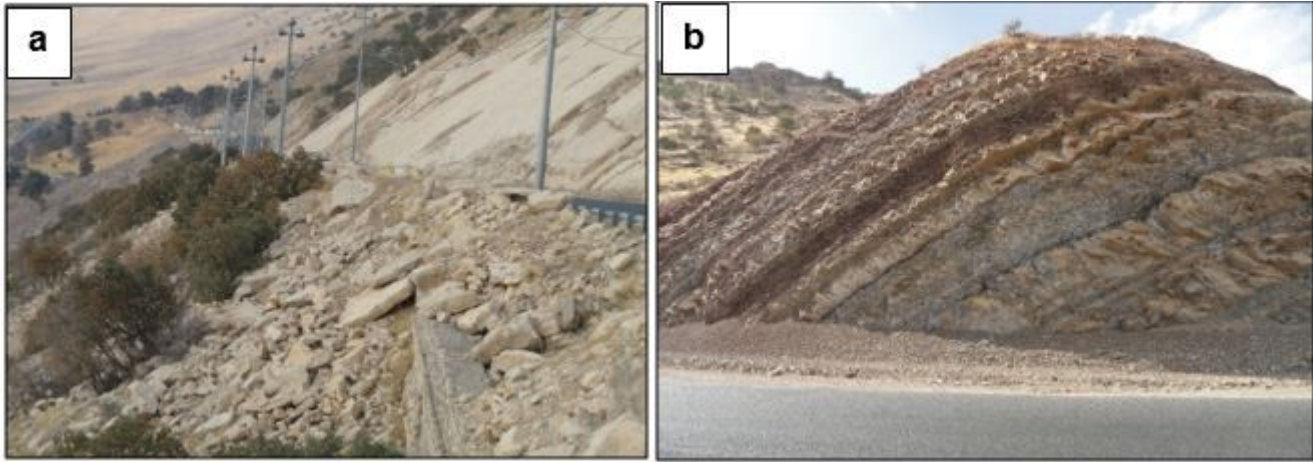
Figure 11

The sliding masses in section B – C are large; up to more than one cubic meter (Fig. 11a), whereas in section C – D, the mass wasting is in the form of very small pieces (Fig. 11b). This is attributed to the exposed Pila Spi Formation (Massive limestone beds) in the former, whereas the Gercus Formation (Thinly bedded soft claystone beds) is exposed in the latter (Sissakian and Al-Jibouri, 2014) .

a. Remains of an old landslide of the Pila Spi Formation dumped down of landslide areas (Near Station No. 7). Note the size of the blocks and damaged parts of safety wall alongside the road, 11b Remains of mass wasting of thinly bedded claystone in the Gercus Formation (Station No. 11).
