# Mechanical wear analysis helps understand a mechanism of failure in retrieved magnetically controlled growing rods: a retrieval study

## Research article

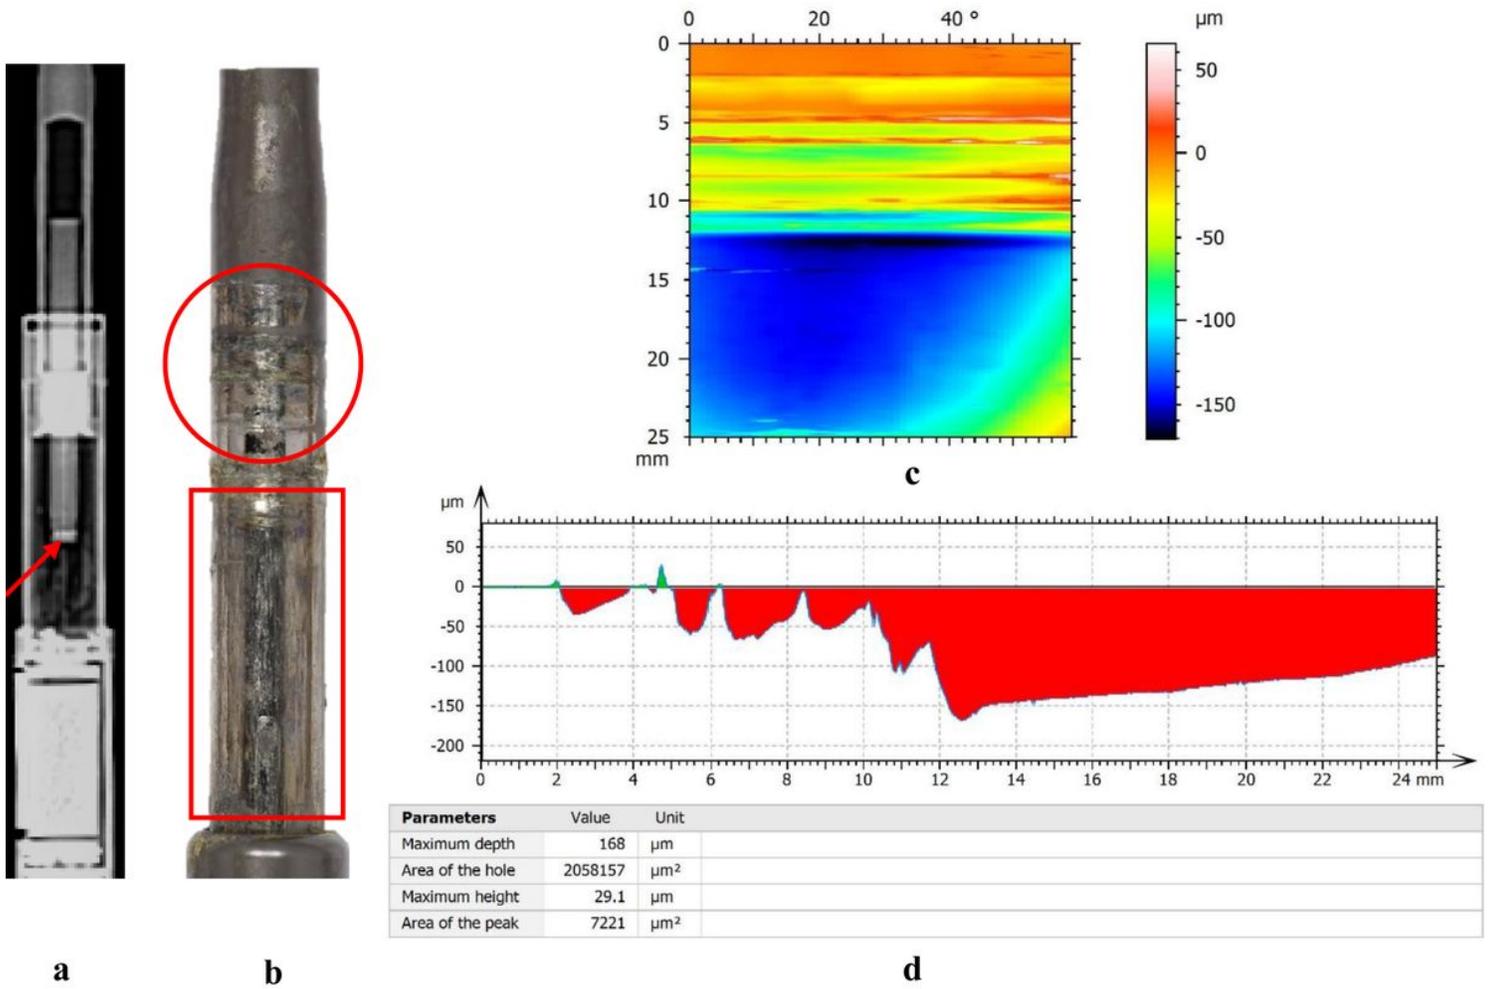
**Figure 1**

Single-side wear marks were seen in the telescopic bars of almost all the rods in our study, indicative of the effect of 'off-axis loading' proposed by a previous study [10]. We found that rods with a damaged internal mechanism showed a prominent wear pattern [9]. Specifically, except for one rod (rod 32) that likely failed to distract after its pin fracture, all the other nine rods with damaged internal mechanism showed longitudinal wear marks, of which five rods showed a mixture of spaced circumferential and consecutive longitudinal wear marks. Coupled with the significant increase of material loss detected in retrieved rods with a damaged internal mechanism, we suggest that 'off-axis loading' accounts for the initial spaced wear marks and breakage of the internal mechanism, while the subsequent uncontrolled lengthening of telescopic bars driven by patients' growing spine contributes to the longitudinal wear marks and further increased material loss (Fig. 11).

**Fig. 11** Plain radiograph (a), photograph (b), surface contour map (c) and trace profile (d) of a retrieved MAGEC rod with a pin fracture. We suggest that 'off-axis loading' accounts for the initial spaced wear marks (*circle*) and the pin fracture (*arrow*) and the subsequent uncontrolled lengthening of the rod contributes to the longitudinal wear marks (*box*) and further massive material loss

Plain radiograph (a), photograph (b), surface contour map (c) and trace profile (d) of a retrieved MAGEC rod with a pin fracture. We suggest that 'off-axis loading' accounts for the initial spaced wear marks (circle) and the pin fracture (arrow) and the subsequent uncontrolled lengthening of the rod contributes to the longitudinal wear marks (box) and further massive material loss

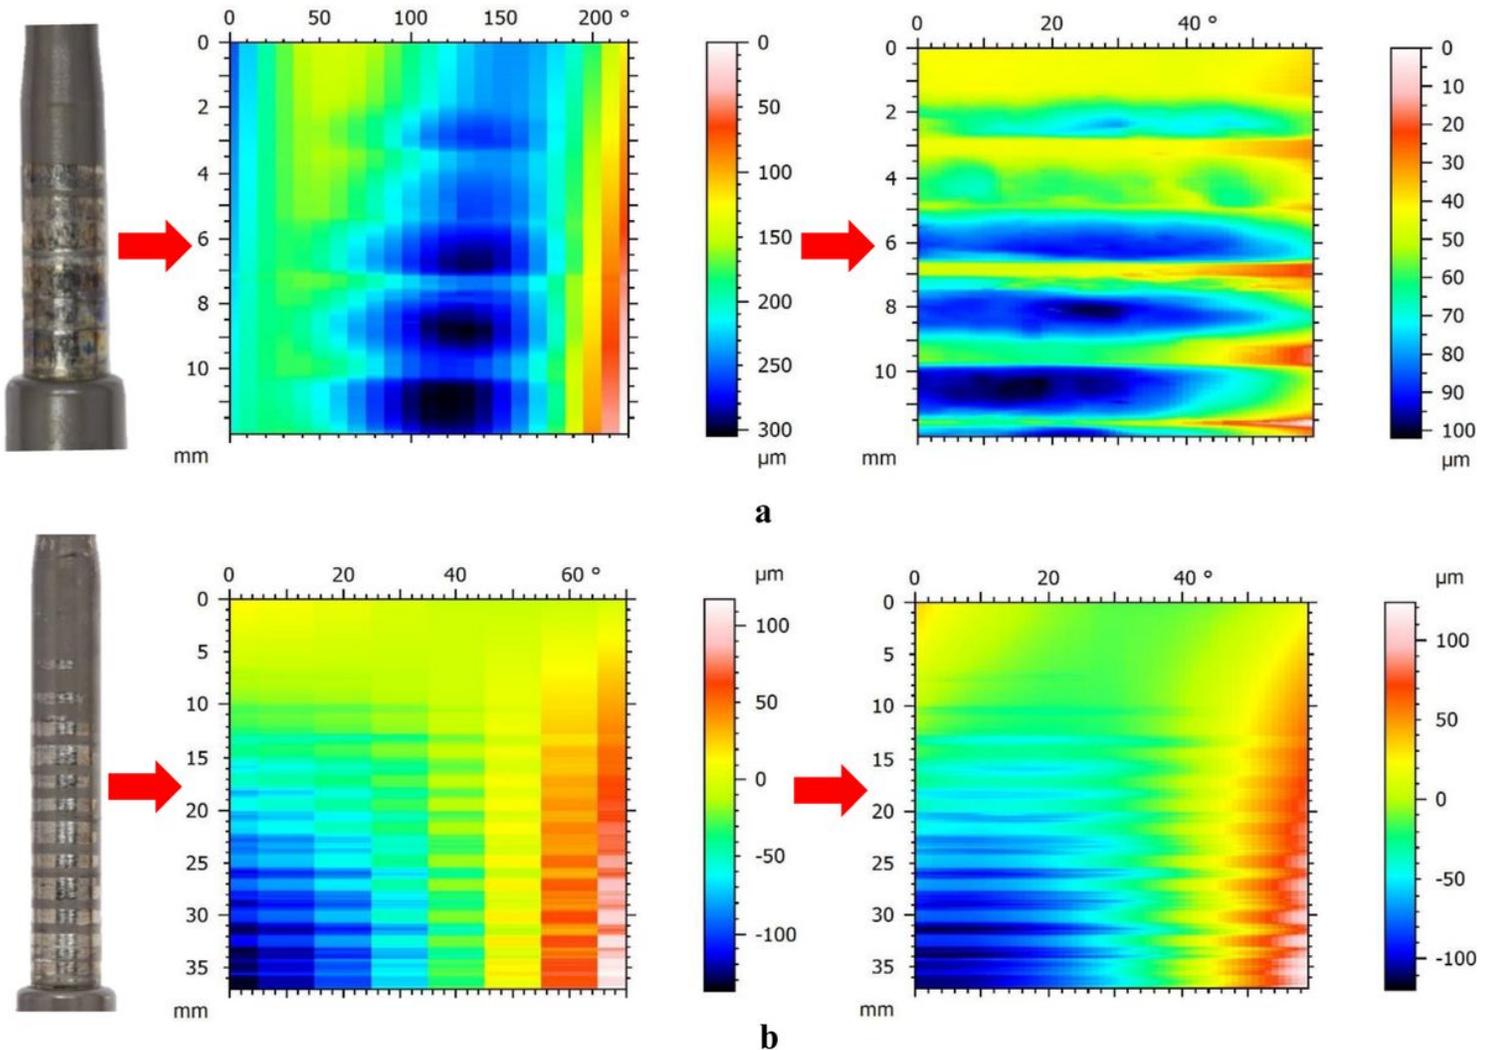
**Figure 5**

The median (INQ) of the measuring length (mm) was 13 (5.8-25), while the median (INQ) number of traces was 12.5 (9-16.5). The resulting contour maps of 24 rods (71%) corresponded to the visible wear marks in the telescopic bars, while surface mapping in 10 rods (29%) failed to reflect the actual profile of surface wear (Fig. 7).

Photographs and surface contour maps of the telescopic region of two MAGEC rods. Each rod was mapped twice with serial traces taken at 10° and 1° interval in the visible worn and the most worn regions, respectively. The surface maps corresponded to the visible wear in the first rod (a), while the surface maps of the second rod failed to depict the actual wear profile (b)

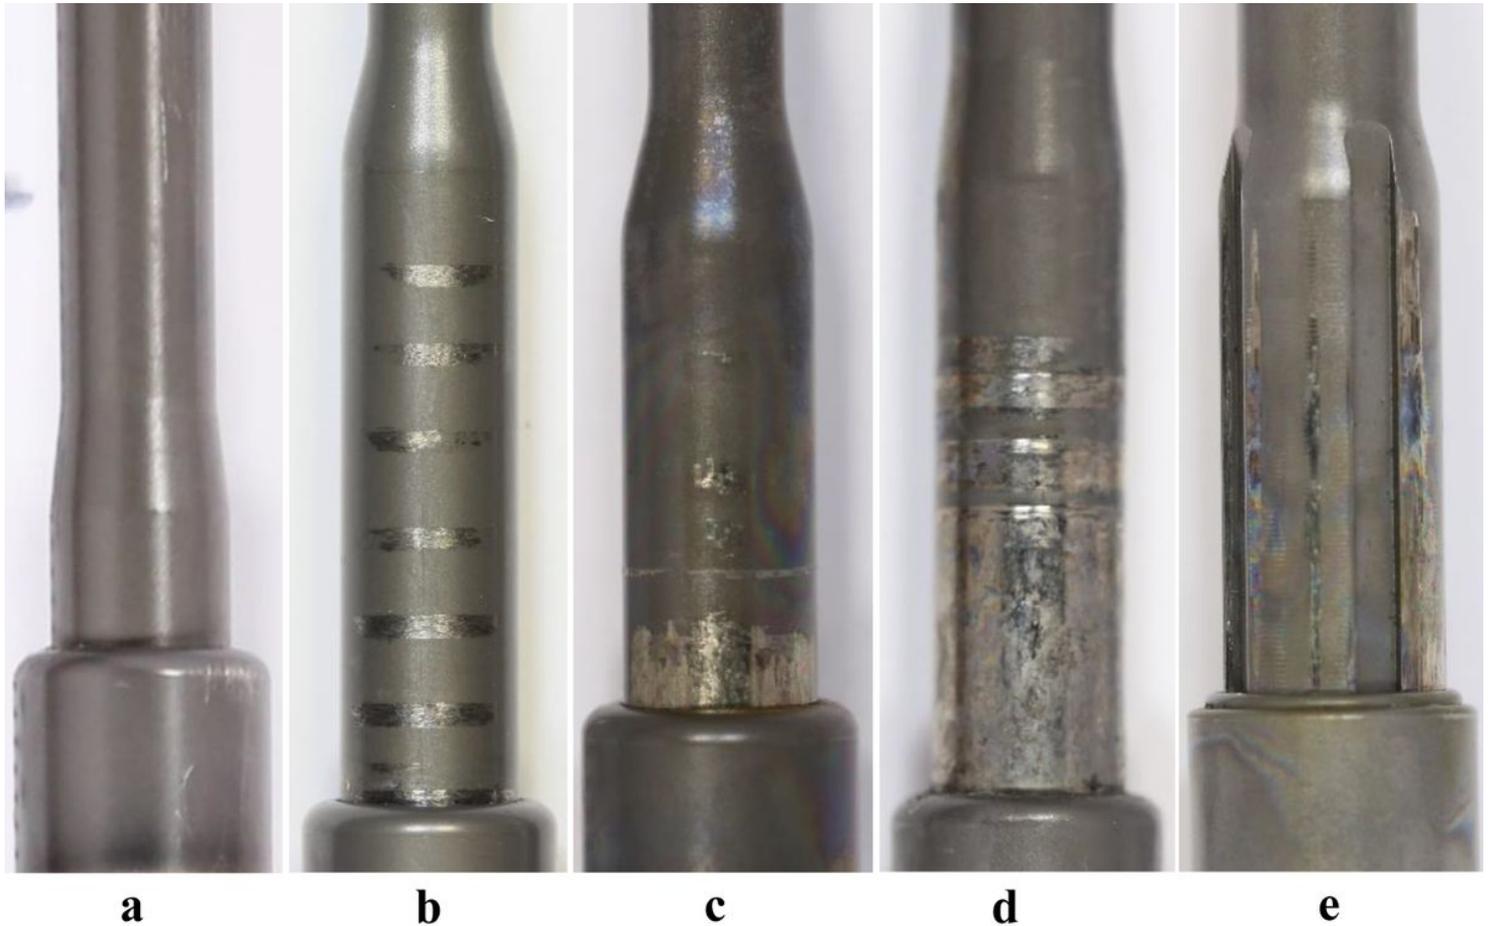
**Figure 6**

33 rods (97%) showed evidence of wear marks on one side of the telescopic bars (Fig. 6). Circumferential wear marks were seen in 24 rods (71%), while longitudinal wear marks were noticed in 9 rods (27%), of which 5 rods were combined with circumferential wear marks. 2 rods (rod 19, 20) showed modified design in the telescopic bars (Fig. 6e).

Photographs of the telescopic region of five MAGEC rods showing no wear mark (a), circumferential wear marks (b), longitudinal wear marks (c), combined wear marks (d) and a modified telescopic design (e)

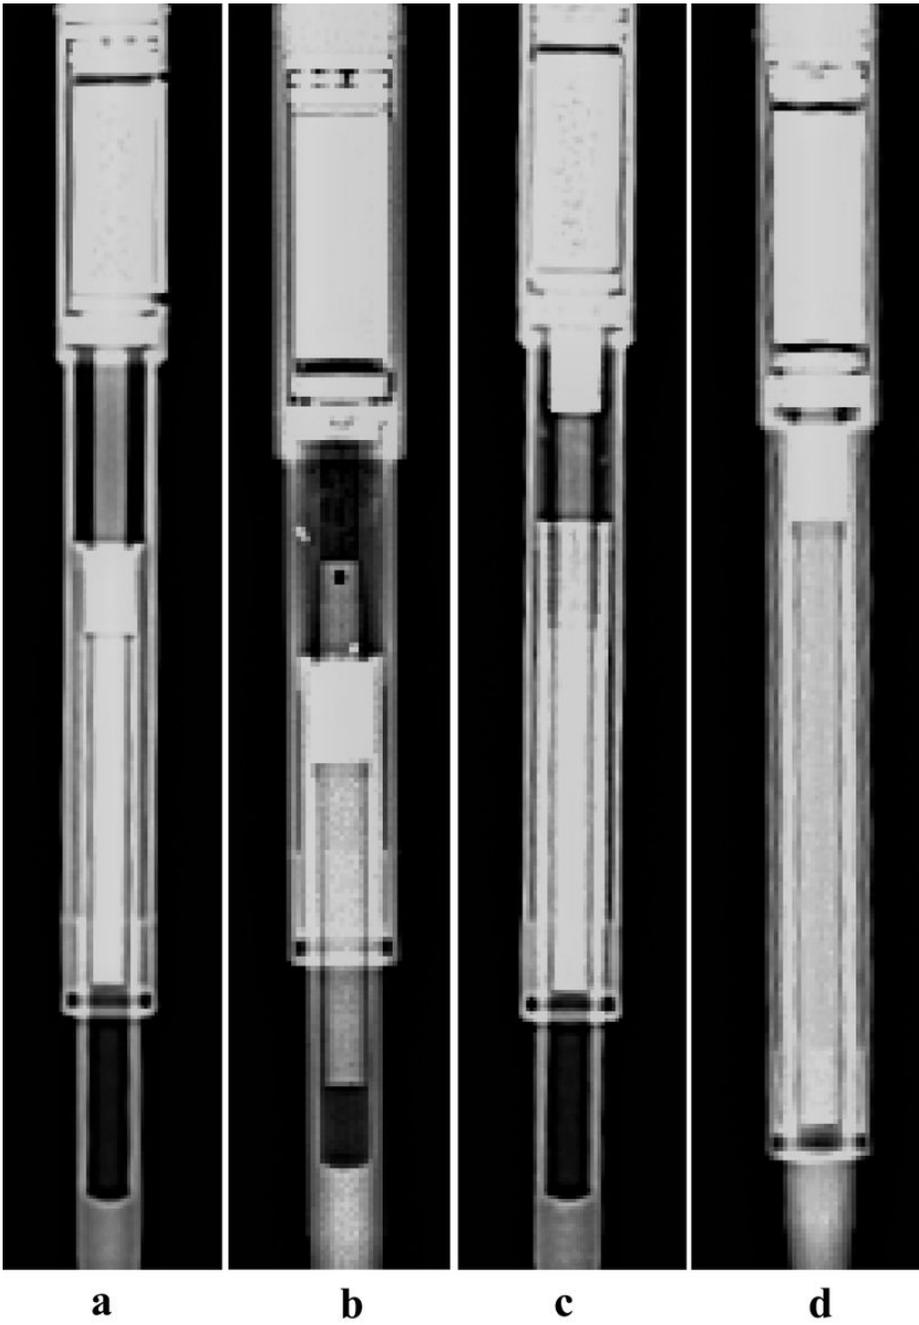
**Figure 7**

An intact internal mechanism was observed in 22 rods (65%), while 10 rods (29%) showed evidence of a damaged internal mechanism (Fig. 5). Fractures of locking pins were detected in 8 rods (24%), while the internal thread mechanism of telescopic bars was dislocated in 2 rods (6%). The status of internal mechanism was unclear in 2 rods (6%).

Plain radiographs of four MAGEC rods showing an intact internal mechanism (a), locking pin fracture (b), dislocated internal thread of the telescopic bar (c) and unsure status of internal mechanism (d)

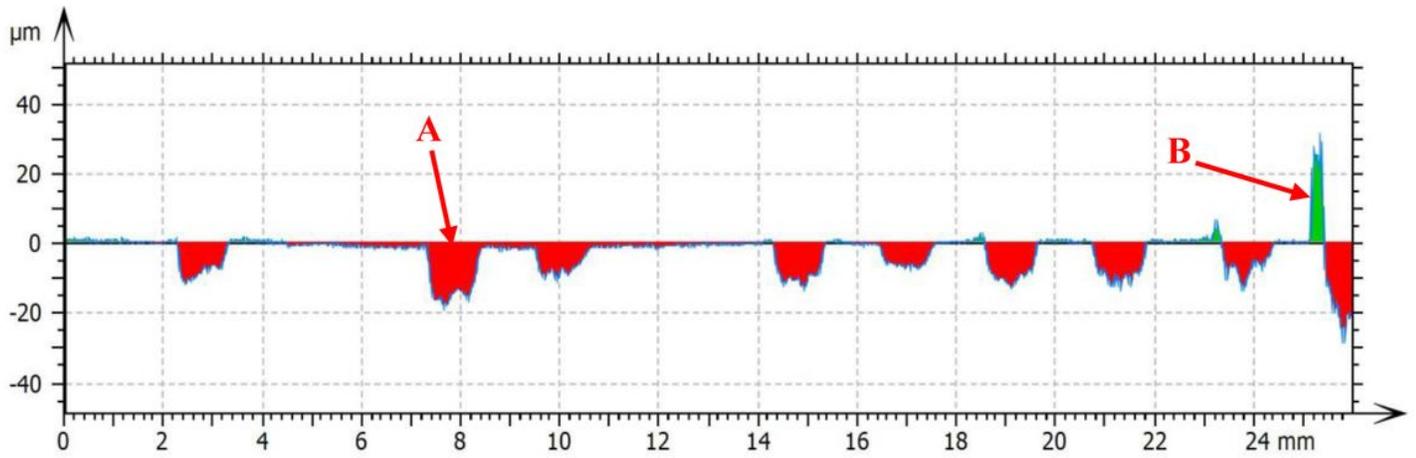
**Figure 8**

Profile of a trace extracted from the contour map of the telescopic region of a MAGEC rod. Surface wear was depicted as several valleys (A, red), while surface debris was shown in green (B, green). The maximum depth of these valleys (C) and the summed area of all the valleys (D) were calculated.

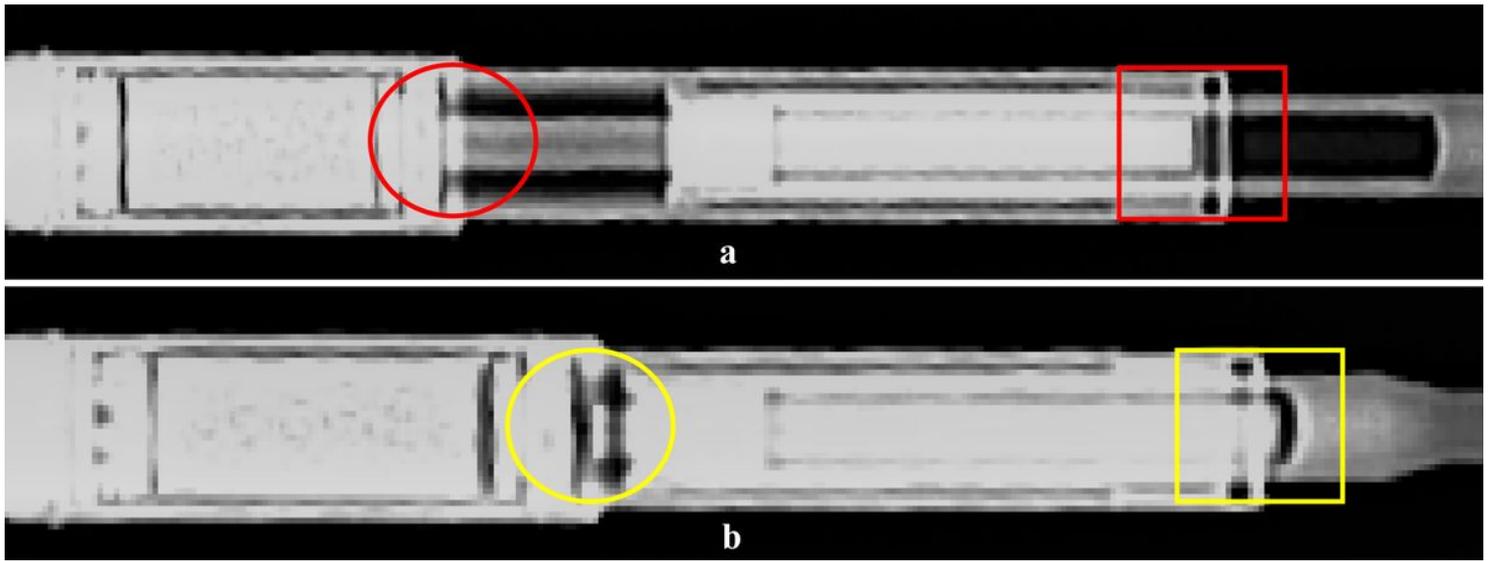
**Figure 10**

We hypothesised that analysing mechanical wear could help understand the failure of the internal mechanism in retrieved MAGEC rods. Using a medical X-ray device at 60 kV and 4 mA, the internal mechanism of all the rods was assessed by plain radiographs. According to a recent notice of MAGEC system announced by the manufacturers in June 2019 [11], the internal mechanism was deemed to be damaged when the internal components were disconnected or the internal driving screw was beyond the actuator case, both as a result of pin fractures (Fig. 2).

Plain radiographs of two MAGEC rods with intact (a) and damaged (b) internal mechanism. In the first rod (a), the connection of internal mechanism was intact (circle) and the internal driving screw was within the actuator case (box). In the second rod (b), the internal mechanism was disconnected (circle) and the internal driving screw was beyond the actuator case (box)
