# The *Samuel F. B. Morse* Statue in Central Park: Toward a Sustainable Regime of Science-Based Monuments Conservation

## Research article

**Keywords:** outdoor sculpture, laser cleaning, conservation, 19th century, coating, gunmetal, corrosion

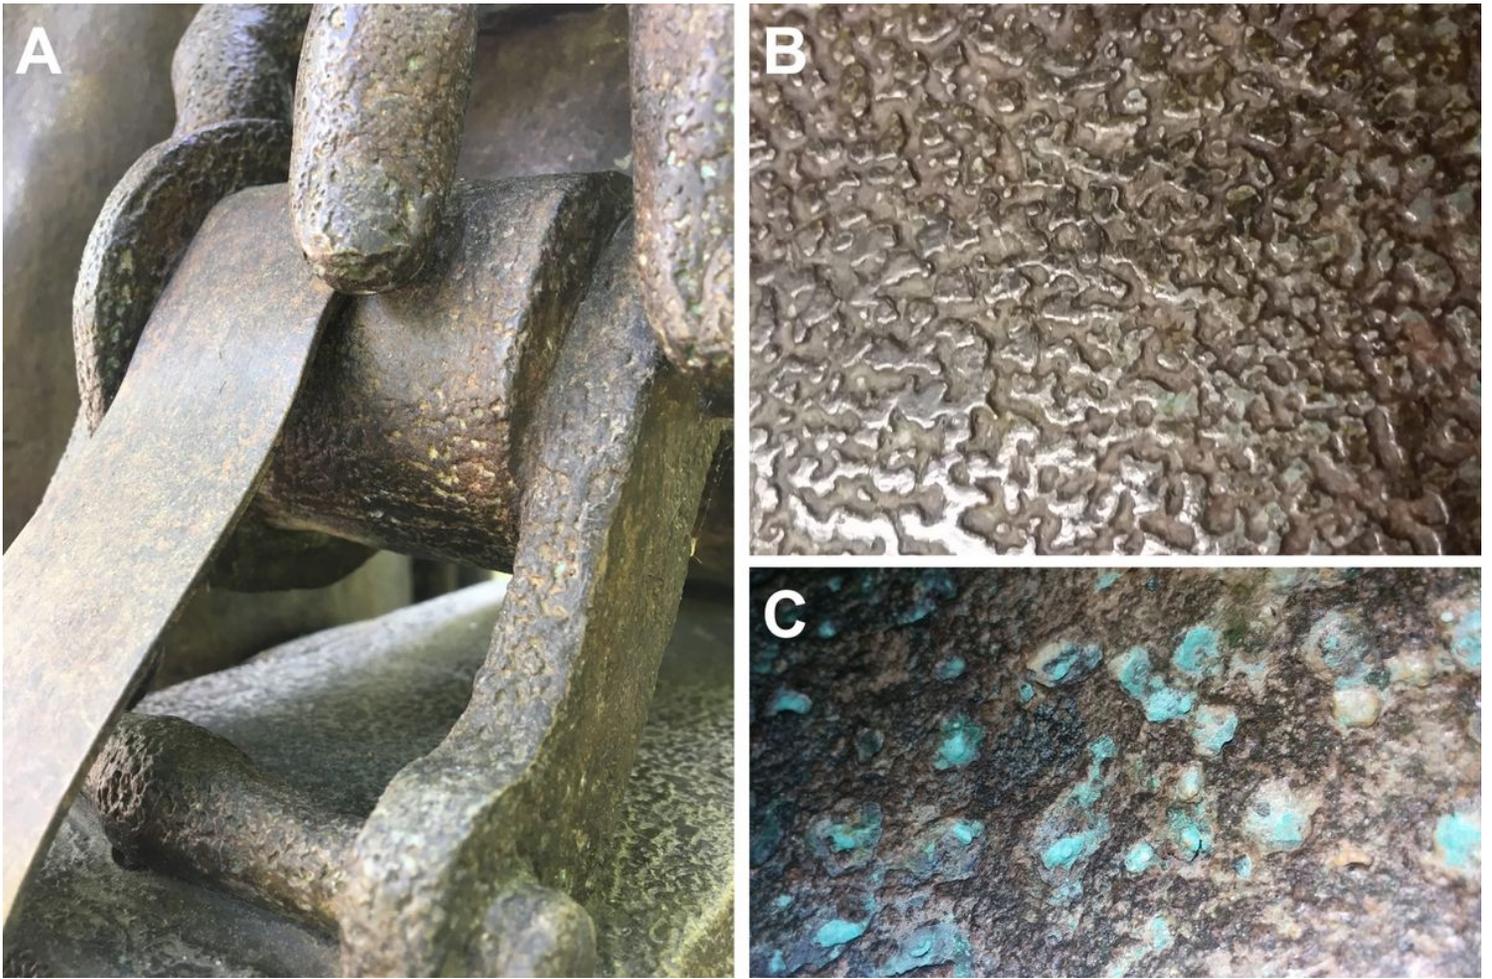
**Figure 2**

Preliminary visual examination of the Morse sculpture enabled conservators to identify the main ongoing conservation issues, which were mostly related to corrosion and to the presence of one or more degraded organic coatings. Over time, the statue's surface has suffered from severe corrosive attack. Pitting and loss of sculptural surface details (Fig. 2) were caused by the exposure to atmospheric pollutants such as acid rain and chlorides from deicing salts and the marine environment, in addition to dry deposition of biogenic and anthropogenic pollutants such as NO<sub>2</sub>, SO<sub>2</sub>, and carboxylic acid. The exposed surfaces have remained stable since being regularly treated with cleaning interventions and protective coatings beginning in the 1990s. However, localized patches of virulent, irregularly shaped pustules of active corrosion were contributing to progressive surface loss (Fig. 3a) and associated coating failure in the deep recesses of the figure's

Condition issues observed on the Morse sculpture (I). (A) Detail of sculptural surface loss. (B) Typical pitting and loss pattern on exposed surfaces. (C) Detail of active corrosion present in the recessed areas.

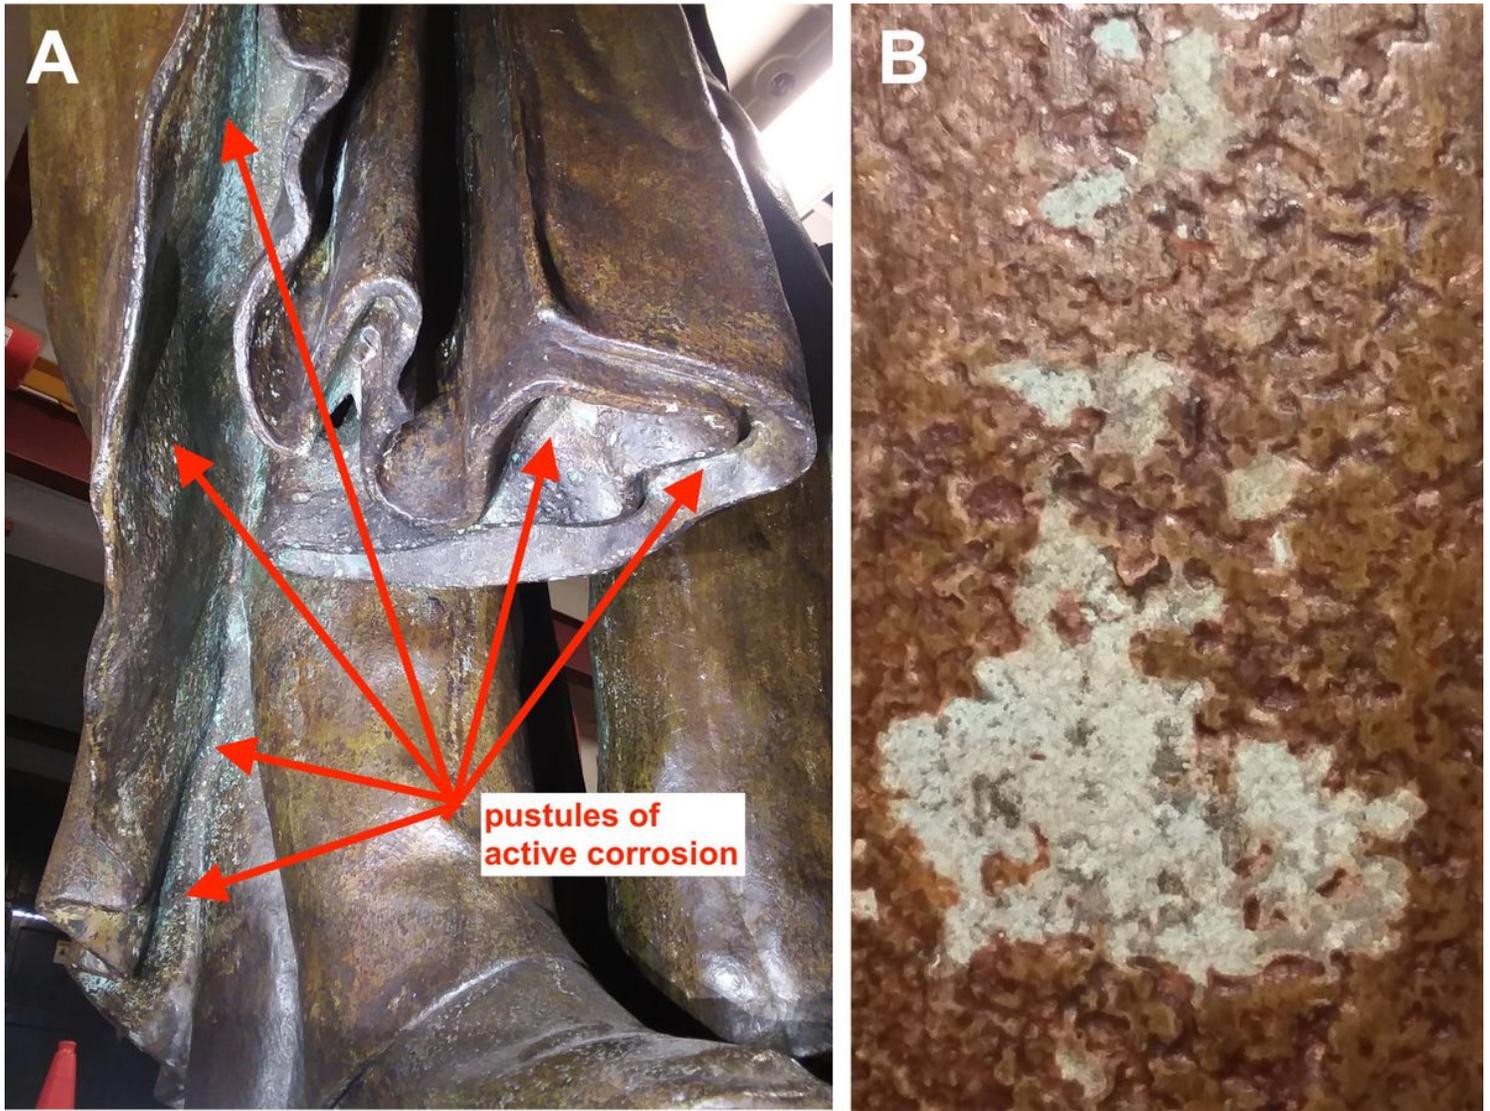
**Figure 3**

long cloak (Fig. 3b). The surfaces within the recesses are so well protected that they do not benefit from washing during typical rain events or associated run off. Morse's sculptural geometry may explain the localization of corrosion phenomena in those recessed and protected locations where elevated chloride concentration accelerates surface loss [15]. The aged and degraded coatings had likely cross-linked and was otherwise admitting moisture and corrosive agents directly onto the bronze substrate, and was no longer providing adequate protection to the sculpture.

Considering that Central Park is relatively close to the ocean and therefore subjected to its atmospheric corrosion environment, and, above all, taking into account the enormous amount of sodium chloride distributed on the roads during wintertime, the detection of copper chlorides on the Morse statue, should not surprise. The sculpture had originally been sited on the Mall in Central Park, a pedestrian promenade, where it remained for more than 100 years. In 1988, the statue was relocated to its current location at the East 72nd Street entrance to the Park on the South side of the Drive roadway and in proximity to Fifth Avenue, where the exposure to ice melting salts is substantial during the winter months. In fact, chloride ions that separate from sodium as the ice melts are extremely corrosive. It seems plausible that the water enriched with these ions could become aerosolized by the constant traffic whisking by and deposited onto the bronze. Thickett and coauthors [18–19] have demonstrated that water may be retained at the interface between the superficial layer of Renaissance wax and the coating underneath, further enhancing the corrosive attack. On ferrous metals, like steel, the prolonged exposure to this trapped moisture after the protective period of the coating might increase the rate of corrosion. A similar process cannot be ruled out for copper-based alloys.

Condition issues observed on the Morse sculpture (II). (A) Extent of active corrosion, or bronze disease, in the protected recesses of the figure's long coat. (B) Detail of toned coating failure and underlying patina.

As some of the Morse statue's surfaces were not easily accessible for laser cleaning, an additional treatment using propane-fueled torches to heat the surface and volatilize the remnant coating and corrosion products was performed in the deepest pits and recesses of the sculpture. Following the technical guidelines of the U.S. General Services Administration [25], two applications of benzotriazole (BTA), an effective corrosion inhibitor, were selectively applied on the undercuts and recesses where pustules had formed in an attempt to stabilize the surface from further loss by arresting or eradicating propagation of the condition. BTA reacts with corrosion products such as cuprite and copper trihydroxychlorides to form Cu(I)BTA and Cu(II)BTA copolymers, resulting in an optimal and stable coating that ensures durability of the artwork [26]. The double application of BTA, guaranteed thorough coverage in recessed areas, ensured complete reaction of this chemical with all the remaining available unstable compounds that were not complexed during the first application. After application of BTA, the treated area was cleaned with soft bronze bristle brushes and allowed to dry. The resulting precipitate matter was then flushed clear and the surfaces thoroughly rinsed with distilled water. After that, the sculpture was carefully steam pressure washed to remove any remaining residue. On the undersides and recesses of the long coat, i.e. the location most affected by bronze disease, the patina had been removed completely by laser ablation, exposing the bare bronze. Apart from this area, complete removal of the corrosion layers was outside the scope of the present project.

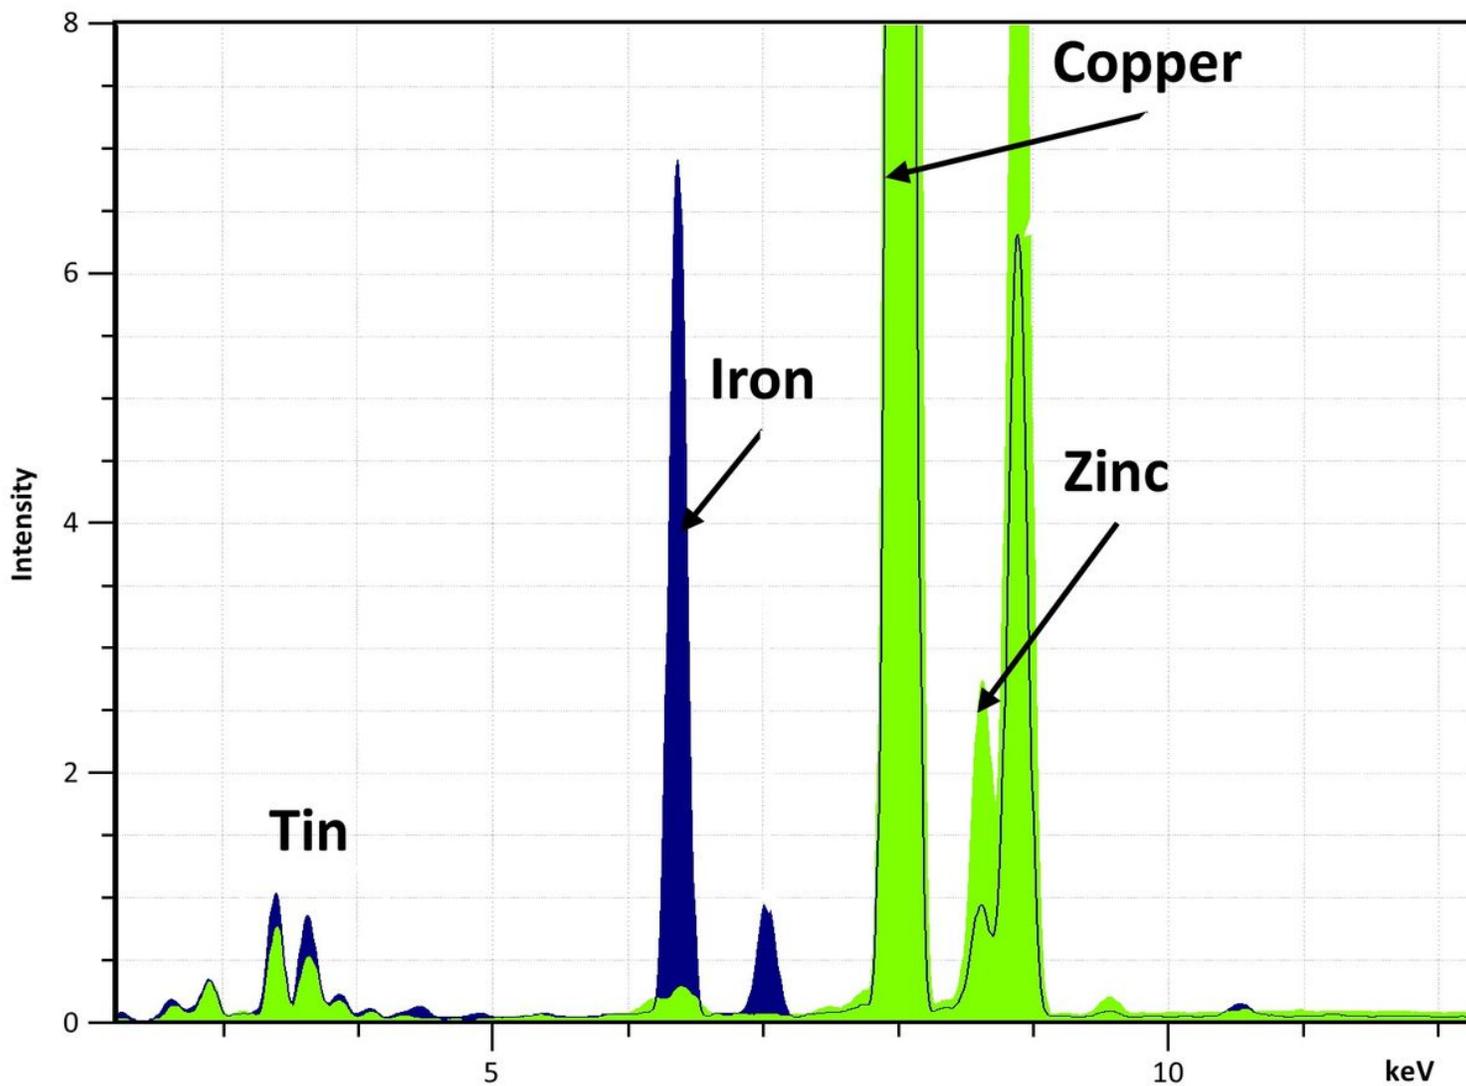
Figure 5

Following the initial phase of the cleaning, pXRF measurements showed relatively high levels of iron in all the spots analyzed, with the exception of a reference reading collected from an area of bare metal. Iron tends to decrease from measurements acquired during pXRF campaign 1 to those recorded in campaign 2, while it is found in trace amounts on the uncoated bronze (Fig. 5). This likely indicates that the occurrence of this element might be limited to the superficial organic coating, and, therefore, associated with the presence of iron oxide/hydroxide pigments in such coating, as mentioned earlier. Minor amounts of lead were also detected on locations yet to be cleaned, with a noticeable decrease in spectra collected upon treatment during campaign 2. This observation, along with the absence of lead in the reference measurements acquired from the bare metal, suggests that this element, whose presence was limited to the uppermost portion of the sculpture's stratigraphy and thus attributable to external causes, may be interpreted as a residue of the atmospheric pollution deposition. Interestingly, the amount of greenish corrosion products, namely chlorine-based and sulfur-based compounds, was found to decrease upon initial lasering, while an increase followed by a small decrease was noted following the second and third phases of treatment. The increased concentrations of chlorine and sulfur after

cleaning phase 2 indicate that the laser cleaning performed up until that point might have exposed a deeper portion of the corroded layer (Fig. 5). Another possible explanation for the observed increase of these elements' peak intensity might lie in the practice of misting the sculpture with distilled water after each lasering session. This process activates entrained chlorides and precipitates them onto the surface, from which they are ablated in subsequent cleaning sequences. As initial pXRF analyses were carried out after misting but before the following cleaning, it is plausible that re-precipitated chlorides were measured. A final phase of overall laser cleaning was applied to add variance of the laser's angle of attack. This was especially important for eradicating the deeply pitted areas where minute undercuts partially obscured direct access to those surfaces. The goal of this additional cleaning step was to further reduce the presence of powdery corrosion products and tenaciously adhered coating residue that may negatively affect proper adhesion of the new coating.

XRF spectra acquired prior to laser cleaning. Example of XRF spectrum acquired from the Morse statue before the laser cleaning treatment (pXRF campaign 1, blue pattern), showing the presence of higher amounts of iron than in the bare metal (green pattern).

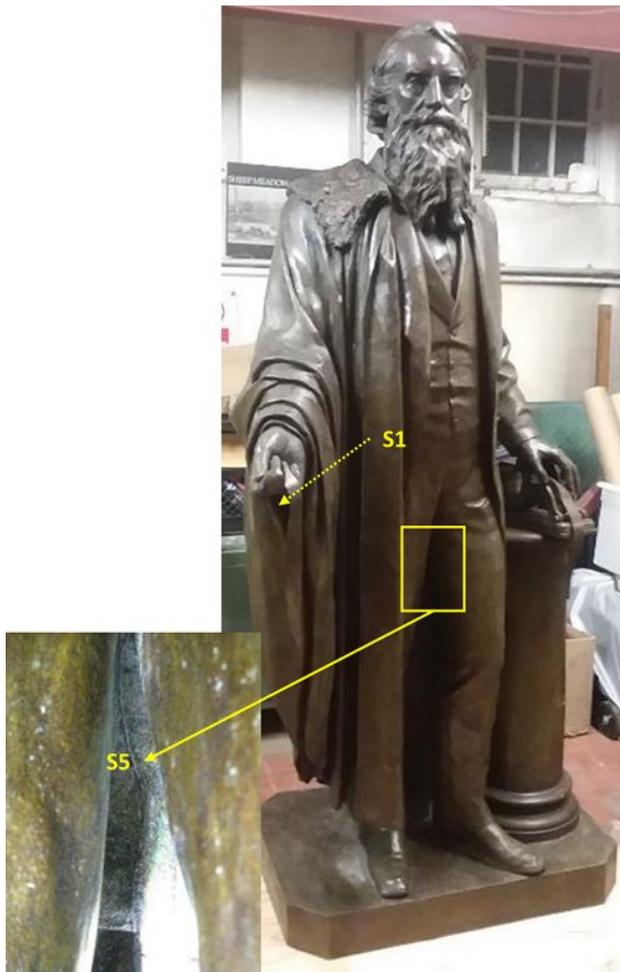
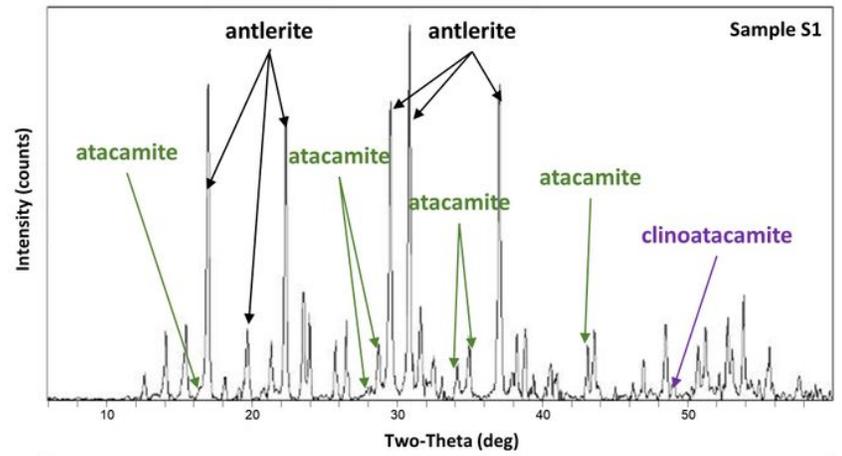
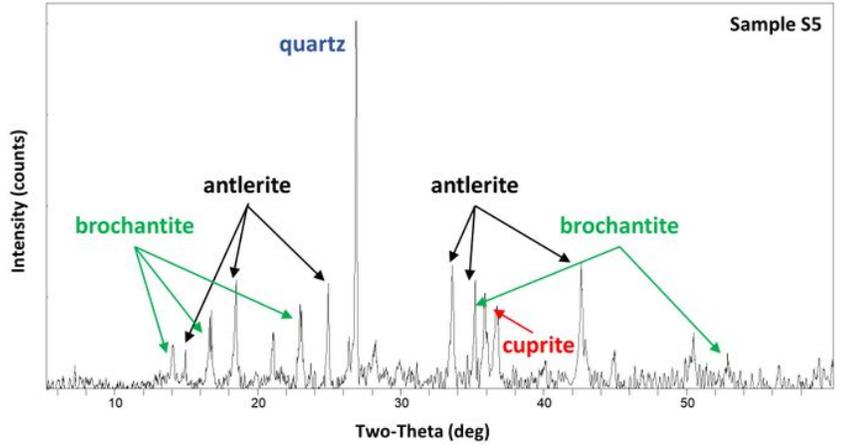
Figure 6

In areas of the Morse sculpture that were less exposed to the atmospheric agents and not covered by the protecting coatings, various shades of green corrosion products were observed and sampled for analysis. XRD detected several compounds mostly attributable to the following categories: sulfates, sulfides, chlorides, and oxides. The hydrous copper sulfate mineral antlerite ( $\text{Cu}_3(\text{SO}_4)(\text{OH})_4$ ), found in all samples examined, appears to be the main sample constituent among those present, sometimes in association with minor amounts of copper trihydroxichlorides such as atacamite or clinoatacamite ( $\text{Cu}_2(\text{OH})_3\text{Cl}$ ) (as in the case of samples S1, S2, S4, S5). In addition, brochantite ( $\text{Cu}_4\text{SO}_4(\text{OH})_6$ ) and cuprite ( $\text{Cu}_2\text{O}$ ) were identified in samples S5 and S7, the latter also containing copper sulfide and gypsum (Fig. 6). All these products are described in the literature as bronze disease typically related to copper alloys [21], either originating from the reaction of copper with water or as a result of its interaction with atmospheric pollutants (leading to the formation of chlorides and brochantite, respectively).

XRD patterns of corrosion products. XRD patterns of two samples of corrosion products, with their sampling locations.

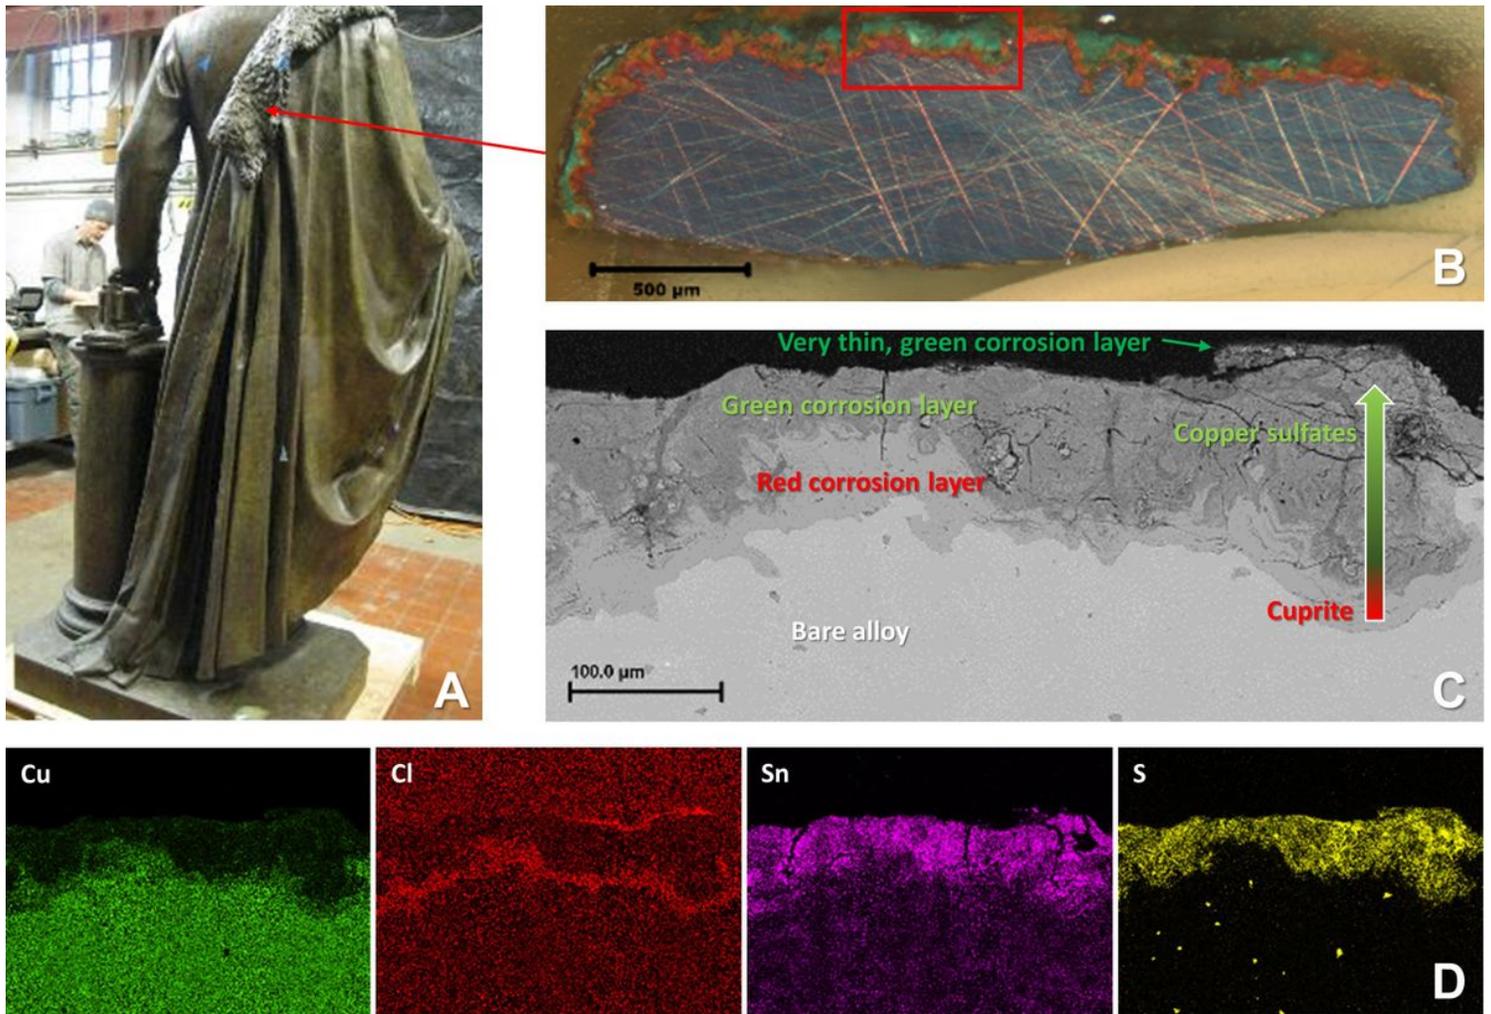
**Figure 7**

To evaluate the distribution and thickness of the various corrosion layers within the sculpture's stratigraphy, and to determine the exact composition of the metal alloy, a small sample removed from the rear of the Morse statue was mounted as a cross section and analyzed by SEM/EDS (Fig. 7). Results on the composition of the sculpture's constituting copper alloy (layer 1), calculated by means of EDS, are reported in Table 2. In detail, the relative amounts of copper (Cu) and tin (Sn) detected, alongside the observed zinc (Zn) content, are consistent with the composition of a ternary alloy and are very similar to gunmetal bronze (also known in the United States as red brass). This alloy was first identified in a 13th -century English memorial sculpture and later used for casting cannon. Its utilitarian characteristics include ease of casting in detail, toughness, resistance to corrosion, and machinability. The frequent use of this alloy to cast statuary in the United States in the mid-19th century may be attributed to the prevalence of the English emigrant group and its craft traditions, or even possibly to an expedient coincidence. For instance, the Ames Manufacturing Company of Chicopee, Massachusetts, is a prominent example of an American foundry concurrently producing military ordnance and "bronze" statuary during that period.

EDS analysis showed the additional presence, in the sculpture's ternary alloy, of small particles of less than 10 µm in size, with irregular shapes, scattered throughout the metal matrix, which were identified as zinc sulfides. These compounds appear to be sometimes associated with copper sulfides. Exact compositions of both zinc and copper sulfides are reported in Table 2. Regarding the pitting phenomenon also observed in the Morse sculpture, one must consider that the presence of pits in copper-based alloys is often related to the dezincification of the alloy [21]. Here, however, this hypothesis is unlikely, as red brass displays less of a proclivity for this type of deterioration than other alloys, in particular when protected by a thin layer of copper oxides, such as cuprite [24]. In the present case, analysis of the corrosion layers shows a clear transition from an underlying cuprite-based layer to a more superficial region that is mostly composed of copper sulfates, as indicated in Fig. 7. The first corrosion layer observed (layer 2, Fig. 7), showing red in the optical microscopy image, was found to be mainly composed of cuprite and enriched in tin. A second corrosion layer (layer 3, Fig. 7) above that, appearing green under polarized light, is characterized by the presence of copper sulfates and is richer in tin than layer 2. Traces of an additional, very thin, green corrosion layer (layer 4, Fig. 7), which contains a mixture of copper chlorides and dirt, are still visible on the surface. These data suggest that the corrosion process might have induced a preferential dissolution of copper and zinc linked to the presence of oxygen within the whole thickness of the corroded layer, as shown by the X-ray elemental maps of copper, chlorine, tin, and sulfur within the corrosion layer (Fig. 7). In outdoor conditions, the initial formation of a reddish-brown layer of cuprite is typically followed by the formation of different additional compounds, as also confirmed in the present study: copper basic sulfates, such as antlerite and brochantite, can be found on bronzes exposed in urban environments, while copper

Optical microscopy, BSE images, and X-ray elemental maps of cross section S12 (metal alloy and corrosion products). (A) Image of the Morse sculpture in Central Park's conservation laboratory. The red arrow indicates a location on the statue from which a multi-layered sample was removed for analysis of the metal alloy and corrosion products (sample S12). (B) Polarized light micrograph of sample S12 mounted as a cross section. (C) BSE image of the portion of sample S12 indicated by a red square in image B. The red and green arrow indicates changes in composition within the stratigraphy when moving from the main metal alloy up to the surface. (D) X-ray elemental maps of copper (Cu), chlorine (Cl), tin (Sn), and sulfur (S) collected from a portion of cross section S12.

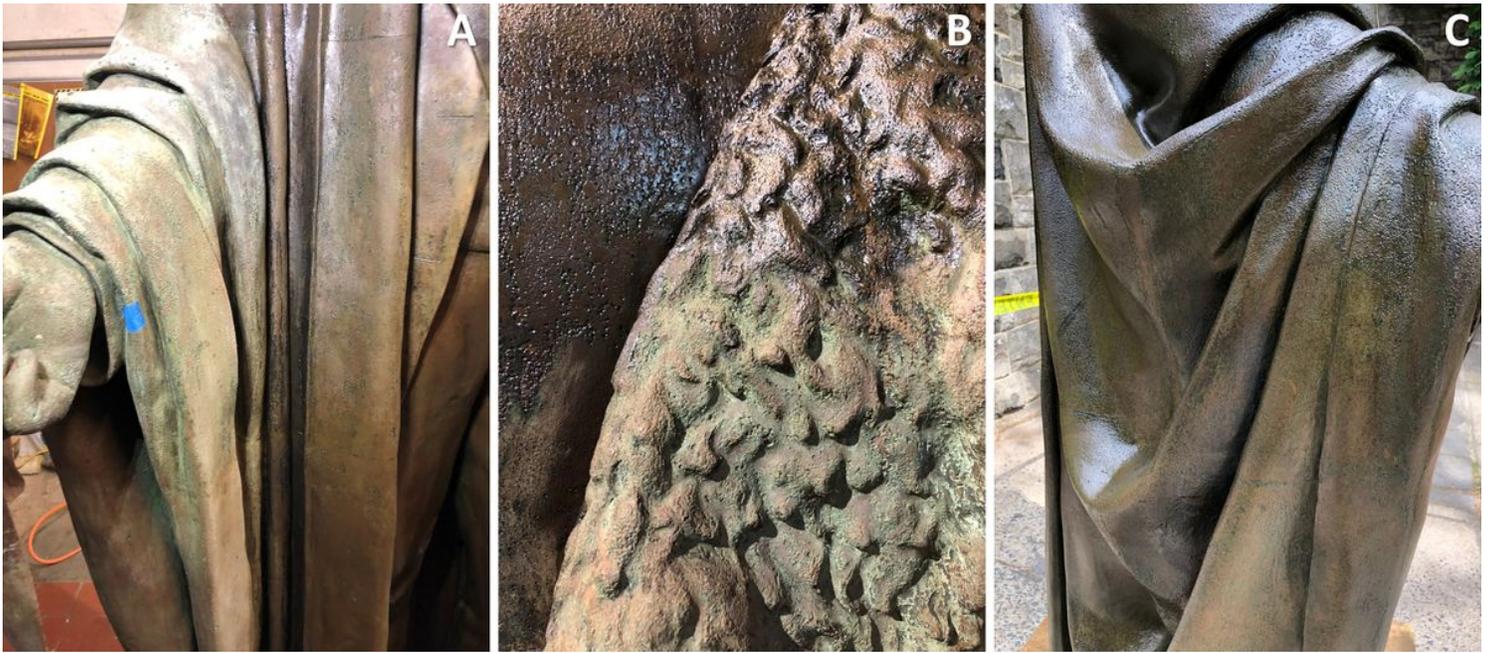
**Figure 8**

Application of new coating. (A-B) Details of the Morse statue collected during the application of the new lacquer coating, including coated and uncoated areas. It is worth noting the contrast between the portion already brushed and the bare surface. (C) Final visual effect upon application of the new coating, after drying, over the green patina.

In terms of coloration, a selective application of cupric nitrate and cupric chloride patina solutions to achieve a range of green, and of ammonium sulfate for darker brown in the recesses of the long coat, were used to blend and unify tone and to enhance legibility of the sculptural forms. Finally, a translucent, warm brown coating that established a contiguous protective film of appropriate dry film thickness and unveiled nuances of the underlying greenish patina was applied as the new finish (Fig. 8). The identification of iron-containing pigments to color the lacquer finish guided the decision of applying a new coating containing the same type of coloring materials. Such lacquer, selected from Nikolas Coatings, is a low volatile organic compounds (VOC) lacquer (#14135 Clear NY Coat RFU) that was specifically formulated and re-named for this project (#15794 Morse brown toner RFU). The new toned lacquer achieved the desired visual nuance for the finish and the iron contained in it may provide sacrificial anodic protection to the bronze. In fact, it has been demonstrated that lamellar micaceous iron oxide, used as inert, electrochemically non-reactive pigment for anticorrosive coatings, reduces the reactivity of the material it is in contact with, acting as a protective barrier [27–28]. However, the substance used in this case is in fact an iron-based pigment composed of spherical particles. The solvent-borne coating was thinned and brush applied twice overall to assure penetration into the pitted texture of the Morse sculpture and to obtain complete coverage in deep recesses and undercuts. Three subsequent high volume - low pressure spray coats completed the coating application.
