# The *Samuel F. B. Morse* Statue in Central Park: Scientific Study and Laser Cleaning of a 19th-Century American Outdoor Bronze Monument

## Research article

**Keywords:** outdoor sculpture, laser cleaning, conservation, 19th century, coating, gunmetal, corrosion

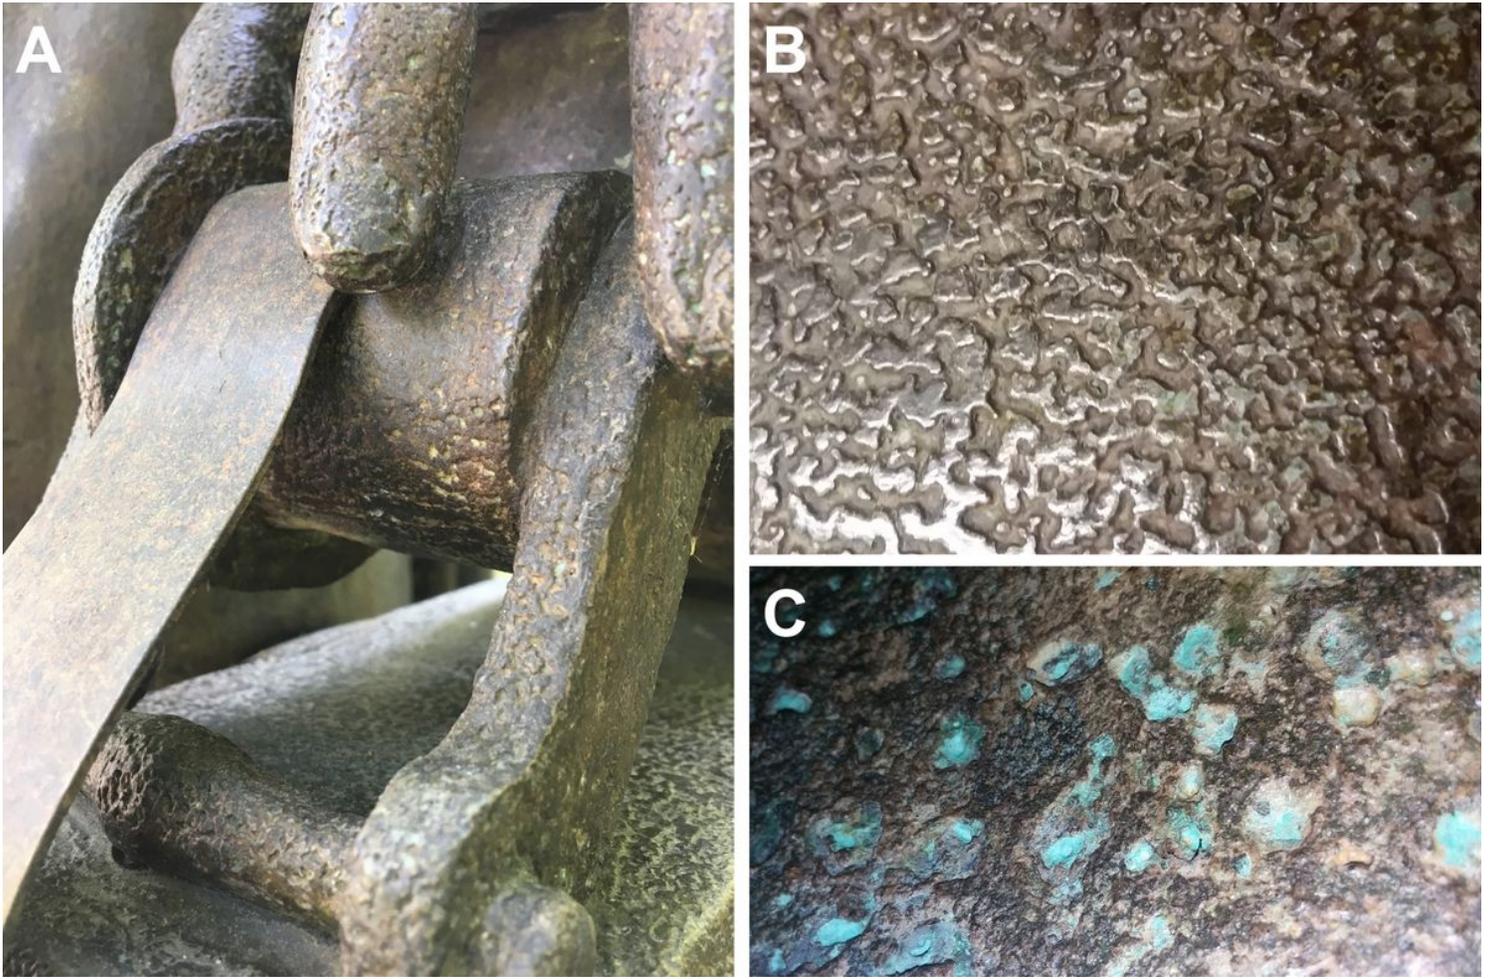
**Figure 2**

Preliminary visual examination of the Morse sculpture enabled conservators to identify the main ongoing conservation issues, which were mostly related to corrosion and to the presence of one or more degraded organic coatings. Over time, the statue's surface has suffered from severe corrosive attack. Pitting and loss of sculptural surface details (Figure 2) were caused by the exposure to atmospheric pollutants such as acid rain and chlorides from deicing salts and the marine environment, in addition to dry deposition of biogenic and anthropogenic pollutants such as NO<sub>2</sub>, SO<sub>2</sub>, and carboxylic acid. The exposed surfaces have remained stable since being regularly treated with cleaning interventions and protective coatings beginning in the 1990s. However, localized patches of virulent, irregularly shaped pustules of active corrosion were contributing to progressive surface loss (Figure 3A) and associated coating failure (Figure 3B) in the deep recesses of the

Condition issues observed on the Morse sculpture (I). Photographs showing (A) a detail of sculptural surface loss, (B) typical pitting and loss pattern on exposed surfaces, and (C) a detail of active corrosion present in the recessed areas.

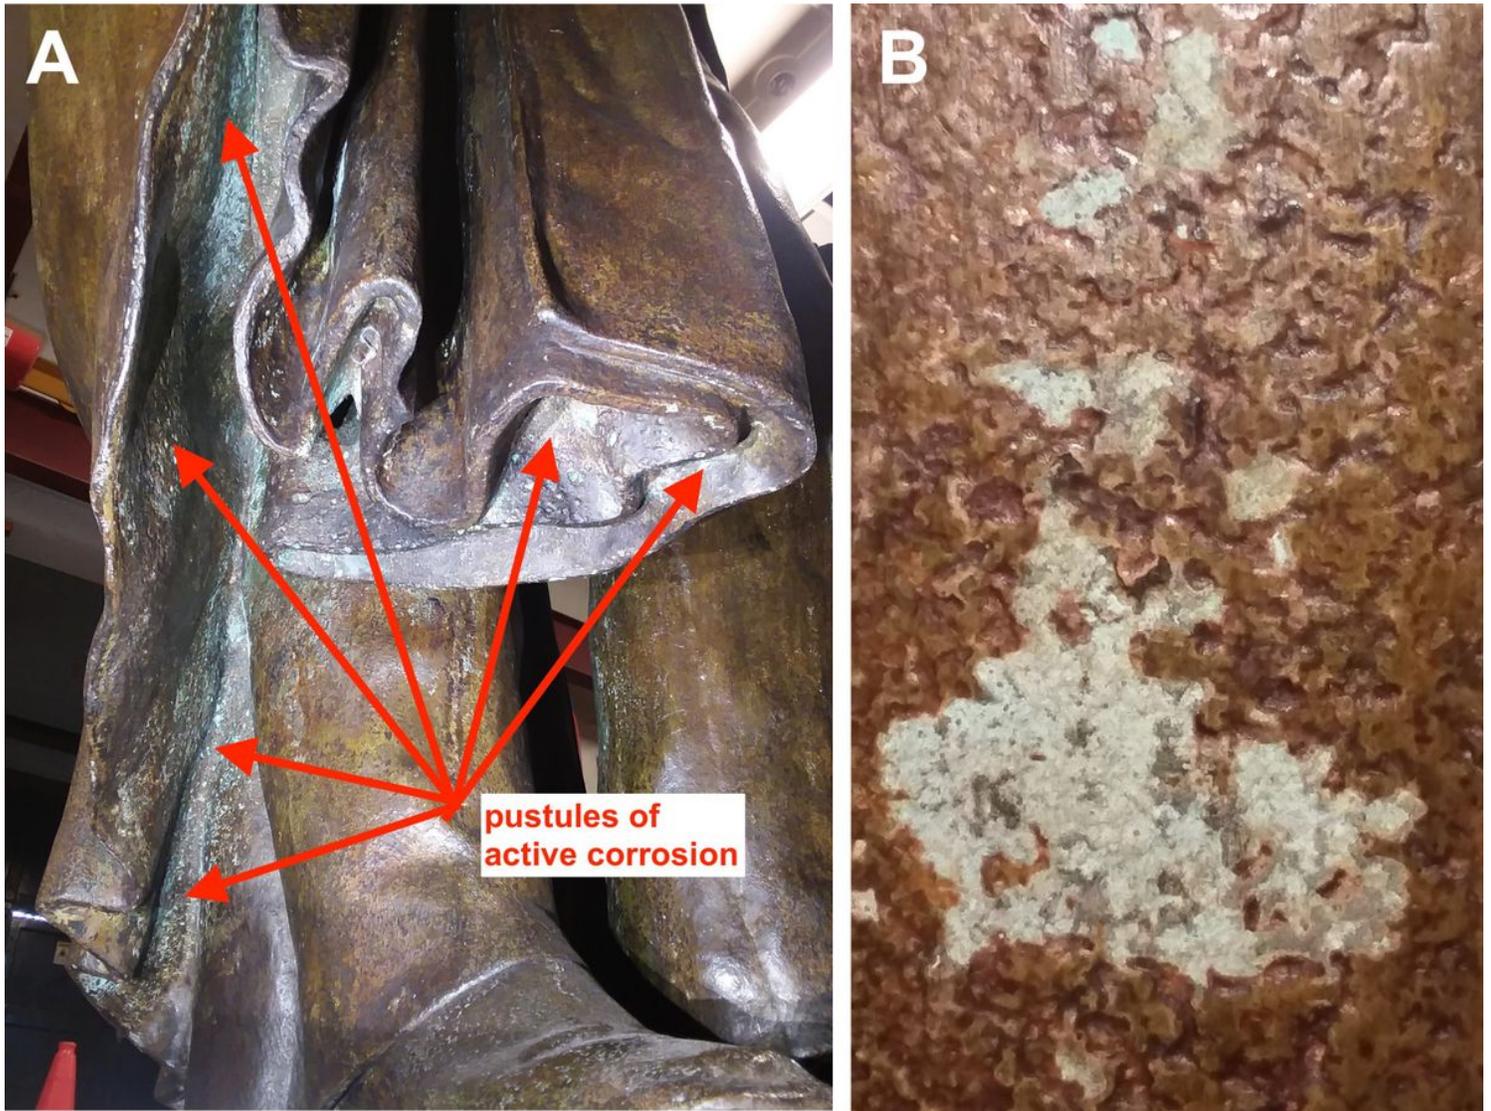
**Figure 3**

figure's long cloak. The surfaces within the recesses are so well protected that they do not benefit from washing during typical rain events or associated run off. Morse's sculptural geometry may explain the localization of corrosion phenomena in those recessed and protected locations where elevated chloride concentration accelerates surface loss [18]. The aged and degraded coating was otherwise admitting moisture and corrosive agents directly onto the bronze substrate, and was no longer providing adequate protection to the sculpture.

Condition issues observed on the Morse sculpture (II). Photographs showing (A) the extent of active corrosion in the protected recesses of the figure's long coat, and (B) a detail of toned coating failure and underlying patina.

As some of the Morse statue's surfaces were not easily accessible for laser cleaning, an additional treatment using propane-fueled torches to heat the surface and volatilize the remnant coating and corrosion products was performed in the deepest pits and recesses of the sculpture. Following the technical guidelines of the U.S. General Services Administration [33], two applications of benzotriazole (BTA), an effective corrosion inhibitor, were selectively applied on the undercuts and recesses where pustules had formed in an attempt to stabilize the surface from further loss by arresting or eradicating propagation of the condition. BTA reacts with corrosion products such as cuprite and copper trihydroxychlorides to form Cu(I)BTA and Cu(II)BTA copolymers, resulting in an optimal and stable coating that ensures durability of the artwork [34]. The double application of BTA, guaranteed thorough coverage in recessed areas, ensured complete reaction of this chemical with all the remaining available unstable compounds that were not complexed during the first application. After application of BTA, the treated area was cleaned with soft bronze bristle brushes and allowed to dry. The resulting precipitate matter was then flushed clear and the surfaces thoroughly rinsed with distilled water. After that, the sculpture was carefully wet-steam pressure washed to remove any remaining residue. On the undersides and recesses of the long coat, i.e. the location most affected by bronze corrosion, the patina had been removed completely by laser ablation, exposing the bare bronze. Apart from this area, complete removal of the corrosion layers was outside the scope of the present project.

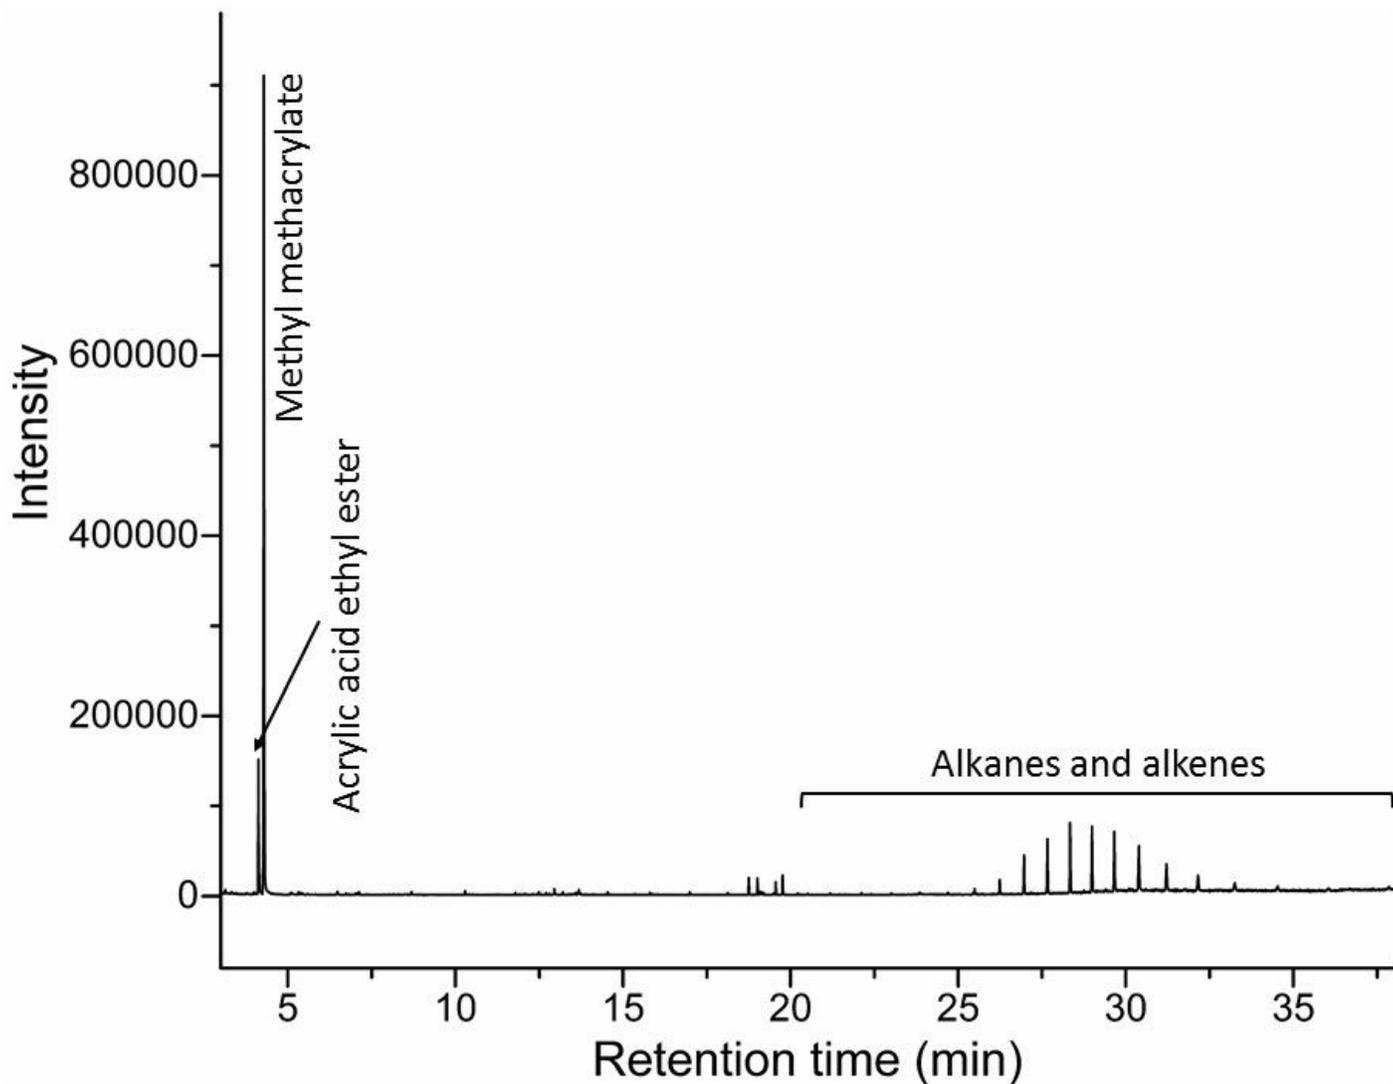
**Figure 4**

The organic coating was investigated to determine its constituent materials and the possible presence of pigments. In order to do so, a sample (S3) was removed from an area of the sculpture underneath the telegraph, below the figure's proper left thumb, and analyzed by Py-GC/MS. All chromatograms obtained with and without TMAH derivatization appeared to contain series of alkanes organized in a specific distribution that is characteristic of mineral waxes (Figure 4). From a conservation perspective, mineral waxes are known for having a limited lifetime, ranging from 2 to 5 years, and for being reversible [19]. Bronzes coated with wax are easily cleaned with water, which makes wax suitable for a low cost and low maintenance application. However, the sample examined was found to contain also high relative amounts of acrylics, mostly methyl methacrylate and acrylic acid ethyl ester. The presence of these compounds is consistent with the use of Incralac<sup>®</sup> [20], which is, in fact, a product commonly used in the past and reported to have been applied to the Morse statue in the early 1990s according to the available conservation records [21]. Acrylic coatings have a longer lifetime compared to mineral waxes, and they also show good reversibility properties [19]. Acrylic lacquers are coupled with a sacrificial wax topcoat that is renewed yearly in the case of Morse. Since 2003, two types of cyclically renewable wax topcoats have been used by CPC's conservators: 1) Boston Polish<sup>™</sup>, also known as "butchers" paste wax, a carnauba-based wax, in use from 2003 to 2006; 2) Renaissance microcrystalline wax<sup>™</sup>, a mixture of Cosmoloid H80 and BASF A wax [22-23], used from 2007 to date for protecting outdoor bronze sculptures in Central Park.

Py-GC/MS chromatogram of sample S3 (organic coatings). Py-GC/MS chromatogram obtained upon derivatization with TMAH of sample S3, i.e. a scraping of the organic coatings. Compounds identified in the chromatogram indicate the presence of mineral wax and acrylics.

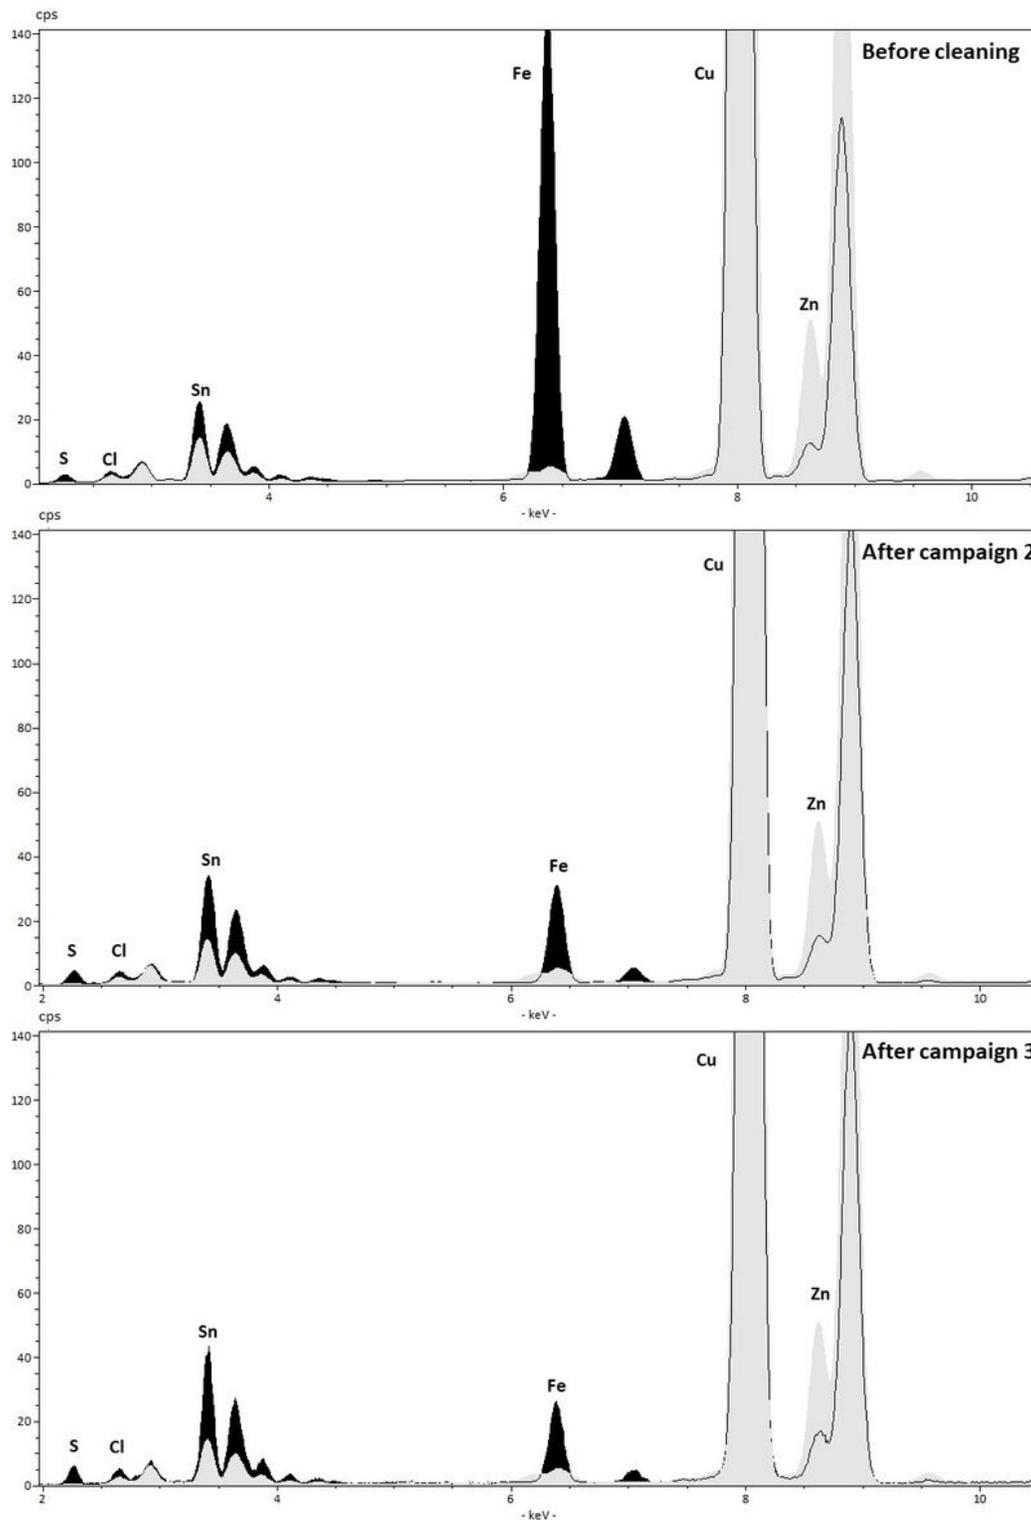
**Figure 5**

In terms of coloring, verbal accounts and visual observation suggested that the Morse sculpture might have been coated with pitch at some early stage, although there are no written records of this intervention. The color of organic coatings in bronze sculptures is also sometimes obtained through the addition of bitumen, which might lend the coating a dark or brown hue [24]. Accordingly, visual inspection indicated that, possibly, very low amounts of pitch or bitumen residues may have been present on the back of the bronze, although, in this case, no samples were removed to verify this hypothesis, given the small dimension of the areas in question and in order to preserve the sculptures' integrity and appearance. However, an unexpectedly high amount of iron (Figure 5, before cleaning) was

detected by pXRF analysis on several locations of the surface still covered by the organic coatings, suggesting the use of iron oxide/hydroxide pigments as coloring agents in the acrylic layer. Comparisons with spectra collected on areas of bare metal confirmed the exclusive presence of iron, and the absence of other elements, in such organic layer.

Following the initial phase of the cleaning, pXRF measurements showed relatively high levels of iron in all the spots analyzed, with the exception of a reference reading collected from an area of bare metal. Iron tends to decrease from measurements acquired during pXRF campaign 1 to those recorded in campaign 2, while it is found in trace amounts on the uncoated bronze (Figure 5). This likely indicates that the occurrence of this element might be limited to the superficial organic coating, and, therefore, associated with the presence of iron oxide/hydroxide pigments in such coating, as mentioned earlier. Minor amounts of lead were also detected on locations yet to be cleaned, with a noticeable decrease in spectra collected upon treatment during campaign 2. This observation, along with the absence of lead in the reference measurements acquired from the bare metal, suggests that this element, whose presence was limited to the uppermost portion of the sculpture's stratigraphy and thus attributable to external causes, may be interpreted as a residue of the atmospheric pollution deposition. Interestingly, the amount of greenish corrosion products, namely chlorine-based and sulfur-based compounds, was found to decrease upon initial lasering, while an increase followed by a small decrease was noted following the second and third phases of treatment. The increased concentrations of chlorine and sulfur after cleaning phase 2 indicate that the laser cleaning performed up until that point might have exposed a deeper portion of the corroded layer (Figure 5). Another possible explanation for the observed increase of these elements' peak intensity might lie in the practice of misting the sculpture with distilled water after each lasering session. This process activates entrained chlorides and precipitates them onto the surface, from which they are ablated in subsequent cleaning sequences. As initial pXRF analyses were carried out after misting but before the following cleaning, it is plausible that re-precipitated chlorides were measured. A final phase of overall laser cleaning was applied to

XRF spectra acquired to monitor the laser cleaning. Examples of XRF spectra collected from the Morse statue before laser cleaning (pXRF campaign 1; black pattern) and during laser cleaning (pXRF campaigns 2 and 3; black pattern). A reference spectrum acquired from an area of bare metal (gray pattern) is also reported in each graph for comparison. The data shows a progressive decrease in the intensity of the iron peak after subsequent treatment phases.

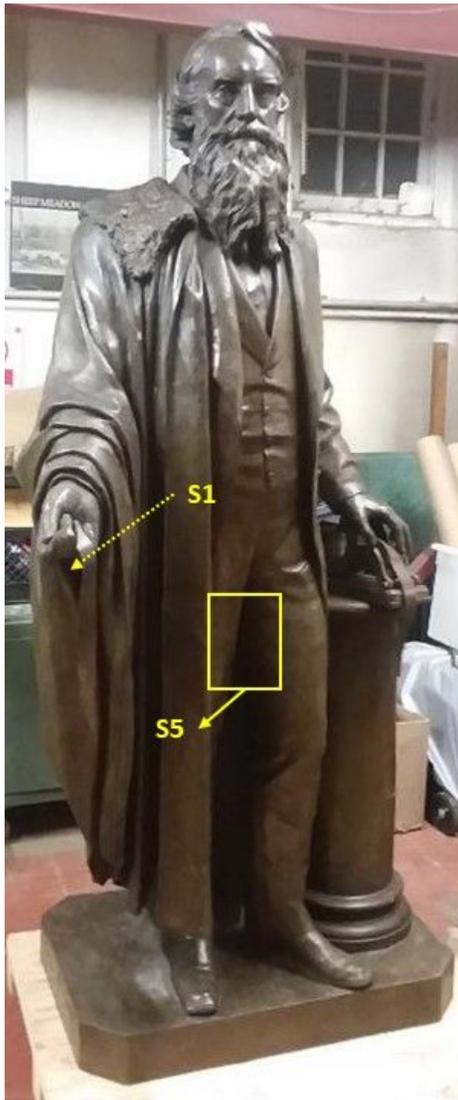
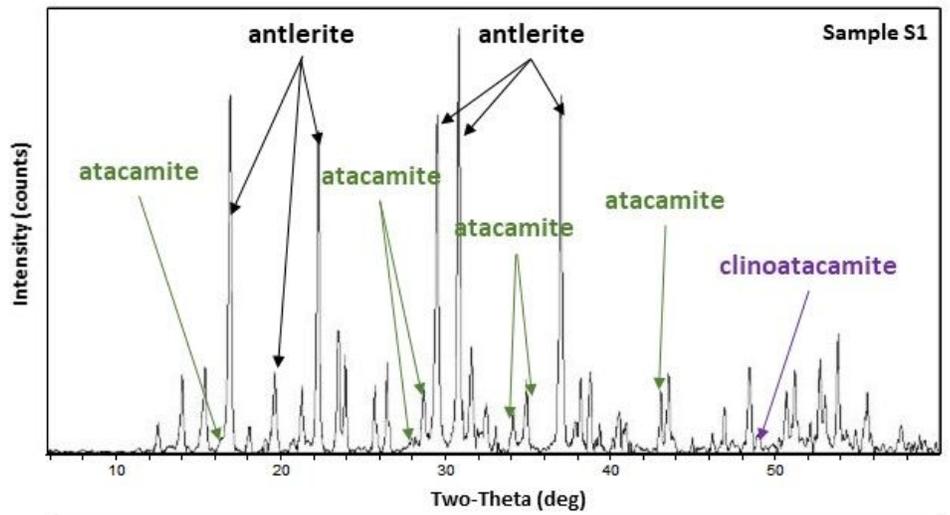
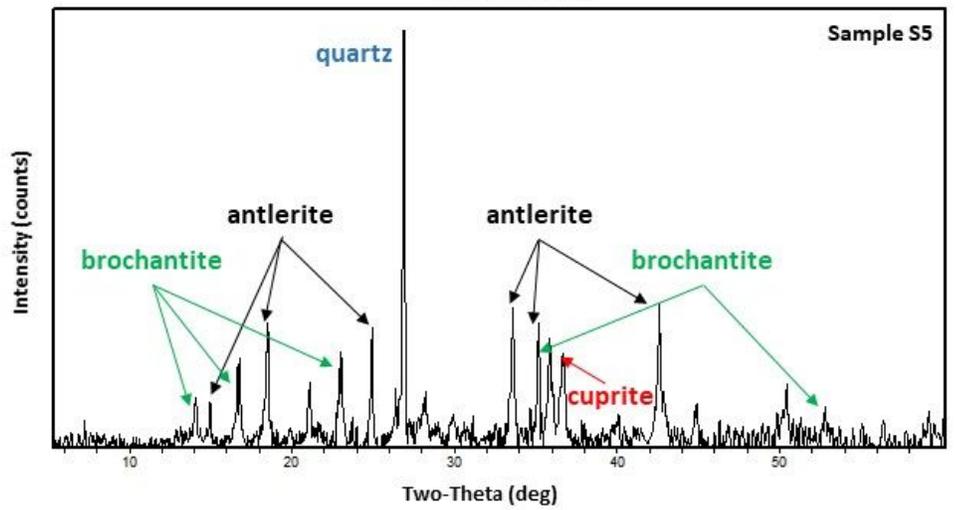
Figure 6

In areas of the Morse sculpture that were less exposed to the atmospheric agents and not covered by the protecting coatings, various shades of green corrosion products were observed and sampled for analysis. XRD detected several compounds mostly attributable to the following categories: sulfates, sulfides, chlorides, and oxides. The hydrous copper sulfate mineral antlerite ( $\text{Cu}_3(\text{SO}_4)(\text{OH})_4$ ), found in all samples examined, appears to be the main sample constituent among those present, sometimes in association with minor amounts of copper trihydroxichlorides such as atacamite or clinoatacamite ( $\text{Cu}_2(\text{OH})_3\text{Cl}$ ), as in the case of samples S1, S2, S4, and S5. In addition, brochantite ( $\text{Cu}_4\text{SO}_4(\text{OH})_6$ ) and cuprite ( $\text{Cu}_2\text{O}$ ) were identified in samples S5 and S7, the latter also containing copper sulfide and gypsum (Figure 6). All these compounds are described in the literature as products commonly associated to bronze disease, affecting copper alloys [25-29]. However, no traces of nantokite ( $\text{CuCl}$ ), the main compound responsible for bronze disease, were detected in any of the samples analyzed. For this reason, the presence of copper trihydroxichlorides on this sculpture may be attributed to a harmful superficial corrosion process, either originating from the reaction of copper with water or as a result of its interaction with atmospheric pollutants (leading to the formation of chlorides and brochantite, respectively).

XRD patterns of samples S1 and S5 (corrosion products). XRD patterns of samples S1 and S5, i.e. two scrapings of corrosion products, with their respective sampling locations.

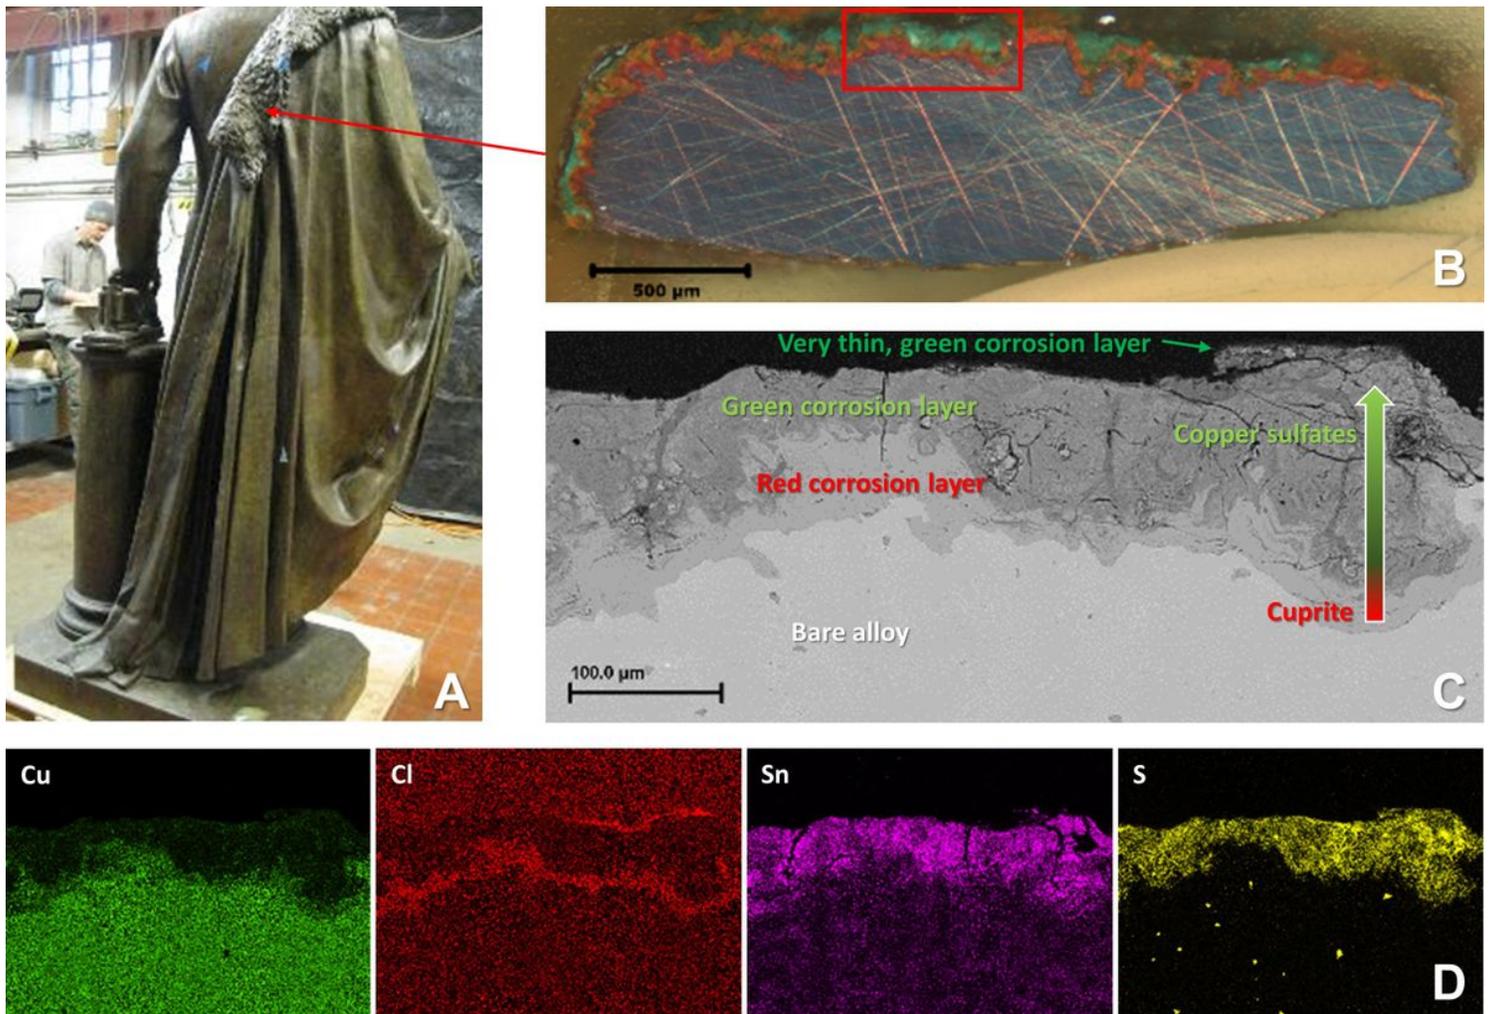
**Figure 7**

To evaluate the distribution and thickness of the various corrosion layers within the sculpture's stratigraphy, and to determine the exact composition of the metal alloy, a small sample removed from the rear of the Morse statue was mounted as a cross section and analyzed by SEM/EDS (Figure 7). Results on the composition of the sculpture's constituting copper alloy (layer 1), calculated by means of EDS, are reported in Table 2. In detail, the relative amounts of copper (Cu) and tin (Sn) detected, alongside the observed zinc (Zn) content, are consistent with the composition of a ternary alloy and are very similar to gunmetal bronze (also known in the United States as red brass). This alloy was first identified in a 13<sup>th</sup>-century English memorial sculpture and later used for casting cannon. Its utilitarian characteristics include ease of casting in detail, toughness, resistance to corrosion, and machinability. The frequent use of this alloy to cast statuary in the United States in the mid-19<sup>th</sup> century may be attributed to the prevalence of the English emigrant group and its craft traditions, or possibly to an expedient coincidence. For instance, the Ames Manufacturing Company of Chicopee, Massachusetts, is a prominent example of an American foundry concurrently producing military ordnance and "bronze" statuary during that period.

Optical microscopy, BSE images, and X-ray elemental maps of cross section S12 (metal alloy and corrosion products). (A) Image of the Morse sculpture in Central Park’s conservation laboratory. The red arrow indicates a location on the statue from which a multi-layered sample was removed for analysis of the metal alloy and corrosion products (sample S12). (B) Polarized light micrograph of sample S12 mounted as a cross section. (C) BSE image of the portion of sample S12 indicated by a red square. The red and green arrow indicates changes in composition within the stratigraphy when moving from the main metal alloy up to the surface. (D) X-ray elemental maps of copper (Cu), chlorine (Cl), tin (Sn), and sulfur (S) collected from a portion of cross section S12.

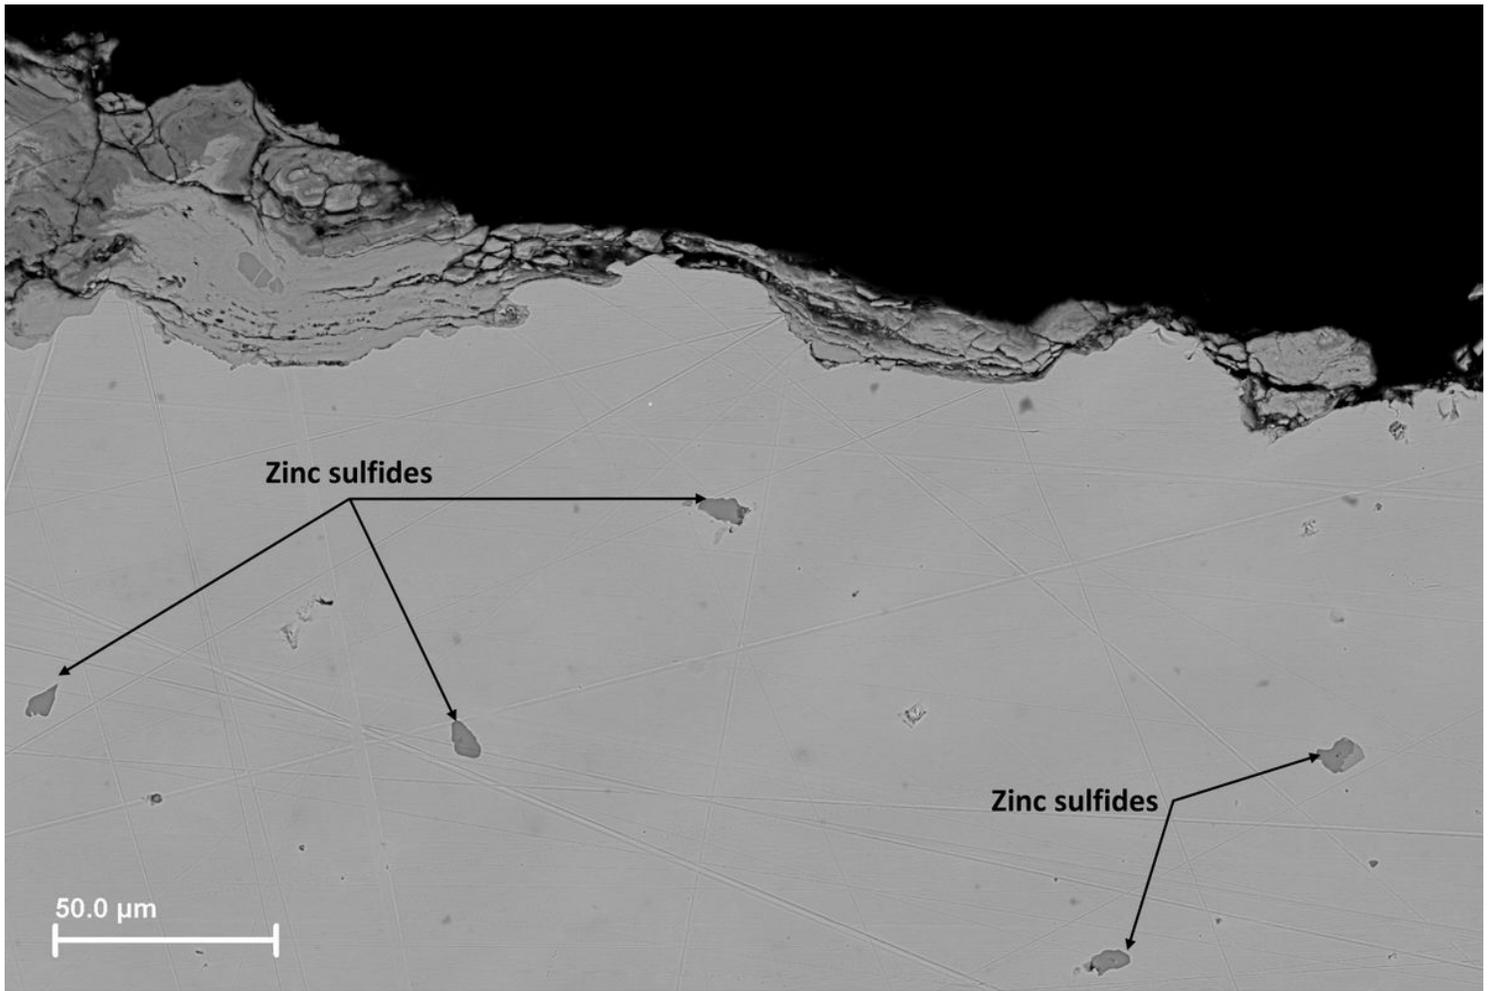
**Figure 8**

EDS analysis showed the additional presence, in the sculpture's ternary alloy, of small particles of less than 10  $\mu\text{m}$  in size, with irregular shapes, scattered throughout the metal matrix, which were identified as zinc sulfides (Figure 8). These compounds appear to be sometimes associated with copper sulfides. Exact compositions of both zinc and copper sulfides are reported in Table 2. Regarding the pitting phenomenon also observed in the Morse sculpture, one must consider that the presence of pits in copper-based alloys is often related to the dezincification of the alloy [28]. Here, however, this hypothesis is unlikely, as red brass displays less of a proclivity for this type of deterioration than other alloys, in particular when protected by a thin layer of copper oxides, such as cuprite [32]. In the present case, analysis of the corrosion layers shows a clear transition from an underlying cuprite-based layer to a more superficial region that is mostly composed of copper sulfates, as indicated in Figure 7. The first corrosion layer observed (layer 2, Figure 7), showing red in the optical microscopy image, was found to be mainly composed of cuprite and enriched in tin. A second corrosion layer (layer 3, Figure 7) above that, appearing green under polarized light, is characterized by the presence of copper sulfates and is richer in tin than layer 2. Traces of an additional, very thin, green corrosion layer (layer 4, Figure 7), which contains a mixture of copper chlorides and dirt, are still visible on the surface. These data suggest that the corrosion process might have induced a preferential dissolution of copper and zinc linked to the presence of oxygen within the whole thickness of the corroded layer, as shown by the X-ray elemental maps of copper (Cu), chlorine (Cl), tin (Sn), and sulfur (S) within the corrosion layer (Figure 7). In outdoor conditions, the initial formation of a reddish-brown layer of cuprite is typically followed by the formation of different additional compounds, as also confirmed in the present study: copper basic sulfates, such as antlerite and brochantite, can be found on bronzes exposed in urban environments, while copper

BSE image of zinc sulfides in sample S12 (metal alloy and corrosion products). BSE image of a portion of cross section S12, showing the presence of sparse zinc sulfide inclusions in the metal alloy.
