Monitoring and Stability Evaluation of the Damaged Landslide Based on Multiple Monitoring Technologies

Research Article

Keywords: Damaged landslide, Emergency monitoring, Rainfall, Failure mechanism, Thermal infrared temperature

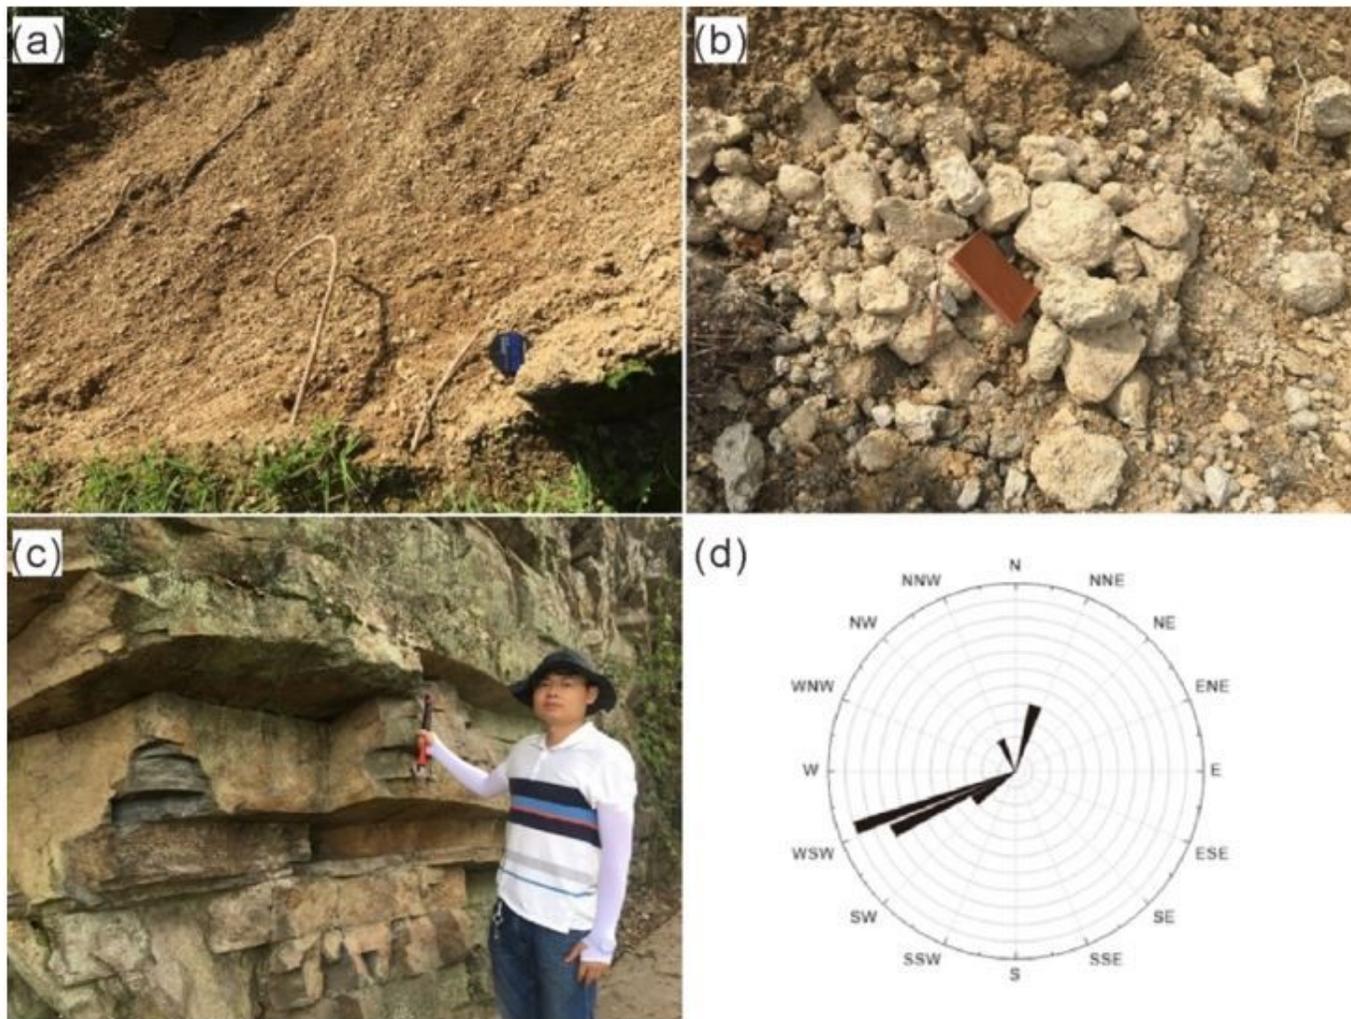
Figure 2

a) Eluvium, b) gravel soil, c) Hanjiadian Formation Shale (S1h) and d) rose diagram of the joints

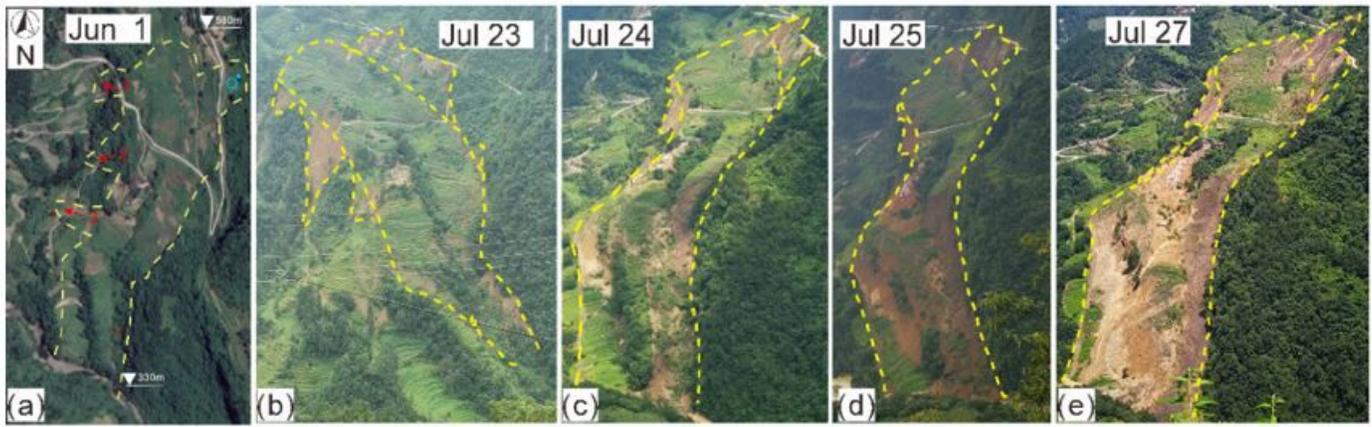
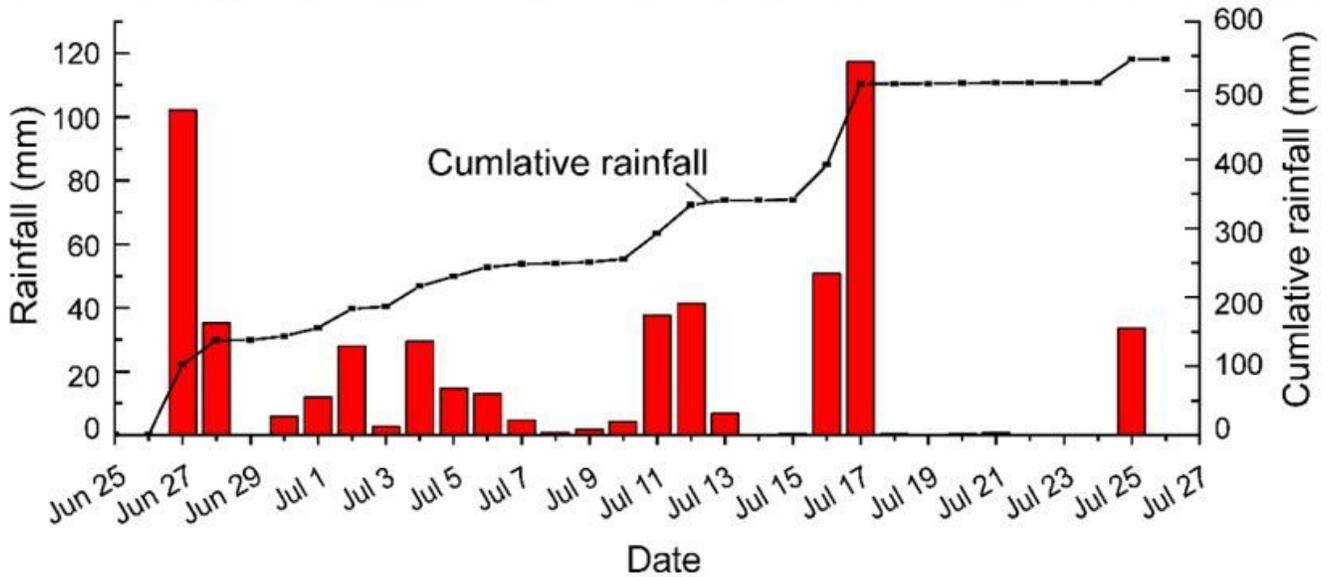
Figure 4

The Zhongbao landslide was firstly found deformed on July 22. Several cracks were recorded at the uphill side of the landslide after a continues intense rainfall. As the landslide deformed, the east boundary of the landslide was generated, then a plenty of tension cracks formed at the Part II while Part I failed (Fig. 4b). The uphill slope slide over 20 m, but the downhill slope had local deformation. On July 24, the sliding mass was transported to the middle and downhill slope; downhill slope gradually failure

(Fig. 4 c). On July 25, there was a strong rainfall, the downslope had obvious deformation, and the sliding mass gradually slid into Yancang River. The barrier lake and bam were formed (Fig. 4d e).

Deformation characteristics and rainfall versus time Note: The designations employed and the presentation of the material on this map do not imply the expression of any opinion whatsoever on the part of Research Square concerning the legal status of any country, territory, city or area or of its authorities, or concerning the delimitation of its frontiers or boundaries. This map has been provided by the authors.

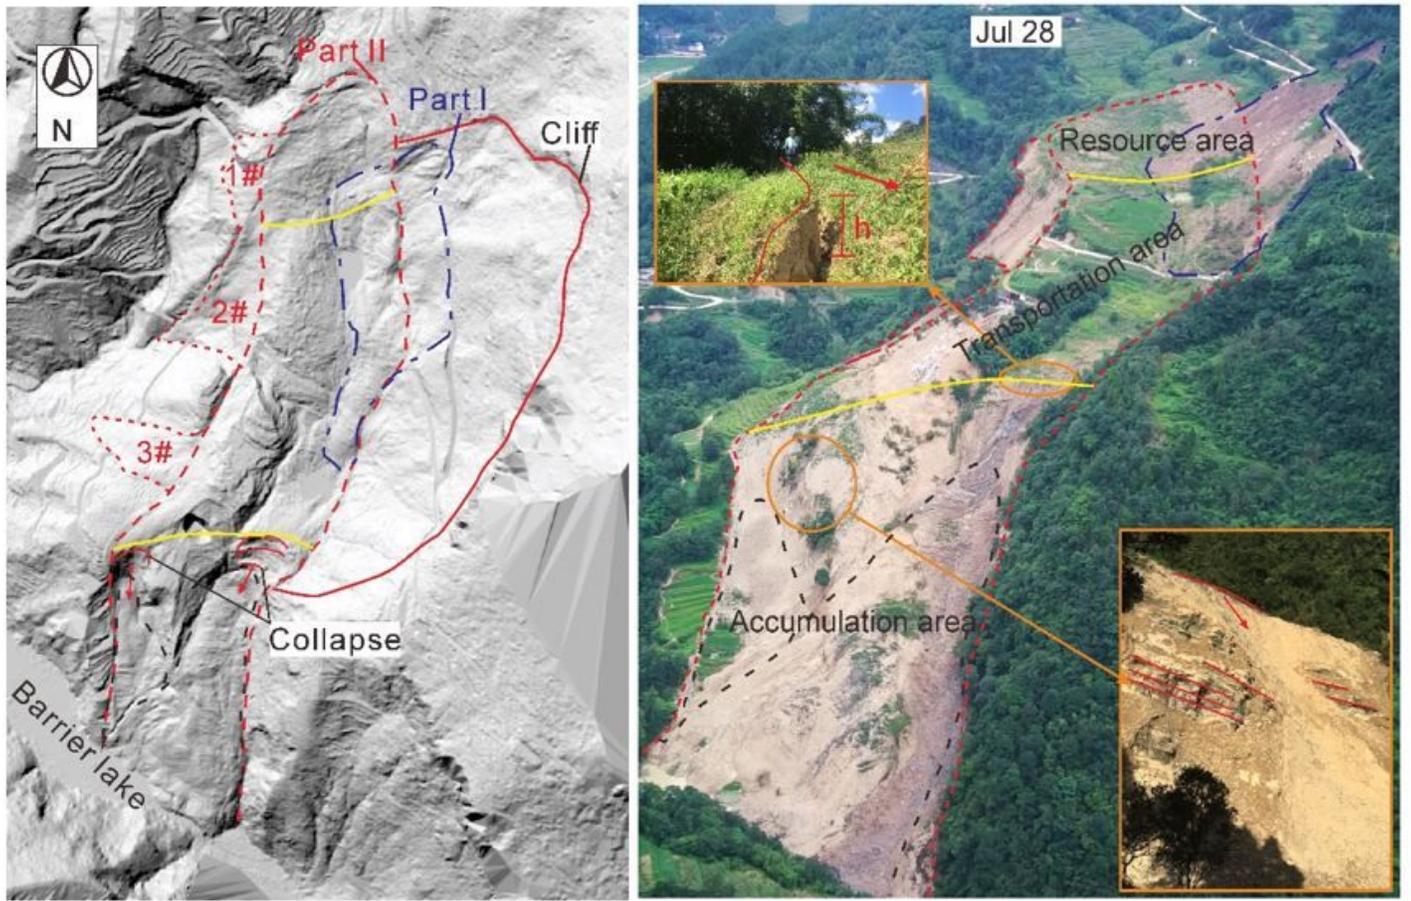
Figure 5

Part I: This portion is located at the north-east side of the landslide (Fig. 5). Reactivated deposits of Part I covered Part II. This part is 140-245 m wide and 230 m long, about 10 m thick with a highest elevation difference of 102 m. The deformation characteristics of the road showed that the accumulation moved with Part II, inferred that Part I failed before Part II. Due to the steep slope, engineering projection and continual rainfall, Part I slipped with velocity and compressed Part II which accelerated the movement of Part II. Therefore, the uplift area and puddle were found in the part II.

Source area (Fig. 5): The length and elevation difference of this area is approximately 207 m and 46 m, respectively. Under the effect of rainfall and part I, the rear section of Part II gradually deformed and developed into scratch (Fig. 6 a) and tension cracks. Those cracks became an infiltration path for rainfall which damaged the yale structure and decreased the shear strength of the soil and rock. The rock became severely fragmented (Fig. 6 b). The deformation of the landslide accelerated. Many scarplets and cracks were found in this portion. Moreover, the boundary between the source area and the transportation area was an uplift zone with an average height of 3.0 m (Fig. 5).

The result of the Airborne Lidar after filter trees. Note the black dashed line is the secondary landslide in the accumulation area. Yellow lines separated the three part (see text). Sub-photographs are the scarplet and local collapse, respectively.

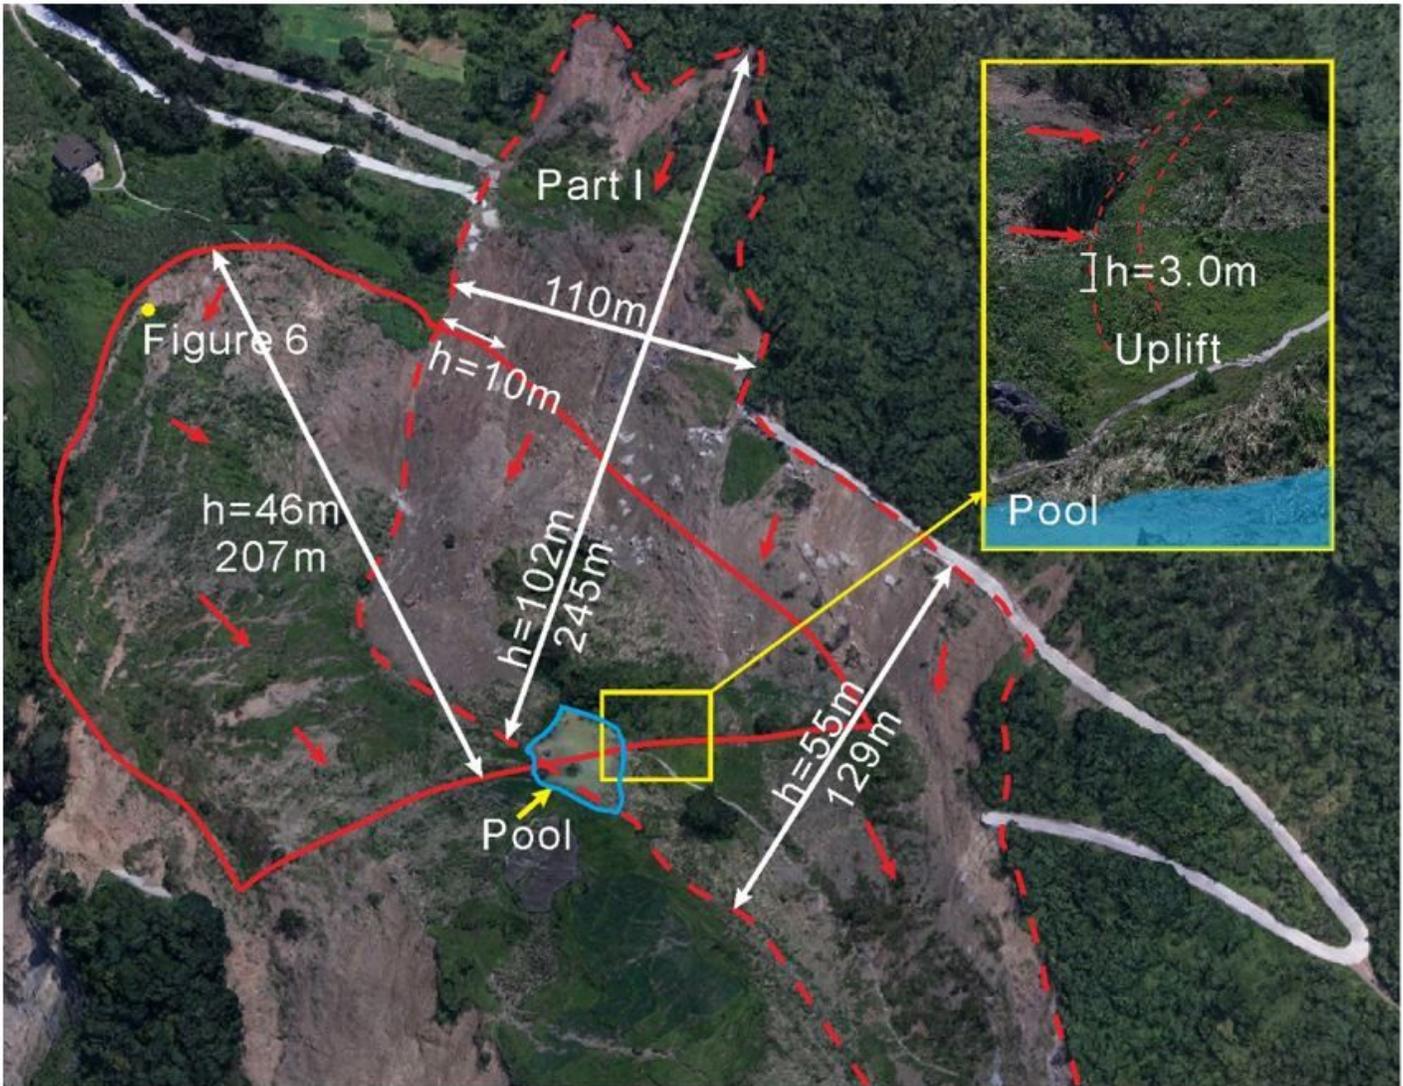
Figure 6

Picture of source area and Part I area. The sub-picture is the uplift zone between source area (left) and transportation area (right). Note, 'h' represents the elevation difference of the landslide area. Note: The designations employed and the presentation of the material on this map do not imply the expression of any opinion whatsoever on the part of Research Square concerning the legal status of any country, territory, city or area or of its authorities, or concerning the delimitation of its frontiers or boundaries. This map has been provided by the authors.

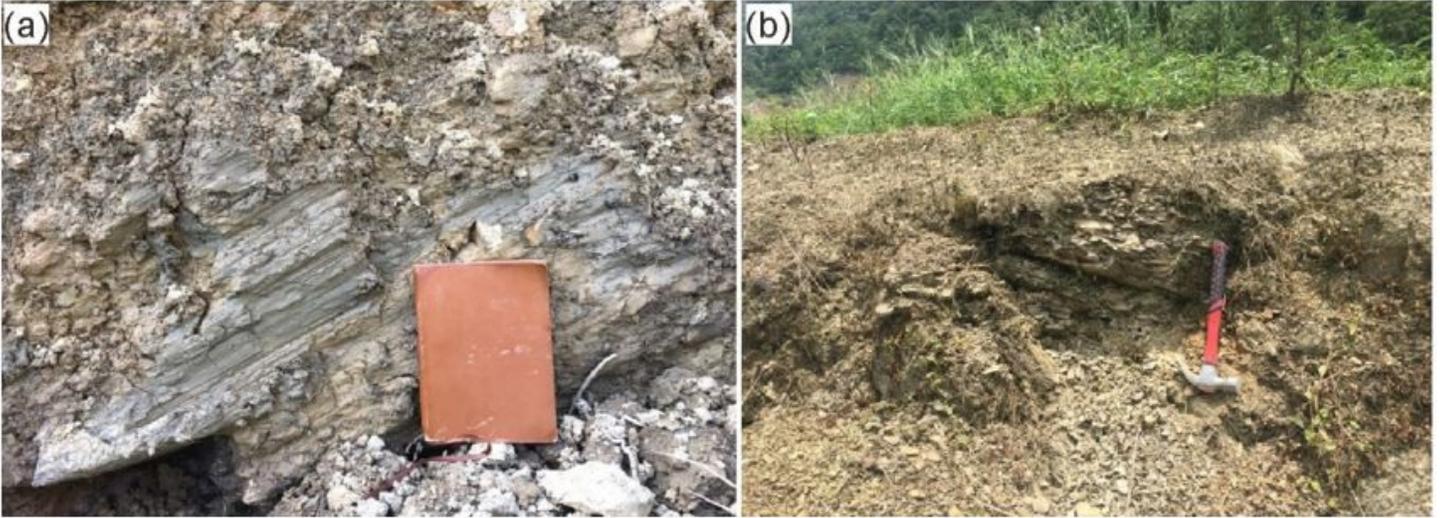
Figure 7

a) Scratch and b) broken rock. See Fig. 3 for the locations of pictures. Note: The designations employed and the presentation of the material on this map do not imply the expression of any opinion whatsoever on the part of Research Square concerning the legal status of any country, territory, city or area or of its authorities, or concerning the delimitation of its frontiers or boundaries. This map has been provided by the authors.

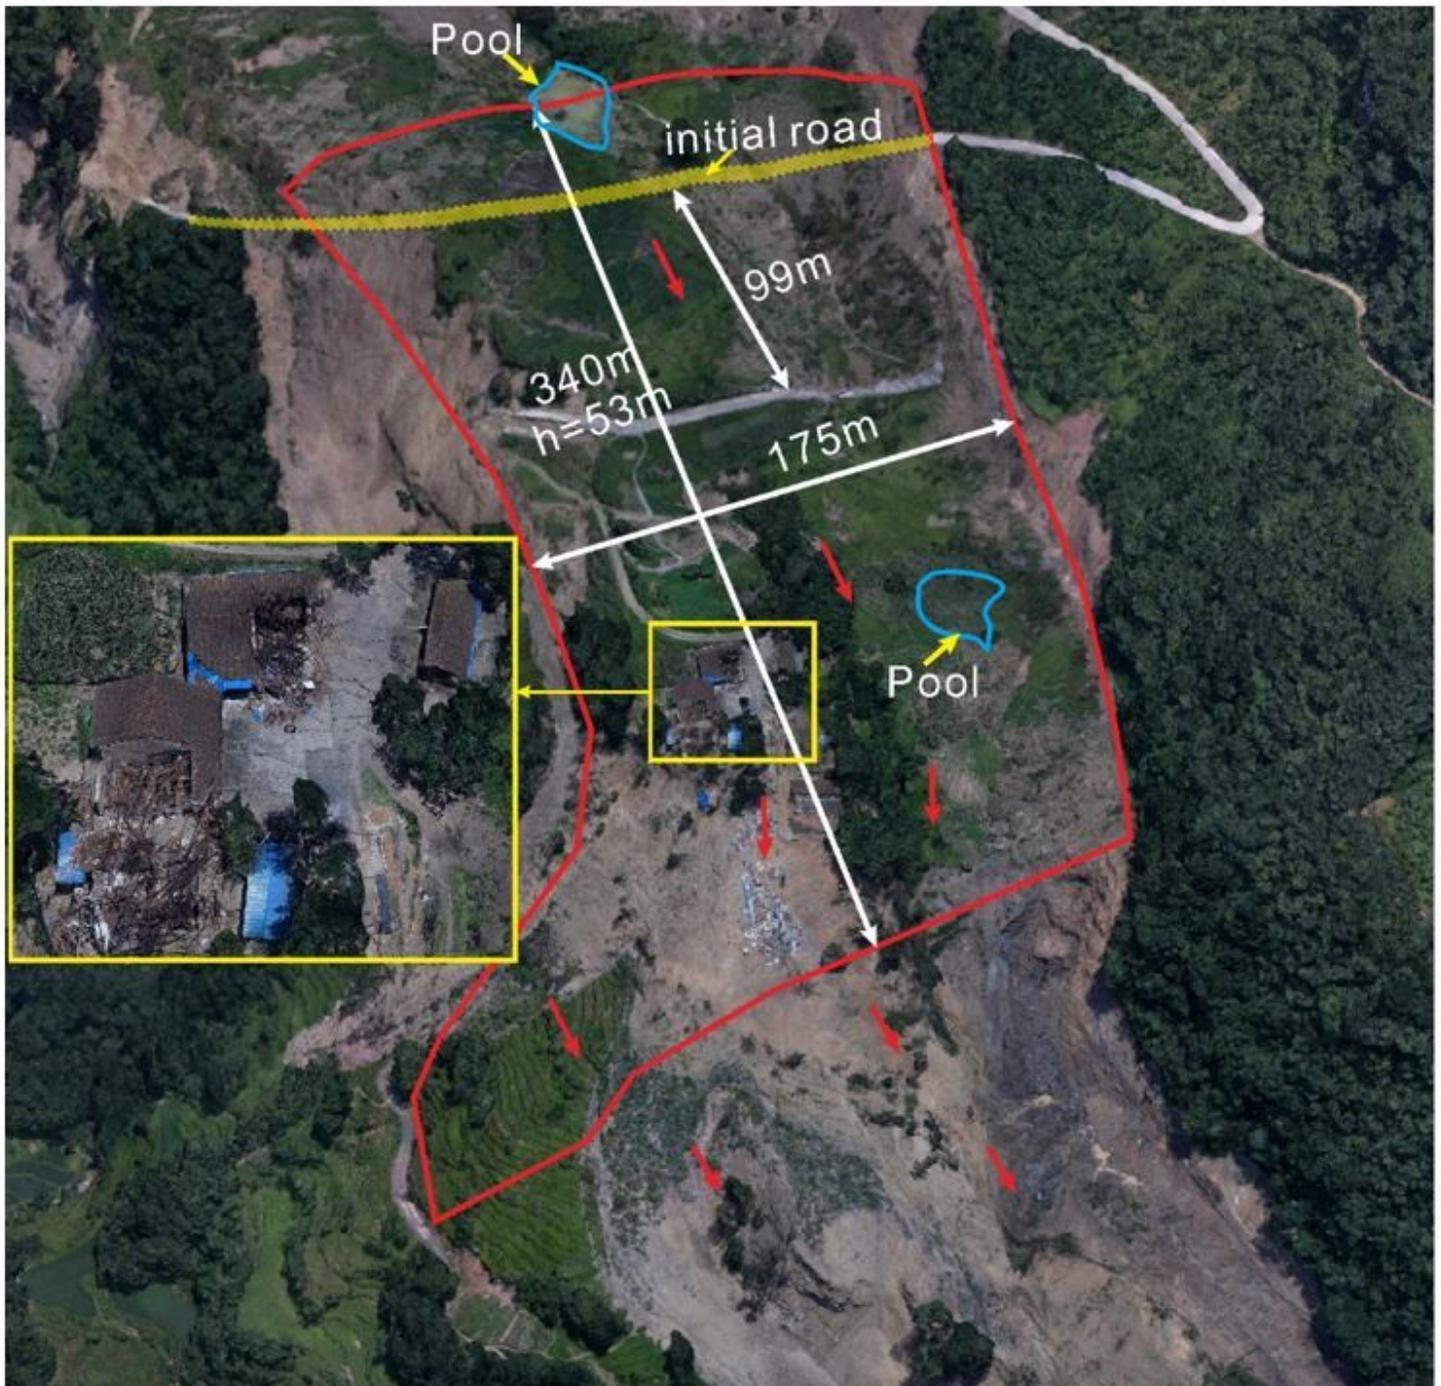
Figure 8

Picture of transportation area. The sub-picture is the village which shows that most of those buildings maintain good integrity. The road also kept good continuity except two sides, even it slid over 90 m. The blue line is pools. Note: The designations employed and the presentation of the material on this map do not imply the expression of any opinion whatsoever on the part of Research Square concerning the legal status of any country, territory, city or area or of its authorities, or concerning the delimitation of its frontiers or boundaries. This map has been provided by the authors.

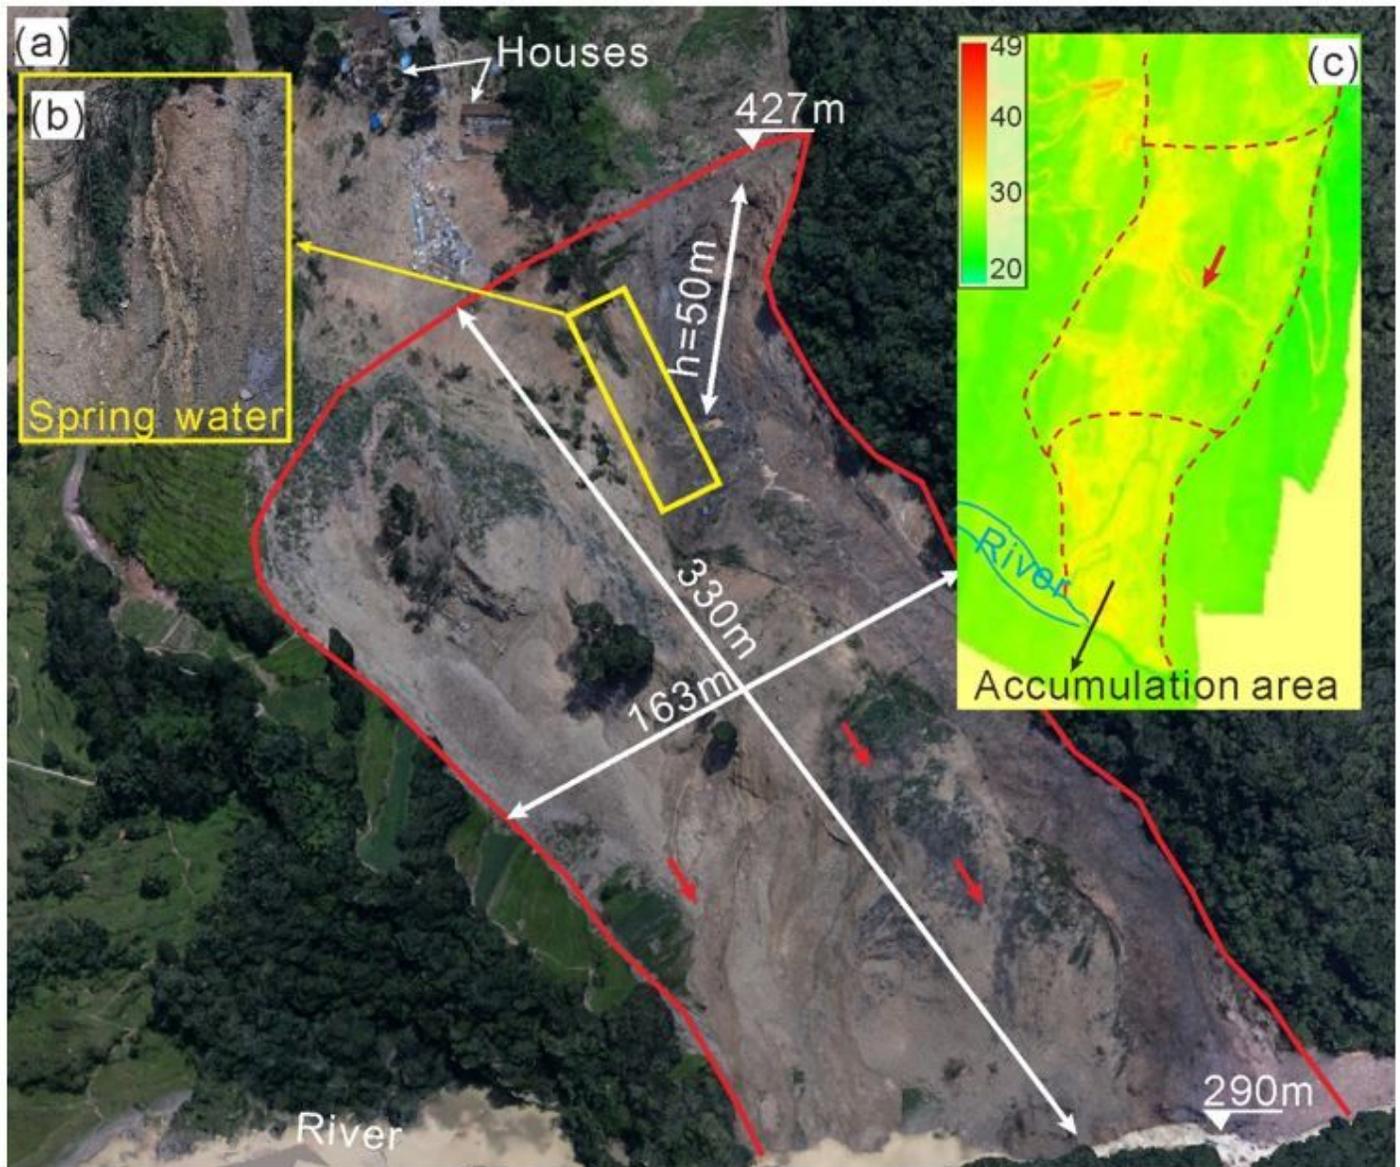
Figure 9

Accumulation area (Figure 8): The rear part became steep again, and the dip direction of the exposed rock was 15° . Thus, the sliding direction of the landslide changed. The sliding mass slip and mobilized surficial deposits in the accumulation area by scraping, entraining, and pushing them downward. Finally, the reactivated deposits accumulated in the toe of landslide and formed a barrier dam and barrier lake. The thermal infrared monitoring found that the temperature field appeared abnormal in the place where the groundwater was exposed. Moreover, the temperatures of the accumulation area were higher than other area.

Picture of accumulation area (a), the spring water (b), and the temperature of the landslide surface (c). Note: The designations employed and the presentation of the material on this map do not imply the expression of any opinion whatsoever on the part of Research Square concerning the legal status of any country, territory, city or area or of its authorities, or concerning the delimitation of its frontiers or boundaries. This map has been provided by the authors.

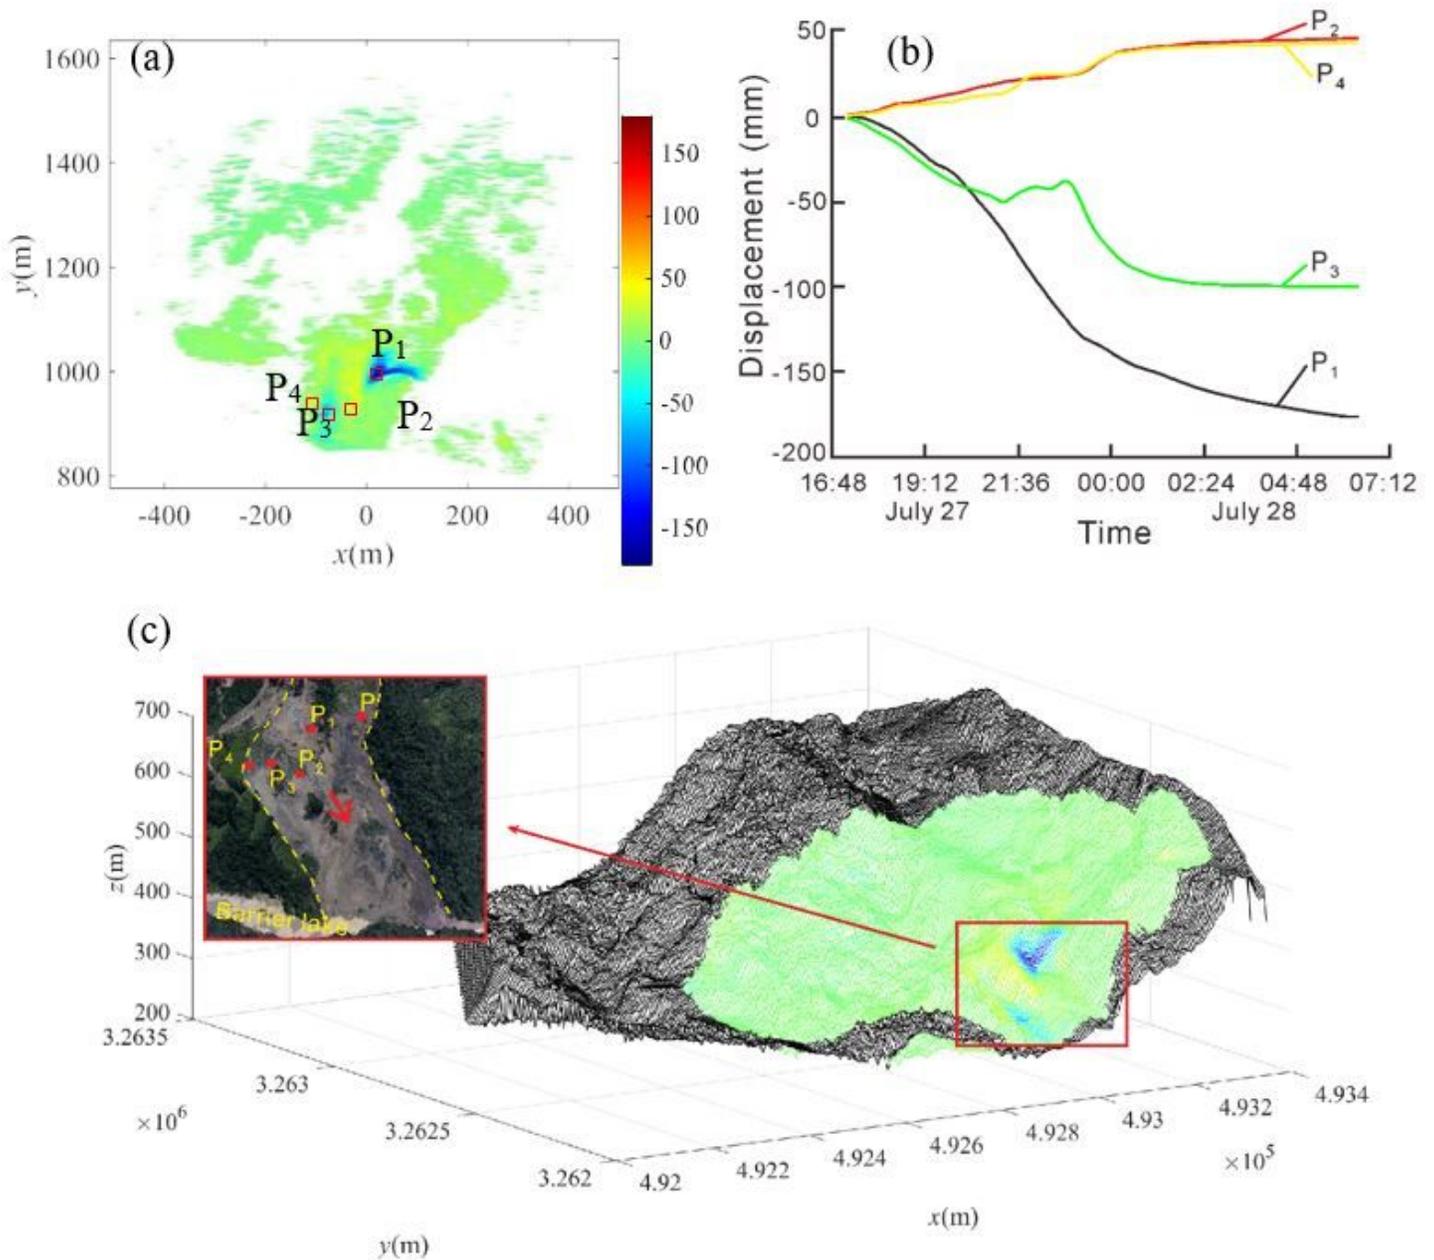
Figure 10 is the monitoring results of the landslide surface from 16:00 pm July 27 to 6: 00 am July 28. The uphill and middle of the landslide has no obvious deformation, but the downhill section has large deformation with largest displacement of 200 mm (Fig. 10a). The displacements of four monitoring points in the downslope are shown in Figure 10b. It is observed that the displacement of P2 and P4 slowly increased and reached about 50 mm. However, the displacement at P1 and P3 had the largest values. The velocity of P1 gradually decreased after July 28. The displacement at P3 sharply increased at 22:00 July 27 and then tend to stable. Moreover, local deformation was also found at the cliff on the northeast side of the downslope (approximately -50 mm).

Deformation of the Zhongbao landslide during July 27-28. (a) Accumulative displacement of the landslide surface; (b) the displacements of monitoring points visé time; (c) Three-dimensional topographic map. Note, negative value of the displacement means that the point moves to Radar. Note: The designations employed and the presentation of the material on this map do not imply the expression of any opinion whatsoever on the part of Research Square concerning the legal status of any country, territory, city or area or of its authorities, or concerning the delimitation of its frontiers or boundaries. This map has been provided by the authors.

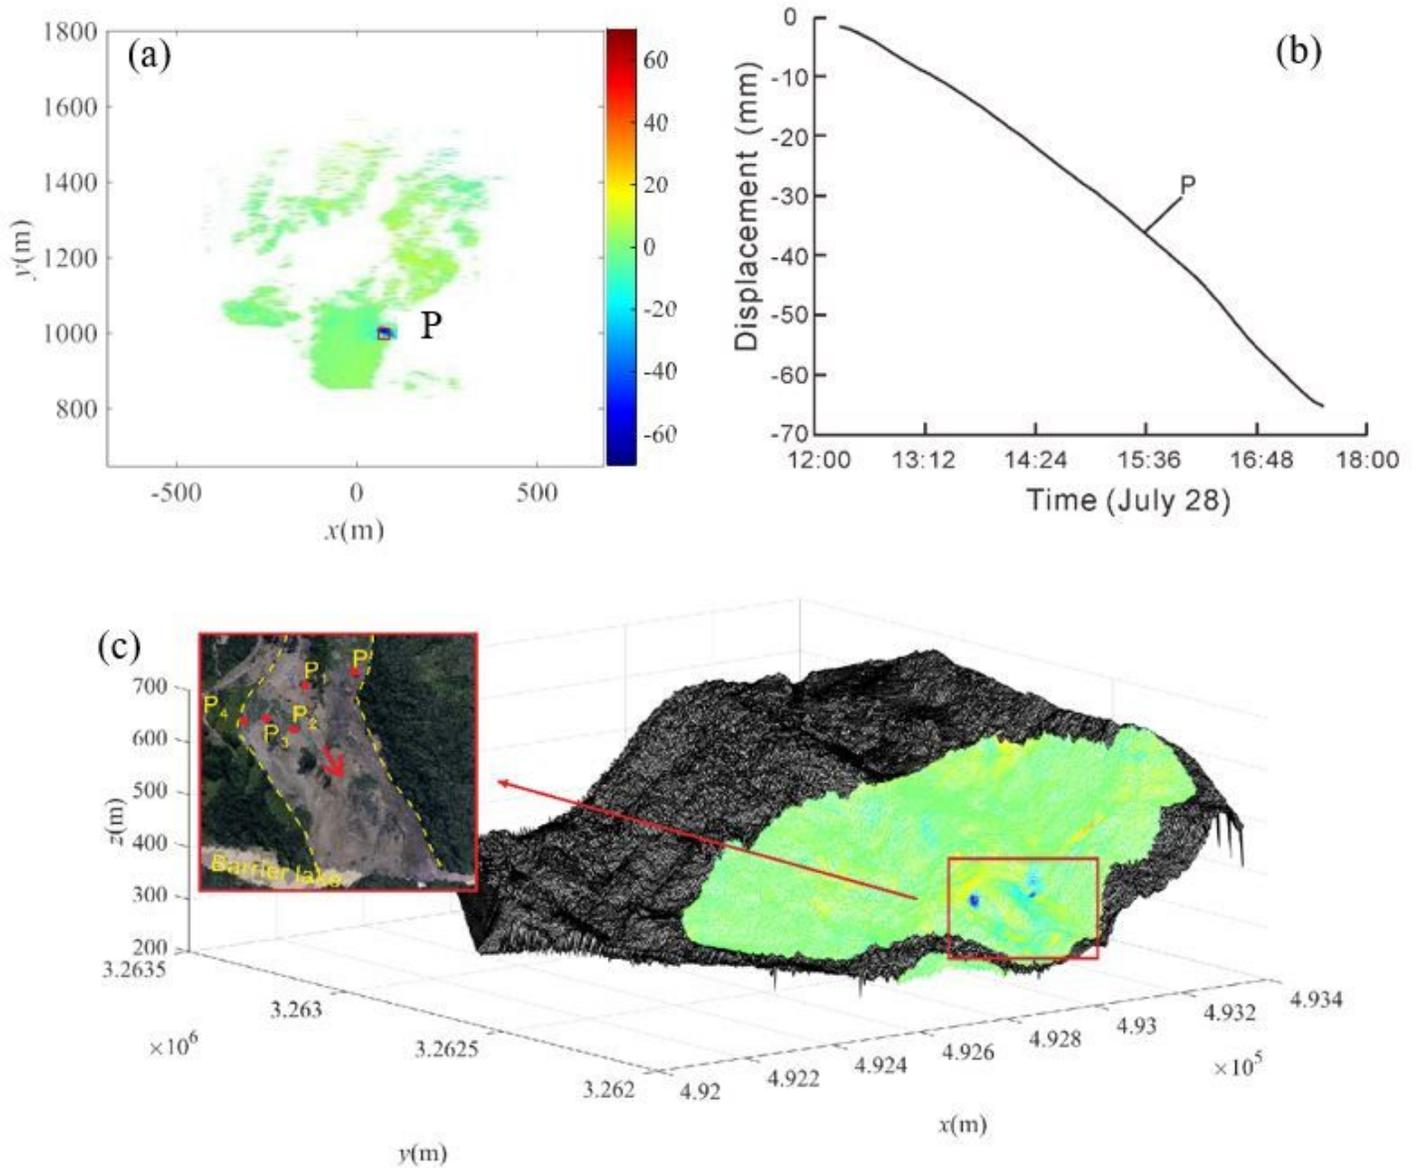
Figure 11 shows the displacement of the landslide surface from 11:00 am to 5:00 pm July 28. It was found that the largest displacement of the landslide is about 70 mm, which is obvious smaller than that in Figure 10 (Figure 11 a). The displacement of the point at P was monitored (Figure 11 b). The displacement increases with a velocity of 12 mm/h, which indicated that the local collapse still occurred. Figure 11 c shows that the upslope also had small deformation (>40 mm) and the whole landslide was stable.

Deformation of the Zhongbao landslide during July 28. (a) Accumulative displacement of the landslide surface; (b) the displacements of monitoring points visé time; (c) Three-dimensional topographic map. Note: The designations employed and the presentation of the material on this map do not imply the expression of any opinion whatsoever on the part of Research Square concerning the legal status of any country, territory, city or area or of its authorities, or concerning the delimitation of its frontiers or boundaries. This map has been provided by the authors.

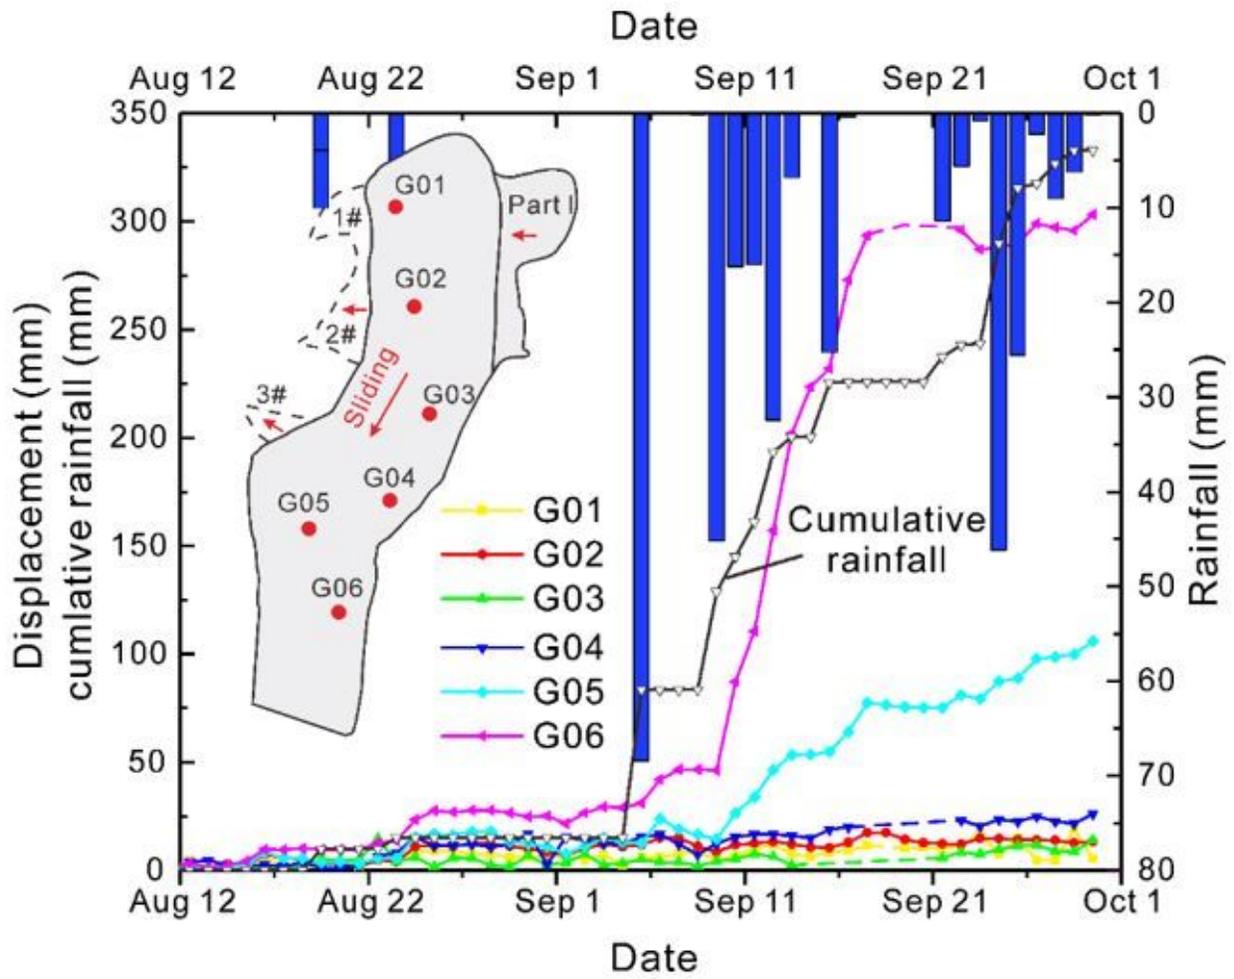
Figure 12

In Fig. 12, the rainfall and displacement from Aug 12 to Oct 1 were recorded. The second wet month (from September to October) was characterized by a 333 mm cumulative rainfall. The downhill slope (G05, G06) had large deformation with a velocity as high as 6 cm/day (G06). The increment displacement of the G06 suddenly decreased tending to zero, but the G05 went on with a constant rate of 3.8 mm/day. Clearly, the rainfall reactivated the landslide. Moreover, the increase of the displacement at G06 and G05 generally lagged 1 day behind the rainfall. Other portion of the landslide had small displacement (<30 mm /month), but also responded to the rainfall and gradually increased.

Rainfall cumulative displacement of monitoring points and versus time
