Seismic Performance of Strengthened Masonry Structures: Actual Behaviour of Buildings in Norcia and Campi Alto During the 2016 Central Italy Seismic Sequence

Research Article

Keywords: post-earthquake damage, usability, strengthening interventions, masonry buildings.

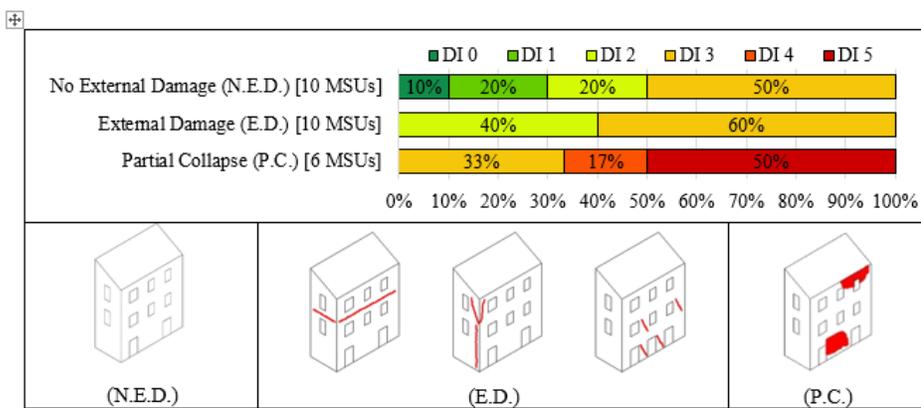
Figure 16

In the N.E.D. group, 3 MSUs had a damage index equal to 0 or 1, see Fig. 16. Although different in size and number of floors, a common factor on such MSUs was the extensive use of strengthening intervention on vertical walls. In particular, the walls that suffered severe damage after the 1979 and 1997 earthquakes were restored by means of several local dismantling and subsequent rebuilding (the so-called "*scuci-cuci*" intervention), and strengthened through G.I. or combining G.I. and R.P. (e.g. project 10, see Annex). Connections between orthogonal walls were improved by inserting S.C. or T.R. (e.g. project 17 and 18, see Annex). Furthermore, a strong replacement of existing walls was carried out by using block masonry (project 10a) or stone masonry (project 17). Thus, extensive intervention on both vertical and horizontal structures clearly led to satisfactory seismic

MSUs with no external damage and damage index equal to 0 (project 18) or 1 (projects 10 and 17)

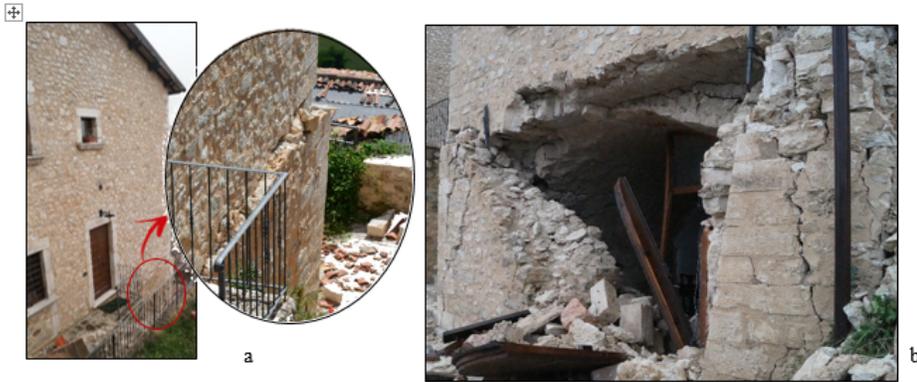
Figure 21

(a) Project 8: crumble of masonry walls at ground floor;(b) Project 2: collapse of the masonry walls at ground and first floor

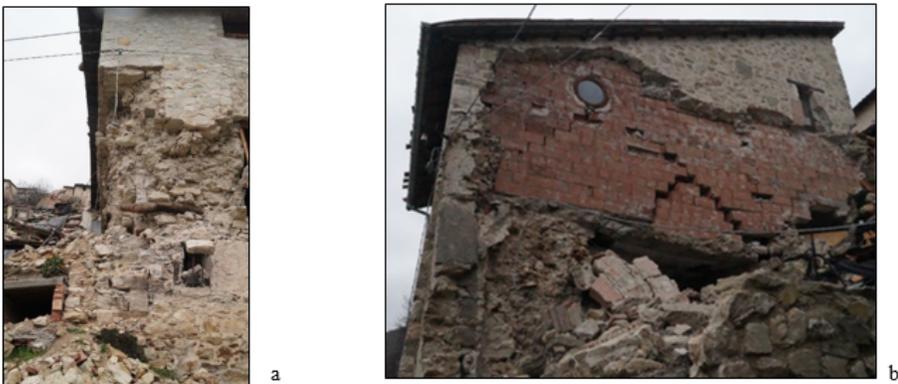
Figure 22

Severe damage after the 2016 sequence was also observed in case of MSUs strengthened by using a very heavy and rigid roof on a bad quality walls which were not adequately reinforced by extensive use of G.I. and R.P. as originally designed, (e.g. MSU of project 11, see Annex A and Fig. 22).

Project 11: collapse of poor quality masonry walls due to the presence of heavy roof: (a) downstream façade; (b) lateral section

The use of connectors at building corners is crucial to avoid significant damage and collapses and they should be adequately designed (i.e. number, length). Finally, the realization of new heavy roof should be accomplished by strong intervention aimed at increasing the mechanical properties of bearing walls or it can result detrimental for the MSU seismic performances.
