Experimental procedure for studying the degradation and alteration of limestone slabs applied on exterior cladding

Research Article

Keywords: Building facade cladding, natural stone, degradation, mineralogical composition, ageing

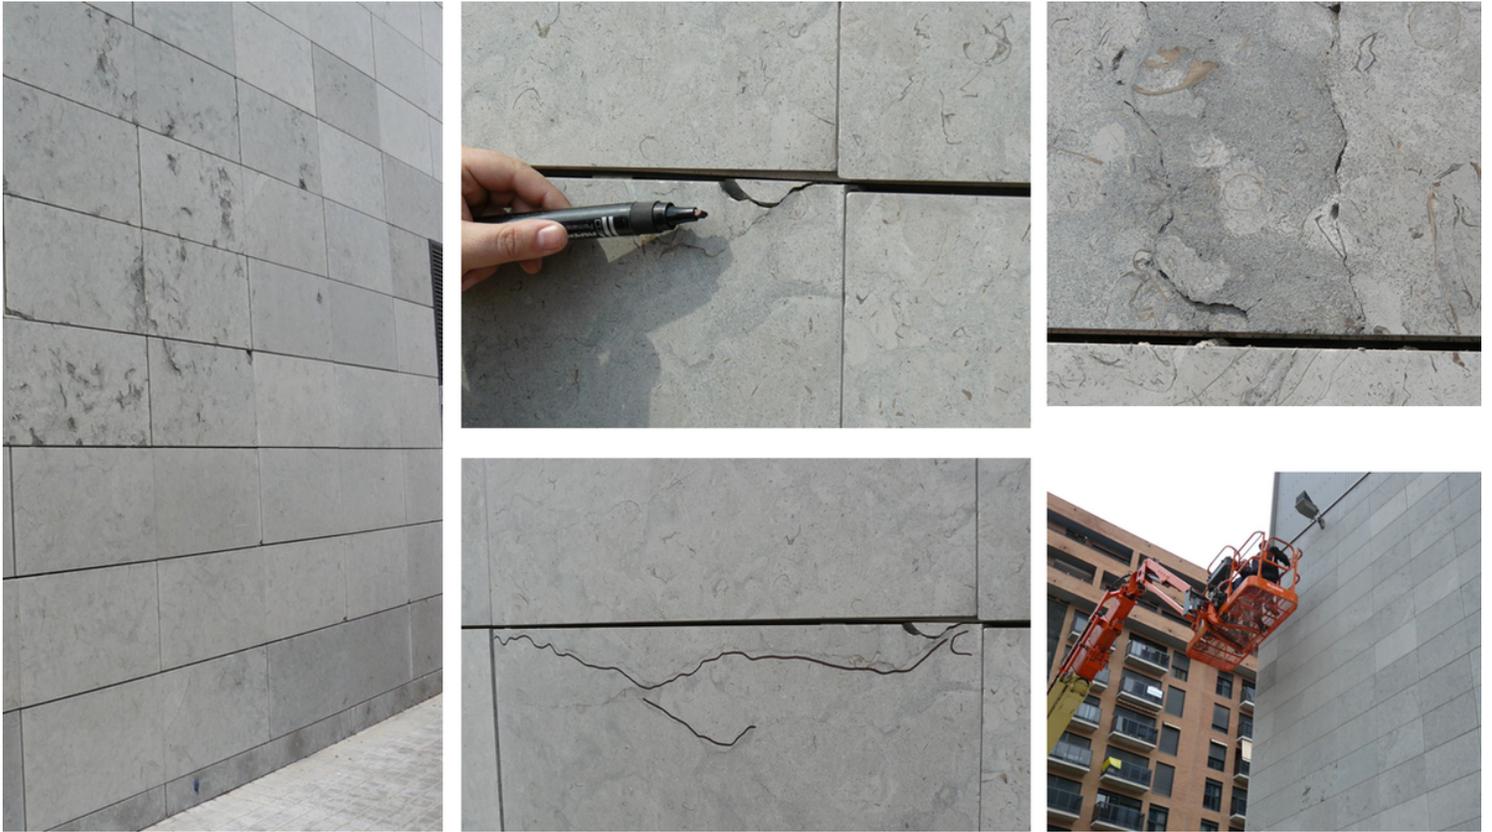
Figure 1

This case study refers to an experimental procedure to study the degradation of Portuguese limestone slabs with dimensions of 500x375x30 (mm) in a building facade in the city of Valencia (Spain) using a standard “Kerf” anchoring system. After 5 years of installation signs of deterioration began to be detected in the external facade of the building that led to changes in color, occurrence of cracks, swelling, fissures and loss of powdery material. These phenomena have caused instability of the facade elements with consequent implications in users’ safety and aesthetics appearance of the building (**Fig. 1**).

Exterior views of the building facade clad with the studied limestone from Portugal and depicting deterioration such as cracks, fissures, colour changes and swelling. Picture credits by Juan José Tejado Ramos.

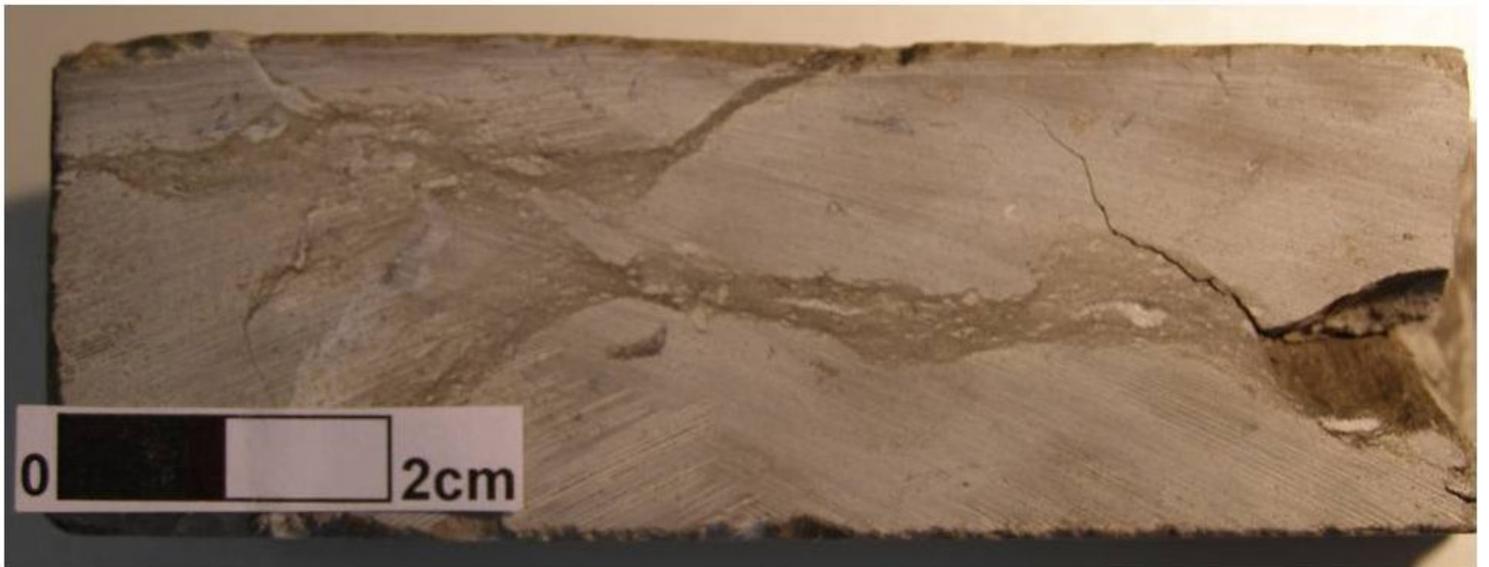
Figure 5

AV limestone has cracks and layers sub parallel to the slabs surface with variable thickness showing darker color (see **Fig. 5**).

Visible cracks, fissures, and layers of on example of a sound AV limestone slab

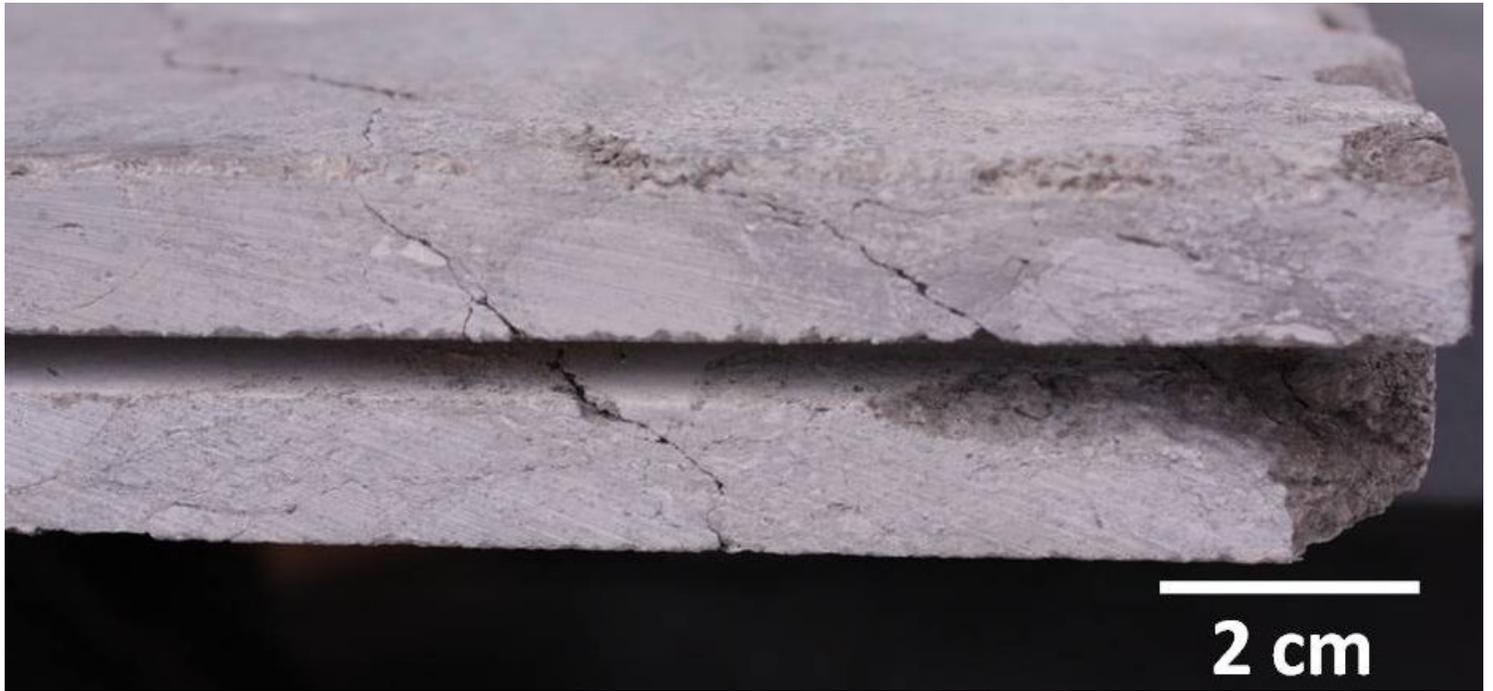
Figure 6

Damaged AV slabs were collected from the building façade and in these an increase in cracking, loss of material (see **Fig. 6**), swelling - shrinking and the appearance of powdery material was clearly detected (see **Fig. 7**).

Fractures and loss of material on the Azul Valverde slabs in the kerf/slot region where the slab interacts with the anchoring system

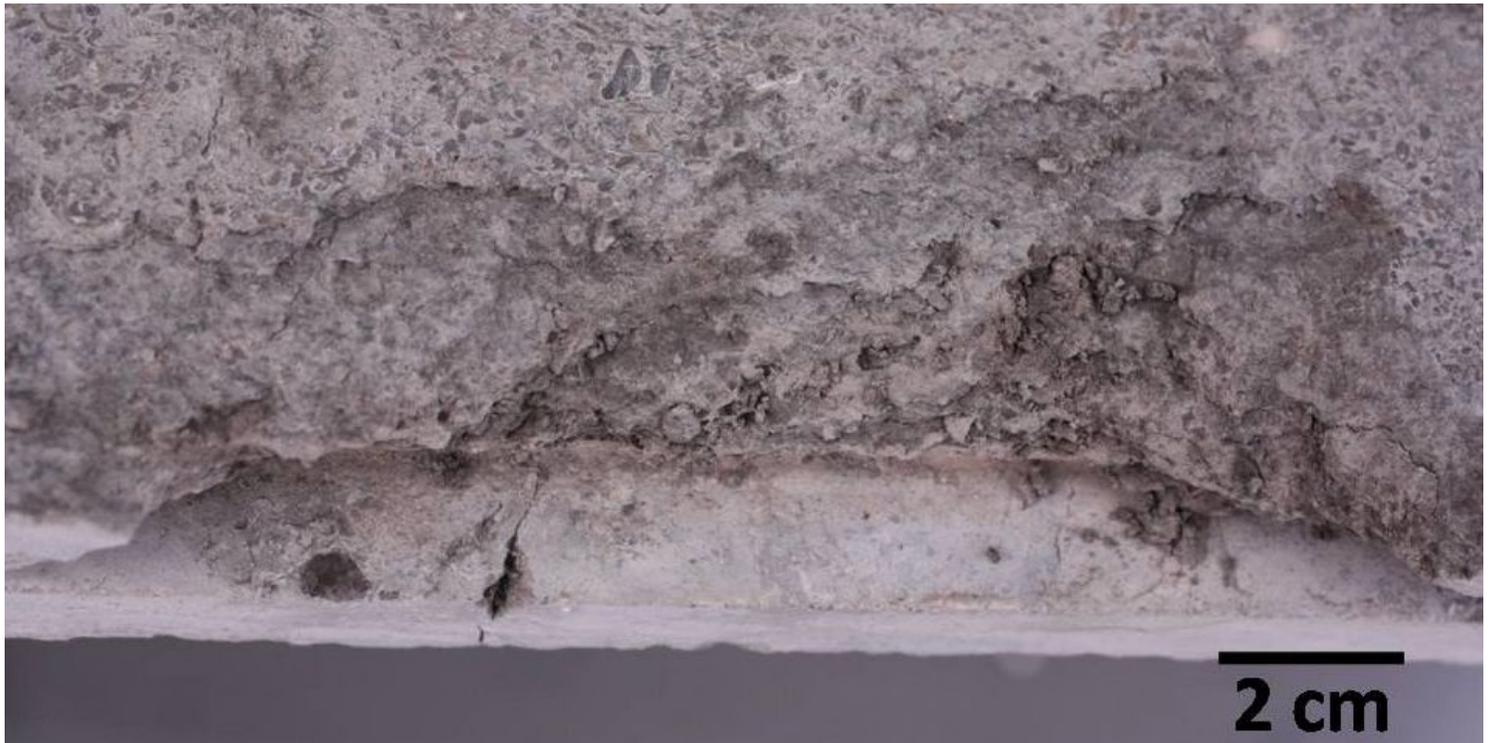
Figure 7

Powdery clay material on the Azul Valverde slabs

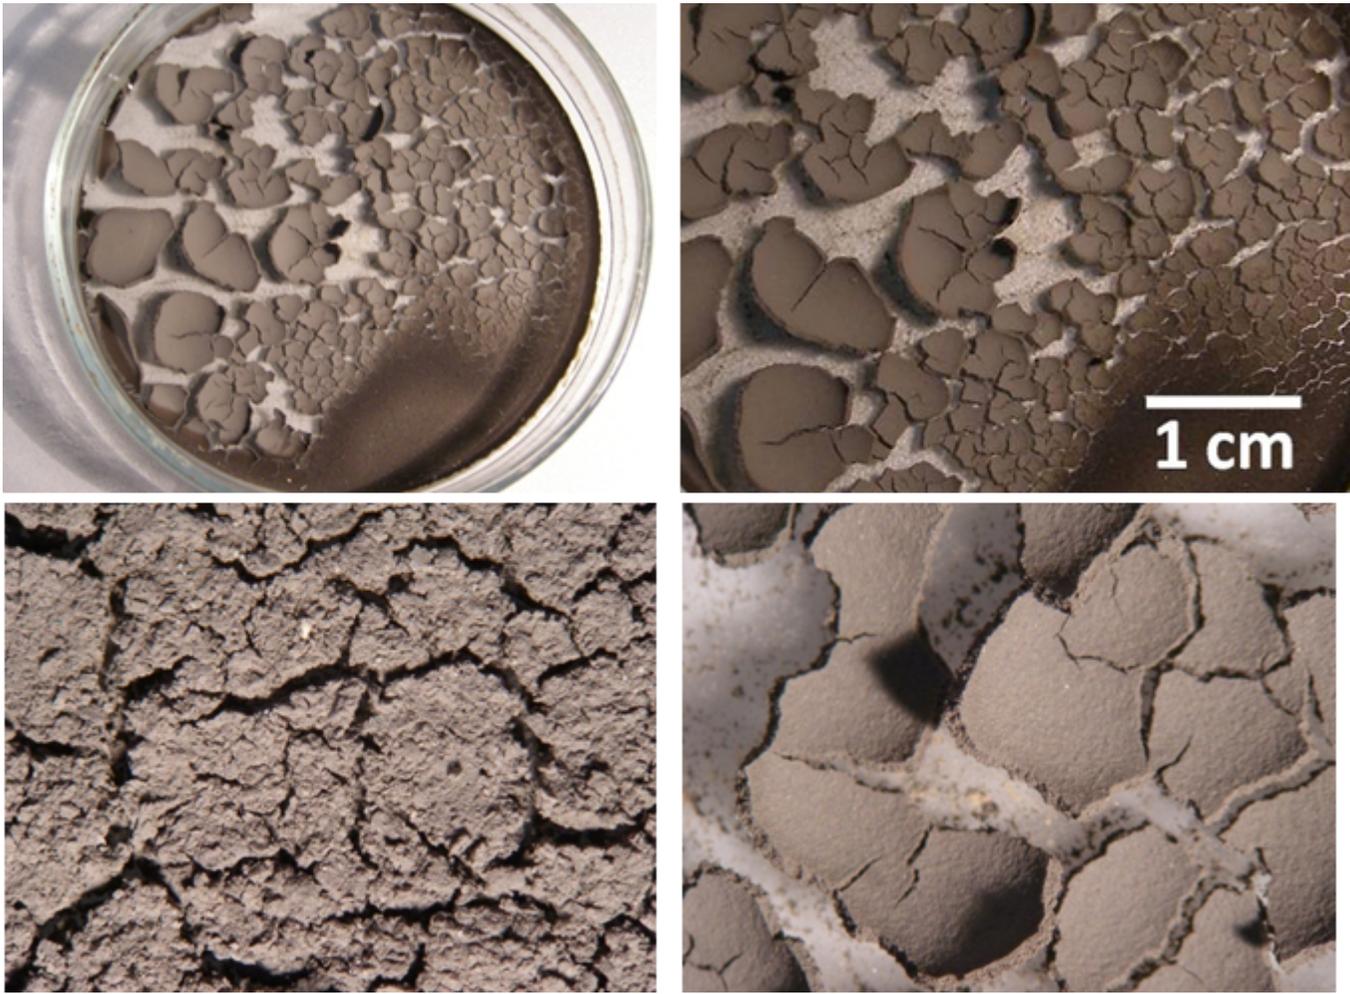
Figure 8

Laboratory determinations of clay content in AV degraded specimens were highly informative and detected 18% of clay and almost no organic matter (0,49 %). These results show that AV is not pure limestone but a marly limestone. After drying, this clay shows high retraction cracks, as it can be observed under the stereoscopic microscopic (**Fig. 8**).

Clay content of sound AV limestone with retraction cracks

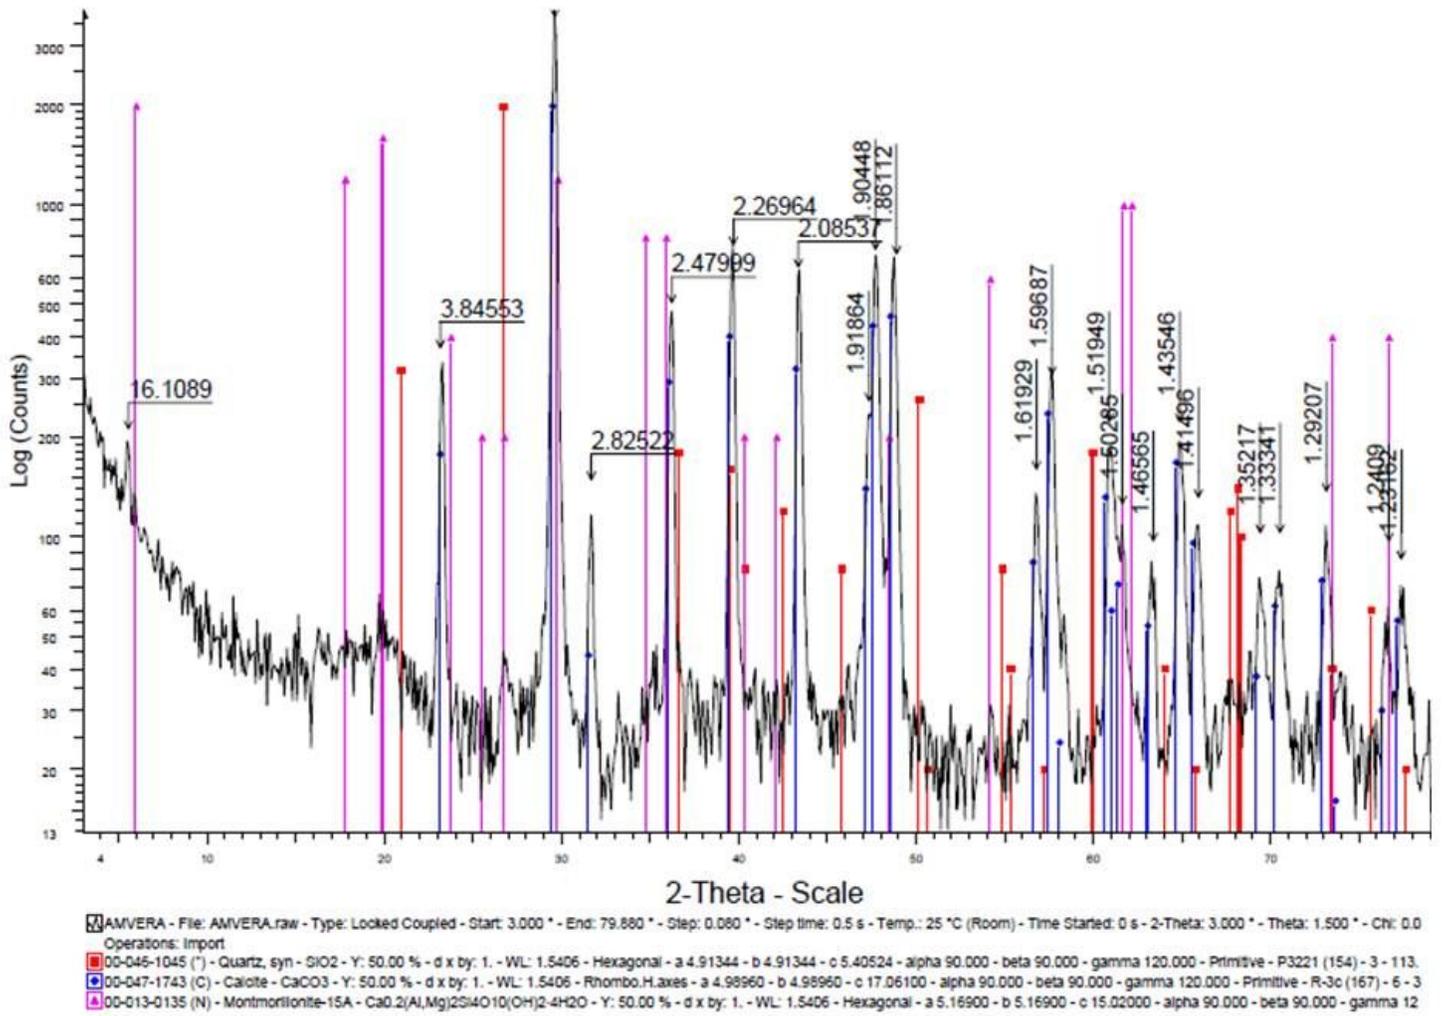
Figure 9

XRD mineralogical analysis on AV degraded specimens (**Fig. 9**) revealed the presence of calcite, a small amount of quartz and montmorillonite (expansive clay mineral from smectite group); no iron oxides were detected by this technique. According to a study published by Delgado Rodrigues (1976), swelling/Shrinking can be defined as the volume increase experienced by any solid body when wetted. This phenomenon is typically associated with the hydration of crystalline substances and with the intra and interparticle adsorption and absorption of water by clay and a few other minerals having peculiar crystalline structures such as the smectites detected in this research with AV limestone (Delgado Rodrigues 1976).

XRD analysis of sound AV limestone

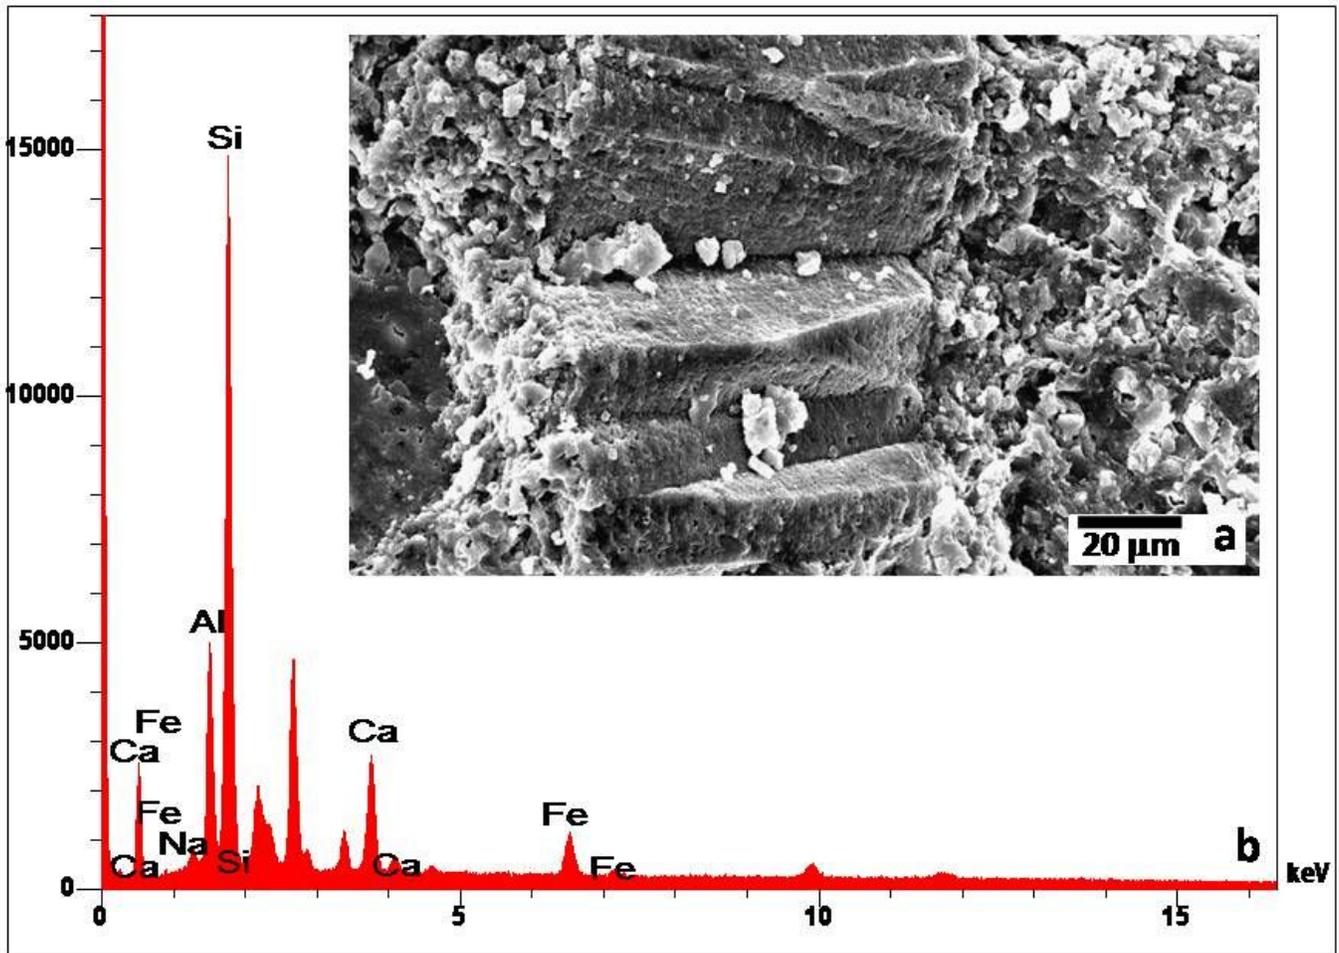
Figure 10

SEM observations allowed a detailed analysis of the clayed veins in AV degraded specimens (**Fig. 10a**) and the microprobe analysis on the clay fraction (**Fig. 10b**) confirmed the presence of a Ca-montmorillonite, a very expansive clay of the smectite group.

SEM observation of a clay vein on Azul Valverde limestone (a) and microprobe analysis of clay fraction (b).
