Assessment of Interaction Between A Waste Storage Dam And Instability In Downstream Right-Side Slope By 3D Numerical Analyses

Keywords: waste dam, slope stability, 3D numerical analysis, deformation, flysch zone

The site which is the subject of this paper is located 18 km from the city Manisa – Gördes of Turkey. It is located 789 to 980 m altitudes where the topography is steep and rugged due to landsliding. The location of the site is shown in Fig. 1.

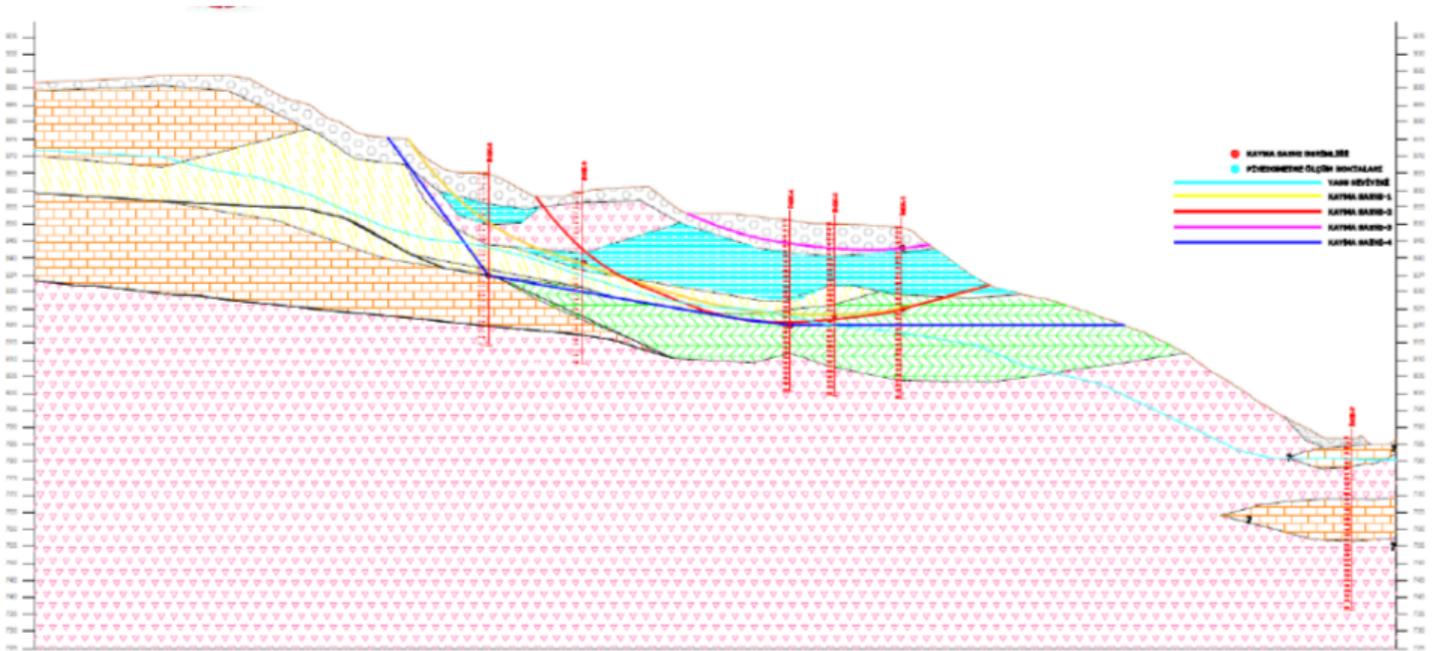
Figure 4

Two detailed engineering geological and slope stability studies were performed by Tuncay et al. (2018) and Topal and Nalçakan (2019). Tuncay et al. (2018) performed 2D static and dynamic limit equilibrium analyzes for the dam body, and they found that there is not a slope stability problem for the dam body. Field observations were carried out by Topal and Nalçakan (2019), and then 7 geotechnical drillings, each 50 m deep, were performed in the landslide area, and inclinometers were installed in the completed boreholes. According to the data obtained from the drillings, mudstone, radiolarite, siltstone, sandstone, limestone and diabase belonging to the Bornova flysch zone were detected in the field. However, old waste material and clays were observed in the upper levels in the landslide zone. The mechanism of the landslide was described by Topal and Nalçakan (2019) (Fig. 4). The safe slope stability conditions were

The mechanism of the landslide occurred at the right-downstream slope of the dam (Section 2 in Figure 3) (Topal and Nalçakan, 2019).

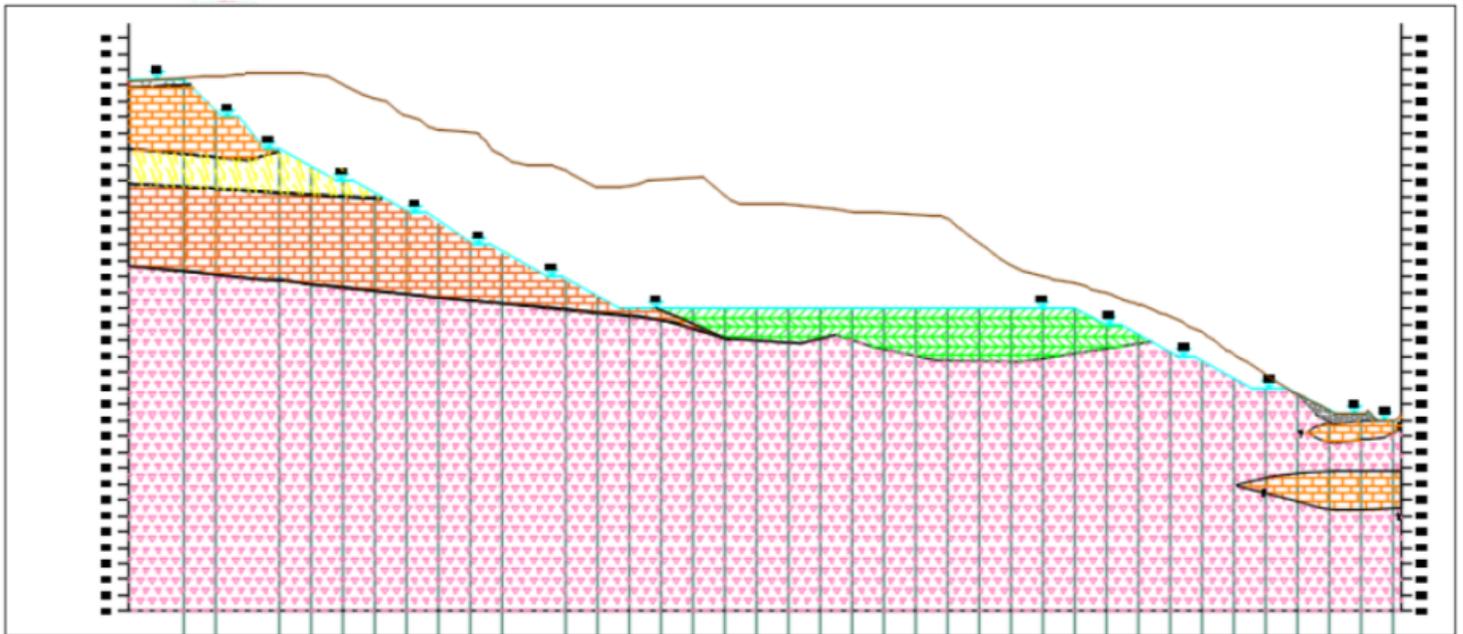
Figure 5

The safe slope geometry proposed by Topal and Nalçakan (2019) (Section 3 in Figure 3)

obtained as shown on Fig. 5. In the present study, the existing geometry of the landslide, and the safe slope geometry proposed by Topal and Nalçakan (2019) are considered for investigation of the effect of landslide and the excavation of the displaced material.

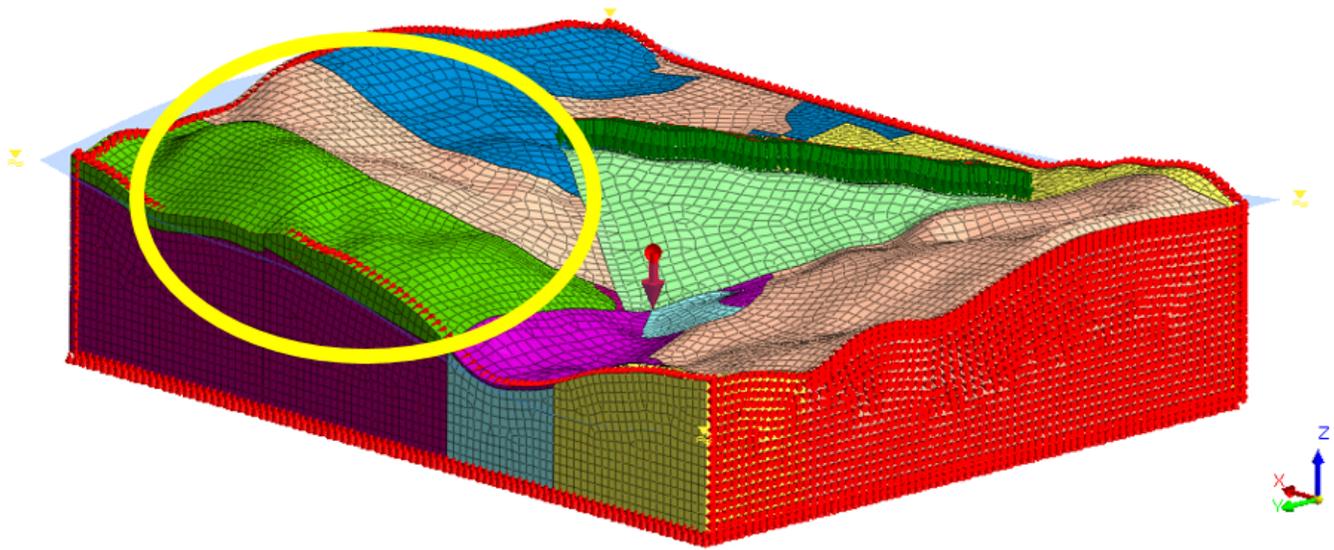
Figure 8

3D model of the site (The circle contains unstable slopes)

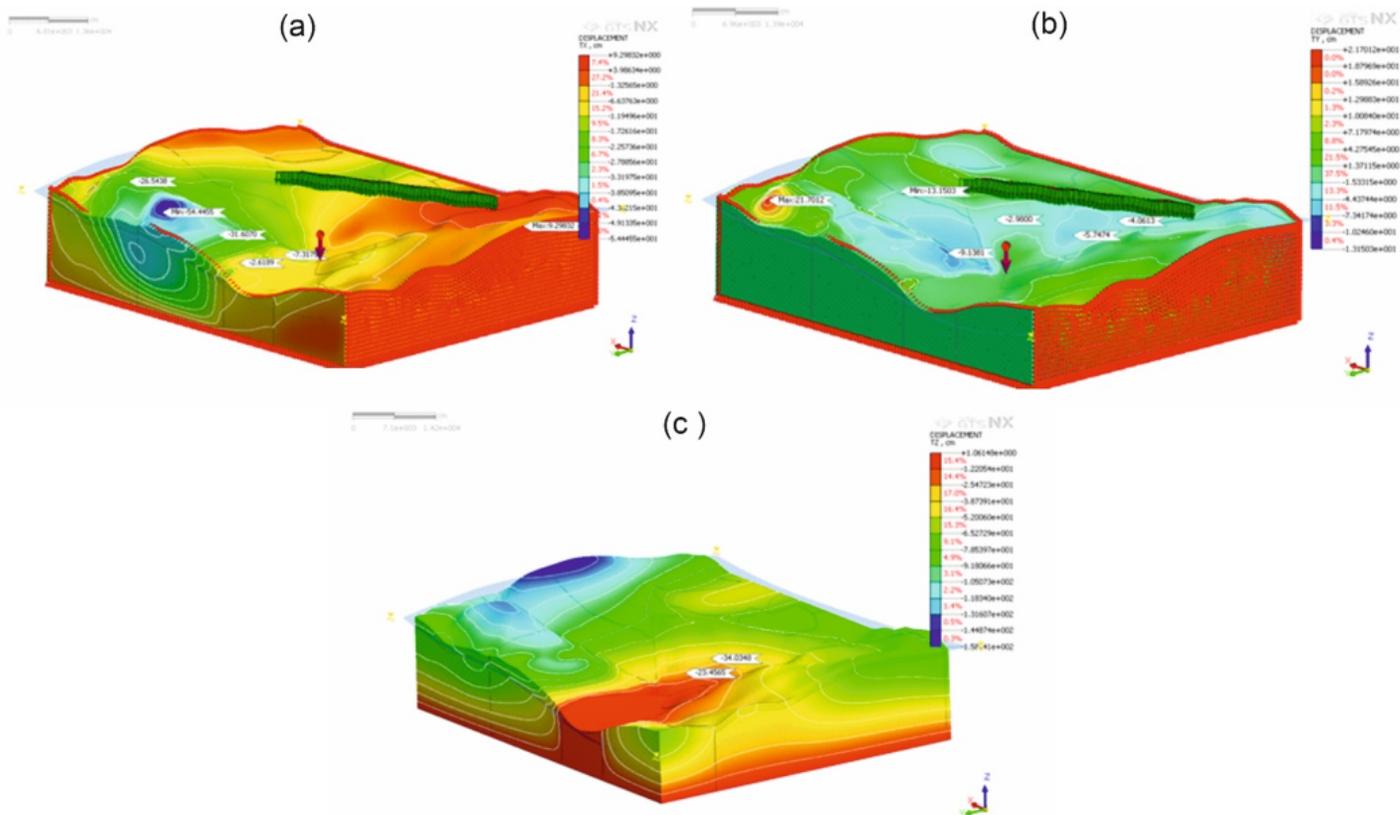
Figure 9

After performing the analyses, the obtained deformations in x-direction is presented in Fig. 9a. The maximum deformation is calculated about 54 cm in -x-direction in the whole area. This is the point, where the slope instability occurred. However, in the mean dam body the maximum deformation in x-direction is calculated to be about 9.3 cm at the left-hand side. Although this 9.3 cm is acceptable in design, the important aspect in this analysis is the 54 cm displacement in the downstream side slopes. Those slopes should be remediated so that no slope failure occurs in that area. Similarly, the deformations in y- direction are presented in Fig. 9b. As can be seen from this figure, the maximum deformations in this direction are calculated in between 3 to 5.75 cm. Deformations in z-direction, i.e. settlements, are presented in Fig. 9c. The maximum deformations are expected in z-direction and as expected a value of 34 cm is calculated in this direction.

Deformations in (a) x-direction, (b) y-direction, and (c) z-direction at the current state

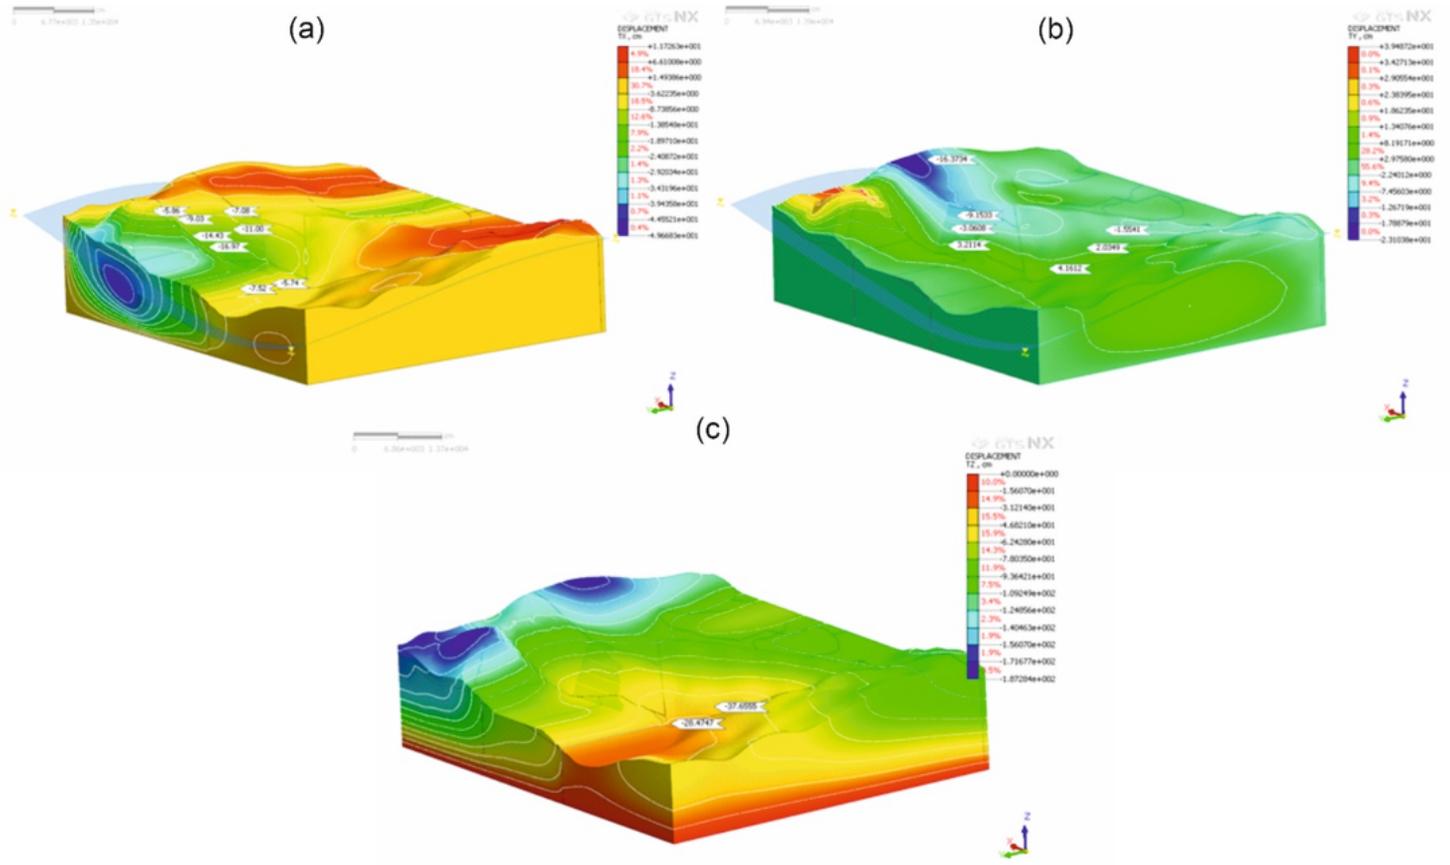
Figure 11

After the cut in the unstable slopes, the maximum deformations observed in x-direction reduces to about 17 cm which is shown in Fig. 11a. The deformations at the dam body is negligible after cutting these slopes. Similarly, when observing the deformations in y-direction, it can be seen that the maximum deformation is about 9 cm in the slopes and 4.2 cm in the dam body which is shown in Fig. 11b. Figure 12c shows the settlements after excavation of the slopes. As can be expected there is not much difference between the settlement values with the previous case, as the settlement of the dam body is mainly due to its weight.

Deformations in (a) x-direction, (b) y- direction, and (c) z- direction after excavation of the slopes

In the analyses of the current state, the deformations reached up to 55 cm in the sliding area. Hence, a slope design (with 2H/1V slope) is proposed and the slope side which reduced these deformations to about 17 cm which is acceptable.

The excavation of the proposed side slopes, there may be a water flow through the rock discontinuities as the groundwater level is near the ground surface. Therefore, it is strongly recommended to take the measures to drain water for the long-term stability. Similarly, water resting in the impermeable rocks can create additional water pressure on the slopes which may result in slope failures. Hence, the drainage of the water must be assured including both the surface and ground waters.
