Architectural Ruins: A geoheritage of the anatomy of buildings as illustrated by Casa Ippolito, Malta

Lino Bianco (✉ lino.bianco@um.edu.mt)

Research article

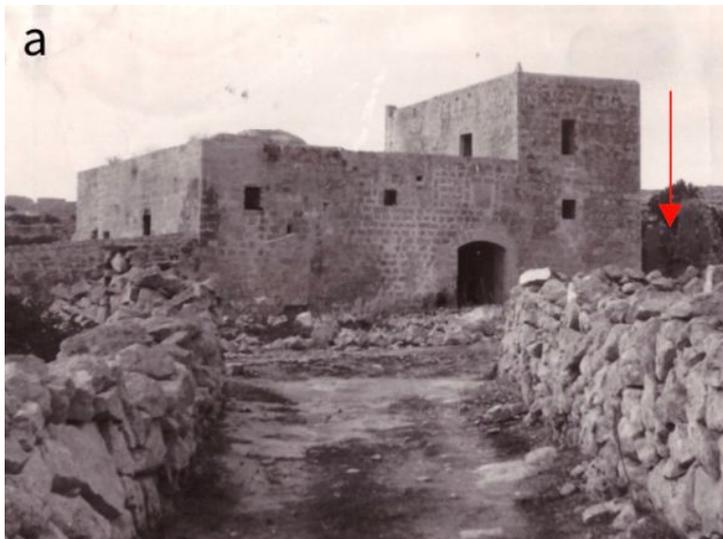
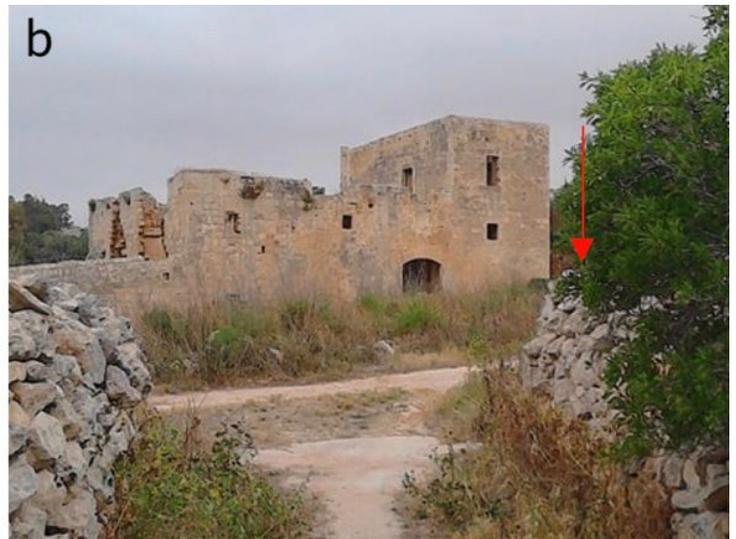
Figure 3

South-East facing elevation a in 1967 (© Heritage Malta), and b at present. Position of ruin of the 'remissa' is indicated by marker

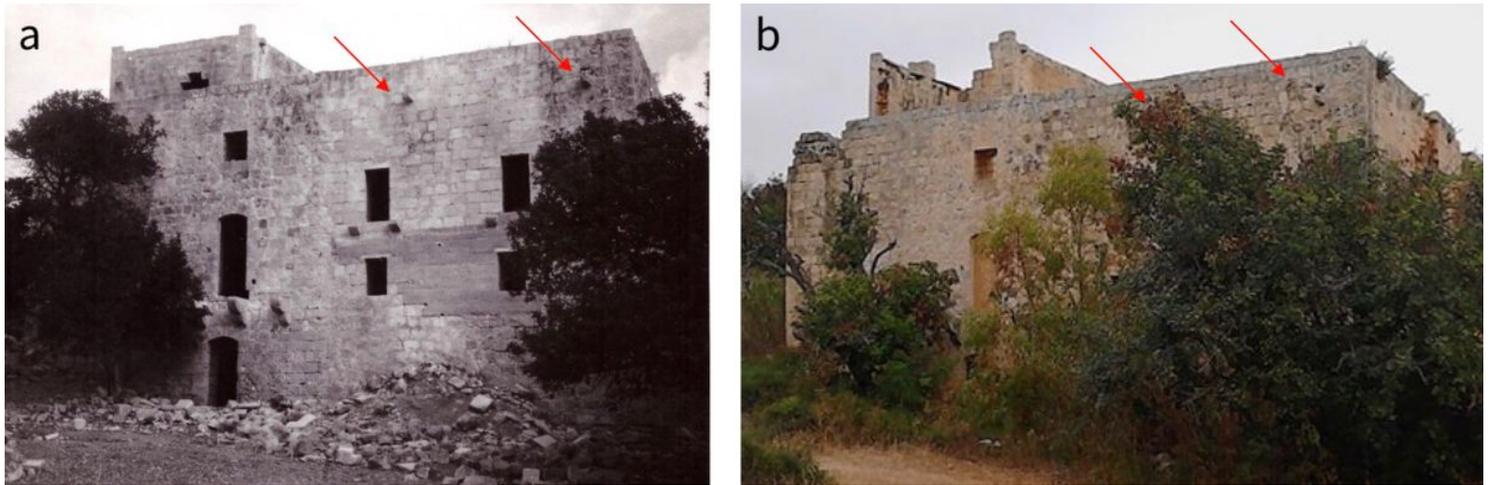
Figure 4

North-west elevation a in 1967 (© Heritage Malta), and b at present. This elevation is exposed to the direction of the predominant wind; masonry water spouts are indicated by markers

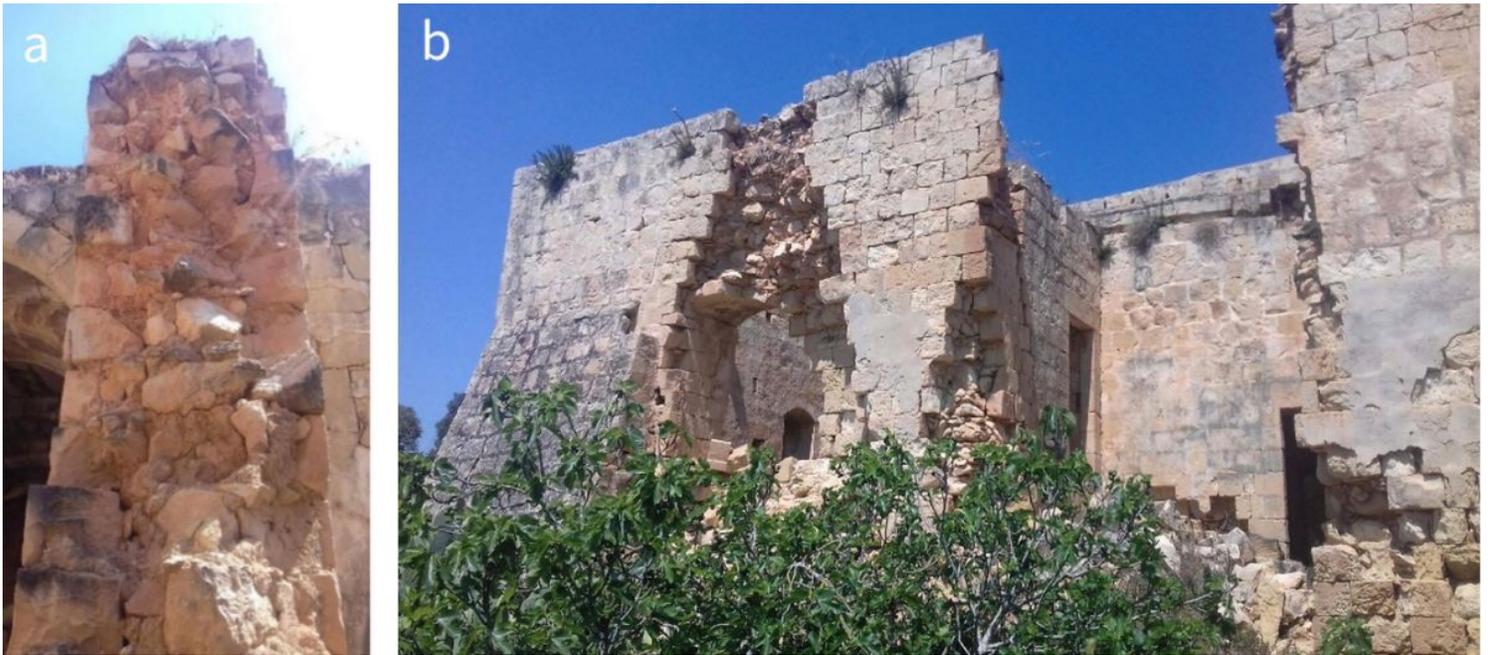
Figure 6

a Section through the collapsed internal wall between the corridor and the mill (and the overlying mezzanine), b buttress-like structure along part of the south-west facing elevation

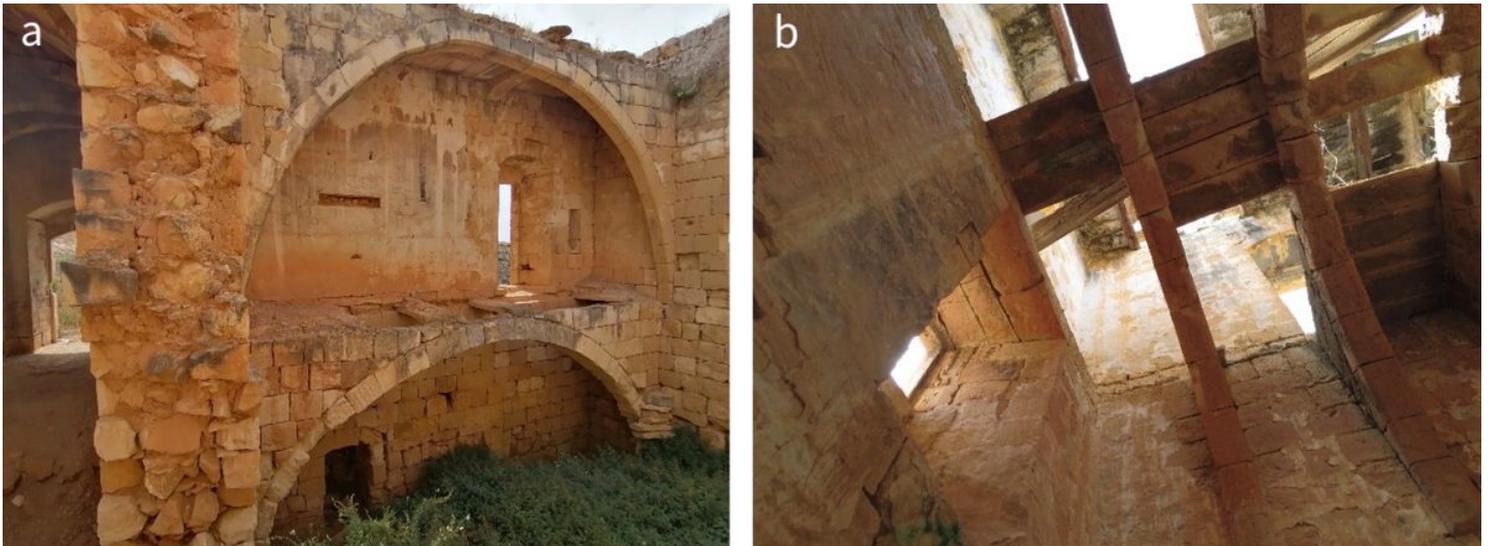
Figure 7

Collapsed roofs of a mill room and overlying space, and b first room on the right on entering the building; note timber beams at the uppermost roof (© Alessandra Bianco)

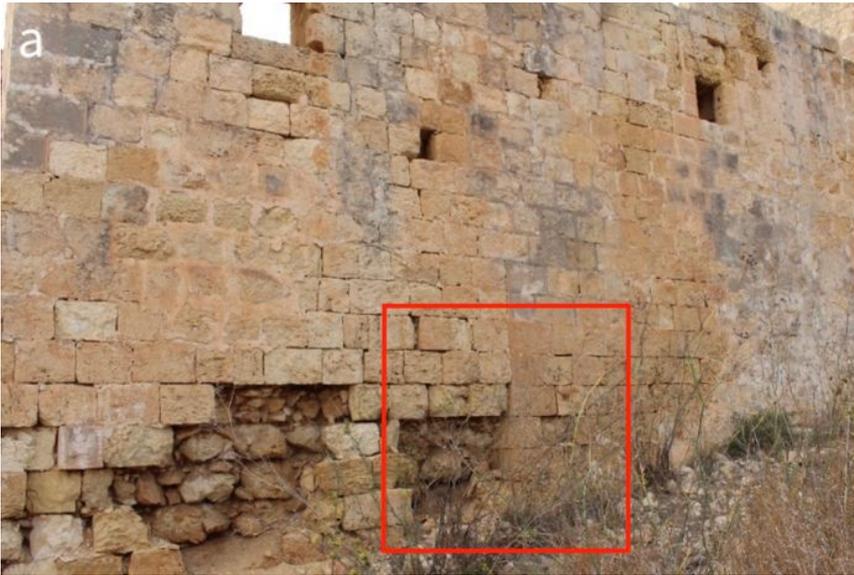
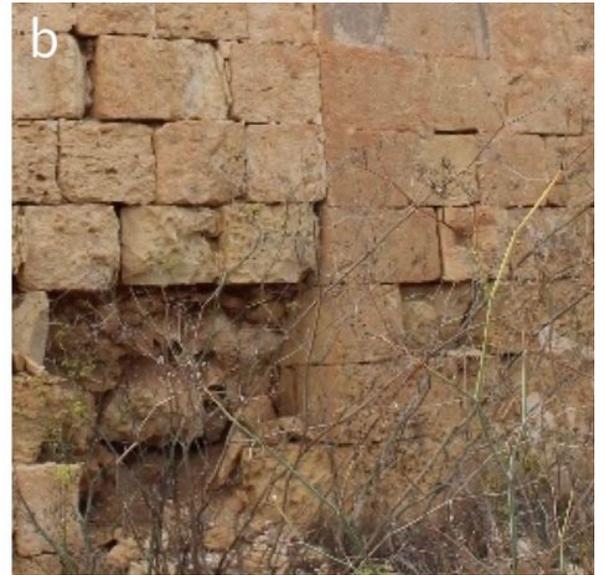
Figure 8

1. an absence of bond stones both on the exterior (Fig. 8) and on the interior up to the level of the lintel of the door of the room on the left upon entering the main entrance;
2. a change in the quality of the LGL used; and
3. the fact that the internal wall common with the mill and the overlying room is the same thickness as the external walls, implying that it was originally an external wall. The internal walls elsewhere in the house are narrower.

a Absence of proper mechanical bonding between stones along the exterior denoting a change in phase in the building construction, b detail of Fig.8a

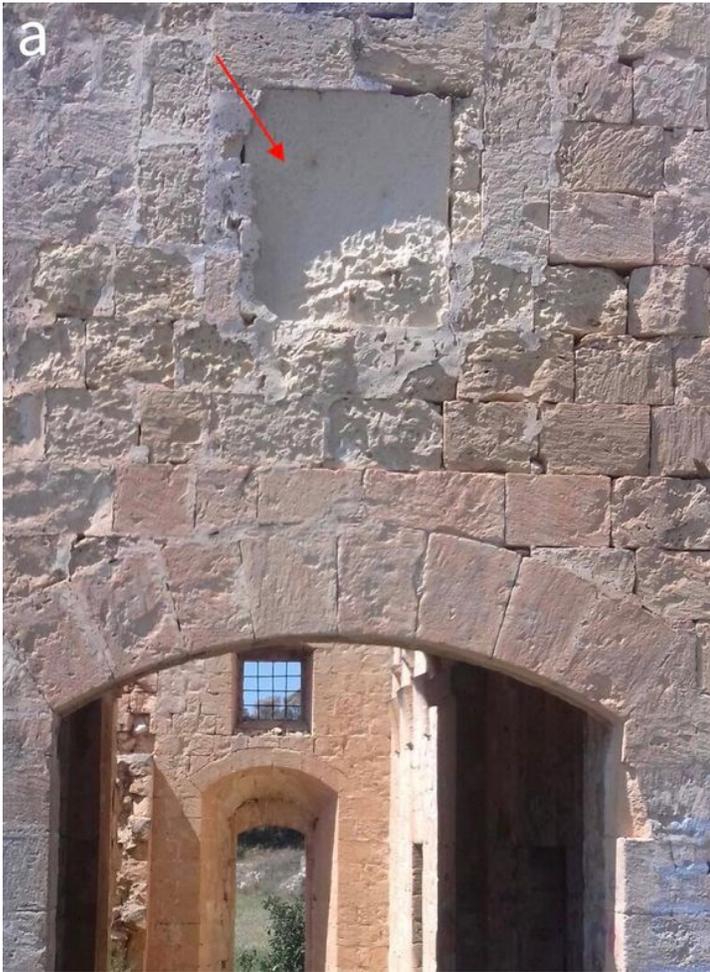
Selective intra-burrow cementation and preferential erosion of the surrounding poorly cemented sediment account for the observed alveolar weathering [35]. The preferential weathering occurs in areas close to burrows. The mineralogy of the burrow infill is both qualitatively and quantitatively different from the host sediment [36]. The unlithified sediment introduced through bio-retexturing modified the permeability and porosity of the original depositional fabric and thus effected the capillary intake of water from the ground, which impinged on its weathering [36, 37]. Severe honeycombing has been observed to occur when moisture penetration is present. The sculpting of freshly quarried LGL has to take place within the first four years, after which point the stone forms a hard crust. If not used within four years, the stone would either be left uninscribed or replaced. If the hard crust is damaged, the fabric deteriorates, with negative effects on the adjacent limestone [11: 199]. The damaged inscription on the main doorway – which a century ago was still decipherable despite the stone being heavily weathered[3] – and the surrounding fabric exhibit such a failure (Fig. 12a).

a The damage to the inscription (indicated by marker) and the surrounding fabric on the main doorway, b The main entrance was bolted at three levels: by means of a bar pivoted on the one of the door leafs at the top (circled), a bar in the middle (triangle) and another at the bottom (square)

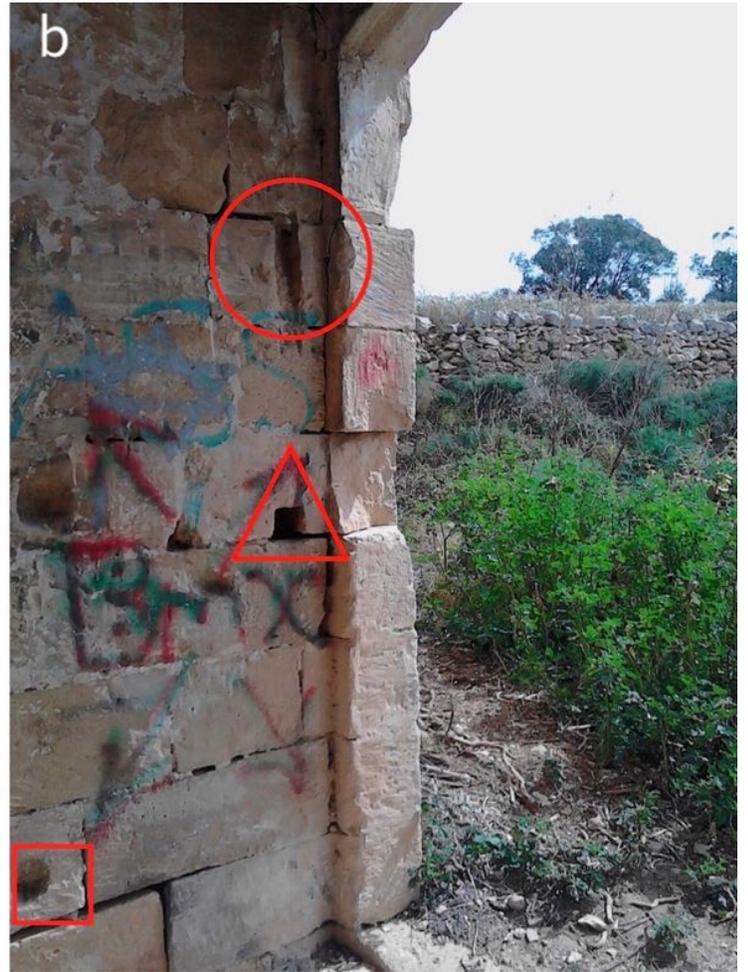
1. At the top: There are two channels, both 50mm wide and circa 370mm long, set at the same height on either side of the door jamb (Fig. 12b). These grooves vary in depth along their length: the one on the right is 0mm at the top and 40mm at its bottom; the one on the left ranges from 0mm at the bottom to 80mm at the top; they appear to mark the outer edges of a circle. This implies they accommodated the clockwise motion of a bar, most likely made of timber, which revolved around a pivot set into the inside of the door. When the bar was in a vertical position the door was unlocked, and when swung clockwise into a horizontal position, its ends would lock into the grooves, securing the door. This mode of bolting was rare in Malta, although a similar mechanism can be found on the old entrance door of the Kitchen Garden (adjoining the official residence of
