# Welding Procedure Qualification Record (WPQR) for Welds Fabricated At Proximity

**Keywords:** Proximity welds, welding procedure qualification record, NORSOK M-101

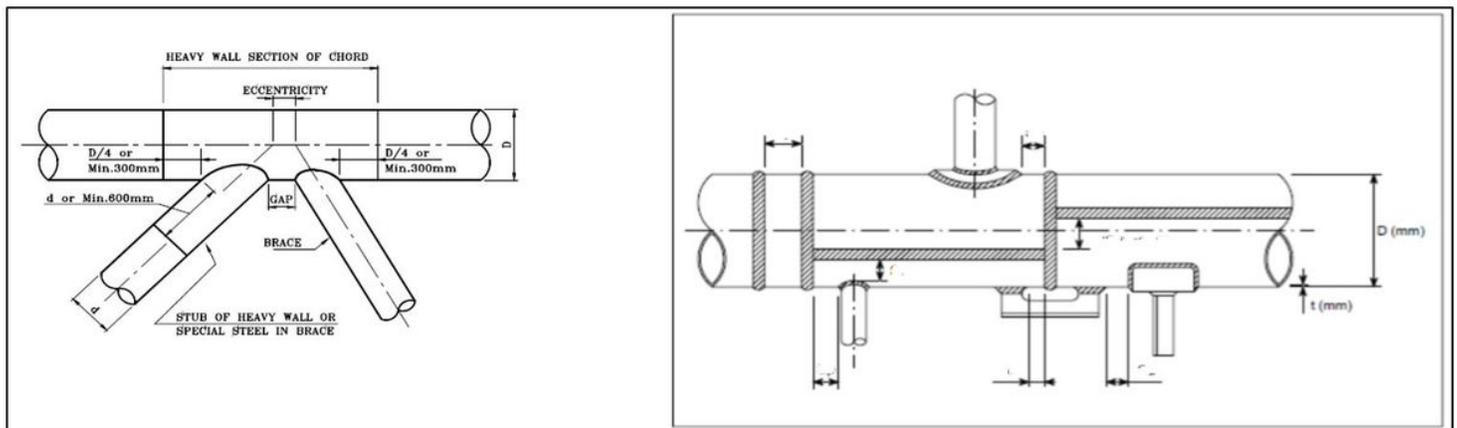
**Figure 1**

a) Detail of offshore joints [9] b) Minimum distance between welds in pressure vessels

Fabrication of large structure like offshore jacket structures, onshore and offshore wind monopiles and tubular truss bridge structures often brings forward the challenge of welds coming in proximity of each other as shown in figure 1. This challenge of maintaining minimum distance between welds is often debated among designers, inspectors, and contractors who often rely on international codes and standards for recommendations [7]. A detailed assessment of these codes and practices for maintaining minimum distance criteria between welds has been performed previously by the authors in [8] where clear lack of consensus has been found regarding maintaining final distance that is based on factor of 4 or 5 times thickness or 1 or 1.5 times the diameter. In replacement procedures of compact layout of piping racks, unavoidable situation of placement of new weld to an existing weld of branched connections, nozzles etc. are often encountered or in offshore jacket critical joints e.g., overlapping braces. International codes and standards in case of repair or replacement procedure offer no or lack of guidance on defining minimum distance between welds and defining welding procedures for proximity welds are left to engineer and contractors' engineering judgement.

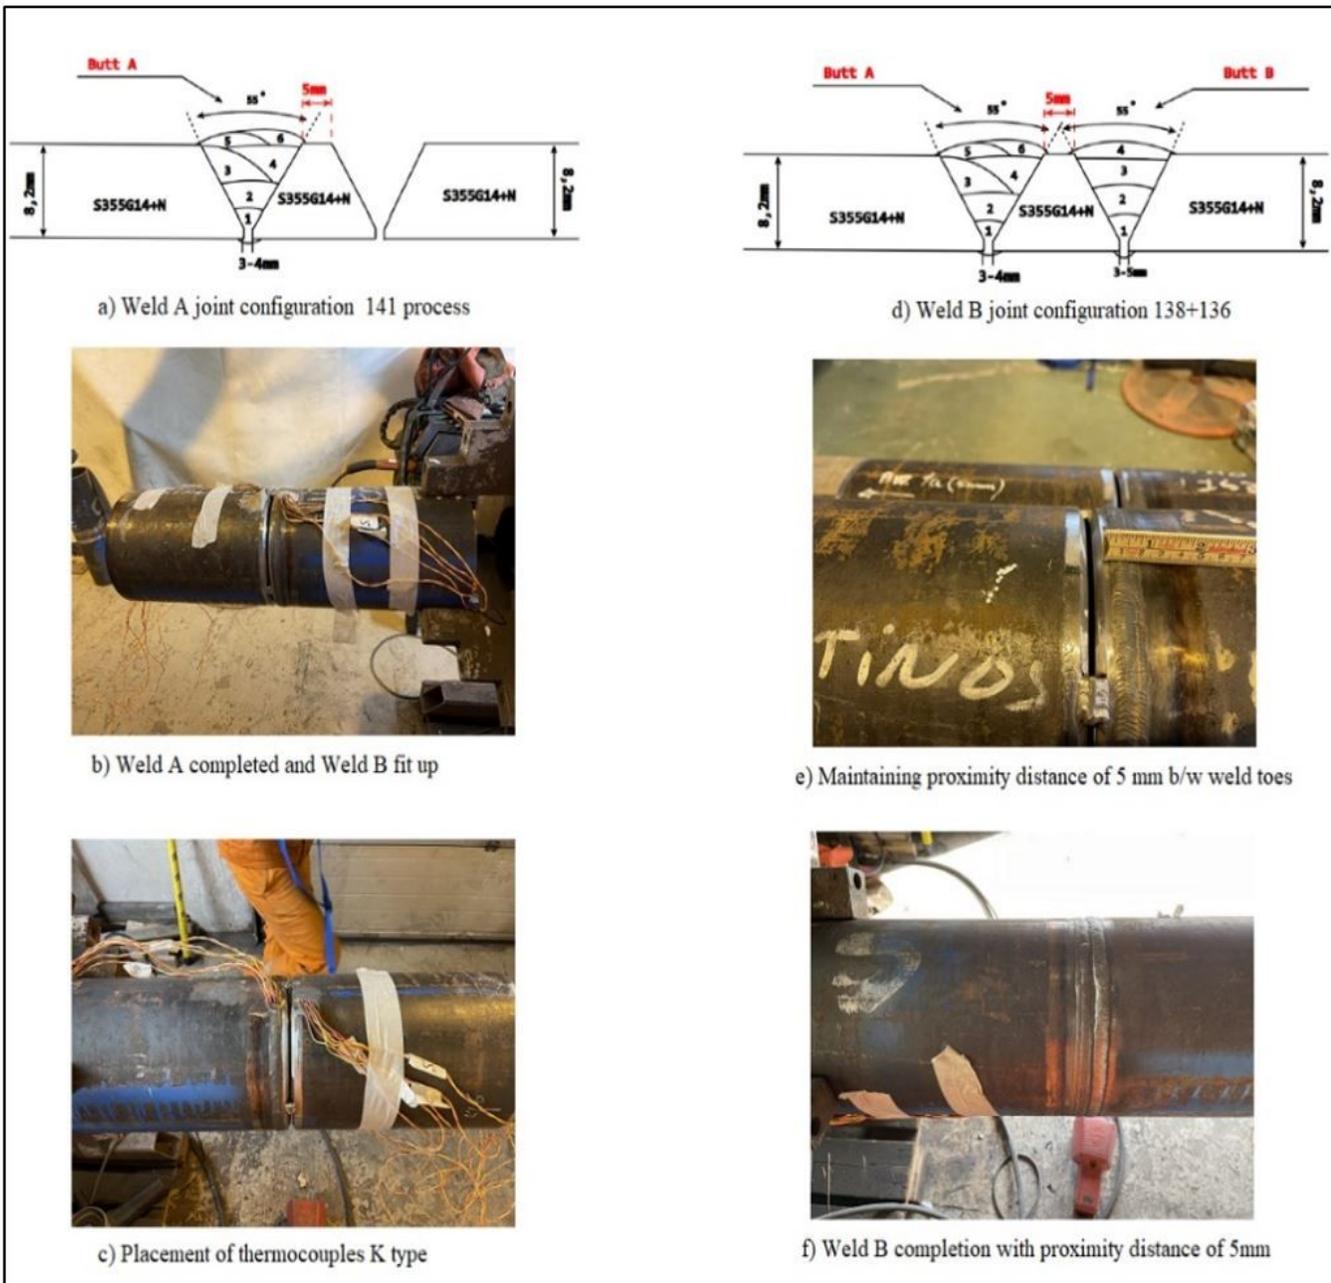
**Figure 2**

Schematic diagram of experimental set up from a) to f)

A schematic diagram of experimental set up shown in figure 2, pictorially display fabrication steps from 'a' till 'f'. Structural steel grade, seamless pipes was selected for this experiment, having dimensions of outside diameter as 219.1 mm and thickness of 8.18 mm. As shown in figure 1.a & d. vee joint geometry was machine cut for welds 'A & B' in accordance with prequalified WPS from M/s Rosenberg Worley. As shown in figure 1.b, initially weld 'A' was fabricated as single weld on a pipe section having an overall length of 700 mm. Weld 'B' was welded after weld 'A' was completed by maintaining a proximity distances between their weld toes as 5mm, 10 mm and 15 mm respectively as shown in figure 1e and summarized in Table 1.

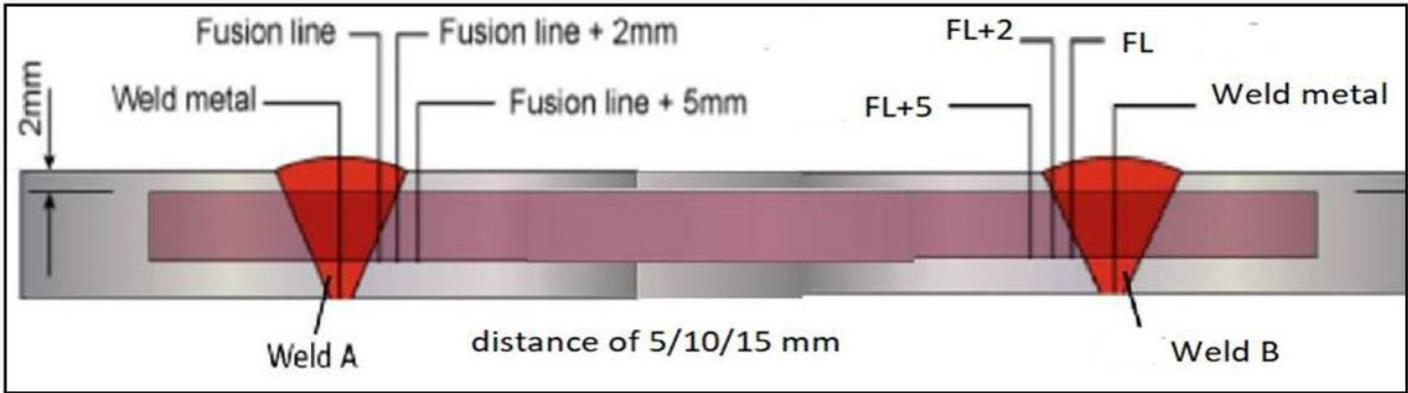
**Figure 3**

Schematic of location for Charpy tests

Visual and radiographic examination was also performed and the general procedure and acceptance criteria mentioned in EN codes code for each method is summarized in Table 7 as per ISO 15614-1[19]. Charpy specification as per EN ISO 9016-2012 was performed however in case of WPQR for proximity weld, Charpy location shown in figure 3 were selected. The notch for Charpy specimens was made as shown in figure 3.

- Notch in center of weld
- Notch in fusion line (FL)

- Notch in heat affected zone (HAZ), 2 mm from fusion line
- Notch in HAZ, 5 mm from fusion line

Hence in case of weld proximity distance of 5mm, six samples and four sets of Charpy locations were extracted as fusion line (FL+5mm) was not possible due to 5mm proximity distance. In proximity case of 10 & 15mm case, total eight samples and four sets were extracted due to sufficient proximity distance.

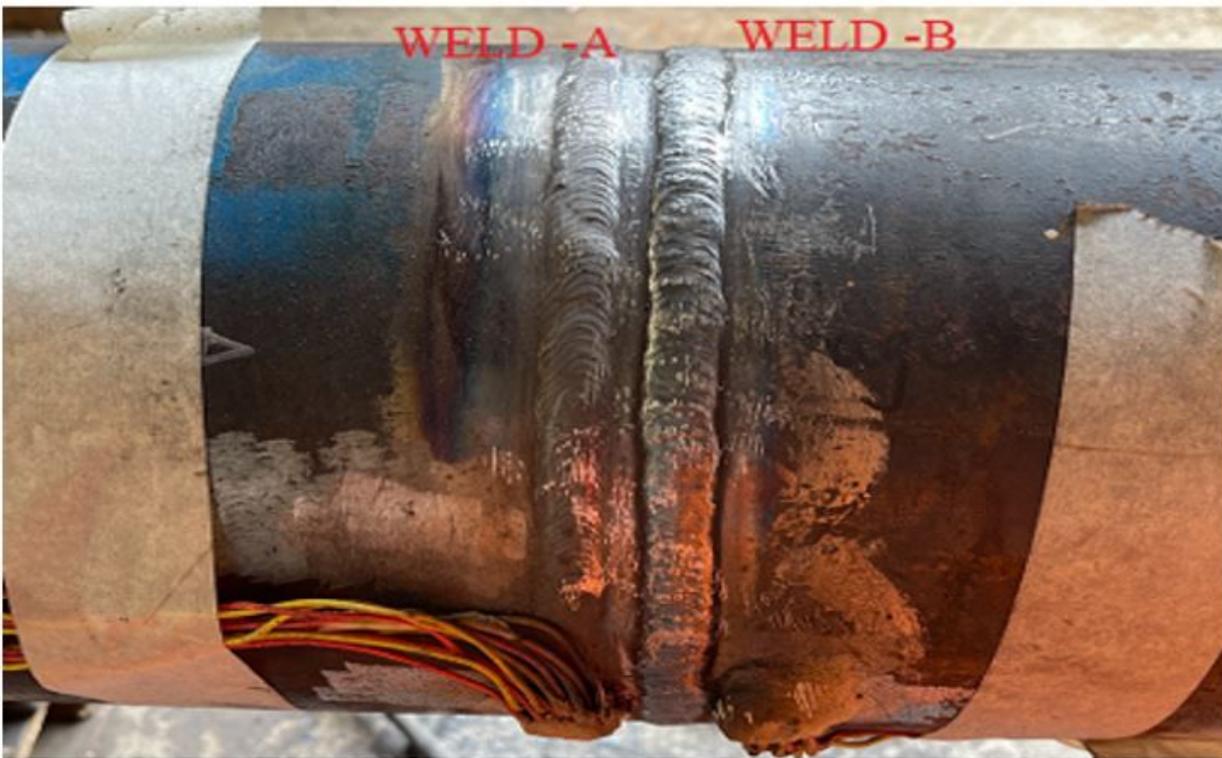
**Figure 4**

Visual image of Weld A & B

As briefed in Table 7, all mechanical and Non-destructive testing (NDT) was performed in accordance with relevant EN standards. Visual and NDT testing of radiography was performed to 100% extent on each sample of proximity distance. Due to spray mode in MAG+FCAW welding process weld B had wider and irregular cap weld bead in contrast to smooth weld cap bead of weld A, which has welded with TIG process as shown in figure 4. As per acceptance criteria of ISO 10675-2016, both joints were accepted in accordance with NDT radiography testing as shown below in figure 5.

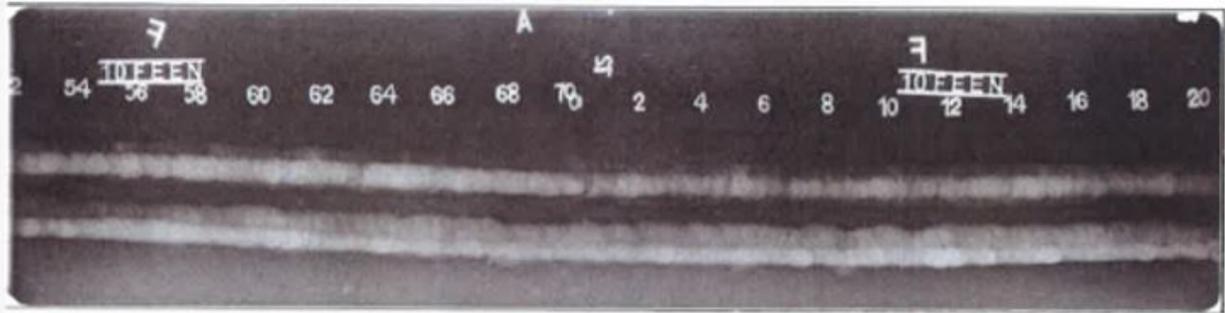
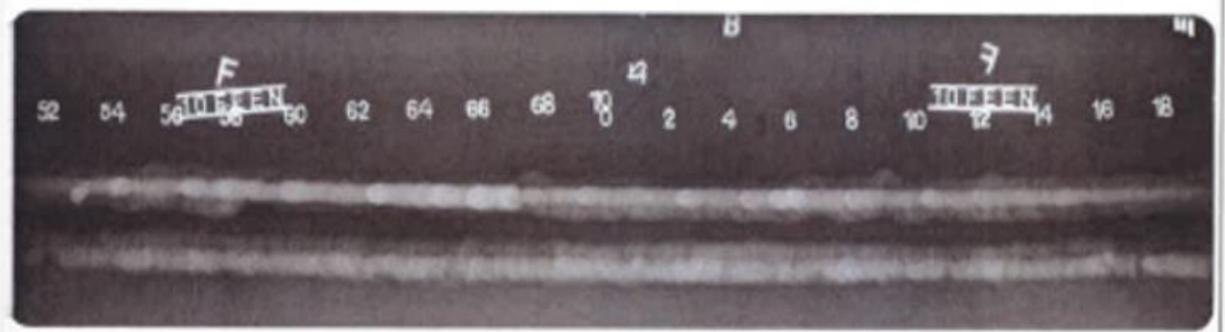
Figure 5

Weld -A

Weld -B

Radiographic images for Weld A and B

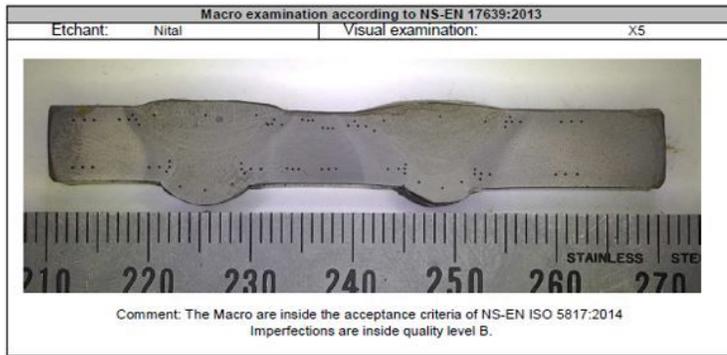
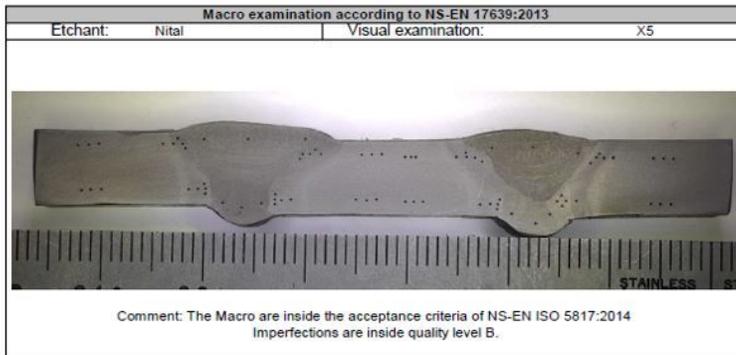
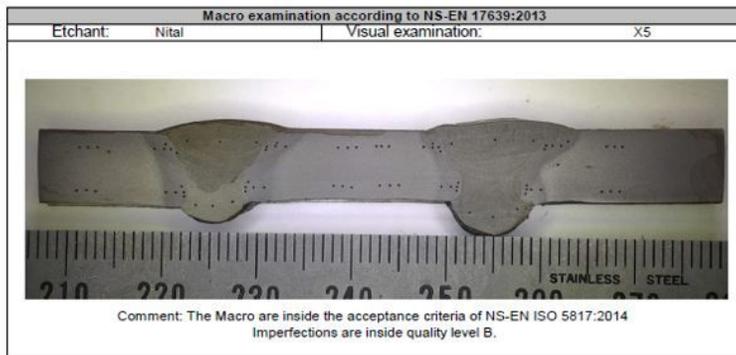
## Figure 6

a. Macro examination and hardness points location for 5 mm weld proximity  
 b. Macro examination and hardness points location for 10 mm weld proximity  
 c. Macro examination and hardness points location for 15 mm weld proximity

Macro examination was performed in accordance with NS-EN 17639-2013 and was accepted as per criteria of NS-EN ISO 5817:2014 with imperfection inside quality level B as shown in figure 6.a-c. In proximity case of 5 mm between its weld toes, overlapping of heat affected zone cannot be observed as shown in figure 6.a however no visual changes in alien metal (metal subjected to successive cycle of heating & cooling) were observed between proximity welds.

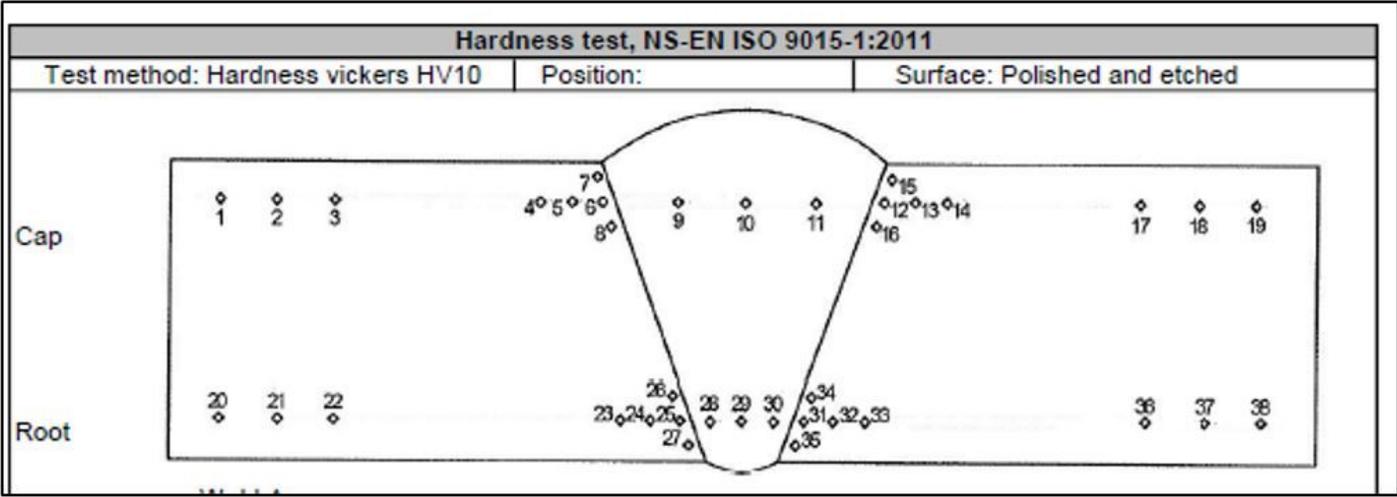
Figure 7

Hardness measurement points horzintally at cap and root level

Vickers hardness testing on each case of weld proximity distance of 5, 10 & 15 mm was performed as per NS-EN ISO 9015-1:2011 as per positions marked shown in figure 7. The indentation marks shown in figure 7 can be seen clearly seen in macro graphs of each weld proximity case in figure 6a-c. As proximity distance was area of concern, hence hardness measurement points between adjacent weld toes at 'weld cap level' for 5 mm proximity is shown in figure 8.a. It can be observed that high hardness values is noticed at proximity distance (PD-A&B) between two weld metal (WM-A&B) and their respective adjacent HAZ-A&B in contrast to parent metal PM as shown in figure 8a. This proximity distance or area called as 'alien metal' has experienced microstructural changes due to high restraint and successive thermal cycles of multipass welds as noticed in [20] for proximity welded joints K-brace joint of offshore jacket structures.

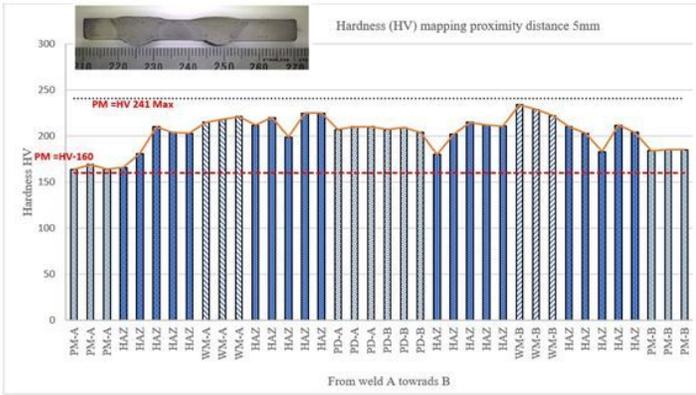
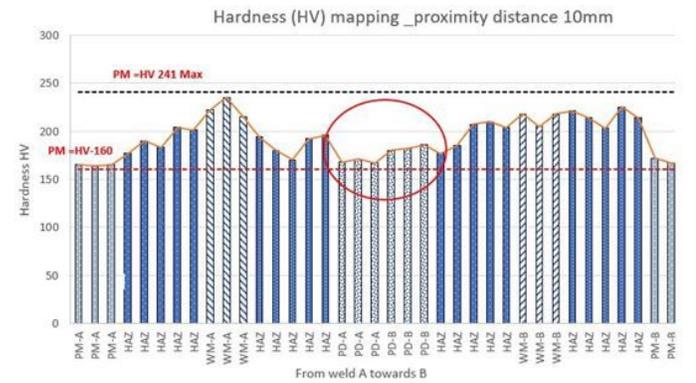
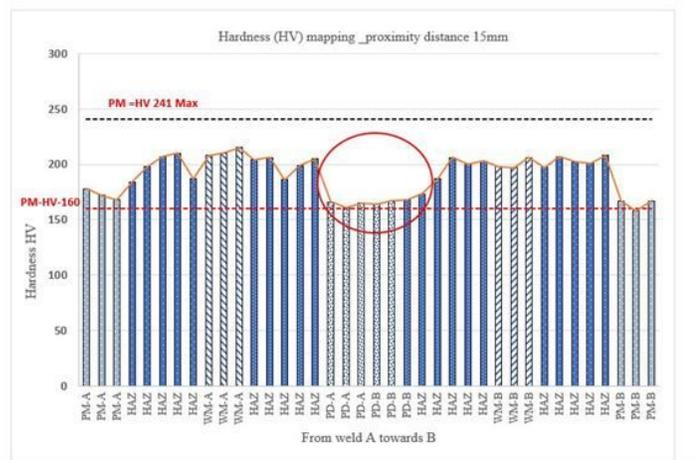
**Figure 8**

- a. Vickers hardness profile from left side PM of weld A to right side PM of weld B at cap level for proximity distance of 5mm
- b. Vickers hardness profile from left side PM of weld A to right side PM of weld B at cap level for proximity distance of 10mm
- c. Vickers hardness profile from left side PM of weld A to right side PM of weld B at cap level for proximity distance of 15mm

A maximum value of 210HV was observed close to HAZ value of 225HV on either side for proximity distance 5mm welds as shown in figure 8a. Cold cracking chances increases if hardness values are between 350-400HV. This region may be prone to cracking as it has accumulated high stresses and chances of martensitic formation have been sustained due to successive

thermal cycle of heating and cooling[20]. Similar hardness points profiles for weld proximity distance of 10 & 15 mm have been shown in figure 8b & c. As proximity distance is increasing, drop in hardness values can be seen and comparable to PM in case 10 & 15mm case. In case of 10 mm proximity distance, highest value of 186 HV was observed at alien metal and 167 HV in case of 15 mm distance which is almost equivalent to parent metal.

Microhardness results at designated location of HAZ and proximity area between welds (PA) corresponds to values of 225 HV close to 210 HV respectively as shown in figure 8a. Based on this information, microstructure in HAZ regions can be mainly composed of composed of ferrite (50 to 80%), bainite (0 to 30%), pearlite (0 to 20%), martensite (0 to 20%) corresponding to Vickers hardness values for steel S355[20] referred from Table 9 [21]

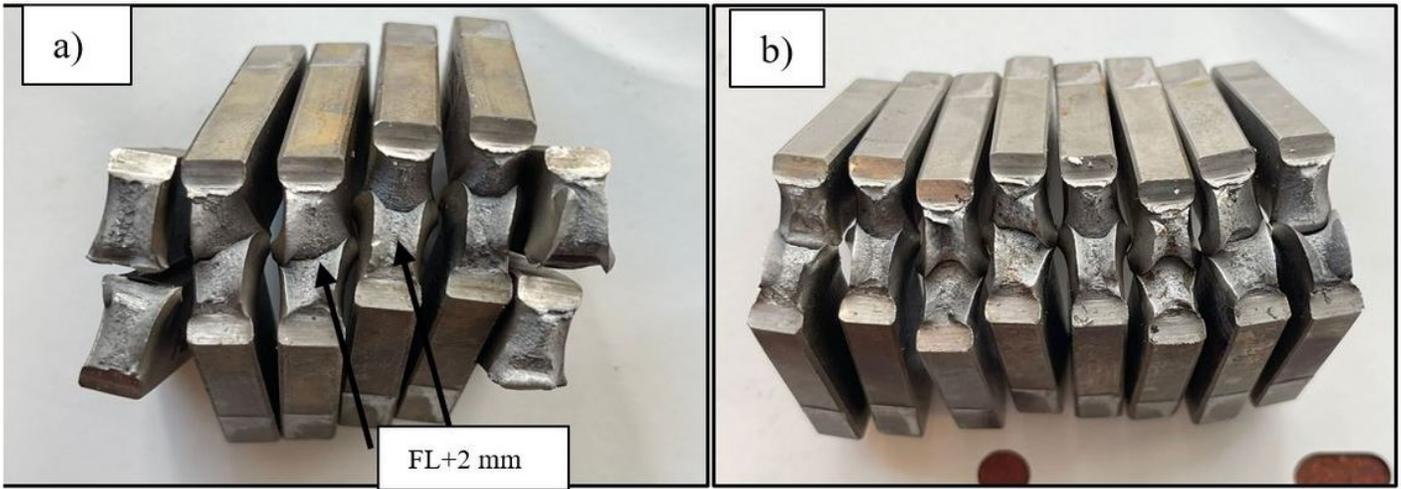
**Figure 9**

Charpy tested samples at -20°C for a) 5mm and b) 10&15mm case

Charpy testing was performed in accordance with KV8, NS-EN ISO 148-1:2016; ISO 9016:2012. As discussed previously in figure 3, due to limited space for FL+5mm samples only six specimens were available for 5 mm proximity distance whereas FL +5 mm was possible for 10- & 15-mm proximity distance as shown in figure 9. Sample size was kept as 5x10x55 mm as thickness of pipe was 8.2 mm hence a conversion factor of 2/3 was applied, when calculating energy values as per code EN 1614-2017.

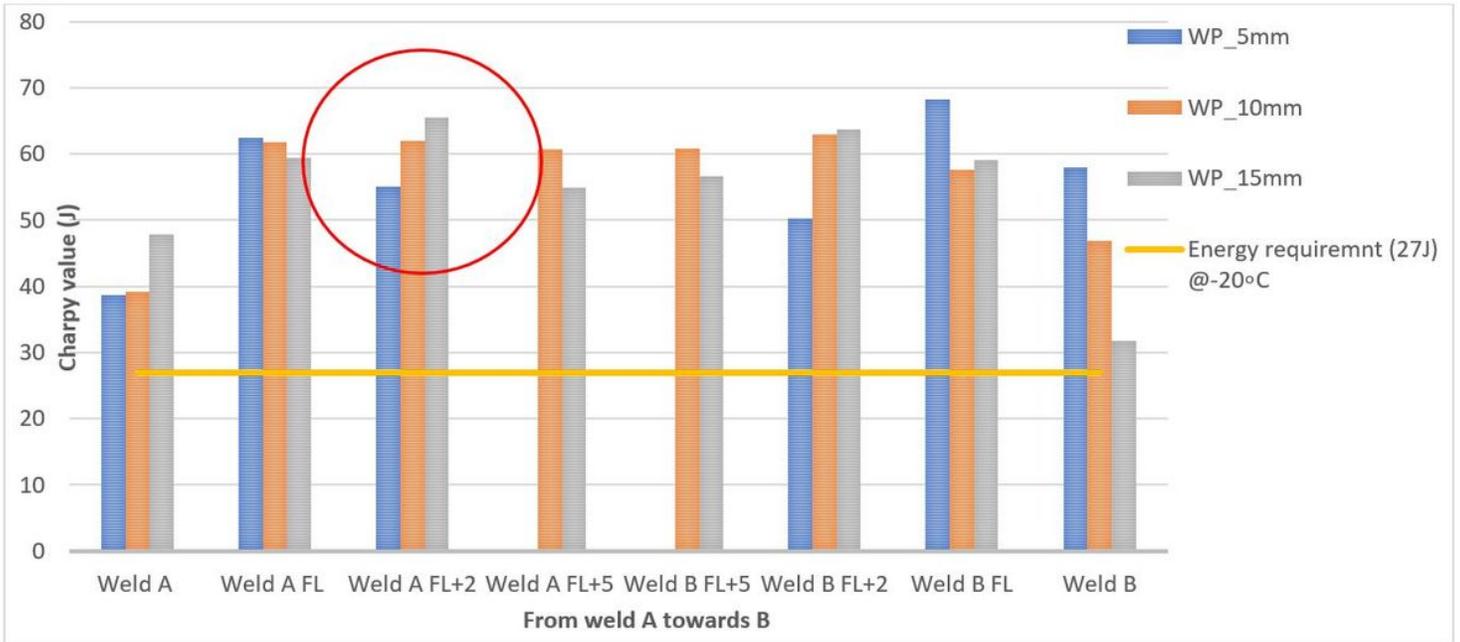
**Figure 10**

Charpy testing values for all proximity distances of 5, 10 & 15 mm

It can be observed from figure 10 that the least energy values of 55J at proximity region i.e., weld A-FL+2 mm for 5mm proximity distance was observed in contrast to 10 & 15mm case. To draw fair comparison, FL+2 mm Charpy values are highlighted in figure 10 and values of 62 J & 66 J was observed i.e., between weld A-B for 10 & 15mm case. Due to high hardness and high restraint in 5mm proximity case, drop in energy values can be observed. This drop can be attributed to high hardness values observed in section 3.3. However, microstructure graphs shown in section 3.6 later, also substantiates, that high hardness values at proximity regions for changed morphology of grain size in proximity region.

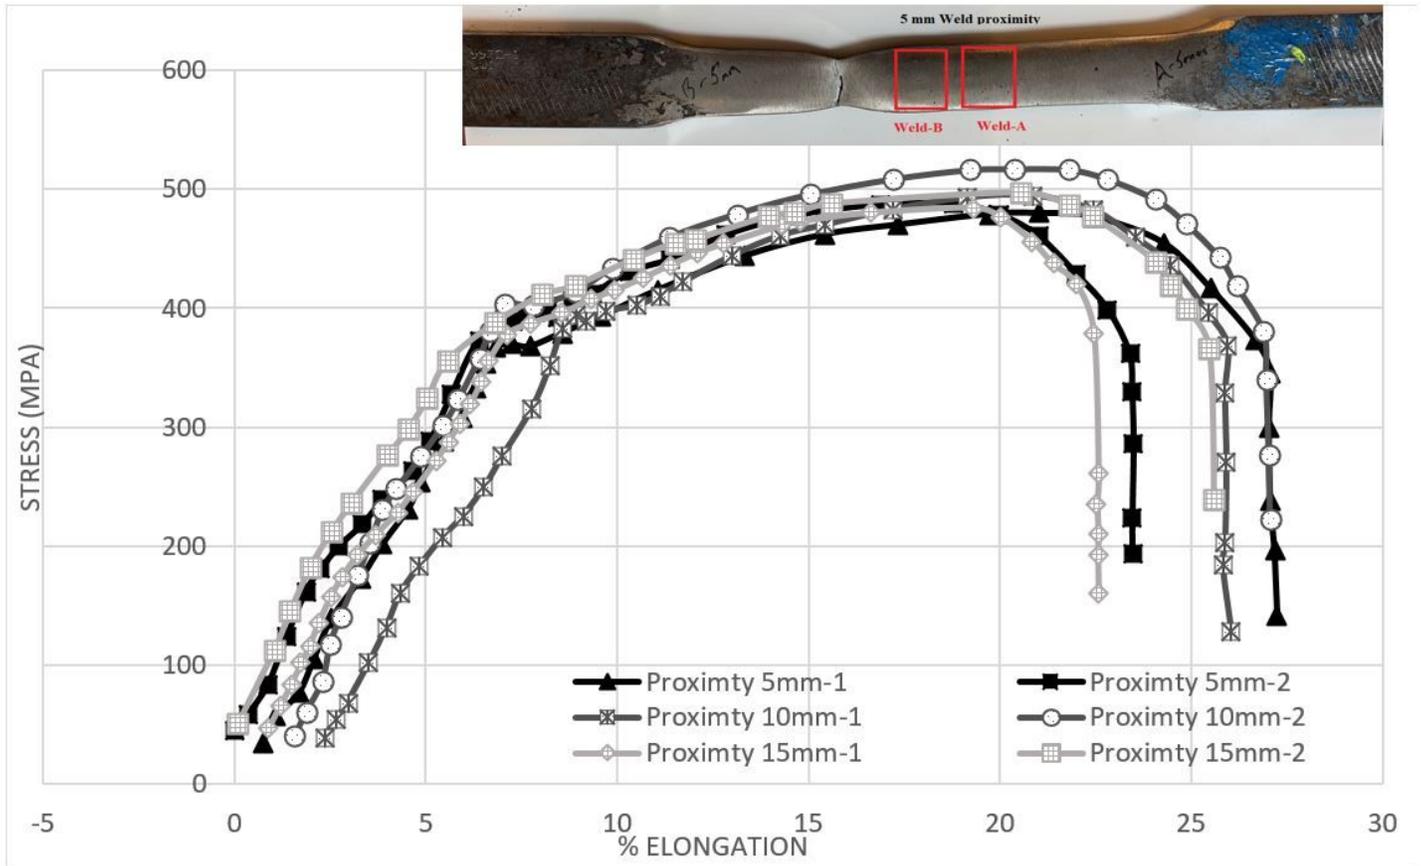
**Figure 11**

Tensile test plots for transverse weld joints for all proximity cases

Figure 11 illustrates the tensile plots for all weld proximity cases tested under monotonic loading. Tensile results sufficiently meet the required strength of 460-620 MPa, however all values were found to be less than pipe measure value of 553 MPa referred from material test certificate mentioned in Table 5. Elongation values in all cases were found to be less than 22% indicating the high restraint and residual stresses caused by welds placed at proximity.

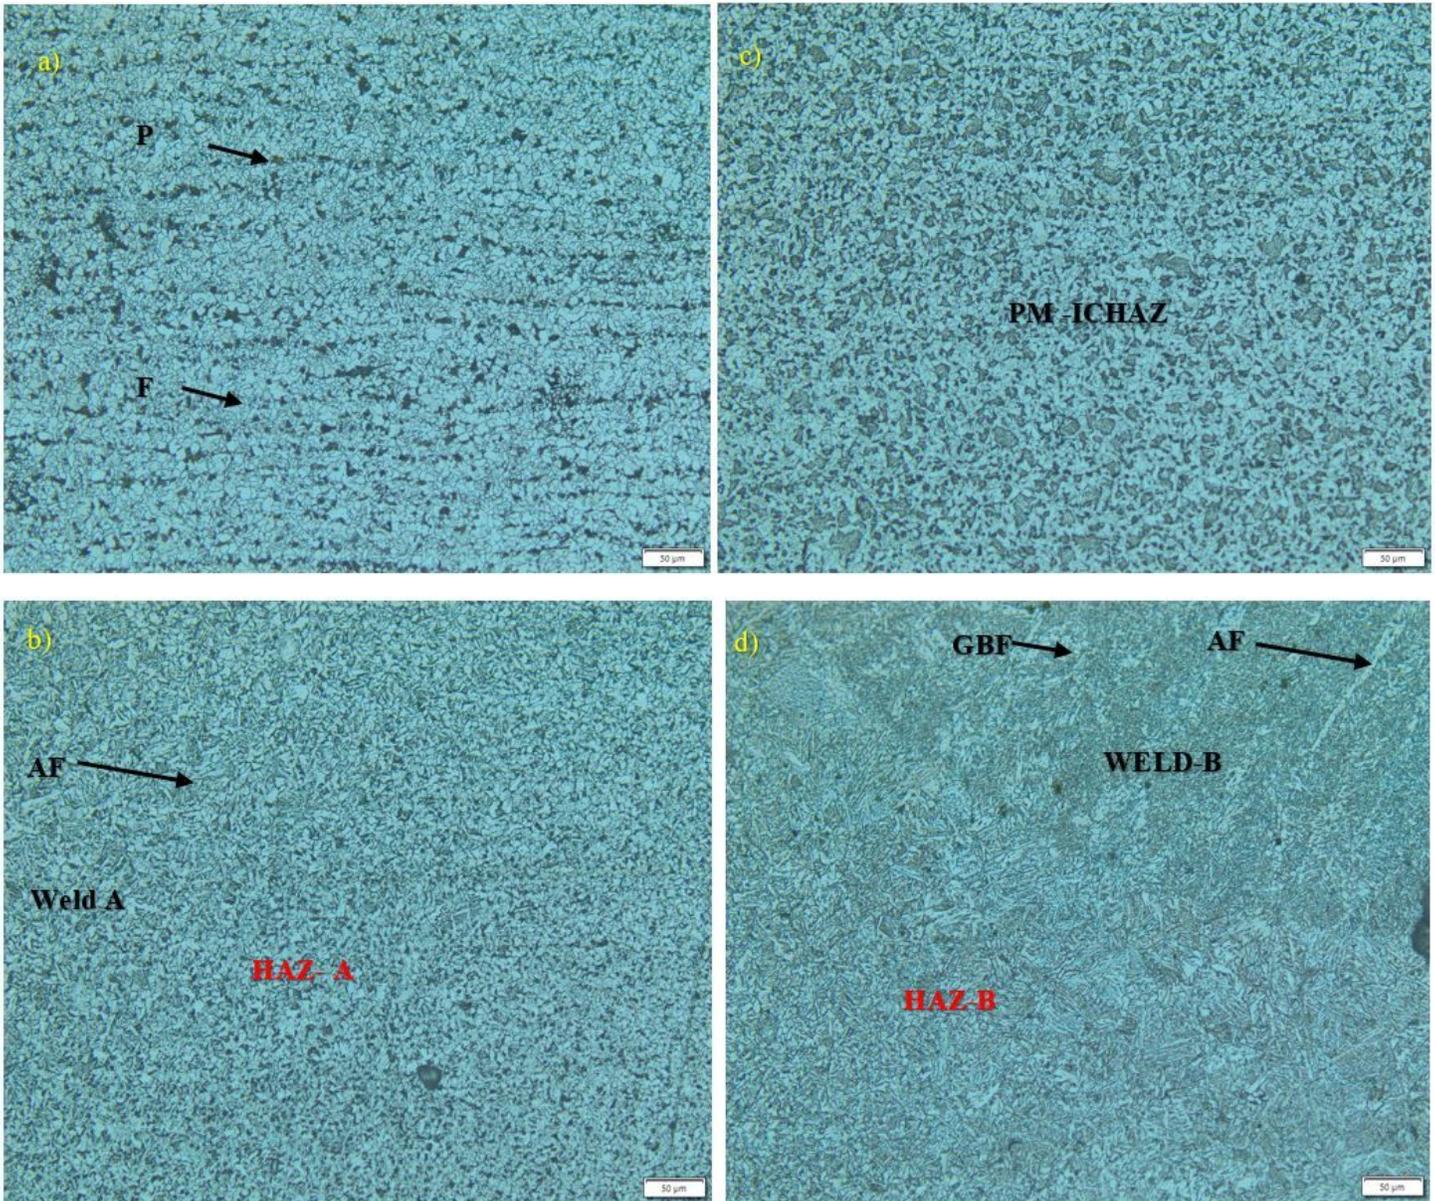
**Figure 12**

Optical microstructures for weld proximity 5mm case a) Parent metal (PM) b) HAZ of weld A c) Proximity area /alien metal between welds (PA) d) HAZ of weld B

Due to high values in hardness and drop in Charpy values for 5mm weld proximity case a need to further investigation of microstructure characterization was initiated. Optical microstructures across the weld interface starting from parent metal to HAZ of weld A to proximity region to HAZ of weld B was performed on macro specimen samples of weld proximity 5mm specimen as shown in figure 12a-d. The microstructures at HAZ showed acceptable weld interface without any defects however different orientation of grains was observed in region identified as proximity region/alien metal i.e., between two welds as shown in figure 12c.

The optical images seem to confirm regions of perlite (P) and ferrite (F) in parent metal as shown in figure 12 a. Acicular ferrite (AF-large light areas) with grain boundary ferrites (GBF) can be observed in weld metal A& B. HAZ depending upon temperature range is divided into coarse-grained HAZ (CGHAZ), fine-grained HAZ (FGHAZ), and the inter-critical HAZ (ICHAZ) [8]. In HAZ, structure is formed upon temperature attained between Ac1 and Ac3 i.e., upper & lower critical temperatures as shown in figure 12 b & d. As proximity area/ alien metal corresponds to fine grained structure in contrast to CGHAZ & FGHAZ hence it can be identified as a region close to ICHAZ that's is subjected to successive cycle of heating and cooling between Ac1 and Ac3 temperatures i.e., 725-915°C with finer grain as confirmed from thermocouple data.

Martensite presence is difficult to identify and quantify its fraction however sufficient evidence of martensite-austenite (M-A) islands have been identified in inter-critically reheated coarse-grained heat affected zone (ICCGHAZ) undergoing partial austenisation and forming austenitic-martensitic (M-A) phases which are brittle and known as local brittle zones (LBZ) [22]. However, their presence needs further investigation by performing scanning electron microscopy (SEM) analysis.
