Unexpected Echocardiographic Findings: Accessory Mitral Valve Tissue in Adults

Case report

Unexpected echocardiographic findings : Accessory Mitral Valve Tissue in Adults

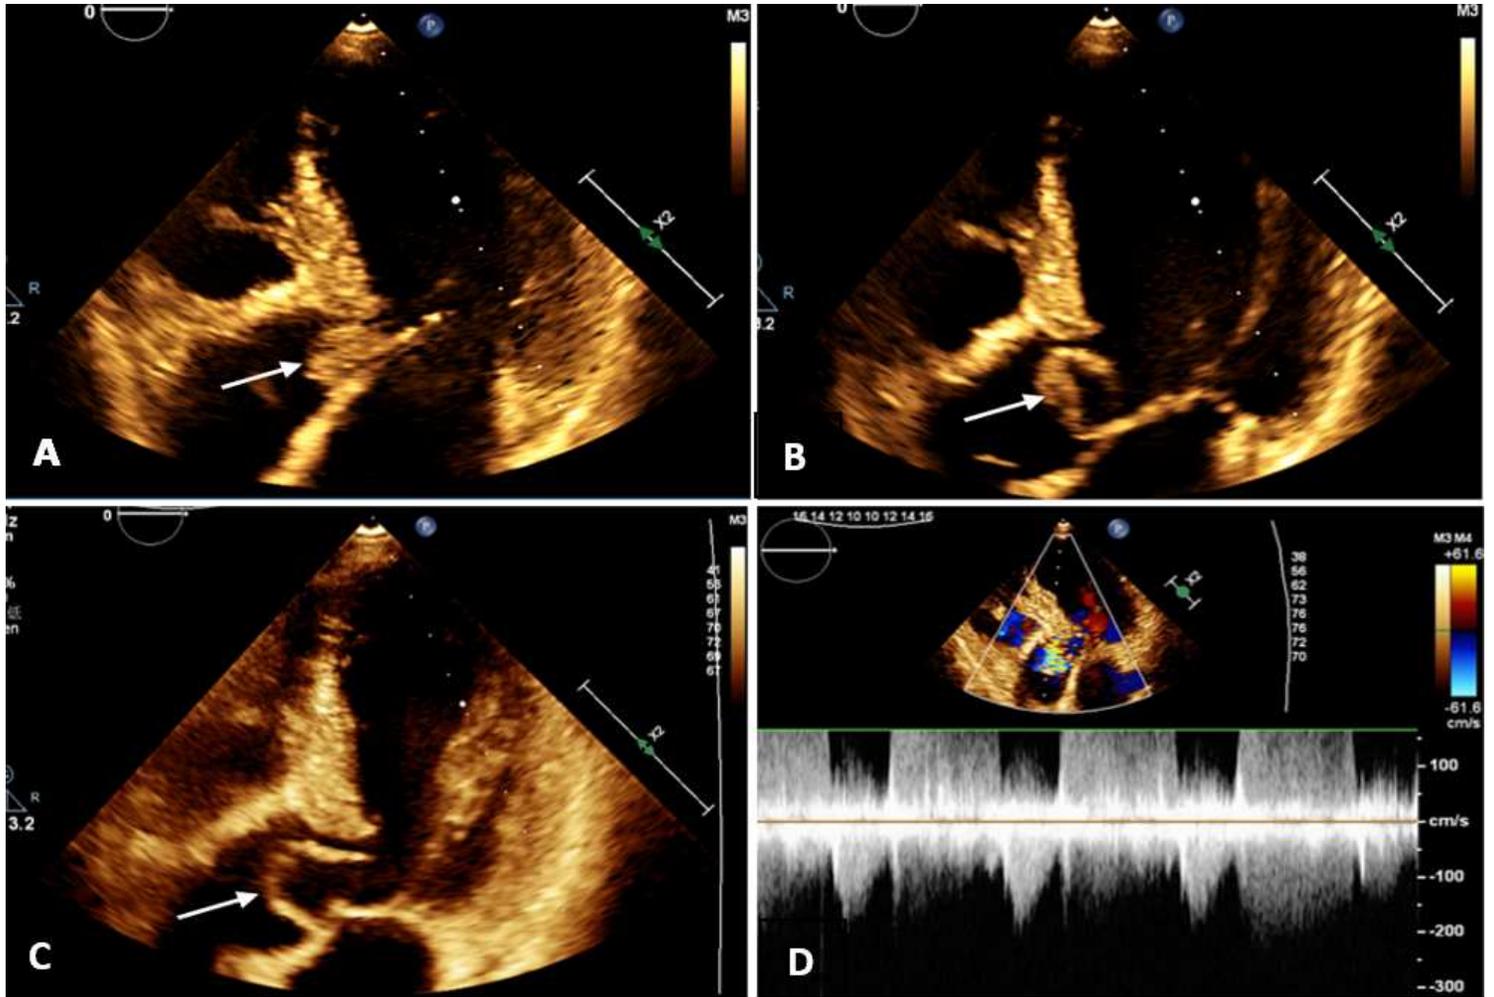
Figure 1

Case 1. Five-chamber view, an abnormal membranous structure in the LVOT and attached to the anterior mitral leaflet. AMVT formed into a lump retracting to the LVOT during early diastole (a), prolapsed into the LVOT with a sac shape during mid diastole (b), and extended into a parachute-structure obstructing the LVOT during systole (c), Peak Pressure gradient of LVOT was 27 mmHg(d).

gradually move into the LVOT and occupied the sub-aortic region, thus proving the description of AMVT (Figure1, Video1). Further evaluation indicated a systolic trace turbulent flow pattern with mild obstruction of LVOT generating a peak velocity of 2.3 meters per second, with a maximum gradient of 27mmHg (Figure1, Video2). Any morphological and functional abnormalities were not observed in the mitral valve and tricuspid valve, but a mild aortic regurgitation was detected on 2D color Doppler TEE. No residual shunt was described after the ventricular septal repair. All cavities diameters were within normal limits. TTE also revealed preserved biventricular systolic function (left ventricular ejection fraction :77%) with normal segmental contractility. 3D echocardiography illustrated that the membrane-like structure in the LVOT was attached between to the rudimentary chordae tendineae of the anterior MV leaflet and the left side of basal interventricular septum (Figure2, Video3). Mobile AMVT was attached to the A1 segment free edge. During hospitalization, the patient underwent cardiac magnetic resonance (CMR) to exclude the possibility of cardiac masses and to further clarify its dimension and location (Fig.3).

Fig.1. Case 1. Five-chamber view, an abnormal membranous structure in the LVOT and attached to the anterior mitral leaflet. AMVT formed into a lump retracting to the LVOT during early diastole(a), prolapsed into the LVOT with a sac shape during mid diastole (b), and extended into a parachute-structure obstructing the LVOT during systole (c), Peak Pressure gradient of LVOT was 27 mmHg(d).

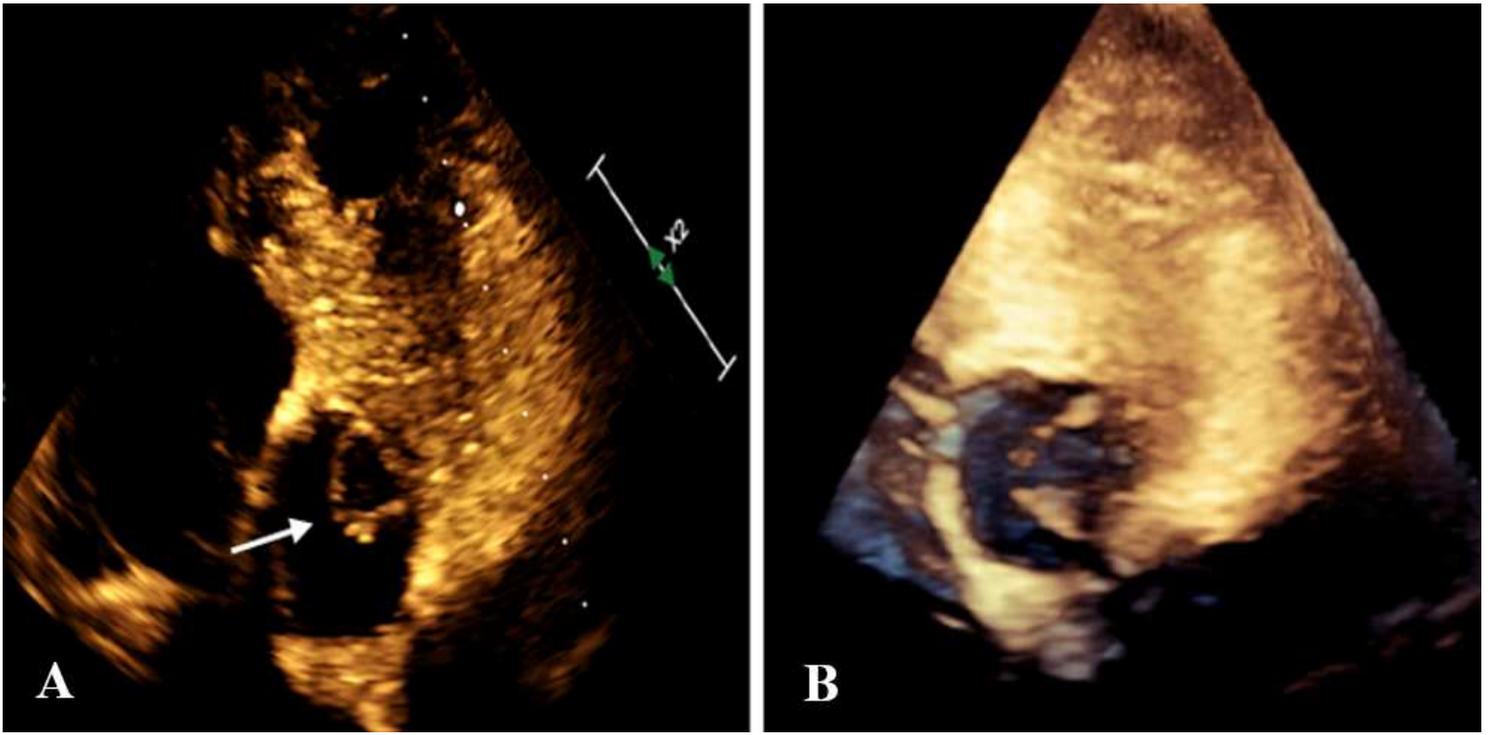
Figure 2

Case 1. (a) Short-axis view of AMVT anatomy morphology. (b) 3D echocardiography demonstrated the relationship between the AMVT and sub valvular apparatus.

Fig.2. Case 1. (a)Short-axis view of AMVT anatomy morphology. (b) 3D echocardiography demonstrated the relationship between the AMVT and sub valvular apparatus.

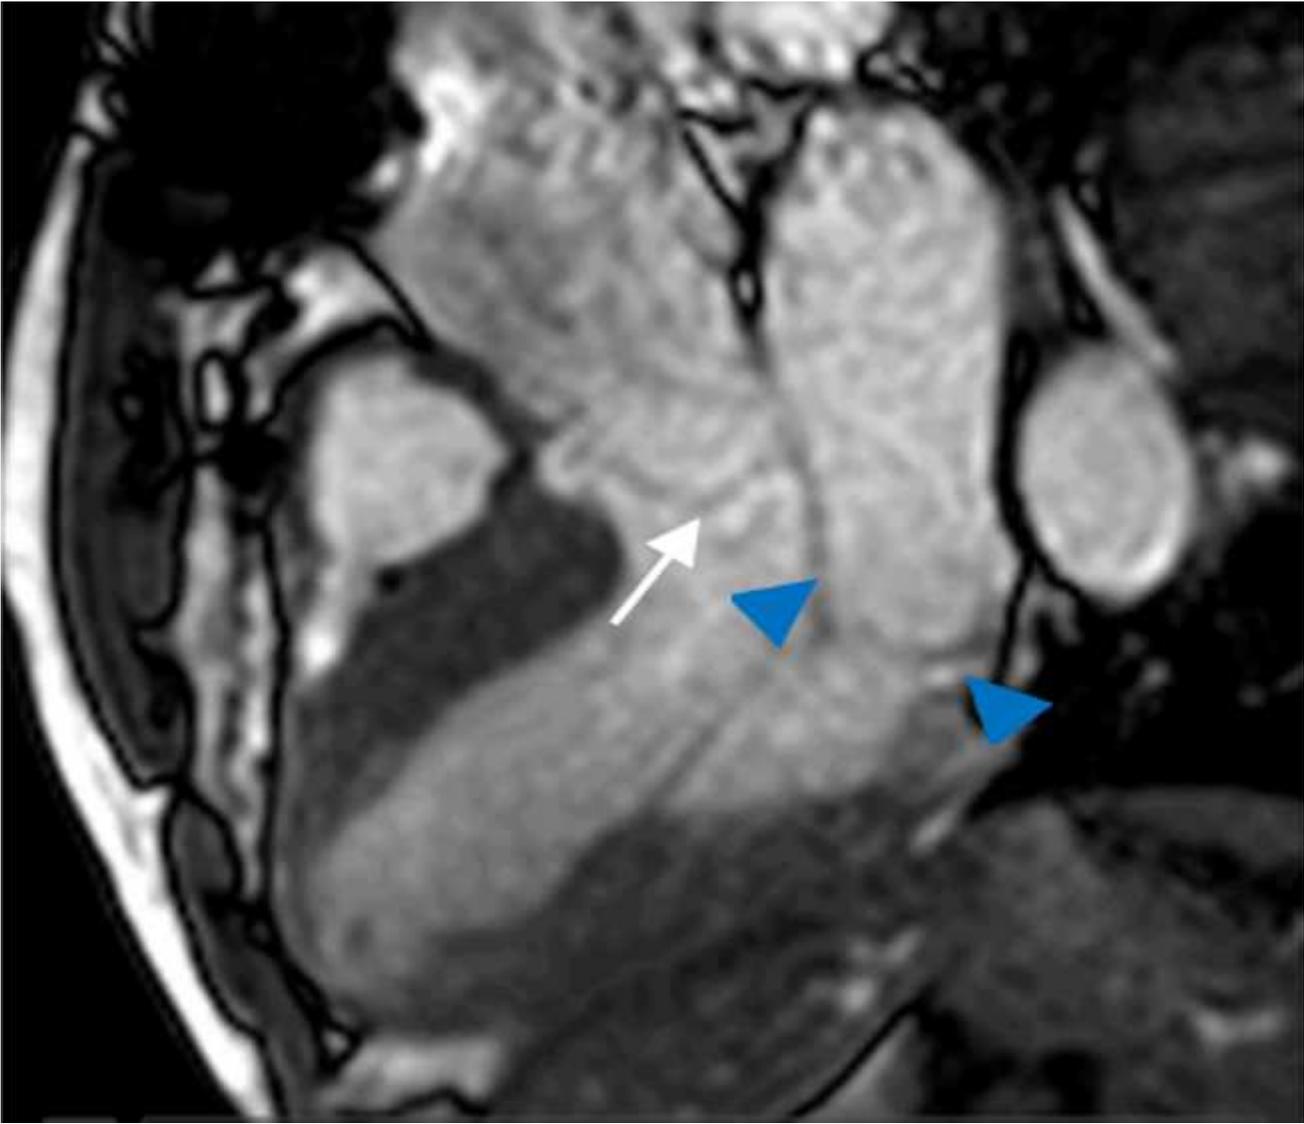
Figure 3

Case 1. Three-chamber view of CMR in the end of left ventricle systole, AMVT located in the middle of LVOT (white arrow) and mitral valve (blue arrow illustrated the mitral valve orifice).

Fig.3. Case 1. Three-chamber view of CMR in the end of left ventricle systole, AMVT located in the middle of LVOT (white arrow) and mitral valve (blue arrow illustrated the mitral valve orifice).

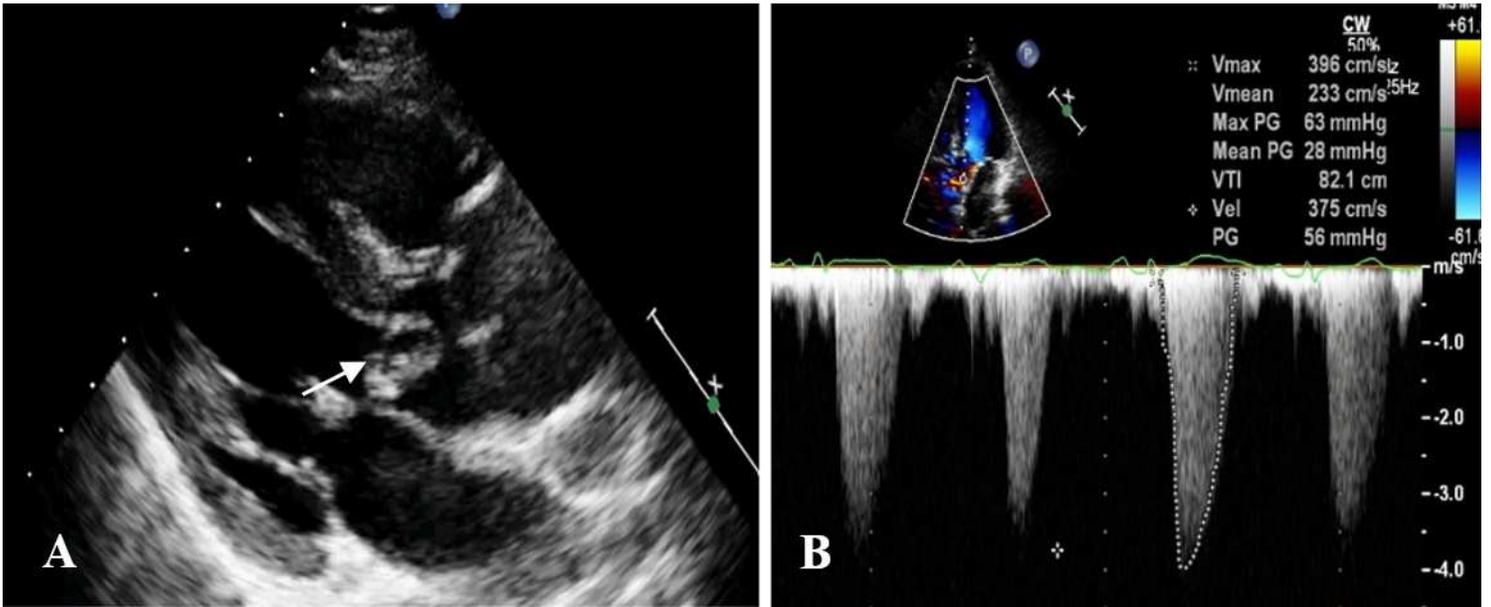
Figure 4

Case 2. (a) Transthoracic echocardiography in the apical long-axis view showed AMVT (arrow). (b) Continuous Doppler measurement traced the instantaneous gradient of 64 mmHg at the proximal LVOT.

Fig. 4. Case 2. (a)Transthoracic echocardiography in the apical long-axis view showed AMVT (arrow). (b) Continuous Doppler measurement traced the instantaneous gradient of 64 mmHg at the proximal LVOT.

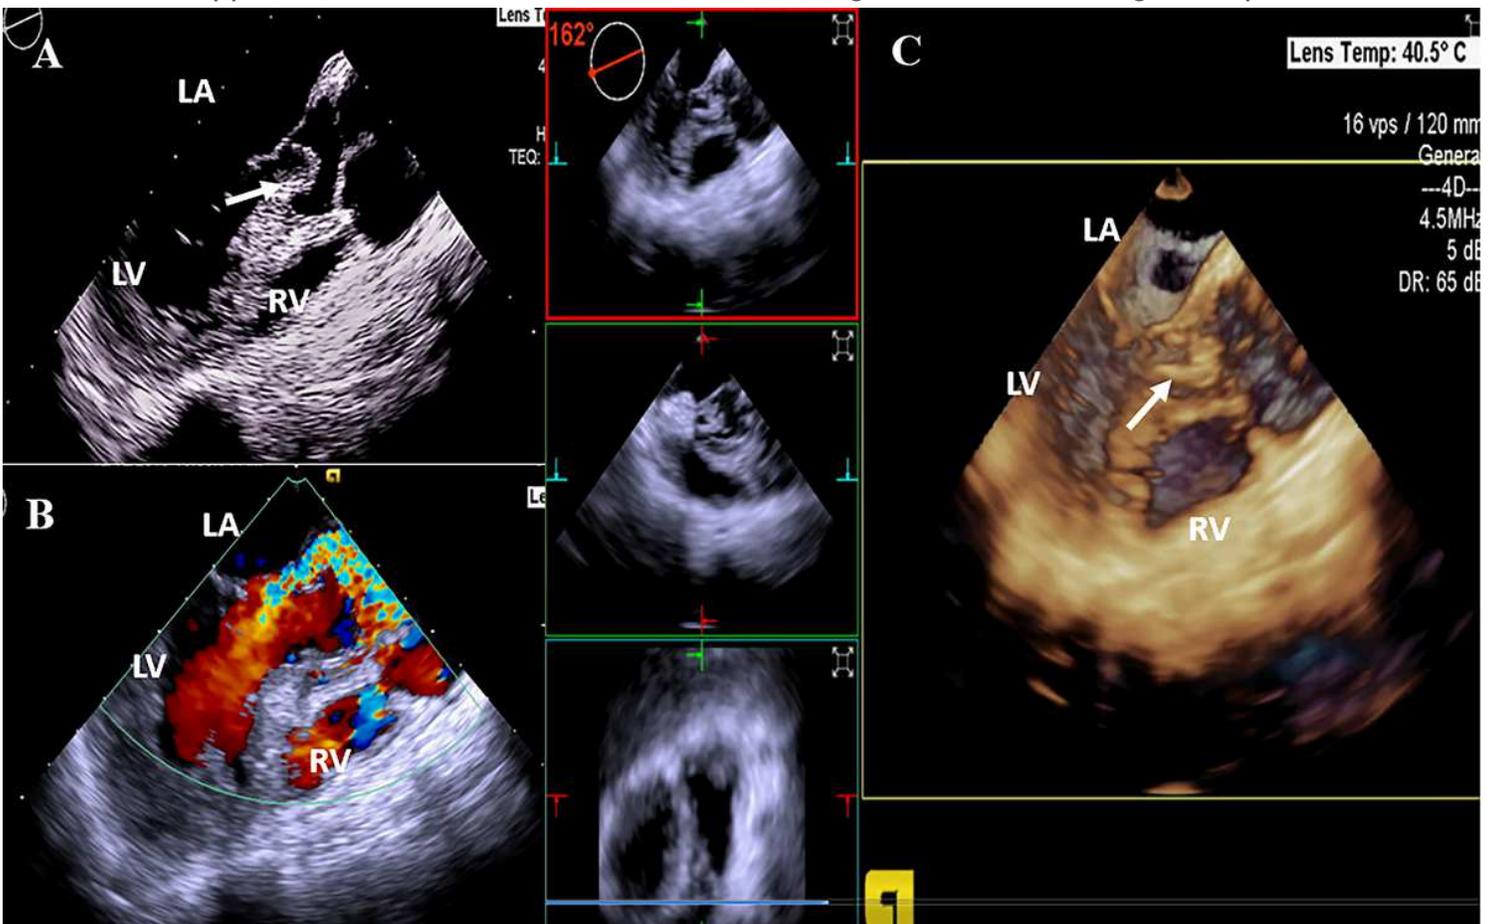
Figure 5

Case 2. (a) TEE, 162-degree view, demonstrated the movement of AMVT being folded into LVOT. (b) Aliasing was clearly seen in LVOT with color Doppler flow frame. (c) 3D rendering of the AMVT viewed from the bottom of the heart towards the apex in the long-axis view.

Fig. 5. Case 2. (a) TEE, 162-degree view, demonstrated the movement of AMVT being folded into LVOT. (b) Aliasing was clearly seen in LVOT with color Doppler flow frame. (c) 3D rendering of the AMVT viewed from the bottom of the heart towards the apex in the long-axis view.

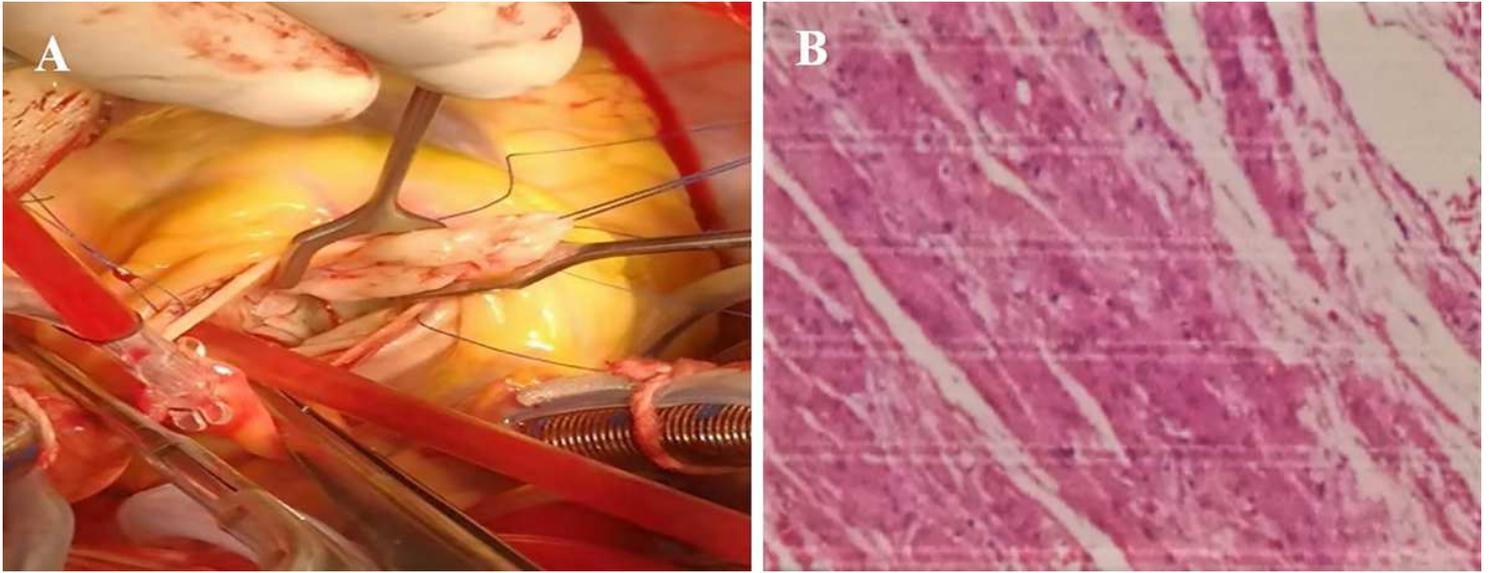
Figure 6

Case 2. (a) Transaortic excision of a mobile mass resembling a leaflet, attached to the anterior mitral leaflet. (b) Histological examination (Hematoxylin-eosin stain) showed myxomatous degeneration.

Fig. 6. Case 2. (a) Transaortic excision of a mobile mass resembling a leaflet, attached to the anterior mitral leaflet. (b) Histological examination (Hematoxylin-eosin stain) showed myxomatous degeneration.
