# Geodetic and Architectural Inventory of the Historic Wooden Church of St. Szczepan in Mnichów (Poland) in Terms of Safety Assessment of the Geometric Condition of the Structure.

# Abstract

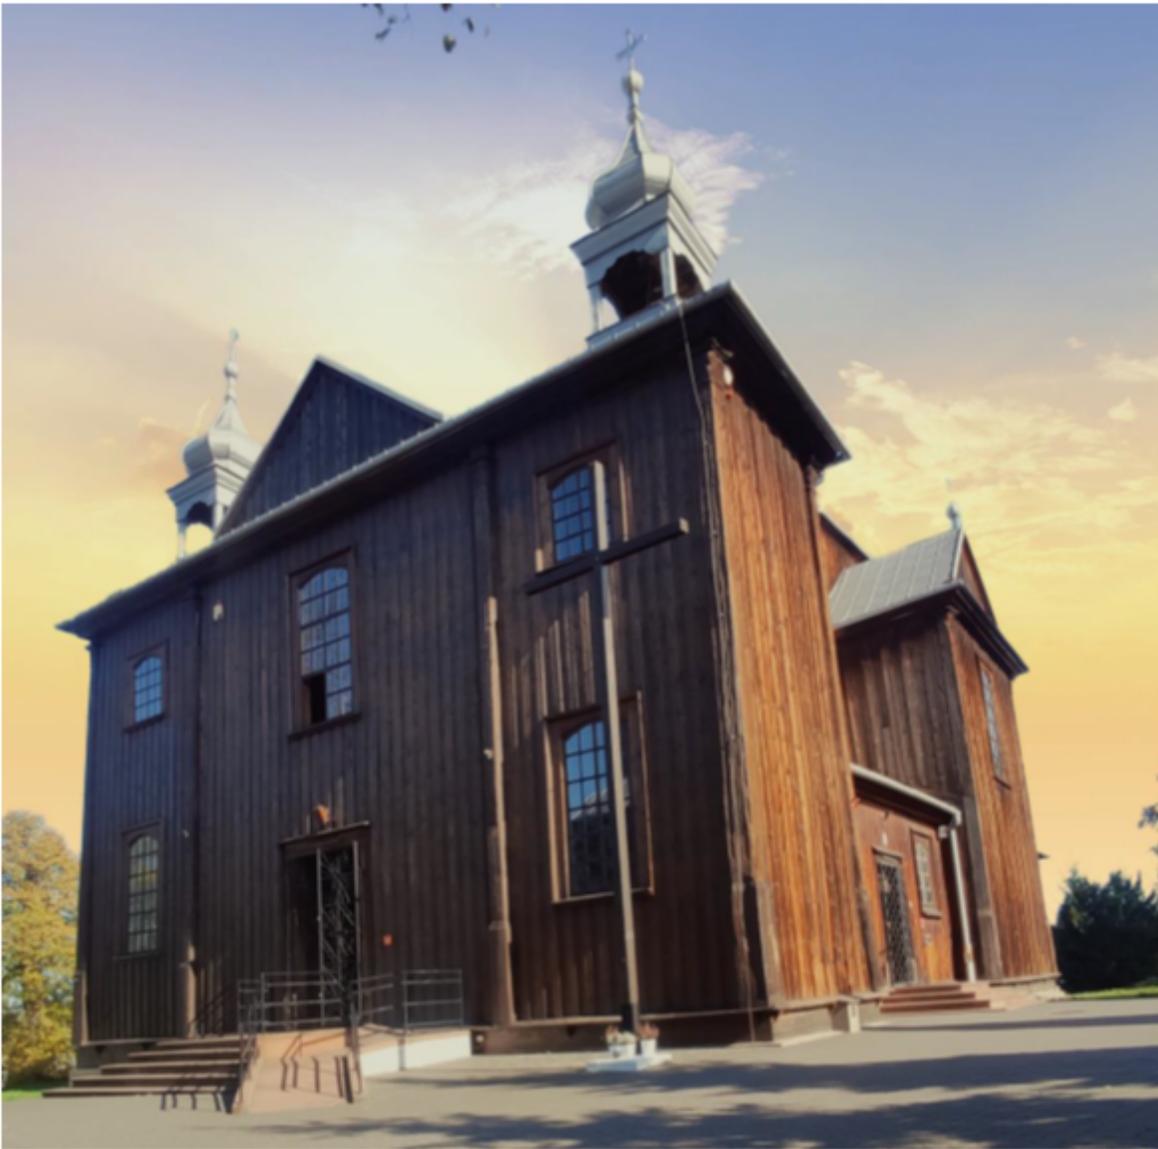
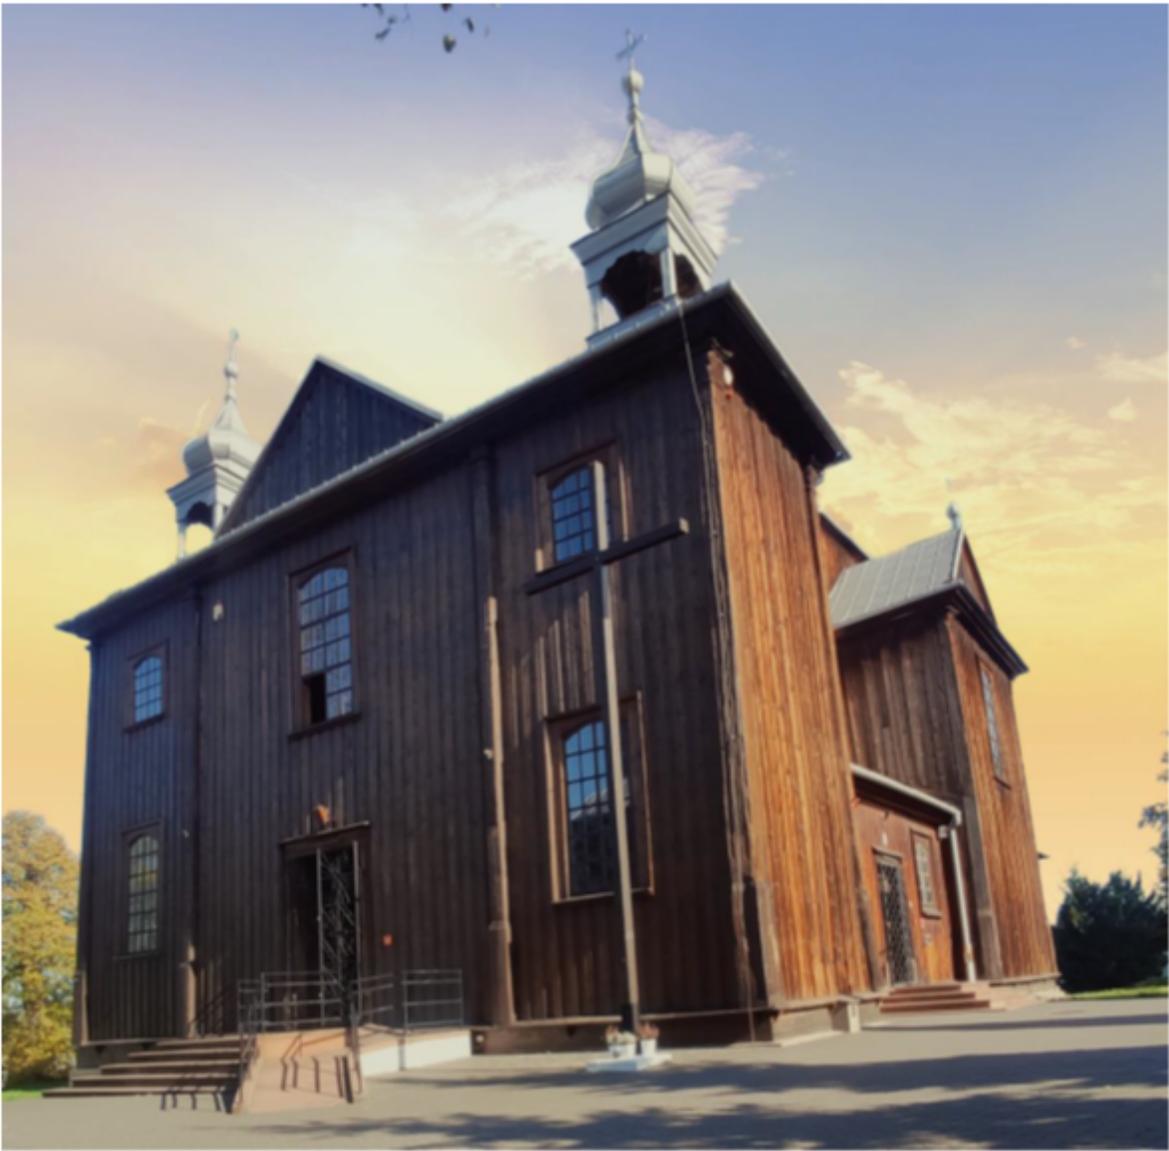
**Figure 1**

The subject of the research of this thesis is a historic, wooden church dedicated to St. Szczepan (Stephen) (Fig. 1), located in Mnichów - a village in the Świętokrzyskie Province. It is one of the few original wooden monuments that have been preserved to this day, as wood is a material susceptible to harmful biological and atmospheric factors. The architectural object in question has a dome with two towers in the facade and unique Rococo interiors, which have been kept in a uniform style.

View of the church of St. Szczepan in Mnichów (source: private archive)

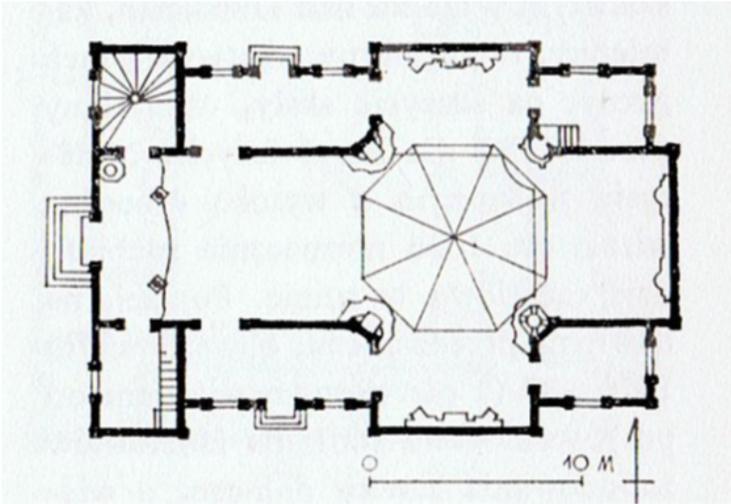
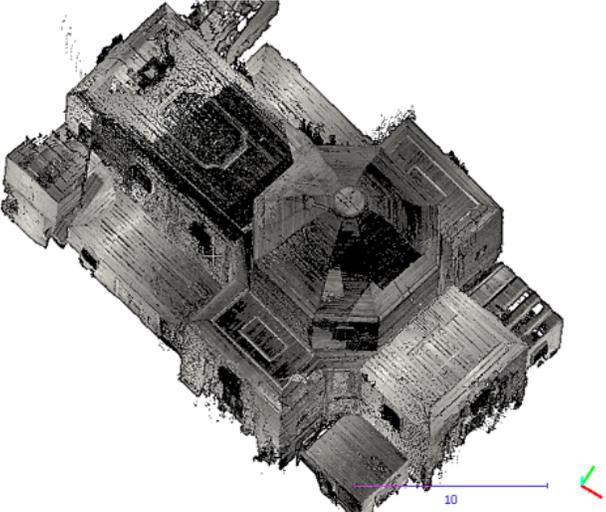
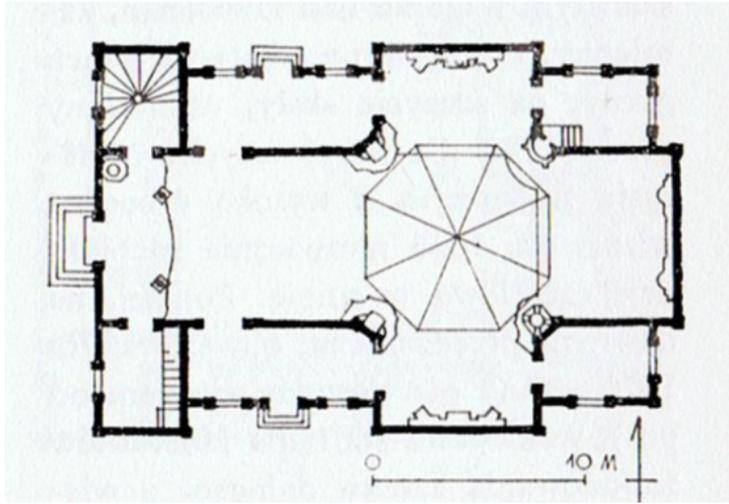
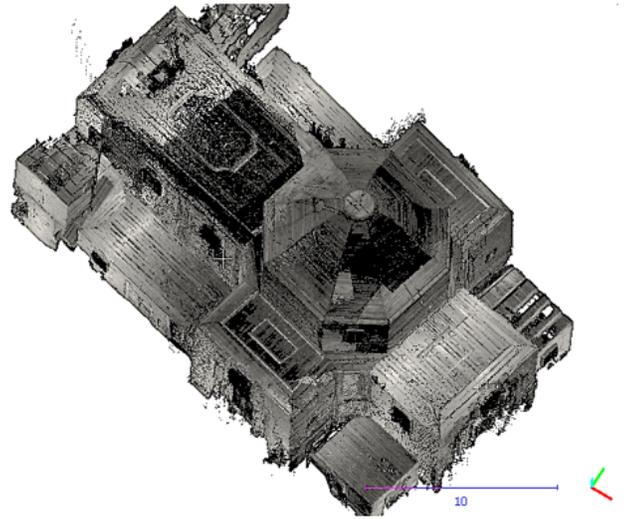
**Figure 2**

Plan of the church of St. Szczepan in Mnichów (a) (source: <http://www.zabytkowekoscioly.net>) and the scanned internal structure of the structure (b)

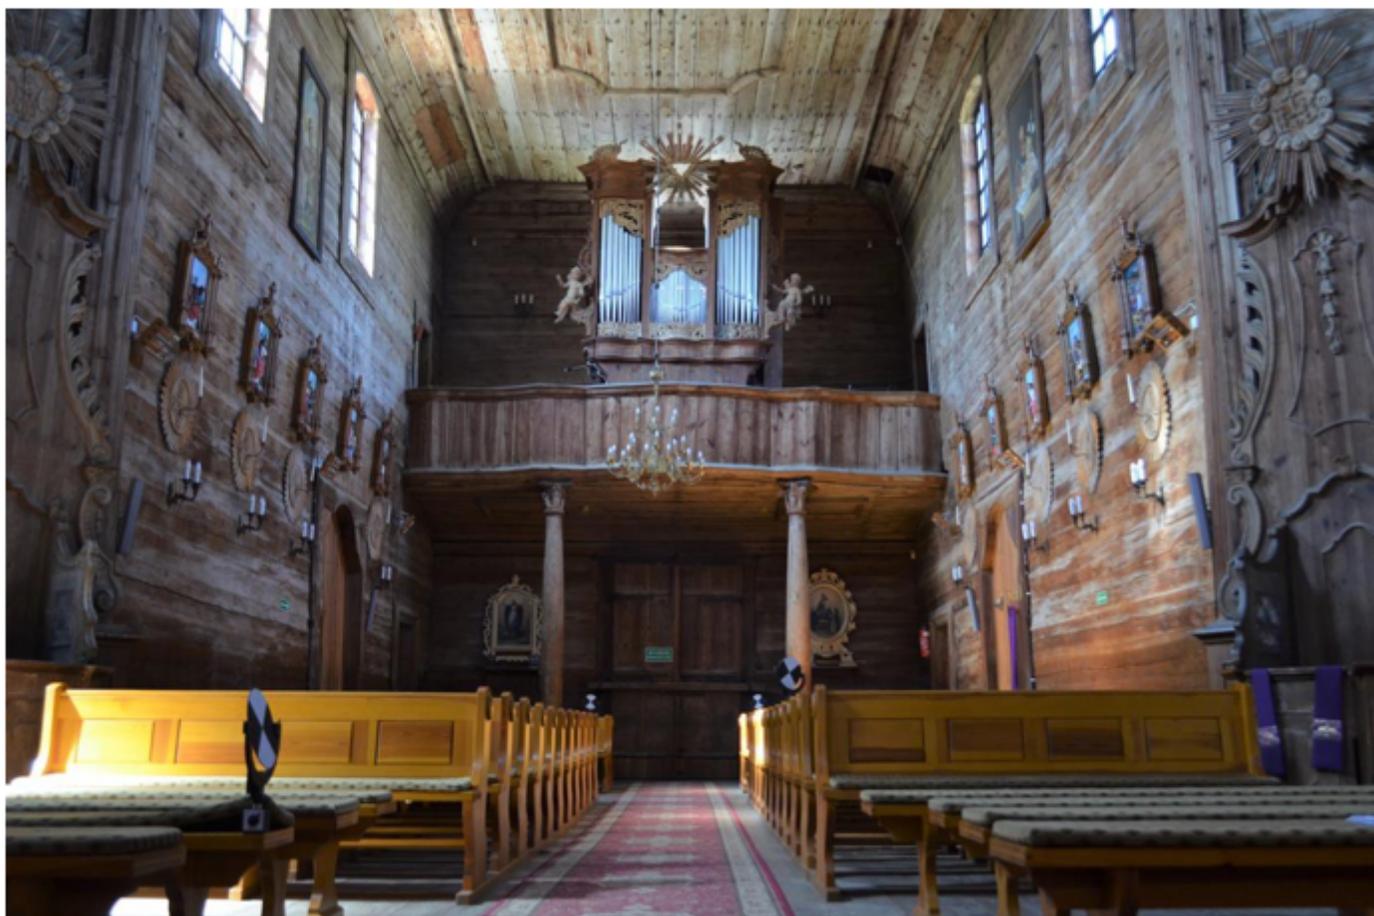
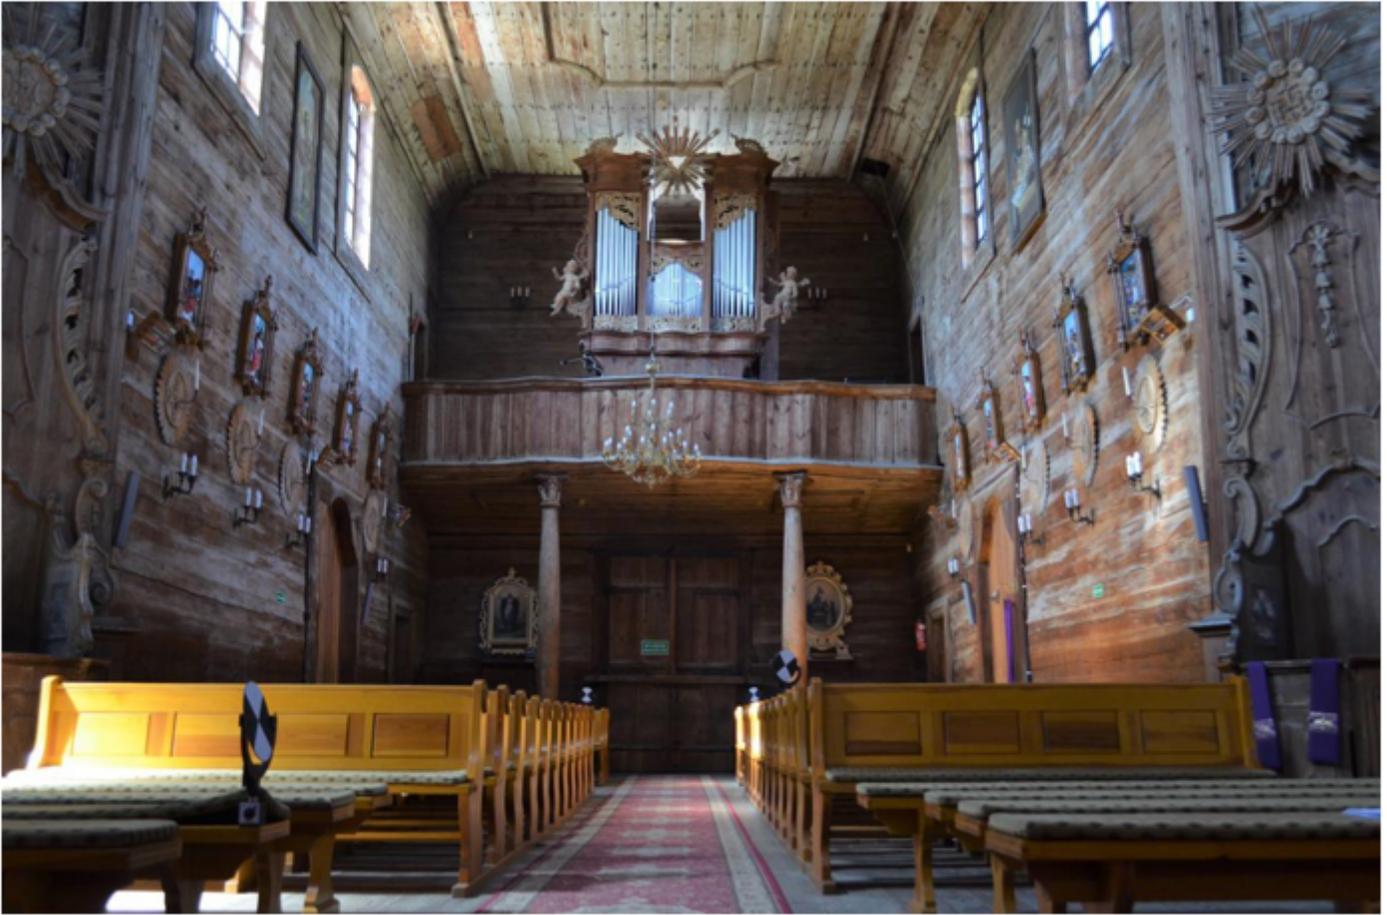
**Figure 4**

On the eastern side of the interior there is a music choir (Fig. 4). It is supported on slender, tall, wooden carved columns made in the Corinthian style. The organ prospectus placed on the choir is decorated with a rococo ornament.

One of the elements of the internal structure, which indicates potential deformation is the analysis of verticality of the columns supporting the floor on both floors.. In the main nave they support the choir (Fig. 4), while in the underground chapel they support the ceiling (Fig. 5). To determine the values of the inclination of the columns, it was necessary to determine their height, as well as the values of the shift of the centres of the columns in the XY plane. It was based on extreme cross-sections for which the geometrical centres of each column contour were determined at individual height levels. The results of the calculations are presented below in Fig. 10.

Music choir in the church of St. Szczepan in Mnichów (source: private archive)

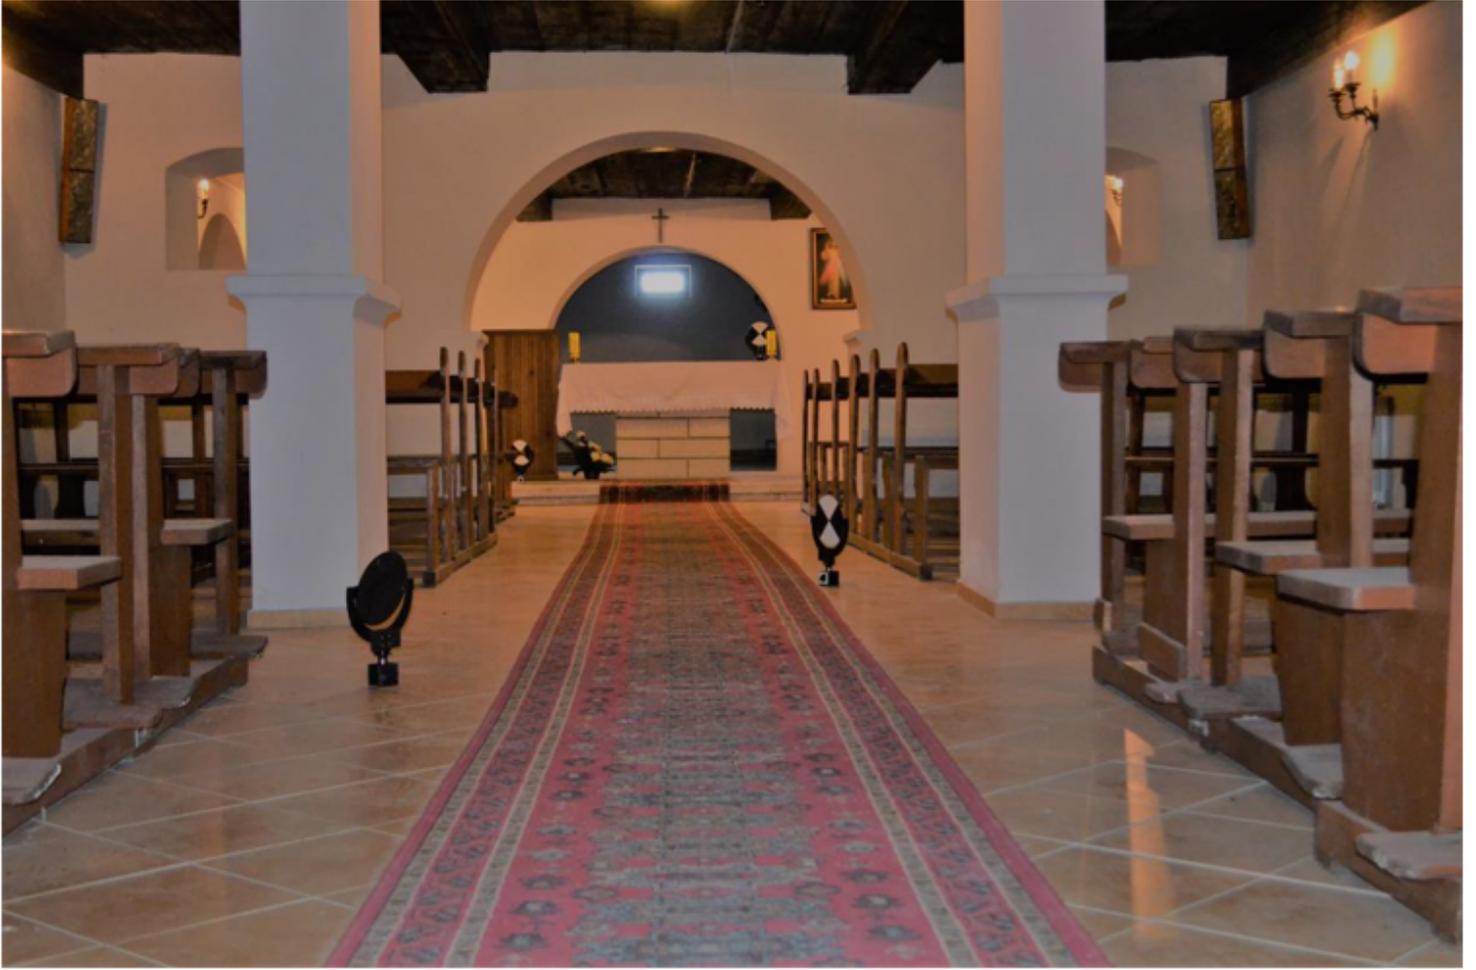
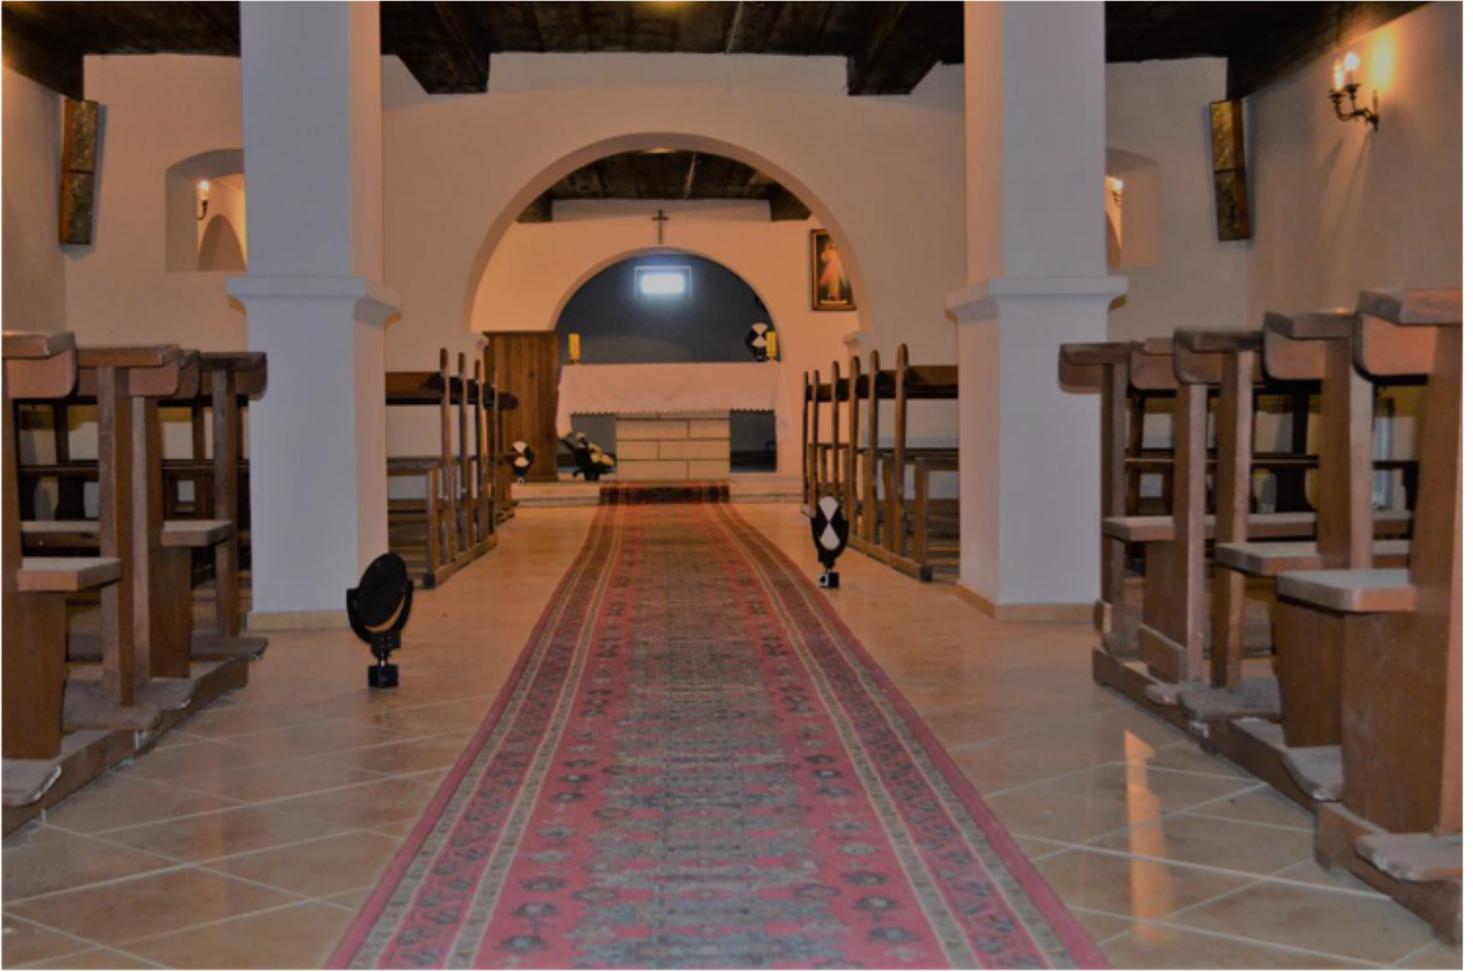
**Figure 5**

Measurement of the Chapel Tomb of Christ (source: private archive)

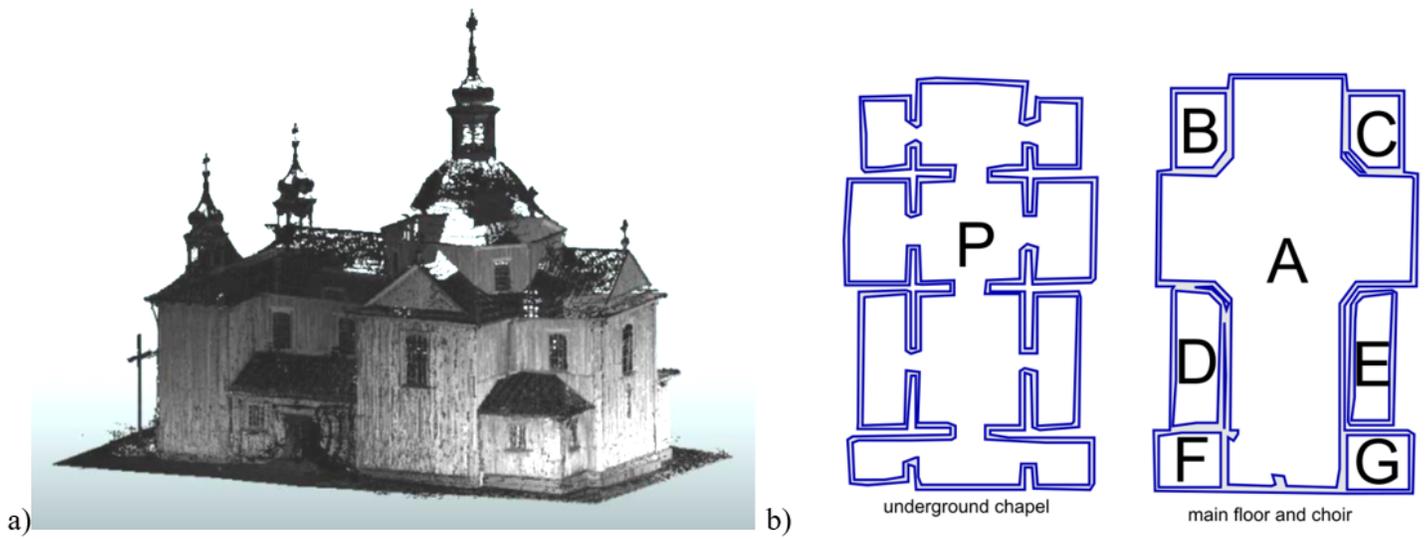
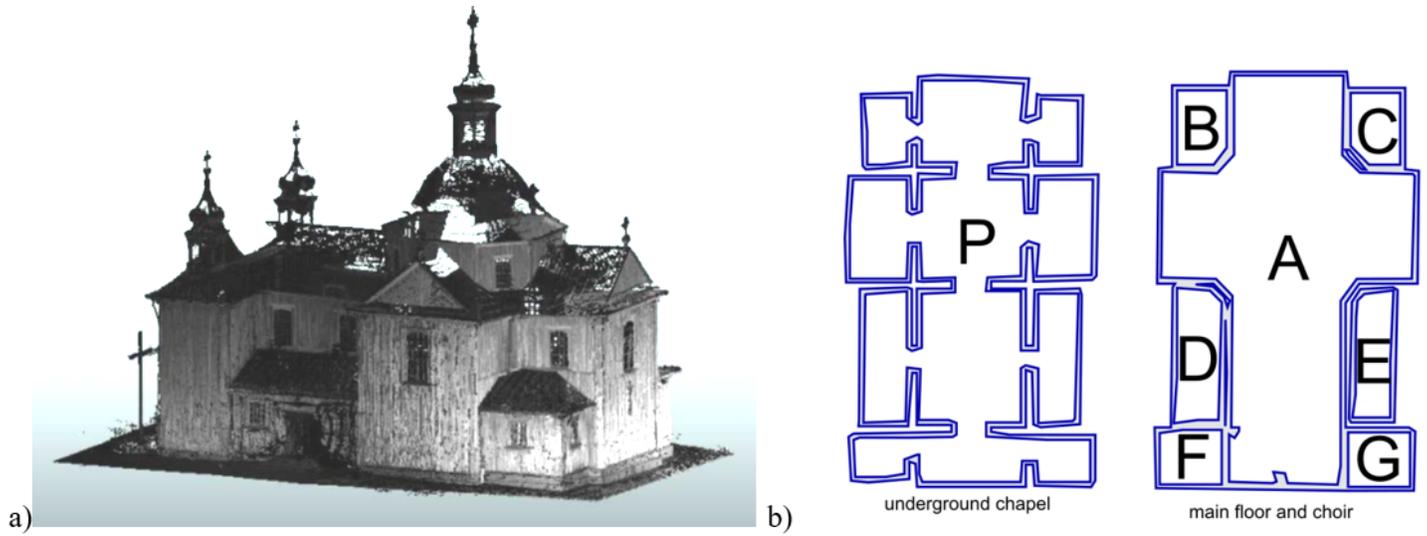
Figure 6

A total of 30 point clouds were obtained from the measurement. The Z + F Laser Control 8.8.1 program was used to connect them. The scans were combined in two stages. The first of them contained 22 scans made inside the building, while the second one contained 8 scans, which were made when measuring the external part of the object. Satisfactory accuracy of a uniform point cloud was obtained, characterized by errors in the position of scanned points in a global system below  $\pm 10$  mm. After performing procedures of filtering point clouds in terms of reflection quality, removing unnecessary elements and overrides, a uniform file was obtained containing scans made inside and outside the object. (Fig. 6a), from which the outline of the rooms of the lower and main floors of the church can be separated (Fig. 6b)

Point cloud representing the church from the outside (a) and a floor plan based on horizontal cross-sections through the point cloud (b).

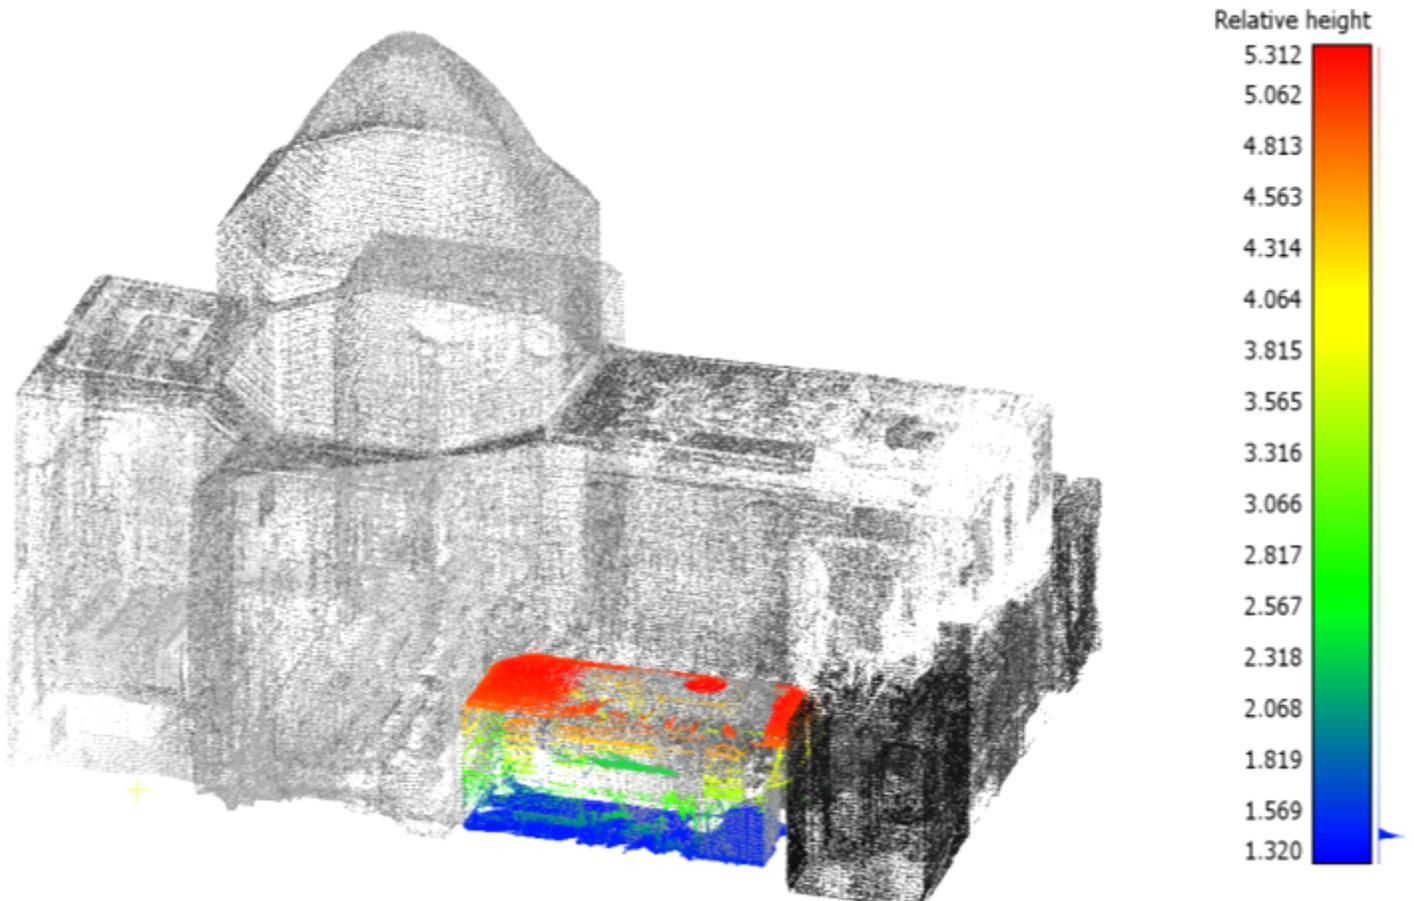
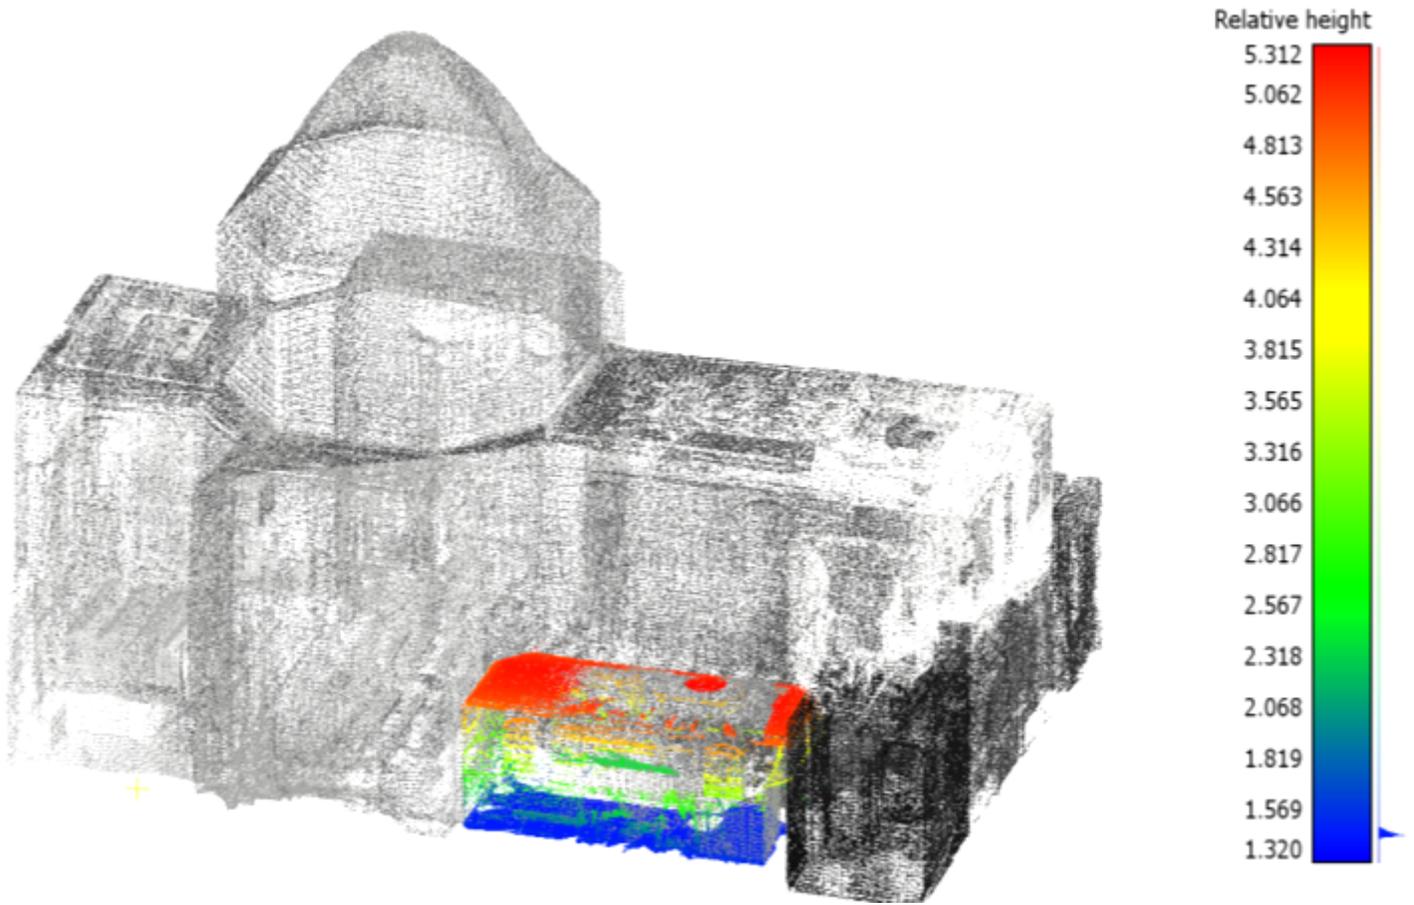
Figure 7

According to analyzes, the church is: 27.75 m high, 695.50 m<sup>2</sup> of total building area and 4150 m<sup>3</sup> of volume. Room volumes were determined based on the area determined in AutoCad 2020 and the average height determined based on the floor and floor identification based on CloudCompare. An example of

conducted analysis for room D shown in Fig. 7 and detailed results for individual rooms are presented in Table 1.

Points used to measure the built-up area, volume and height of the room D (source: own study)

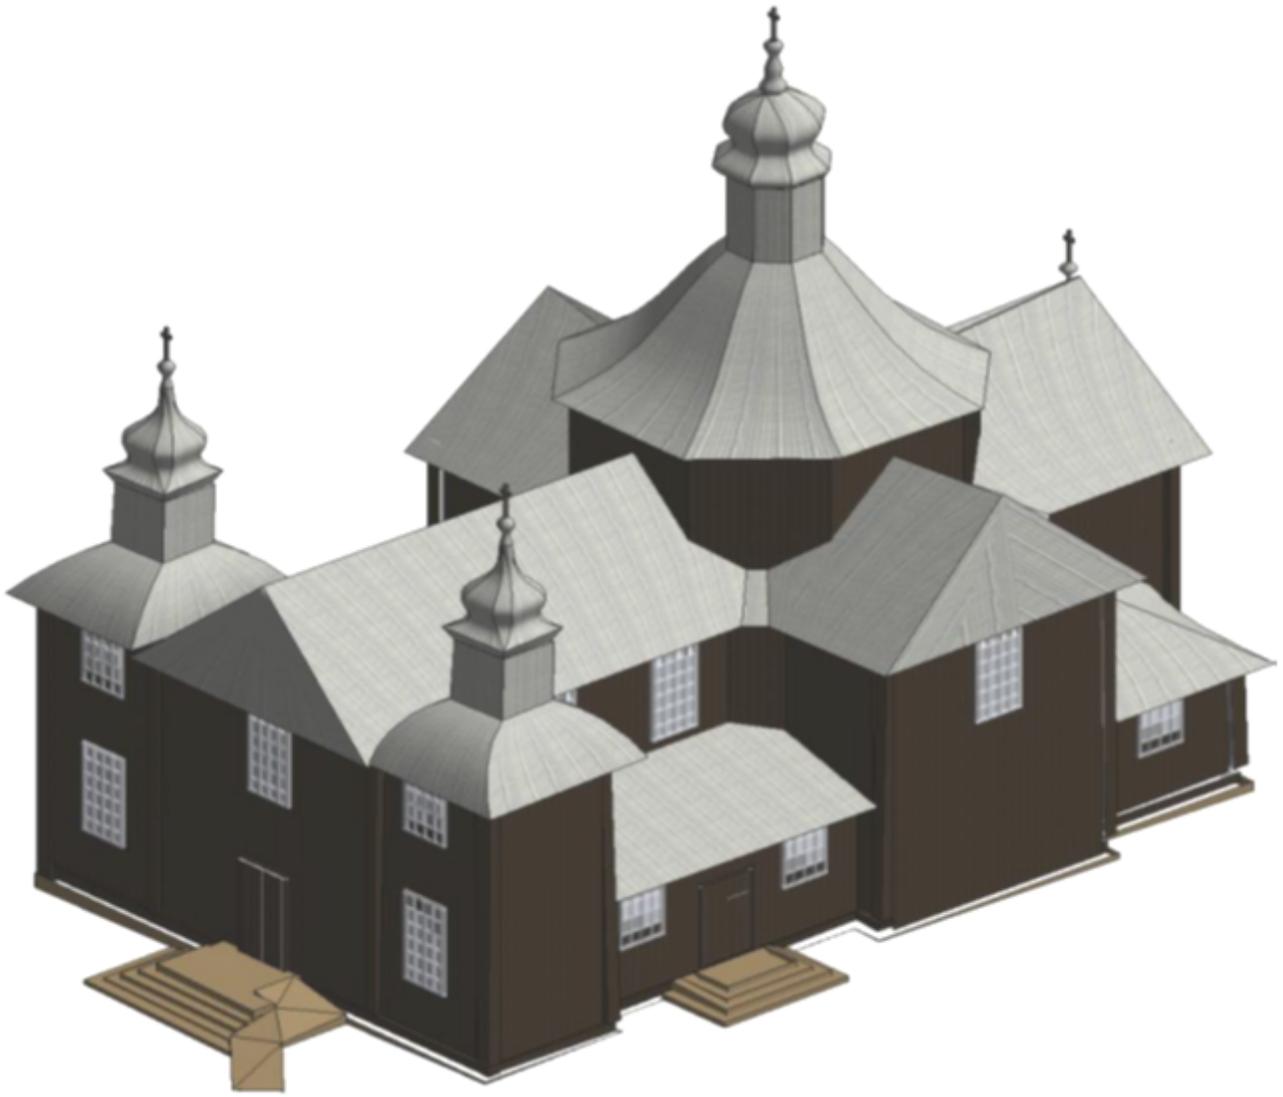
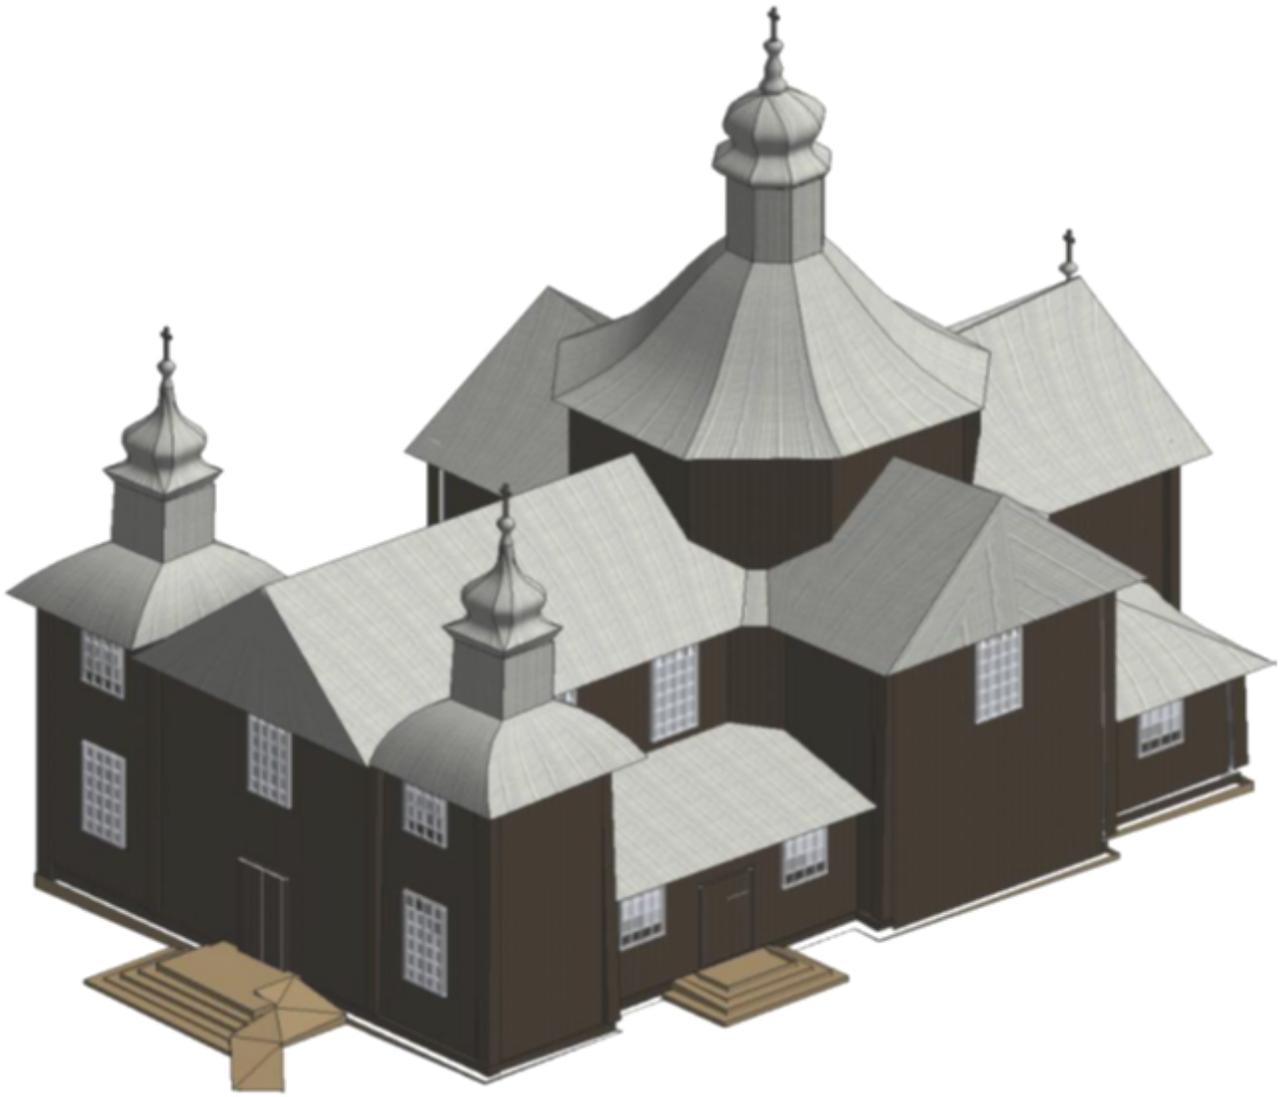
**Figure 8**

As a result of the inventory work carried out, a virtual replica of the building was created in the form of a 3D model, which is shown in Fig. 7. In order to reproduce the colour of the outer walls of the church, RGB colour obtained from simultaneously taken photos was used.

Model of the church St. Szczepan in Mnichów - southwest view

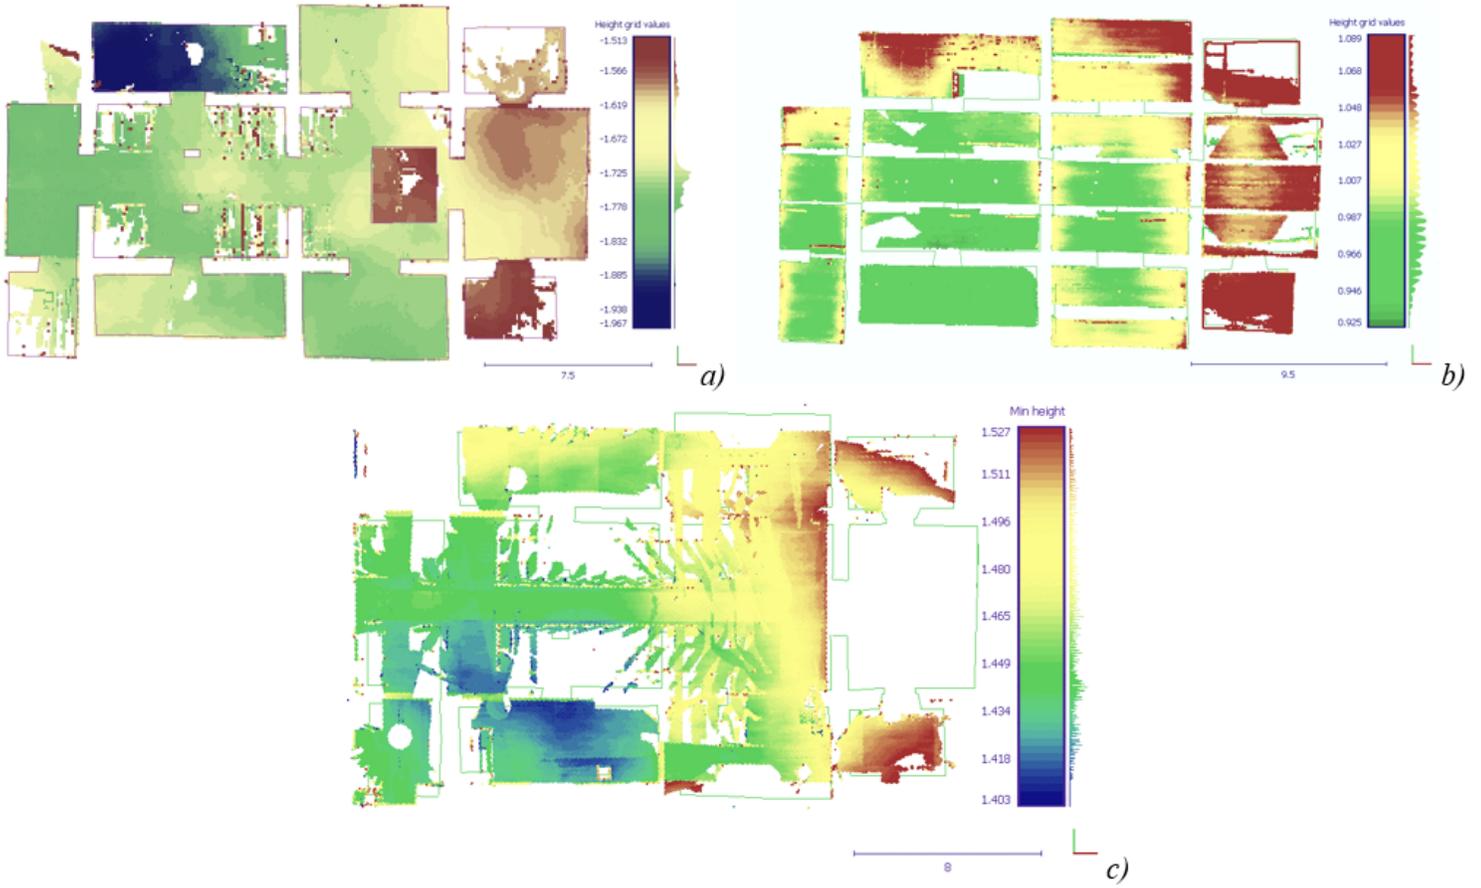
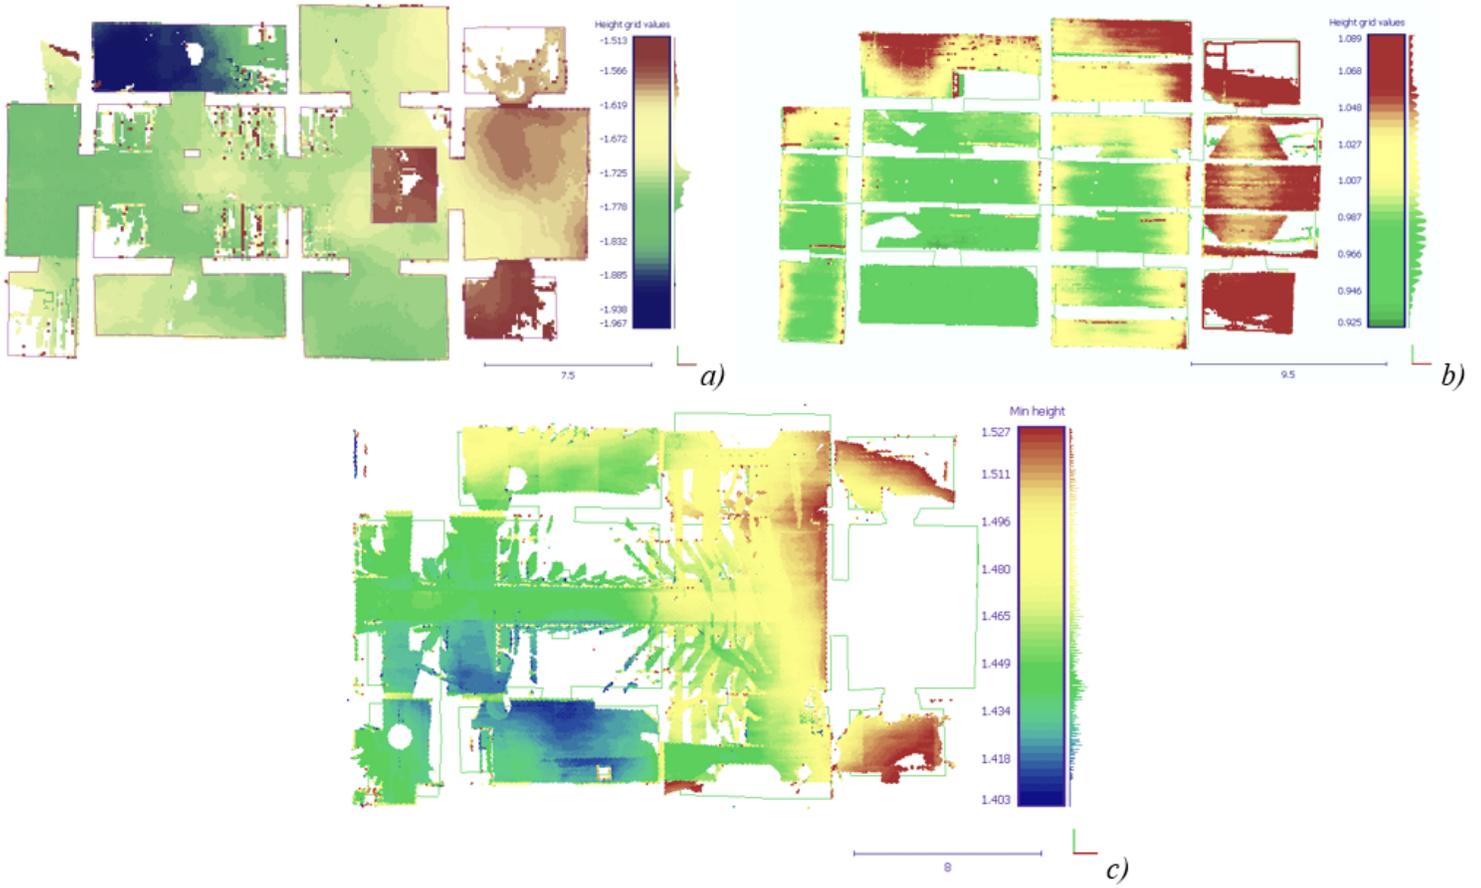
**Figure 9**

To determine the condition of geometric invariance, a number of analyzes were performed based on the acquired uniform point cloud. Among other things, an analysis of the floor level of both floors was carried out, based on the measured points after the filtration process (removal of building elements) and thinning of the cloud. A matrix of points of the tested surfaces at regular intervals of 0.05 m was obtained, which was then subjected to the process of determining the floor height changes in the CloudCompare program and controlling the interpolation of the contour lines in the Surfer® program using the Nearest Neighbours algorithm. Figure 8 presents hypsometric plans for the level of floors in the rooms of the underground chapel (Fig. 8a) and its ceiling (Fig. 8b) in the adopted system of local height.

The maps presented in Fig. 8 indicate the diversity of levels of individual floors and most importantly, a change in their level in the same room can be observed. Unfortunately, due to the status of the monument, it was impossible to make measurements for covered structural elements (foundations), however, the changes in the level shown in this way, which are within the limits of 5 cm in individual rooms can be considered statistically significant. The same conclusion can be drawn from the analysis

of the level of the underground chapel ceiling. Similar procedures were also carried out for the nave floor. However, due to its very large construction elements of equipment that could not be removed and the fact that the boards covering the floor are not a structural element, but only a masking one, the height difference determined may not accurately reflect the levelness of the floor. However, it indicates the tendency of inclination in the west-south direction, as the ceiling of the underground part indicates.

Verticality of the floor of the underground chapel (a) and its ceiling (b) and the floor of the nave (c)
