# Geodetic and Architectural Inventory of the Historic Wooden Church of St. Szczepan in Mnichów (Poland) in Terms of Safety Assessment of the Geometric Condition of the Structure.

# Abstract

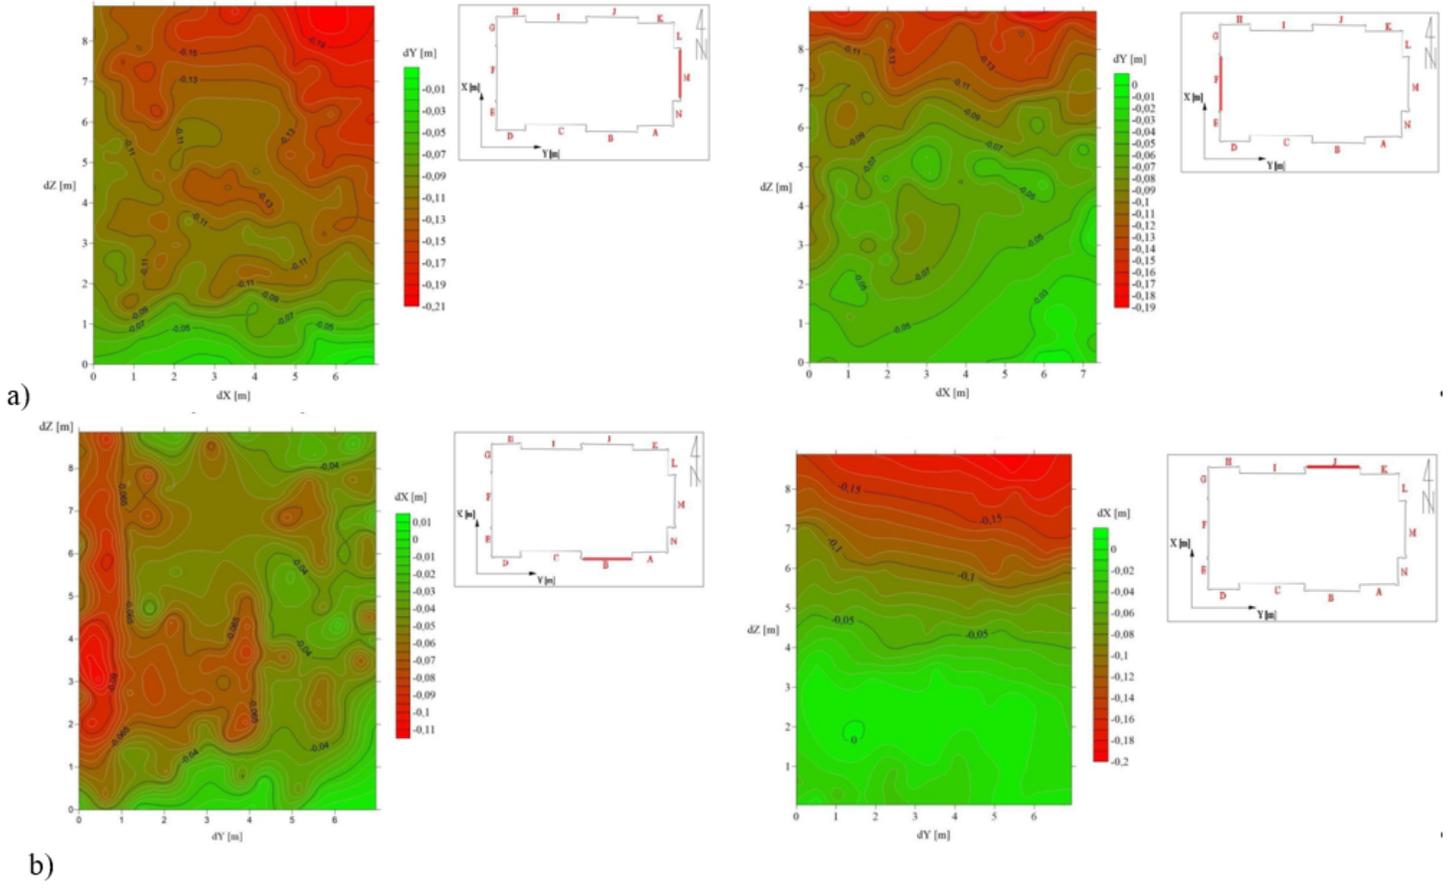
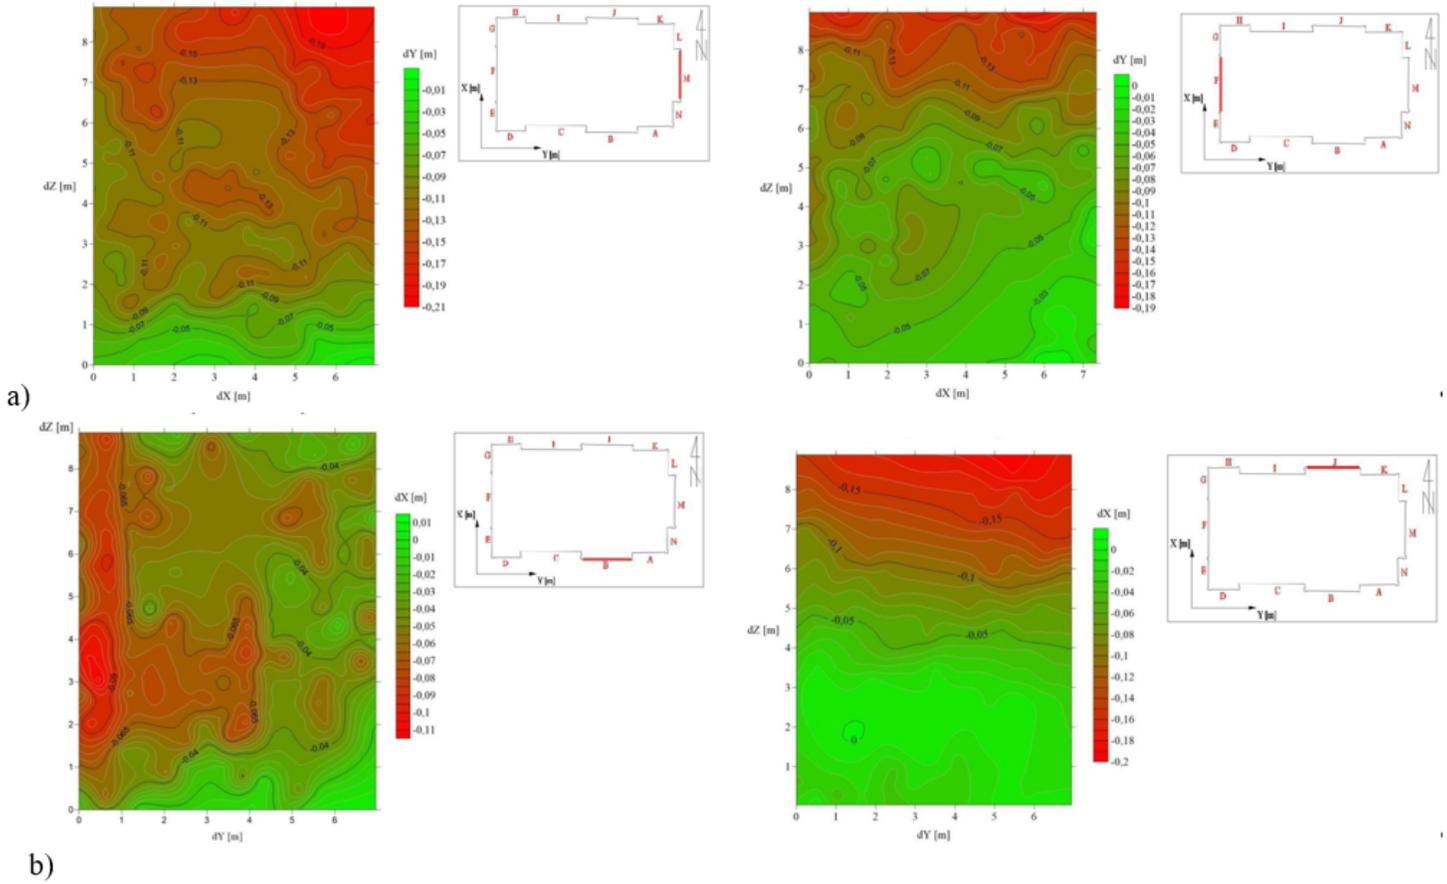
**Figure 10**

An important aspect of the stability of a wooden structure is the verticality of the walls. Failure to comply with this condition may indicate areas with an increased risk of stress transmission and worsening of the unfavourable condition for the structural statics. The church in Mnichów has 14 external walls and they have been subjected to verticality analysis. The designations of the walls that have been measured are marked in Fig. 9. Similar to the floor level test, points belonging to individual walls were selected and points corresponding to window and door openings were removed. Then the point cloud was thinned out so that the minimum distance between points was 0.5 m. In the analysis of contour plans, the local coordinate system of the building used local systems, in accordance with the tested planes, in which the flat coordinates referred locally to the tested plane and as an indicating coordinate for non-verticality, the value perpendicular to it was considered. It was found that the walls of the building are tilted west (towards the main entrance, opposite the altar) within  $(6 \div 34 \text{ mm} / \text{m})$  and to the south  $(9 \div 21 \text{ mm} / \text{m})$ . Sample charts of vertical line isolation are presented in Fig. 8 and detailed data in Table 2.

The reported deviations from the vertical indicate that the structure is tilting southwest. The resultant value cannot be directly indicated here, because these walls are not connected into one monolith. Nevertheless, a tendency to south-west swing has been shown. It should be remembered that the church was built in the 18th century from larch wood, which is considered to be the most durable and resistant to deformations caused by weather conditions and the passage of time. However, the inclination of the walls may have been influenced by the way the building was erected and the lack of precise technology for preparing elements of the wooden structure.

Deviations from the vertical wall of the external walls of the structure - a) walls "M" and "F" on the west-east axis, b) walls "B" and "J" on the north-south axis

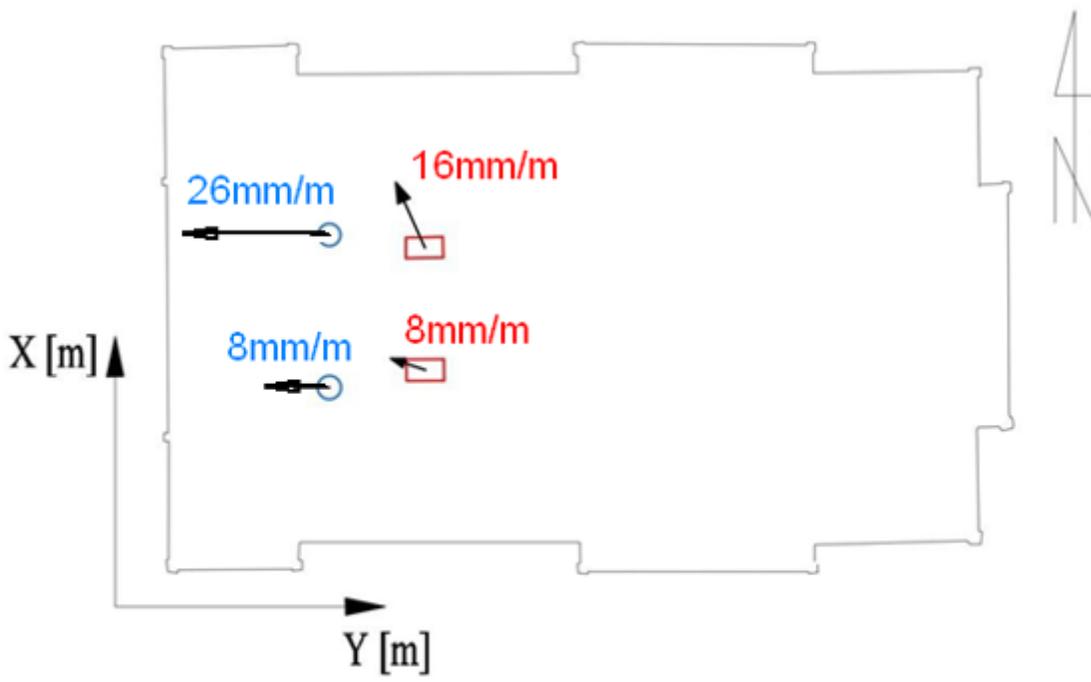
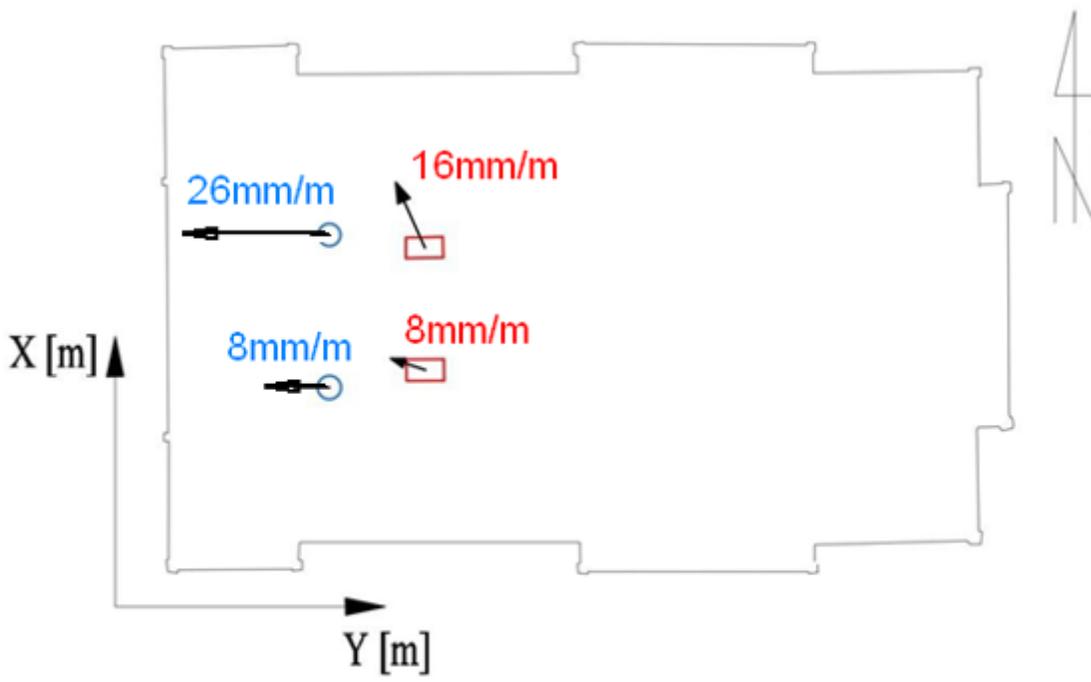
Figure 11

One of the elements of the internal structure, which indicates potential deformation is the analysis of verticality of the columns supporting the floor on both floors.. In the main nave they support the choir (Fig. 4), while in the underground chapel they support the ceiling (Fig. 5). To determine the values of the inclination of the columns, it was necessary to determine their height, as well as the values of the shift of the centres of the columns in the XY plane. It was based on extreme cross-sections for which the geometrical centres of each column contour were determined at individual height levels. The results of the calculations are presented below in Fig. 10.

The columns in the underground chapel of the Holy Sepulchre are tilted to the north-west. The northern column has a greater inclination, i.e. 16 mm/m. The columns located in the nave of the church lean only

to the west. The northern column also has a greater inclination, i.e. 26 mm/m. Also these analyses indicate that the inclination of the structure at the level of the main nave is predominant in the western direction, similarly to the external walls of the church structure.

- columns in the nave
- columns in the basement

Determined vectors of inclination of the column axes from the vertical.

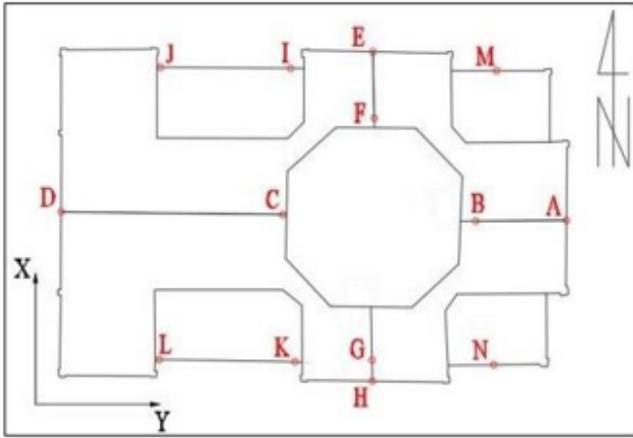
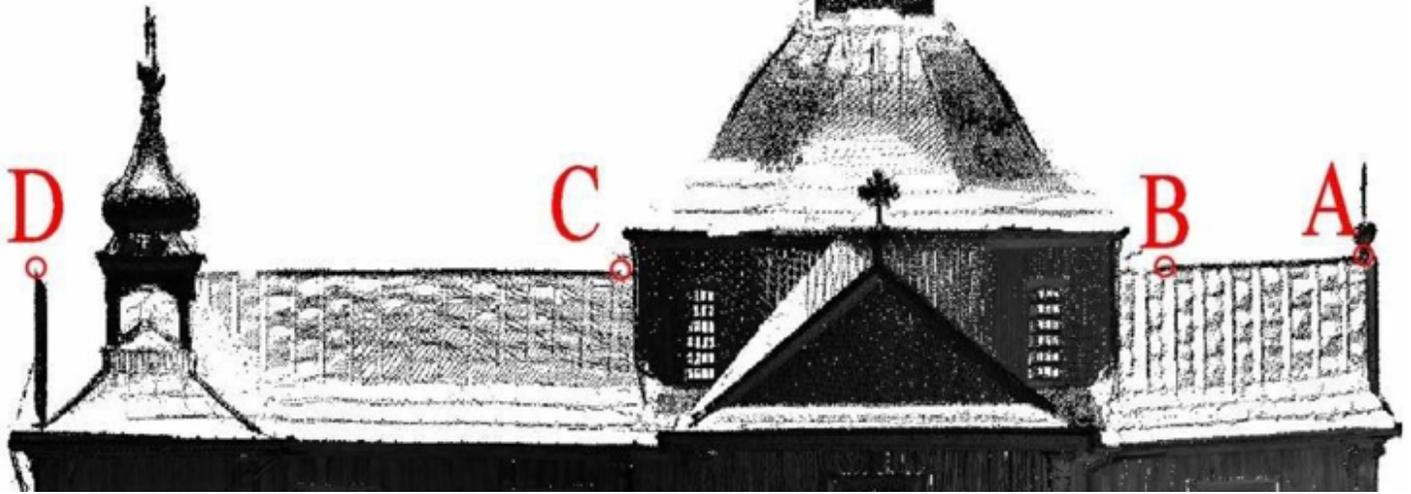
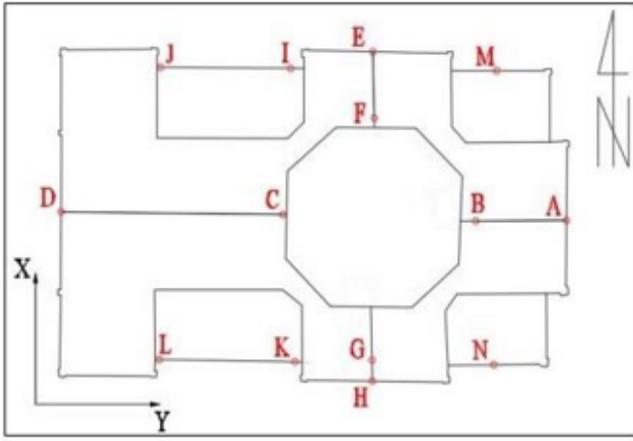
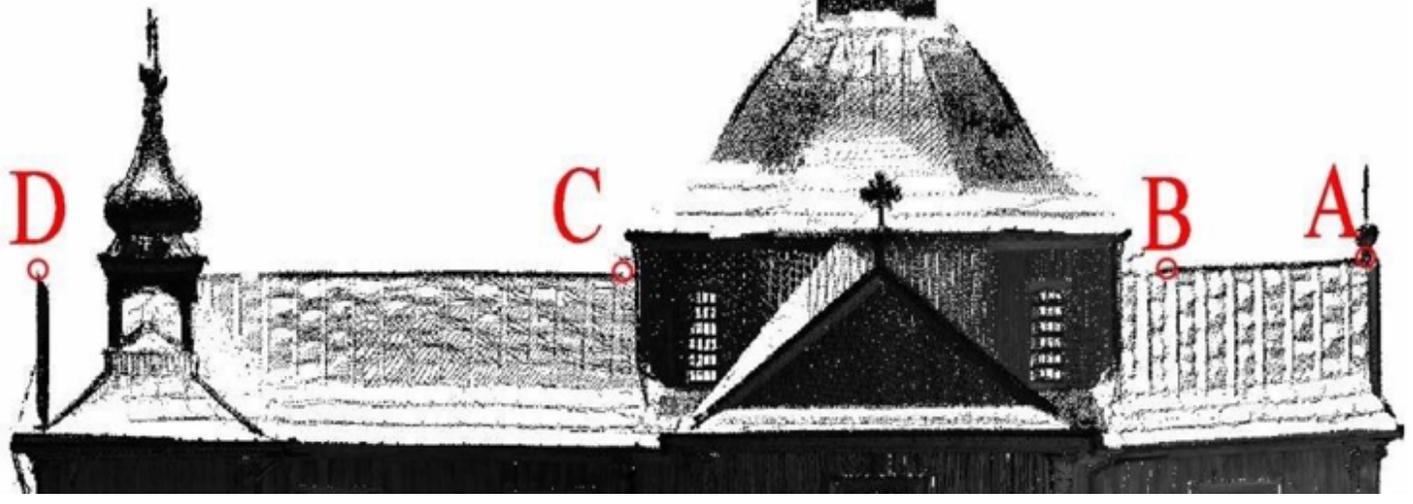
Figure 12

The church's structure is reinforced by a roof truss, which cooperates with elements of the wooden skeleton in a much more active way than in modern concrete and brick constructions. For this reason, checking the shape of the truss, by analyzing its symmetry, may allow additional inference regarding the condition of the entire structure. For this purpose, the analysis of the levelness of the roof edges (ridge) in the longitudinal and transverse direction and the analysis of the roof slope inclination were made. The ridge slope was calculated on the basis of the distance between the characteristic points (Fig. 11) and the height difference between them using trigonometric functions.

Maximum gradients were found on the B-A section (+ 38 mm / m) (Fig. 11) but also on the north-south direction for the E-F section (-40 mm / m). Roof slopes analyzed in cross-sections indicate their warping and torsion of their planes, however, not exceeding  $\pm 1.4\%$  (up to 70 mm / 5 m).

View of the ridge of the church roof west-east.
