Subacromial Erosion after Hook Plate Fixation in Acute Acromioclavicular Joint Dislocation

Research Article

Keywords: Acromioclavicular joint injury, Locking Hook plate, Subacromial erosion, shoulder

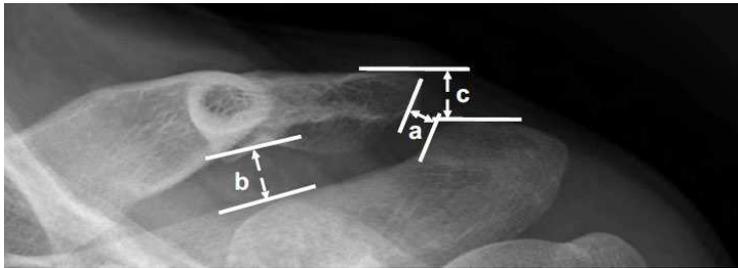
98 Figure. 1 Radiologic analysis on the plain anteroposterior radiograph for the assessment of postoperative reduction
99 quality. a: acromioclavicular distance, b: coracoclavicular distance, c: acromioclavicular interval.

85 Anteroposterior radiographs of the affected and contralateral unaffected ACJ in neutral rotation were obtained
86 with patients in a standing position immediately after operation and in each follow-up examination including the
87 last one. To evaluate the postoperative reduction quality, the following radiologic factors were measured. (Figure
88 1):1. Acromioclavicular interval (ACI), 2. Coracoclavicular distance (CCD), 3. Acromioclavicular distance (ACD)

89 ACI was defined as the perpendicular distance between clavicle distal end and acromion; CCD was defined as
90 the perpendicular distance between the upper border of the coracoid process and the inferior cortex of the clavicle;
91 ACD was defined as the perpendicular distance between the line passing the upper border of acromion and the
92 line parallel to the upper border of the lateral part of clavicle. All radiographs were analyzed by two authors who
93 reached a consensus. Reduction loss was decided by comparing ACI, CCD, and ACD in the immediately
94 postoperative and the last follow-up radiographs. Radiologic results of contralateral unaffected side and affected

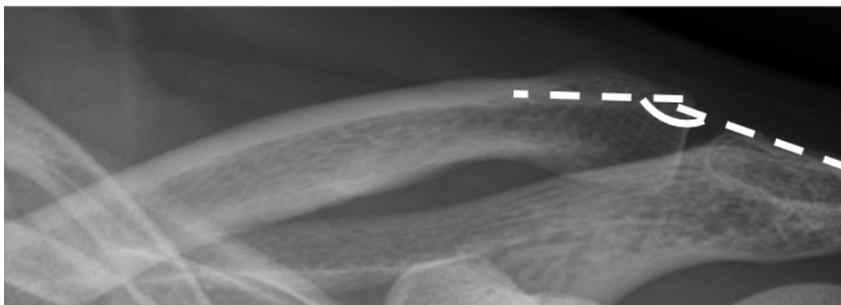
110 Figure 2.1)

117 Figure 2. Risk factor analysis for the subacromial erosion. 1) Acromioclavicular slope (AC slope), 2) Acromion-
 118 hook angle (AH angle), C) Acromioclavicular AP distance (AC-AP distance) D) Acromioclavicular interval (ACI)

119 The AC slope was defined as the angle formed between the upper surface of the acromial process and the upper
 120 surface of the distal clavicle on the plain anteroposterior radiograph. The AH angle was defined as the angle
 121 formed between the upper surface of the acromial process and the hook of the locking hook plate on a plain
 122 anteroposterior radiograph. The AC-AP distance, which was measured in the axial view of the CT, was defined as
 123 the distance between the two lines tangent to the anterior margin of the acromial process and the anterior margin
 124 of the distal clavicle. In addition, the pre-operative ACI of the affected side was included as a risk factor and
 125 measured together with the above three items.

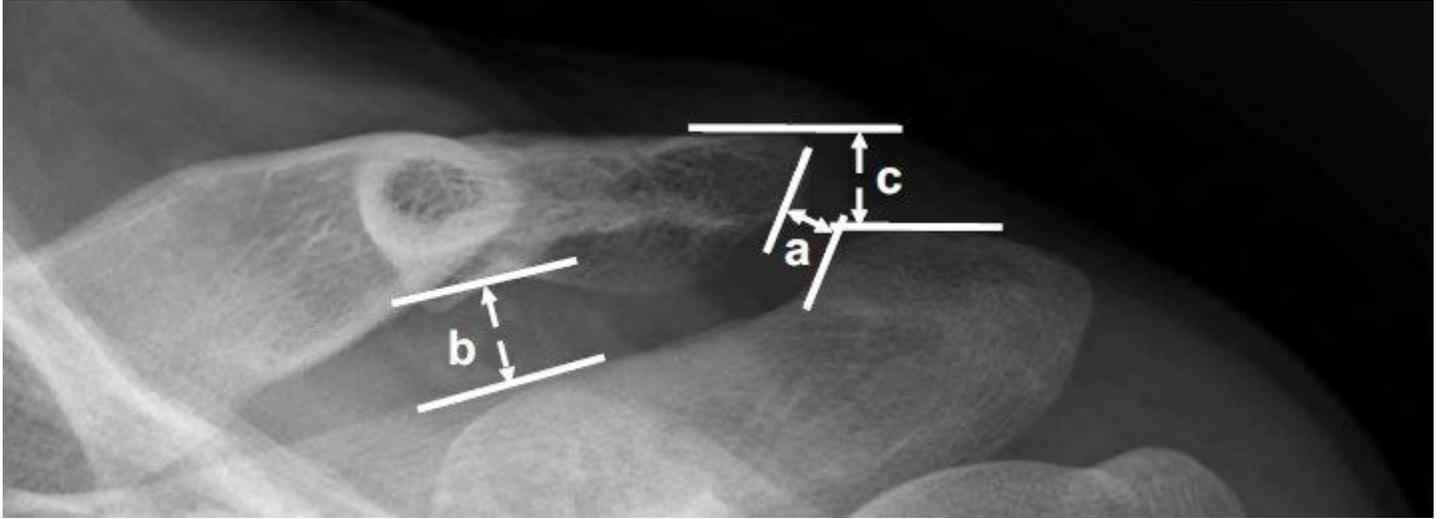
Figure 1

Radiologic analysis on the plain anteroposterior radiograph for the assessment of postoperative reduction quality. a: acromioclavicular distance, b: coracoclavicular distance, c: acromioclavicular interval.

316 Figure. 1 Radiologic analysis on the plain anteroposterior radiograph for the assessment of postoperative reduction
317 quality. a: acromioclavicular distance, b: coracoclavicular distance, c: acromioclavicular interval.

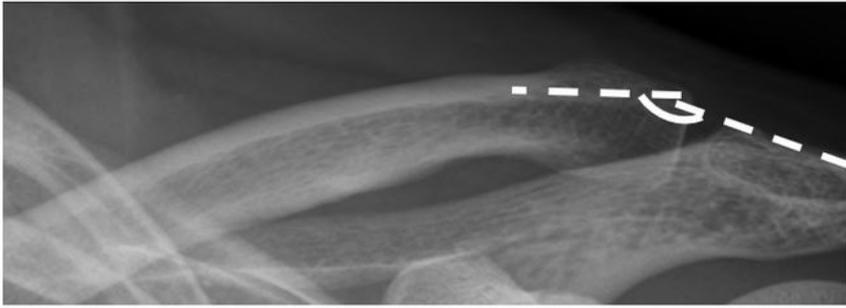
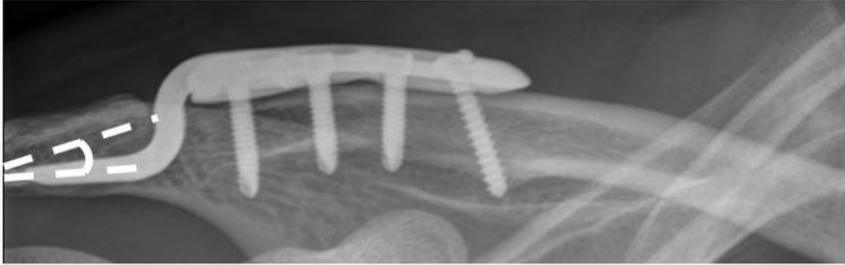
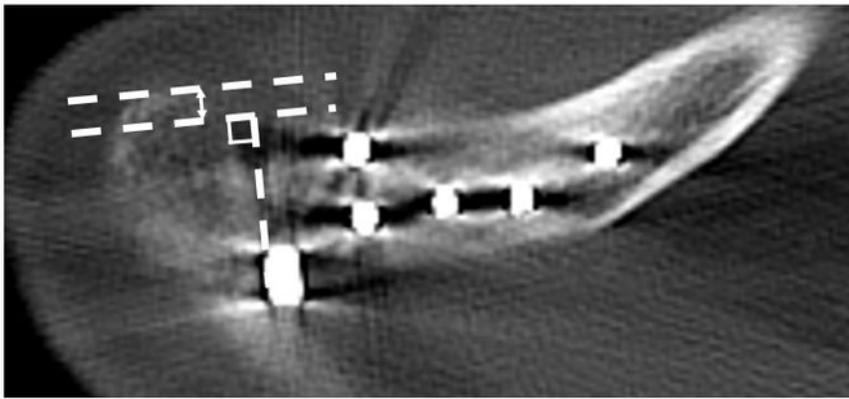
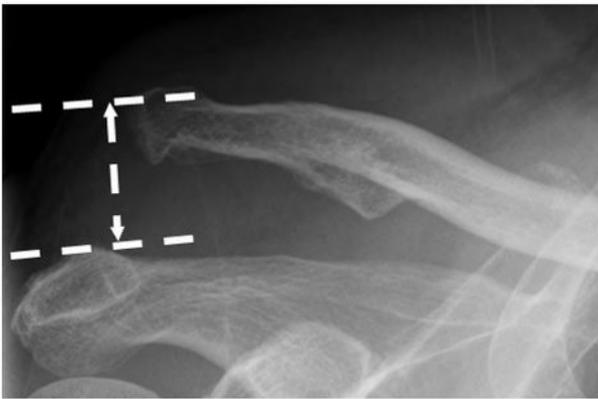
Figure 2

Risk factor analysis for the subacromial erosion. 1) Acromioclavicular slope (AC slope), 2) Acromion-117 hook angle (AH angle), C) Acromioclavicular AP distance (AC-AP distance) D) Acromioclavicular interval (ACI)

318 Figure 2. Risk factor analysis for the subacromial erosion. A) Acromioclavicular slope (AC slope), B) Acromion-
319 hook angle (AH angle), C) Acromioclavicular AP distance (AC-AP distance) D) Acromioclavicular interval (ACI)
