# A Study of Isothermal Mechanical Fatigue of Welded Reactor Steel (15H2MFA)

## Research Article

**Keywords:** Nuclear Power Plant, Reactor pressure vessel, 15H2MFA

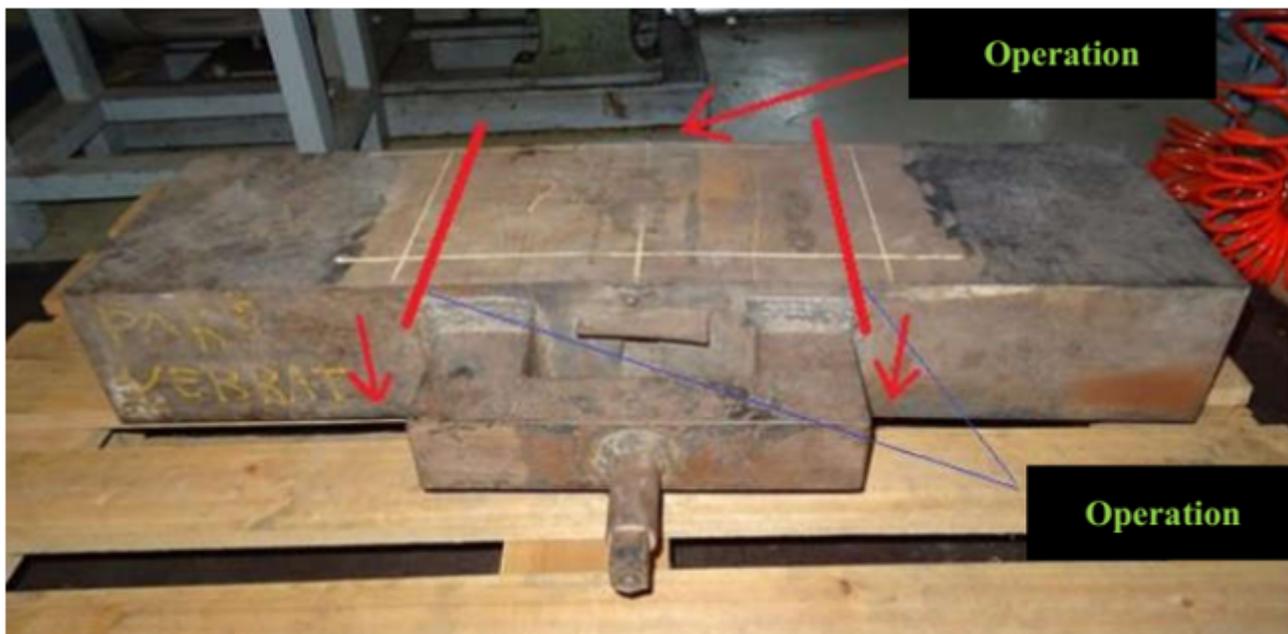
Figure 1

The raw material of specimens used for experimental work

The welding seam used in the experimental work is illustrated in Fig. 1. The piece was made at the reactor vessel manufacturing plant at Skoda Power Plant in Plzen at the same time as the Paks reactor vessels were manufactured.

The material shown is 140 mm thick Cr-Mo-V alloy steel with ferrite structure which, after forging, is heat-treated to a state of precipitation hardening. This material state is stable in terms of durable mechanical and heat demand. The arrow-marked side is provided with titanium-stabilized chrome-nickel alloy corrosion-resistant cladding.

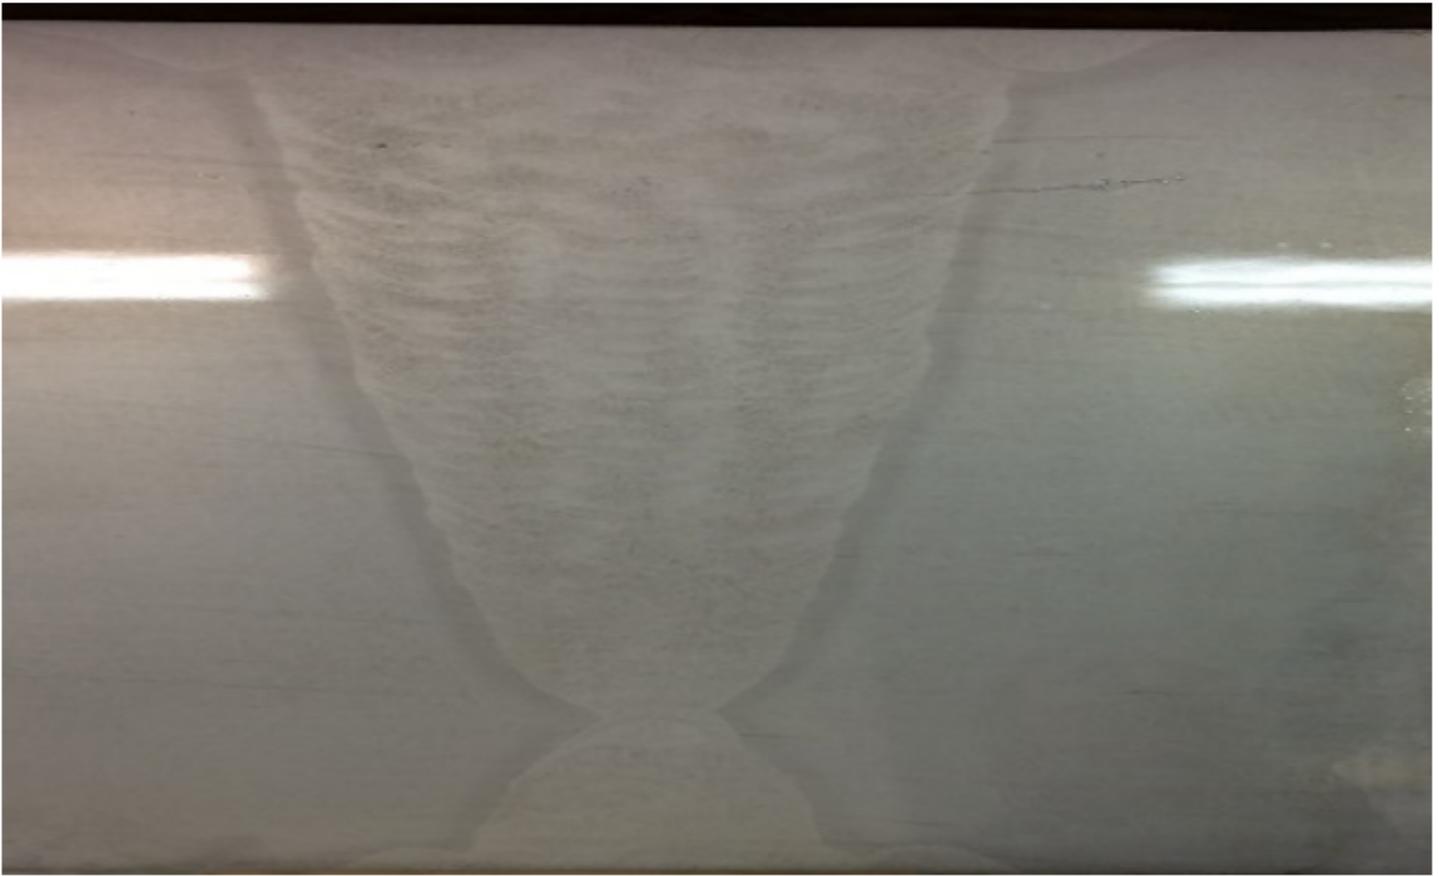
Macro-metallographic image of the welded joint

- Cutting the work-piece at the points marked with a red line in the picture taking care to mark the machining position with a pin on the surface of the work-piece.
- Planning and grinding of the surface marked with red arrow (cross section of weld seam), preparation for macro metallographic etching.
- Polishing the surface marked with a red arrow in several steps, finishing with a sanding cloth of 1200, then polishing.
- Development of polished surface fabric structure with 8% Nital etching agent. Figure 2 below shows the result of metallographic etching. The figure shows the structure of the multilayer, sealed seam, and the heat effect zone, as illustrated in the Fig. 3. Having a macro metallographic image, It can determine the exact location of the specimens to be machined.

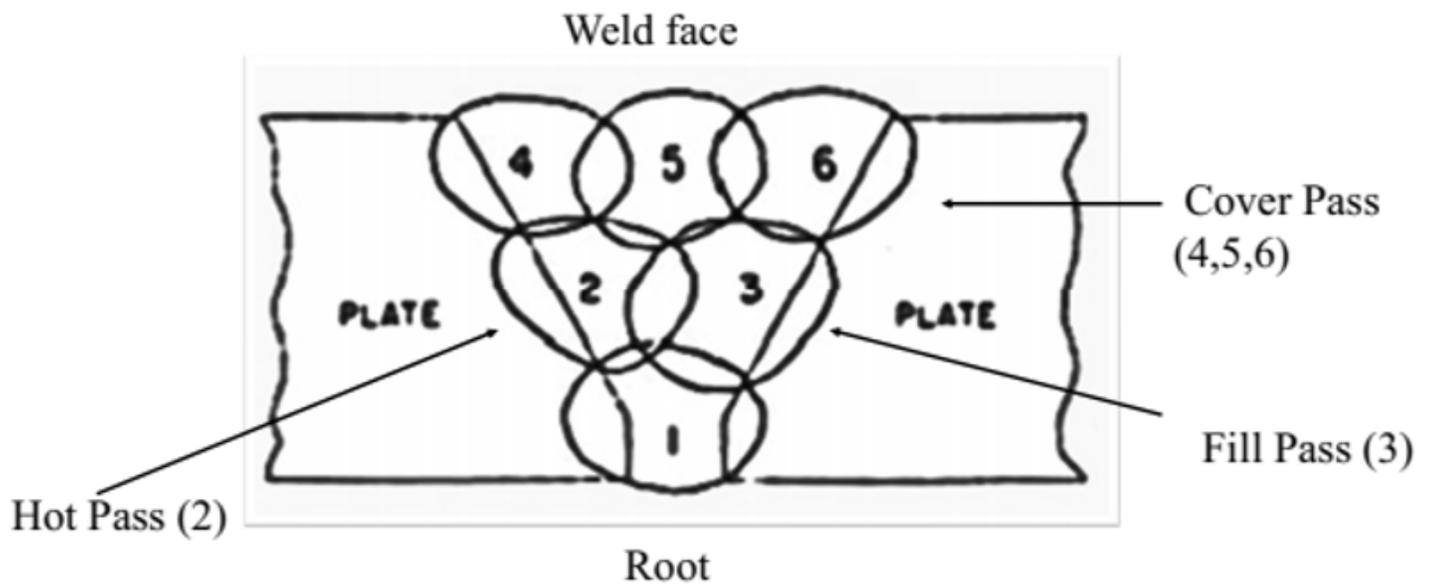
Figure 3

## The structure of a multi-row seam

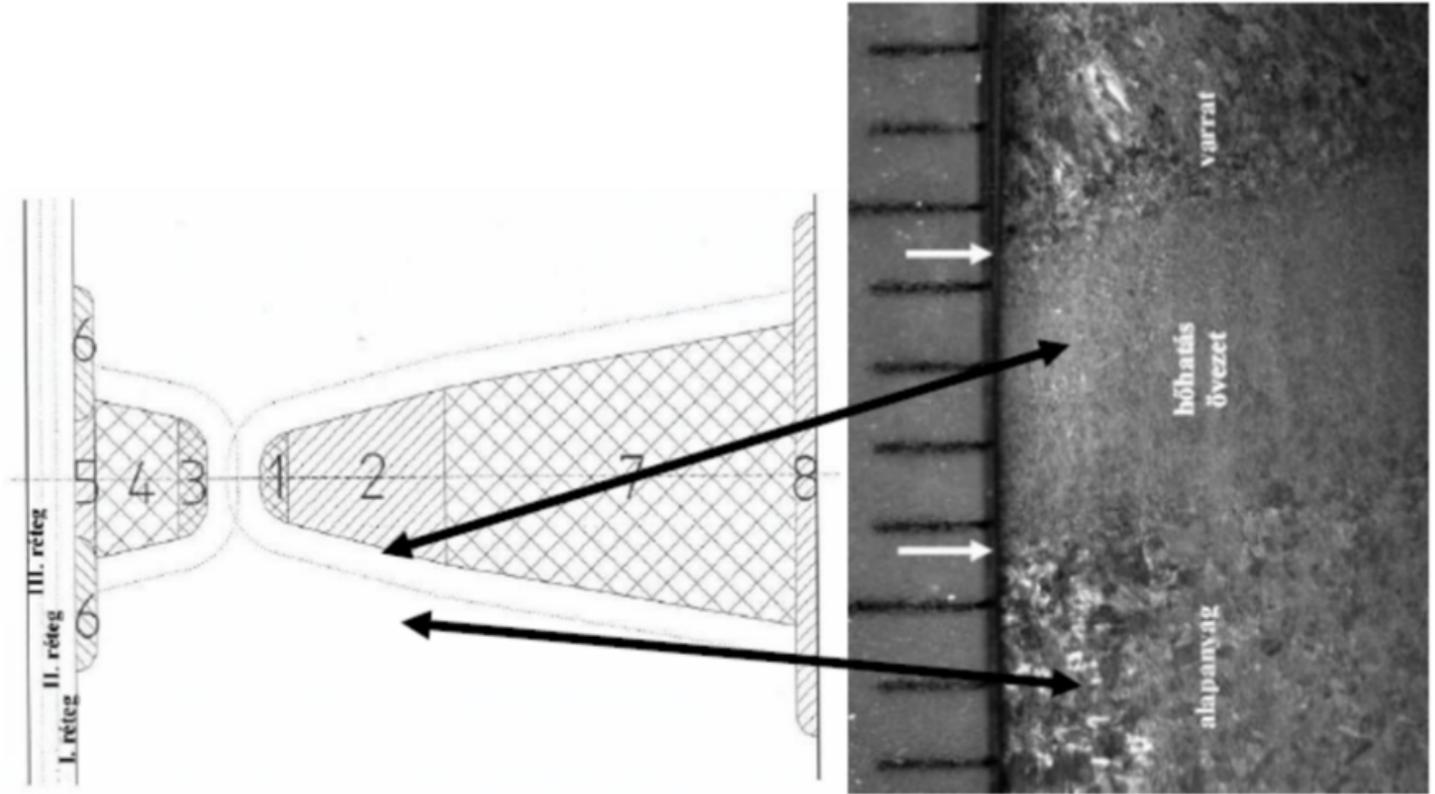
Figure 4

Schematic diagram of a welding seam of a reactor vessel

A schematic diagram of the welded joint is shown in Fig. 4

In addition to knowing the structural homogeneity of the suture, the homogeneity of the composition of the seam is essential to determine the number of specimens required for the fatigue tests. To determine the alloy content distribution along the seam, a numerical sampling at the locations indicated in Fig. 4 was performed for composition analysis. Composition testing was performed at Dunafer Zrt's Metallographic Laboratory using ICP-OES composition testing equipment. The test required 5g of chips, which were obtained by drilling with 12 to 15mm deep perpendicular borehole drill bit.

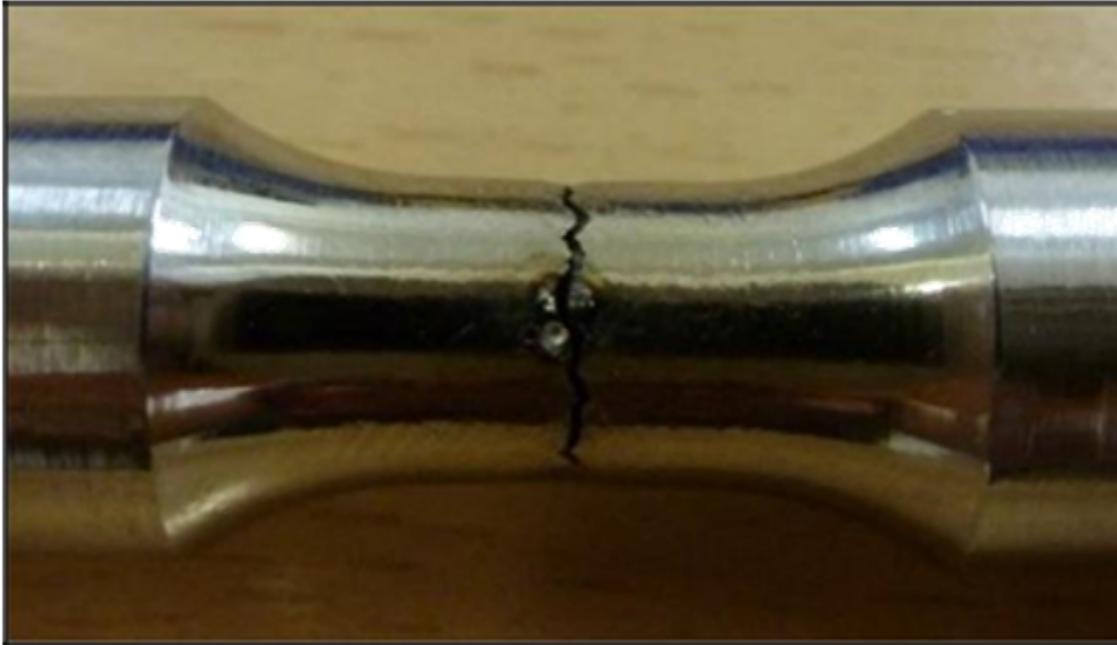
Figure 6

Test piece manufactured with 10 mm rounding after fatigue test

made further test measurements. It is clearly visible that each of the 10 mm rounded specimens had a crack in the middle third of the cylindrical section, as shown in Fig. 6

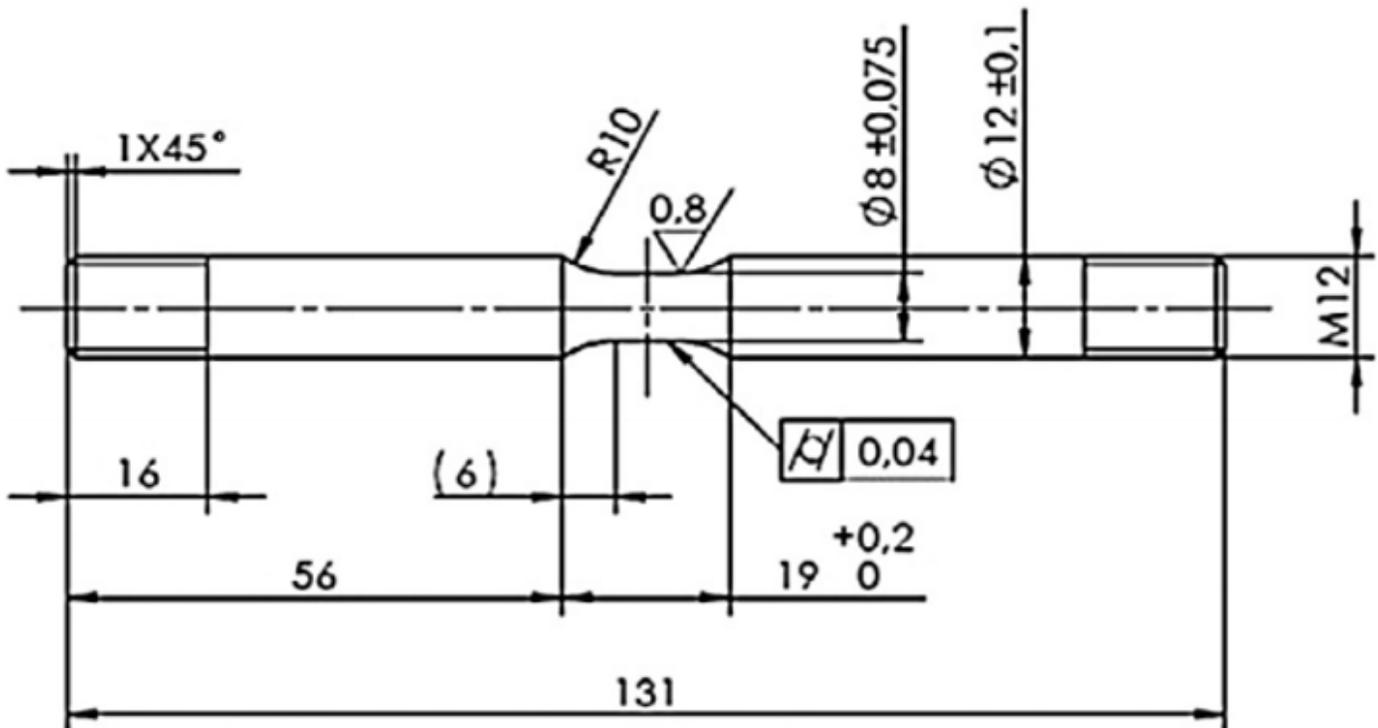
Figure 7

# Dimensions of 10mm specimen required for fatigue tests

The samples used for the experiment are made of 13 mm edge-length square column prefabricated on the CNC lathe. Before the start of the tests, all samples have been polished to the same surface grade on conventional lathes to minimize the impact of the surface irregularity from production on the wearable test results. The 2D geometry of the sample is shown in Fig. 7

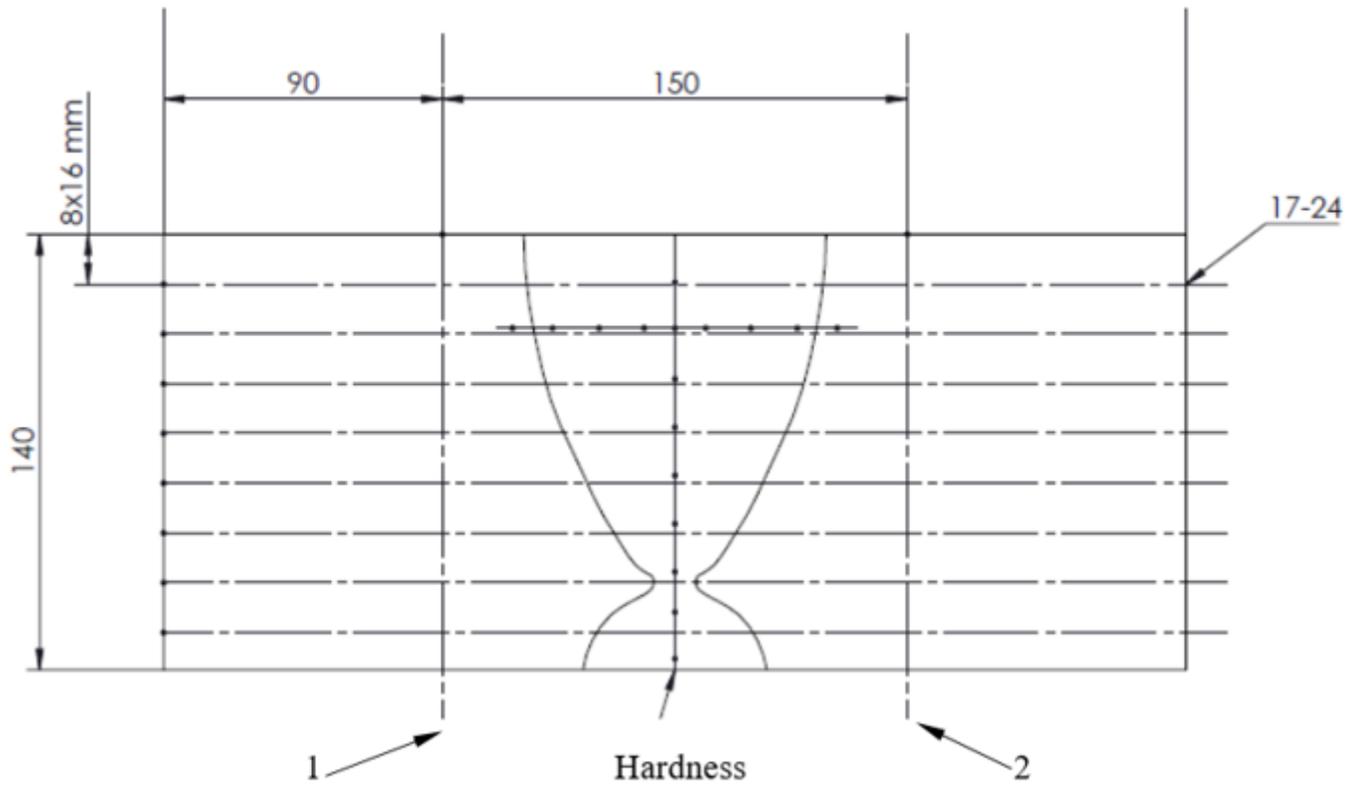
Figure 8

Cutting plan

Based on the specimen enclosure dimensions and the size of the welded block, the welding splitting plan is determined as shown in Fig. 8. Cutting of the weld block started with the knowledge of the finished cutting plan shown in the Fig. 10 below and the fabric image of the seam shown above (Fig. 9). The completed specimens are shown in Figs. 9–13.

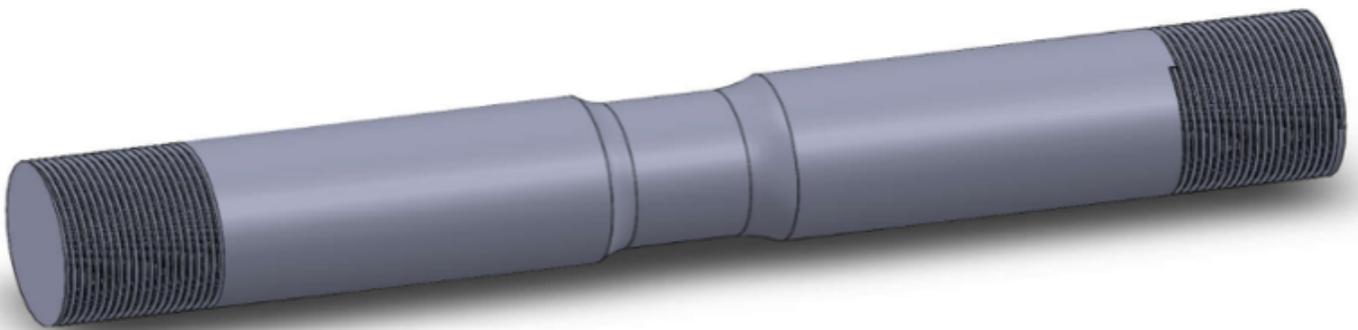
**Figure 10**

**Drawing of the test specimen**

The eighty pieces of samples were prepared by marking their exact location with an (X, Y) coordinate and for those that their position in the seam can be accurately identified and manufactured as shown in the 3D drawing of the Fig. 10 below.

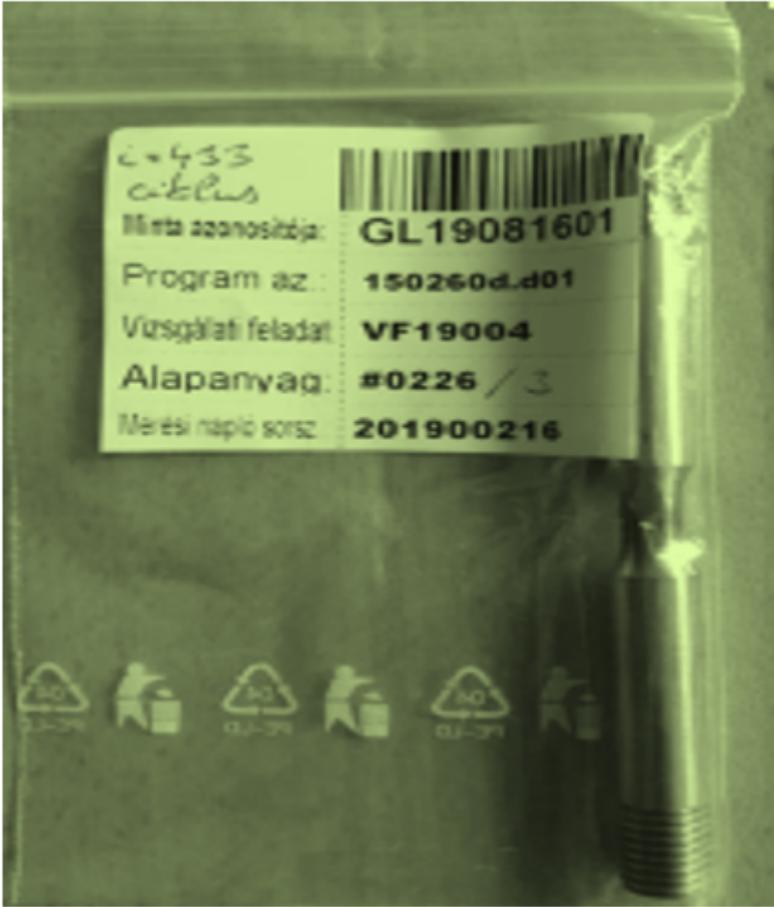
Figure 11

Specimen with a bar-code

Barcode label is given to all samples selected for fatigue test to identify them during the operation as shown below in Fig. 11.

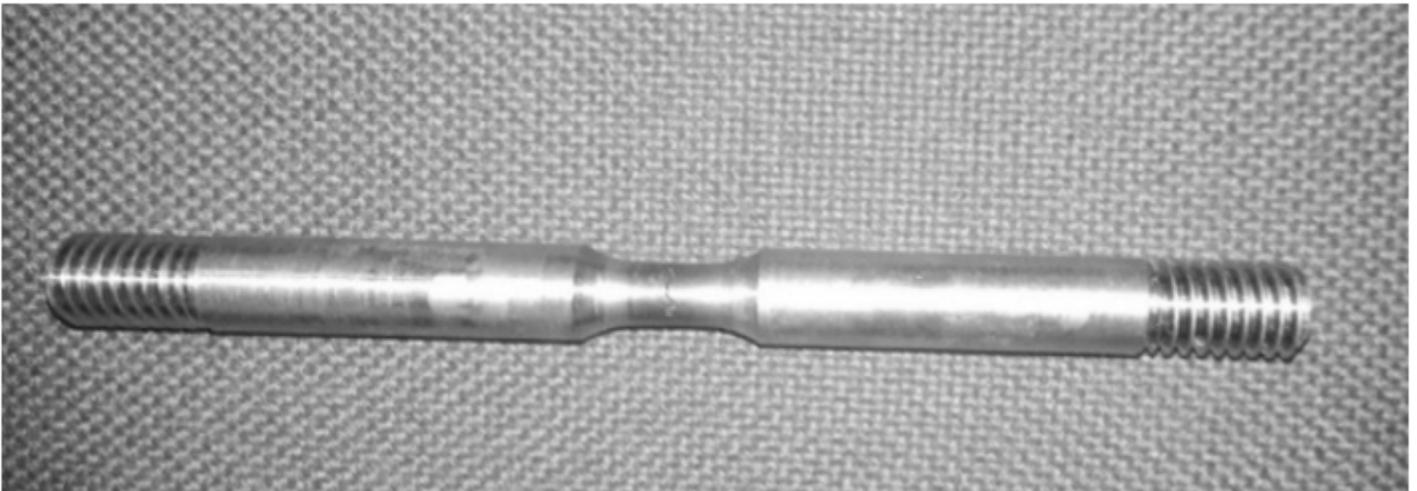
Figure 12

Turned specimen

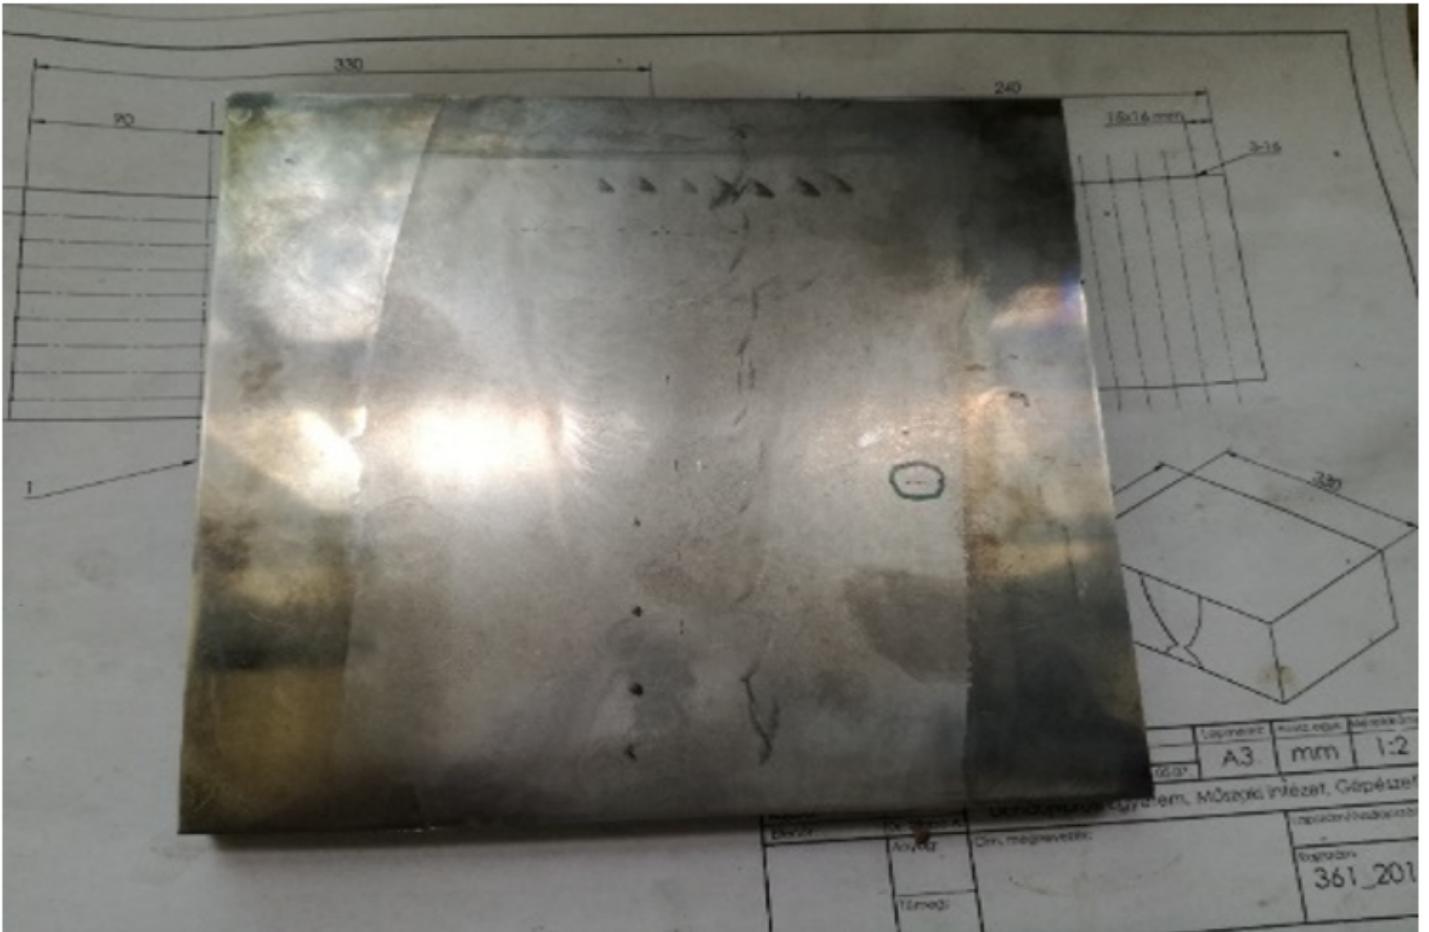
Figure 13

Machined milled seam profile

In the first phase of cutting, a section parallel to the weld cross-section was cut and subjected to repeated metallographic examination. The purpose of this is to make the weld contour and the heat effect zone visible and to facilitate hardness measurement (See Fig. 13).

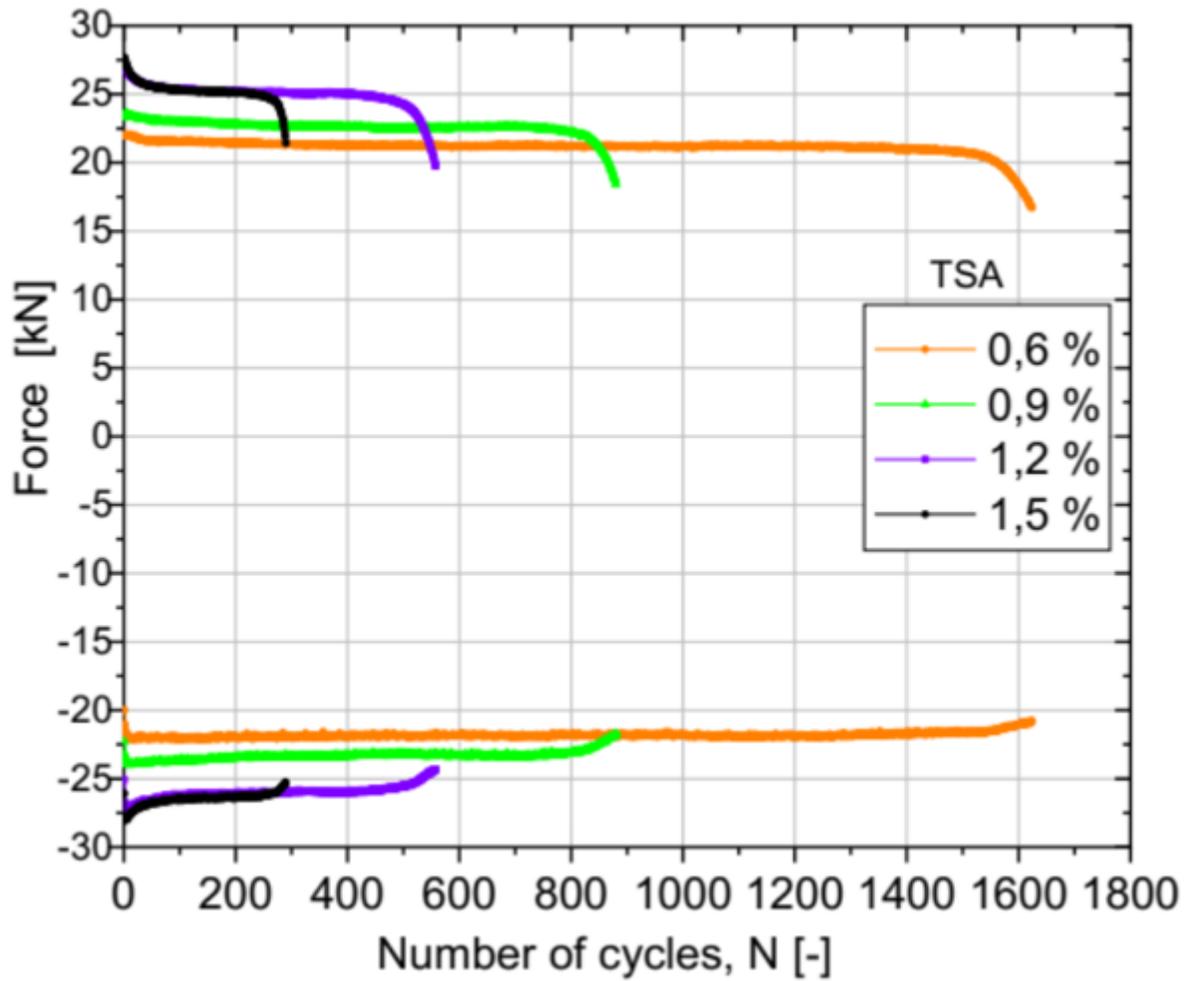
Figure 15

Extreme values of voltages recorded per cycle are 15H2MFA IZOT

determine the voltage level at which the test is performed when entering the stable phase of the fatigue test. The extreme values of the voltages as a function of cumulative damage are shown in Fig. 15.

The cyclical mechanical behaviour of 15H2MFA material is similar to that of regular center lattice steel with similar strength. During the initial phase of the tests, it showed intense cyclic softening, followed by a secondary softening phase during the stable cycles, which lasted until the appearance of a macroscopic size crack. The appearance and propagation of the crack may be related to the starting point of the definite reduction shown in the voltage diagrams in Fig. 15.

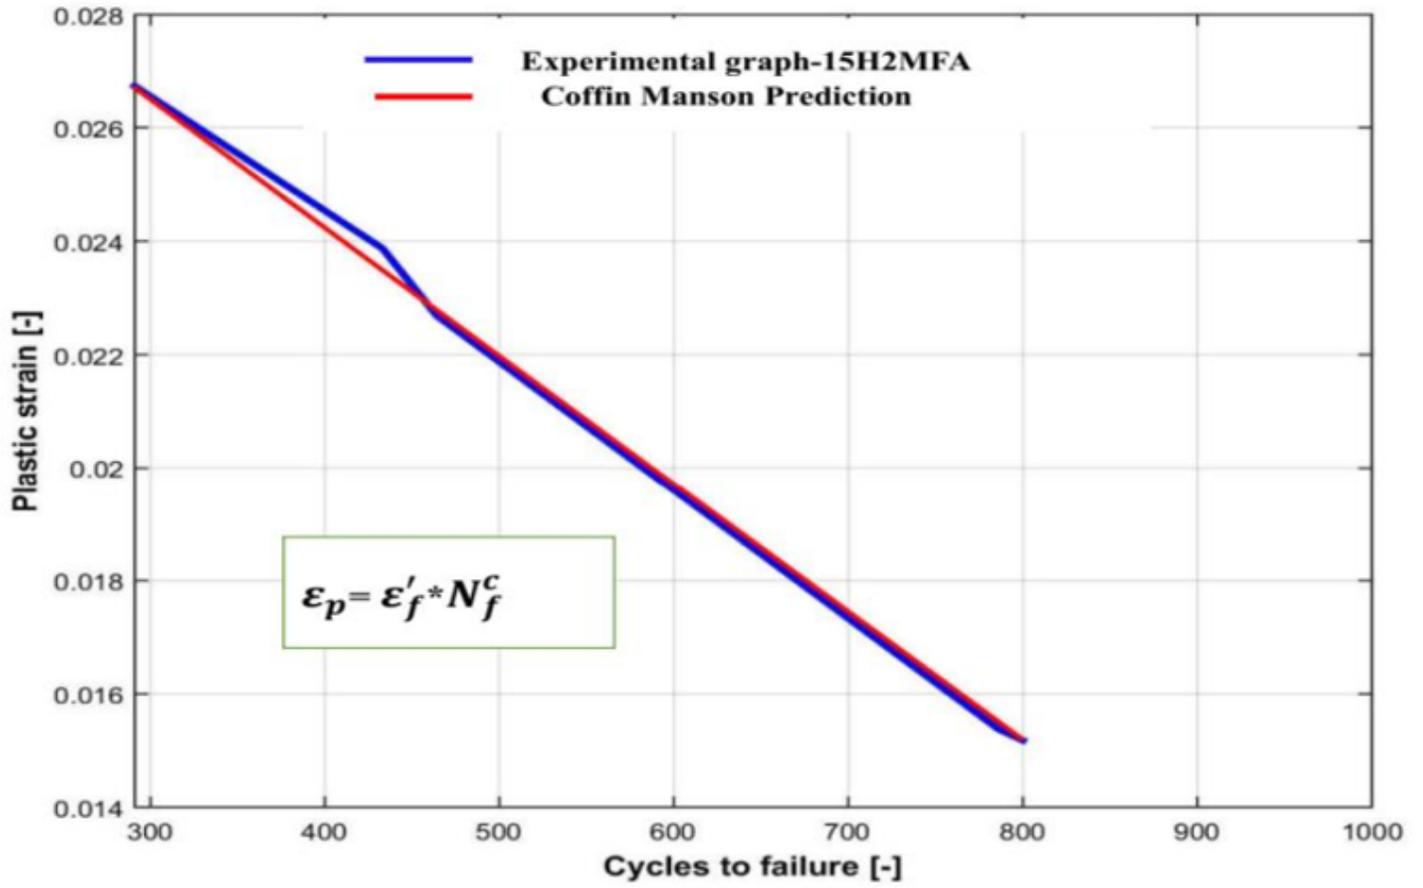
Figure 16

Coffin-Manson straight for 15H2MFA (IZOT) Seam

Here  $\epsilon_p$  plastic strain amplitude;  $\epsilon_f'$  fatigue ductility coefficient;  $N_f$  cycles to failure; and  $c$ , fatigue ductility exponent. To evaluate the experimental data using the Coffin-Manson model, the amplitude value of the plastic deformation was determined per load level, and the curves for each fatigue work order are shown by regression, as shown in Fig. 16 and Coffin-Manson model's parameters of 15H2MFA are listed in Table 3.
