Response of nonconforming RC shear walls with smooth bars under quasi-static cyclic loading

Research Article

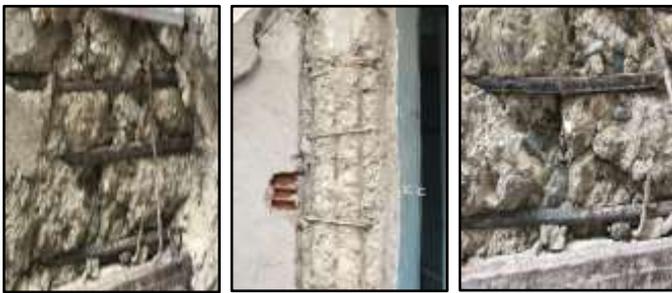
Fig. 1. Damaged RC columns in old buildings, smooth bar and low transverse reinforcement content (Caglar et al., 2021).

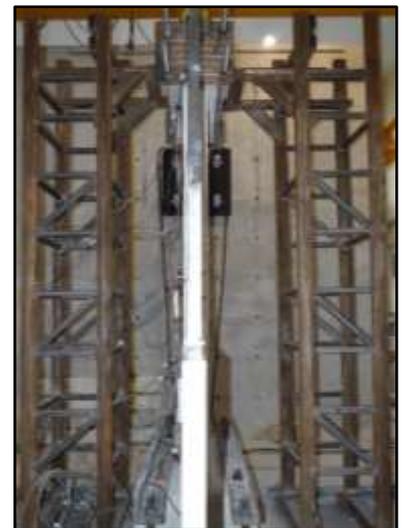
Fig. 6. Instrumentation setup used in the experiment, a) front and b) side views, c) Linear potentiometer locations, d) Out-of-plane support system and rolling wheels. Dimensions in (mm).

The concrete of every tested shear wall was poured in one stage, including the base and the loading beam, while the specimen was laid horizontally to ensure a correct placement of the concrete. And after curing for at least 28 days the shear walls were placed into upright position till the day of the experiment. In the test setup used in this study, only lateral load was applied and the axial force was assumed to be equal to zero. Generally, the normalized axial load values ($N/(A_g f_{co})$) in shear walls are small and less than 10 percent, especially in old buildings with few stories. Also, the axial load has a minimal effect on the behavior of flexure-controlled shear walls (Christidis & Trezos, 2017; Shegay et al., 2018). Therefore, axial loads were not considered within the scope of the current experimental study to eliminate any effect on the observation of bar slip behavior expected in the test specimens. At the beginning of the test, the specimens were mounted to the rigid floor as seen in Fig. 6, and a cyclic lateral load was applied using a 500 kN capacity servo-controlled actuator connected to the reaction wall.

The responses of the tested shear walls under quasi-static cyclic loads were monitored using an array of linear potentiometer on the surface, and strain gauges fixed on the steel bars before casting the walls. A total of 18 linear potentiometer displacement transducers (LPDT) were used in the experimental setup to measure the global and local deformations. Three of them were used to measure the global lateral displacement of the tested specimen on three different levels, as seen in Fig. 6a. Four LPDTs placed in diagonal X shaped configuration over two levels were used to measure the shear displacements in the tested walls. Moreover, the flexure displacement was measured with the help of six potentiometers placed vertically along the height of the wall. Two more devices were placed on both sides of the wall and fixed at 300 mm height from the surface of the base, to measure the rotation of the wall at base level, mostly due to reinforcement bar slippage. Three other spring-return linear potentiometers were used to control the potential horizontal sliding and rotation of the concrete foundation of the wall.

In order to prevent any out-of-plane displacements that could affect the test results, a newly fabricated steel braced frame system was installed on both sides of the tested wall. Furthermore, the upper loading beam was supported through roller wheels contacting the surface of the beam to ensure the continuity of the lateral movement at the support point. Fig. 6d shows the out-of-plane support system and the rolling support wheels.

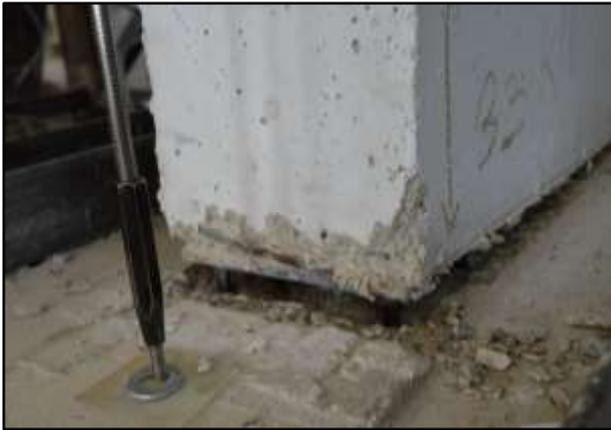
Fig. 12. Crack at base level in specimen NCSW2.

Crack patterns of all the NCSW specimens at the end of the experiment are shown in Fig. 11. Also, Fig. 12 shows an example of the big crack that formed at the base level in all the nonconforming shear walls. As seen from the figures, very few cracks have occurred during the experiment (3 to 4 for the shear walls with CBZS, and only one for the specimens with distributed reinforcement). All the cracks started before the observation of the big crack at the base surface, and none have been seen after that point. Additionally, the response of the NCSW specimens showed a big drop in lateral capacity after the creation and propagation of the crack at base level, and the behavior in the following cycles was controlled by rigid body rotation. It was obvious that the reinforcement bar-concrete adherence was lost due to the use of smooth steel and significant bar slip was observed. Furthermore, few of the longitudinal reinforcement (most-outer bars) reached their yield point, and none of the bars inside the base yielded, which indicated the fundamental loss of adherence. Fig. 13c and d presents the variations of the strain in the reinforcement during the experiment for the nonconforming specimens NCSW1 and NCSW2. Since the behavior was dominated by bar slip, concrete crushing or cover spalling was not observed in the compression zone, and the lateral shear reinforcement variations exhibited a negligible contribution to the total response of the shear walls built with smooth bars. Moreover, after the significant drop in strength of the NCSW specimens, two more drift levels were applied till the lateral capacity was settled at a residual lateral force about 22.0, 16.7, 20.1, and 23.8 kN for the specimens NCSW1, NCSW2, NCSW4, and NCSW5, respectively, and the experiment was ended there.
