Failure mechanism and treatment measures of supporting structures at portal for a shallow buried and asymmetrically loaded tunnel with small clear-distance

Research Article

Keywords: Tunnel engineering, Shallow buried and asymmetrically loaded, Small clear-distance, Failure mechanism, Treatment measures.

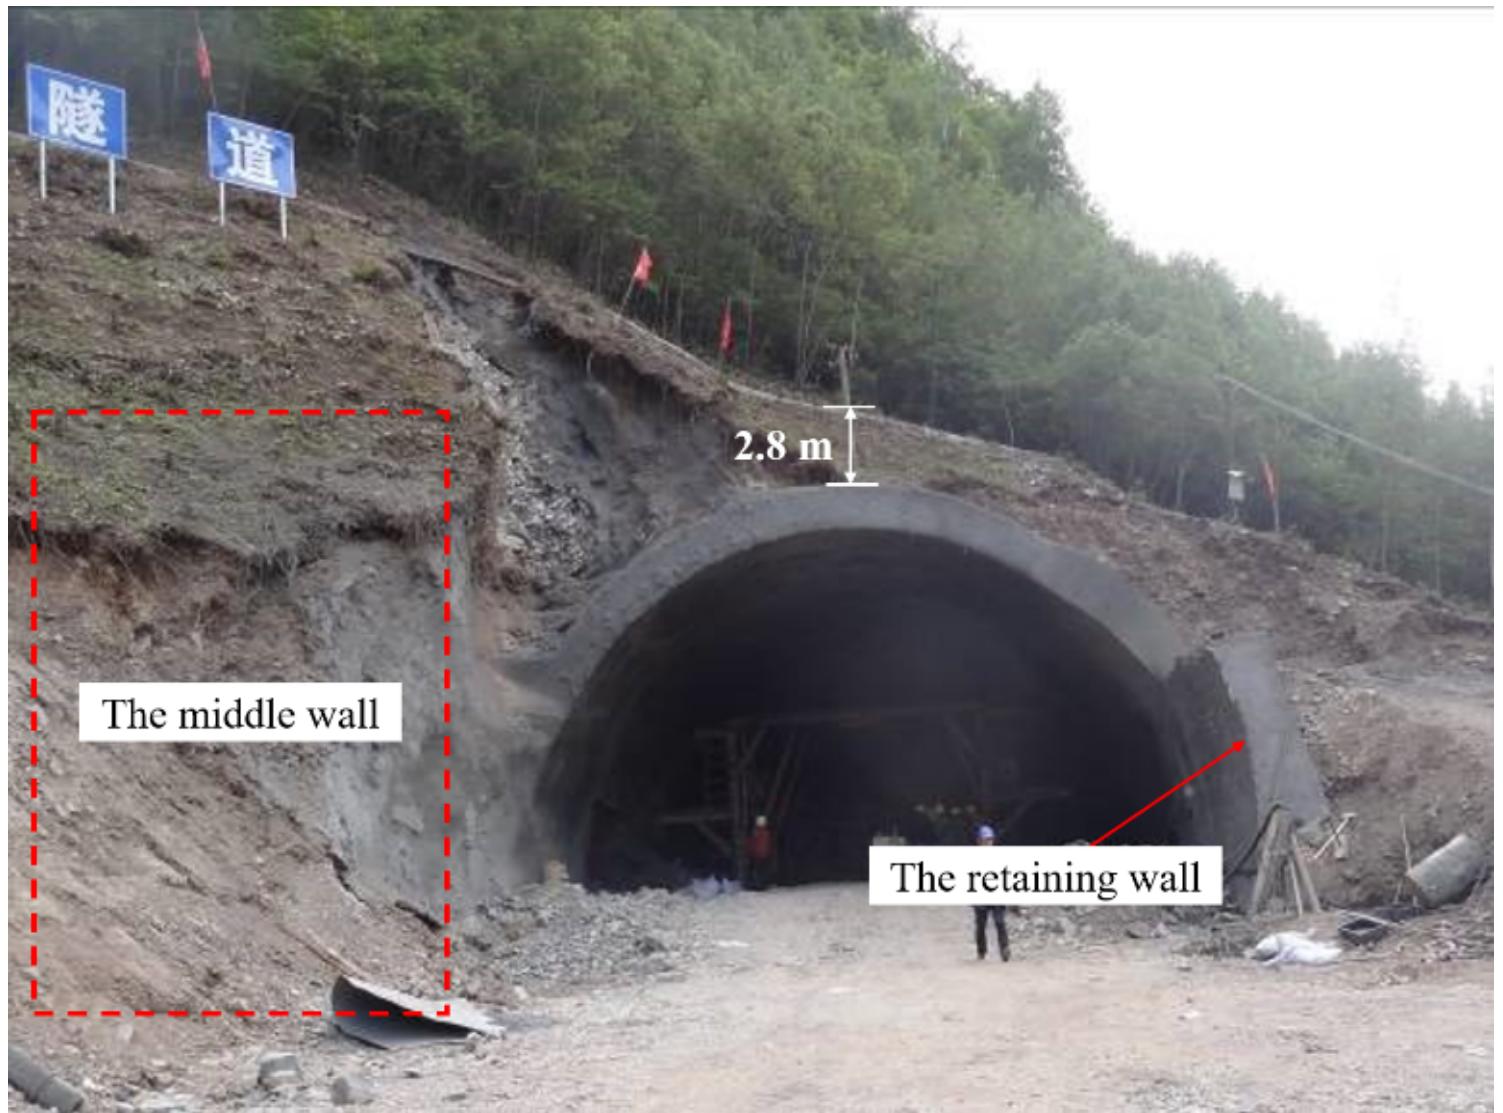
Figure 3

The shallow buried and asymmetrically loaded situation at the right tunnel portal

The tunnel portal is located in the gravel soil layer. The overburden thickness of right tunnel portal is less than 3.0 m and the slope gradient exceeds 30°, which belongs to a typical shallow buried and asymmetrically loaded tunnel portal, as shown in Fig. 3. According to the results of field drilling exploration and laboratory rock mechanics tests, the surrounding rock grade from the portal section to YK/ZK39 + 930 is classified as grade Ⅲ.

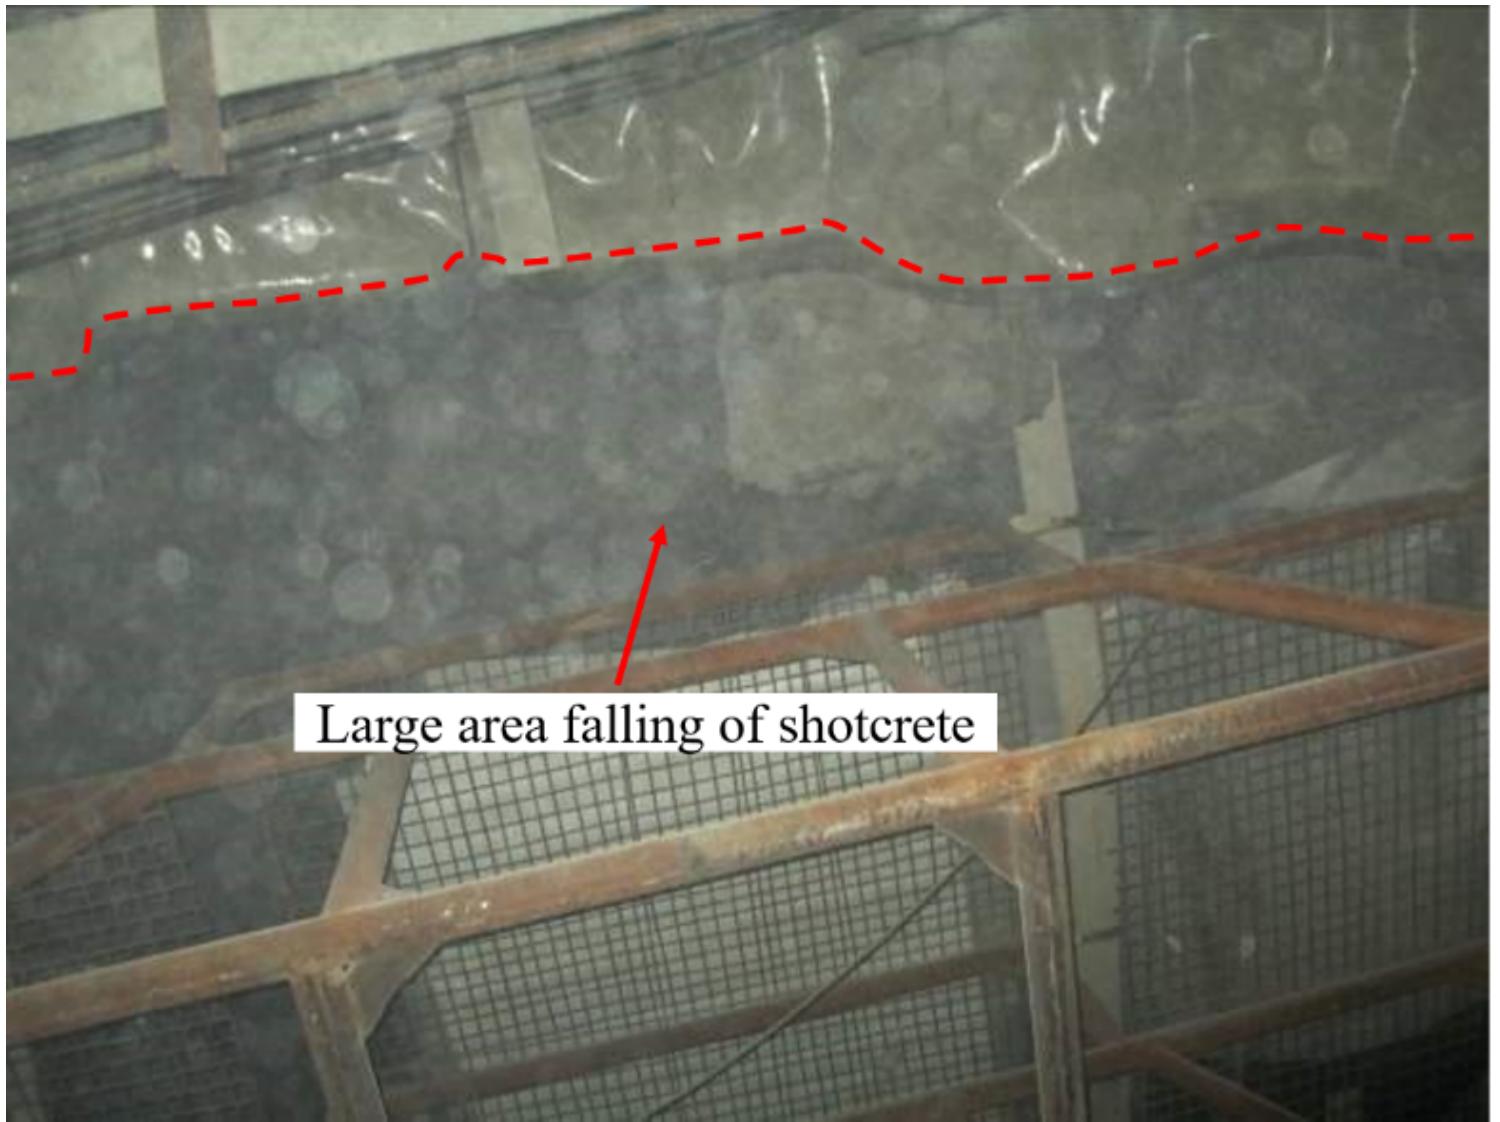
Figure 6

Block falling of the primary support concrete at the right tunnel

The primary support concrete cracks first appeared at right tunnel portal, and mainly concentrated on the left arch shoulder and waist. When the right tunnel was excavated to YK39 + 902-YK39 + 910, more serious cracks appeared in the primary support concrete, which were mainly distributed at the vault, arch shoulder and arch waist. There was even a large area of concrete falling off at right side of the vault at YK39 + 902, as shown in Fig. 6. Meanwhile, a large number of small cracks with a width of 0.3 ~ 5 mm appeared in the primary support concrete of ZK39 + 870-ZK39 + 890 in the left tunnel, of which the circumferential cracks were the majority.

Figure 13–14 presented the tensile stress and shear stress of primary support concrete at two typical sections, respectively. From Fig. 13 (a) and Fig. 14 (a), affected by the loose rock load on the deep buried side, the maximum tensile stress and shear stress at YK39 + 871 appeared between left arch shoulder and waist under case ④, that is, the position with the maximum deformation of tunnel. After the left tunnel was excavated, the maximum tensile stress increased from 1.703 MPa to 1.952 MPa (Fig. 13c), which was very close to the ultimate tensile strength of C25 concrete (JTG 3370.1–2018). The maximum shear stress also increased from 1.501 MPa to 2.328 MPa (Fig. 14c). The concrete at arch shoulder and waist was prone to cracked due to obvious tensile stress and shear stress. As the excavation progresses, the thickness of overlying soil increased, and the position subjected to the maximum tensile stress and shear stress on the primary support concrete shifted to right shoulder (Fig. 13b and 14b), that is, the position with the maximum deformation of tunnel at YK39 + 902. After the left tunnel excavation, the maximum tensile stress and shear stress increased from 1.387 MPa and 1.042 MPa to 1.826 MPa and 1.728 MPa, respectively (Fig. 13c and 14c). And then the maximum tensile stress and shear stress increased rapidly to 2.555 MPa and 2.881 MPa when the surrounding rock was immersed and deteriorated. Under such significant tensile stress and shear stress, the primary support concrete was easily cracked, peeled and even collapsed. The stress concentration position was also consistent with the position of cracking and falling blocks of the primary support concrete in actual project (Fig. 6).

For the large area falling of primary support concrete at YK39 + 902-YK39 + 910, the construction spacing of steel arches was shortened from 75 cm to 50 cm. And the length of small grouting pipes was increased from 3.0 m to 5.0 m. For the invert cracks at portal, the concrete within 75 cm on both sides of the cracks were removed to the depth of invert bottom, and then grouted with cement slurry. Then, the C25 concrete was used to fill to the top surface of the backfill layer.

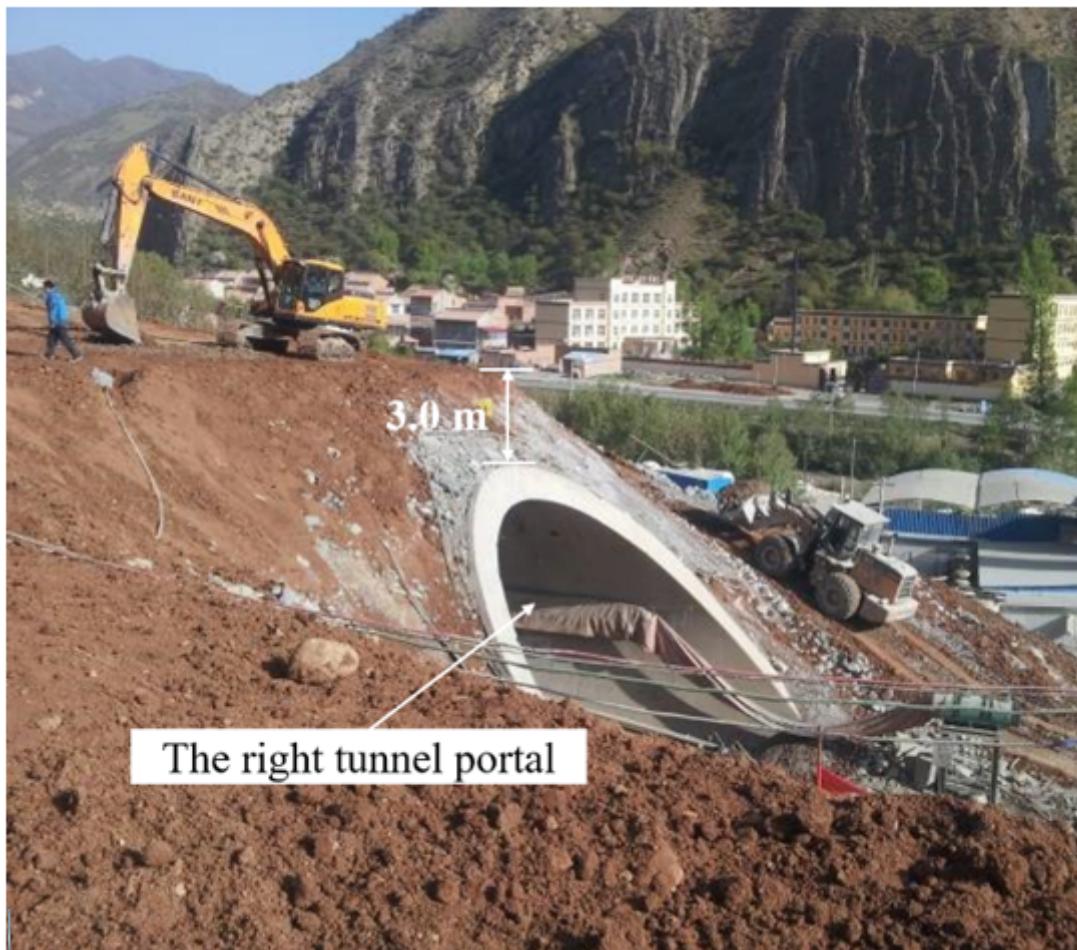
Figure 17

The shallow buried side was backfilled and compacted

First, during the tunnel portal excavation, the shallow buried side of right tunnel was backfilled and compacted in time (Fig. 17). The backfilling height was 3.0 m higher than tunnel vault, and the backfilling slope rate was 1:1.5, and compactness was more than 90%. And then the slope rubble was adopted for slope protection.

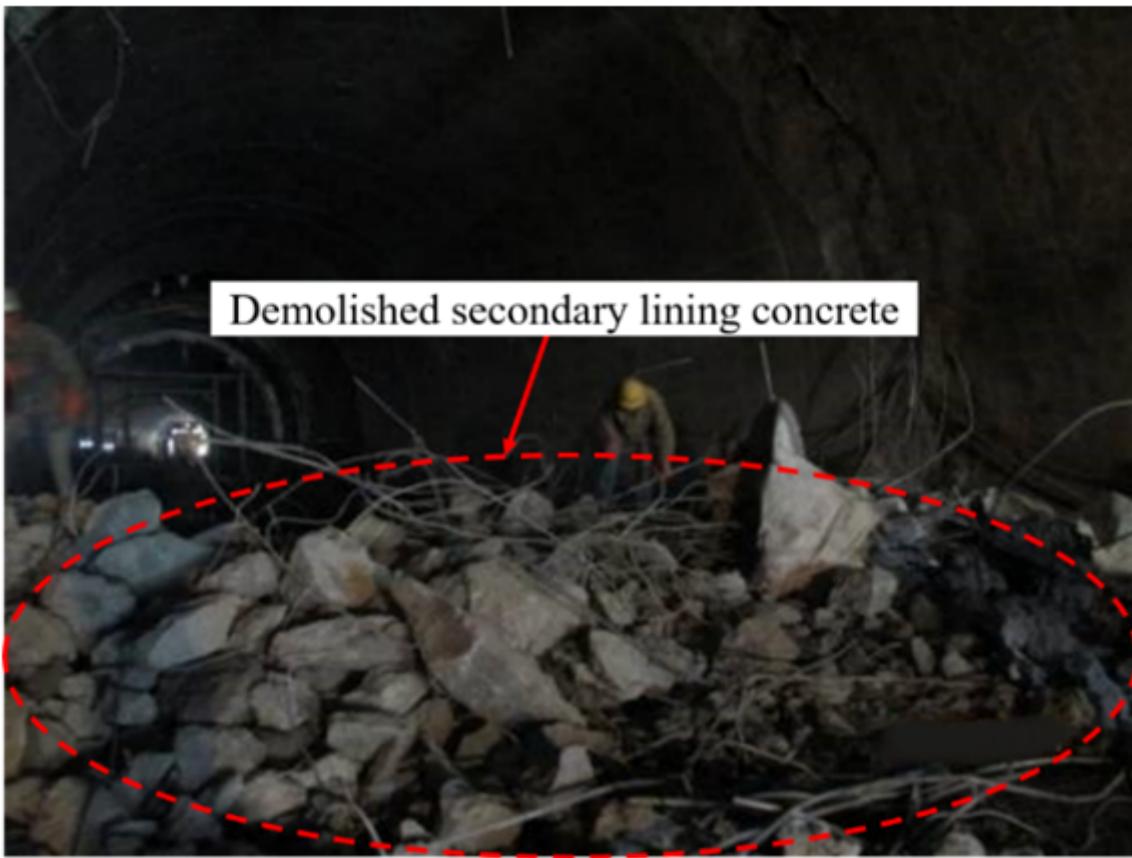
Figure 19

Demolition and reconstruction of the severely cracked secondary lining concrete

According to the cracking degree of secondary lining, different treatment measures were adopted to repair it: ① For cracks with a depth of less than 5 cm, the low-pressure rapid grouting method was used to fill the cracks. That is, a U-shaped groove with a width of 2 cm and a depth of 1 cm was cut out at crack, and then wiped the groove surface with acetone and filled the groove with epoxy resin mortar, and finally painted the crack surface with epoxy resin slurry. ② For cracks with a depth of more than 5 cm but less than 15 cm, grooves with a width of 50 cm were cut out on the both sides of cracks with same depth as the crack depth, and then C30 concrete was used for backfilling and pouring. ③ For the cracks with a depth of more than 15 cm, the secondary lining at cracked section was demolished and reconstructed (Fig. 19), and adjusted the $\varphi 22$ circumferential steel bars to $\varphi 28$ in lining.
