Effects of ecological roofs in water quality: an experimental study over a humid tropical climate

Research Article

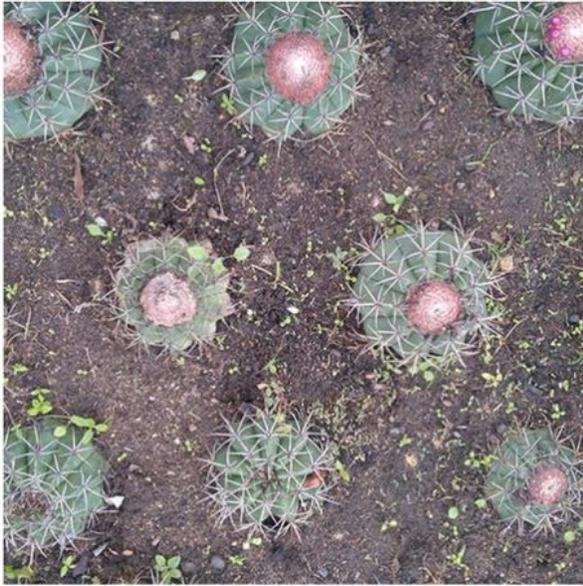
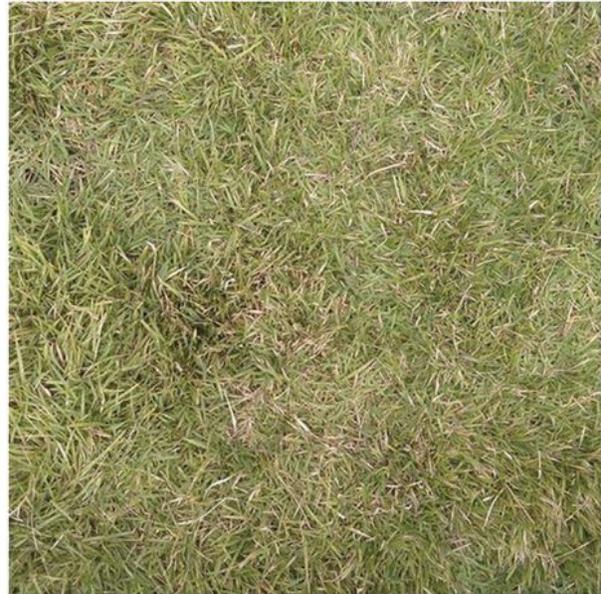
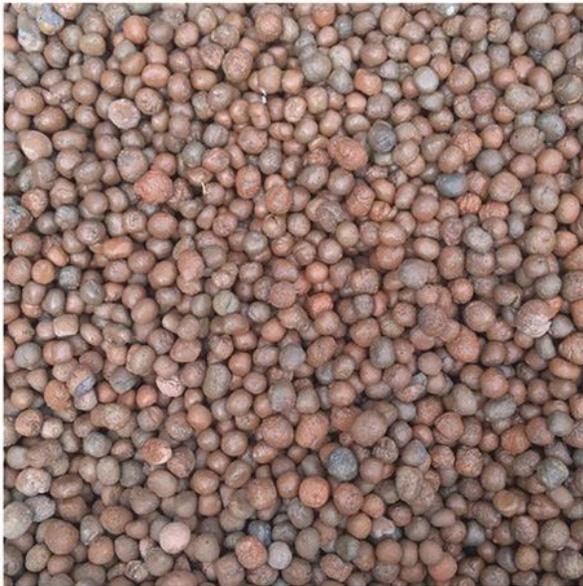
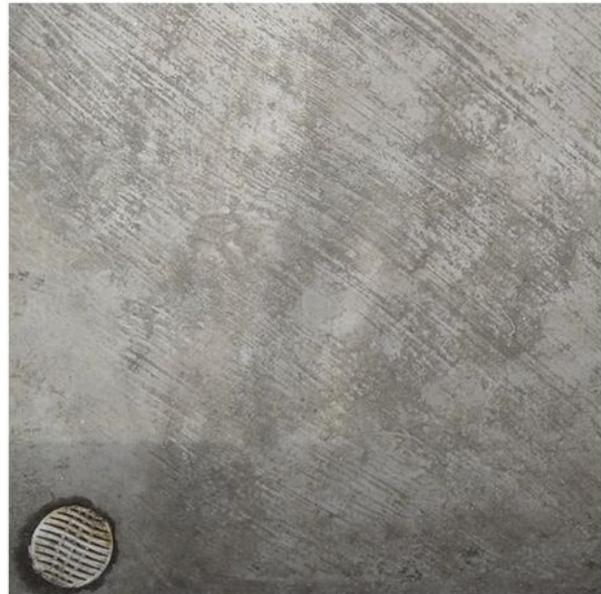
Figure 1

(a) Cactus “Coroa-de-Frade”

(b) Grass “Grama Esmeralda”

(c) Expanded Clay Aggregate

(d) Waterproofed slab

Roof types assessed in the experiment.

Four experimental units of ecological roofs were built in the Federal University of Pernambuco (8.0549° S e 34.9527° W). All experimental units were built with dimensions of 1.30 m x 1.30 m (useful area of 1m²) at a height of 2.75 m above soil. Roofs were properly waterproofed following Brazilian Technical Standards test for infiltration in buildings (ABNT 2013). Three ecological roofs were settled: one green roof covered with substrate and a cactus locally called "Coroa-de-Frade" (*Melocactus zehntneri*), which survives in poor nutrient, water scarcity and high temperature conditions (Fig. 1a); one green roof covered with substrate and a grass vegetation locally called "Grama Esmeralda" (*Zoysia japonica*), which has more ramified roots and covers the whole soil (Fig. 1b); one brown roof only covered with expanded clay aggregate (Fig. 1c). The remaining of four roofs is a control roof (Fig. 1d) to compare results from the three ecological roofs. All roofs except the control roof have a drainage bed followed by a 10 cm sand layer to favor water percolation.
