Slope Mass Rating-based Analysis to Assess Rockfall Hazard on Yogyakarta Southern Mountain, Indonesia

Research

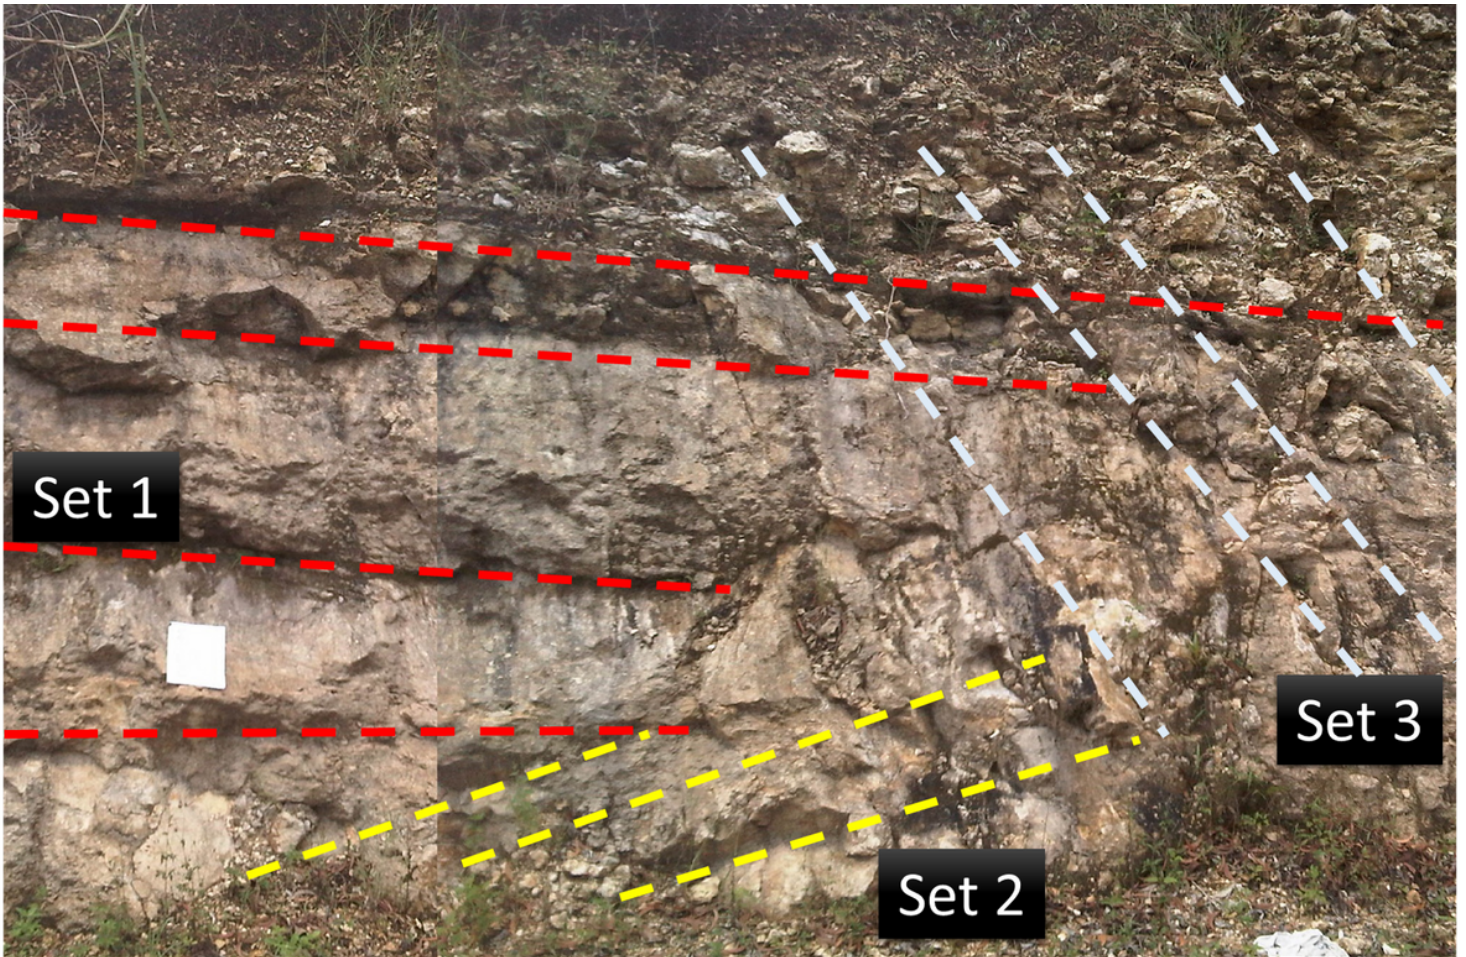
Figure 2

Three sets of joints were measured in indirect RQD observations (without borehole). The picture was taken at Station 4 ($110^{\circ}20'53.25''\text{E}$, $8^{\circ}0'15.08''\text{S}$) with an A4 paper as a scale.

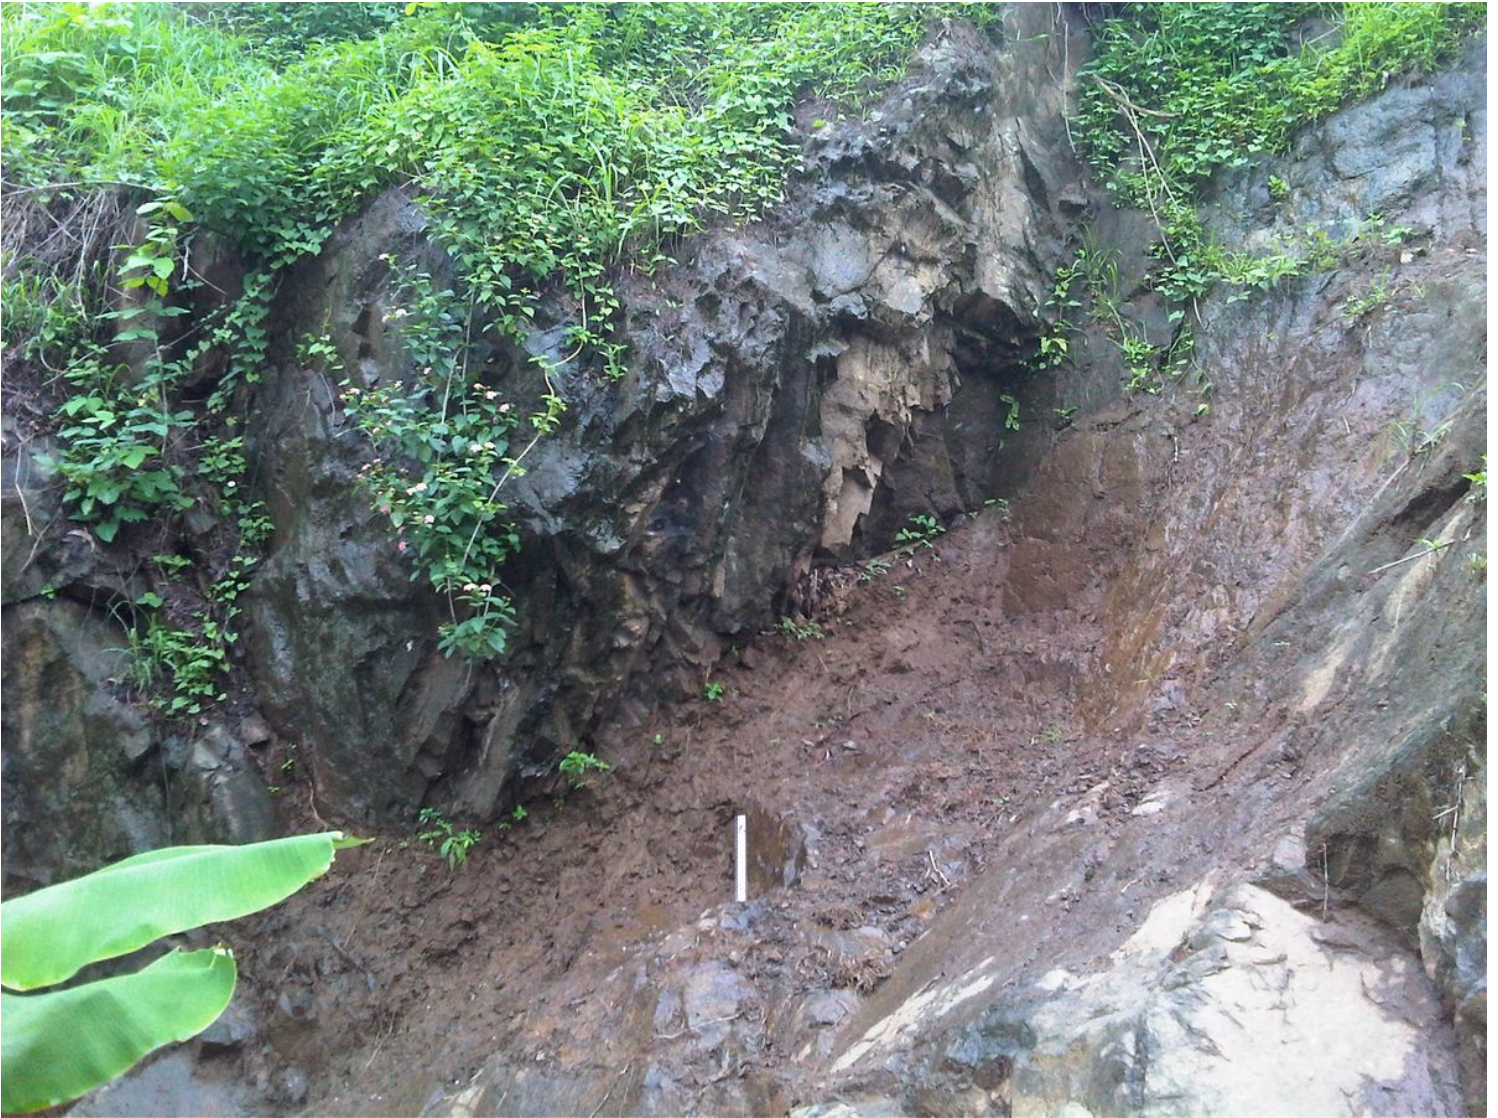
Figure 5

The condition of groundwater flowed through joints to the surface of andesite rocks. The groundwater flows consistently and weathers the underneath rock surfaces. The photo was taken at Station 1 with a 30 cm ruler as a scale.

The groundwater conditions were observed based on general conditions found on rock surfaces of outcrops/slopes and categorized as dry, moist, wet, dripping, and flowing (Bieniawski, 1989). The groundwater conditions in the study area were dominated by humid and dry on rock surfaces, but there was 1 (one) exception station with a significantly different state. Station 1, which is composed of andesite unit, has a flowing groundwater condition (Figure 5). Meanwhile, the other slopes composed of crystalline, fragmental, and reefal limestone have between dry and moist groundwater conditions. Table 14 shows the groundwater conditions in the study area.

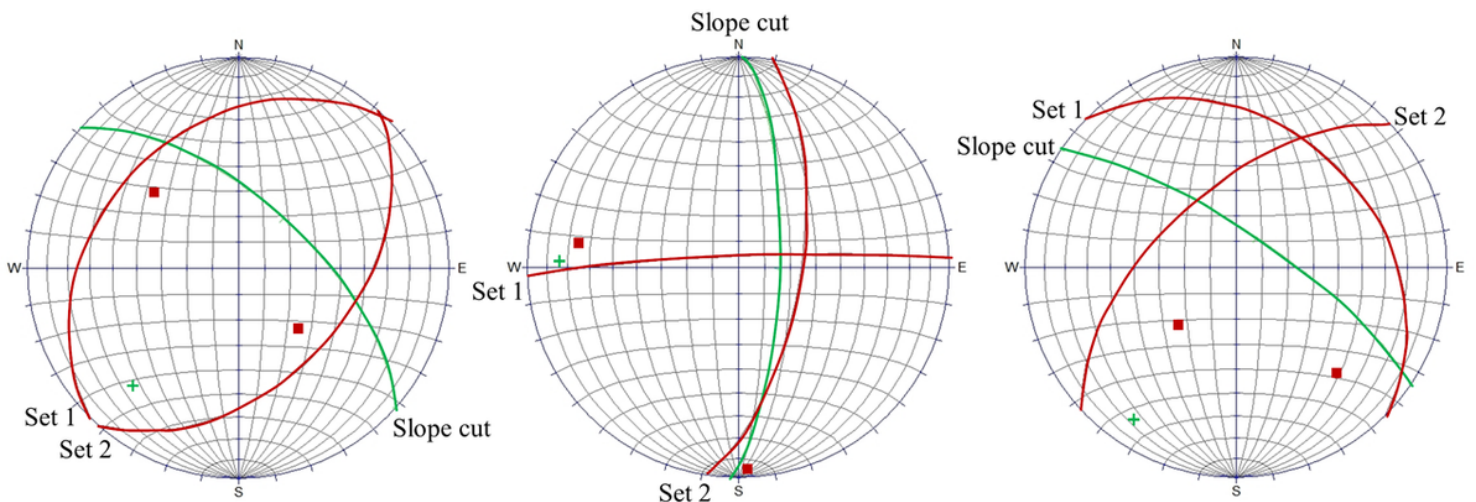
Figure 6

The stereographic projections of (a) Station 7; (b) Station 13; and (c) Station 14. Set 1 and set 2 of the projected discontinuous planes in Station 7 show wedge failure type in both sets. In Station 13, set 1 shows toppling failure while set 2 shows planar failure type. Lastly, the types of planar and wedge failure were shown in set 1 and set 2, respectively, in Station 14.

In this study, the stereographic projection was also carried out to determine the rockfall types that could or had occurred in the discontinuous planes on a slope, i.e., planar failure, wedge failure, and toppling failure, as mentioned in the Slope Mass Rating (SMR) analysis by Romana (1993). Furthermore, this stereographic projection analysis was also conducted to find out whether a rock volume from a slope could fall naturally due to the condition of the discontinuous planes or not. If the parallelism of the discontinuous plane orientation and the slope face orientation (resulted from the cutting hills) was known to be in a stable condition, then without any disturbance from natural phenomena or human disturbances, the rockfall could not happen by itself and vice versa.

More information obtained from the stereographic projection of the 17 stations was that the rockfall type of wedge failure has more potential and occurred more frequently than the planar failure and toppling failure types. It was resulted due to a large number of discontinuous plane sets, which have many variations of orientation and causing intersections between discontinuous planes. Some examples of stereographic projections from 3 (three) stations were shown in Figure 6. The detail of slopes and discontinuous planes orientation (strike and dip), and also the failure type of each station were shown in Table 15.

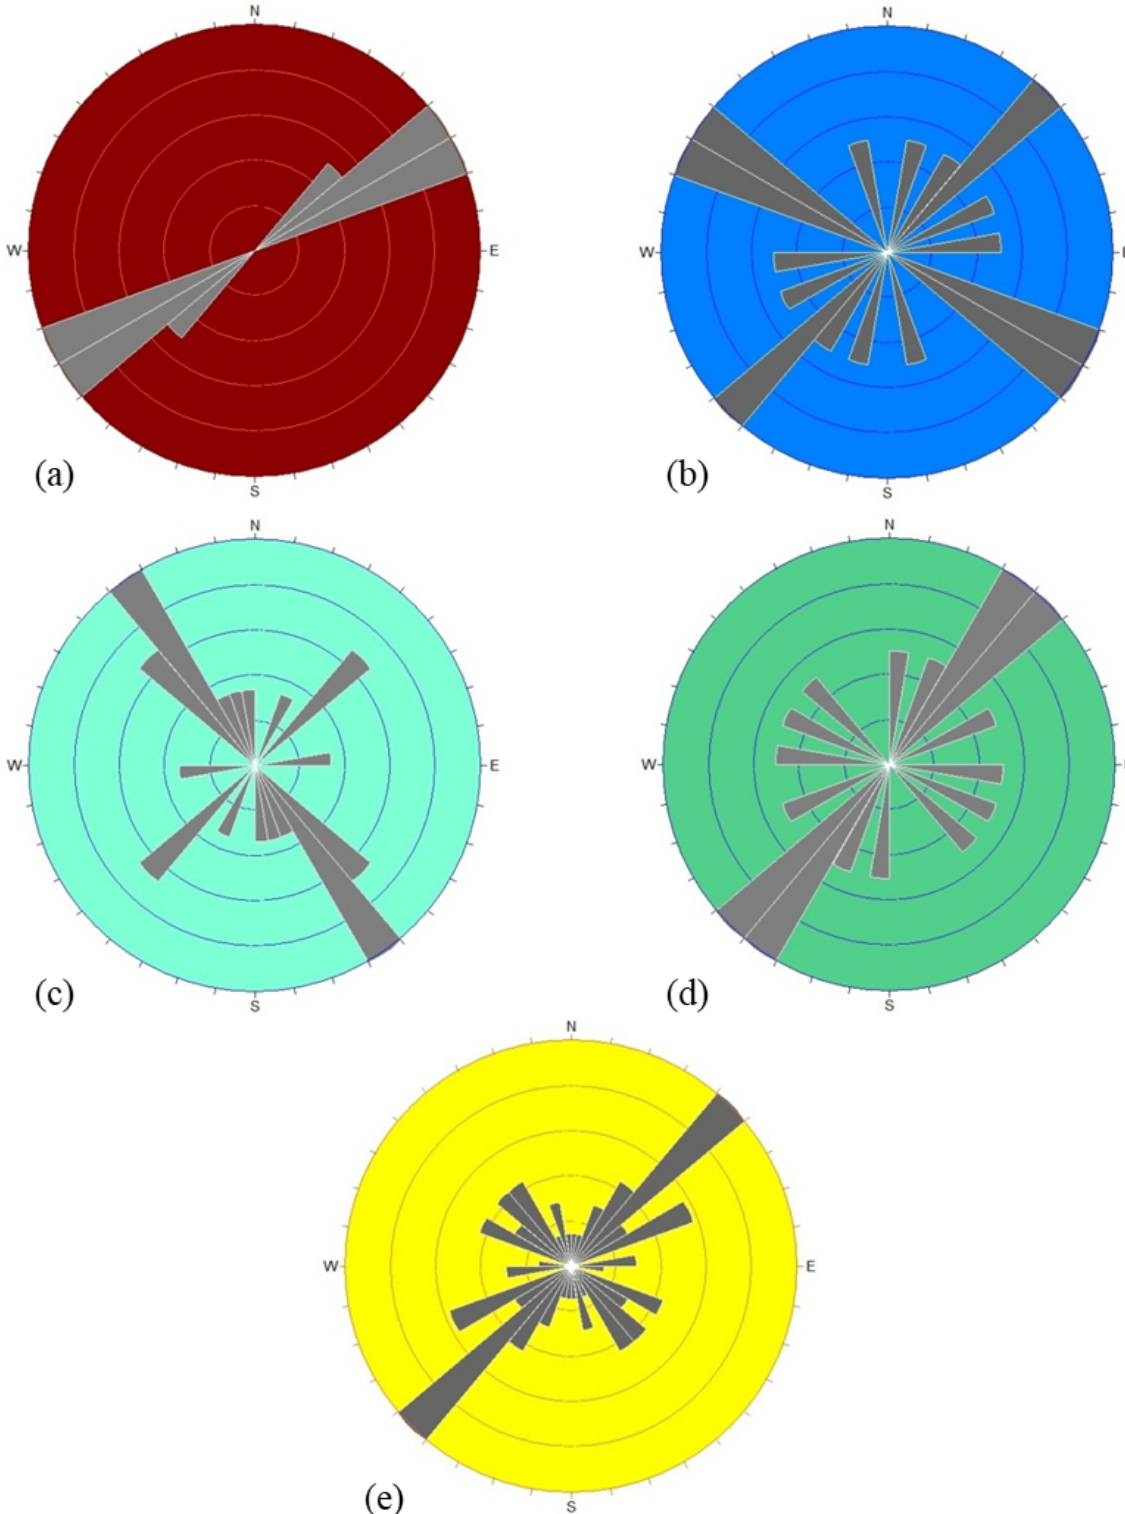
Figure 7

Rose Diagrams of (a) Andesite unit; (b) Crystalline limestone unit; (c) Fragmental limestone unit; (d) Reefal limestone unit; and (e) all units.

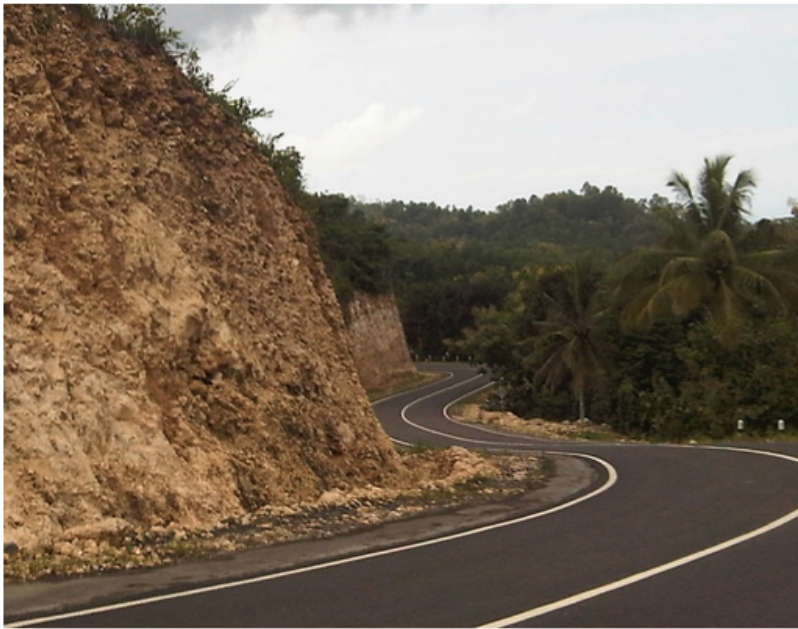
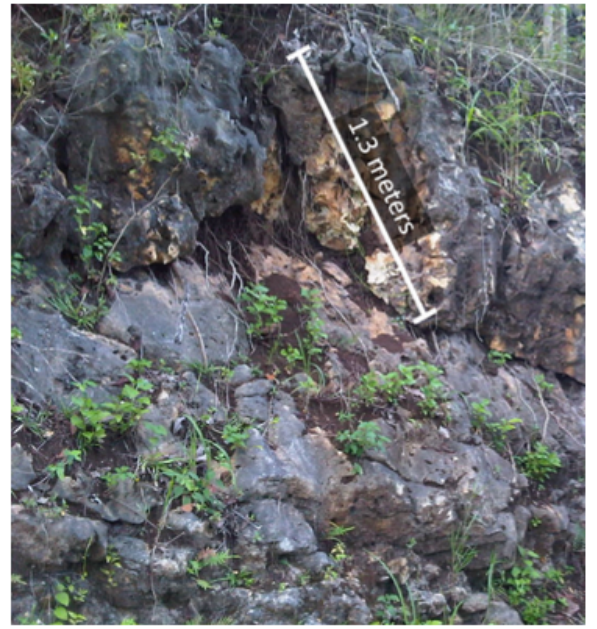
Figure 9

(a) shows a slope formed by crystalline limestone at Station 6 with a 191 m of length and ± 9 m of height. (b) shows a slope formed by reefal limestone at Station 13 with a 1.3 m of rock block size. Rockfall was indicated to had occurred in both locations.

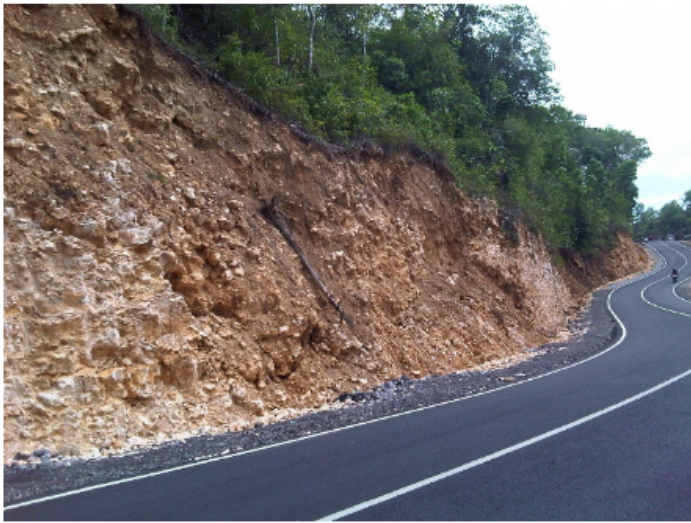
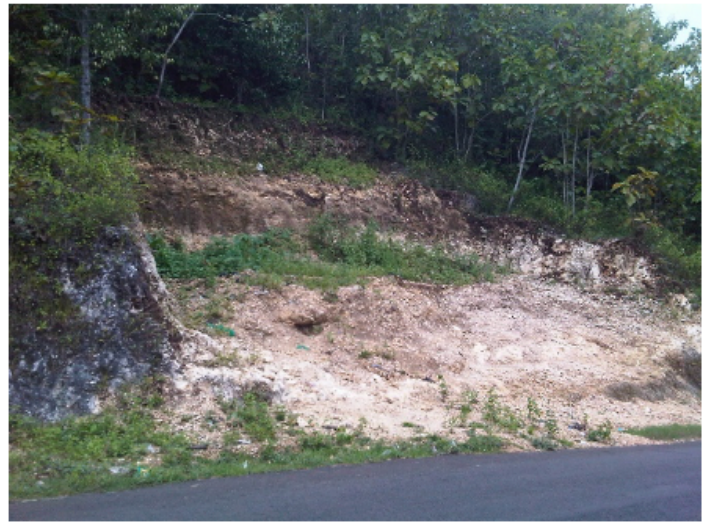
Landslides evidence at coordinate (a) $110^{\circ}20'27.60''E, 8^{\circ}0'16.24''S$ and (b) $110^{\circ}22'15.60''E, 8^{\circ}1'33.60''S$. None of slope reinforcement installed at the locations.

The extension of Girijati and Parangtritis Fault which forms a semi-circular crown structure (Prasetyadi et al., 2011) produced paleo-landslides deposits with estimated dimensions of 2,700 m long, 1,500 m wide, and 810 million m³ of landslide volumes (Husein et al., 2010) in a gravel–boulder grain size. These landslide deposits are very prone to move and/or collapse and believed to be one of the causes of most recent landslide events in the study area. On these landslide potential areas, the stakeholders should consider to re-excavating or at least covering the slopes with an anchored wall. Figure 11 below shows the occurred landslides at several locations in the study area.

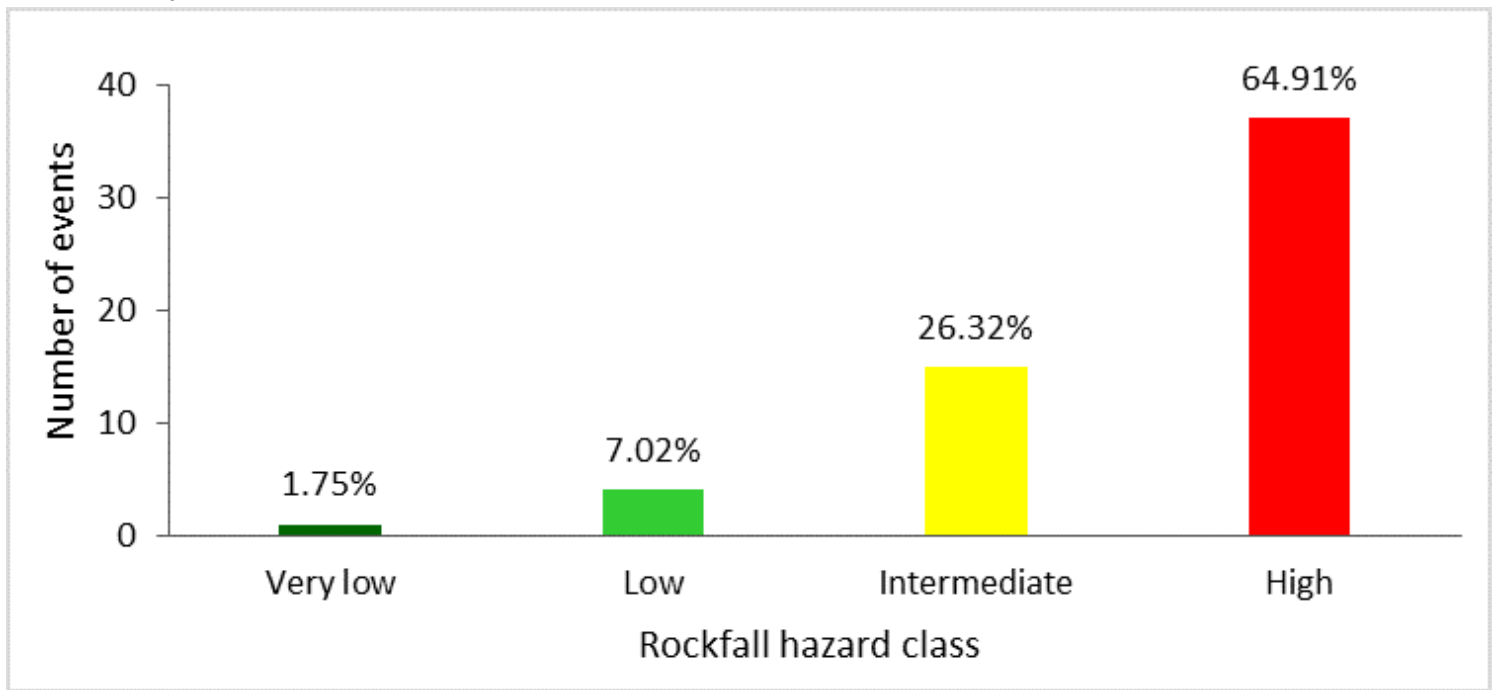
Figure 12

Percentage of rockfall occurred in each rockfall hazard class.

Historical rockfall points were overlaid over the Rockfall Hazard Zonation Map to validate the predicted hazard zones, and the number of rockfalls that occurred in each hazard class was calculated. Information about occurred rockfalls was obtained from the local authorities of transportation, facilities, and infrastructure. In some stations without administrative data sources, the number of rockfalls estimated based on observations around the stations and information from residents. The estimation was carried out by observing the holes in the former slope or the rock blocks found on the trench/ditch. From this validation, rockfalls have occurred in the classes of very low, low, moderate, and high with the percentages of 1.75%, 7.02%, 26.32%, and 64.91%, respectively (Figure 12). Since 91.23% of the rockfall occurred in the moderate and high hazard classes, the Rockfall Hazard Zonation Map considered reliable to predict future rockfall.
