Field investigation and analysis of rockburst and spalling in a deep hard-rock mine

Research Article

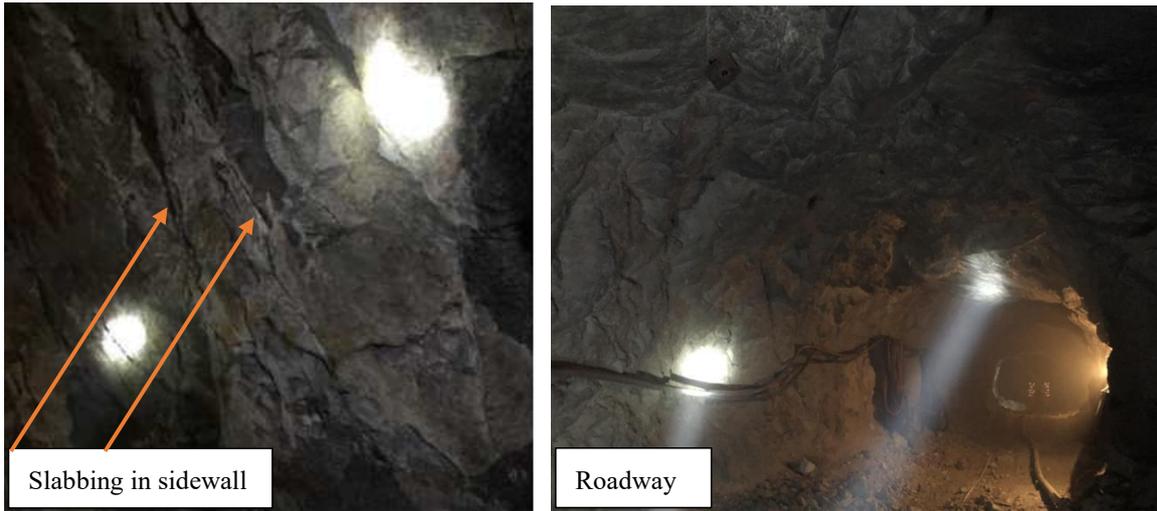
Fig. 1 Mining depth 745m

Buried depth/ m	Related ground pressure disaster phenomenon (partial area)
745	Surrounding rock of roadway is broken, and there are obvious joints and cracks, as show in Fig. 1
830	Surrounding rock is broken, roof spalling and slabbing are common in roadways, which cause rock bolts falling off, as show in Fig. 2
930	Roof of roadway spalling and fragmentation are common, and roadway deformation is large. As shown in Fig. 3, roof of stope has pumice stones, and surrounding rocks on both sides are relatively broken. There are many obvious joint cracks on roof and both sides
980	A rockburst occurred during construction of a cutting lane in a stope, ore ejected from excavation face. Spalling occurred on both sidewalls of surrounding rocks after rockburst. Exploded rocks are uniform and small in size, as shown in Fig. 4. A rockburst occurred when the first layer was mined in a stope, and a large amount of rock was ejected. A rockburst occurred in cutting roadway, and rock on one sidewall ejected out in flakes. Surrounding rock often produces rumbling sound when drilling rock.

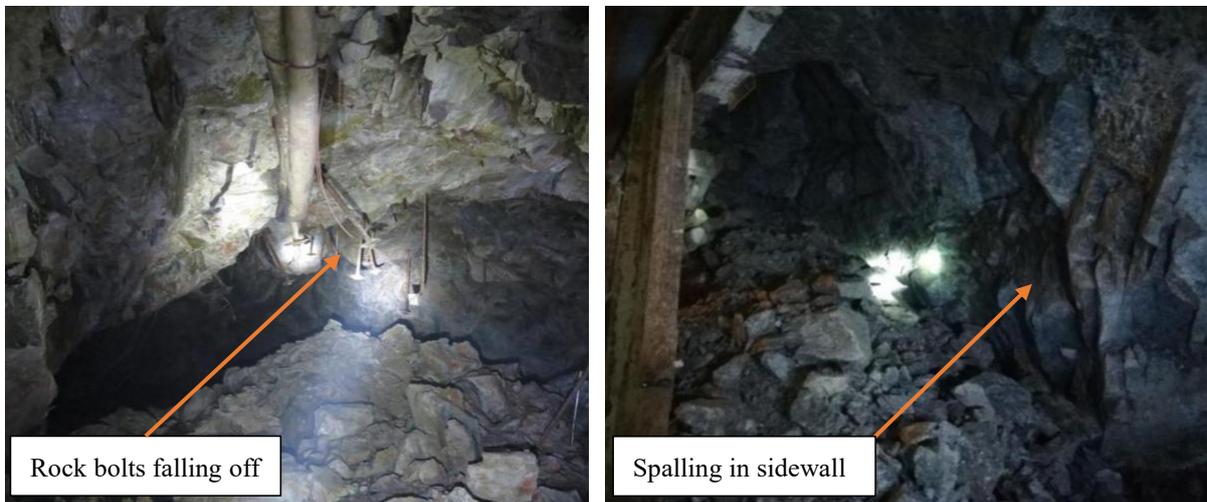
Fig. 2 Mining depth 830m

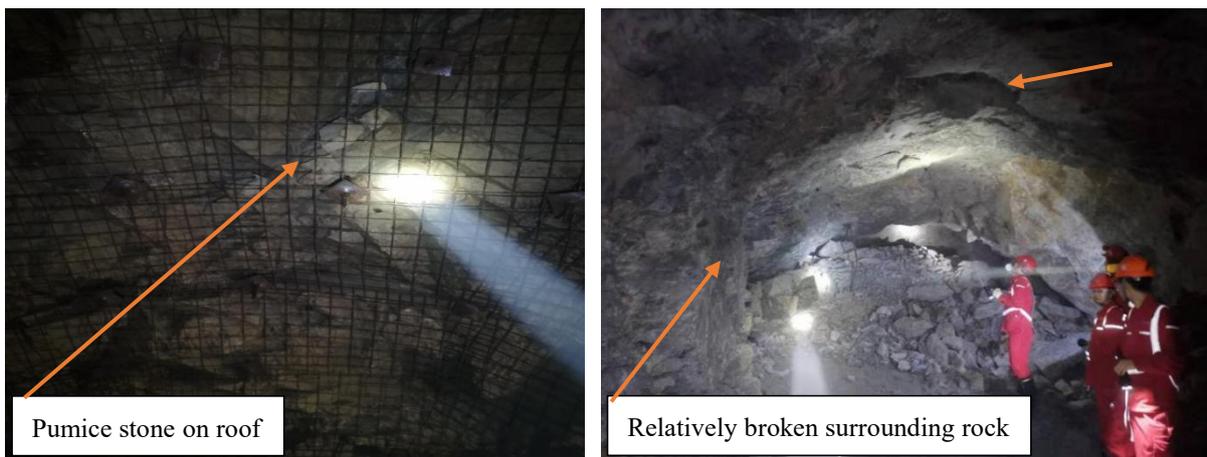
Fig. 3 Mining depth 930m

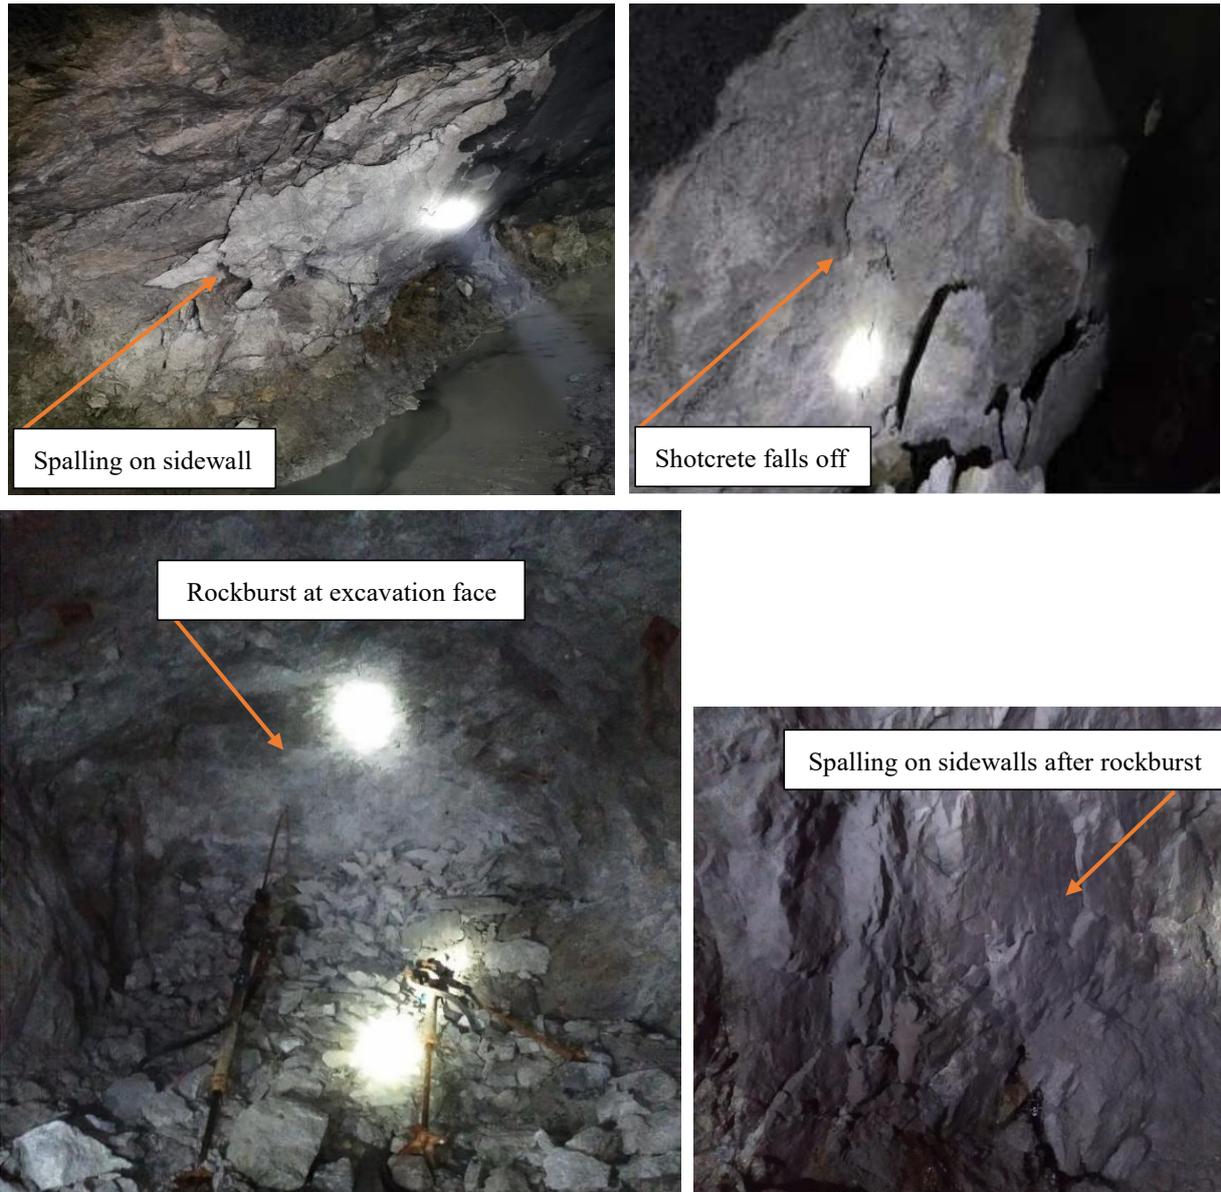
Fig. 4 Mining depth 980m

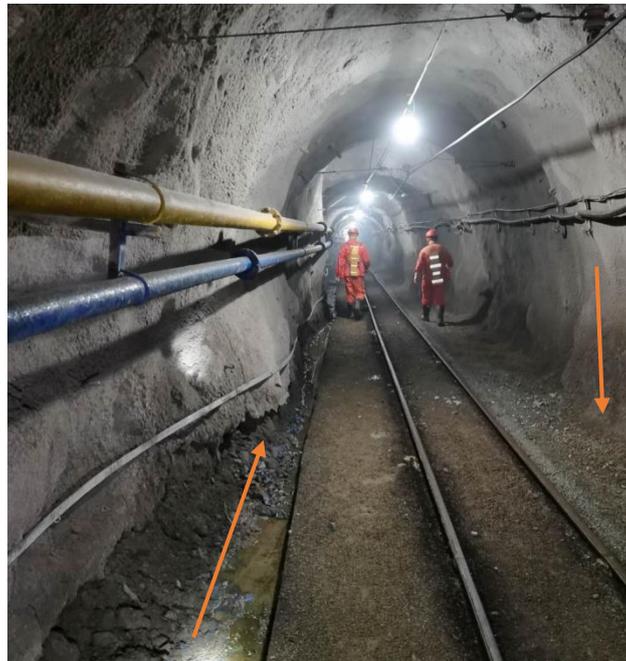
The influence range of excavation on surrounding rock is about three times of roadway span. It is known that the width of transportation roadway in the mine is 4.5m, then the influence range of sidewall is 13.5m, and the displacement of sidewall is about 13.5m times the rebounded strain. Through calculation, the displacement of sidewall at depth of 1000m is 25.6mm, which is small compared with the size of roadway. However, in the soft rock roadway with small elastic modulus, it can be known from Eq. (6) that the rebounded strain will be large. If the elastic modulus of soft rock is 0.2 times that of the hard rock, the displacement of soft surrounding rock will reach 128mm, which is the reason why the soft rock roadway is prone to large deformation, as shown in Fig. 10.

Fig. 10 Large deformation of sidewall in a soft rock roadway

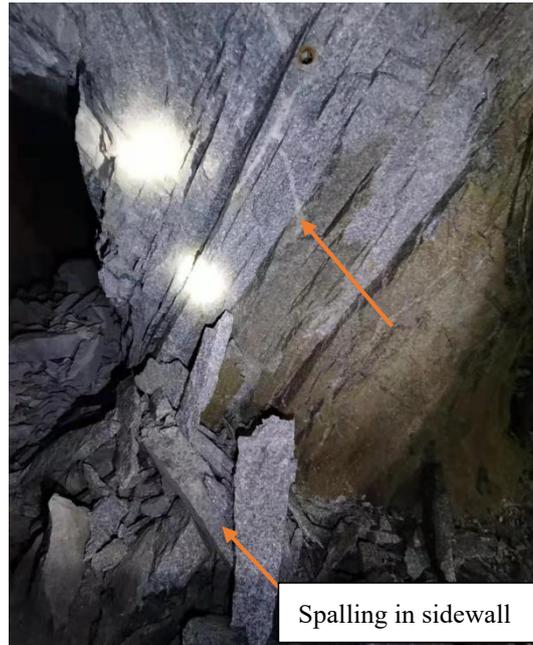
Fig. 14 A large number of rock spalling and cracks produced in sidewall of roadway with buried depth of 720m

Therefore, the release of strain energy of surrounding rock after excavation should be paid attention in the mine. In deep engineering, high-strength rock bolts often suffer brittle fracture, and high energy-absorbing materials are more suitable for surrounding rock support than pure high-strength materials. Adopting energy-absorbing support methods to absorb the released strain energy of surrounding rock can achieve good results, which is also a view that scholars increasingly agree [18, 37].

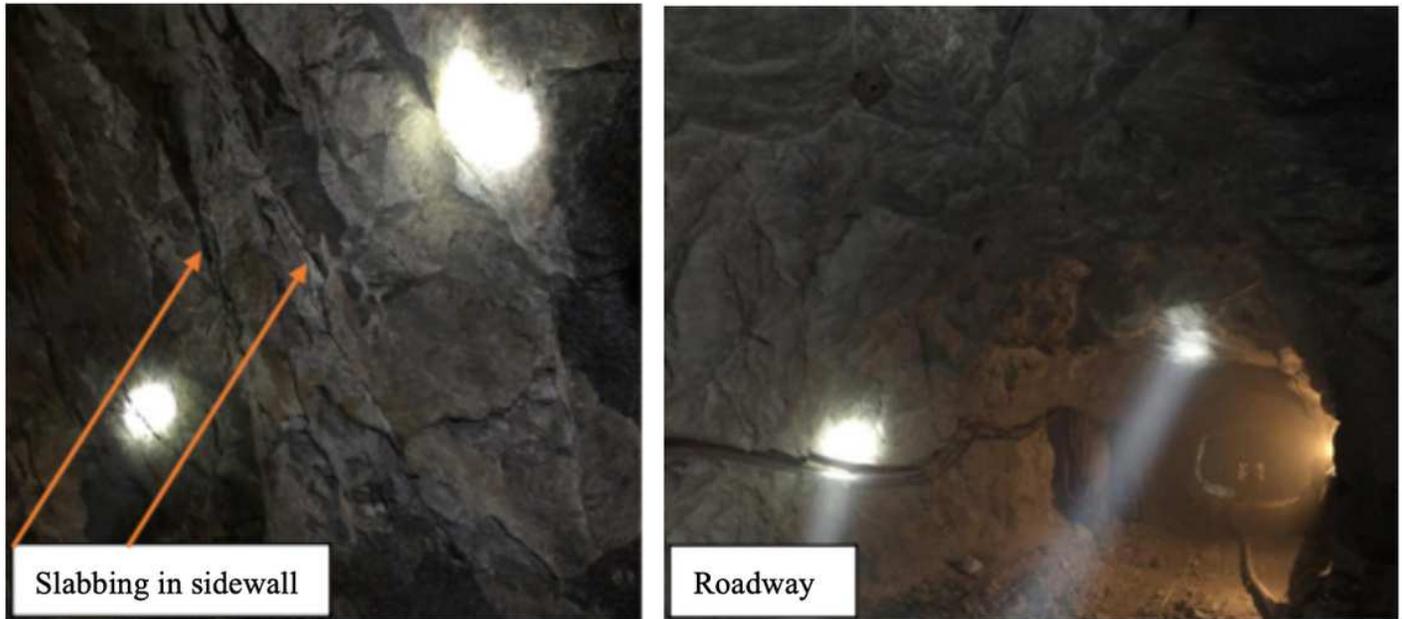
Figure 1

Mining depth 745m

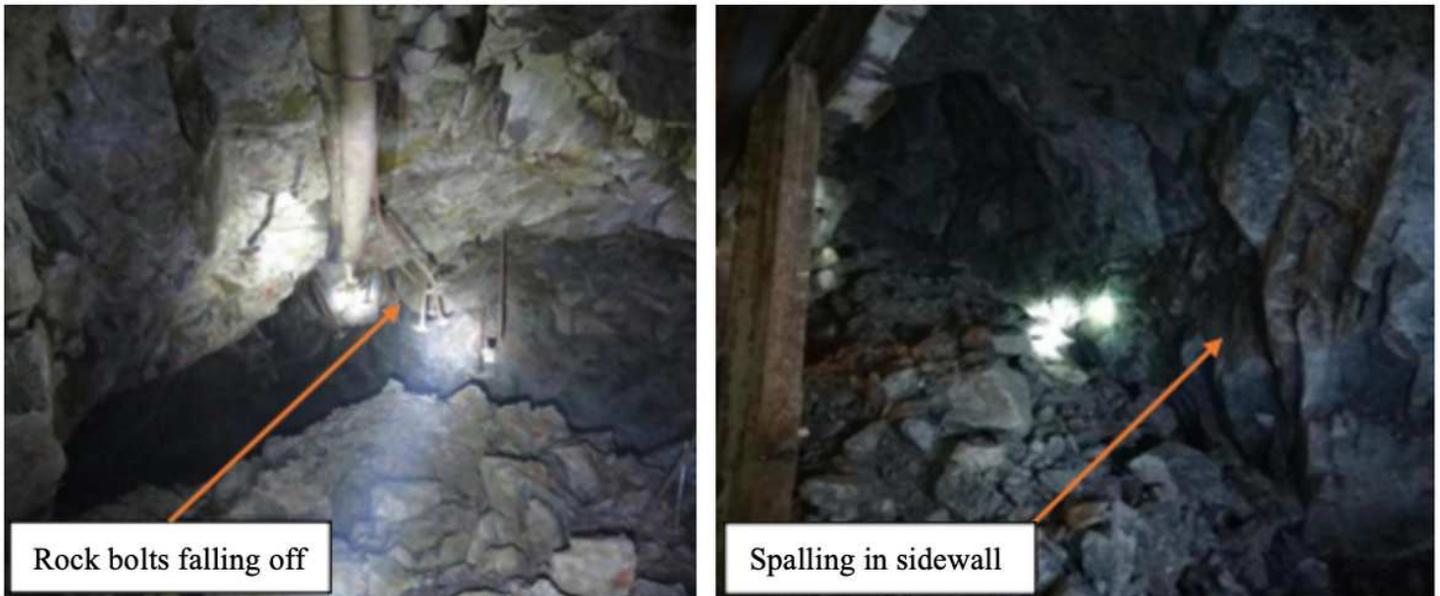
Figure 2

Mining depth 830m

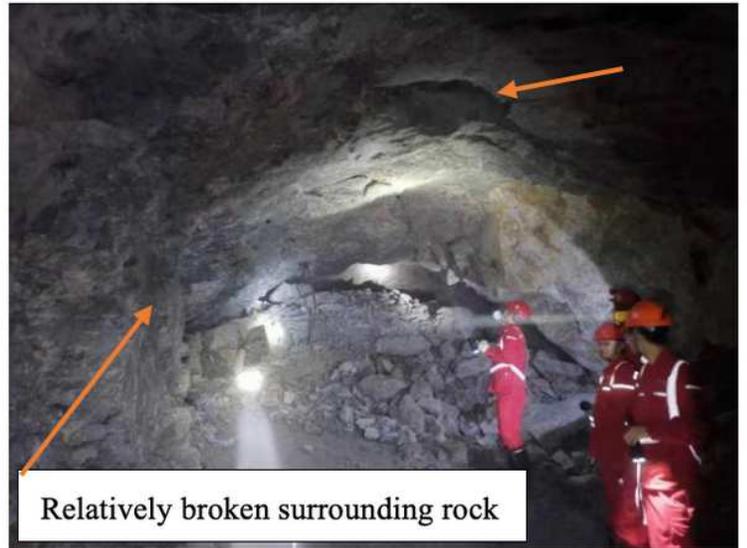
Figure 3

Pumice stone on roof

Relatively broken surrounding rock

Mining depth 930m

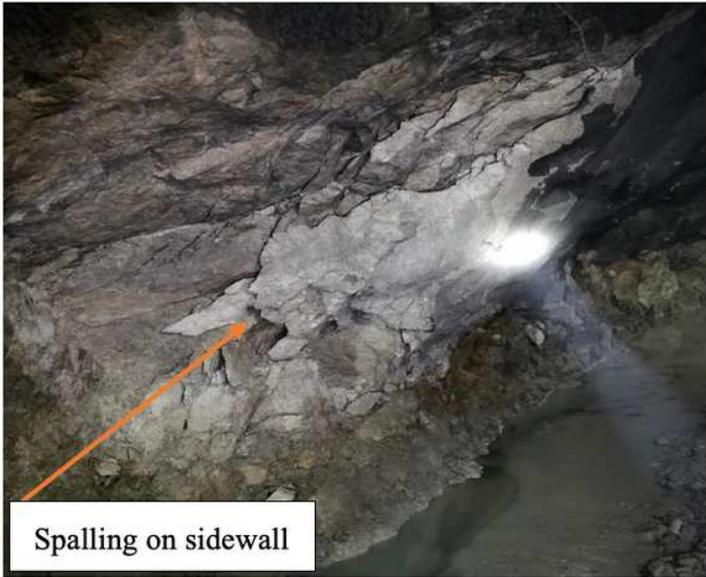
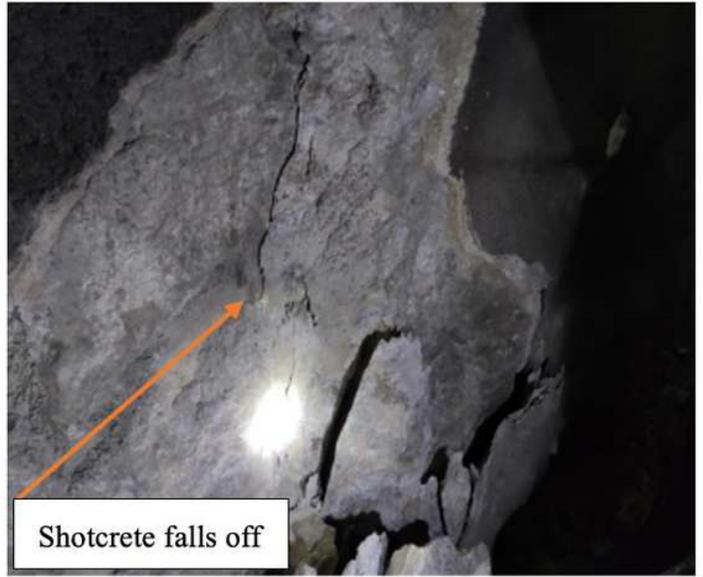
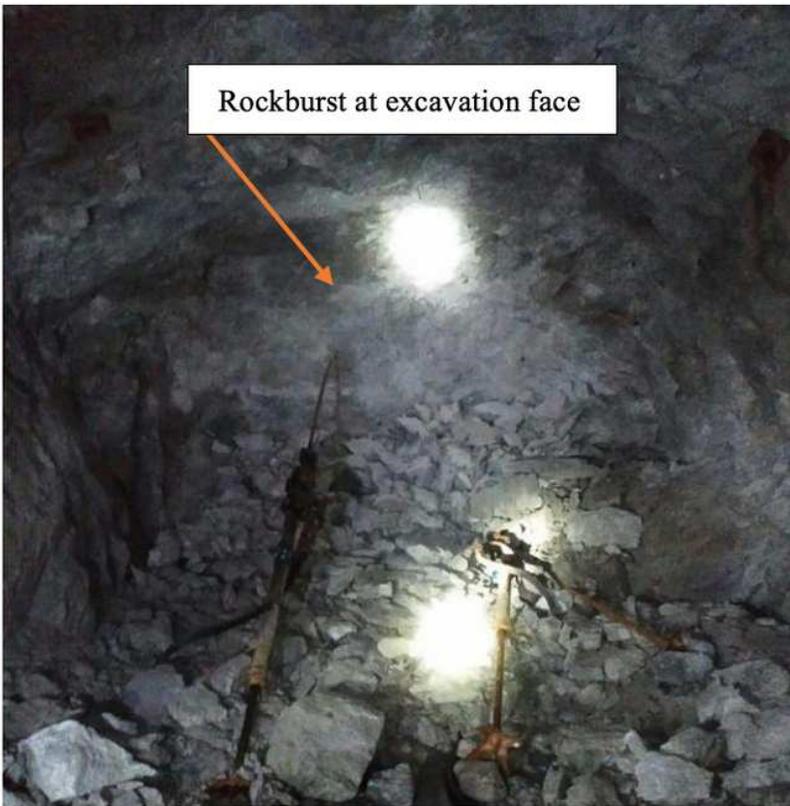
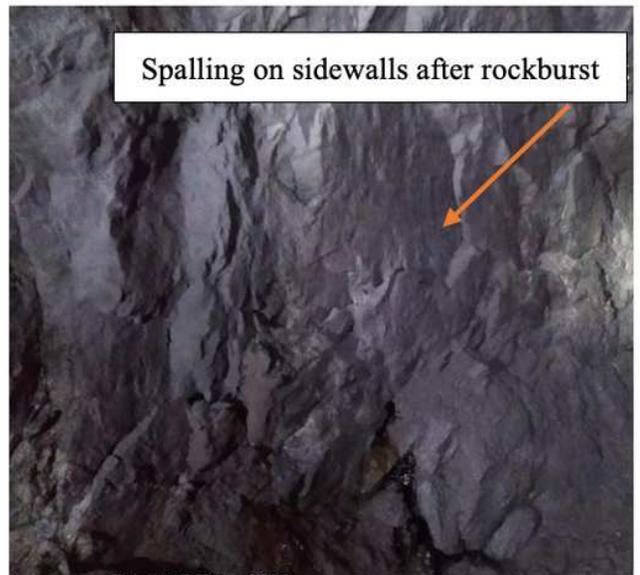
Figure 4

Mining depth 980m

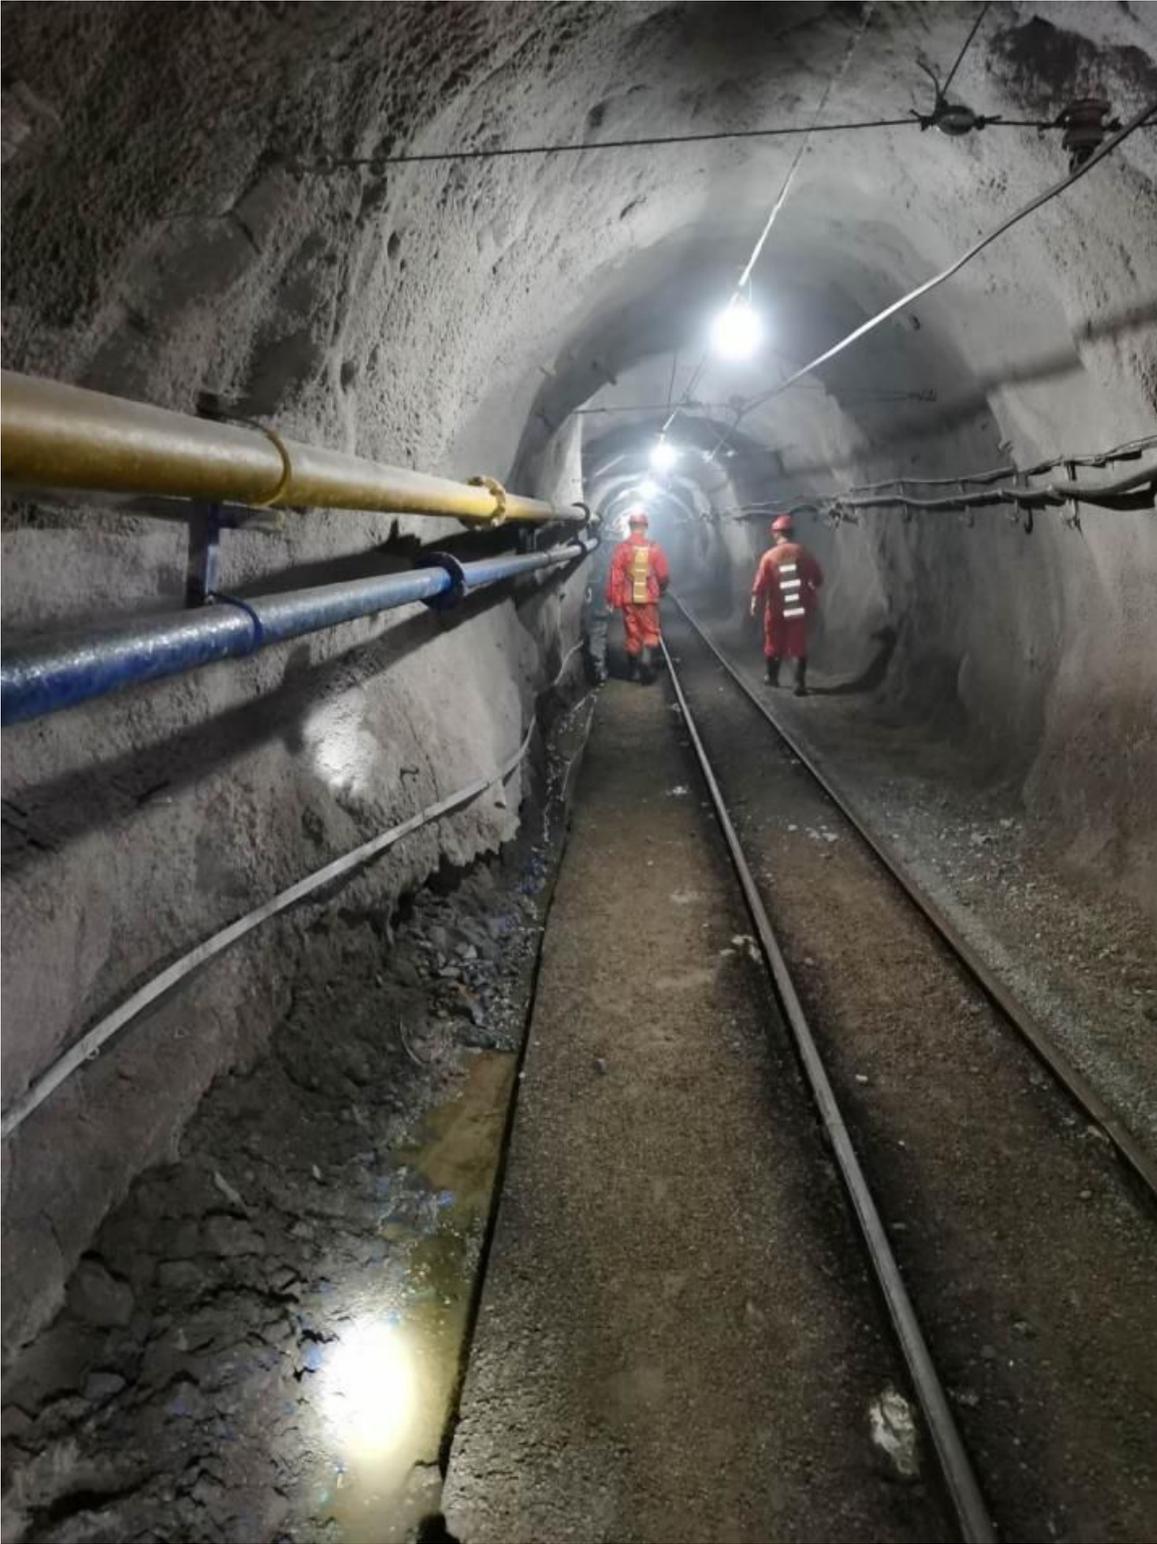
Figure 10

Large deformation of sidewall in a soft rock roadway

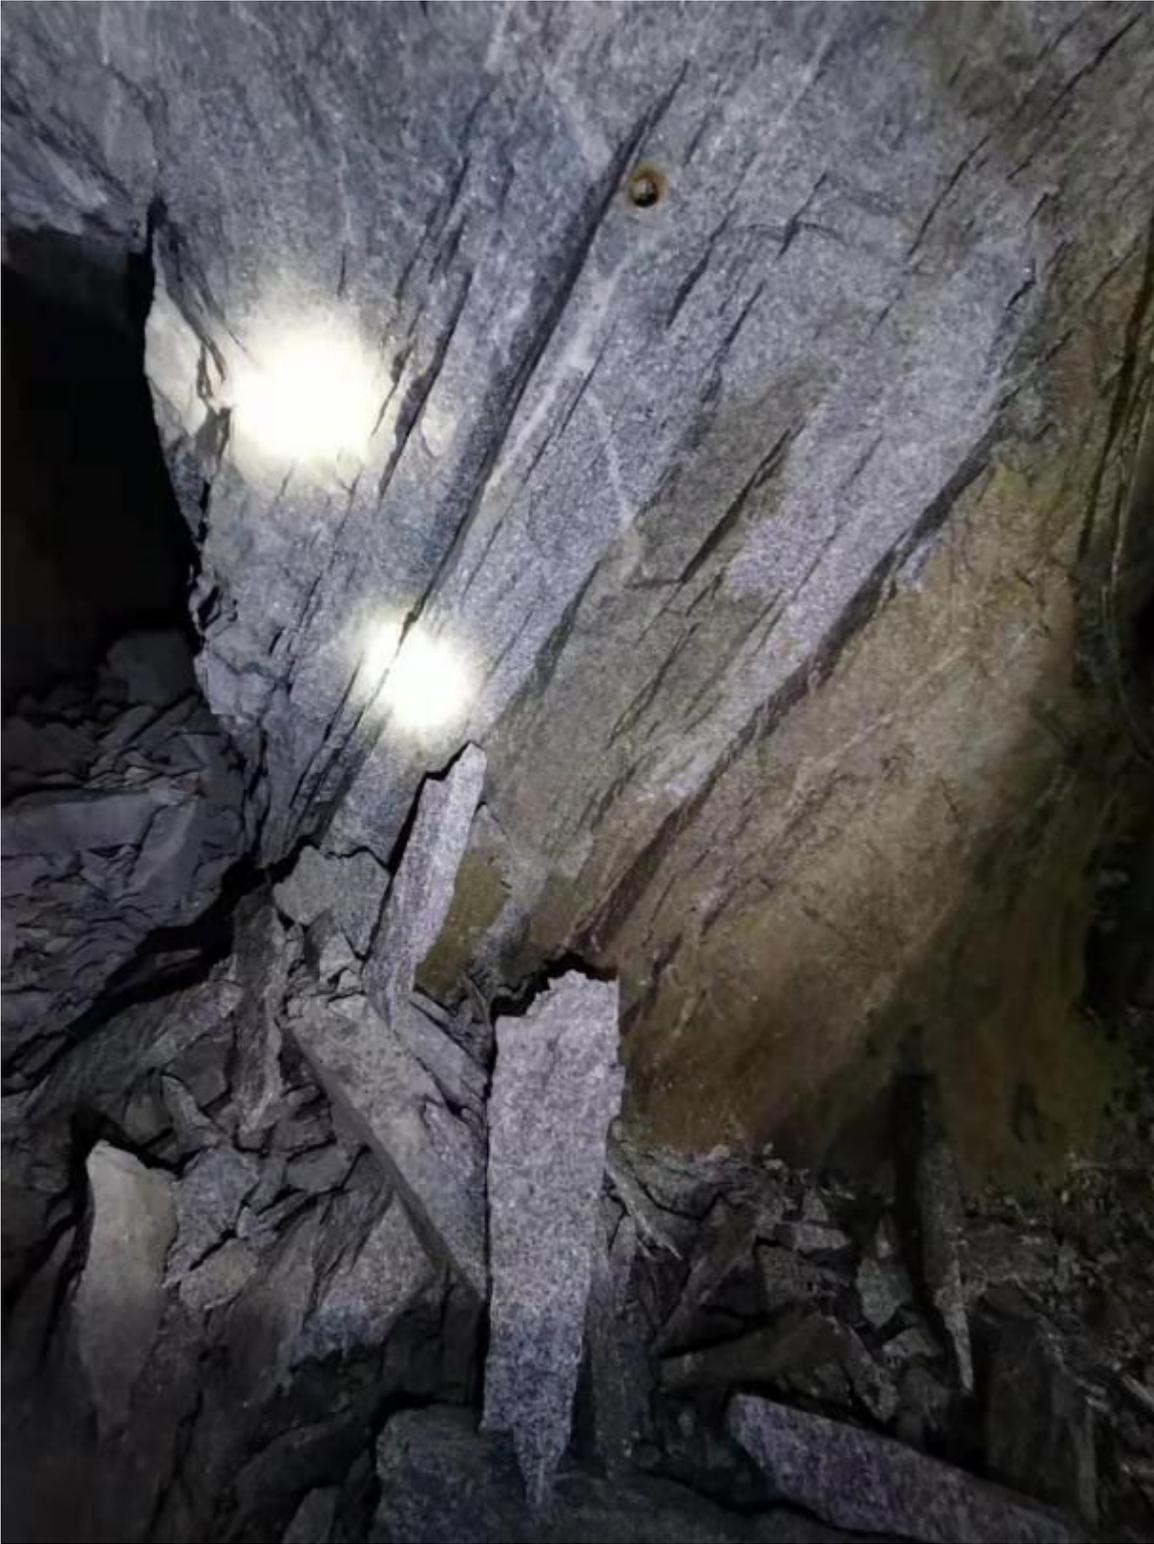
Figure 14

A large number of rock spalling and cracks produced in sidewall of roadway with buried depth of 720m
