Structural Stability and Behavioral Characteristics of the Fortress Wall from the 6th Century Baekje Kingdom in Ancient Korea

Research article

Keywords: Gongsanseong Fortress, Morphological characteristics of ramparts, Automated monitoring system, Behavioral monitoring, Environmental change

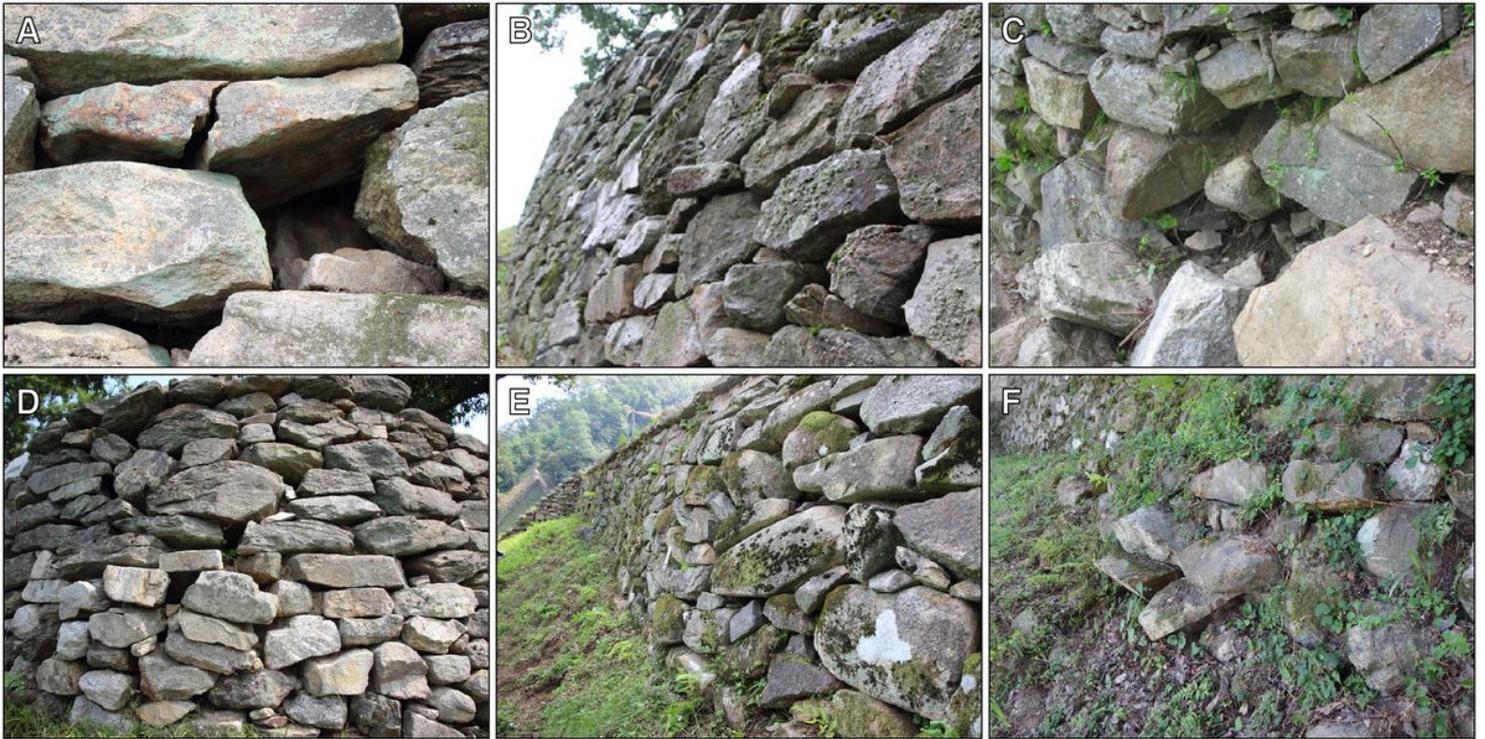
Figure 2

Occurrences of representative deterioration status. (A) Crack. (B) Protrusion. (C) Loss. (D) Structural relaxation. (E) Inflating phenomenon. (F) Unstable foundation.

Damage types on individual rocks are manifested in the form of cracks, protrusion and loss while structural deformations of the ramparts are further categorized into the structural relaxation, inflating phenomenon and unstable foundation (Fig. 2). Only a single type of damage may be observed on the fortress wall but, from time to time, a number of damage types occur complexly. Also, it is possible to observe damages on individual rocks without any structural deformation but, on the ramparts that have experienced a structural deformation, damages are often identified on individual rocks.

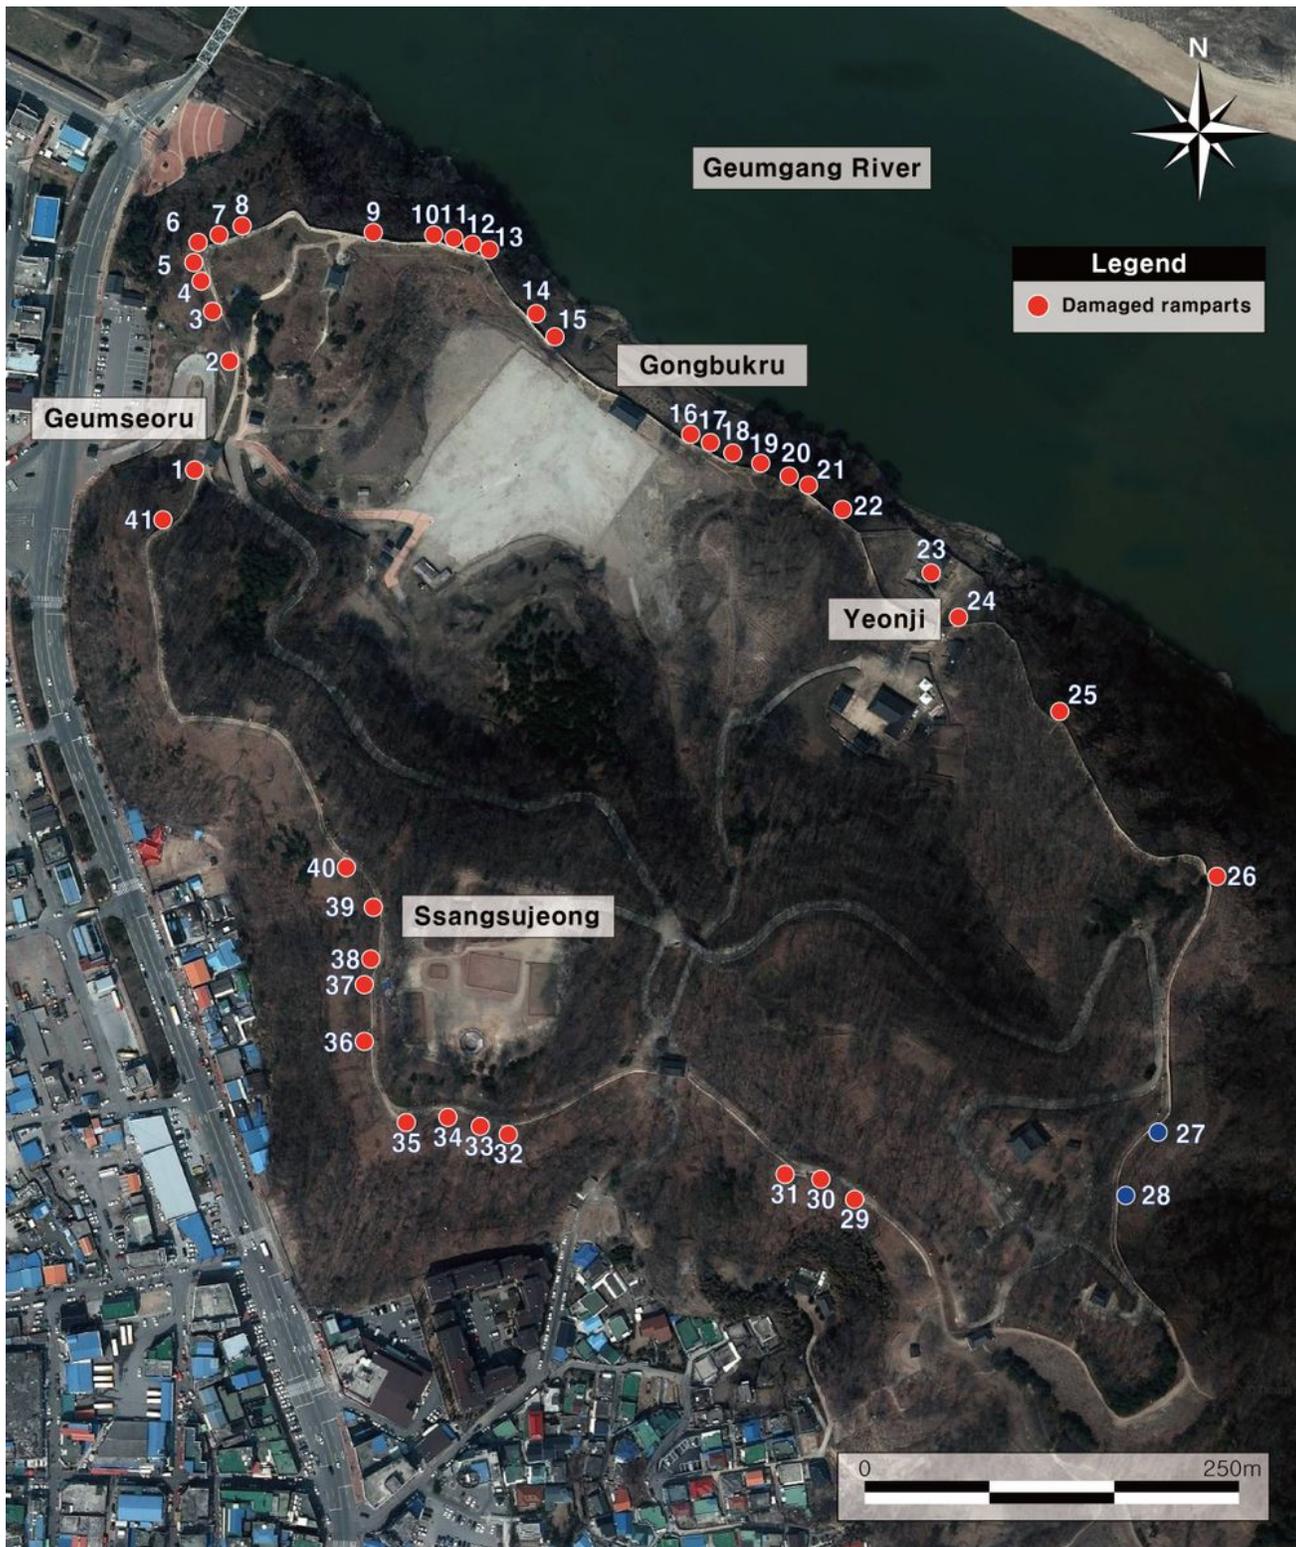
Figure 3

Distribution map showing the 41 sections of representative damaged ramparts in the fortress. Note: The designations employed and the presentation of the material on this map do not imply the expression of any opinion whatsoever on the part of Research Square concerning the legal status of any country, territory, city or area or of its authorities, or concerning the delimitation of its frontiers or boundaries. This map has been provided by the authors.

Results of inspections confirmed the 41 spots of the ramparts with damages and, in case several different types of damages are complexly observed in a single section, all of the types were recorded (Fig. 3). Looking at the types of damages that occurred on the fortress, damages on individual rocks are observed with any structural deformation on 7 spots. The 24 of the 34 sections where structural deformation spots occurred only displayed structural deformations without any damage on individual rocks and, at the remaining 10 spots, a variety of damage types were shown in a complex manner. Looking at the percentages of different damage types, inflating phenomenon and unstable foundation occurred at 24 (38.1%) and 16 (25.4%) spots, respectively, which tells us that structural deformations have happened on more than half of the ramparts (Fig. 4). Other damage types shown were losses at 12 (19.0%), cracks at 5 (7.9%), protrusion at 2 (3.2%) and structural relaxation at 1 (1.6%) spots, respectively.

Looking at the distribution of sections where damages occurred, we can see that 23 of the total 41 spots with damages are concentrated in the section between Geumseoru and Yeonji along the Geumgang River (Fig. 3). On the west and east sides, an extremely small number of sections have damages and, in contrast, damaged sections are shown to be concentrated on the ramparts near Ssangsujeong Pavilion on the south side. The root-cause investigation of the collapse of the ramparts reported that the incident was comprehensively affected by slopes of the surrounding topography, rampart construction techniques, surface water, underground water flows, conditions of the ground, and the distribution pattern of damages on the ramparts is also believed to have been influenced by such environmental factors [18, 19].

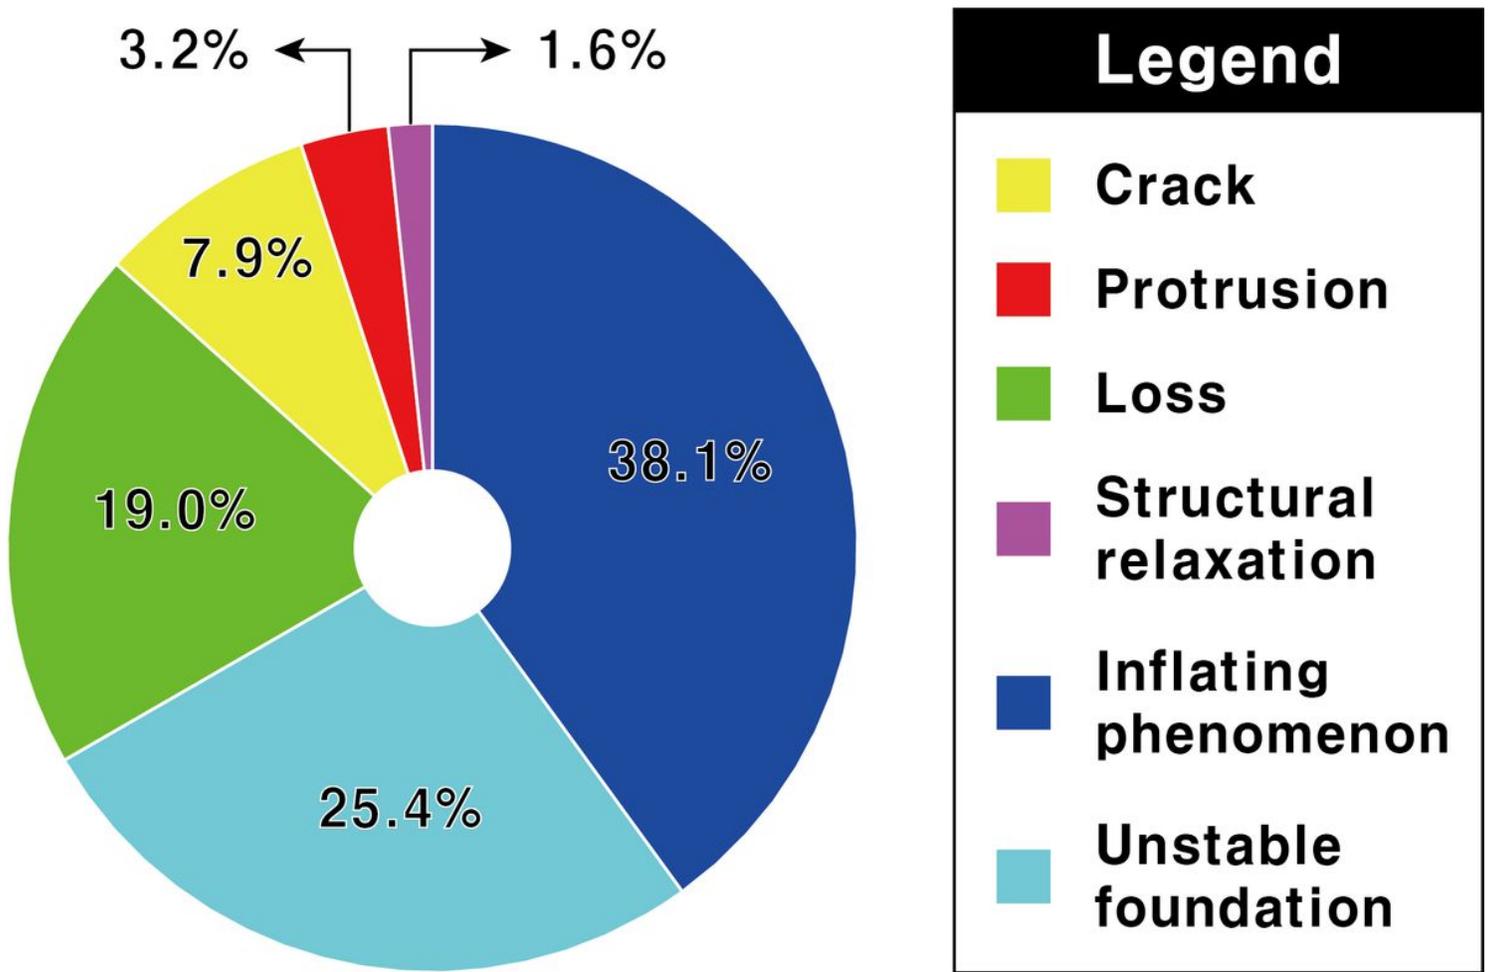
Figure 4

Shares as the deterioration types on the damaged ramparts.

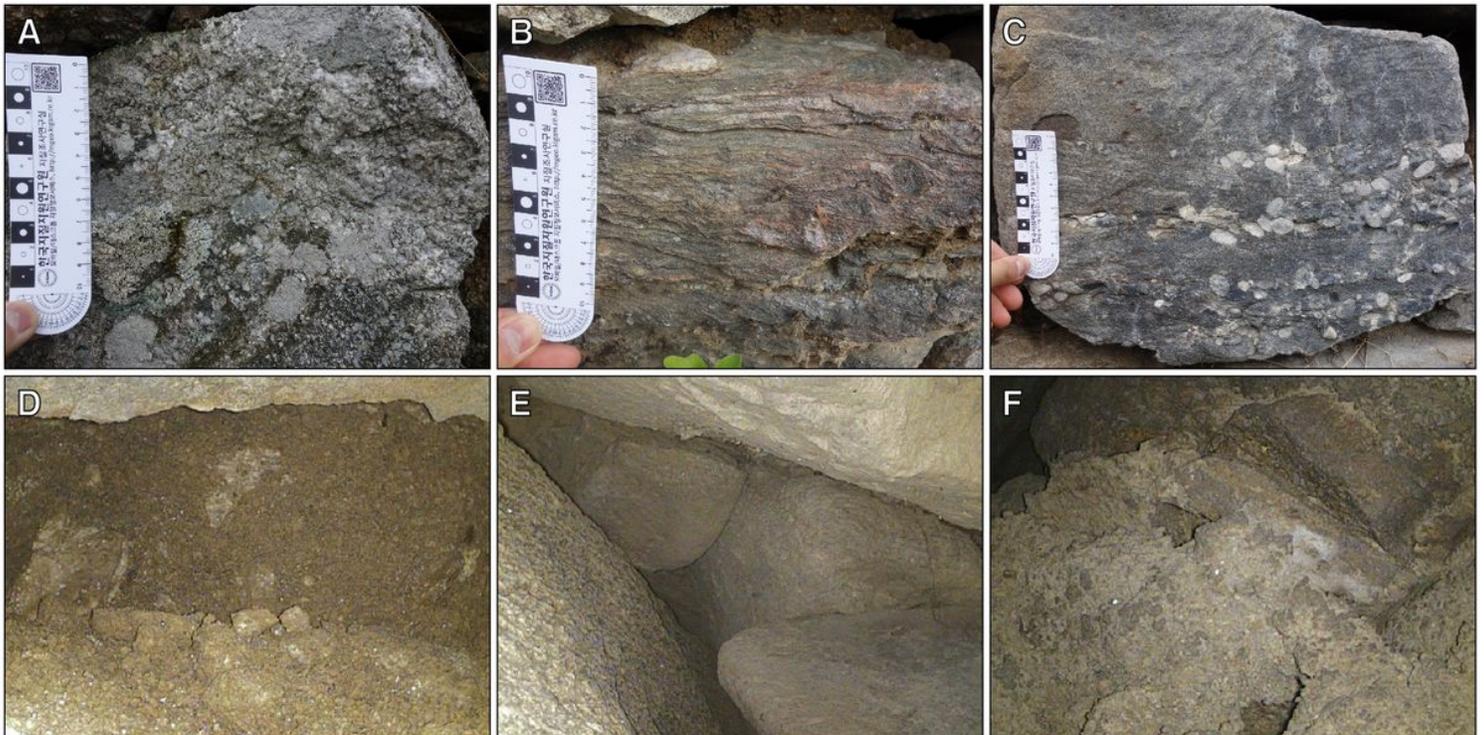
Figure 5

Construction materials of the fortress wall. Rock properties origin as igneous (A), metamorphic (B), sedimentary (C) process, and internal fillers of sand (D), gravel (E) and cement mortal (F).

The construction of the Gongsanseong Fortress used igneous, metamorphic and sedimentary rocks, which are further subdivided into over 10 different types of rocks. Among them, gneiss and leucocratic granite are observed the most dominantly, and they show signs of quartzite and miscellaneous rock types mixed together (Fig. 5A to 5C). Leucocratic granite was dominantly used on most of the ramparts while a great amount of gneiss is observed on northwest ramparts of the Gongsanseong Fortress from Geumseoru to Gongbukru.

Another construction material in addition to the rocks is internal fillers. Internal fillers refer to gravel, sand, clay and cement mortar. used to fill the interior of the ramparts in order to help transfer loads, and, although only one of these materials is sometimes used for an application, a number of them are mixed together for use in other cases. An endoscope camera was utilized to find out the types of internal fillers of the Gongsanseong Fortress, and natural materials such as gravel, sand and clay were mainly identified (Fig. 5D and 5E). However, some of the restored sections were confirmed to have used cement mortar on the inside (Fig. 5F) and considering the differences in the type and mixture ratio of the aggregates depending on the location, it is understood that they were arbitrarily manufactured without any particular specification.

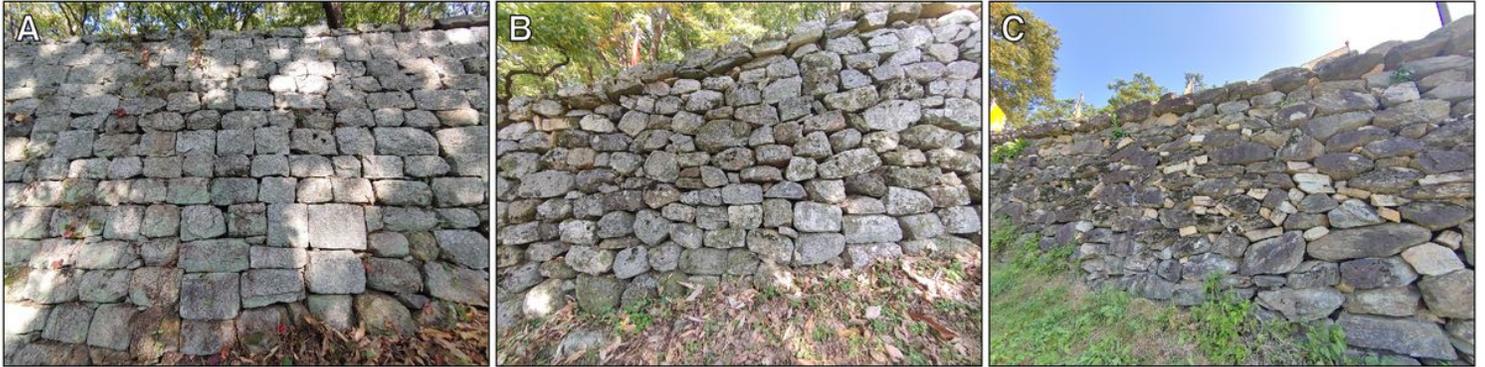
Figure 6

Classification of the fortress walls through morphological characteristics. (A) Type of straight rock piling. (B) Type of uneven rocks layer piling. (C) Type of uneven rock piling.

Different construction techniques are applied depending on the curves of the ramparts, angles of outer ramparts, construction methods, and the Gongsanseong Fortress shows clear discrepancies from one section to the next because of different construction methods. A construction method is based on continuity of joints and standardization of stones, and three construction techniques, which are straight stones piling; uneven stones layer piling; and uneven stones piling, are applied to the Gongsanseong Fortress. Straight rock piling is a technique in which rocks that are standardized and, thus, nearly uniform

in size are built to fit the joints (Fig. 6A) whereas uneven stones layer piling is a technique of constructing stones of atypical shapes in line with the joints (Fig. 6B).

Uneven stones piling is found in the ramparts to which no particular construction technique is applied and refers to the form in which stones of atypical shapes are piled up by simply matching the external surfaces (Fig. 6C). After classifying the ramparts based on the shapes of the stones and construction techniques, we were able to see that most of the Gongsanseong Fortress are built by the uneven stones layer piling method. Straight stones piling is applied mainly in restored sections while the section restored in the 1970s on the northwestern side of the fortress is mostly built by the uneven stones piling method.

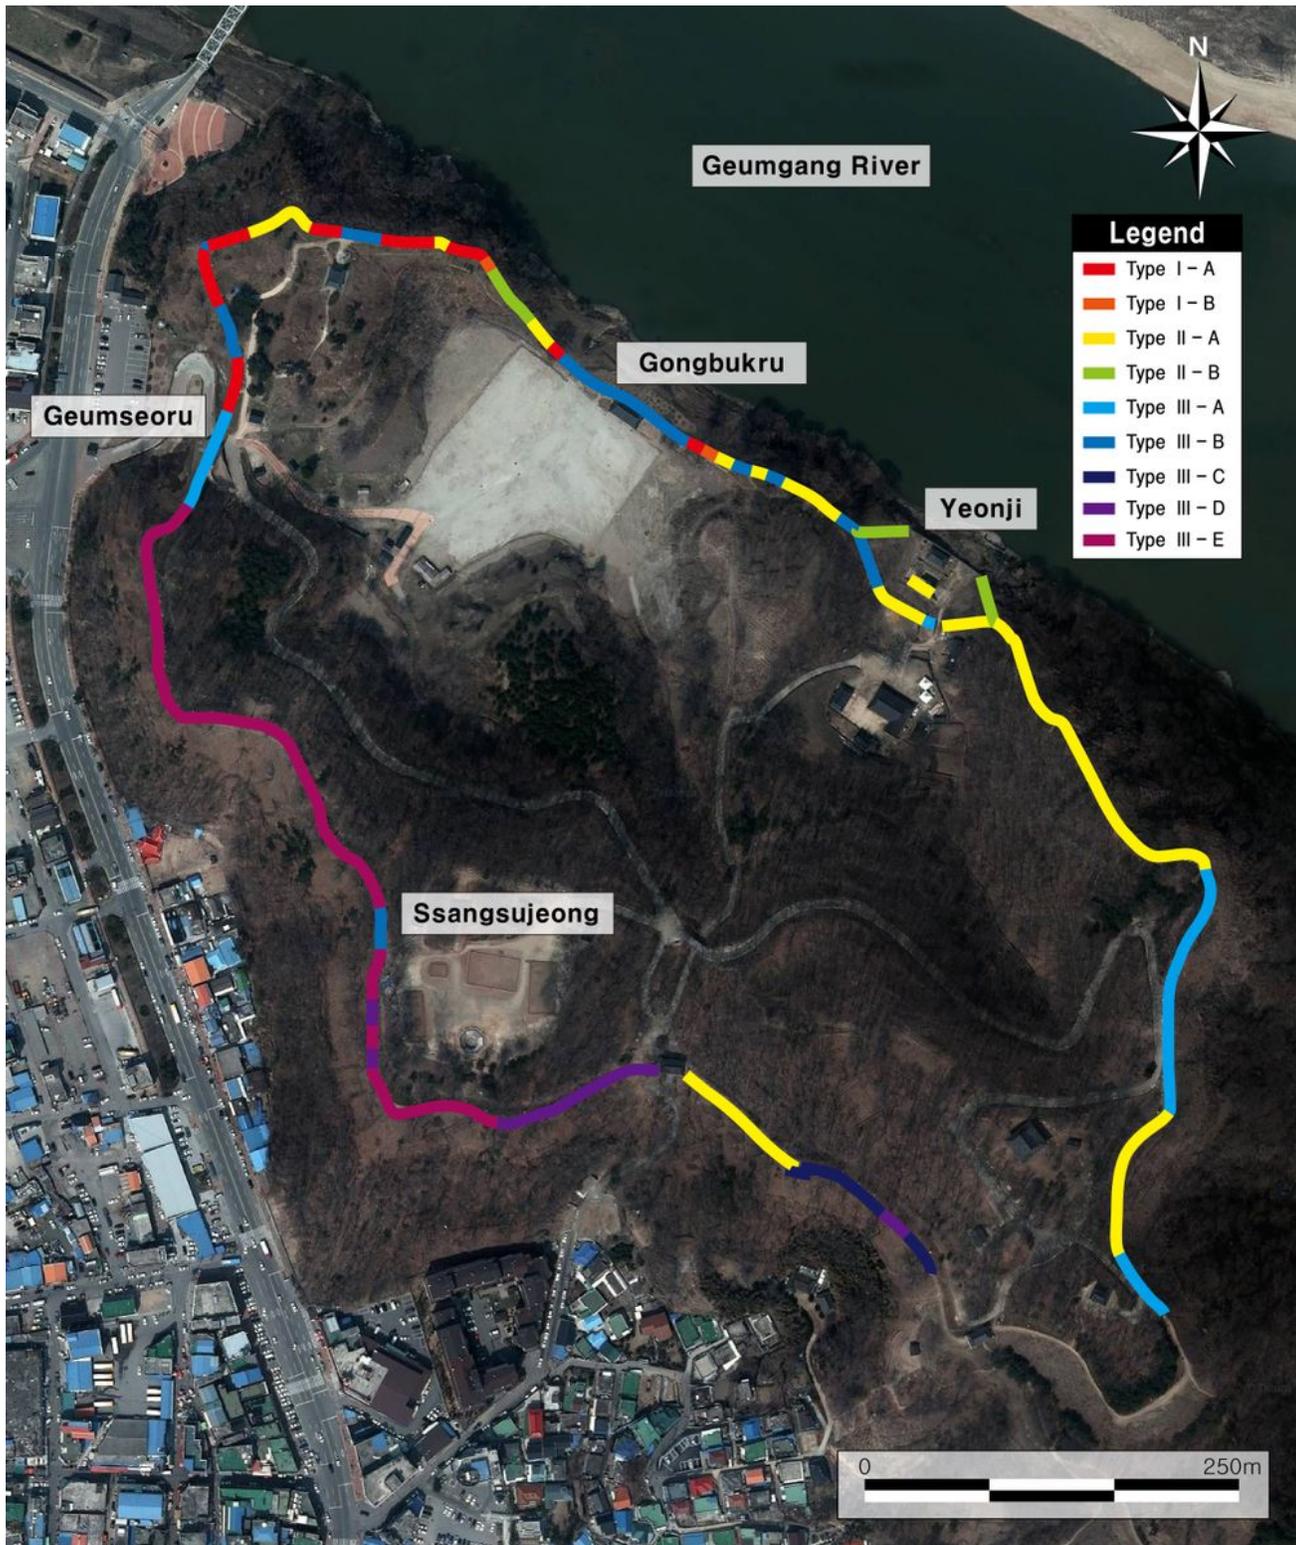
Figure 7

Distribution map showing the classified construction types of the fortress. Note: The designations employed and the presentation of the material on this map do not imply the expression of any opinion whatsoever on the part of Research Square concerning the legal status of any country, territory, city or area or of its authorities, or concerning the delimitation of its frontiers or boundaries. This map has been provided by the authors.

Looking at the locations for each type (Fig. 7), Type I is concentrated on the northwestern side of the Gongsanseong Fortress and shown to be distributed along the Geumgang River. Type II is observed on some parts of the northeastern and southern sides of the fortress and normally distributed along slopes. Type III has the highest share and is extensively distributed along the southern ridge of the Gongsanseong. Therefore, we can see that most of the Gongsanseong Fortress have been affected by

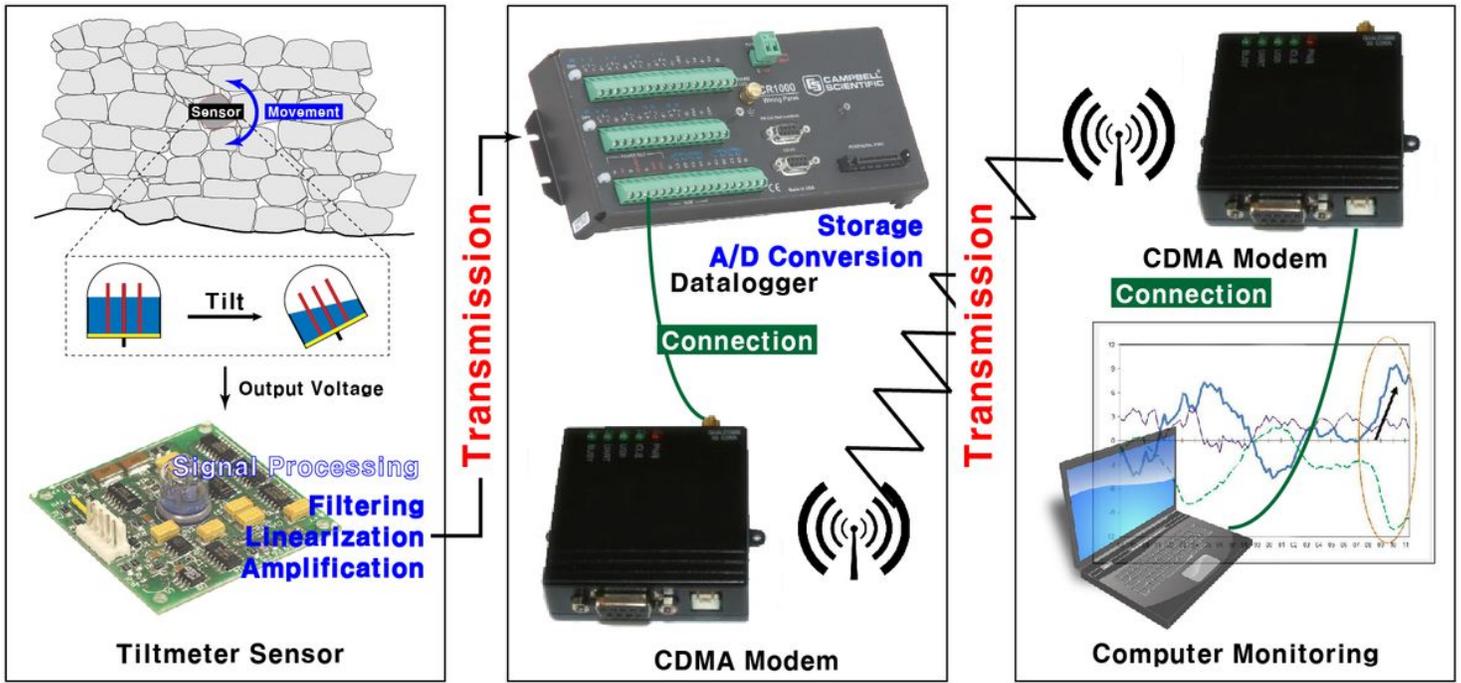
Figure 8

Schematic photographs showing the monitoring system in this study.

These sensors were installed at 20 locations with high degrees of risk among the points where structural deformations, confirmed through visual inspections, have occurred. After projecting the original forms prior to the occurrence of structural deformations and considering the progress until now, we selected locations where we believed changes in physical quantity would manifest the most definitely and attached measuring sensors. We also installed environment monitoring devices in order to measure the changes in microclimate such as the temperature, humidity, rainfall, direction and speed of the wind in the area surrounding the Gongsanseong Fortress (Fig. 8).

The monitoring system consists of sensors that measure changes in the ramparts and a data logger that stores the measured values and sends them via communication. First, considering the fortress' locational characteristics, it is difficult to supply electricity so solar panels were installed, also, storage batteries were utilized to supply electricity to the sensors both during the day and at night. Structural changes of the ramparts affect the physical quantities measured by the sensors, which detect such changes by differences in electrical signals.

The data is then stored in the logger as digital signals, and a wireless communication device is utilized to send the data to the server computer in the lab. Once the data in the digital format is enabled to infer the form of the analog signal through the process of inverse transformation, we can visually check the behavior of the ramparts easily. Several sensors can be connected to a logger but, because the direct connection with the sensors must be formed by cables, 4 locations were designated considering the distribution of damaged sections in the Gongsanseong Fortress to establish the monitoring system. The measurement cycle of individual sensors was set as minimum of 10 minutes and maximum of 30 minutes.

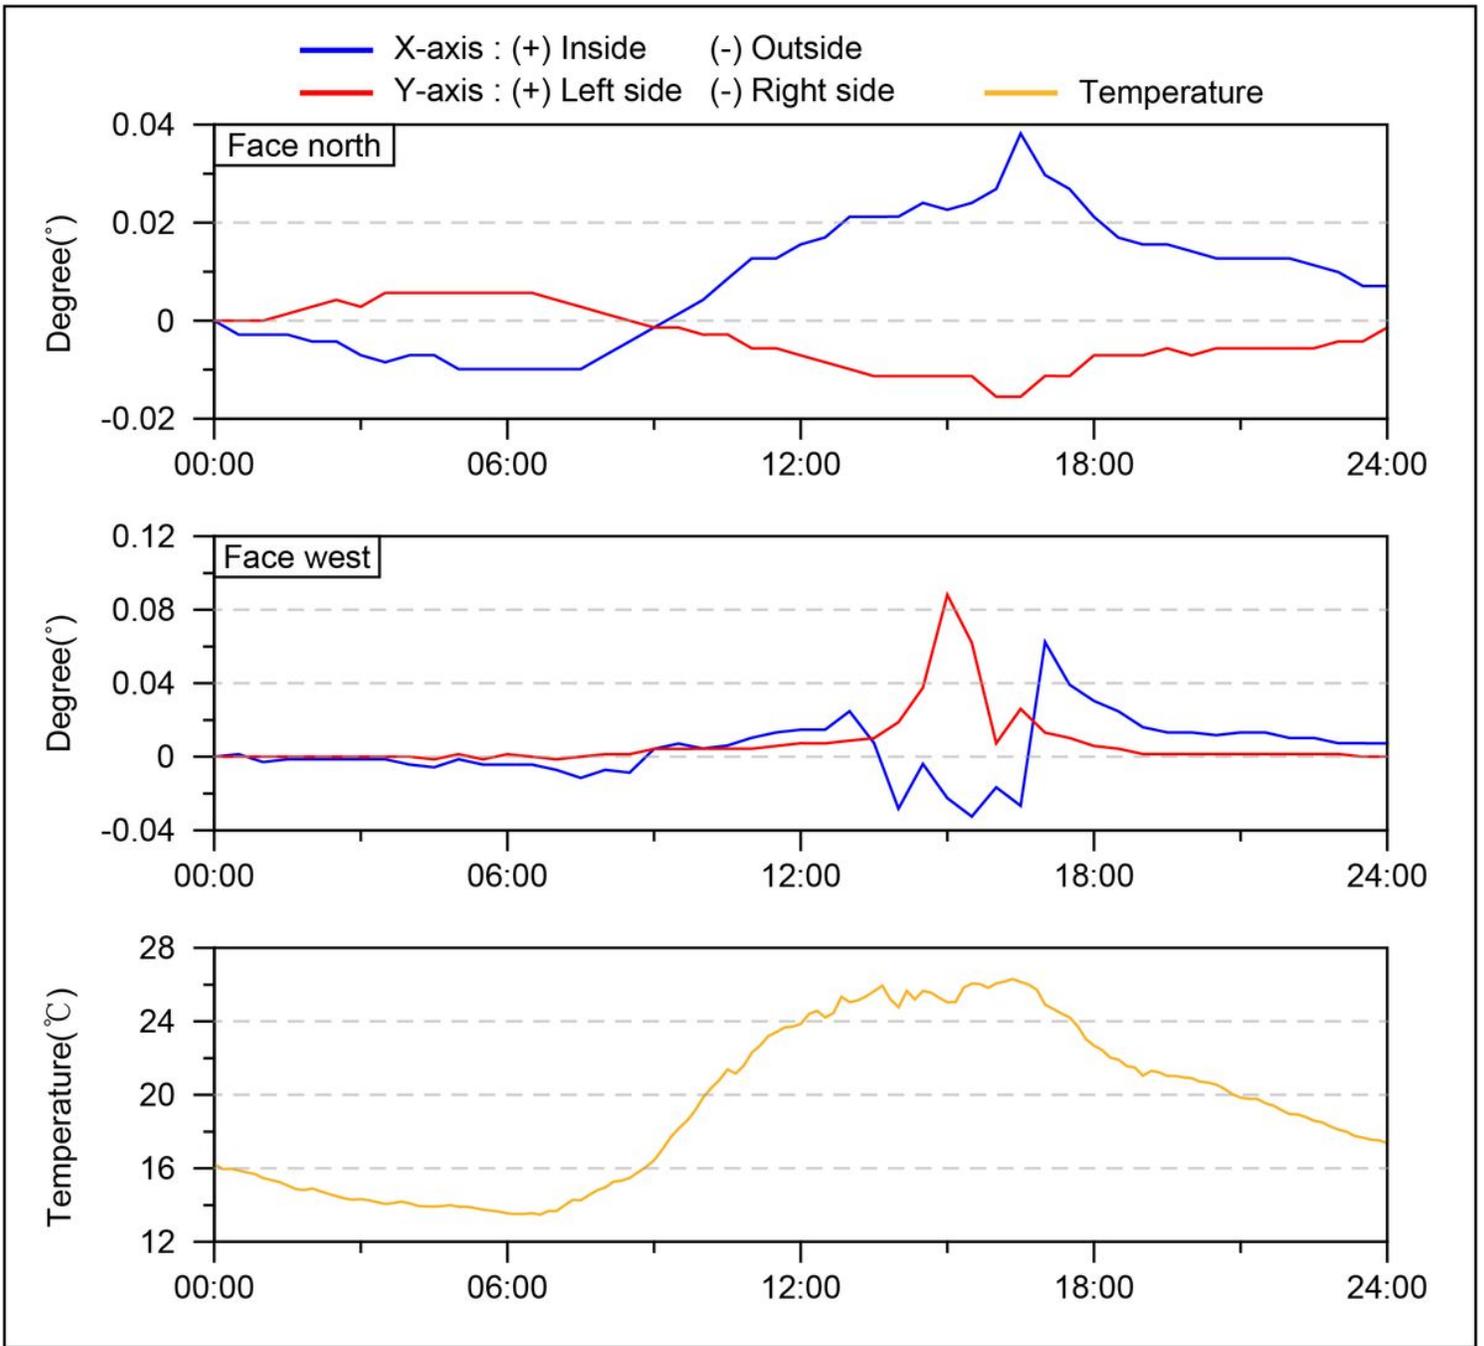
Figure 9

Diagram showing the daily behavior as time series on some sensors of north and west faces in the ramparts.

Through the measuring sensors installed on the Gongsanseong Fortress, daily changes of the behavior were examined in comparison to the changes in temperature and, in order to minimize the effect of the amount of sunshine. We used measurement results from spring and fall, two seasons with identical lengths of day and night (Fig. 9). Looking at the temperature change first, the temperature begins to increase at about 6 AM when the sun rises and reaches the maximum around 2 PM. The maximum temperature is maintained until about 4 PM, from which the temperature starts to drop and continues to fall until sunrise on the following day.

Most of the sensors observed gradual movements as the temperature began to go up after sunrise and, after 4 PM, showed a patterns in which they return to the state prior to the behavior change starts to occur. Although the temperature continued to drop until sunrise on the next day, the ramparts showed almost no movement after 8 PM and maintained a stable state.

However, the breadths of change and the main hours of movement slightly vary depending on the direction ramparts are facing. The monitoring sensors currently installed to face west, south and north, and those that face north and south demonstrate movements that are extremely similar to the temperature change. The ramparts that face west display stable behavior changes until the noon but, after this point until sunset, drastic behavior changes are observed. The fine movements detected by monitoring sensors attached on the ramparts can be interpreted to be mainly driven by expansion and contraction of the stones due to the thermoelastic coefficient depending on the temperature change and, subsequently, influenced by direct sunlight, which changes according to the sun's diurnal motion.

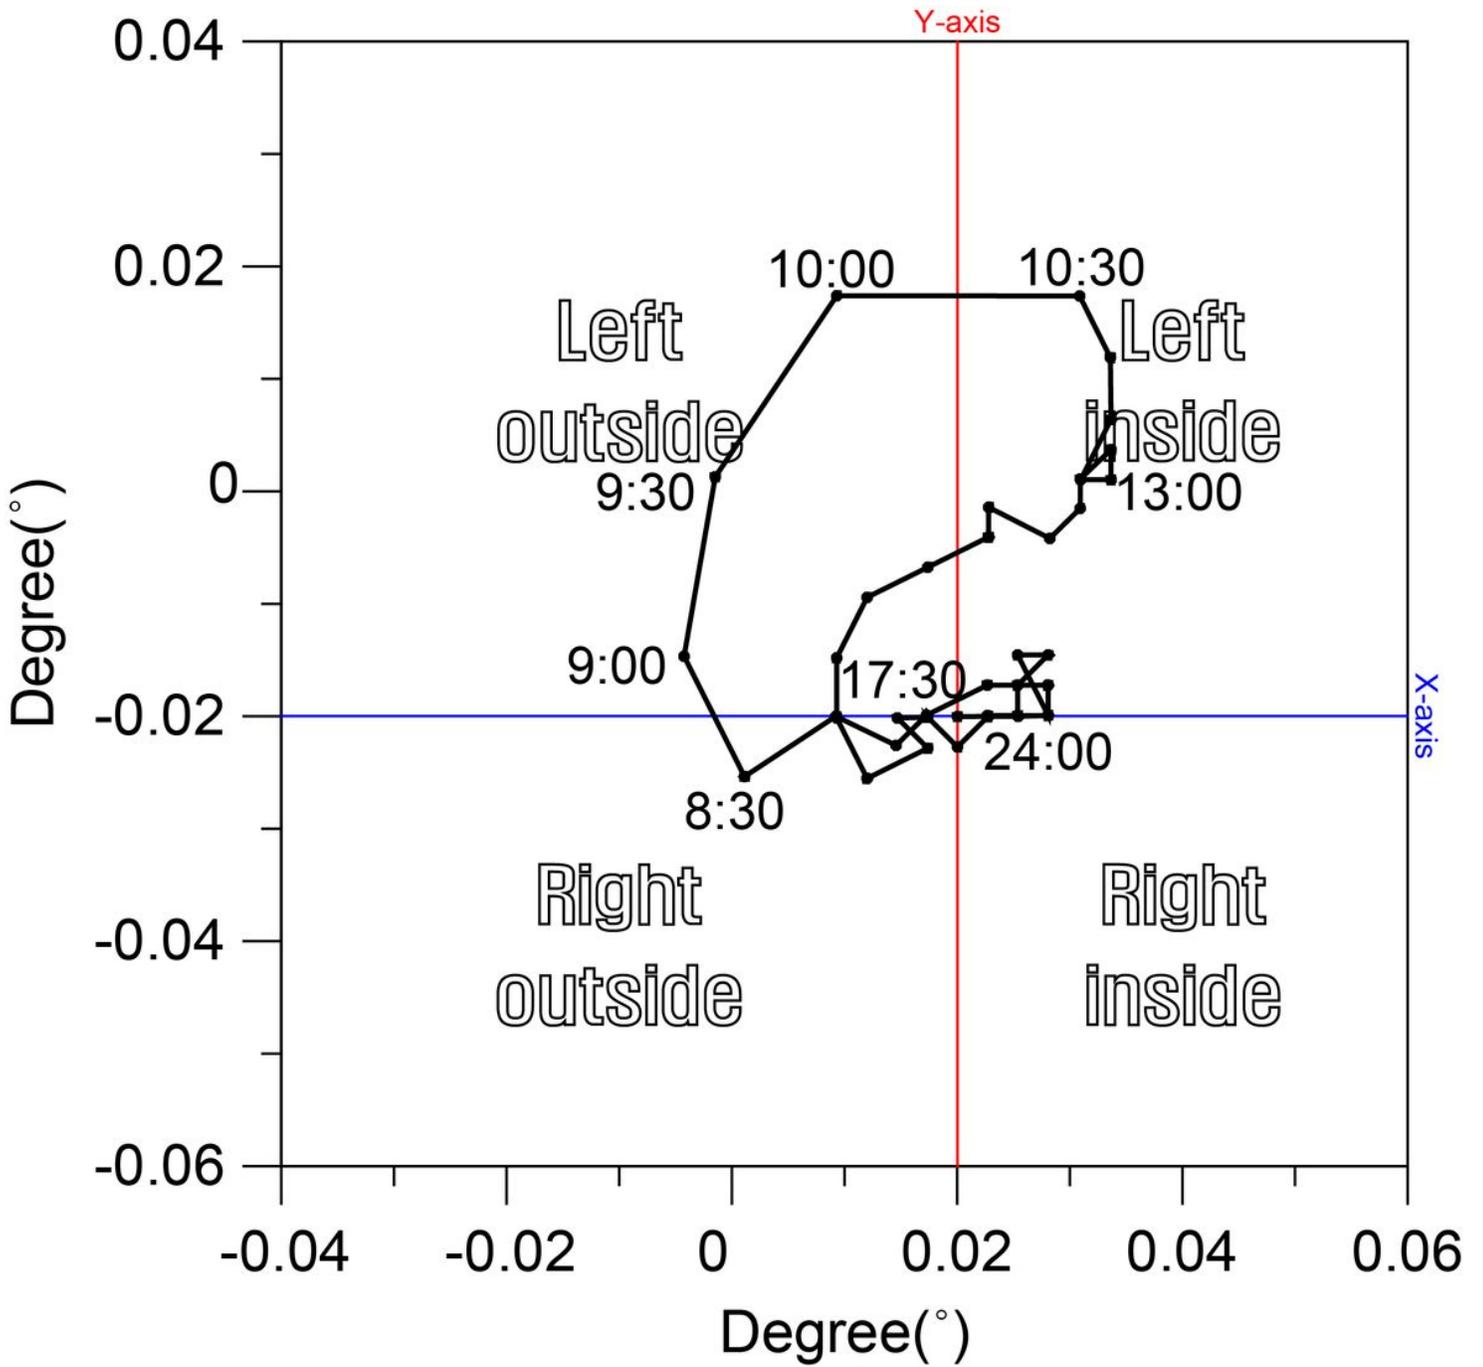
Figure 10

Diagram showing the daily behavior in two dimensions on one sensor of typical movement on representative stones in the rampart.

Showing the movements of the Gongsanseong Fortress on a two-dimensional plane, we see that movements as minutes occur at sunrise and behavior changes progress in a rotating form (Fig. 10). But it is also confirmed that the ramparts do not perfectly return their original positions after 24 hours, which means that slight differences occur. Such differences accumulate every day at all measuring points to make the rocks lean to a certain direction or produce gaps in between, and huge changes are detected in some sections. The direction to which stones move varies depending on the ramparts where sensors are attached, and some of them rotate in the clockwise direction while others rotate counterclockwise. To explore the factors that influence the direction of rotation, the data was compared with various morphological characteristics of the ramparts but no particular correlation was found.

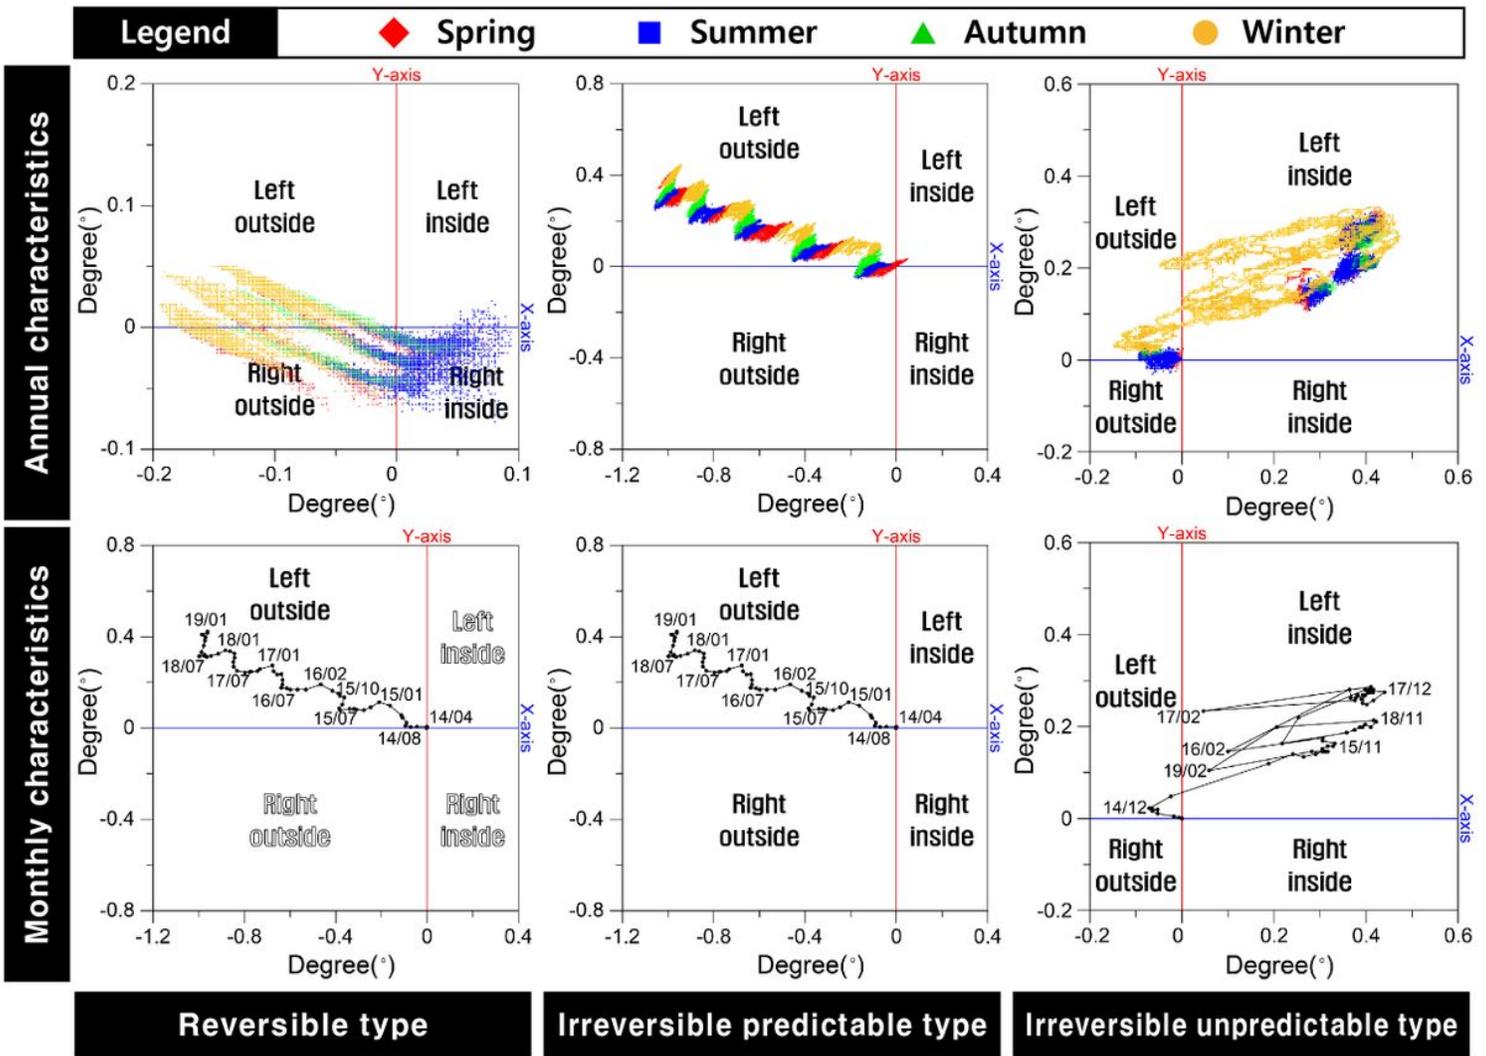
Figure 11

Annual changes and monthly behavior characteristics on sensors of representative stones as types in the ramparts.

deformation occurs throughout the ramparts. To check the ramparts' movements and behavior changes over a one-year cycle, three to five years of measurement data was shown in the form of a distribution graph on a two-dimensional plane. The number of measured data sets accumulated in a single sensor over a year is over 50,000 and, as it may be difficult to accurately understand the behavior due to an excessive volume of data, movements during a month were shown on a graph together at 12 AM on the first of every month to check the general trend.

As a result, we were able to classify behavior changes of the Gongsanseong Fortress into reversible changes and irreversible changes based on the reversibility of the change. Irreversible changes can then be subdivided into the predictable type and unpredictable type depending on the degree of predictability (Fig. 11). First, the reversible change type vibrates with periodicity centered on the origin of measurement and forms points of inflection during summer and winter each year.

This is the outcome to which the ramparts' thermoelastic behavior due to annual temperature changes is reflected, and it can be interpreted as that the ramparts retain structural restoring force. However, the ramparts do not perfectly return to the original state after a one-year period and, instead, their slopes or distances slightly change to a certain direction. The magnitudes of changes generated are very similar from one year to the next, and the changes are continuously repeated without any change in the direction.

Among the irreversible change types, the predictable type has points of inflection during summer and winter, and allows to observe the progress of behavior changes with periodicity but also shows a pattern of slowly drifting away from the origin of measurement, causing the ramparts to move. The general form of behavior changes is very much standardized, and the same pattern repeatedly occurs every year so future trends of the changes can be projected approximately.

The direction to which an irreversible behavior proceeds does not change but, rather, continues to be maintained but the amount of change varies depending on the year measured. It was confirmed that periods during which characteristically significant changes occurred vary from one sensor to another, which may possibly be an effect of external factors such as the ground, structure and underground water near the ramparts rather than yearly differences in the weather environment.

Lastly, the unpredictable type of irreversible changes continuously produces irreversible structural deformations on the ramparts and no specific periodicity and regularity are observed, which makes it impossible to predict future behavior trends. This type ramprats tend to exhibit stable and predictable movements in spring, summer and fall but, during winter, these ramparts commonly show abnormal behaviors as the direction and amount of increase of behaviors fluctuate frequently. The fact that abnormal behaviors only occur in the wintertime is believed to be due to moisture remaining inside the ramparts that, as it goes through a process of freezing and melting and changes the volume, therefore, directly affects the structural deformation.

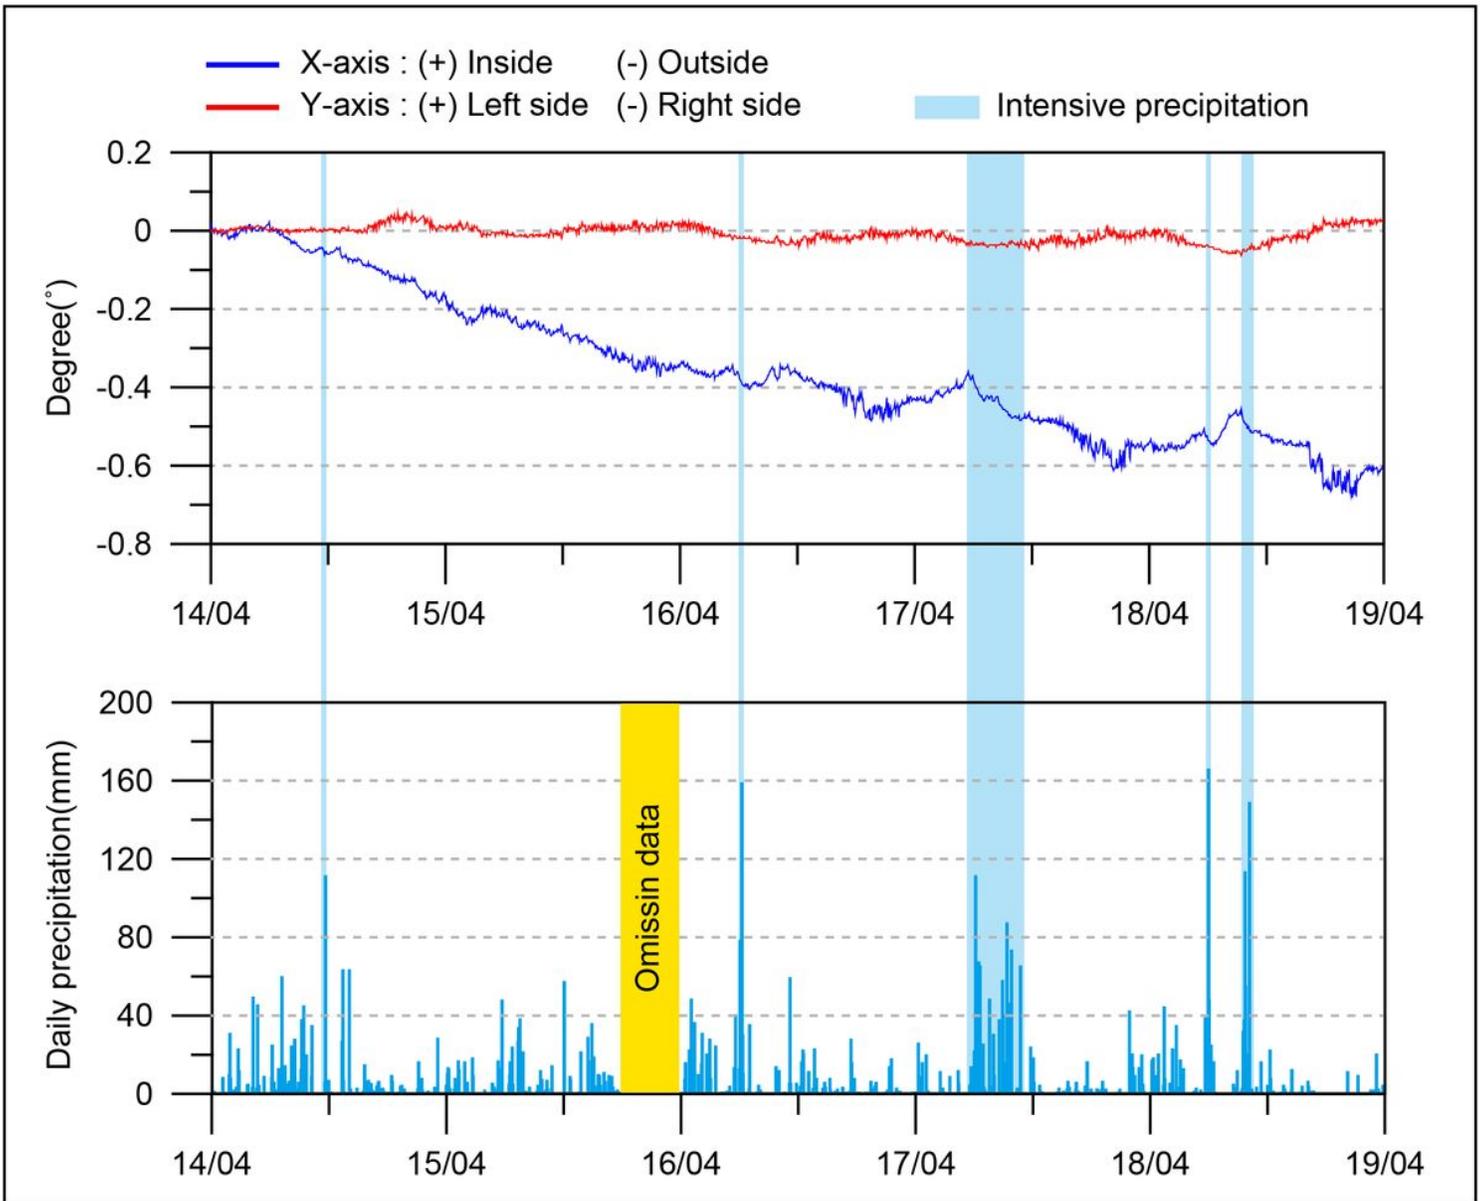
Figure 12

Diagram showing the representative environmental movement variation of the rampart.

Most monitoring sensors were affected by temperature changes the most, and the effect of direct sunlight was detected principally by the direction. To check the effect of humidity, rainfall, wind direction and speed in addition to temperature, a comparative analysis was conducted with environmental measurement results, and it has been confirmed that the occurrence of rainfall and behavior changes coincide on some sensors (Fig. 12). However, not all the ramparts exhibited movements during rainfall, and behavior changes were only displayed in case of precipitation greater than a certain level.

The amount of precipitation needed for the behavior to occur varies from one rampart to the next and, on some sensors, movements of ramparts were observed even for a small amount of rainfall that lasts a long period of time. This points to the possibility of the behaviors affected not only by the rainfall taking place in an instant but also by the percentage of water content in the soil, which supports the ramparts.
