Structural Stability and Behavioral Characteristics of the Fortress Wall from the 6th Century Baekje Kingdom in Ancient Korea

Research article

Keywords: Gongsanseong Fortress, Morphological characteristics of ramparts, Automated monitoring system, Behavioral monitoring, Environmental change

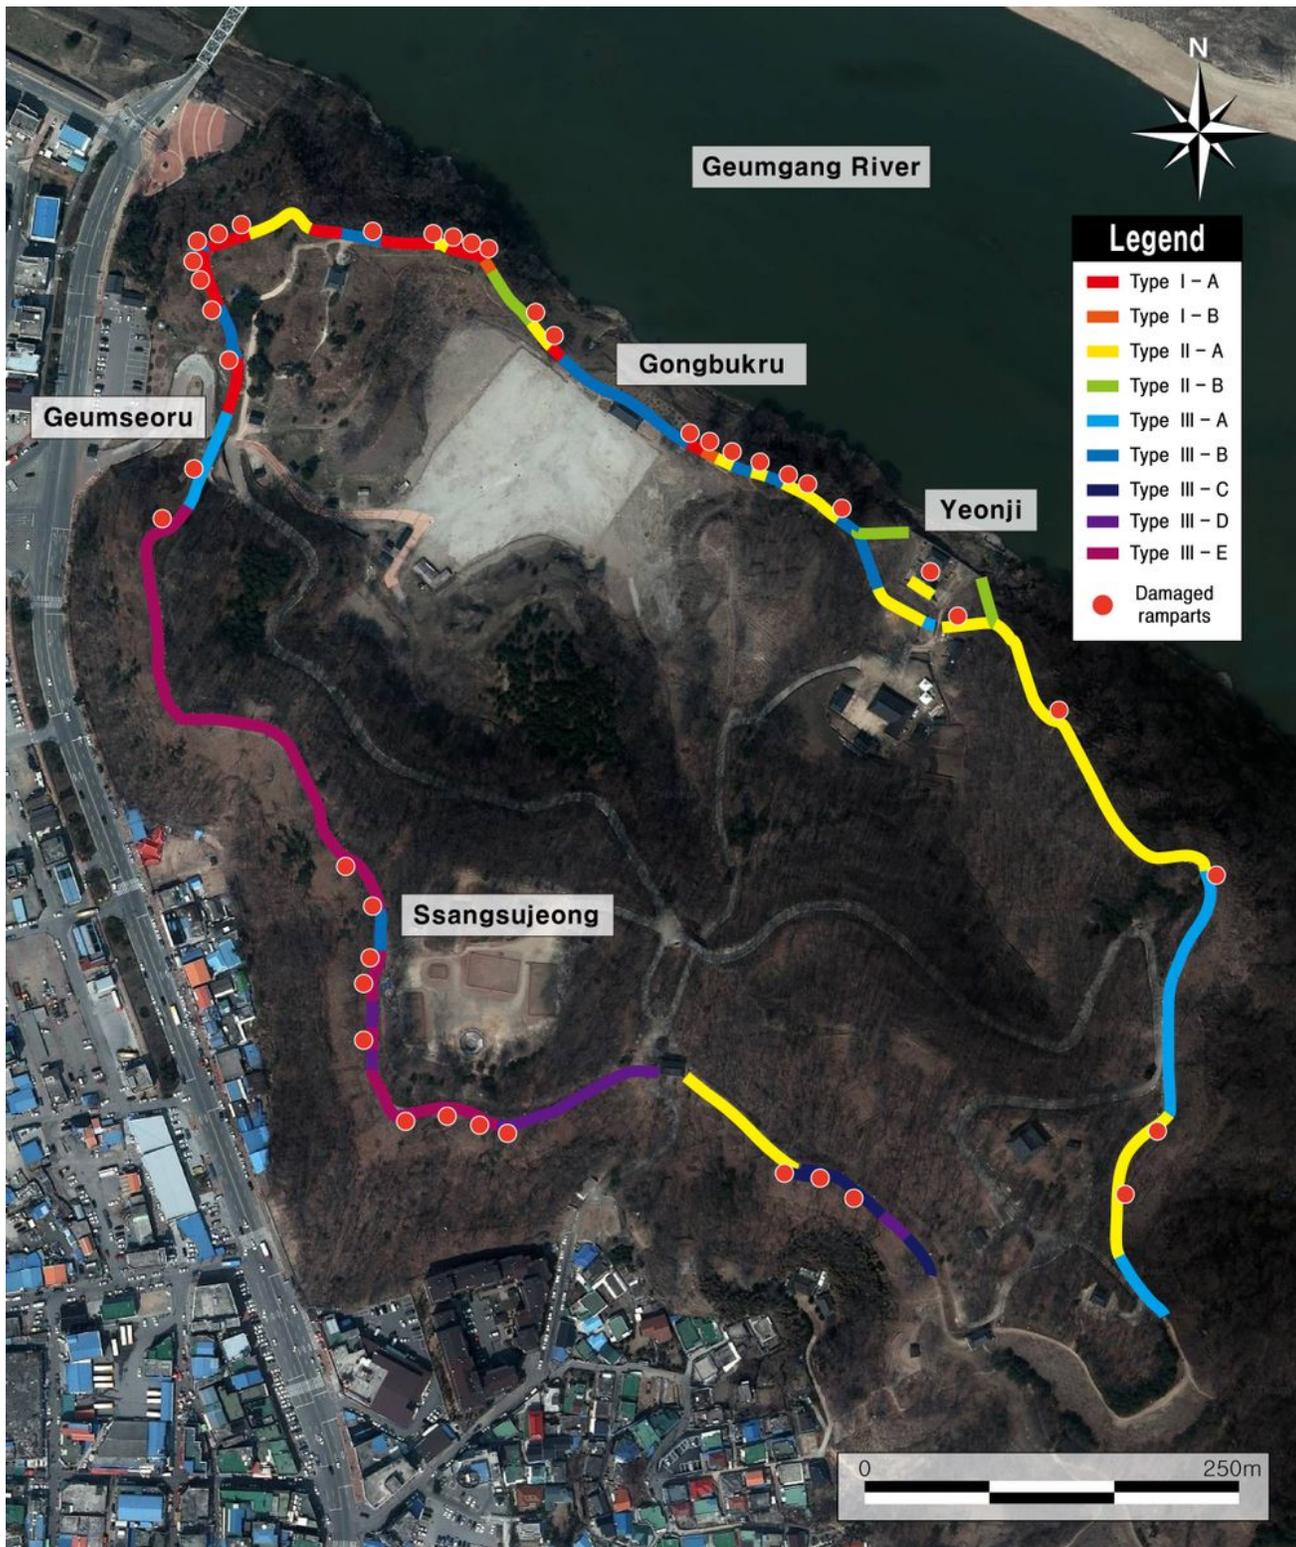
Figure 13

Distribution map showing the overlapped damage and construction types in the fortress. Note: The designations employed and the presentation of the material on this map do not imply the expression of any opinion whatsoever on the part of Research Square concerning the legal status of any country, territory, city or area or of its authorities, or concerning the delimitation of its frontiers or boundaries. This map has been provided by the authors.

Also, the classified construction types and the locations on the ramparts where structural deformations have occurred were overlapped to examine the distribution pattern (Fig. 13). First, many of the damaged sections in the Gongsanseong Fortress are located on northern slopes whereas the distribution of

damaged ramparts is shown to be reduced on southern slopes. Among the different construction types, the most distributed type is type II, and the highest share of damaged ramparts compared to the length is shown in type I (Table 2).

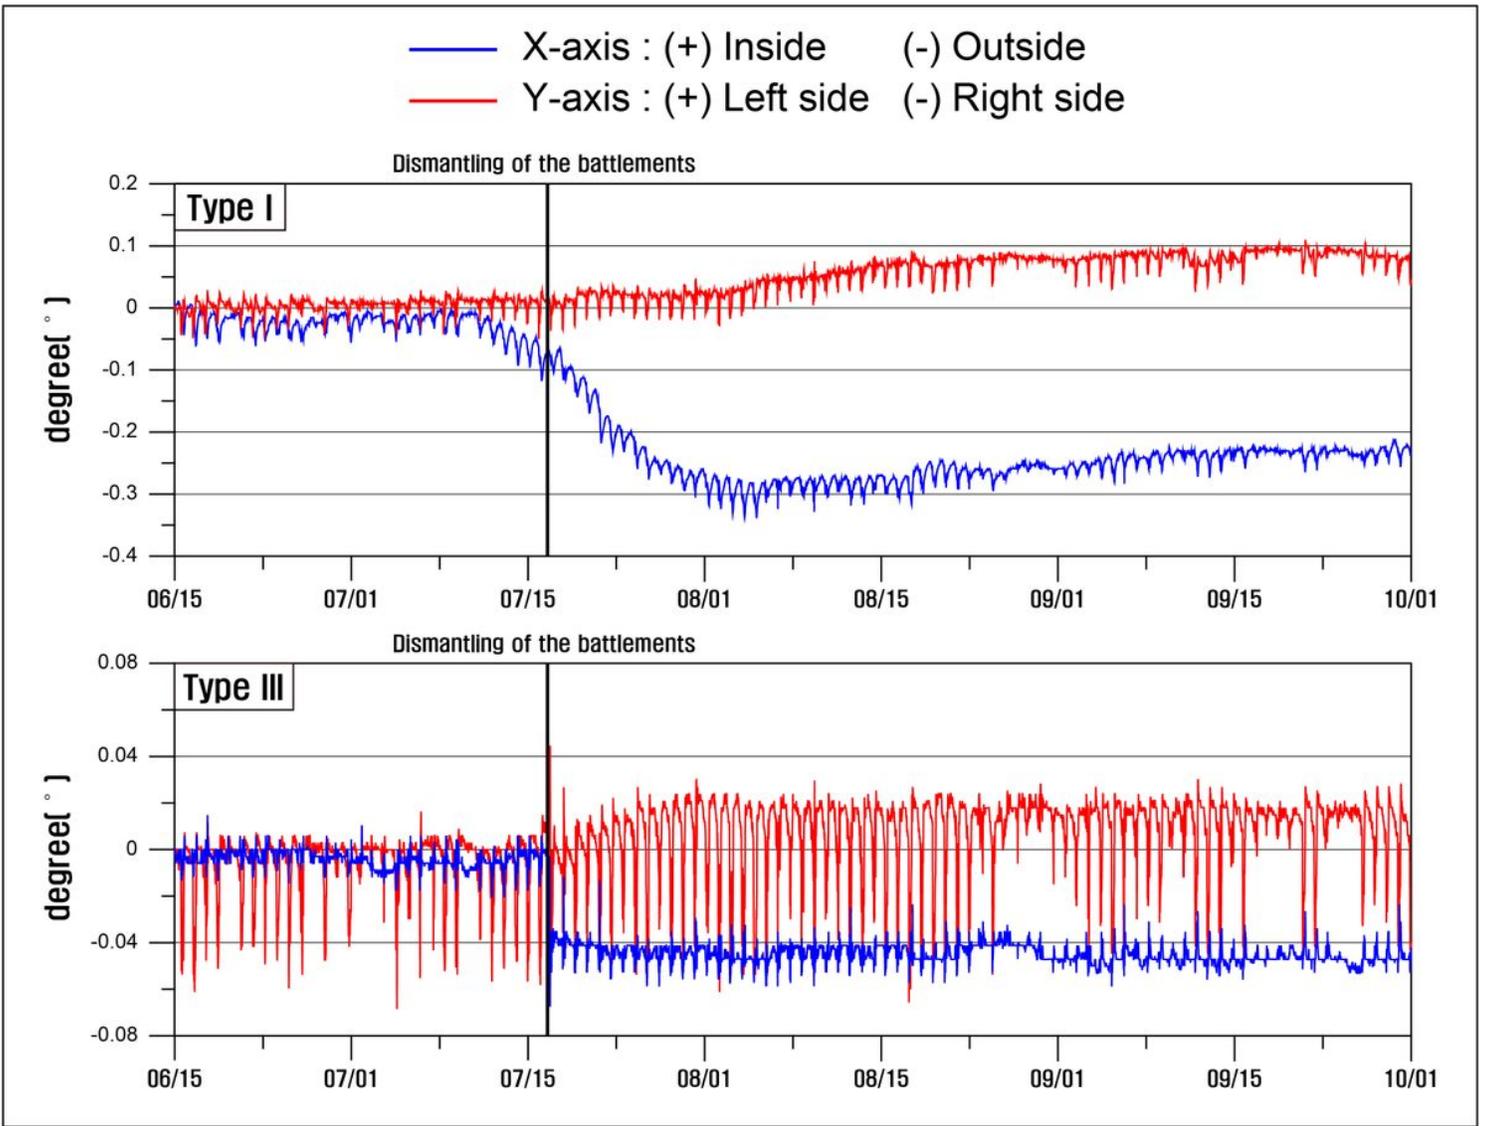
Figure 14

Diagram showing the representative behavior difference as construction types of the ramparts.

A battlement was installed on the rampart near the entrance but, after the issue of structural stability of the rampart was raised due to the load of the battlement, it was dismantled in 2015. During the process of removing this load, minute behaviors were detected on the ramparts, and different forms of movements were observed depending on the construction type (Fig. 14).

First, near the entrance, the rampart that was restored after the 2000s and corresponds to type III is located and, on the left of the entrance, the rampart classified as type I neighbors the type III rampart. Looking at the results of behavior measurement before and after the dismantling of the battlement, type I experienced a gradual behavior change over 2 weeks after the dismantling while type III showed brittle changes and a stable pattern immediately after the dismantling. Type I ramparts were built to align the external surfaces only without processing the stones and, thus, the contact faces between stones are irregular. So, in order to maintain a structural equilibrium along with a change in loads, each of the stones behaved independently to proceed stabilization.

On the other hand, type III ramparts processed the stones in a rectangular form and constructed to match the joints. The contact faces between the stones are also very broad. Thus, it can be interpreted as a phenomenon in which an entire the rampart behaves like a single continuum along with a load change and creates a brittle change instantaneously before reaching stabilization. So, even in the same environment, different forms of behavior changes may be manifested depending on the construction type, and the effect of different behavior changes may occur as structural instability on the boundary between different construction types.
