Conservation State of Two Paintings in the Santa Margherita Cliff Cave: Role of the Environment and of the Microbial Community

Research Article

Keywords: cave painting, sulphates and chlorides, bacterial community, environmental monitoring, conservation plan

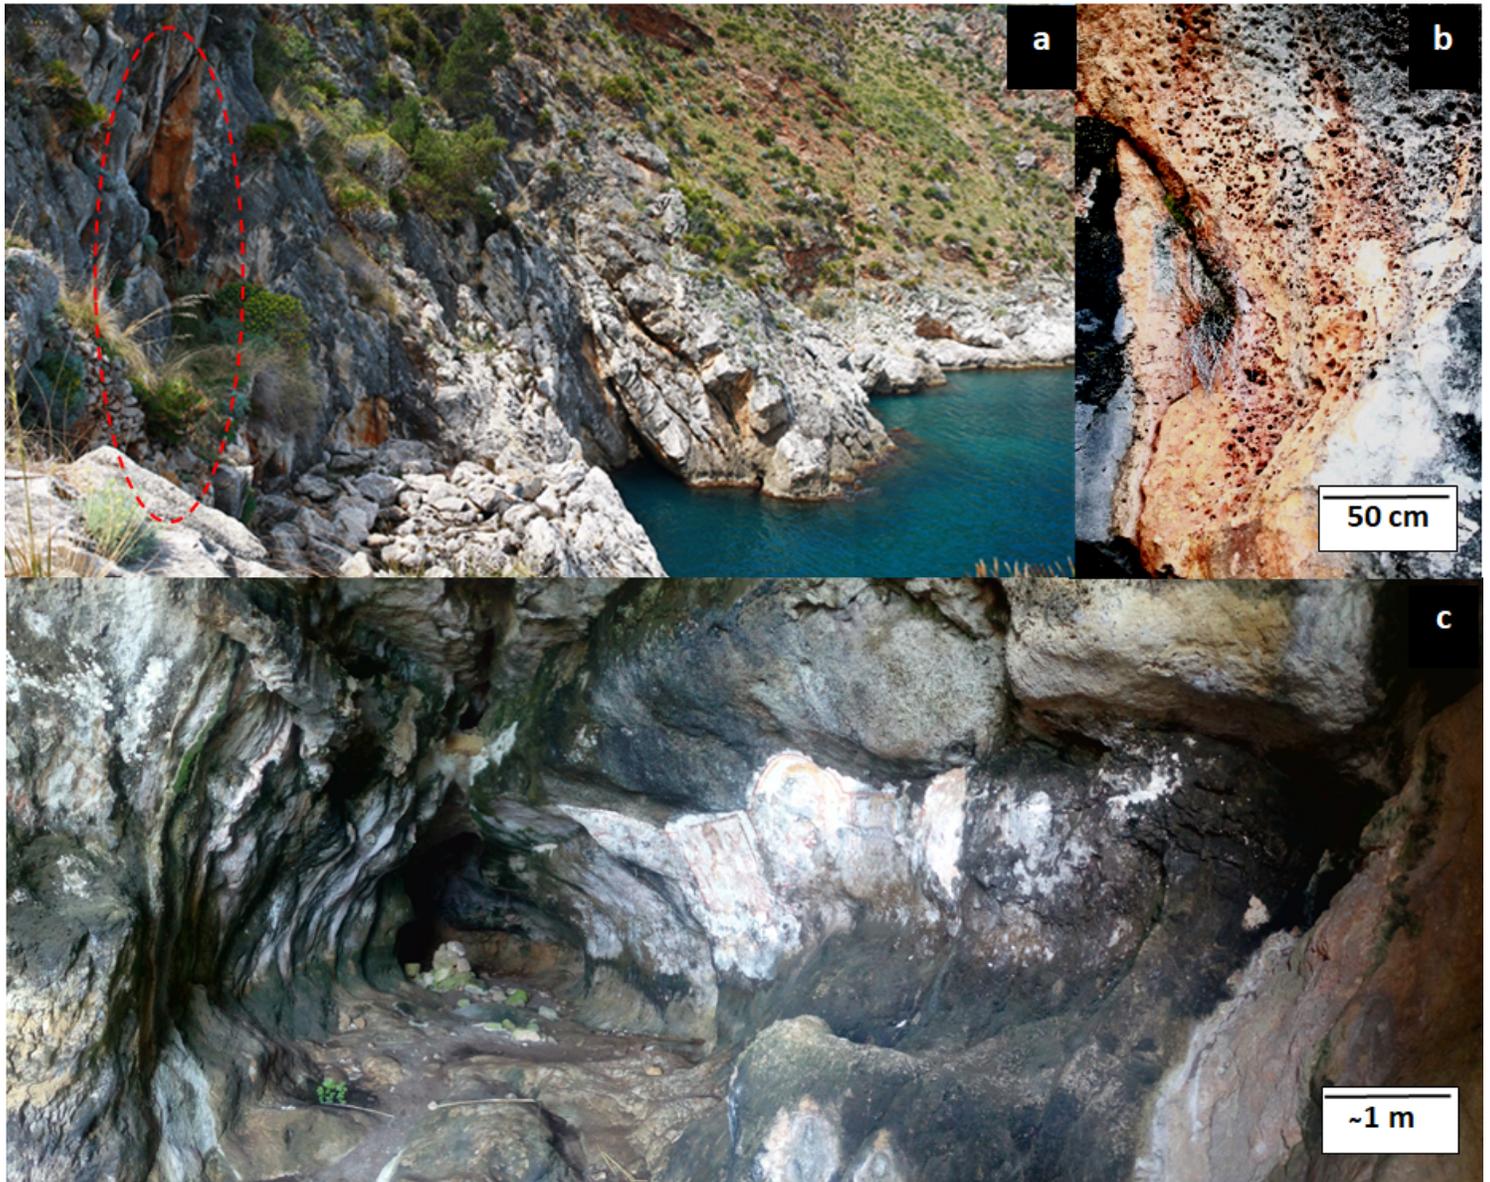
Figure 1

Coastal cliff in which the site is located, the entrance of the cave is indicated by a red circle (a); detail of the cavities on the surface eroded at the entrance of the cave (b); general view of the interior of the cave (c), the eastern wall is to the left side of the picture and the western wall to the right. Note: The designations employed and the presentation of the material on this map do not imply the expression of any opinion whatsoever on the part of Research Square concerning the legal status of any country, territory, city or area or of its authorities, or concerning the delimitation of its frontiers or boundaries. This map has been provided by the authors.

According to the description of Galante (Galante 2011), the paintings correspond to the Byzantine style from the XII Century (Purpura 1999), being located in both east and west walls and featuring a different degree (Fig. 1).

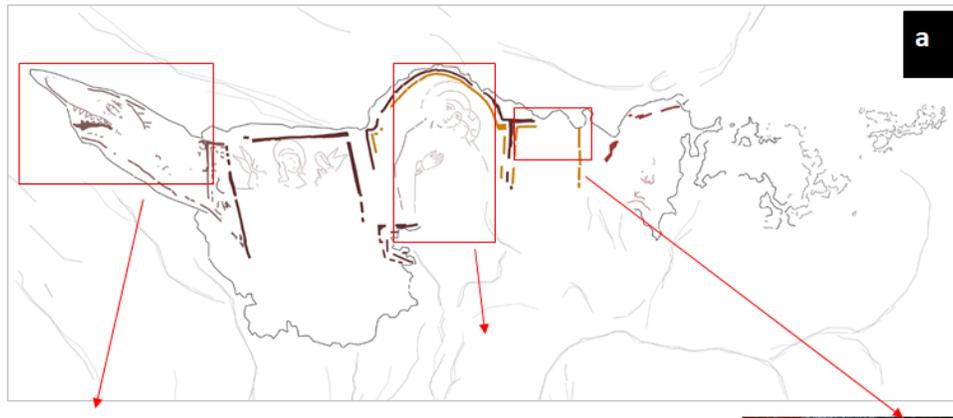
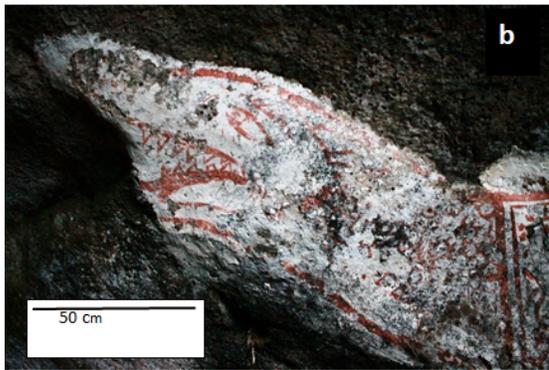
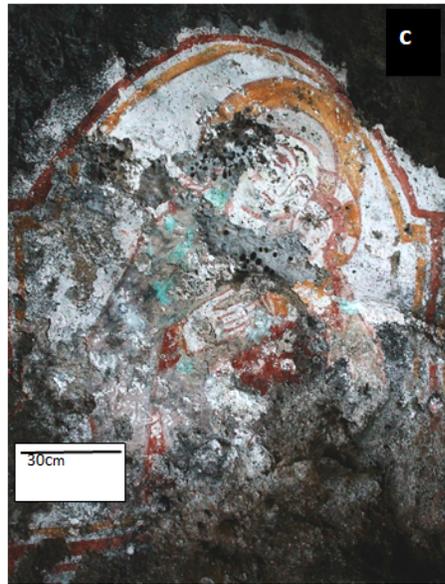
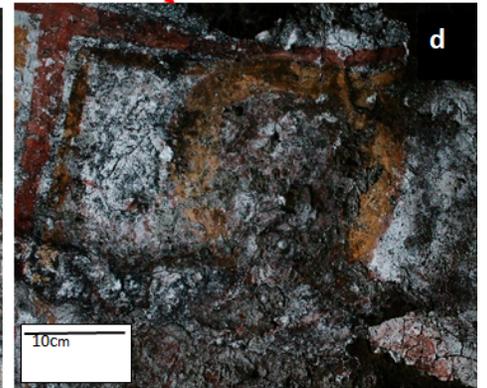
Figure 2

Map (a) and details from the scenes represented on the first layer of painting from the west wall, mostro marino (b), Madonna col bambino (c), figure not identifiable (d). Note: The designations employed and the presentation of the material on this map do not imply the expression of any opinion whatsoever on the part of Research Square concerning the legal status of any country, territory, city or area or of its authorities, or concerning the delimitation of its frontiers or boundaries. This map has been provided by the authors.

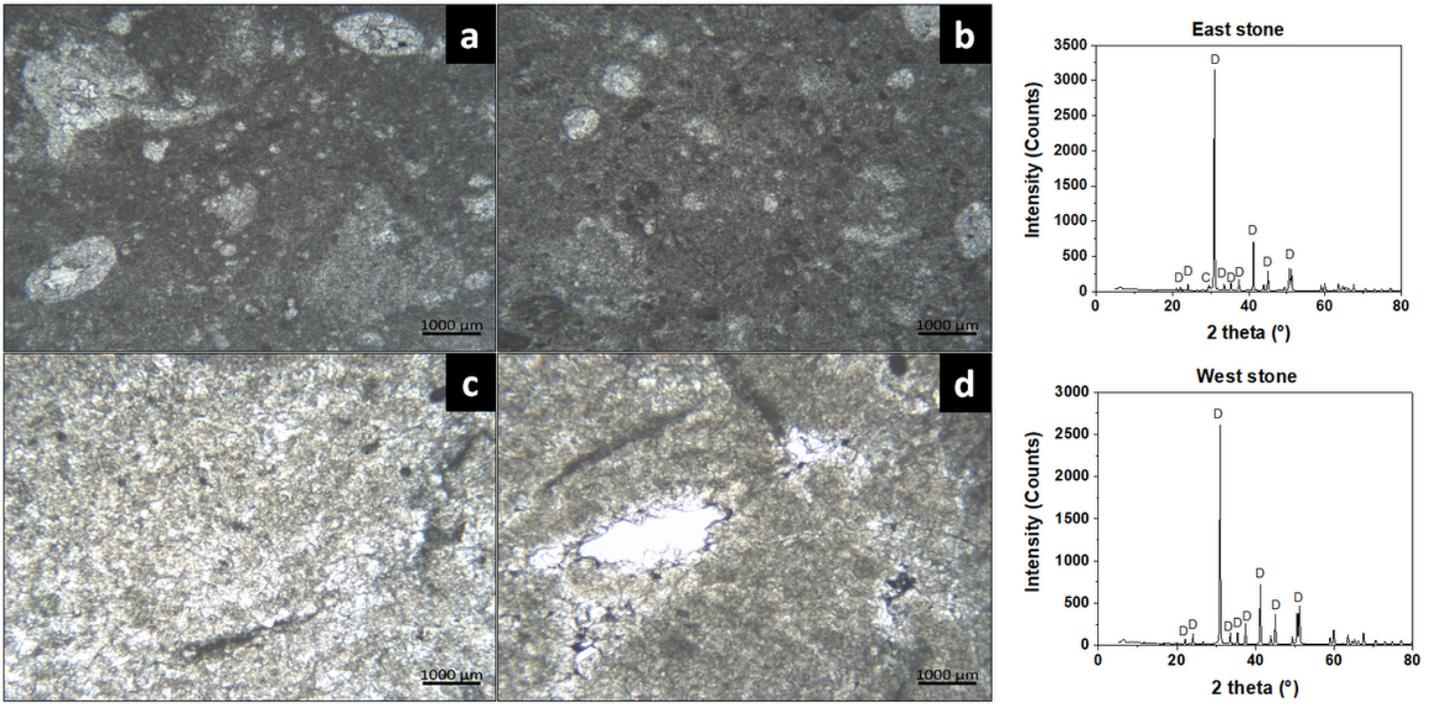
Figure 3

Microphotographs of the thin sections from east wall (a-b) and west wall (c-d). XRD patterns obtained from samples east and west stone (e). The crystal phases correspond to Dolomite (D) (Ref Code 01-075-1655) and Mg Calcite (Ca) (Ref Code 01-086-2335).

East wall microphotographs of stones thin-section from the host rock (Fig. 3a,b). The sample consists of a small amount of calcite together with dolomite phase (Fig. 3) and match to a dolomitized limestone. The carbonate matrix contains fine-grained dolomite crystals and recrystallized bioclasts, probably benthic foraminifer's tests, that appear as small globular grains.

West wall sample (Fig. 3c,d) shows the features of a dolostone. It is composed of a fine to medium crystalline mosaic of dolomite as evidenced by the XRD pattern (Fig. 3e).

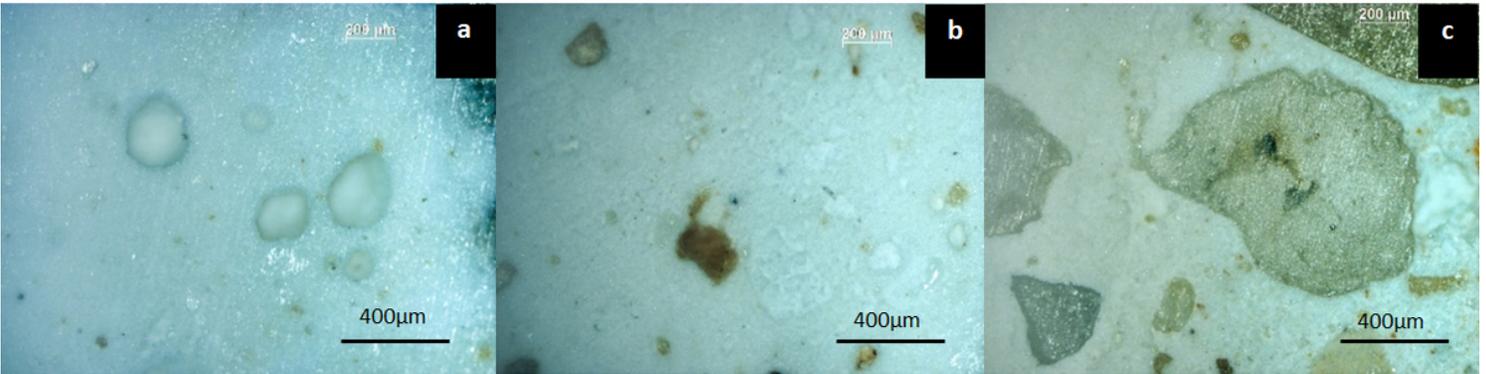
Figure 4

Photo of samples from East Mortar (a), West 1 Mortar (b) and West 2 Mortar (c) observed under the optical microscope.

The microscopic observation of mortars cross sections reveals that East Mortar (EM, Fig. 4a) consists of a fine-grained matrix constituted by 90% of binder fraction and 10% of amorphous and well-rounded aggregates with particles size between 5µm and 500µm with colours varying from white to reddish

brown. West 1 Mortar (W1M, Fig. 4b) similar to east mortar consists of a fine-grained matrix constituted by 85% of binder fraction and 15% of amorphous and rounded aggregates between 5µm and 200µm with colours varying from white to reddish brown. West 2 Mortar (W2M, Fig. 4c) consists of a matrix constituted by 60% of binder fraction and 40% of angular and rounded aggregates with particles size between 50 µm and up to 2 mm. The colours change from white and grey to reddish brown. W2M is thus different from the two others.

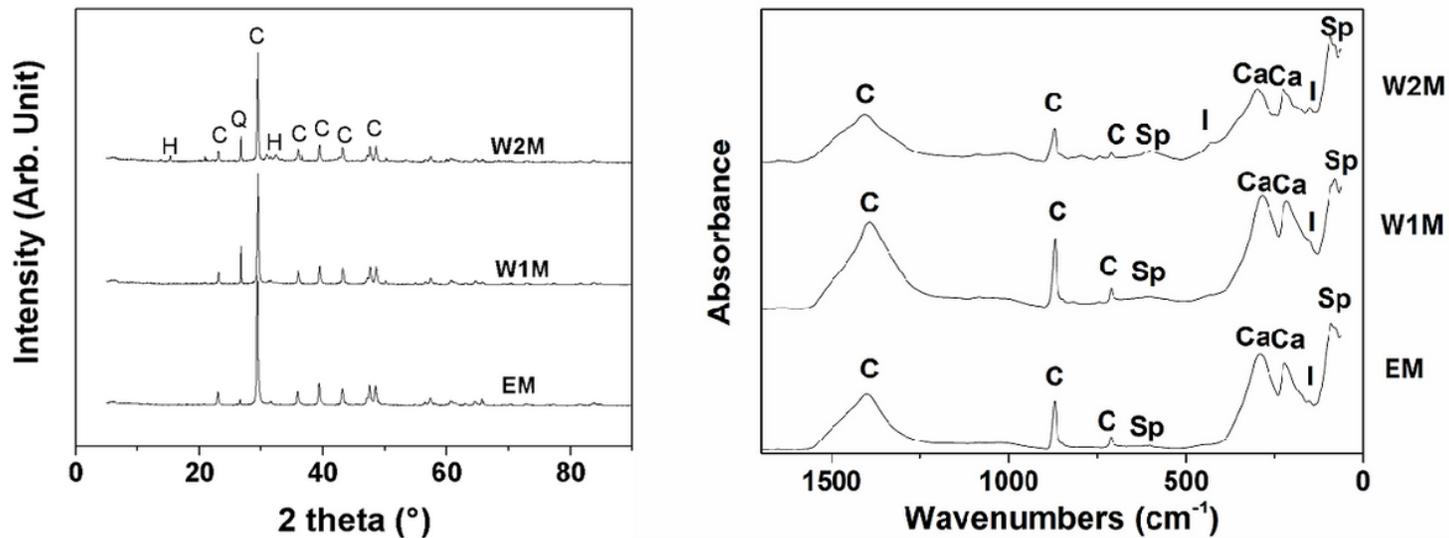
Figure 5

FTIR spectra of east mortar (EM), west 1 mortar (W1M), west 2 mortar (W2M) showing the bands associated to calcite (C), other carbonates (Ca), sulphates (Sp), iron oxides (I). XRD patterns of East Mortar (EM), West Mortar 1 (WM1), West Mortar 2 (WM2). The crystal phases correspond to calcite (C), Hydromagnesite (H) and quartz (Q).

The FTIR spectra of the three samples (Fig. 5a) show the characteristic bands of calcite (713, 874, 1396 cm^{-1}). In addition, the spectra suggest the presence of different compounds based on carbonates (816, 746, 295, 220 cm^{-1}), sulphates (614, 601, 81 cm^{-1}) and iron oxides (432, 150 cm^{-1}). The XRD patterns (Fig. 5b) show that the mineral phases occurring in all the samples correspond to calcite (C), quartz (Q) and hydromagnesite (H). According to the literature, these components are related as follow, calcite to the binder fraction, quartz to the aggregates fraction and gypsum to the alteration products of the mortars (Carozzi 1960). It is noted that in coastal regions, the atmosphere is enriched with particles that are naturally generated by the action of wind on the seawater. These particles contain ionic species, principally chlorides and sulphates. Thus, probably sulphates penetrate into the inner of the mortars through ionic diffusion (Salvadori et al. 2003; Rizzo et al. 2008). The knowledge of the presence of gypsum is very important because it is well known that it influences the mechanical stability of the mortars and its presence requires specific approaches of conservation (Grassi et al. 2007; Carretti et al. 2007; García-Vera et al. 2020; Salvadori et al. 2003).

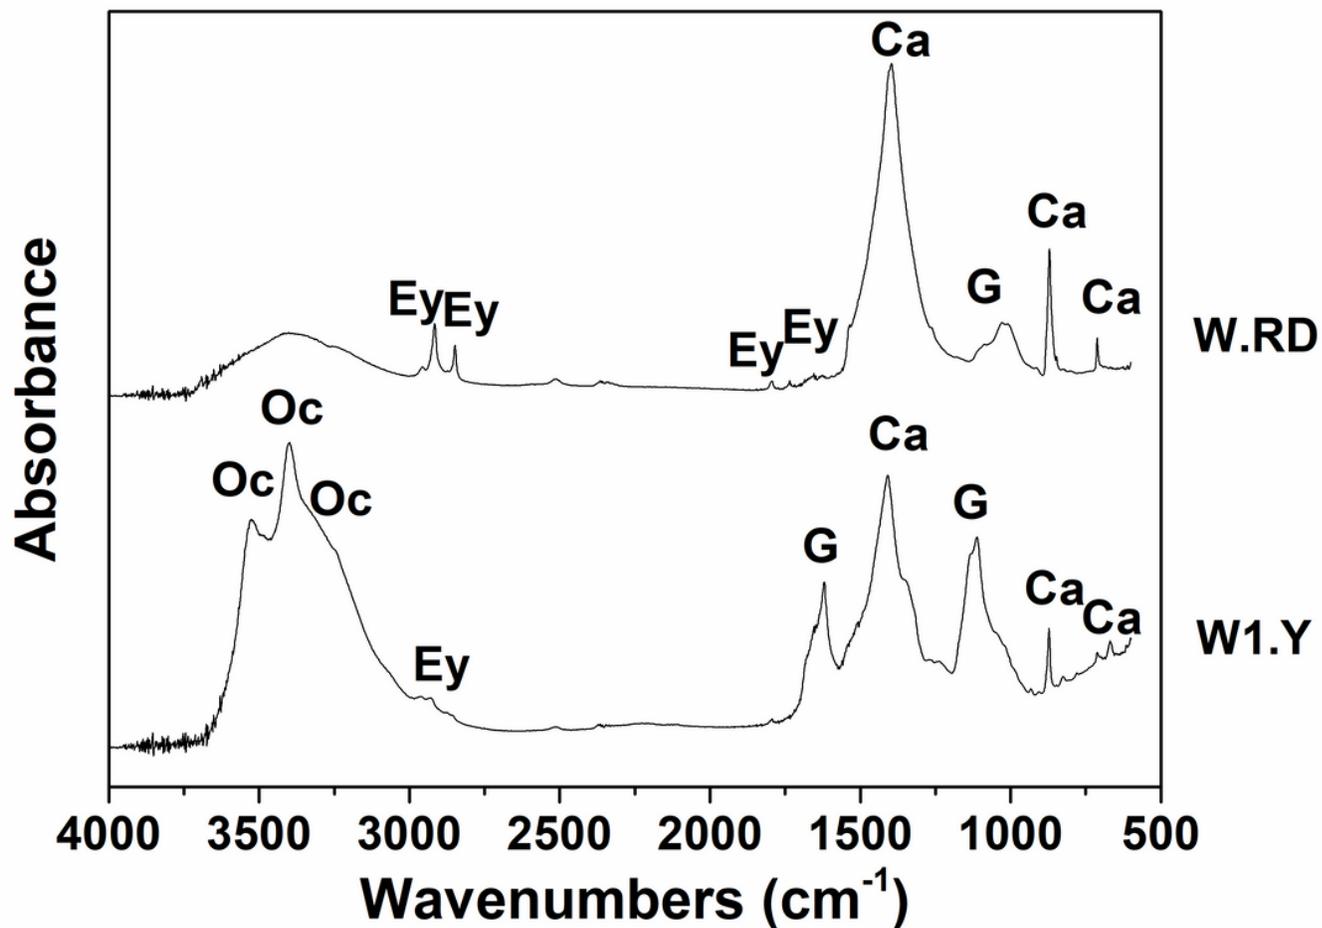
Figure 6

μ FTIR spectra of the yellow pigment (W1.Y) from painting 1 and dark red (W.RD) from the West wall. The bands obtained suggest the presence of calcite (Ca), gypsum (G), italian gold ochre pigment (Oc) and egg yolk (Ey).

The organic part of the picture layer (binding and varnish) was investigated by Infrared and NMR Spectroscopy. μ FT-IR spectra (Fig. 6) show the presence of both inorganic and organic compounds. The bands at 1396, 874, 713 cm^{-1} are ascribable to the calcite, while the bands at 1624, 1105, 596 cm^{-1} to gypsum in agreement with the results obtained for the mortars. In addition, the IR spectrum of the yellow colour show the bands at 3524, 3400, 3240 cm^{-1} suggesting the presence of the pigment gold ochre (Tortora et al.2016). The IR spectrum of the dark red colour show bands at 2954, 2918, 2851 cm^{-1} which

could be due to the presence of egg yolk binder (Tortora et al. 2016; Vahur et al. 2016); the bands at 1792, 1733, 1716 cm^{-1} could indicate that an oxidation process involving triglycerides of the egg binder took place (Raymond et al. 1993).

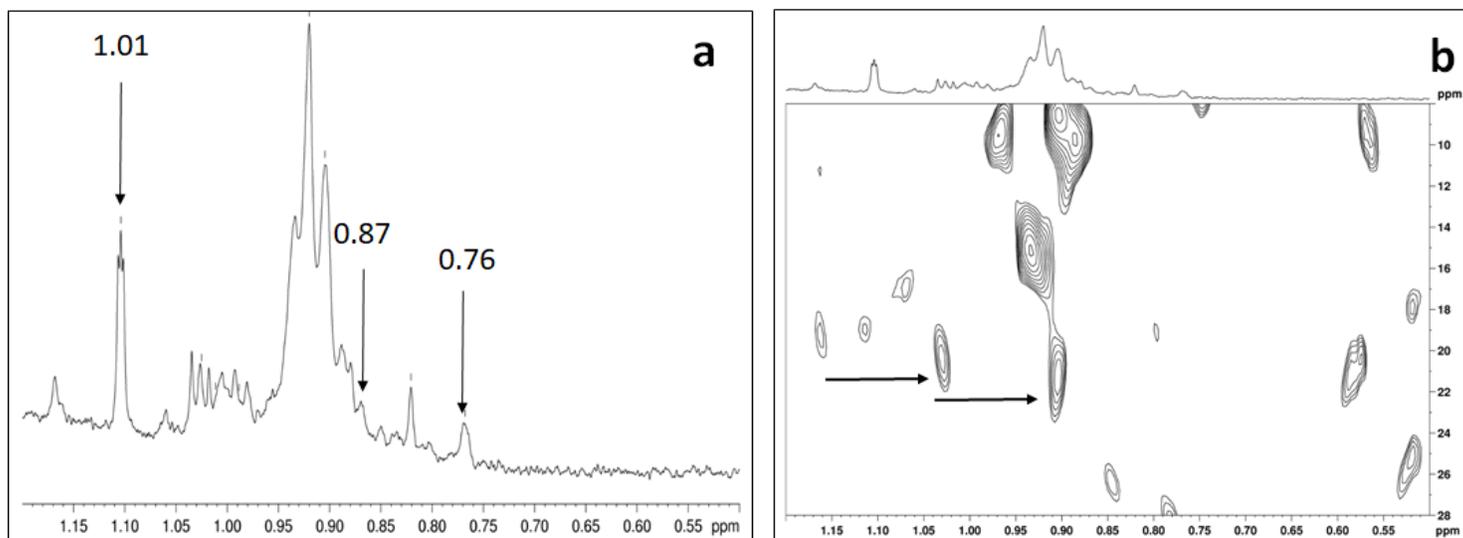
Figure 7

¹H NMR spectra in acetone-d₆ solution of the dark red pigment at magnetic field strength of 400.15 MHz showing peaks of acetone and methyl groups (a). Aliphatic methyl region of the 400.15 MHz ¹H 2D HSQC NMR spectra of the sample, the arrows indicate the characteristic pattern of the cholesterol methyl groups appearing (b)

The signals of ^1H NMR spectrum (Fig. 7a) at 0.76, 0.87, and 1.01 ppm could be due to the methyl groups of cholesterol. The 2D HSQC experiment shows that the ^1H ^{13}C correlation peaks positions (Fig. 7b) confirming the presence of cholesterol in the analysed sample. The presence of this molecule, according to Sofia et al 2014, is justified by the fact that the oxidation process involving the fatty acids in the egg binder does not affect the original carbon skeleton of the cholesterol. The presence of the cholesterol methyl groups confirms the use of egg yolk as binding media for the paintings.

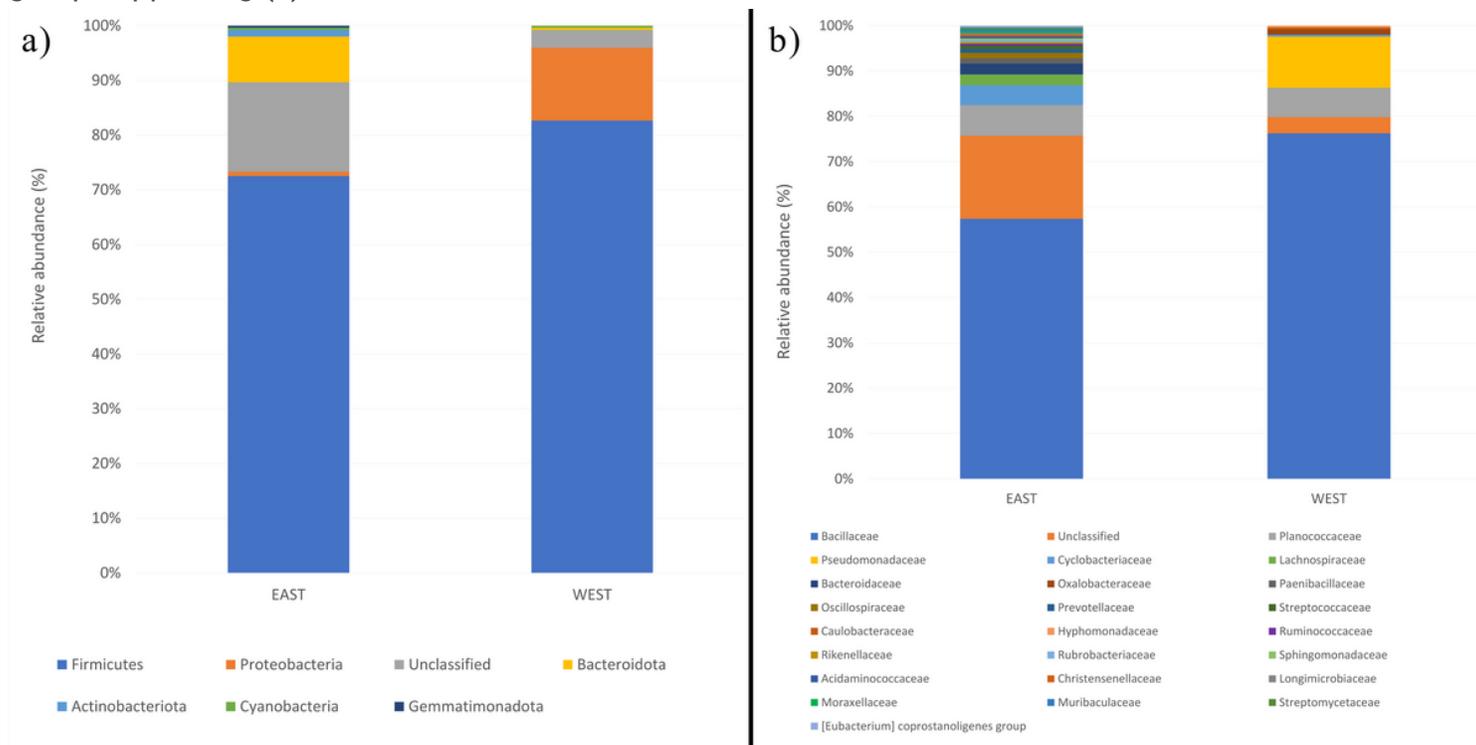
Figure 8

Relative percentage abundance of bacterial phyla (a) and families (b) found in the east and west walls of the Santa Margherita's cave.

The microbial survey carried out in the Santa Margherita's cave was aimed to evaluate the microbial community harboured by this unique environment on one hand, and on the other hand, to give insights about the possible role of microorganisms as a potential risk for paintings conservation. Similarly to what was previously unveiled in related cave environments (Ma et al. 2015; Portillo et al. 2008; Pavlik et al. 2018; Yasir 2018; Alonso et al. 2019), the bacterial community of both east and west walls was represented by Firmicutes, Proteobacteria, Bacteroidetes, Actinobacteria, Cyanobacteria, and Gammatimonodota phyla (Fig. 8a).

Firmicutes, mostly featured by Bacillaceae and Planococcaceae members, was the most represented bacterial phylum found in both walls, accounting for 57% (east) and 76% (west) of the entire microbial community (Fig. 8a), likely due to the capability of these bacterial strains of overcoming the challenge exerted by the abundant minerals such as carbonates (CaCO_3) and silicates (SiO_2) (Laiz et al. 2000; Randazzo et al. 2015), which were found in the Santa Margherita's cave. Indeed, bacilli strains such as *Bacillus pasteurii*, *B. cereus*, *B. megaterium* (all belonging to the Bacillaceae family), are bacterial members deeply investigated as bioconsolidants of limestone (De Muyne et al. 2013), concrete (Kim et al. 2013; Achal et al. 2011), and plaster (Anne et al. 2010), as result of biotic processes that catalyse the hydrolysis of urea and organic acids (i.e., oxalates and acetates) as carbon and energy sources to support urease activities, which will result in the production of carbonates (Dhami et al. 2014; Dick et al. 2006). Since the bacterial surface is negatively charged, microbial cells can acquire calcium atoms from the surrounding environment, which can precipitate with carbonates forming CaCO_3 at the cell surface.

Despite the higher relative percentage of Firmicutes in the west wall than the east one, the latter displayed a more heterogeneous microbial composition, as were also present – with a relative percentage abundance ranging from 1 to 2% (Fig. 8b) – bacterial members belonging to Lachnospiraceae, Paenibacillaceae, Streptococcaceae, Ruminococcaceae, Oscillospiraceae, Acidaminococcaceae, Christanellaceae, and Eubacteriaceae families, which were not found in the microbial community of the west wall. A similar conclusion can be drawn for Bacteroidota, Actinobacteriota, and Gemmatimonodata phyla (Figs. 8a) that, although a minority, were solely present in the east wall. This aspect, alongside the higher percentage abundance of unclassified bacterial species in the east wall (16%) *versus* the west one (3%), might be ascribed to the far more proximity of the former to the external cave environment, easily allowing microbial colonization to occur in this area. Another contributing factor could derive from the high chlorine extent found in the east area of the cave, explaining its high microbial heterogeneity in terms of bacterial families such as Paenibacillaceae, Streptococcaceae, Ruminococcaceae, Cyclobacteriaceae, Rubrobacteriaceae, Sreptomycetaceae, and Sphingomonadaceae in which are included bacterial strains that can moderately tolerate or even thrive under halophilic conditions (Schabereiter-Gurtner et al. 2001; Remmas et al. 2017; Corral et al. 2020; Chen et al. 2010).
