Identification of damage development in the core of steel cord belts with the diagnostic system

Research Article

Results of measurements with the Diagbelt diagnostic system in an underground mine

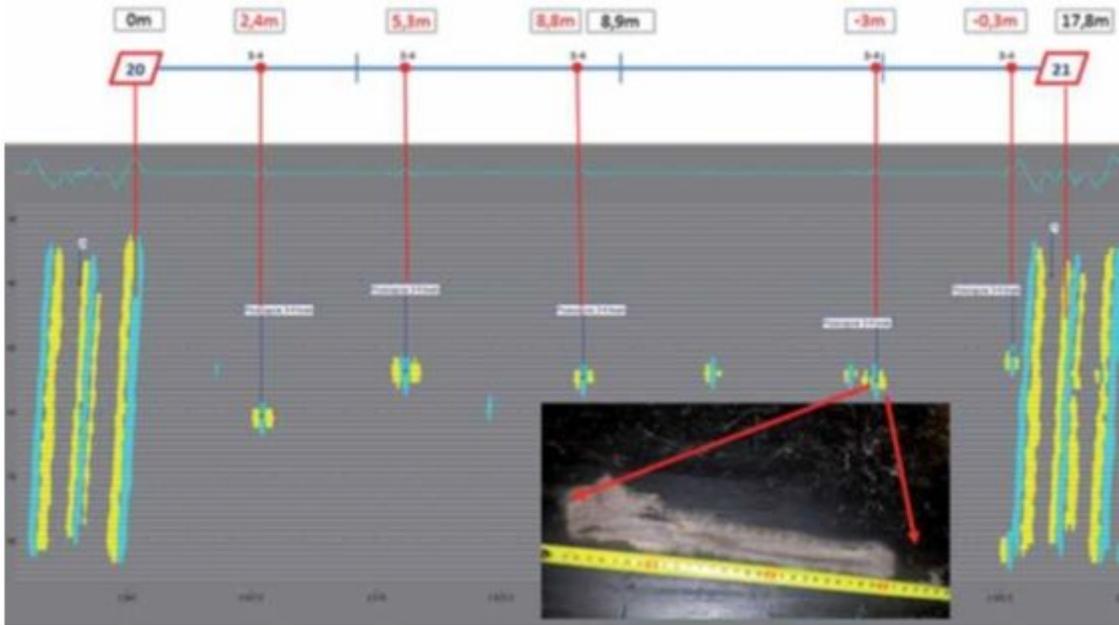
Condition of a belt section between joints with actual defects and their locations indicated (internal documentation) [13]

The DiagBelt system has been described in a number of publications [e.g. 7, 12, 14]. Figure 1 shows the method of damage imaging with the use of the BeltGuard probe confronted with an image of a significant belt defect [13].

Changing the belt damage representation from a one-dimensional signal to a 2D signal (Fig. 1-2 and Fig. 5) allows for quick data interpretation and belt condition assessment. Damage concentrations that pose a risk to the continuous operation of the belt loop on the conveyor can be clearly identified. Users can independently estimate the number, scale and location of defects. The analysis of one-dimensional signals (Fig. 1) from many measurements requires a trained specialist, and detailed interpretation is time-consuming. It is very difficult or practically impossible to quantify the size of a single defect and observe its changes over time.

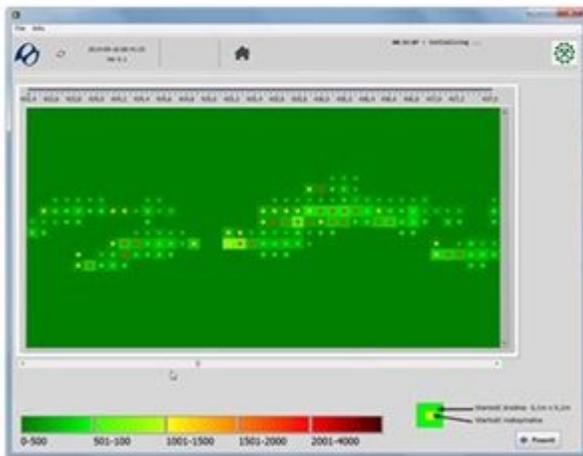
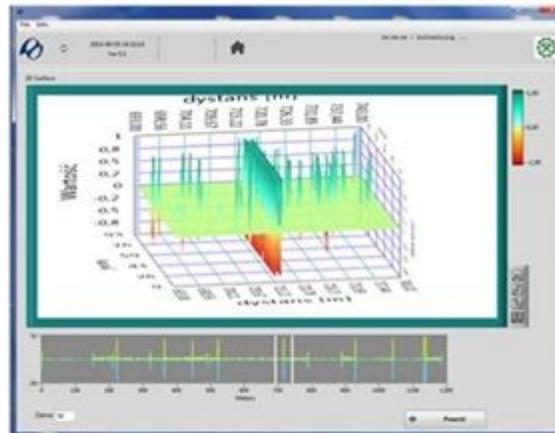
Figure 2

2.5D image of belt damage - matrix of 10 cm x 10 cm squares

3D image of belt splice and belt failures with 1D source signal below

Various methods for imaging defects in the core and in the splice: 2.5 D matrix 10x10cm (left) and 3D and 1 D signal (top right and bottom right) (<http://diagbelt.pwr.edu.pl/> [13].

As the system is of high resolution and offers the possibility to analyze field changes on various sensitivity levels, it allows 3D damage visualizations (Fig. 2, on the right), and their aggregation to squares 10 cm x 10 cm provides a 2.5 D image, in which the background color represents mean signal intensity level and the central point represents the maximum for the area (Fig. 2, on the left).

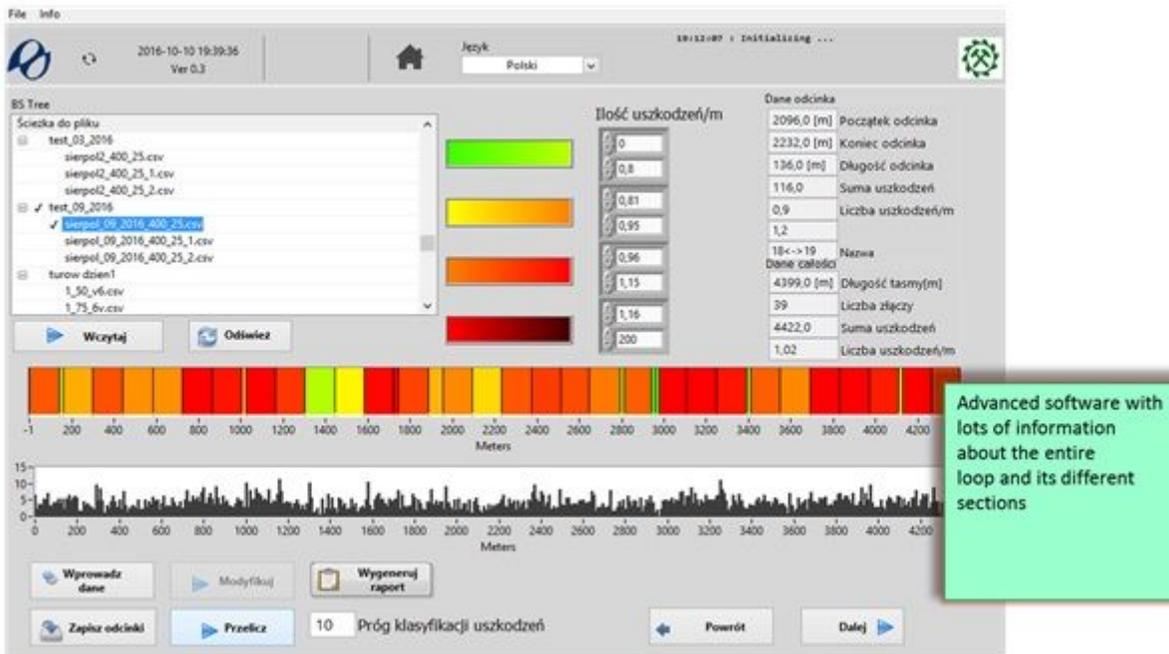
Figure 3

Belt loop on a conveyor viewed in DiagBelt with averaged and color-coded identification of the condition of successive belt sections and with a histogram of damage density along the belt axis

The system has sufficient resolution to allow a precise inventory of defects and the representation of aggregated damage level measures, such as for example damage density and area per running meter and the damage histogram on the belt section for a particular belt fragment or for the complete belt section from splice to splice [14]. Aggregating numerous defects into a synthetic measure is necessary to evaluate the general condition of a belt section, which is coded with colors (Fig. 3) enabling the user to instantly evaluate the degree of wear and tear in each of the segments in the loop. Green color corresponds to no damage and red color indicates a significant number of defects which may pose a threat to the functioning of a transportation system (Fig. 3).

The digital recording (-1, 0, +1) of changes in the magnetic field corresponding to the defects enables the compression of the resulting description of the belt condition (by removing nonsensical zeros from the record) and the storage of data from subsequent scans of the same belt loop for individual conveyors. By registering these changes at different sensitivity levels, it is possible to assess not only the location and size of damage, but also its intensity, and then visualize it on 2D and 3D charts (Fig. 3).

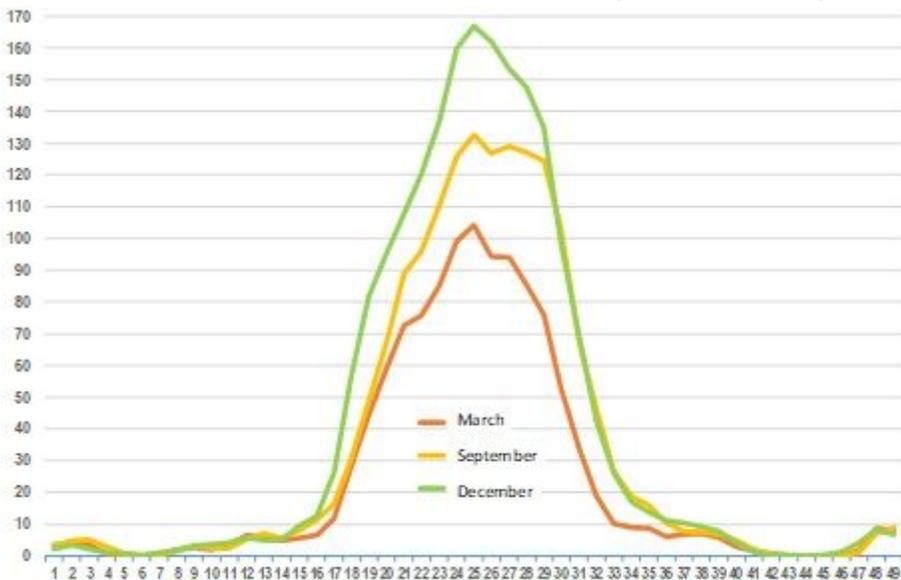
Figure 4

Histogram of average damage density in the cross-section of the belt, for 4 sections analyzed during 3 measurements in 2016, [33].

Visual representation of belt sections and their fragments allows both the scope of each defect and the damage density to be identified along the belt axis and in the cross-section (Fig. 4), and also provides information on the locations in need of repair (Fig. 1-4). Owing to the system's resolution, the size of each defect can be estimated and tracked over time [11].

identify damage distribution in the cross-section of the belt. The DEM software [6, 15, 27,40, 41] enables evaluations of how the shape of the hopper or the transfer chute influences the energy of the lump and the drop locations [30, 31, 36], as well as wear processes in both the belt covers and the transfer devices [22, 42]. However, it was impossible to verify this data in practice – a procedure of great significance in the validation of simulation models. From the user's perspective, damage distribution should be importantly even and not concentrated in the central part (Fig. 4), as in such case the belt wears faster in the central part while its edges or side parts practically remain in good condition. A belt which is evenly worn in its central part cannot be refurbished and therefore its core cannot be reused (two or even three times). Belt refurbishment consists in milling its worn external covers and in re-vulcanizing new covers with the old core. As such, the procedure meets the conditions of circular economy [8, 9, 28]. Disposal of the belt due to its overly worn central part is considered wasteful, as a large part of the belt is still in operating condition. As can be seen in Fig. 4, more than 50% of the belt cross-section remains in good condition.

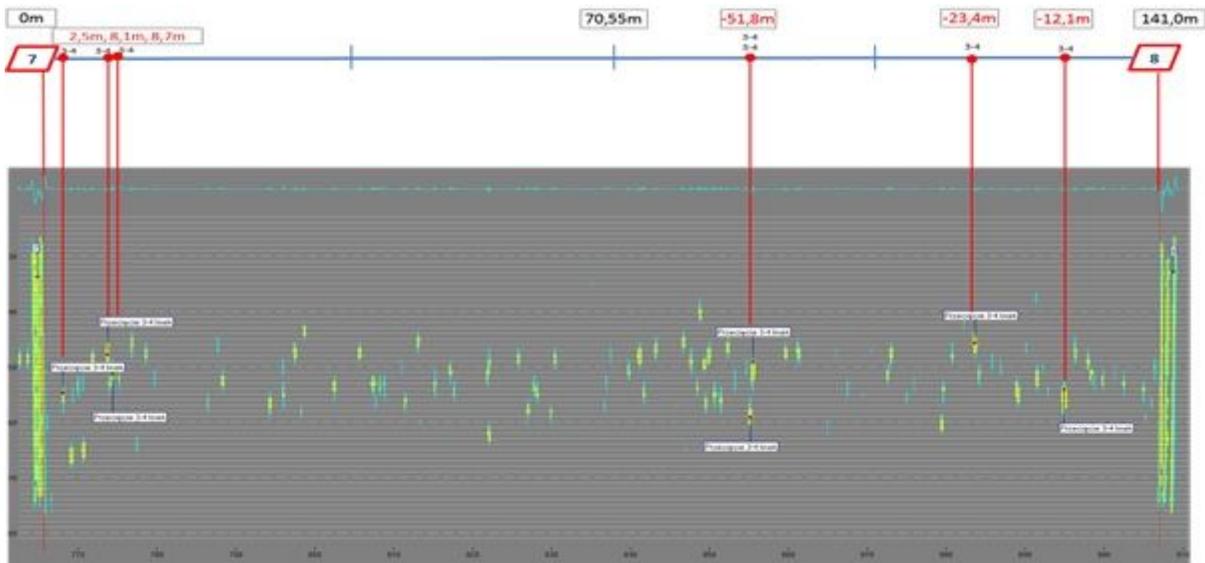
Figure 5

2D representation of a belt section after 86 months in operation [34, 35]..

The identified defects are indicated by a change of colour from yellow to blue (change of the magnetic field from negative to positive) (Fig.5). The total of the aggregated source signals from all sensors is shown above as a blue signal line in the grey background. Splices (7 and 8) are visible on both ends of the belt section. The required repairs are indicated above, along with their precise locations measured from the left splice in meters and with information on the number of defective cables.

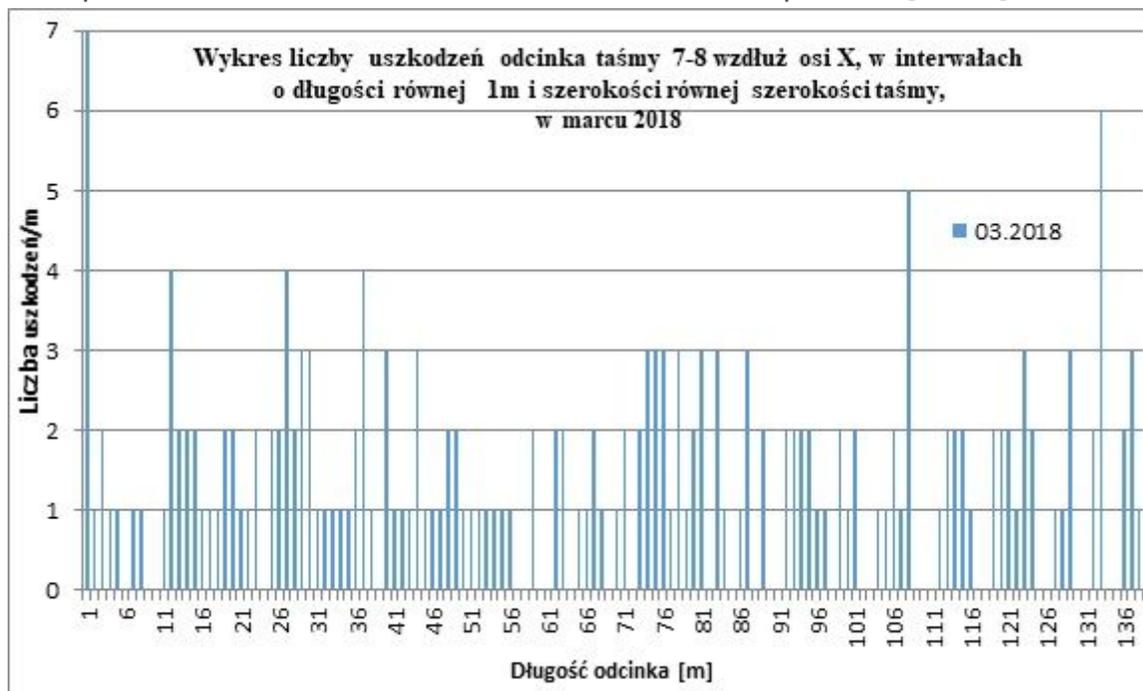
Figure 6

Damage density in 1-meter-long belt segments along belt axis, for the analysed belt section 7-8 – state of March 2018 (4th measurement) [34, 35].

The numbers of defects (their densities) are natural numbers. Zero represents no defects and n represents n defects identified in a particular 1-meter segment. This is shown in the graph of Fig. 6. The graph in Fig. 7 shows the change of damage density over time in consecutive scans of the 7-8 section from March, September and December 2016, as well as from March 2018. As can be seen, even after many years in operation, some 1-meter belt sections still show no trace of damage. Some other fragments, on the other hand, reach 7 defects per 1 meter.

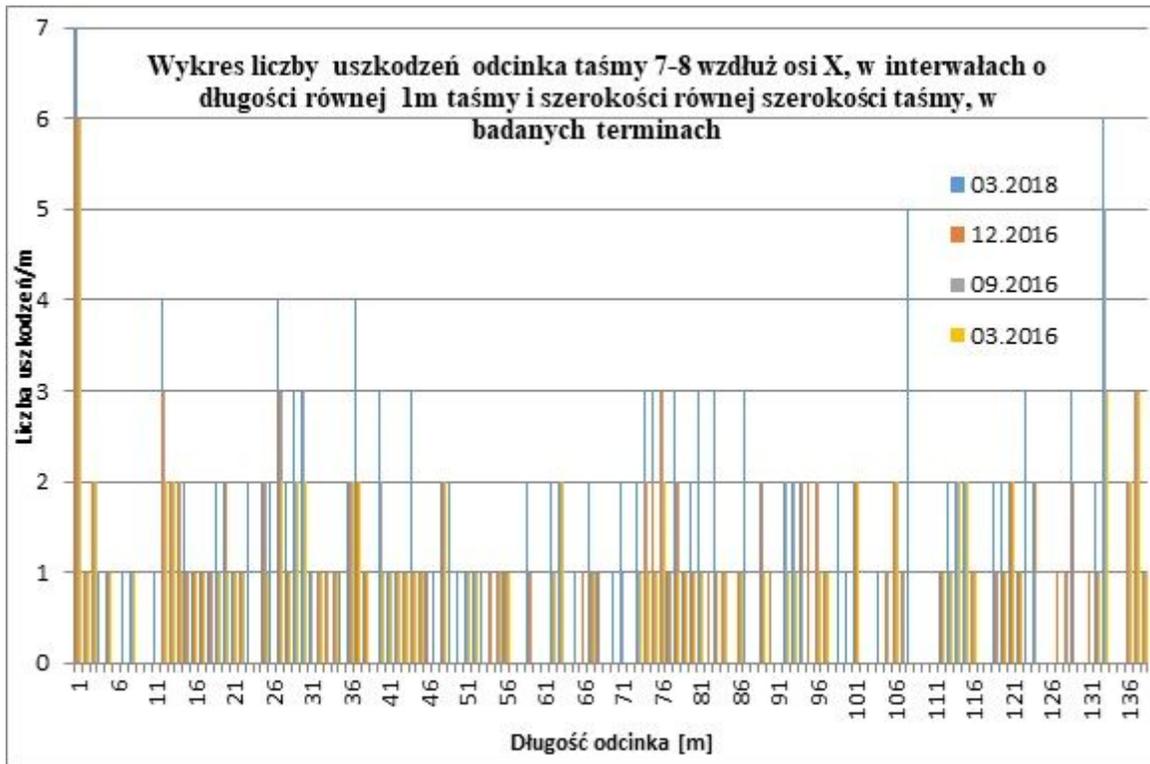
Figure 7

Number of defects in 1-meter segments of the belt section along its axis (X direction) in consecutive scans from March, September and December 2016, as well as from March 2018 [34, 35].

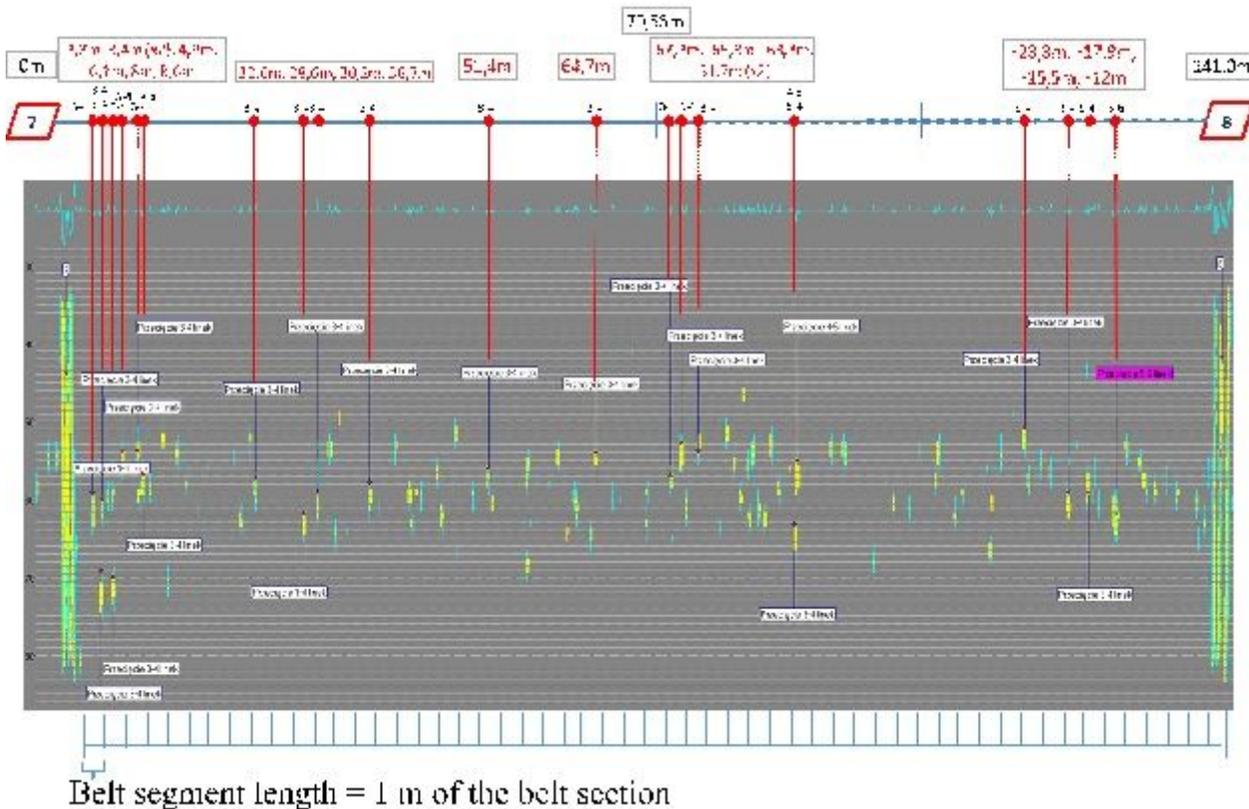
Figure 8

Two-dimensional image of core damage in the belt section with 1-meter segments, which served to calculate damage – state of March 2018 [34, 35].

The calculations of the number of defects in consecutive segments were performed by analyzing the defects identified in the digital image of magnetic field changes in the area of the 7-8 belt section, in its consecutive 1-meter segments (Fig. 8).

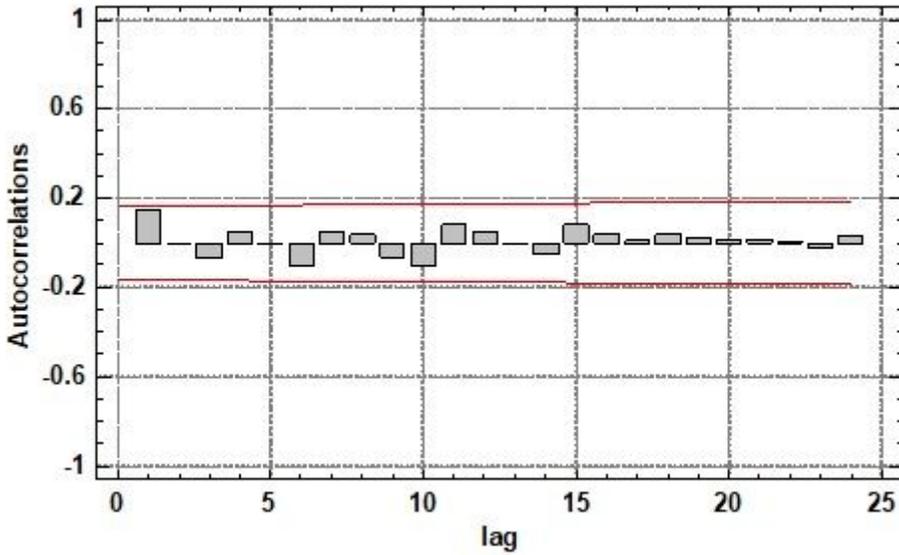
Figure 9

Estimated autocorrelations for various lags for the number of defects (density) in 1-meter segments of the 7-8 belt section, for the 1st measurement [34, 35].

The graph in Fig. 9 shows estimated autocorrelations of the numbers of defects in segments (their density) for 24 lags. In this case delay means a geometric lag by one meter along the belt section axis. The autocorrelation coefficient for lag k is the measure of correlation between the number of defects in a segment in position t and in a position shifted to $t-k$. The figure also shows the 95% confidence interval around 0. If the autocorrelation for a given lag exceeds this limit, then a statistically significant correlation exists for this lag with 95% confidence level. No statistically important autocorrelations were identified for the first measurement of the condition of the 7-8 belt section, which suggests that the number of defects in 1-meter segments is completely random and constitutes the so-called white noise.

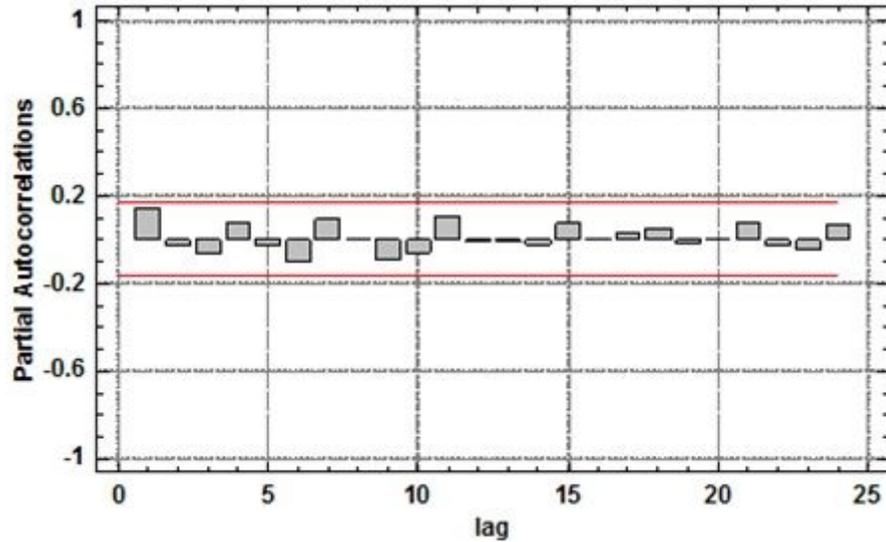
Figure 10

Estimated partial autocorrelations for various lags for the number of defects (density) in 1-meter segments of the 7-8 belt section, for the 1st measurement [34, 35].

The graph in Fig. 10 shows estimated partial autocorrelations between the number of defects in 1-meter segments of the belt section for various lags. The partial lag autocorrelation coefficient k is a measure of the correlation between the number of defects in the t and $t+k$ location with allowance for the correlation for all shorter lags. It may serve to evaluate the sequence of the autoregression model required to fit the data. The figure also shows the limits of 95.0% confidence intervals around 0. The fact that the estimated coefficients remained within the limits for all of the 24 lags indicates that no statistically important partial correlations exist at the 95% confidence level.

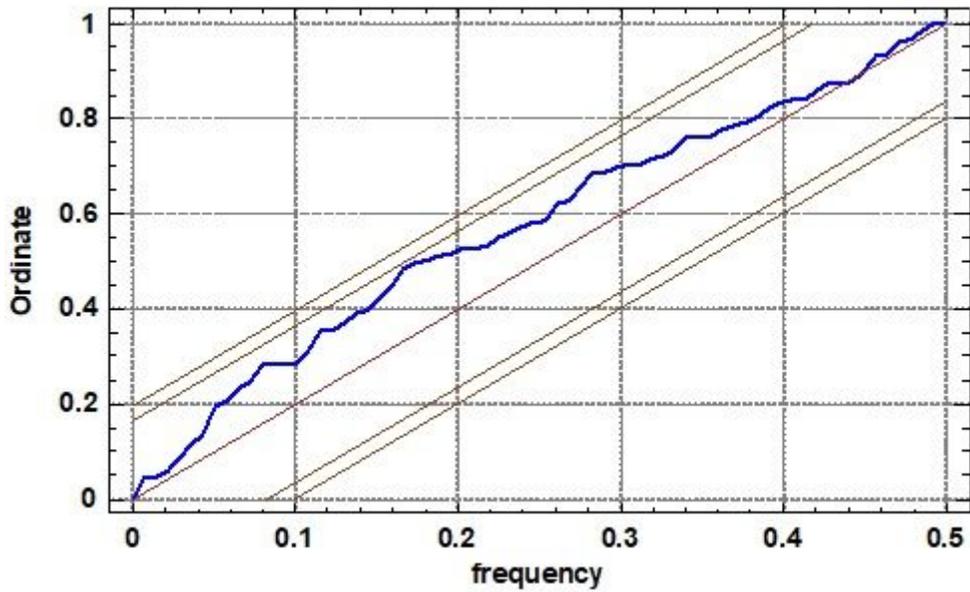
Figure 11

Integrated periodogram for the number of defects (density) in 1-meter segments of the 7-8 belt section along its axis for 1st scan [34, 35].

The integrated periodogram (fig.11) represents an accumulated total of the periodogram ordinates. It also shows the 95% and 99% Kolmogorov-Smirnov limits. If damage densities of the sections in the 1st measurement are only a random series of values, then the integrated periodogram should remain within the strips around the diagonal line. The fact that the plotted line remains within the 95% limits makes it impossible to reject the hypothesis that the series of damage densities in consecutive segments is random at a 95% confidence level. Similar results were obtained for the number of defects in segments, their autocorrelations and partial autocorrelations, as well as periodograms for consecutive scans, as illustrated in Figures 12-15.

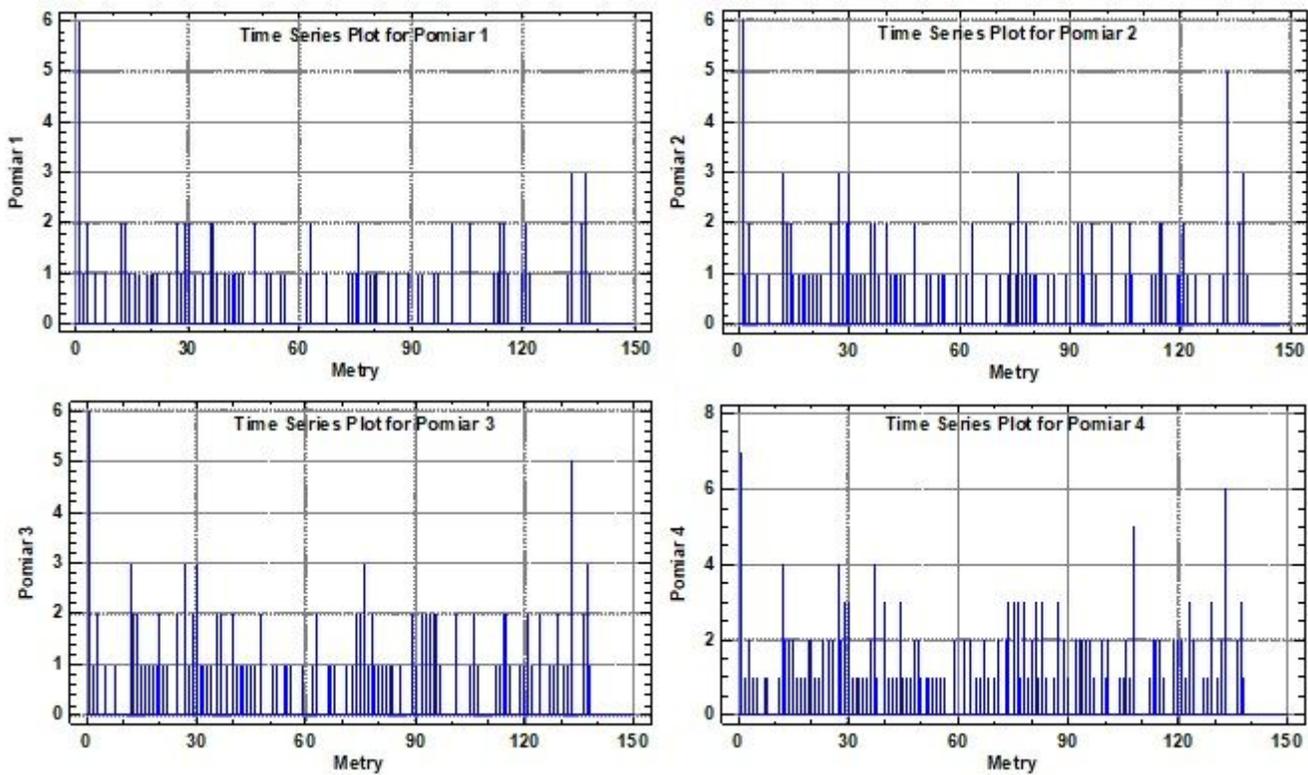
Figure 12

Number of defects (damage density) for consecutive 1-meter segments of the 7-8 belt section 138 m in length, in consecutive scans [34, 35].

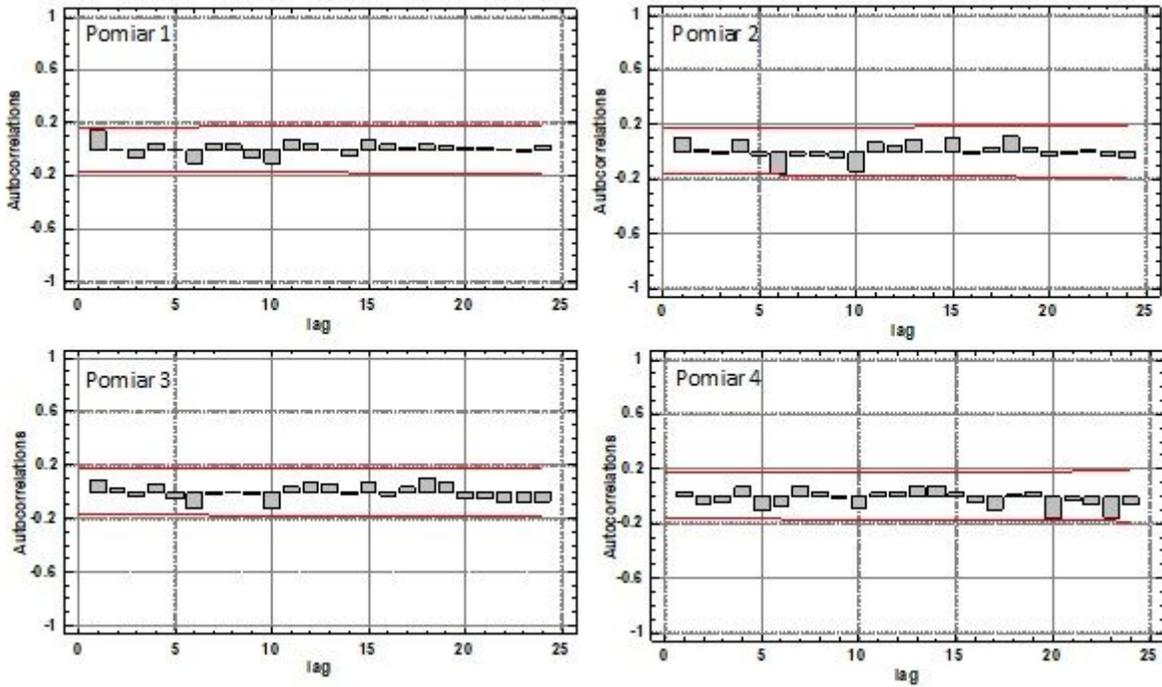
Figure 13

Estimated autocorrelations for various lags for the number of defects (density) in 1-meter segments of the 7-8 belt section, for the consecutive scans [34, 35].

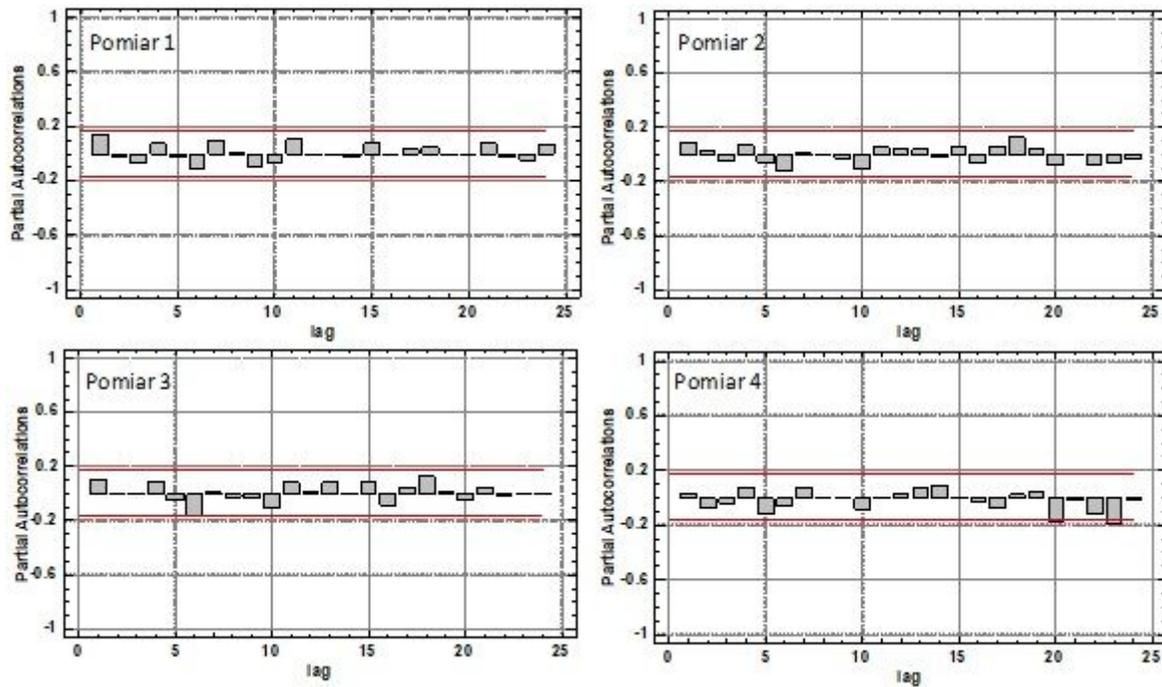
Figure 14

Estimated partial autocorrelations for various lags for the number of defects (density) in 1-meter segments of the 7-8 belt section, for the consecutive scans [34, 35].

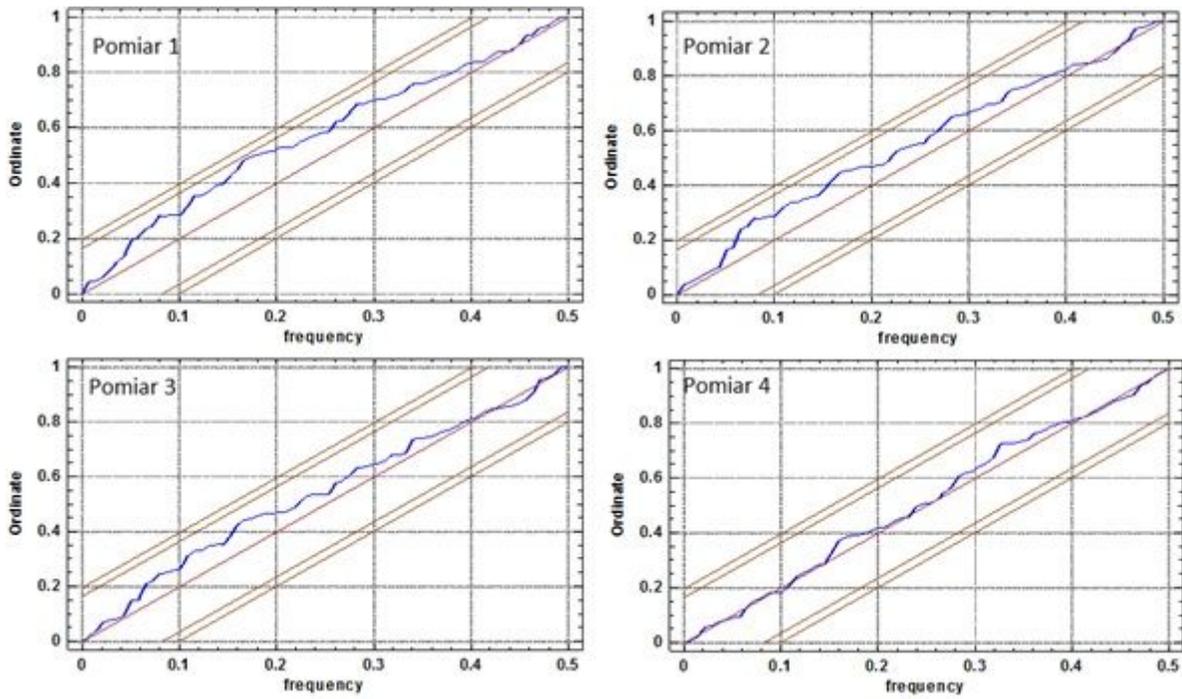
Figure 15

Integrated periodogram for the number of defects (density) in 1-meter segments of the 7-8 belt section along its axis for consecutive scans [34, 35].
