Numerical simulation analysis of anchorage characteristics of constant-resistance and large-deformation anchor cable for highly weathered rock masses

Case study

Keywords: Slope, NPR anchor cable, FLAC3D, numerical simulation, anchorage length, anchorage characteristics

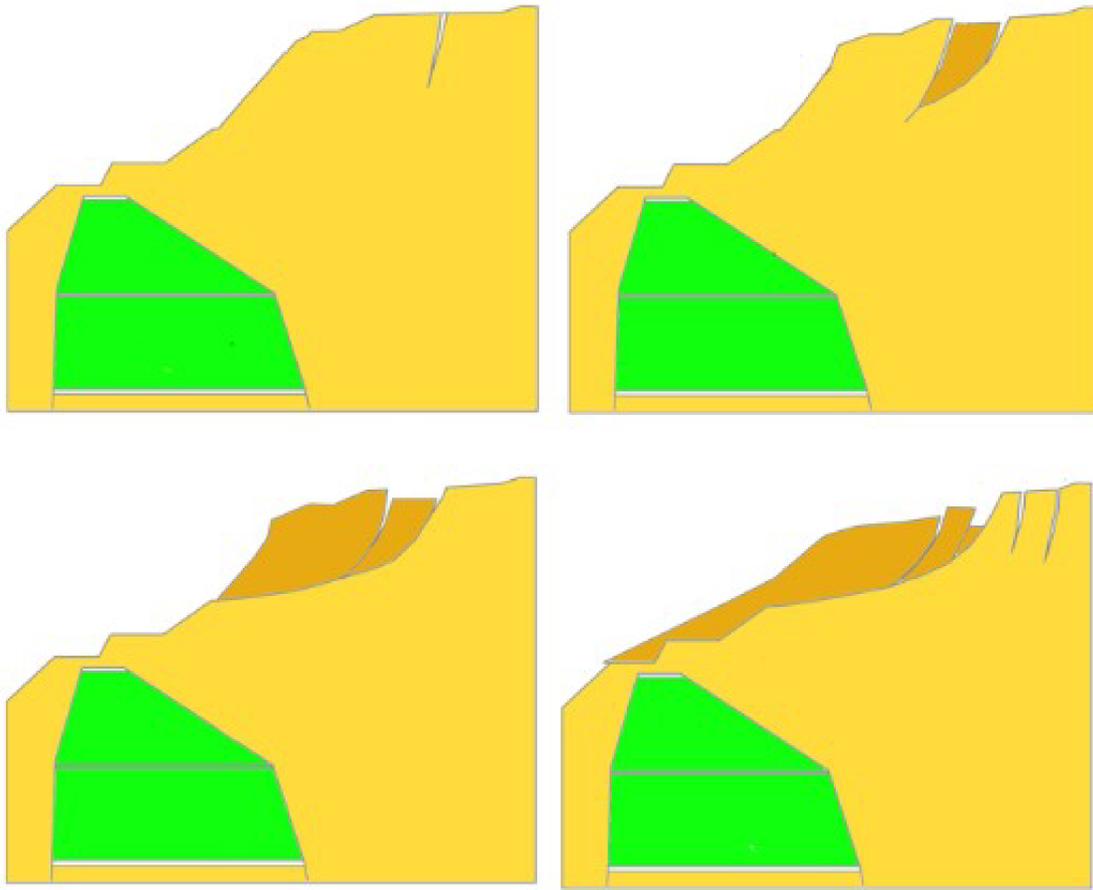
Figure 4

Elevation geological section of each section

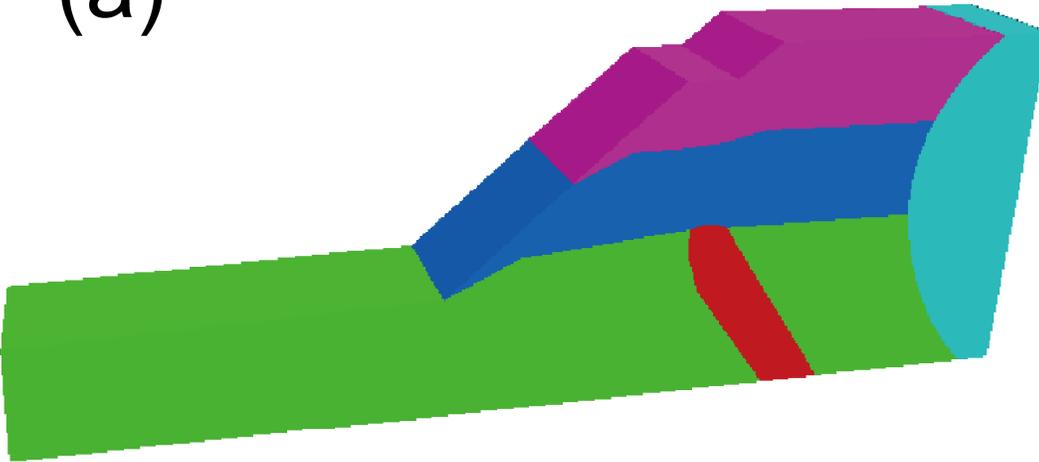
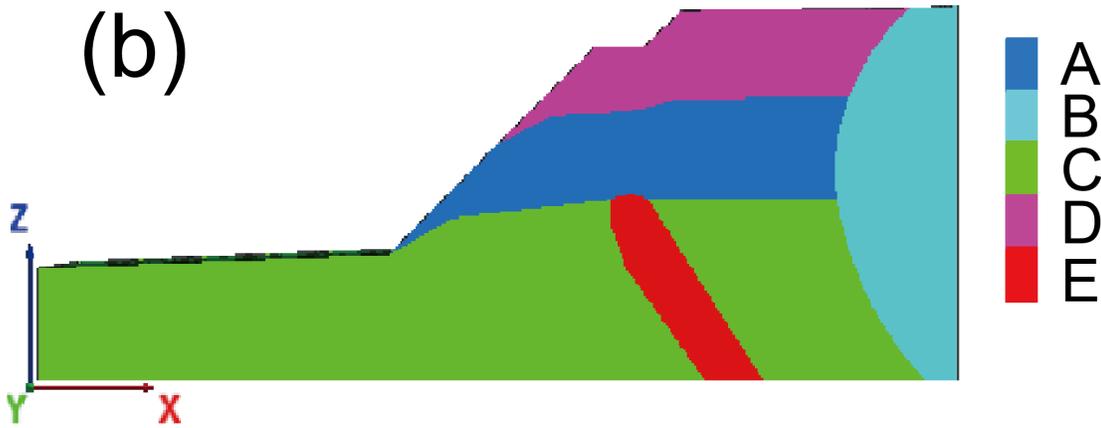
Figure 7

C-C' section view of site slope A: Quaternary stratigraphic soil, B: Strongly weathered syenite porphyry, C: Moderately weathered syenite porphyry, D: Weakly weathered diorite

According to the location map of each section in Figure 6, section C was approximately perpendicular to the slope as a whole, for which, the inter-platform span was larger, while this section significantly reflected the formation composition and geological structure. Section C was selected as the main research object. According to the engineering geological and relevant survey data, the geological composition and stratigraphic distribution of section C were analyzed, while the strata of the calculation model was divided into 4 layers (Figure 7).
