Evaluation of rockfalls at a historical settlement area in the Ihlara valley (Cappadocia, Turkey) using different methods

Mehmet Sari (✉ mehmetsari@aksaray.edu.tr)

Aksaray University <https://orcid.org/0000-0001-9441-9256>

Research Article

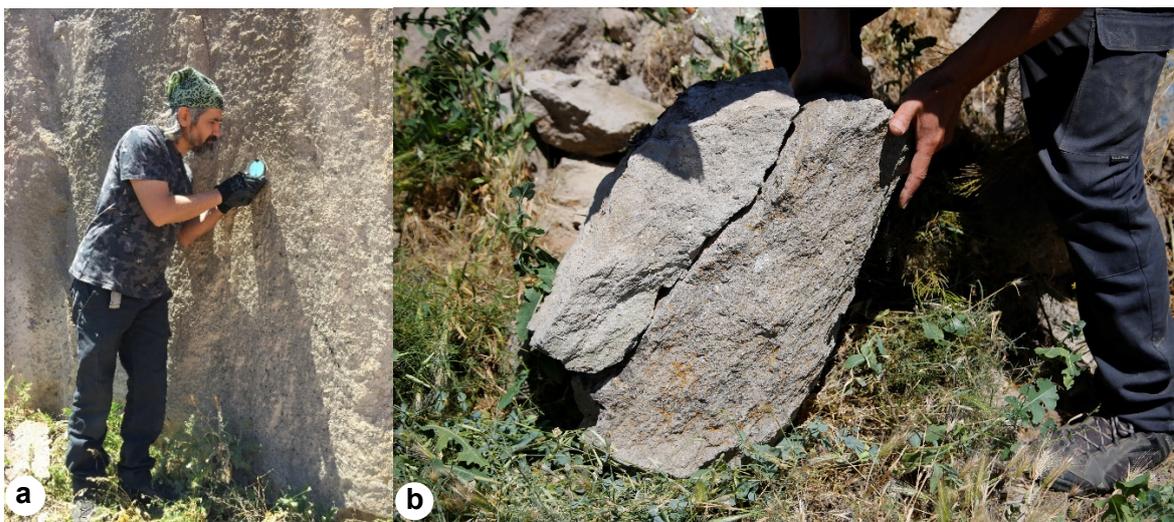
Fig. 5. **a** Discontinuity orientation measurements in the field using Brunton compass, **b** Tilting test on rock blocks.

Given that discontinuities play a critical role in the kinematical analysis, 53 discontinuity measurements were performed on the hard ignimbritic unit covering the slope (Fig. 5-a). Two sub-vertical orthogonal joint sets were delineated from the rock mass forming the slope crest. A third joint set lying horizontally is almost perpendicular to these two sets (Fig. 6). Sub-vertical joint sets (Set 1 and Set 2) were developed as a result of thermal cracks formed while the cooling of ignimbrite massif took place. Near horizontal joint set (Set 3) was formed from different outflow facies during ignimbritic deposition (Sarı and Çömlekçiler 2007). Table 1 presents some characteristics of the discontinuity sets in the rock mass and other input parameters necessary for the kinematic analysis. Tilting tests were conducted in the field to estimate the friction angle of the discontinuity surfaces (Fig. 5-a). This test is based on measuring the friction angle between two blocks placed on top of each other in the field directly when the upper one starts to slide on the lower one. It is an in-situ test for better reflecting the actual conditions in the field and considering the size effect. The average of three tilting tests was calculated as $\phi=45^\circ$.

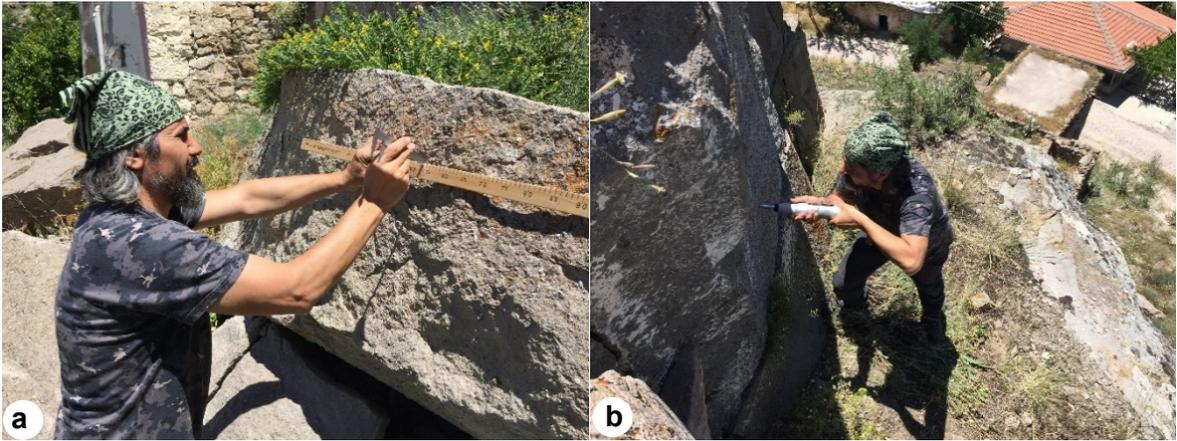
Fig. 12. **a** Measurement of asperity amplitude and **b** Schmidt hardness value of rock surfaces in the field.

The joint roughness coefficient (JRC) was extracted from the joint surfaces of hard ignimbrite in the slope crest. As seen in Fig. 12-a, a wooden ruler 1 m in length was placed on the joint surface to measure asperity amplitude using a vernier caliper. The average asperity amplitude value ($a=22.2$ mm) measured on the discontinuity surfaces was located

on the graph in Fig. 13 to find a JRC value of 10. The joint wall compressive strength (JCS) was obtained from the Schmidt hammer test. This test is a practical indirect method for predicting the compressive strength of joint planes in the field. The hammer was applied perpendicular to the discontinuity surfaces during the test. Accordingly, the JCS value of joint surfaces in ignimbrite rock was found using the graph in Fig. 14, which was developed by Barton and Choubey (1977) from the equation proposed by Deere and Miller (1966). The JCS value was found to 55 MPa for the unit weight $\gamma_d=21.95 \text{ kN/m}^3$ and Schmidt hardness value, $r=38.2$, measured on the weathered joint surfaces in the field.

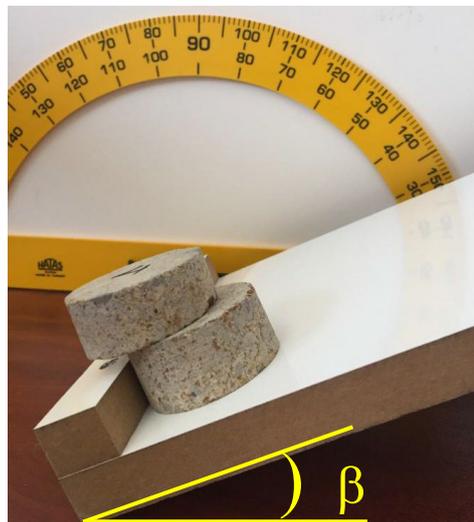
Fig. 15. Application of the tilt test to Brazilian disc samples in the laboratory.

In this study, the basic friction angle was obtained by performing a simple tilt test where a manually-operated wooden table was utilized in the experiments. The most widely used method for this test was early proposed by Stimpson (1981), and later this method was revised by Alejano et al. (2012). As shown in Fig. 15, two disc-shaped specimens prepared for the Brazilian tensile test were used in the experiments, which had more conservative values than other sample shapes. Eq. (4) was used for the conversion of β to the basic friction angle.
