# Impact of sea level rise and shoreline changes in the tropical island ecosystem of Andaman and Nicobar region, India

## Research Article

**Keywords:** Sea level rise, Shoreline changes, Remote Sensing, GIS, Andaman and Nicobar islands

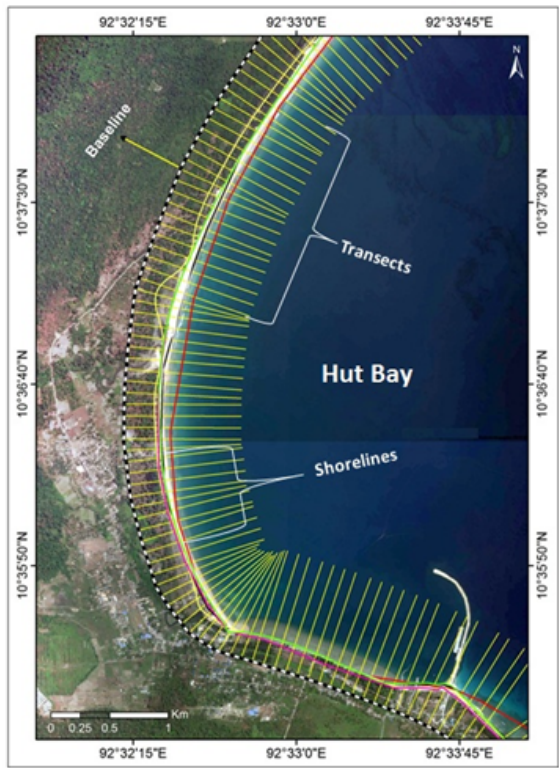
Figure 2

Baseline, transects and different shoreline constructed along Hut Bay

In this study, we have adopted the wet-dry boundary as shoreline and using visual interpretation technique, shorelines were manually digitized in ArcGIS 10.2.1 software for different periods. The extracted shorelines of different periods were fed into Digital Shoreline Analysis System (DSAS) to estimate the change rate. The DSAS is a freely available software, which runs as an additional tool within ArcGIS software and calculates statistical methods using various shorelines. Moreover, the DSAS generates transects lines perpendicular to the shoreline with the transect spacing and length are set at 100 m and 1 km respectively (Fig. 2).

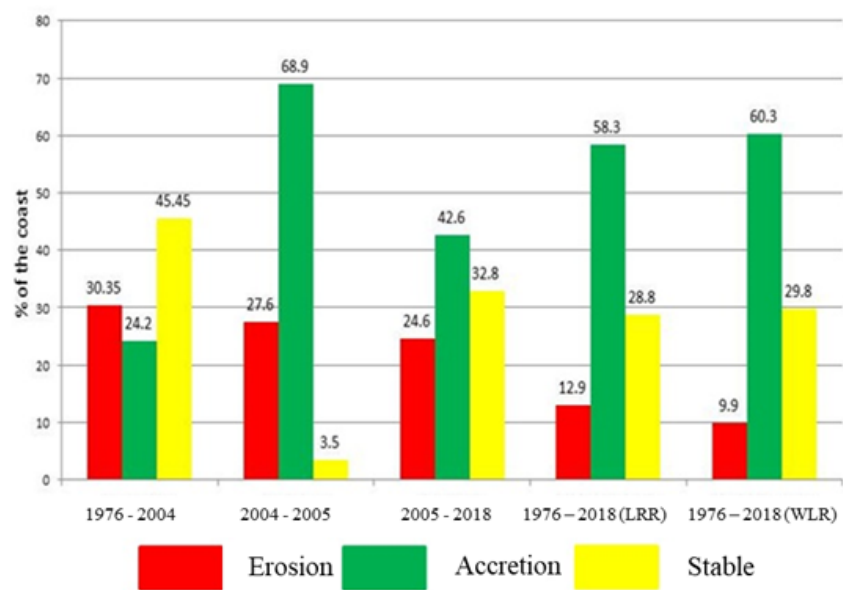
Figure 5

Statistics of shoreline change status in different periods

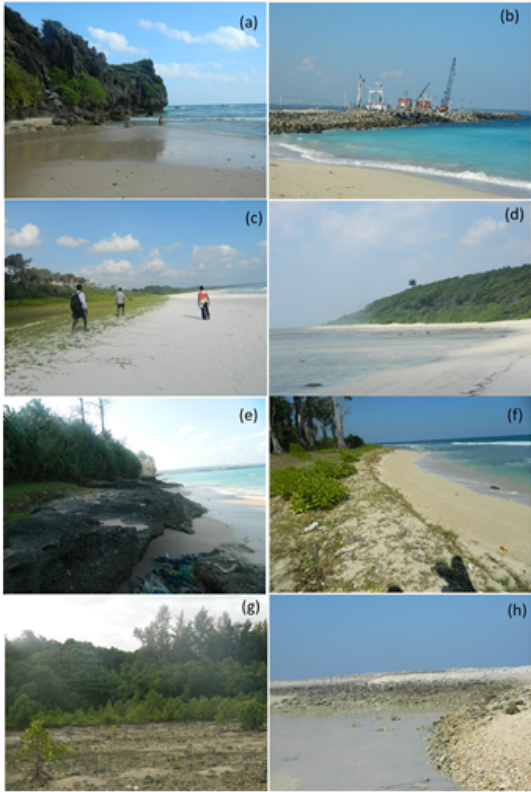
Figure 7

Field photographs. (a) cliff in Netaji nagar (b) Hut Bay jetty (c) beach view north of Hut Bay (d) cosatal forest in the southern tip (e) beach view south of Hut Bay jetty (f) eroding site in Harminder Bay (g) mangroves in Dugong creek (h) coral debris near Bumila creek

Coral reef of Little Andaman exhibits narrow, linear and extensively well-developed fringing reefs in all around the island, except at Hut bay, West bay and Jackson creek (Fig. 6). The area covers around 3621.29 ha (4.9%) and comprises three important coral genera are *Acropora* spp., *Psammocora* spp. and *Goniastrea* sp. According to Coastal Ocean Research and Development in the Indian Ocean status report (CORDIO 2008), an estimate of 12.85 sq.km of reef area was damaged in Little Andaman due to the 2004 tsunami. The island hosts white sandy beaches in Butler Bay, Hut Bay, Harminder bay, John Richardson Bay, South Bay, West Bay and Ekiti Bay which covers an area of 351.91 ha (0.4%). The Butler Bay and Hut Bay beaches of Little Andaman serve as tourist hotspots. The sandy beaches of Little Andaman also host nesting of turtles and the major turtle species of this island includes Hawksbill, Green, Olive ridley and Leatherback. The nesting site of Green turtle's is more than other turtle's, which was reported in West Bay, South Bay, north of Hut Bay, Butler Bay, south of Bumila Creek, north and south of Jackson Creek, (Andrews and Tripathy 2004). The field photographs of LULC and coastal features of Little Andaman were shown in figures 7 & 8.

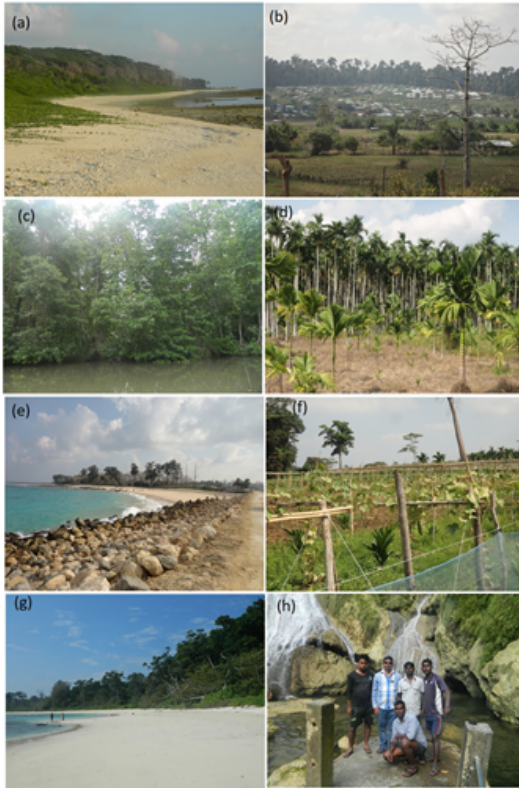
**Figure 8**

Field photographs. (a) coastal forest and exposed rocks during low tide (b) tsunami rehabilitation area in Hut Bay (c) mangroves in Bumila creek (d) arecac nut plantation (e) jetty area (f) agricultural activity (g) Butler Bay beach (h) White Surf waterfalls
