Geo-Environmental investigation of Sahure pyramid complex, Abusir Archeological site, Giza, Egypt

Research article

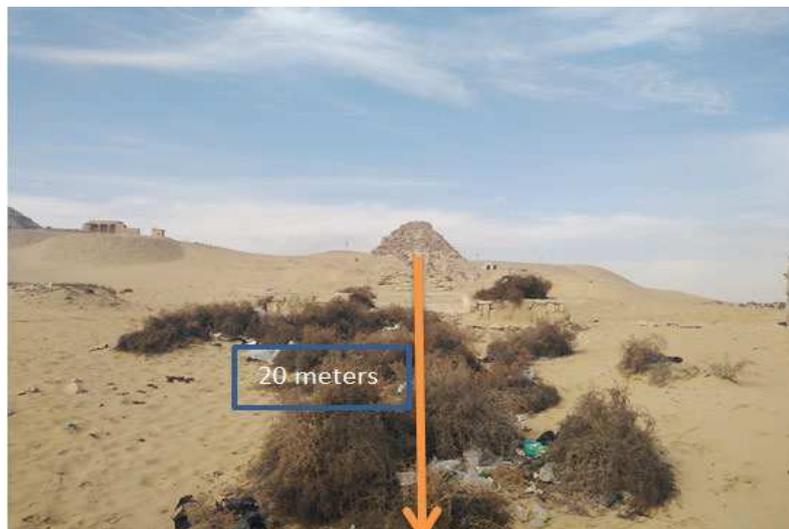
Figure.3. The elevation level shows the distance between the pyramid and the valley.

The pyramid of Sahure located on hill and the distance from the valley temple which was adjacent to Nile about 20 meters figure 3(verner,M.20001)[10].The burial pyramid of Sahure is relatively small, only having a base of around seventy-eight meters and rising to a height of forty-seven meters. However, it was built using better quality stone of more diverse types than the pyramids of the fourth dynasty (verner,M.20001)[10]. It is thought that the pyramid was built on a base of at least two layers of limestone, but the base has not been excavated so this is simply an educated guess based on comparisons with other structures from the same area. The pyramid core was composed of six steps figure 4 of limestone held together with mud mortar with an entrance to the north and it was cased in fine white limestone from Maasara(verner,M.20001)[10].

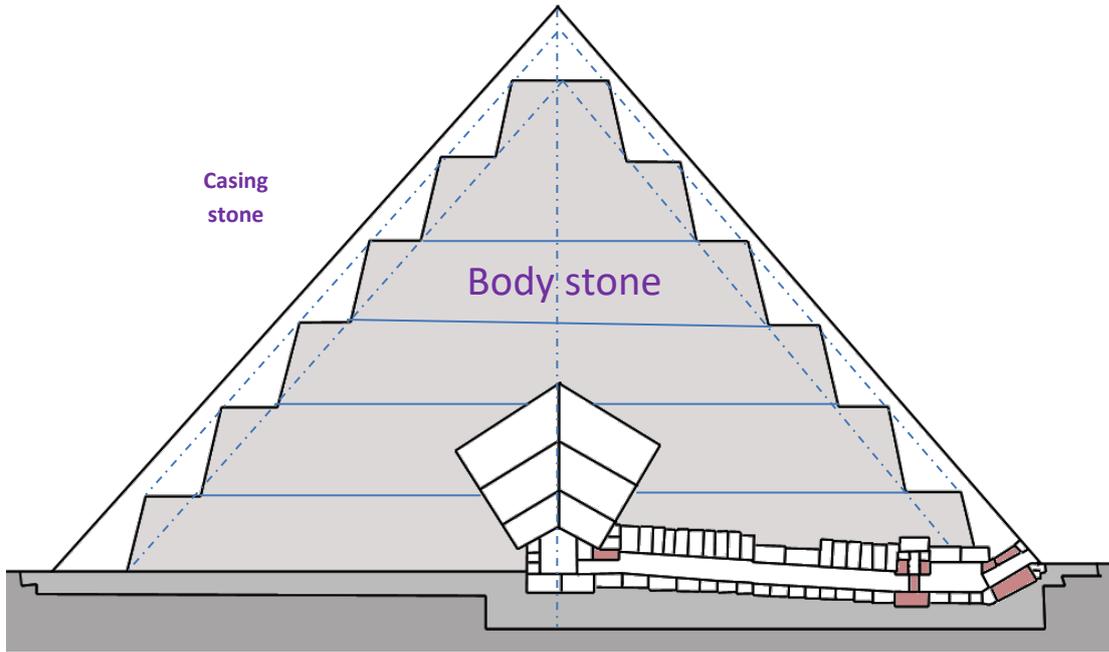
Figure.4. Cross section of Sahure's pyramid, white: white Fossiliferous limestone from Tura quarry (casing stone), red: granite, body of the pyramid: Laminated sandy argillaceous limestone (marl), dark and white grey: bed rock from limestone, edited after reconstruction of Ludwig Borchardt.

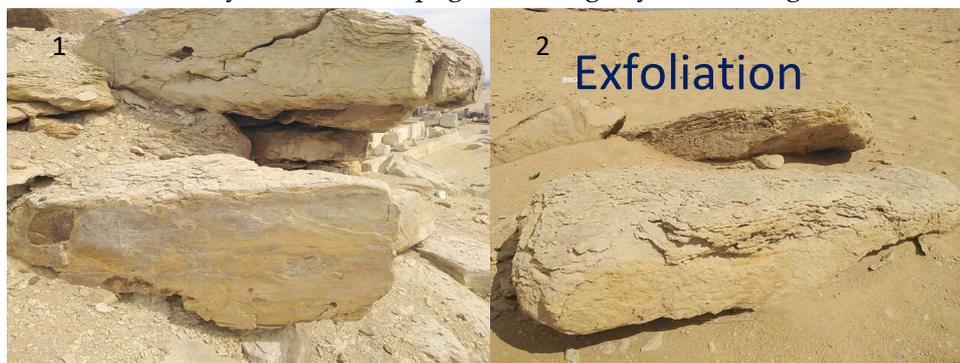
- 1) **Exfoliation**; it is thin layers like book pages and slightly bonded figure 7.

Figure.7.1,2 Exfoliated stones of the pyramid built materials.

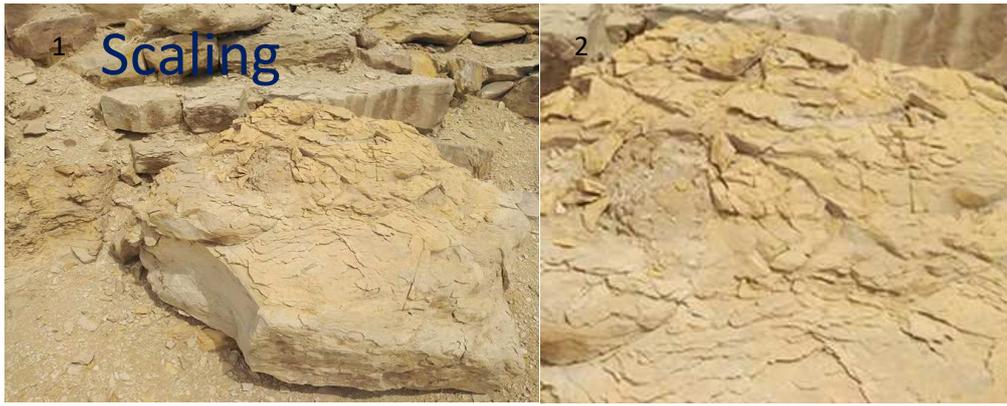
- 2) **Scaling**; it is sort of delamination and totally of stone body, figure 8.

Figure.8.1,2 scaled limestone blocks of pyramid construction.

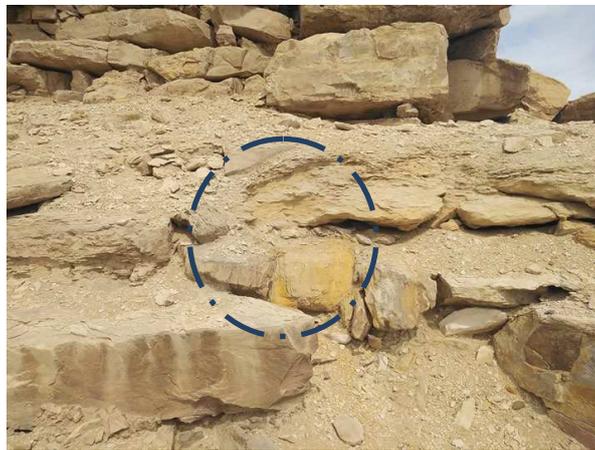
3) **Powdering or Chalking**; it is the disintegration of the stone grains to powder shape, figure 9.

Figure.9. Powdered sandy limestone of pyramid core blocks.

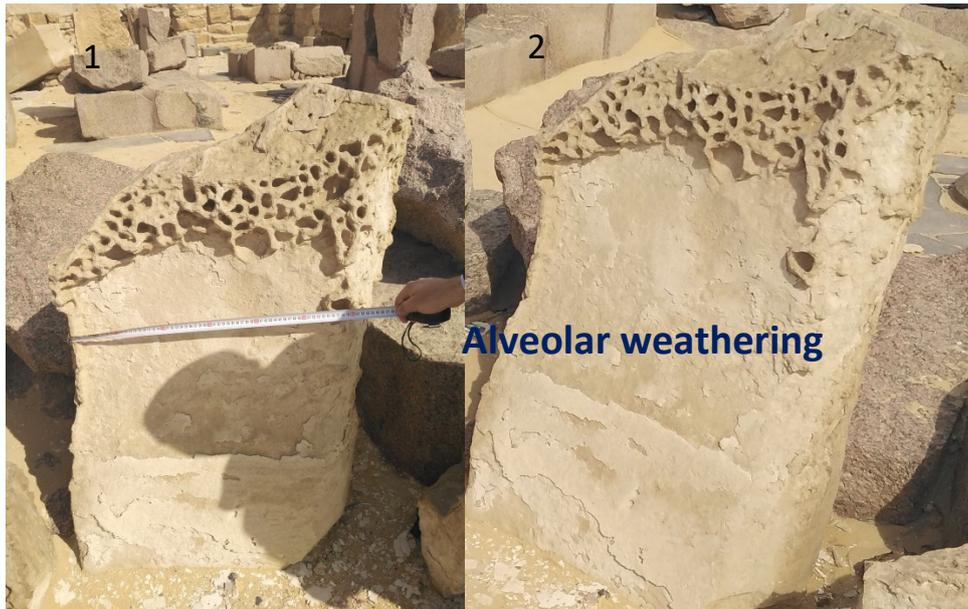
4) **Alveolization or Honeycomb**; it is kind of cavities created in most construction materials surfaces of the pyramid and it looks like the air sacs in the lung, it is described as an extensive network of small cavities that form honeycomb patterns, the sickness of this hard layer ranged from millimeters to centimeters (Mustoe.G.1982)[22],figure10.

Figure.10. 1,2 Alveolization in the pyramid construction materials.

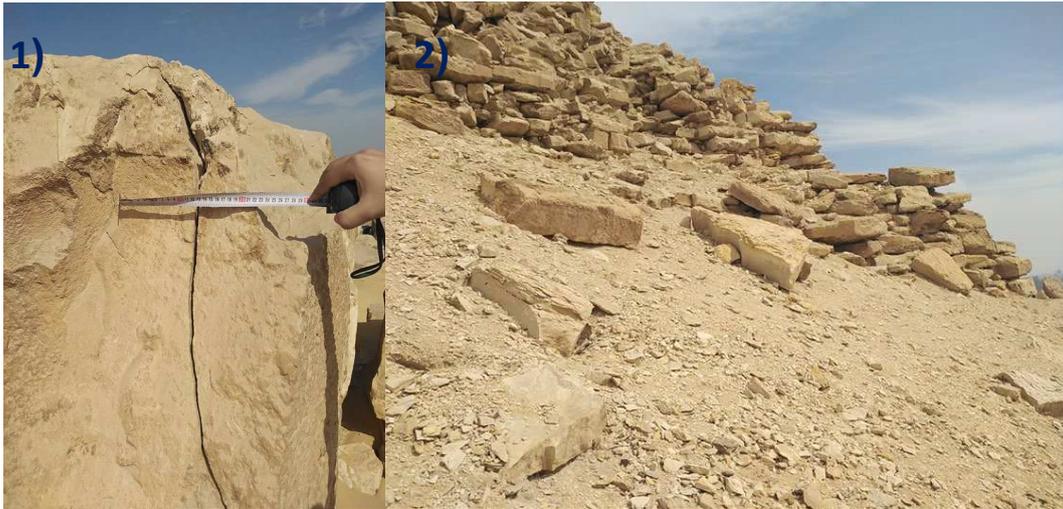
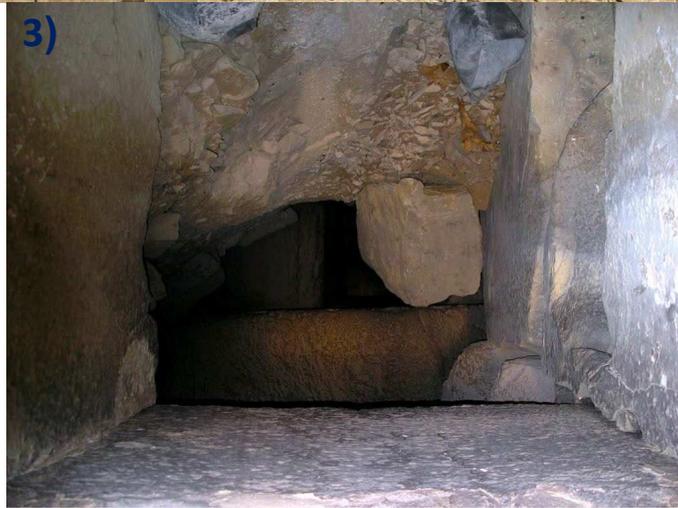
According to the geological setting of Abusir archaeological site and the recordings of historical seismological data, the pyramid structure have suffered from shear forces due to previous earthquakes and stresses due to soil settlements, the most important factor that effectively caused major deterioration and structural problems of the red pyramid near to Abusir archaeological site was the old earthquakes. specifically the last Dahshur earthquake happened in 1992 AD, which estimated with a local magnitude 5.3 M (duration magnitude) on the Richter scale occurred at Dahshur (Hemeda,S et al 2019) [23,24]. So the crumbling and structural cracks in the pyramid of Sahure occurred as a result of earthquakes hits in addition to the environmental conditions/ weathering impacts figure 11 and 12.

Figure.11. The blocks splitting, cracking and crumbling of the Sahure pyramid, 3) from, <https://ancientegyptianfacts.com/abusir.html/entrance-sahure>.

Sahure pyramid has been affected by many factors of deterioration and damages for its construction materials and a lot of fallen stone blocks and fragments existed so the urgent restoration and conservation is needed to protect the pyramid. The presented research is important as it identified the construction materials used in the pyramid. In restoration of the pyramid we should use the same traditional and ancient materials of pyramid which presented in this research.

The preservation plan includes the fine restoration, structural interventions, preventive conservation and management of archaeological site of Abusir. For fine restoration; many procedures and restoration steps should be done such as cleaning for the dusts over the whole body of the pyramid partially, salts removal from the stone surfaces, consolidation of stone blocks bodies, gap filling by using improved traditional mortars such lime mortar and distinguished and integrated replacement for highly weathered blocks with new blocks from the same old quarry with same mechanical and physical properties. For structural intervention, this kind of structural repairing based on needed complicated structural analysis for the pyramid structure and the soil, in this process of preservation the authors suggested putting the falling intact blocks to its original places in inner or outer positions, designing steel or wooden supports for the inner unsafe chambers and corridors, joining huge blocks by using structural pins, geotechnical study is needed and assessment for the soil problems as well.

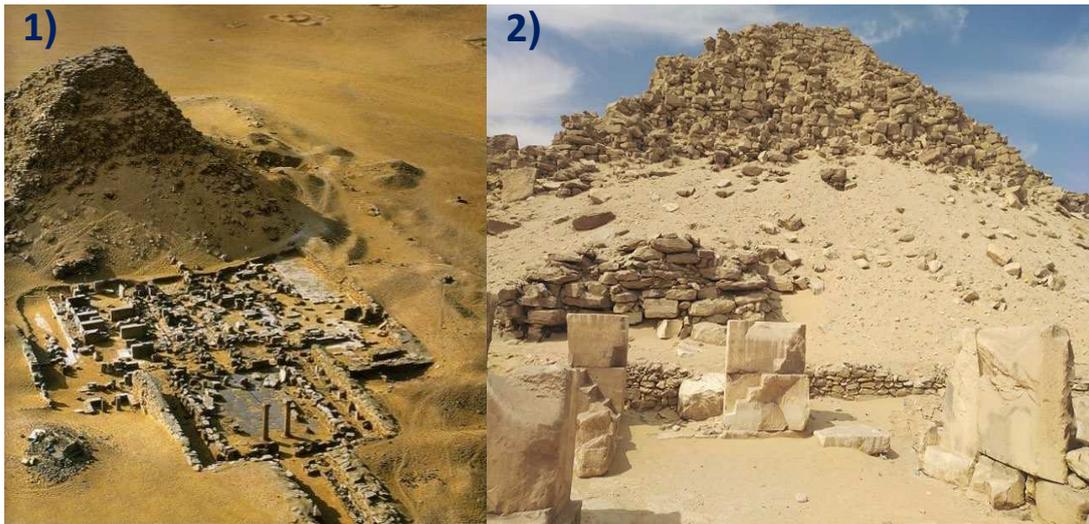
Figure.12. 1,2 1) Aerial view for the pyramid of Sahure and the state of preservation, from <https://www.tumblr.com/search/mortuary%20complex>, 2) current structural failure state of Sahure pyramid.

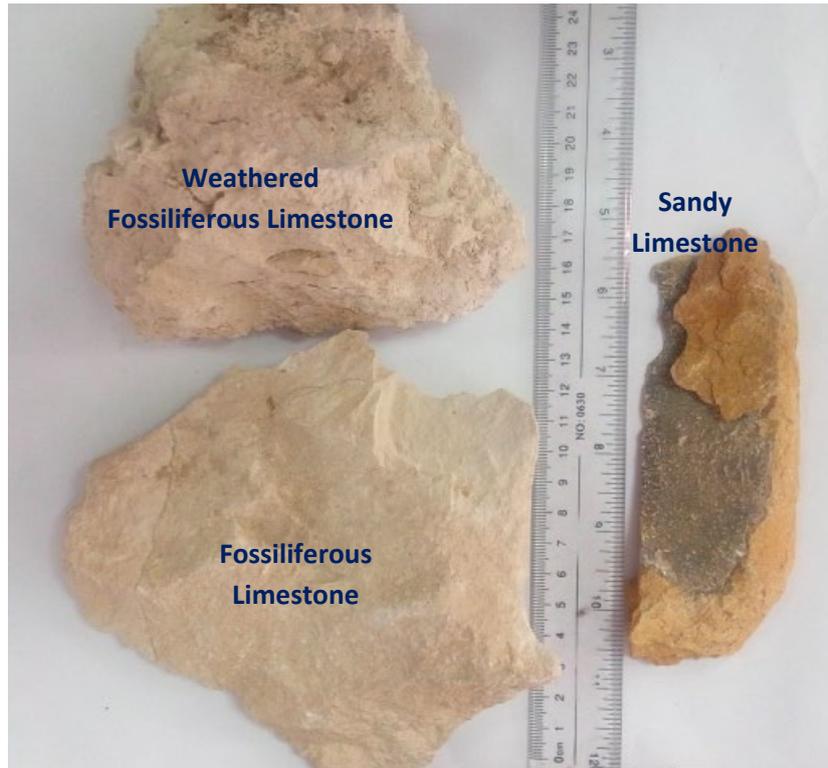
Figure.14. The construction materials of Sahure pyramid, Fossiliferous Limestone as a casing stone and Sandy limestone as a core building material.

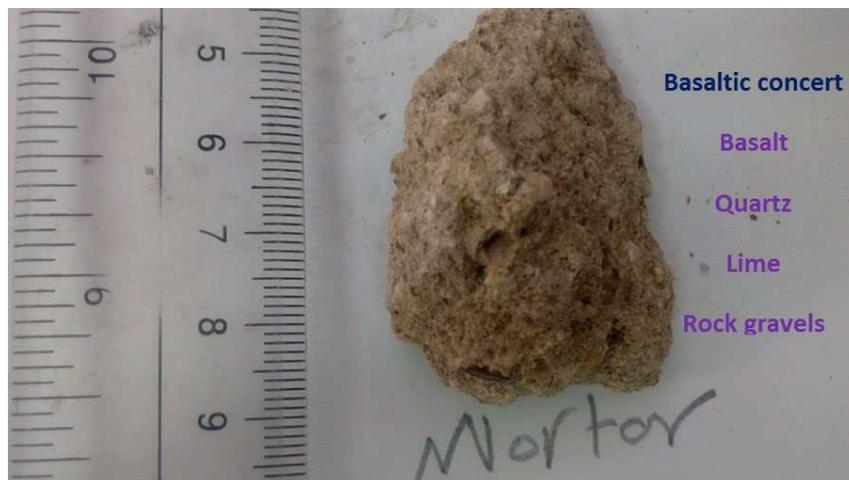
Figure.15. Archeological basaltic concert (basaltic mortar) as a building material in Sahure pyramid complex.

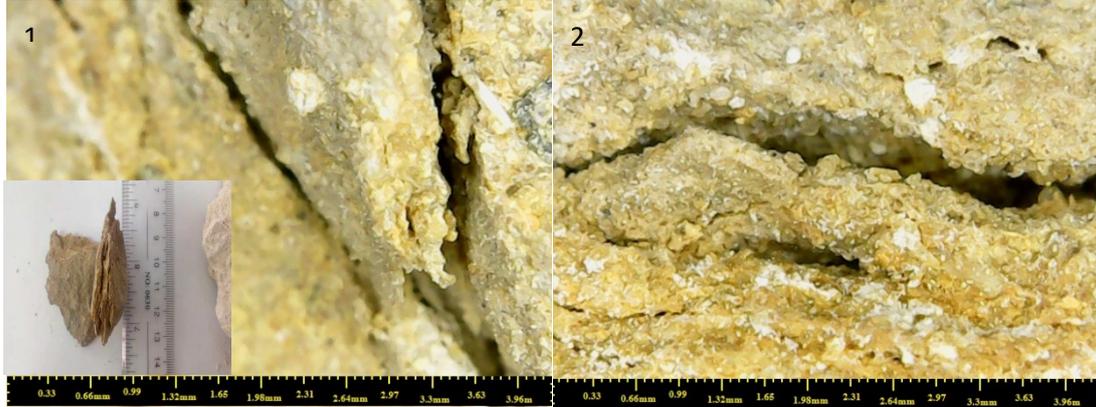
pyramid is Laminated sandy argillaceous limestone marl (organic sedimentary rock). The stone is 312
 thinly laminated due to relative variation in mineral compositions, fissile, exhibiting obvious 313
 lamination. Microscopically, the core stone texture of the pyramids very fine to fine-grained. 314
 Significant amount of microfossils and fossil fragments are observed scattered in the matrix. 315
 Considerable amount of sand grains are observed scattered in the sample. Some irregular pore 316
 spaces and channels are detected in the stone as shown figure 16 under USB digital microscope. 317

Figure.16.1,2 photographs under digital microscope shows the grains of the quartz 318
 admixed with calcite, the channels and micro cracks are detected. 319
 320

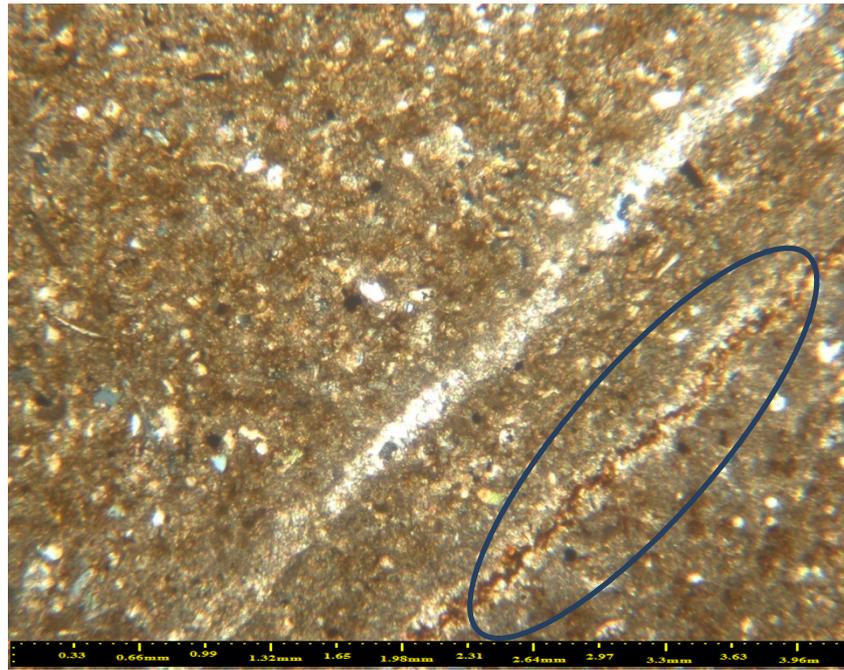
Significant amount of microfossils and fossil fragments are observed scattered in the matrix. Some 330
 irregular pore spaces and channels are detected in the sample; some microfossils are filled by 331
 recrystallized secondary calcite and secondary quartz. Some microvioletlets filled by recrystallized 332
 secondary calcite, quartz and iron oxides cut across the rock. Quartz presents as a secondary 333
 replacement mineral over carbonates. Ankerite may present as alternation mineral after calcite 334
 (dolomatization process) figure17. 335

Figure.17. Thin section for the core stone investigated under polarizing microscope (3. 25X, C.N), the sample shows the pore spaces, channels (microcracks) and Ankerite presented as alteration mineral after calcite (dolomatization process).

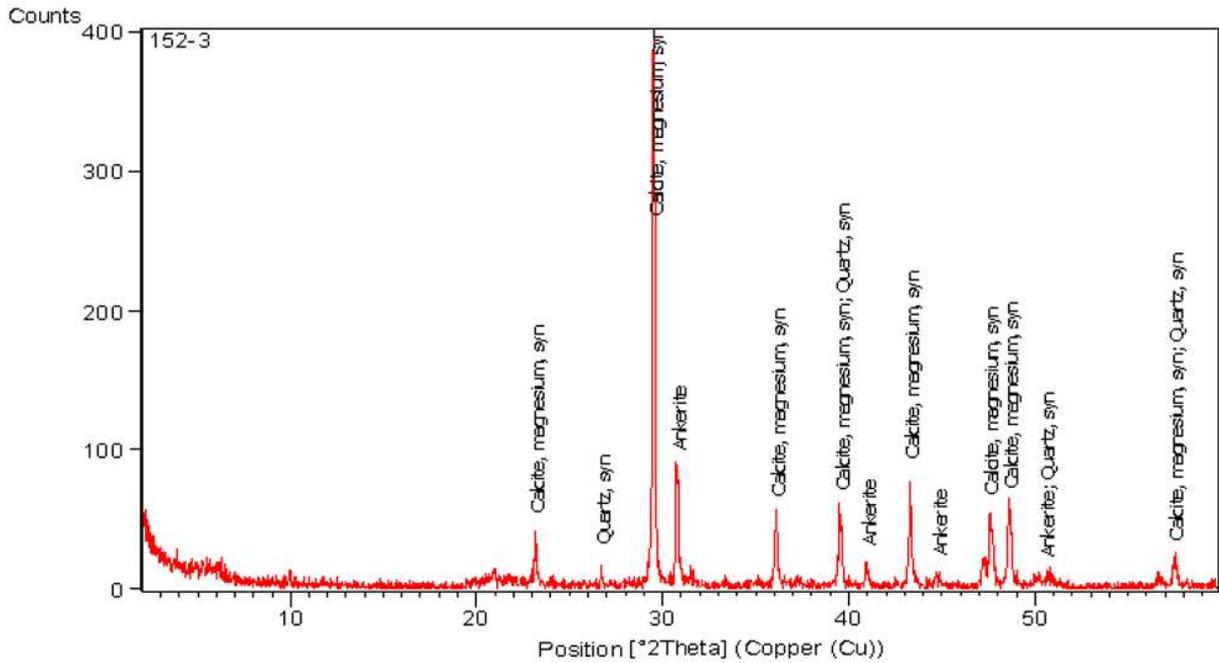
Figure.18. XRD pattern for the core stone of Sahure pyramid.

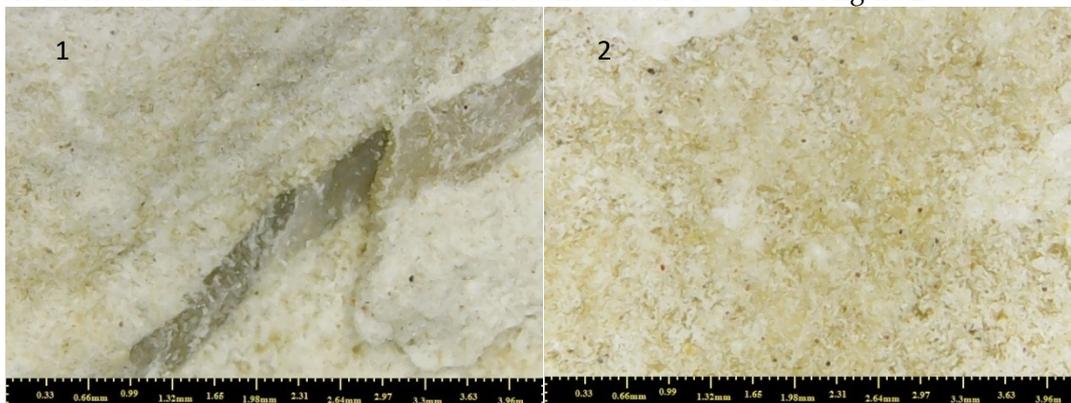
Figure.19. 1,2 Microscopic photos for the unweathered casing limestone of the pyramid.

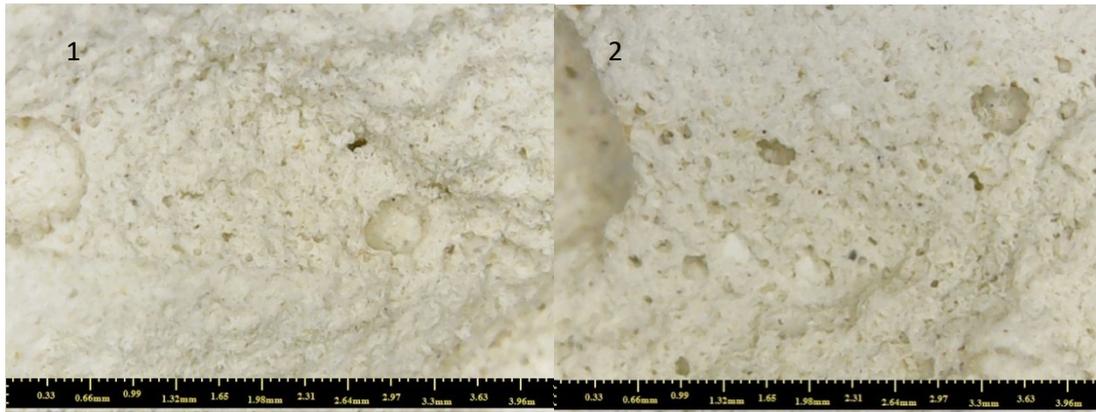
The casing stone of the pyramid had been brought from the Tura and Massara quarries on the other hand of western bank of Nile. This kind of stone (Fossiliferous Limestone (biomicrite)) is a very white and more resistant for the environmental conditions after it was polished and prepared to blocks for the construction of the pyramids but generally the chemical limestone is harder and homogeneous than fossiliferous limestone. Accumulative impact of weathering can affect the casing stone but not more the core stone especially most of core blocks converted to powered shape unlikely the casing stone is still durable and resistant; samples have been prepared and examined under digital microscope to find that the stone is a very fine-grained (micrite). Significant amount of microfossils and fossil fragments are observed scattered in the matrix. Some irregular pore spaces are detected in the sample. Microvienlets filled by recrystallized calcite and secondary quartz are observed. Comb texture is observed in some microvienlets figure19. In weather samples of casing stones, the sample is very fine to fine-grained. Significant amounts of microfossils of different sizes and shapes are scattered in the very fine-grained matrix of calcite. Some irregular pore spaces are present in the carbonate matrix of the stone and Comb texture is observed figure 20.

Figure.20. 1.2 Microscopic photos for the weathered casing limestone of the pyramid, some irregular pore spaces are present in the carbonate matrix of the stone and Comb texture is observed.

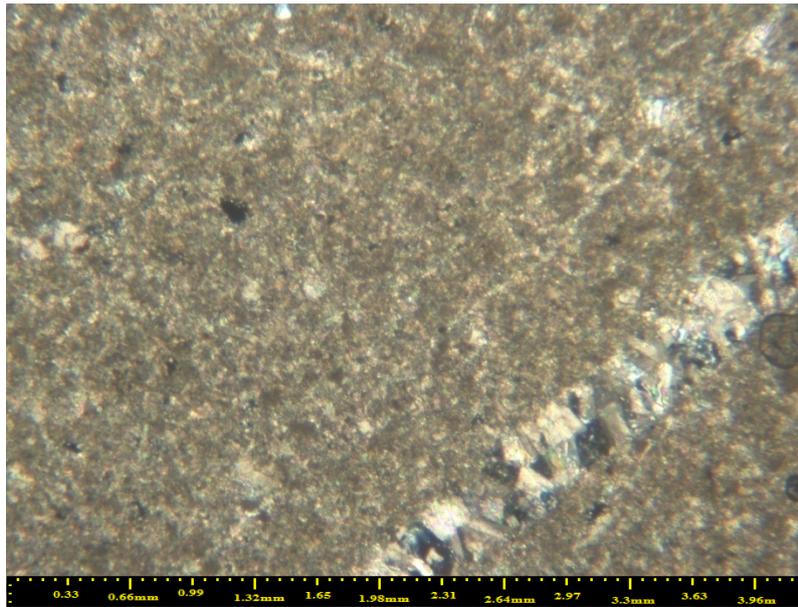
Additionally, the casing stone is investigated by using polarizing microscope (3.25X, C.N), for the unweathered sample, the rock is composed mainly of very fine-grained calcite (micrite) as the essential component associated with minor amounts of ankerite (ferrodolomite) and rare iron oxides, quartz, phosphate mineral (collophane) and opaques. Calcite represents the matrix of the rock and occurs as very fine-grained (micrite), anhedral to subhedral interlocked crystals. Iron oxides are observed as staining over some parts of the sample. Quartz is detected as very fine-grained crystals scattered in the matrix. Phosphate occurs as very fine bone fragments scattered in the rock. Considerable amount of microfossils and fossil fragments are observed scattered in the matrix. The microfossils are filled by recrystallized fine-grained calcite. Some pores of irregular shapes and various sizes are observed scattered in the rock. Microvioletlets filled by recrystallized calcite and secondary quartz are observed cutting through the sample. Some microfossils are filled by recrystallized secondary calcite (sparite). The rock is cut by interstitial microvioletlets filled by recrystallized secondary calcite and traces of secondary quartz. Quartz presents as a secondary replacement mineral over carbonates, especially microfossils figure 21.

Figure.21. The casing stone under polarizing microscope (2. 25X, C.N), the stone is cut by interstitial microvoids filled by recrystallized secondary calcite and traces of secondary quartz. Quartz presents as a secondary replacement mineral over carbonates, especially microfossils.

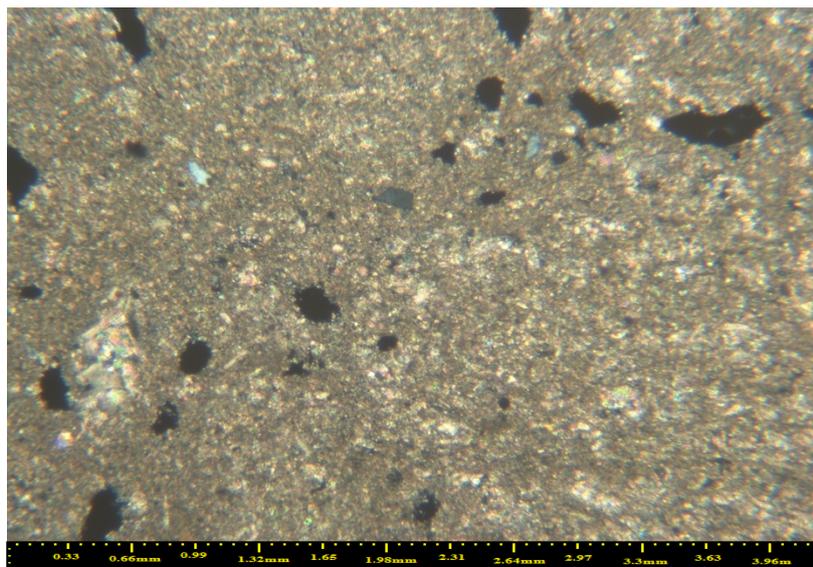
For the weathered samples, the stone is composed mainly of calcite and quartz as the essential components associated with minor amount of ankerite (ferrodolomite) and rare amounts of feldspars, gypsum, biotite, cellophane, opaque minerals, iron oxides and clay minerals. Calcite occurs as very fine-grained (micrite), anhedral crystals that represent the matrix of the sample. Quartz occurs as very fine to fine-grained, anhedral grains scattered in the matrix. Significant amounts of microfossils of different sizes and shapes are scattered in the matrix of the sample. Some microfossils are filled by recrystallized secondary calcite (sparite). Some parts of the rock are stained by traces of iron oxides. Microfossils are filled by recrystallized secondary calcite. Secondary quartz replaces calcite both in the matrix and in some microfossils. Secondary gypsum replaces calcite and partially fills cavities and pore spaces figure 22.

Figure.22. The casing stone under polarizing microscope (1. 63X,C.N),Secondary quartz replaces calcite both in the matrix and in some microfossils. Secondary gypsum replaces calcite and partially fills cavities and pore spaces.

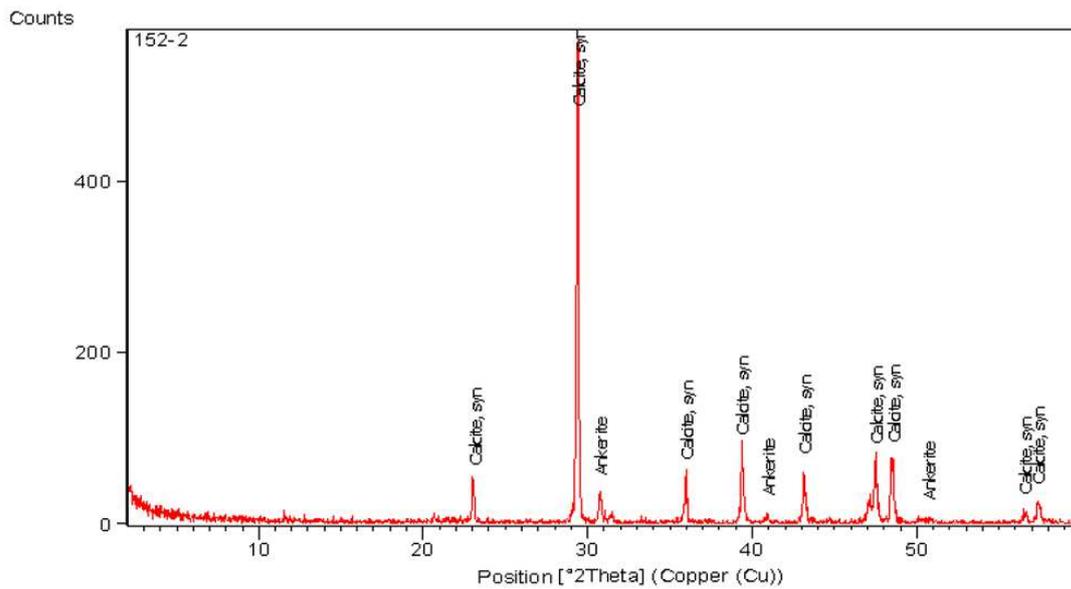
Figure.23. XRD pattern of the unweathered casing limestone of the pyramid.

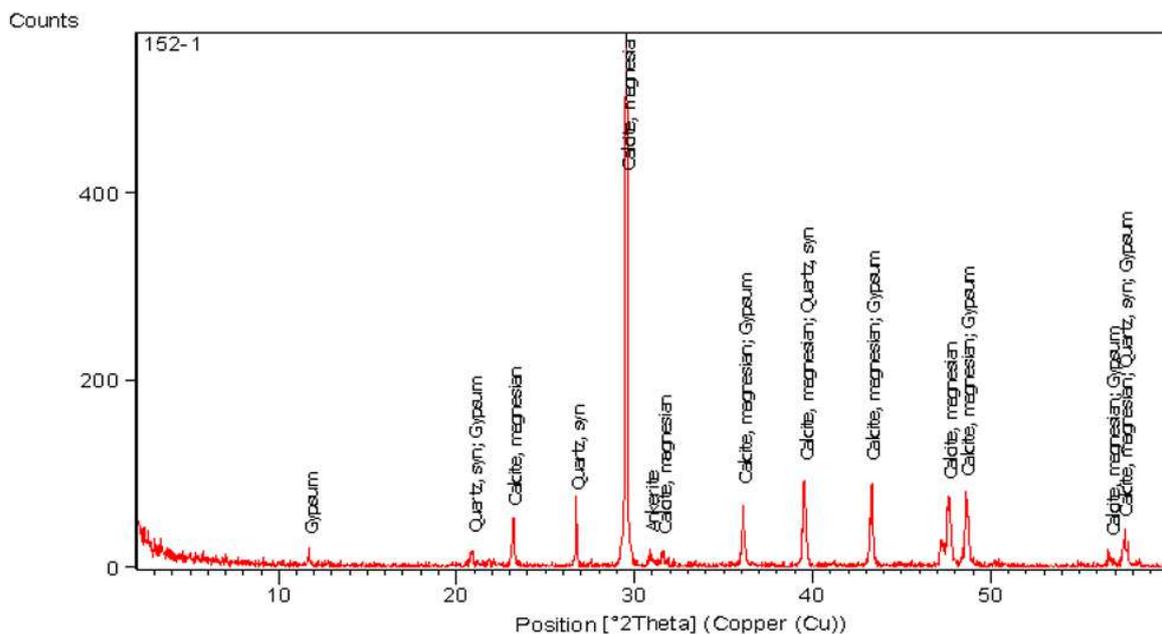
Figure.24. XRD pattern of the weathered casing limestone of the pyramid.

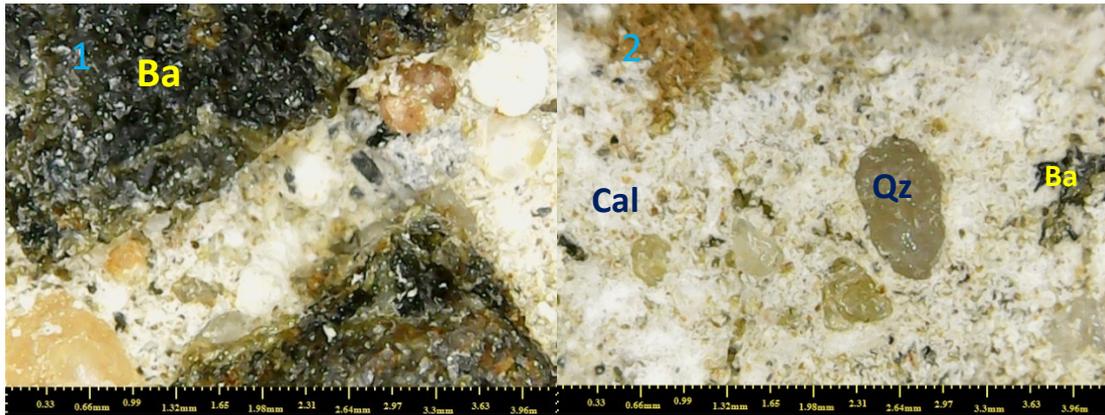
The Basaltic mortar have been found in fragments and mostly used for the flooring in the pyramid complex, this kind of mortar or concrete is so unique and this gives more attention for the impressive mentality of ancient Egyptians in technology of building materials. The sample have been prepared is very fine to coarse-grained, composed of numerous grains minerals (allochem) and stone fragments spread in a very fine-grained matrix. Significant amount of microfossils and fossil fragments are observed in the carbonate fragments and in the ground mass as well. Several irregular interparticle pores are detected in the sample figure 25.

Figure.25.1,2 Archaeological Basaltic mortar, Ba(basalt), Cal(calcite) and Qz(quartz), Significant amount of microfossils and fossil fragments are observed in the carbonate fragments and in the ground mass as well. Several irregular interparticle pores are detected in the sample.

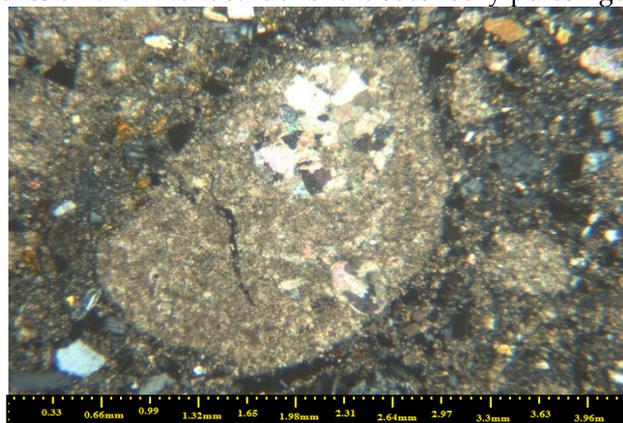
Figure.26. Observed stone fragments are of sedimentary (fossiliferous limestone, gypsum(chemical alteration byproduct), feldspathic greywacke, and ironstone) and igneous (porphyritic basalt and rhyolite) origin.

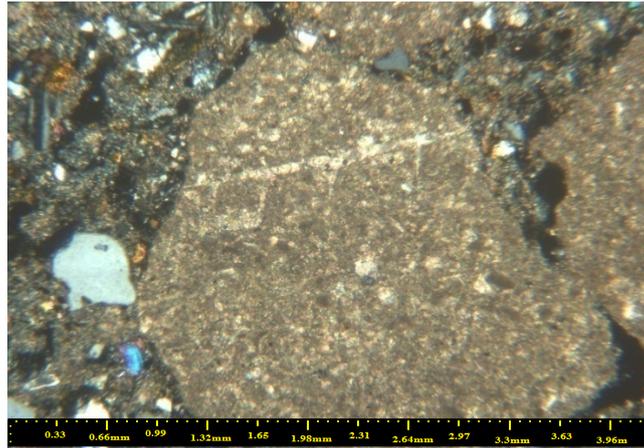
Figure.27. Some noticed limestone fragments are cut by fine microveinlets filled by recrystallized secondary calcite.

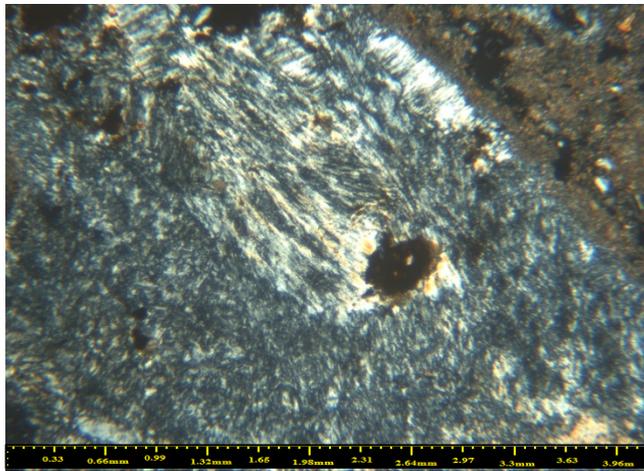
Figure.28. Gypsum rock fragments are composed of a network of very fine-grained irregular gypsum crystals. This texture is characteristic for secondary gypsum after anhydrite.

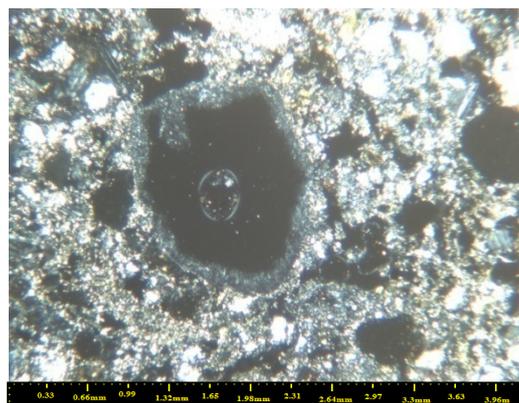
Petrographically, the basaltic mortar is composed mainly of rock fragments, gravels (aggregate particles), quartz and feldspar associated with minor amounts of iron oxides, mafic minerals (mainly pyroxene & olivine) and opaque minerals cemented by carbonate minerals admixed with gypsum, clay minerals and iron oxides. Observed stone fragments are of sedimentary (fossiliferous limestone, gypsum, feldspathic greywacke, and ironstone) and igneous (porphyritic basalt and rhyolite) origin. Rock fragments are coarse to medium-grained and have rounded to subangular outlines. Limestone fragments are the most abundant constituent. They comprise very fine to fine-grained, subhedral to anhedral interlocked calcite crystals. Most of limestone is fossiliferous with microfossils of different sizes and shapes. Some of the fossils are filled by recrystallized secondary calcite figure 26. Some of limestone fragments are cut by fine microvioletlets filled by recrystallized secondary calcite figure 27. Few limestone fragments have rare fine-grained quartz grains. Gypsum rock fragments are composed of a network of very fine-grained irregular gypsum crystals. This texture is characteristic for secondary gypsum after anhydrite figure28. Some gypsum fragments are dissolved leaving relics on the inner boarder of the secondary pores figure 29.

Figure.29. some gypsum fragments are dissolved leaving relics on the inner boarder of the secondary pores.

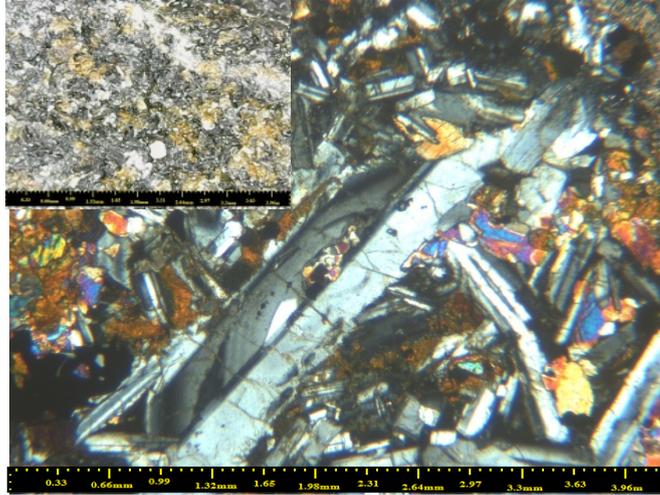
Figure.30. Alteration of basalt components, plagioclase to sericite, olivine to iddingsite, iddingsite to limonite and pyroxene to chloride and iron oxides.

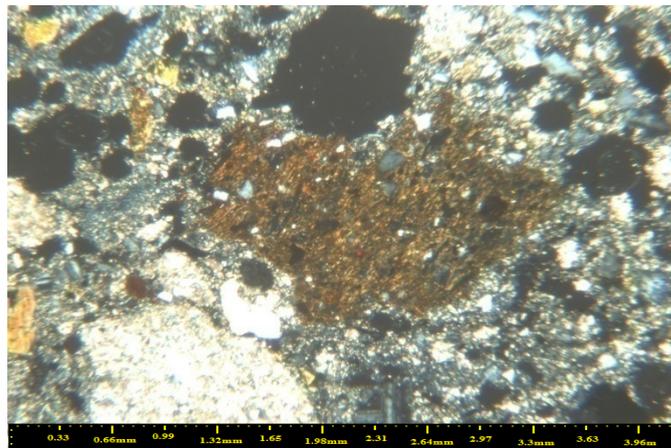
quartz (sand grains) associated with major feldspars and rare mica embedded in a very fine matrix of clay minerals and iron oxides figure31. Iron stone fragments are composed of very fine to fine-grained quartz and minor calcite, embedded in a cement of iron oxides and opaque minerals. Iron stone fragments are generally porous figure 32. Rhyolite fragments are the least abundant and are composed of very fine to fine-grained quartz and potash feldspars (mainly microcline) figure 33. Potash feldspars are slightly altered to clay minerals.

Figure.31. Feldspathic greywacke fragments with minor feldspars and rare mica embedded in a very fine matrix of clay minerals and iron oxides.

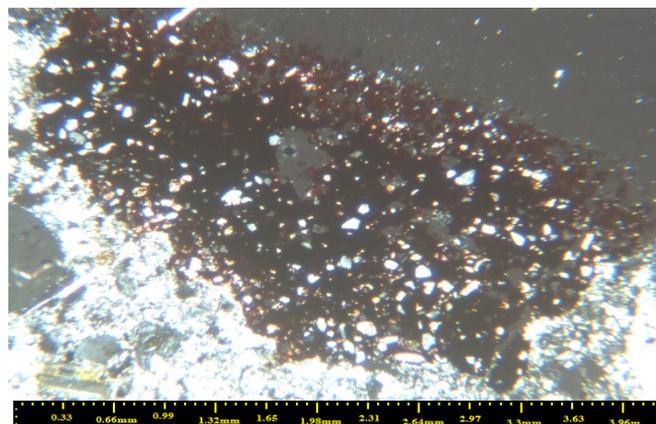
Figure.32. Iron stone fragments embedded in a cement of iron oxides and opaque minerals.

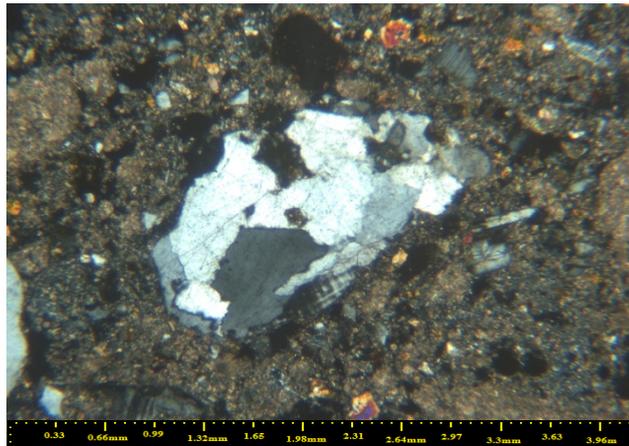
Figure.33. Rhyolite fragments are the least abundant and are composed of very fine to fine-grained quartz and potash feldspars (mainly microcline); Potash feldspars are slightly altered to clay minerals.

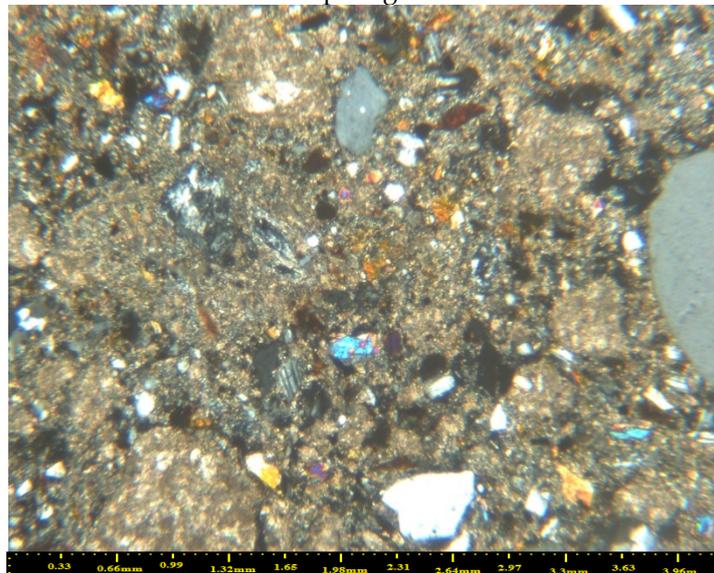
Free quartz grains occur as very fine to fine-grained with rounded to subangular outlines. Some grains of quartz are polycrystalline. Feldspar (anorthite) occurs as fine-grained euhedral to subhedral crystals scattered in the matrix of the sample. Calcite occurs as very fine-grained (micrite) aggregates that represents the majority of the matrix of the rock. Iron oxides and opaque minerals occur as very fine to medium-grained scattered in the sample. Mafic minerals (pyroxene & altered olivine) present as very fine to fine-grained crystals that are observed in the matrix which reflects strong deformation of the rock fragments and the whole sample. Gypsum occurs as very fine-grained, fibrous aggregates to needle-like crystals scattered in the matrix of the sample. Clay minerals occur as very fine-grained admixed with all the matrix components. Some irregular pore spaces and fine channel are detected in the sample figure 34.

Figure.34. Some grains of quartz are polycrystalline, Feldspar (anorthite) occurs as fine-grained euhedral to subhedral crystals scattered in the matrix, Calcite occurs as very fine-grained (micrite), Iron oxides and opaque minerals occur as very fine to medium-grained, Gypsum occurs as fibrous aggregates to needle-like crystals and Some irregular pore spaces and fine channel are detected.

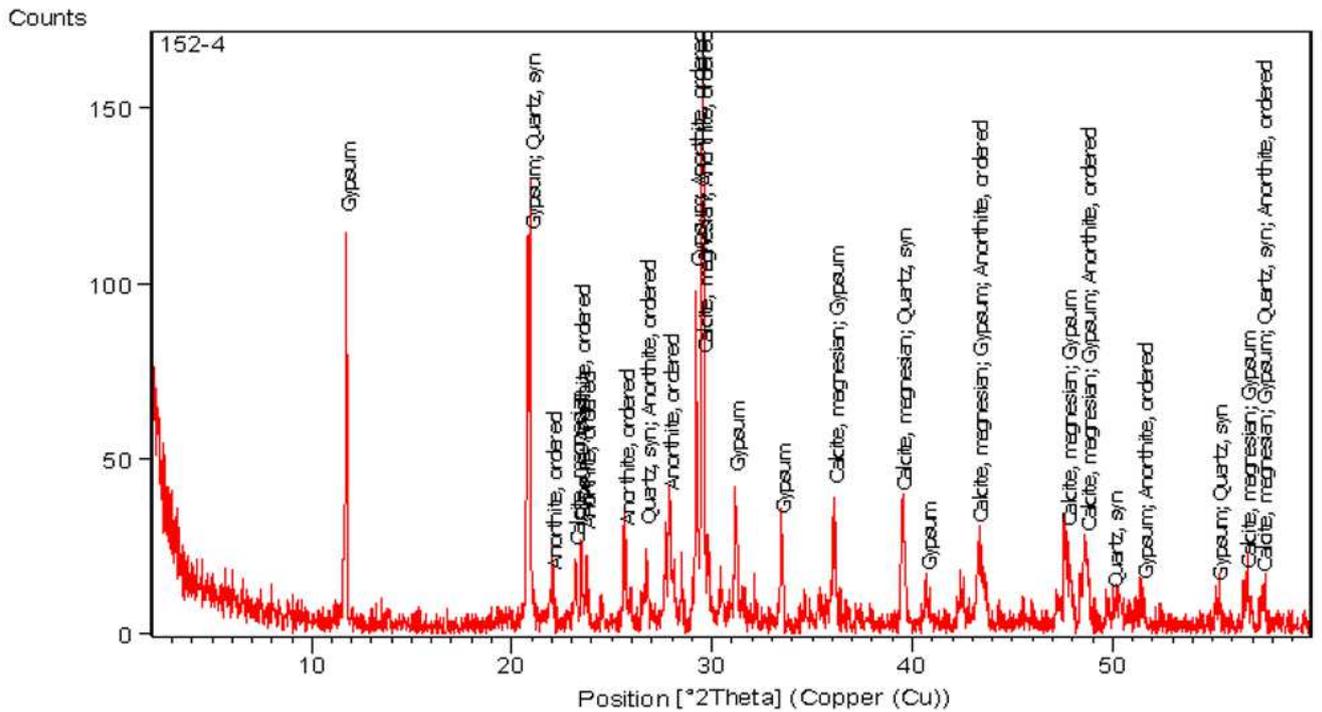
Figure.35. XRD pattern of the basaltic mortar.

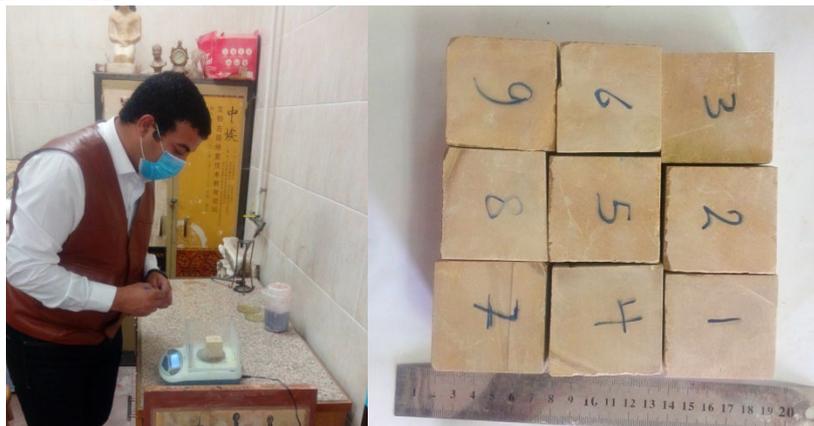
To determine the petro-physical properties such as specific gravity, apparent density, porosity nine cubic samples have been prepared from local sandy limestone at Abusir archaeological site 5 cm x5 cm x 5 cm figures 36. The samples have been weighted naturally, after drying in 105° and then the samples saturated in the water to determine the natural weight, dried weight and saturated weight table11.

Figure.36. Preparations of the samples and measurements works for petro-physical properties for the core stone (sandy limestone) of the pyramid.

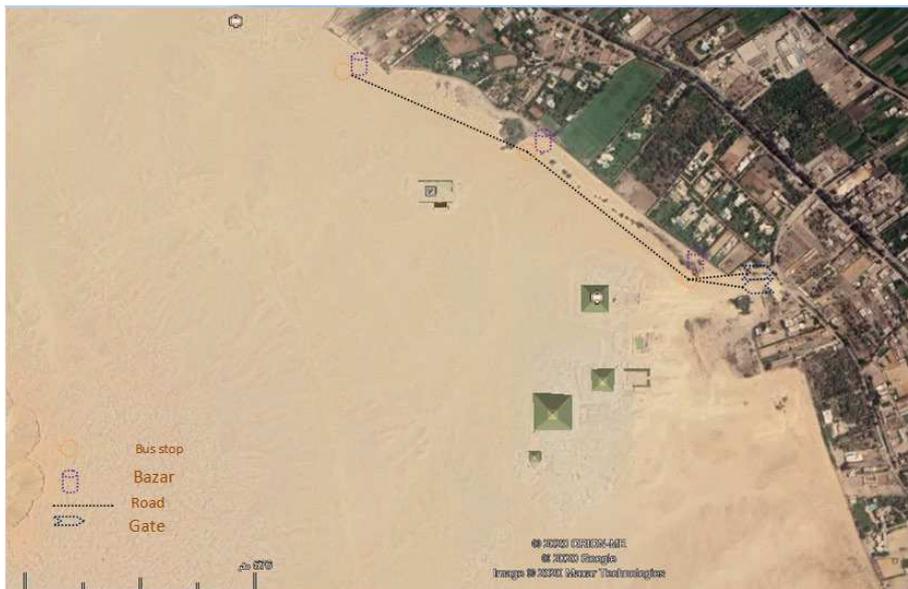
For the site management, this process is considered one of the most important steps for the preservation of the site in indirect way. By site management, Infrastructure of Abusir will be improved such as sewage system, roads and also improving the tourism infrastructure. Currently Abusir archaeological site is ignored from tourism management although it is part of Memphis and listed as a world heritage site with all Memphis. After application of the management plan figure37, this site will be strongly a significant destination for all tourists in Egypt. Site management isn't only for infrastructure improvement and services but also the application of the strategy of preventive conservation on site scale and for the buildings.

Figure.37. Google earth map shows the suggested proposal for the site management of Abusir archaeological site.
