# A technique for the extraction of the Proximal Femoral Nail Anti-rotation (PFNA) after unlocking failure

## Technical note

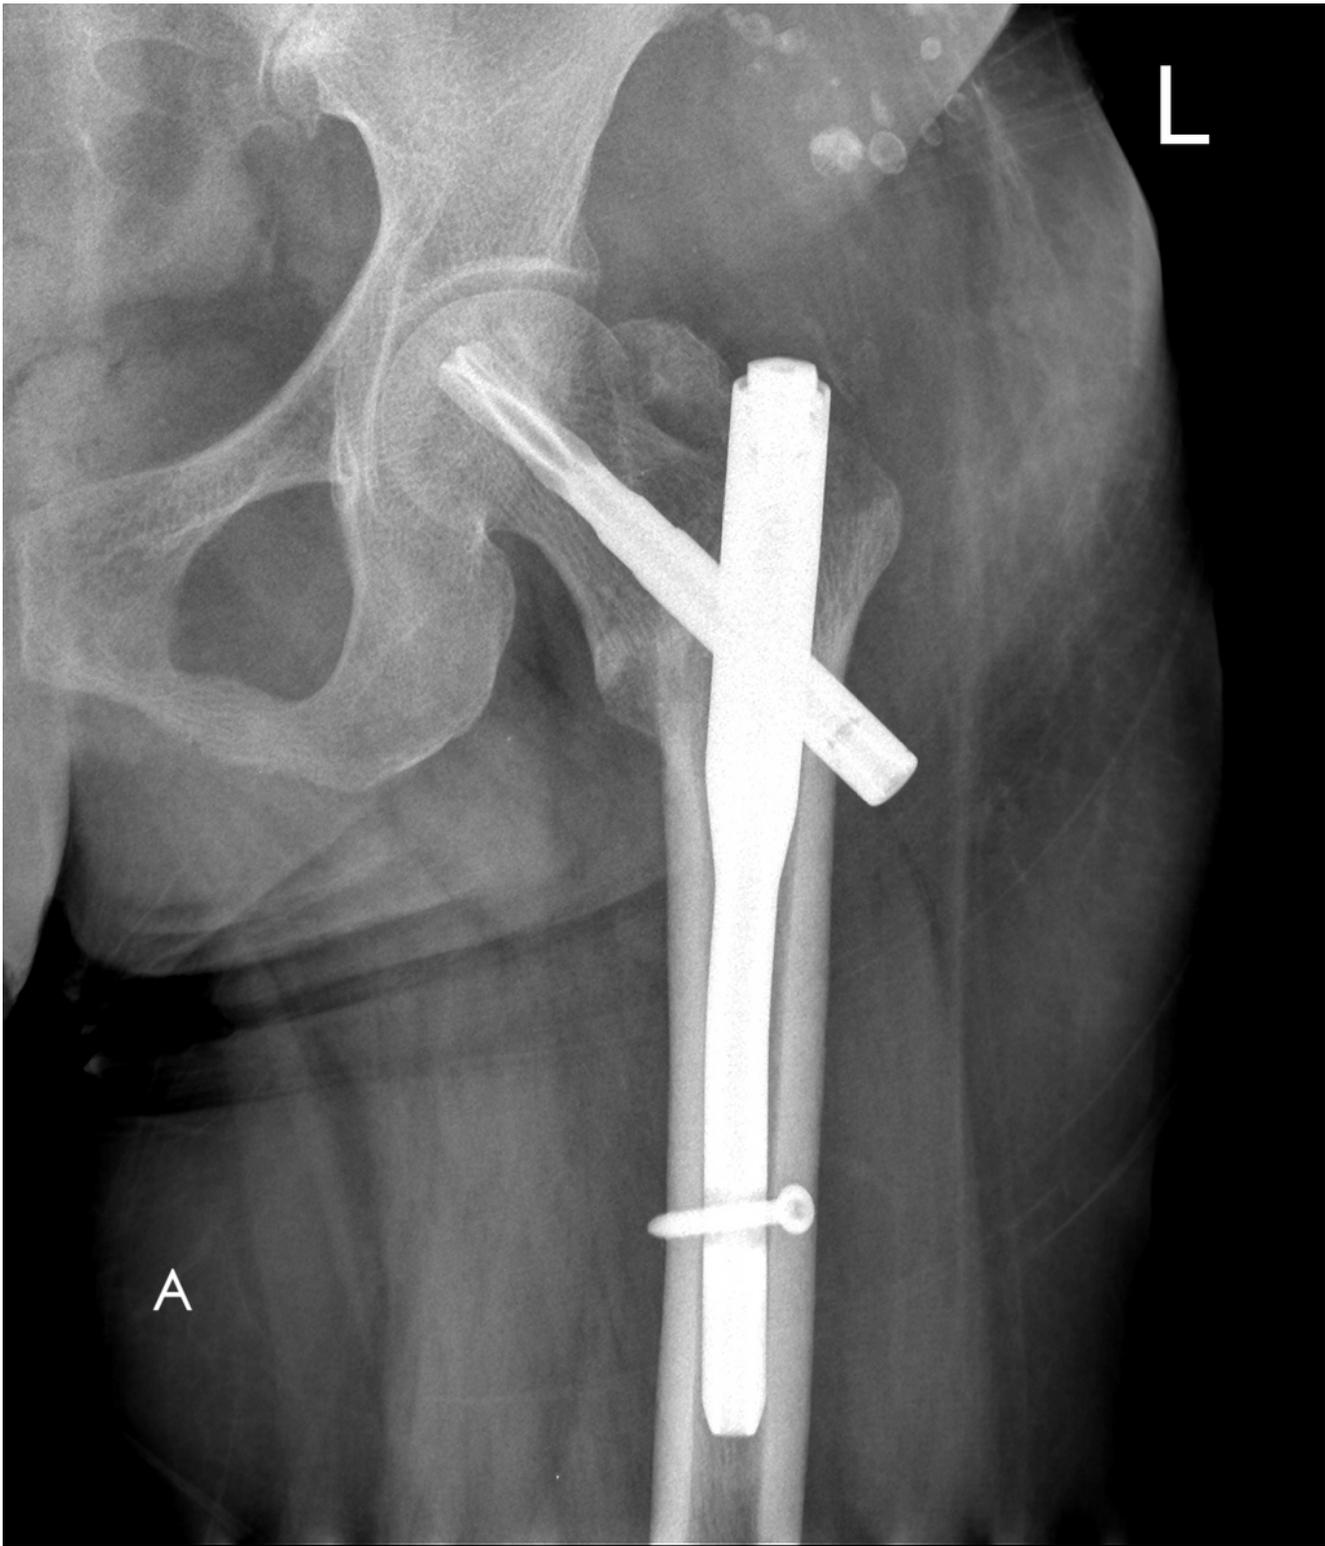
**Figure 1**

The anteroposterior radiograph of left hip after the PFNA fixation.

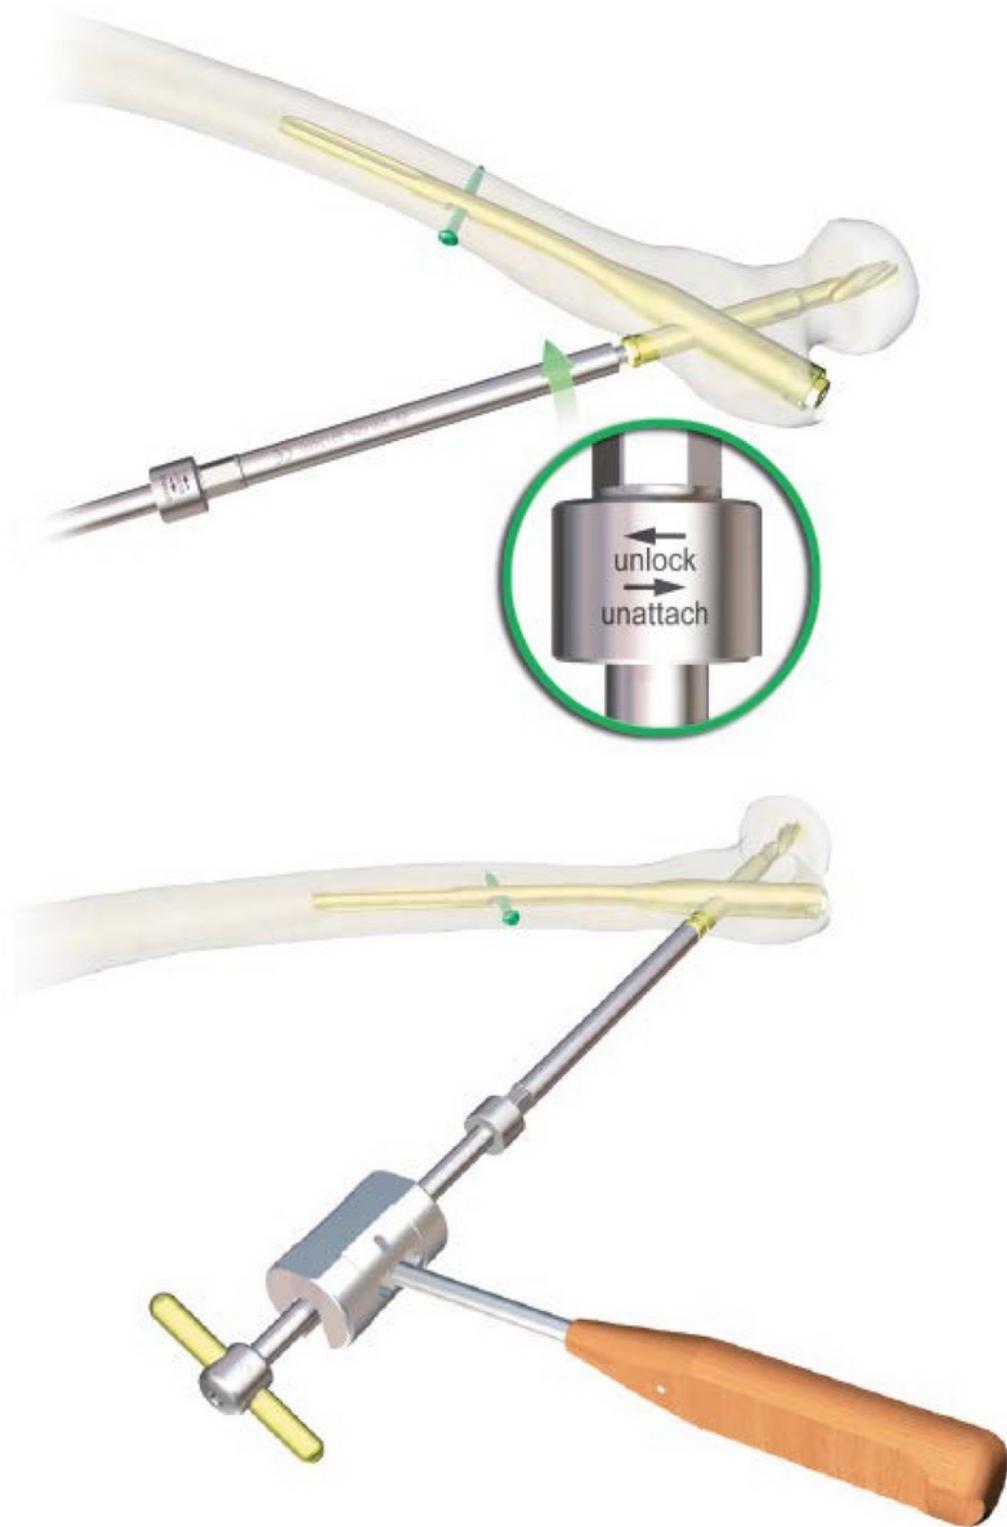
**Figure 2**

The standard procedure of PFNA blade removal.

approach. During the first part of the procedure, the end cap and distal locking bolt were successfully removed. However, when we tried to remove the anti-rotation blade follow the instructions (Fig. 2), it found that hexagonal socket stripped (Fig. 3) and couldn't lock up with the extraction screw for PFNA blade, thus the locking blind nut couldn't dispatch with the main body of the anti-rotation blade. After loosening the attachment of the blade and the greater trochanter, locking pliers were used to pull out the blade. However, pliers couldn't provide enough tensile. Meanwhile, multiple failed attempts were made to remove the nail with regular techniques. Thus, a uni-cortical hole was dilled by a 5 mm tungsten carbide bur at the end of the blade, and 2 mm double-strand steel wire was threaded through the previously drilled hole (Fig. 4a and 4b). The wire was twisted and strongly tied up to the extraction by hard loop. Eventually, the blade was removed by applying blow of the combined hammer, in the direction of the blade. The post-operation X-ray (Fig. 5) showed the fixation was completely removed. And the patient was encouraged to take full weight two week after surgery with anti-osteoporosis treatment.

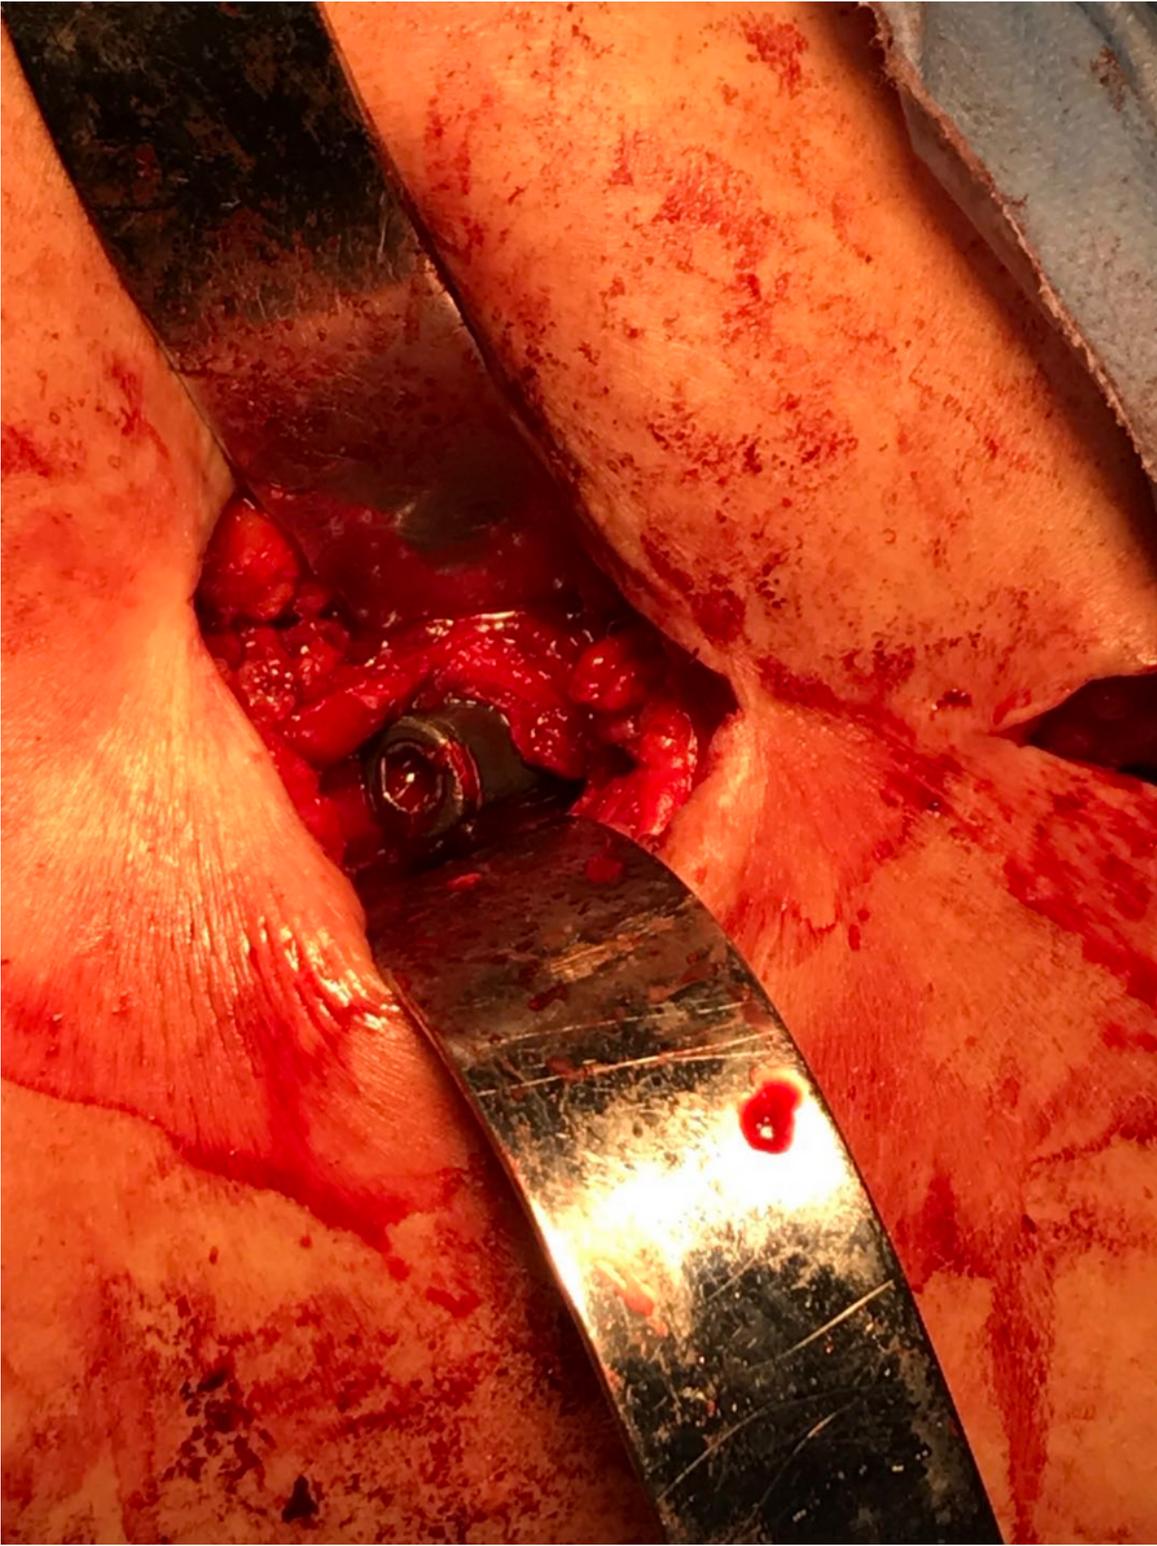
**Figure 3**

Intraoperative image

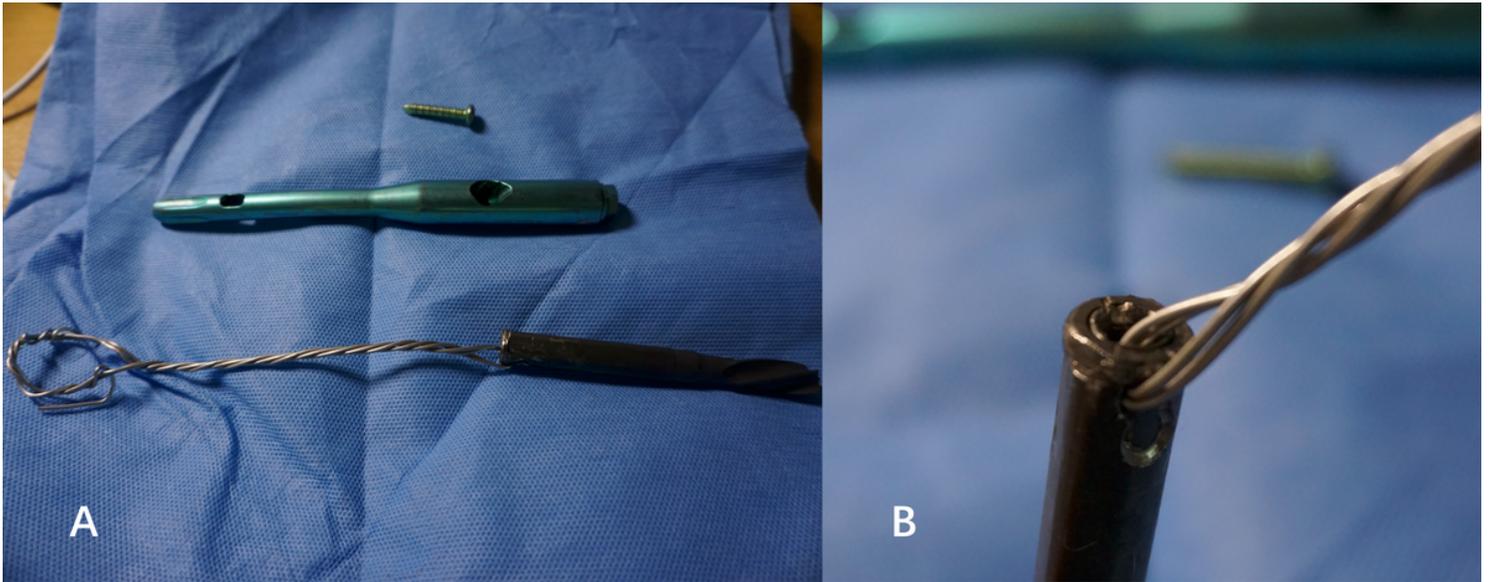
**Figure 4**

The steel wire loop was threaded through the helical blade(A), detailed structure of the helical blade end(B).

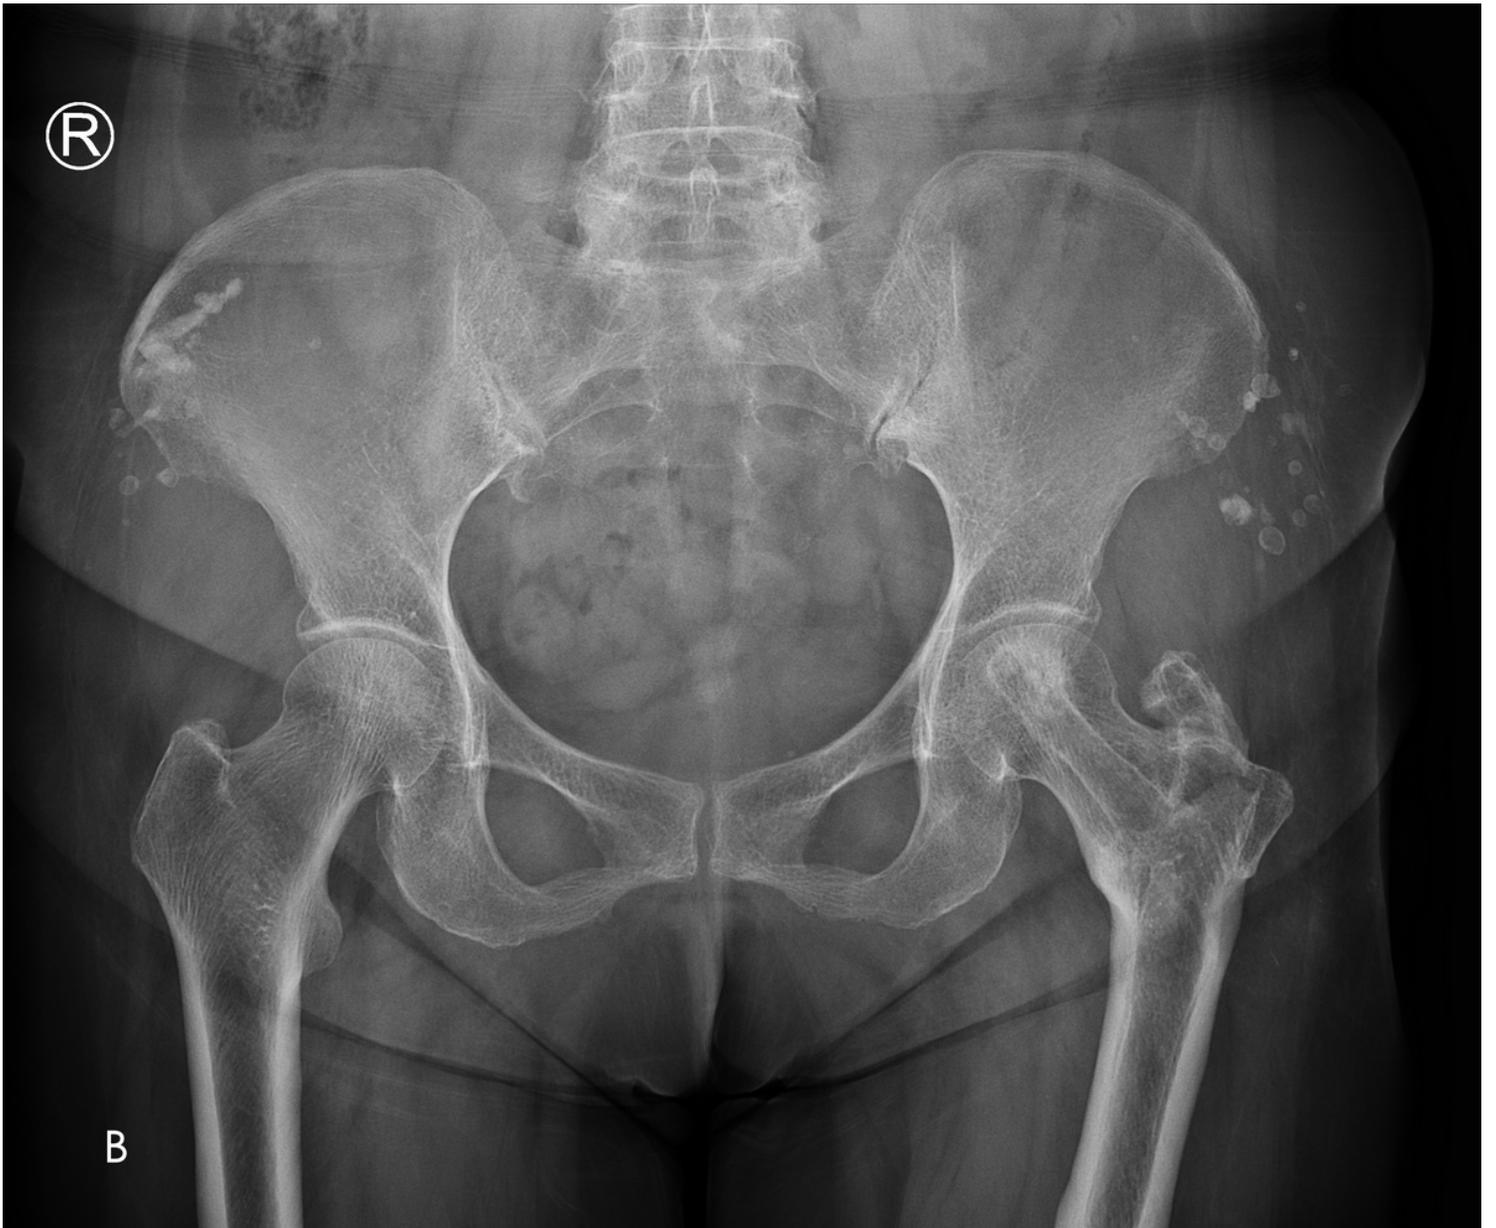
**Figure 5**

The anteroposterior radiograph of the pelvis after the PFNA removal.
