Evaluation of Geohazards in the Cape Girardeau area using LiDAR and GIS, Southeast Missouri, USA

Research Article

Keywords: Cape Girardeau, New Madrid Seismic Zone, LiDAR, landslide, sinkhole, geohazard mapping

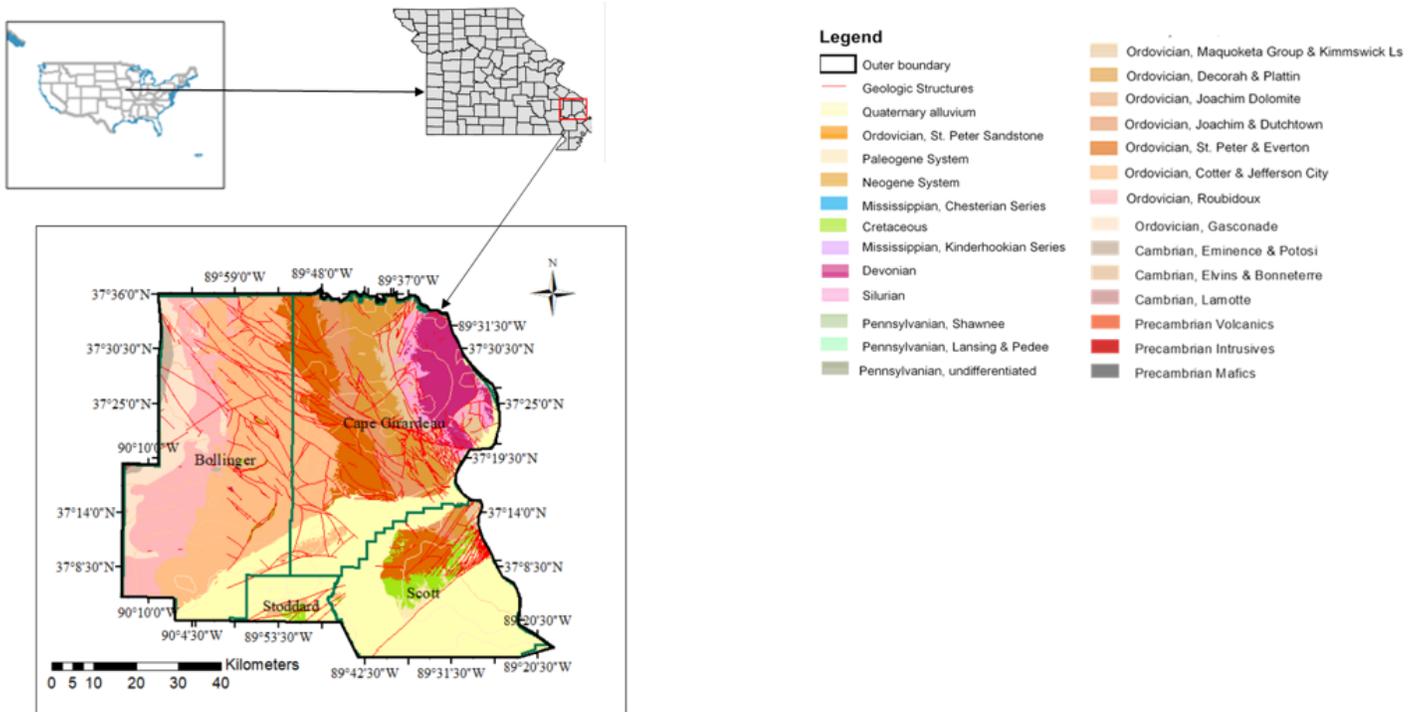
Figure 1

The political map of conterminous United States (top left), the State of Missouri (top right), and the geologic map of Cape Girardeau and Bollinger counties and parts of Stoddard and Scott counties in southeast Missouri showing, the regional controlling faults trending northwest–southeast in the study area in the New Madrid Seismic Zone. (Source Missouri Department of Natural Resources). Note: The designations employed and the presentation of the material on this map do not imply the expression of any opinion whatsoever on the part of Research Square concerning the legal status of any country, territory, city or area or of its authorities, or concerning the delimitation of its frontiers or boundaries. This map has been provided by the authors.

The dolomite-limestone formations in southeastern Missouri (Figure 1) pre-dispose the upland slopes to landslides and slumps that tend to favor steep slopes underlain by unconsolidated material or thick soils. Karst features form in carbonate units, such as limestone and dolomite, and other soluble rocks like anhydrite, gypsum, and evaporated salts (Bansah 2018). Karst features are usually formed over long periods of time through cation exchange with oxygenated groundwater percolating along joints, fissures, and stratigraphic horizons. Mining of clay and crushed limestone requires frequent blasting and vibration of heavy equipment. Frequent vibration combined with small amounts of moisture (e.g. 10% by weight) can actually enhance the bulk density of cohesionless gravel-sand mixtures. The high solubility of karst terrain makes it of immense concern to authorities and residents.

The geo-political extent of the study area covers Cape Girardeau and Bollinger counties and parts of Stoddard and Scott counties in southeastern Missouri (Figure 1). Greater Cape Girardeau is a key commercial center of the New Madrid Seismic Zone, which includes portions of Missouri, Illinois, Arkansas, and Kentucky. The topology of the area has changed significantly in the last 50 years, especially in pockets of expanding urbanization. The Mississippi Embayment (Fig. 1, in yellow) borders the study area in the southwestern section, while gentle hills covered by Holocene-Quaternary alluvium

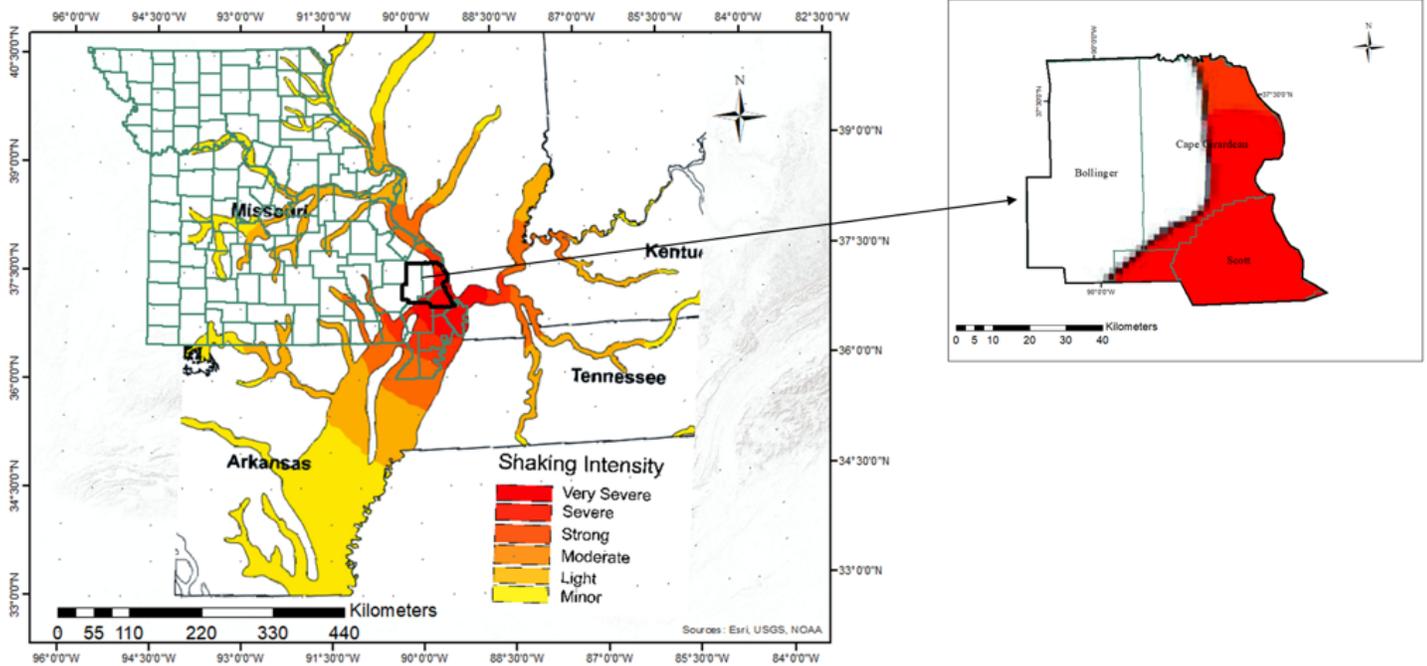
Figure 2

Modified USGS Earthquake Shaking Intensity map for the NMSZ showing an insert of the study area. The 2017 intensity shaking map projects that areas along the Mississippi River are most at risk of earthquake-induced ground shaking (Rogers 2010). Note: The designations employed and the presentation of the material on this map do not imply the expression of any opinion whatsoever on the part of Research Square concerning the legal status of any country, territory, city or area or of its authorities, or concerning the delimitation of its frontiers or boundaries. This map has been provided by the authors.

An even more significant problem might be the reactivation of dormant landslides or lateral spread features triggered by earthquake shaking in 1811-1812 in the NMSZ; approximately 100 earthquakes occur annually in the Wabash Valley Fault Zone (WVZ), 220 km to the northeast (McBride 2002). An extensive lateral spread feature occupying 67 km² has been identified near Advance, Missouri, placing it among the most extensive of such features globally (Watkins and Rogers, 2009a, b). This lateral spread feature formed as part of the series of structural alterations that occurred during the 1811- 1812 New Madrid earthquakes. Much of the NMSZ lies beneath the Mississippi Embayment, a trough filled with sediments that may greatly amplify earthquake shaking. (USGS 2002) (Figure 2). Some sliding occurred

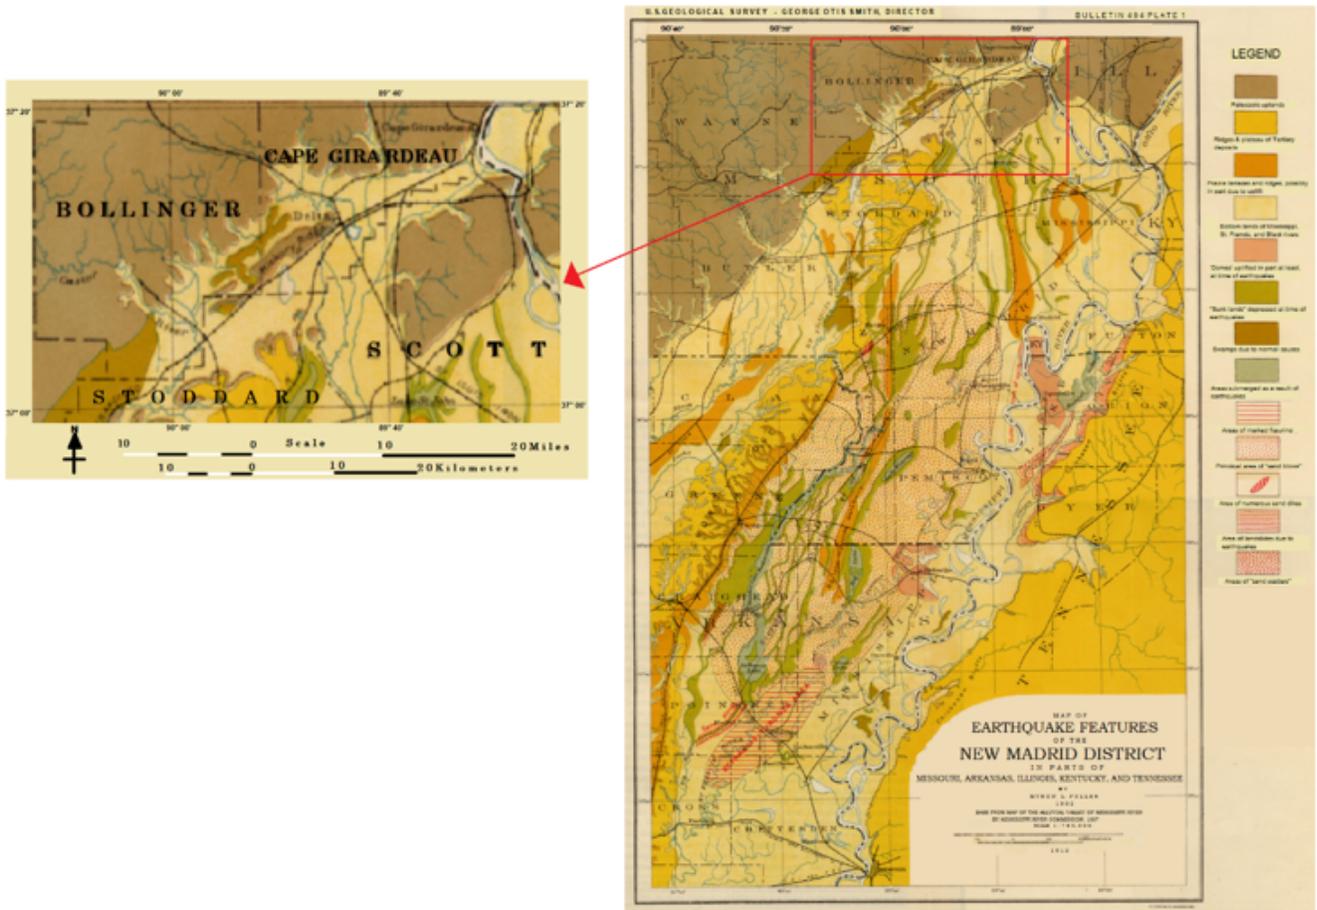
Figure 3

Map of Earthquake Features of the New Madrid District (1912) in Parts of Missouri, Arkansas, Illinois, Kentucky and Tennessee (Fuller 1912). The subset is a detailed map of the study area showing the Paleozoic uplands and paleo-landslides of Cenozoic deposits. Note: The designations employed and the presentation of the material on this map do not imply the expression of any opinion whatsoever on the part of Research Square concerning the legal status of any country, territory, city or area or of its authorities, or concerning the delimitation of its frontiers or boundaries. This map has been provided by the authors.

d. Co-seismic Hazard Evaluation: For hazard evaluations, credible sources of ground shaking in the area were used. This process usually begins with a simple evaluation of the historicity of earthquakes in an area (Figures 2 and 3) using the map of Earthquake Features of the New Madrid District (1912), the New Madrid Seismic Zone map and the Earthquake Hazards Map of Southeast Missouri (1993).

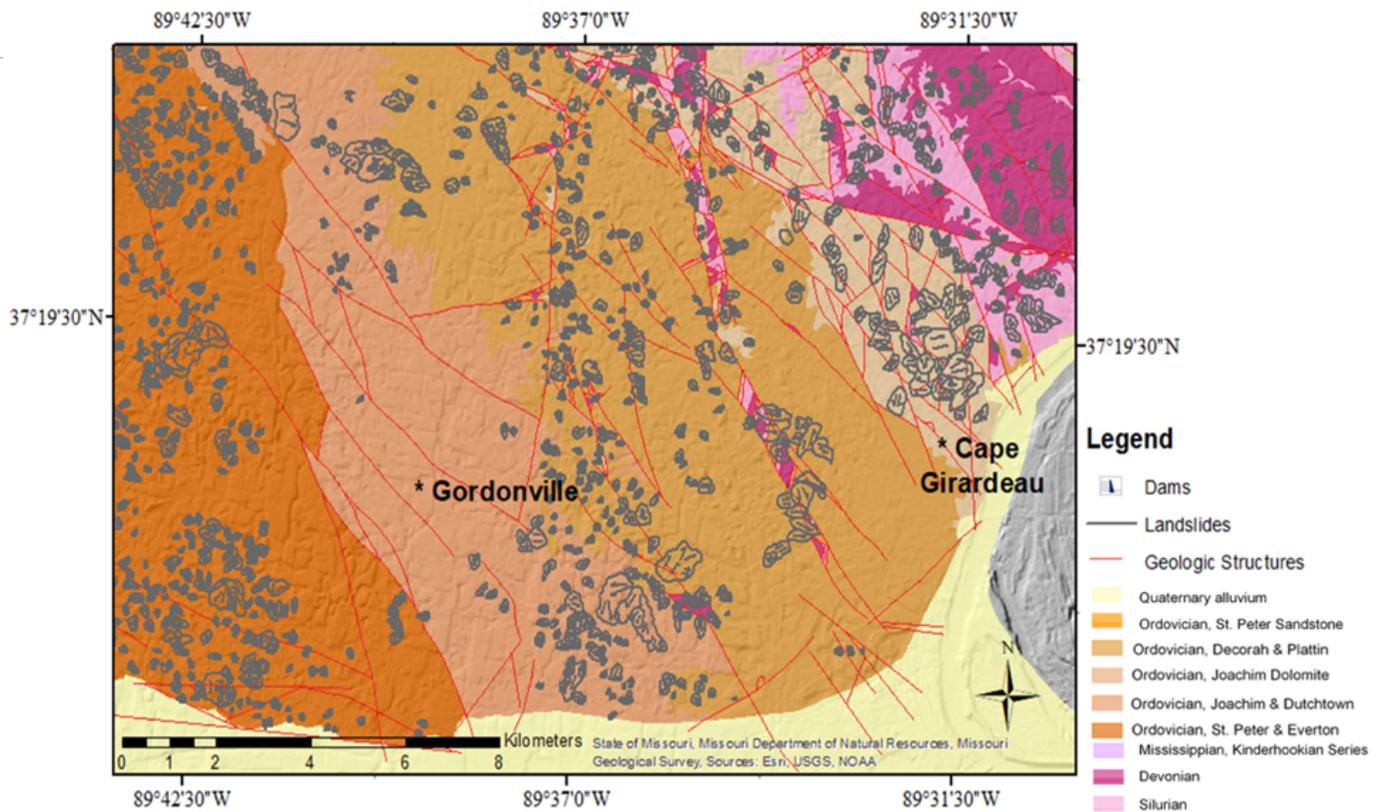
Figure 4

The geological map of the Cape Girardeau and Gordonville Quadrangles showing mapped landslides (in gray) and the expected distribution of ground accelerations emanating from the active fault strands (in red). Note: The designations employed and the presentation of the material on this map do not imply the expression of any opinion whatsoever on the part of Research Square concerning the legal status of any country, territory, city or area or of its authorities, or concerning the delimitation of its frontiers or boundaries. This map has been provided by the authors.

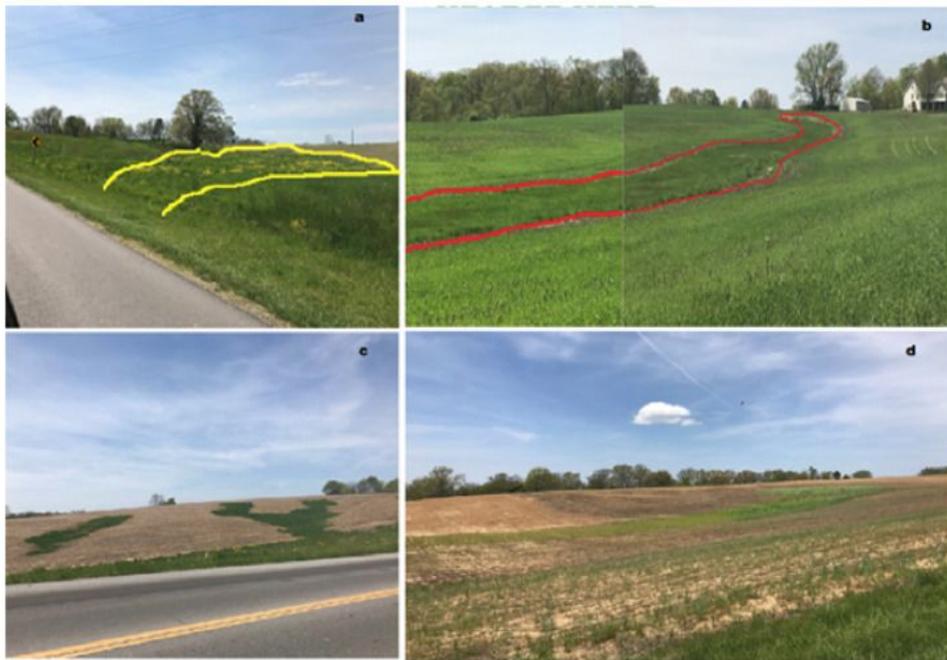
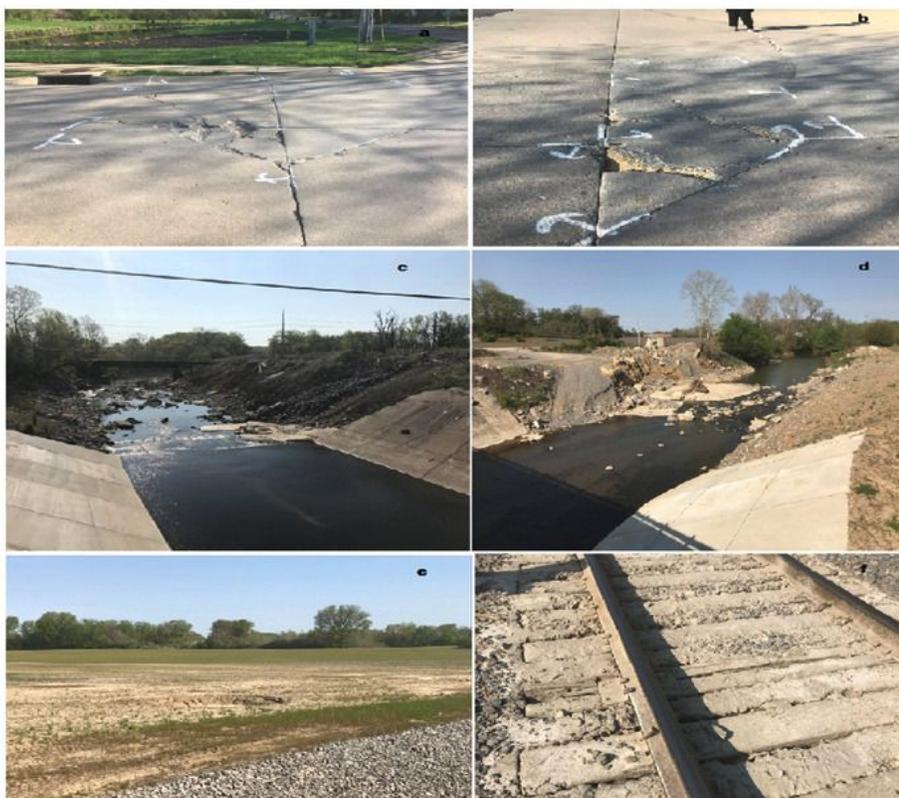
Figure 5

5.1: Field pictures taken in May 2018 showing changes in vegetation. (a) Plants with yellow flowers due to the change in soil characteristics and moisture resulting from shallow mass wasting on slope sides. (b) Grasses with a deeper green coloration that is distinctly different from the surrounding grasses. (c, d) Hillsides with vegetated patches indicative of different adiabatic conditions. 5.2: Field photos showing mass wasting in limestone terrain. (a, b) Cracks on the pavement as a result of differential settlement of

the compacted soils. (c, d) Sides of a river channel collapsing. (e) Sink hole shows subsidence in the topsoil, which is indicative of an incompetent subsurface layer. (f) Mud cracks along the Buzzi Unicem rail tracks showing evidence of flooding of the tracks.

Field Observations: The site observations in some areas indicate steep slopes that experience repetitive mass wasting. Changes in vegetation were observed from the changes in soil characteristics and moisture resulting from shallow mass wasting on slope sides (Figure 5.1). Figures 5.1a and 5.1b illustrate plant with yellow flowers and grasses with a deeper green color that is distinctly different from the surrounding grasses, respectively. In Figures 5.1c and 5.1d, hillsides were observed to exhibit vegetated patches indicative of different adiabatic conditions. The verified landslides are characterized by shallow earth flows, rotational slumps, and block slides, while other areas were altered by building construction and infrastructure. Mass earthwork grading for site development was observed in several rural locations. Many hills mapped as landslide terrains have recently been excavated, re-worked, and re-compacted for residential developments with paved streets, lot pads for houses, man-made lakes and/or ponds, and golf courses within gated communities. Although some of the grading appeared to be in areas prone to earth movement, we were unable to discern any evidence of the nominal age of such features. Some of the hillside developments exhibited pavement cracks (Figures 5.2a, and 5.2b), which may be ascribable to differential settlement of compacted subgrade soils. Mass wasting was also observed along reaches of improved water courses (Figures 5.2c, and 5.2d). The subsidence of topsoil occasionally exposed underlying limestone where active sinkholes were impacting channels and public streets (Figure 5.2e). Desiccation cracks prevalent in the southeast portion of the study area may be influenced by seasons of intermittent flooding and drying (Figure 5.2f). The field observations were then integrated with the results obtained from the earthquake, precipitation, and seismic data map layers (landslide inventory). In Figures 5.2c and 5.2d, the sides of the western bank of the Mississippi River exhibit the most severe angular differences in elevations.

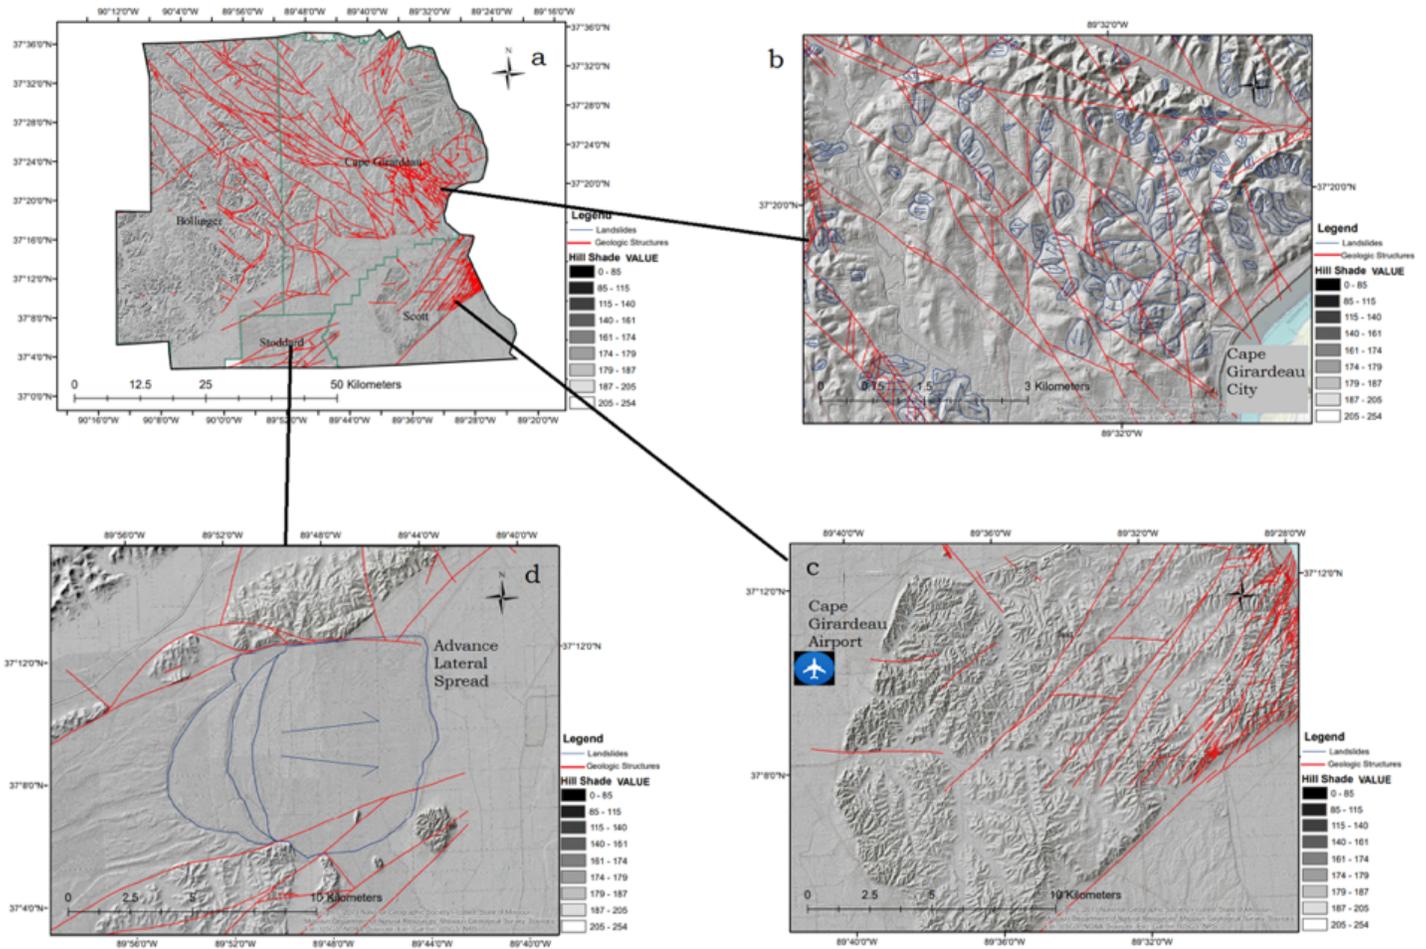
Figure 6

Hillshade maps of the study area and snap shots of the areas reflecting the different types of landslides produced from LiDAR-derived DEM maps. The red lines are mapped faults, while the light blue lines are the mapped landslide and lateral spread features. Note: The designations employed and the presentation of the material on this map do not imply the expression of any opinion whatsoever on the part of Research Square concerning the legal status of any country, territory, city or area or of its authorities, or concerning the delimitation of its frontiers or boundaries. This map has been provided by the authors.

Data Interpretation and analyses: Hillshade analysis provided information on the bare-earth topology of the study area. The relief expressed in the hillshade shows the shape of hills and mountains illuminated by the sun's relative position (levels of gray) on the map. The light gray shades indicate relative slope

angles, mountain heights and peaks (Figure 6). Dark gray shades indicate areas where there are relative steep angle changes that are unstable with high potential for slope failures, and landslides (Figure 6b). In the lighter areas, changes are reflected by the difference in the illumination of a surface. Consequently, the variation in the intensity of light can expose the patterns and intricate changes in morphology over a larger area. The Advance, MO lateral spread feature is expressed in Figure 6c as a flat, pancake-like feature straddled by two parallel faults. The intricate changes allow inferences based on geomorphic expressions typical of lateral spreads, and striations consistent with parallel faulting signatures (Figures 6c and 6d).

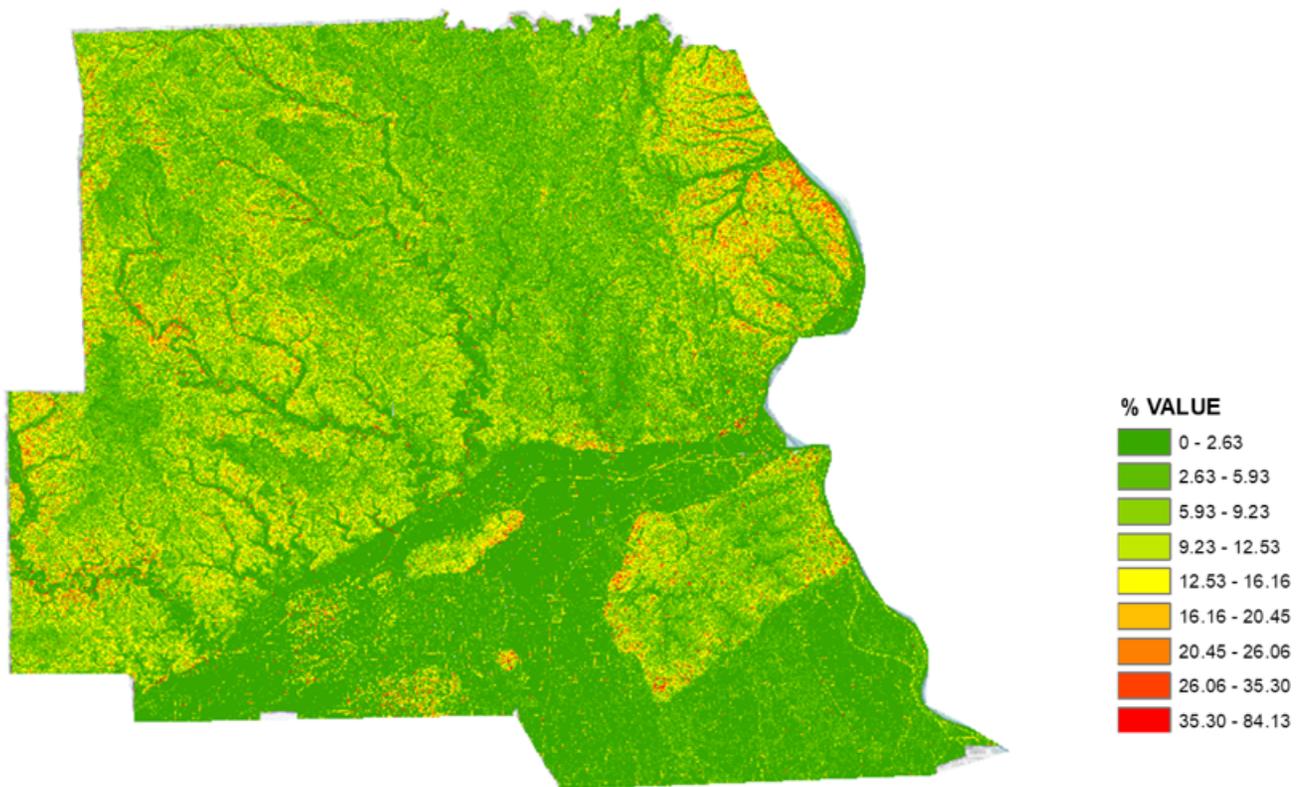
Figure 7

The slope analysis for the study area. The steepest areas (red) are the areas with high landslide risks, which are coincidental with river banks and watersheds. The lowest areas (green) are flat-lying alluvial plains currently cultivated for agriculture. The slope percentage reflects the steepness of the slope value. Note: The designations employed and the presentation of the material on this map do not imply the expression of any opinion whatsoever on the part of Research Square concerning the legal status of any country, territory, city or area or of its authorities, or concerning the delimitation of its frontiers or boundaries. This map has been provided by the authors.

The slope analyses describe the steepness and azimuth of the slopes (Figure 7). The lower slope values (green to yellow) indicate relatively gentle undulating terrains, while the higher slope values (orange to red) indicate high angle slopes with steeply dipping terrains. The steepest areas in red have high landslide risks, and are coincidental with riverbanks and watersheds. The lowest areas (green) are flat-lying alluvial plains currently cultivated for agriculture.

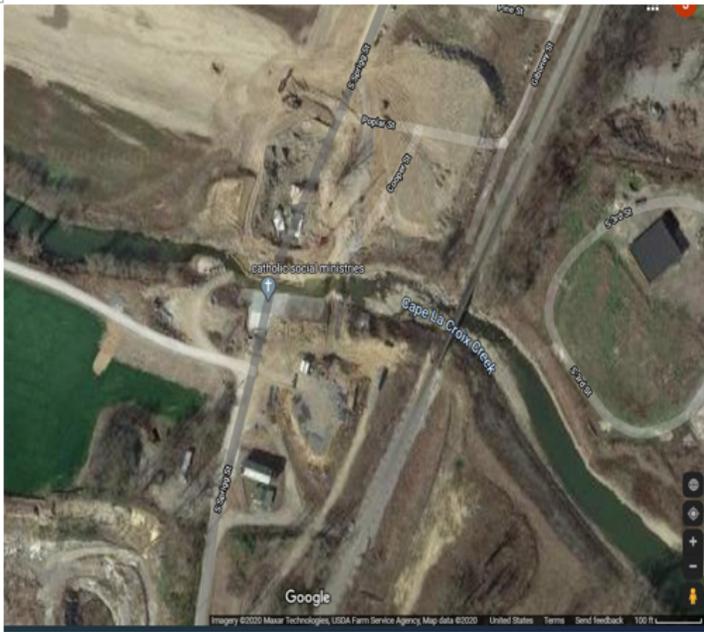
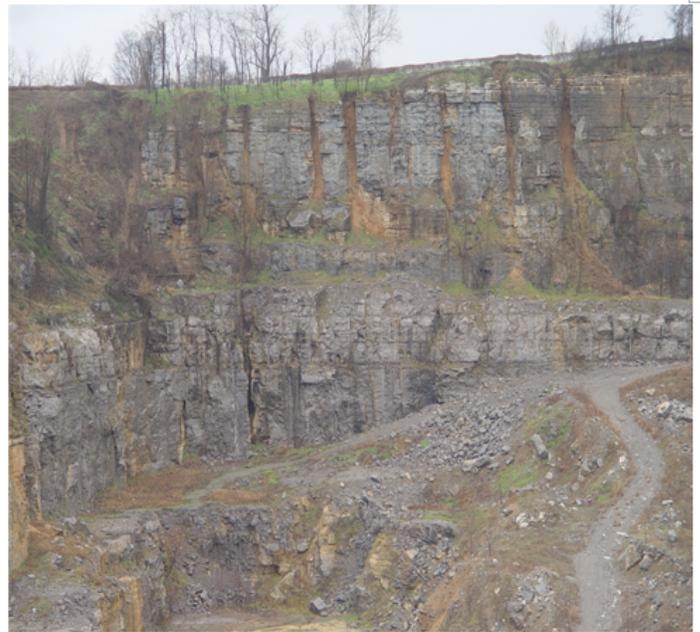
Figure 8

(a) The Google map imagery of the Cape La Croix River by Buzzi Unicem accessed October 16, 2020. (b) Field photo of the northeastern corner of the Buzzi Unicem mine pit showing the natural conduits for selective point recharge leading to a series of sinkholes.

Google orthoimagery was used to evaluate the current extent of mining activities in the southeastern portion of Cape Girardeau County (Figure 8a and 8b). The hydrology of the Cape La Croix Creek has allowed local runoff to recharge the river channel as it flows into the Mississippi River channel (Figure 8a). During the spring, the area receives more precipitation and runoff. Whenever precipitation continues unabated for days at a time, runoff is absorbed into joint-controlled "cutters" or soil-filled voids in the formation, which are observed to extend up to >60 m deep. These provide natural conduits for selective point recharge, which led to a series of sinkholes around the northeastern corner of Buzzi Unicem's open pit limestone quarry in 2007-2008, which extended to depths of >91 m (Figure 7b). The presence of linear soil-filled cutters can increase the risk of sinkholes developing if a low head outlet is established with an underground opening or with an open pit mine.

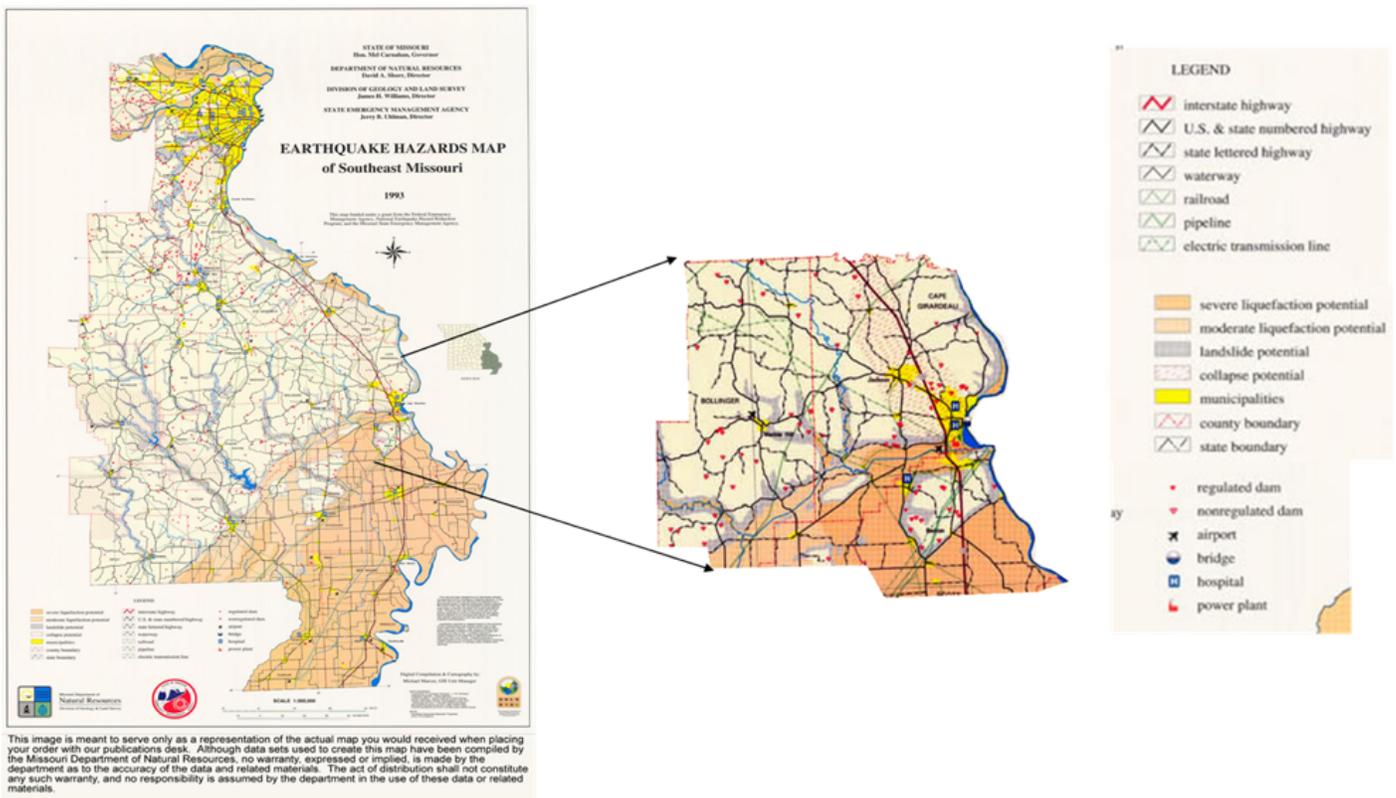
Earthquake Hazards Map of Southeast Missouri (1993) with an inset of a detailed map of the study area extracted for analysis. The study area shows severe liquefaction in the Mississippi embayment, while the collapse potential is projected along Interstate Highway 55. This zone falls within the high-volume Ordovician limestone, dolomite, and sandstone perturbed by high-angle, interconnected faults (see Figure 1). The landslide potential is higher along river courses due to channel down cutting along hillsides. Note: The designations employed and the presentation of the material on this map do not imply the expression of any opinion whatsoever on the part of Research Square concerning the legal status of any country, territory, city or area or of its authorities, or concerning the delimitation of its frontiers or boundaries. This map has been provided by the authors.

The co-seismic hazard potential susceptibility map combines all the risks various geohazards present in the study area and prioritizes the highest and/or combined threats. The co-seismic map derived from the analysis of GWLR risks, and Earthquake Hazards Map of Southeastern Missouri (1993) (Figure 9) evaluated the consequences of failure on the communities that may be affected. The gray zone in the earthquake hazard map highlights the erosional escarpments and slopes that are most susceptible to seismically-induced landslides. Dam failure potential is considered a risk factor to the lives and infrastructure that are situated down-gradient. Seventeen dams regulated by the State of Missouri are located in the study area (regulated dams have a total height of >10.7 m [35 ft] or volumes >15 acre-feet). Nine of the dams are classified as high risk, based on storage capacity, elevation, and location on highly fractured terrain. The dam heights range between 3.65 m and 13.10 m, with only one dam above the state-regulated height of 10.7 m. The maximum storage capacity of the high-risk dams falls between 100,000 and 580,000 gallons of water. These dams present both individual and cumulative hazard potentials to the population and infrastructure that could be impacted by their sudden failure.

Sustained earthquake vibration can trigger liquefaction of saturated cohesionless soil materials, like rock flour, silt, and sand. Of great concern are the high impact areas where 10 oil and gas pipelines (green lines on Figures 9 and 10) as well as the 14 highway and railroad bridges (red squares on Figure 10) that traverse the Upper Mississippi Embayment. Therefore, hazard evaluations should consider credible sources of ground shaking in the area. Since the local network of seismographs were installed in the Upper Mississippi Embayment in 1973-1974 (including one in Cape Girardeau), only 29 earthquakes of Mw 1.5 and Mw 3.1 have been recorded. The earthquake energy released increases 1024 times/Mw; therefore, the 29 events that occurred between 1996 and 2017 were capable of causing weak vibrations. While the mining and quarry activities from crushed stone, limestone, sand, and gravel trigger regular vibrations capable of producing topsoil liquefaction over time, the risk factor appears to be rather low.

Co-seismic Hazard Potential Susceptibility Map: The gray zone in Figure 9 highlights the erosional escarpments and slopes most susceptible to seismically-induced landslides. The bedrock is characterized by high volume Ordovician limestone, dolomite, and sandstone perturbed by high-angle, interconnected faults. Accordingly, the factors that increase geohazard risks in the study area to damaging impact were the clusters of landslides in places that identified the potential for smaller earth flows to coalesce into larger landslide complexes. The preponderance of crystalline limestone bedrock with interconnected fault patterns and much younger unconsolidated materials like wind-blown loess and alluvial cover leads to the susceptibility of the northwest quadrant. This area has 17 embankment dams that fall just below the jurisdiction of Missouri’s dam safety statutes, so the state does not exercise any oversight of their design or maintenance. As these structures age, they will likely pose increasing risks to downstream inhabitants and infrastructure. The failure consequences arises from dam storage

The other areas noted in Figure 9 are considered as lower risk with less threat to the population, private properties, and public infrastructures. However, the preexisting landslides can be triggered by earthquake shaking, precipitation, or flood-induced erosion, either along channels, within alluvial valleys, along levees, dams, spillways, man-made embankments, or natural hillsides. Over-steepened erosional escarpments are also subject to undercutting, slope creep, and dilation, which can hasten slope instability, such as rockslides and debris torrents. The porous loess blanketing upland areas like Crowley's Ridge are highly erodible once saturated. These conditions cause earth materials to reach the limiting slope angle for cohesionless materials like loose rock and sandy soils.

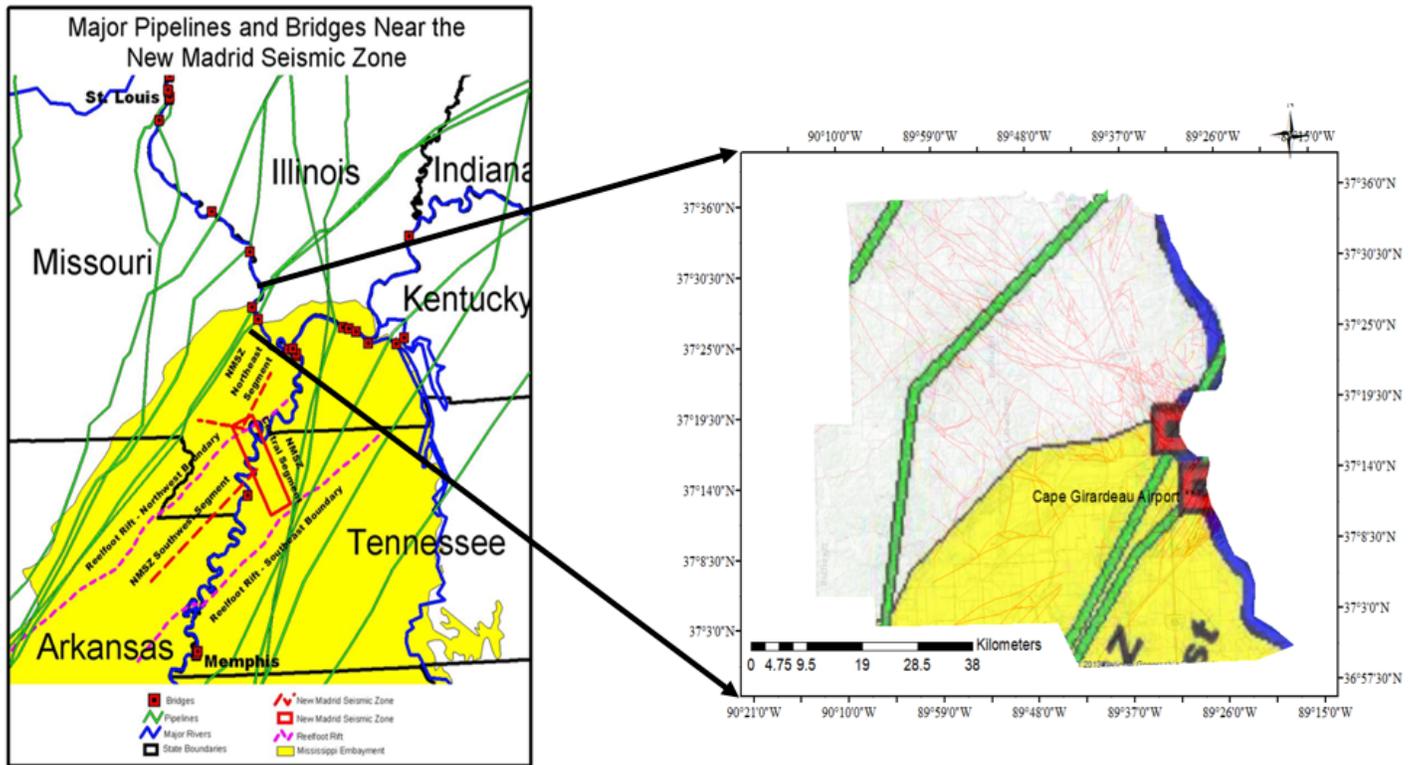
Figure 10

Left - New Madrid Seismic Zone map showing major pipelines and bridges crossing through the Mississippi Embayment in the Reelfoot Rift, compiled by David Hoffman at Missouri University of Science and Technology. Right - Map of study area showing rock bearing faults (lines in red) that run almost perpendicular to the major oil pipelines. The southwest portions of the map in the Mississippi Embayment are at risk of liquefaction when high seismic loading occurs in the NMSZ (Rogers, 2010). Note: The designations employed and the presentation of the material on this map do not imply the expression of any opinion whatsoever on the part of Research Square concerning the legal status of any country, territory, city or area or of its authorities, or concerning the delimitation of its frontiers or boundaries. This map has been provided by the authors.

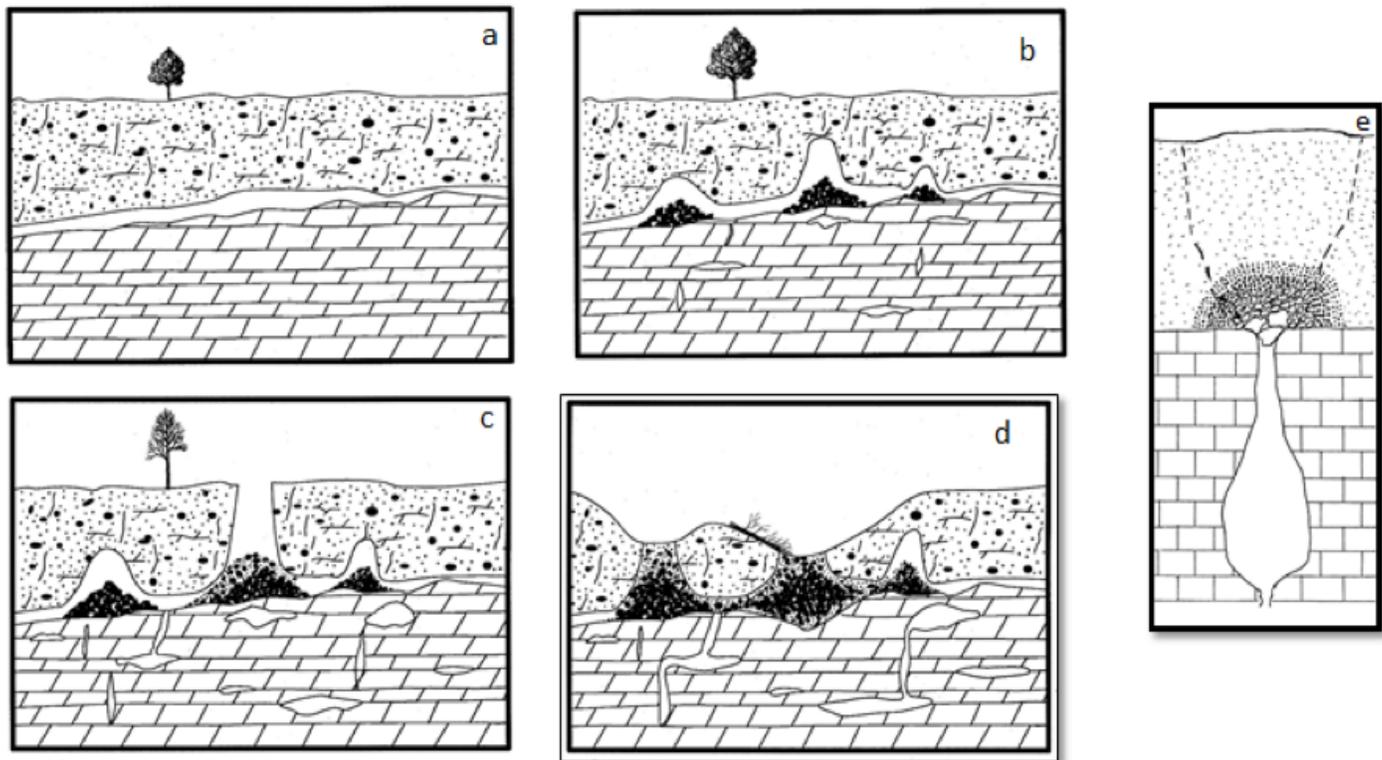
Figure 11

Stages of sinkhole formation in carbonate environment; (a) Dissolution by groundwater circulating through the rock. (b) As the rock dissolves, spaces and caverns develop underground. (c) After the underground support for the topsoil has been dissolved, it loses support, and sudden collapse occurs. (d) Multiple collapses can result in shapes like shallow bowls or saucers, while others have vertical walls, and some hold water, forming natural ponds. (e) inverse filter used in reversing the hydraulic piping in sinkholes (source: Missouri Geological Survey).

The limestone bedrock in southern Cape Girardeau exhibits a rapid response to flooding and supports a high-water table, which enhances the dissolution of the rocks. Figures 11 and 12a-f show the schematics of the stages of water-induced dissolution in a carbonate environment and examples of sinkholes in the Missouri Bootheel (Roberts 1964; Lolcama 2003; Palmer 2004; Lolcama and Gauffreau 2008; Lolcama 2009; Bansah 2018). In 2007, the North-South BNSF Railroad line paralleling the Mississippi River, south of Cape Girardeau, was threatened by multiple sinkhole collapses adjacent to the Buzzi-Unicem Limestone Quarry. The impacted zone has been fitted with telemetered downhole monitors to measure settlement and provide real-time warnings to the railroad and local officials (Figures 5.2e and 12f).

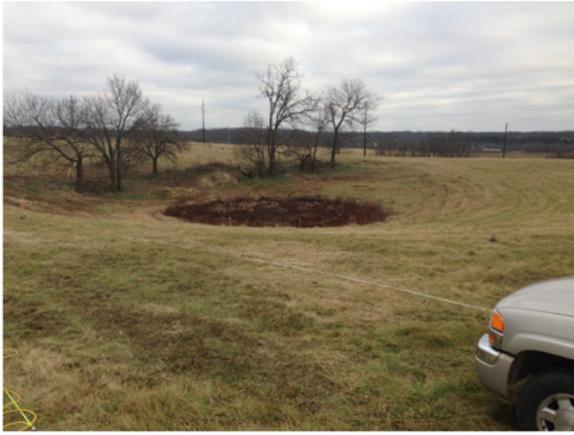
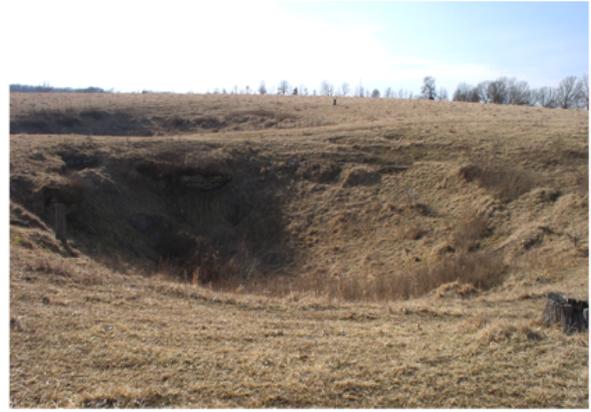
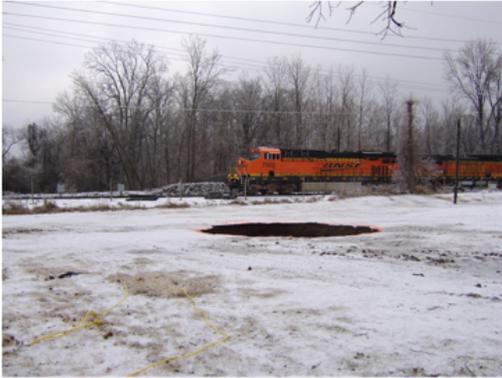
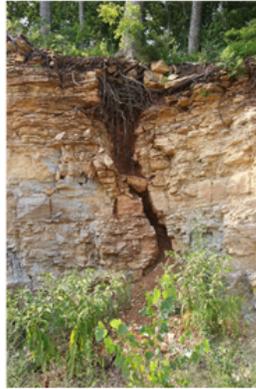
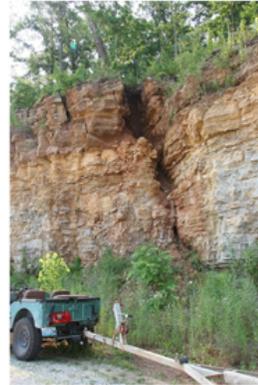
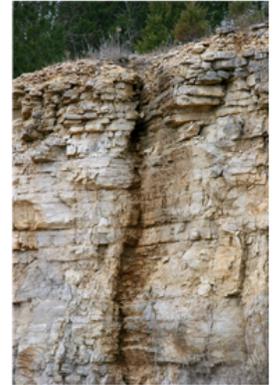
Figure 12

(a, b) Sinkhole formation in the Missouri Bootheel region. (c) Sinkhole adjacent to the Buzzi Unicem Quarry and the BNSF Railway line. (d- f) Vertical section showing the early stages of sinkhole formation, as solution widening occurs.

The spate of sinkholes was clustered around the northeastern corner of the Buzzi-Unicem Quarry (Figures 12a-f), undermining the channel of lower Cape La Croix Creek, necessitating the demolition and replacement of the highway bridge carrying South Spring Street across the channel, and severing buried utilities along Spring Street. The City of Cape Girardeau also undertook a series of engineered mitigation measures to reopen South Spring Street and restore the operative discharge along the Cape La Croix Creek. In order to achieve this goal, the City undertook an extensive renovation of the creek channel and the South Spring Street Bridge. These corrective measures included reconstruction of 100 m of the channel's right bank, just upstream of South Spring Street and closest to the northeastern corner of the Buzzi-Unicem Quarry.

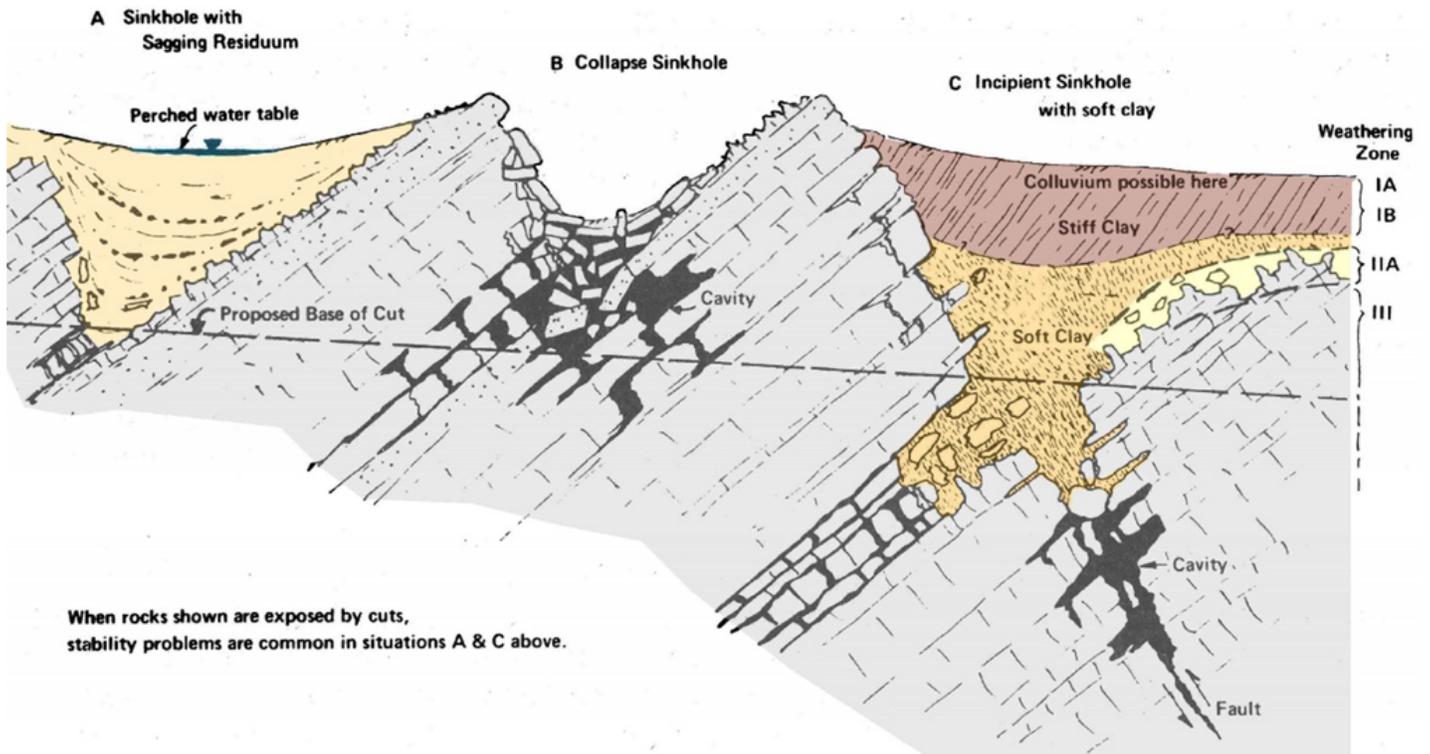
Figure 13

Schematic view of the reconstruction of a series of sinkholes in the same area (Modified from Deere and Patton 1971). (a) Collapsed sinkhole which has been infilled with residuum, forming a basin with perched water. This phenomenon is common in areas with slopes covered with unconsolidated materials. (b) A fresh sinkhole collapse which has not been filled. (c) An incipient sinkhole filled with layers of soft clay, stiff clay, and colluvium. The proposed base of cut is a line that shows optimum depth of excavation of the weakened carbonate layers in order to stabilize the failed karst zone. An inverse filter array is typically used to retard hydraulic piping through the open jointed rock.

An embankment of well-graded rockfill was constructed over a series of sinkholes that were over-excavated and backfilled with an inverse filter, to retard hydraulic piping along joint-bordered fissures (see Figure 13). A more comprehensive correction was undertaken along South Spring Street, which began with the removal of the damaged bridge across the Cape La Croix Creek. In late 2007 to early 2008, the sinkholes in this area also began diverting seepage into the quarry floor, welling upward from the Cambrian-Precambrian contact at the base of the Plattin Limestone. The seepage increased to a level necessitating the backfilling of 15.3 vertical meters (50 feet) of graded rockfill to increase the confining pressure, which served to retard the flow from the base of the Plattin Limestone.
