Dhaka City Water logging Hazards: Area Identification and Vulnerability Assessment through GIS-Remote Sensing Techniques

Research Article

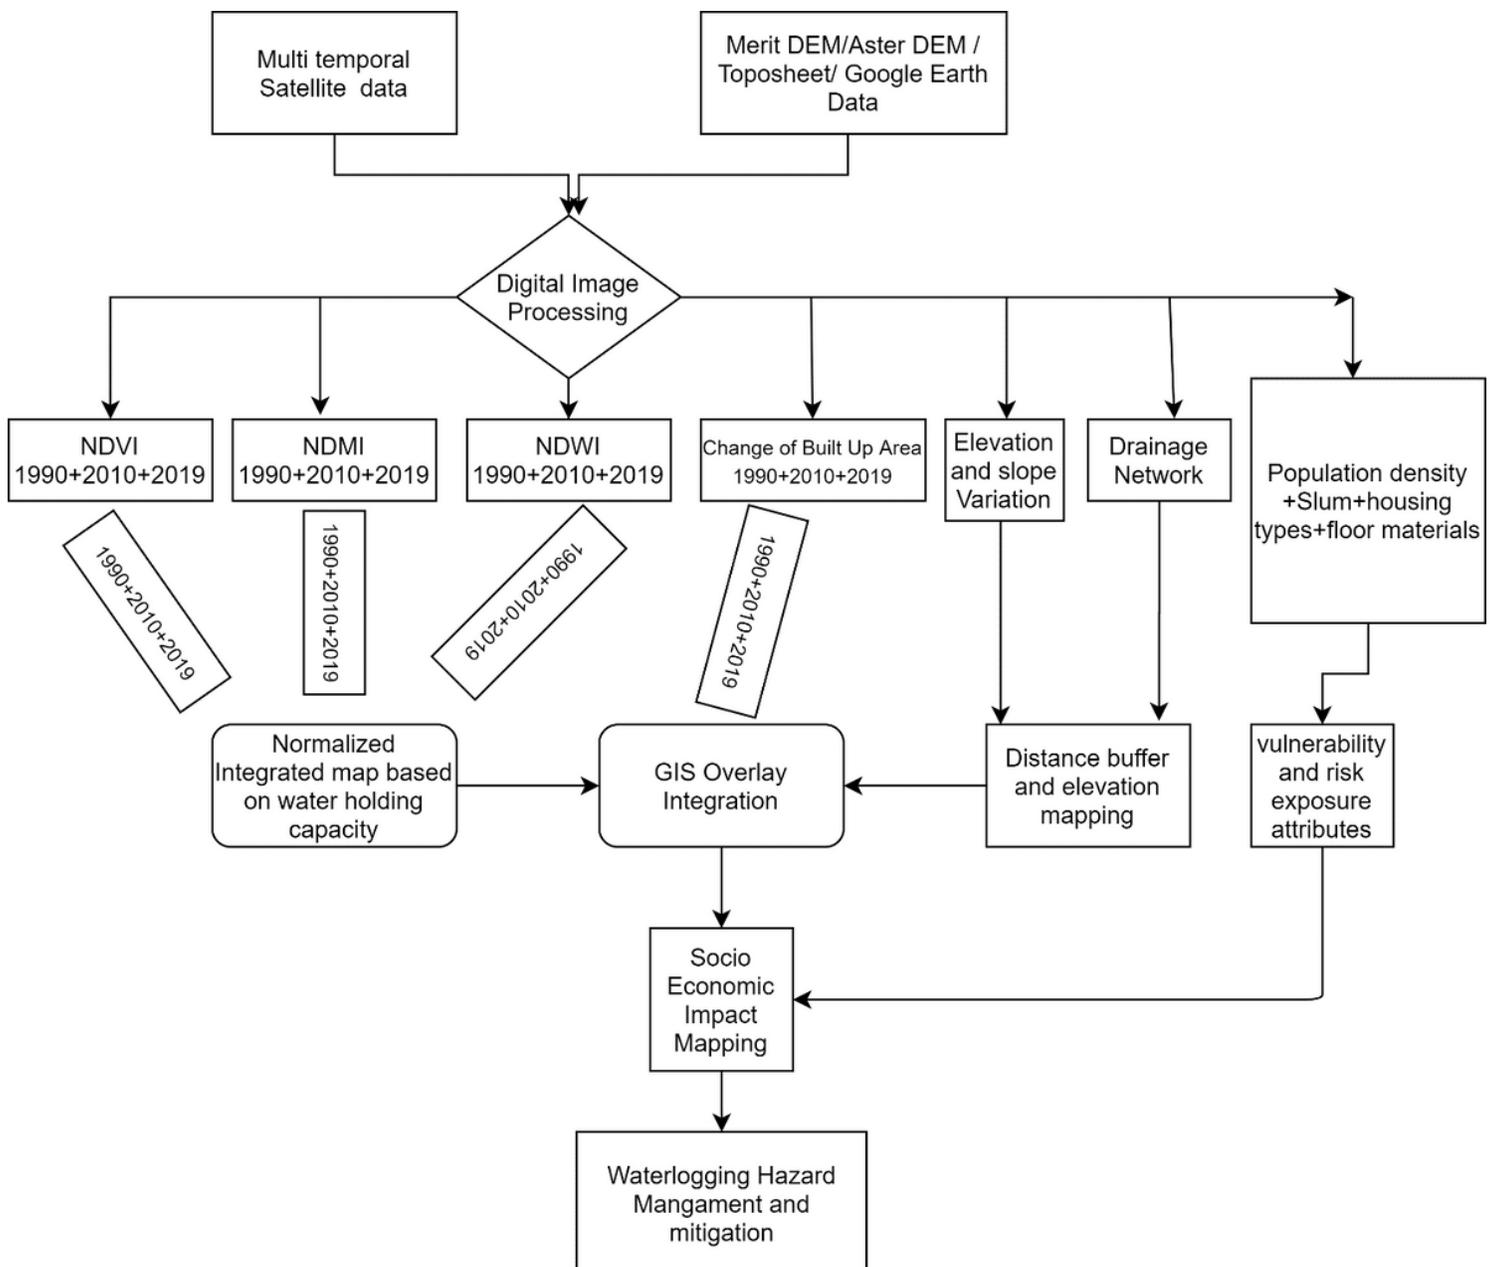
Figure 1

Flow diagram of research and data integration method

This study was conducted in two steps. First, we utilized different spatial hazard attributes using multi-temporal Landsat and Sentinel satellite imagery. We combined images from 1990, 2010 and 2019 with topographical data including slope, elevation and drainage network to detect the water logging hazard zones. Then we merged the social attributes with spatial data of the hazard zones across Dhaka city to assess the exposure and vulnerability of Dhaka residents to water logging. Our data collection and analysis workflow have been elaborated in Fig. 1.

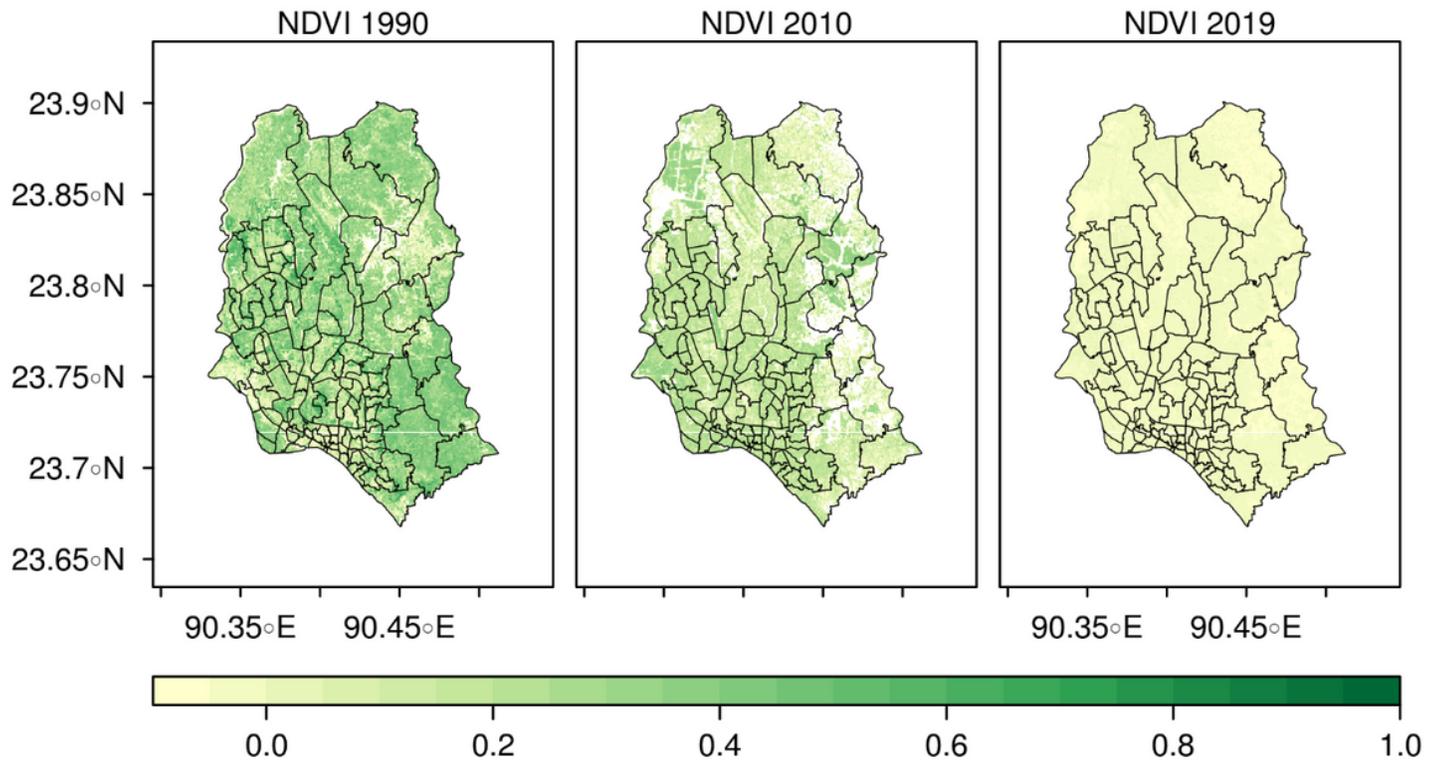
Temporal distribution of the NDVI map of Dhaka city in 1990, 2010 and 2019 respectively. Note: The designations employed and the presentation of the material on this map do not imply the expression of any opinion whatsoever on the part of Research Square concerning the legal status of any country, territory, city or area or of its authorities, or concerning the delimitation of its frontiers or boundaries. This map has been provided by the authors.

In our present study, NDVI technique on multi-temporal data has been used for the identification of water containing pixels. Figure 2 depicts the NDVI map for 1990, 2010 and 2019. In 1990, the ranges of NDVI was found to be greater than 0.2 which indicates moderate to high vegetation coverage in some areas. On the other hand, in 2010, the NDVI value became lower than 0.2 indicating lower vegetation coverage than 1990. In, 1990, the city had a large number of vegetation coverage which were later covered up by land due to the higher growth rate of population and rapid urbanization. Later in 2019, the vegetation coverage declined sharply and made the city more vulnerable to water logging. The value of NDVI reveals that the city did not have much dense forest cover since 1990, while the NDVI value in 2010 and 1990 represents the agricultural land. In 1990, the city had a large coverage of natural and artificial canals, vegetation compared to other years. Subsequently, in 2010, rapid urbanization took place, which slightly decreased greeneries. This notion also supports the study findings of Rahman et al (2011), where they found Dhaka obtained copious vegetation from the 1989 to 2010 period. However, from the measured values both vegetation coverage, greeneries and water bodies has declined drastically in 2019, as shown in Fig. 2

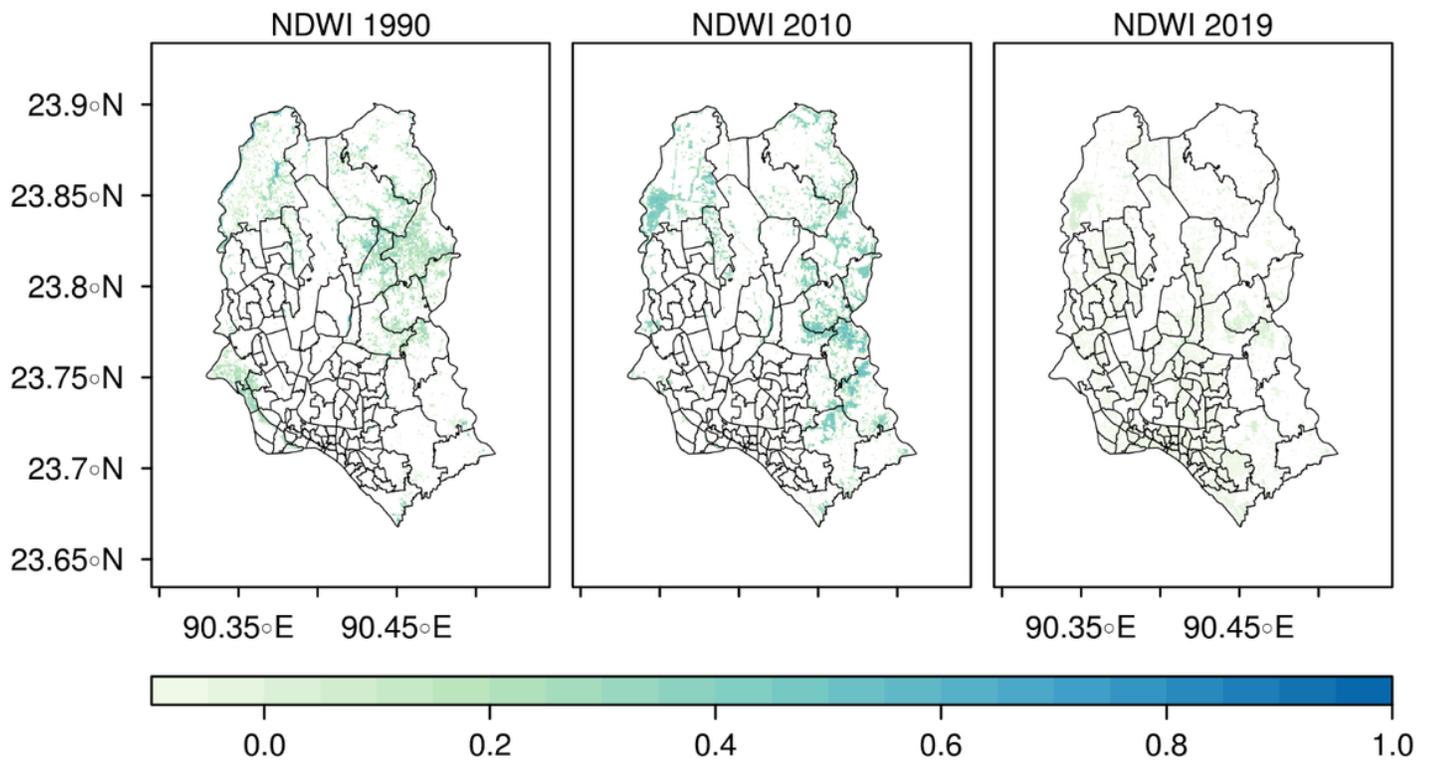
Figure 3

Temporal distribution of the NDWI map of Dhaka city in 1990, 2010 and 2019. Note: The designations employed and the presentation of the material on this map do not imply the expression of any opinion whatsoever on the part of Research Square concerning the legal status of any country, territory, city or area or of its authorities, or concerning the delimitation of its frontiers or boundaries. This map has been provided by the authors.

The NDWI map illustrated in Fig. 3 shows the temporal variation of NDWI value between the years of 1990 to 2019. The highest value of NDWI was observed in 1990 and 2010. In 2019 the highest value of NDWI was observed as 0.12 since urbanization and expansion of built-up areas took place, which was also responsible for lowering water content in 2019. According to Chatterjee et al (2015), the NDWI value ranging from -0.34 to $+0.59$ represents some water logged areas. Nevertheless, in Dhaka city, poor drainage networks and other anthropogenic factors have influenced the value of the index.

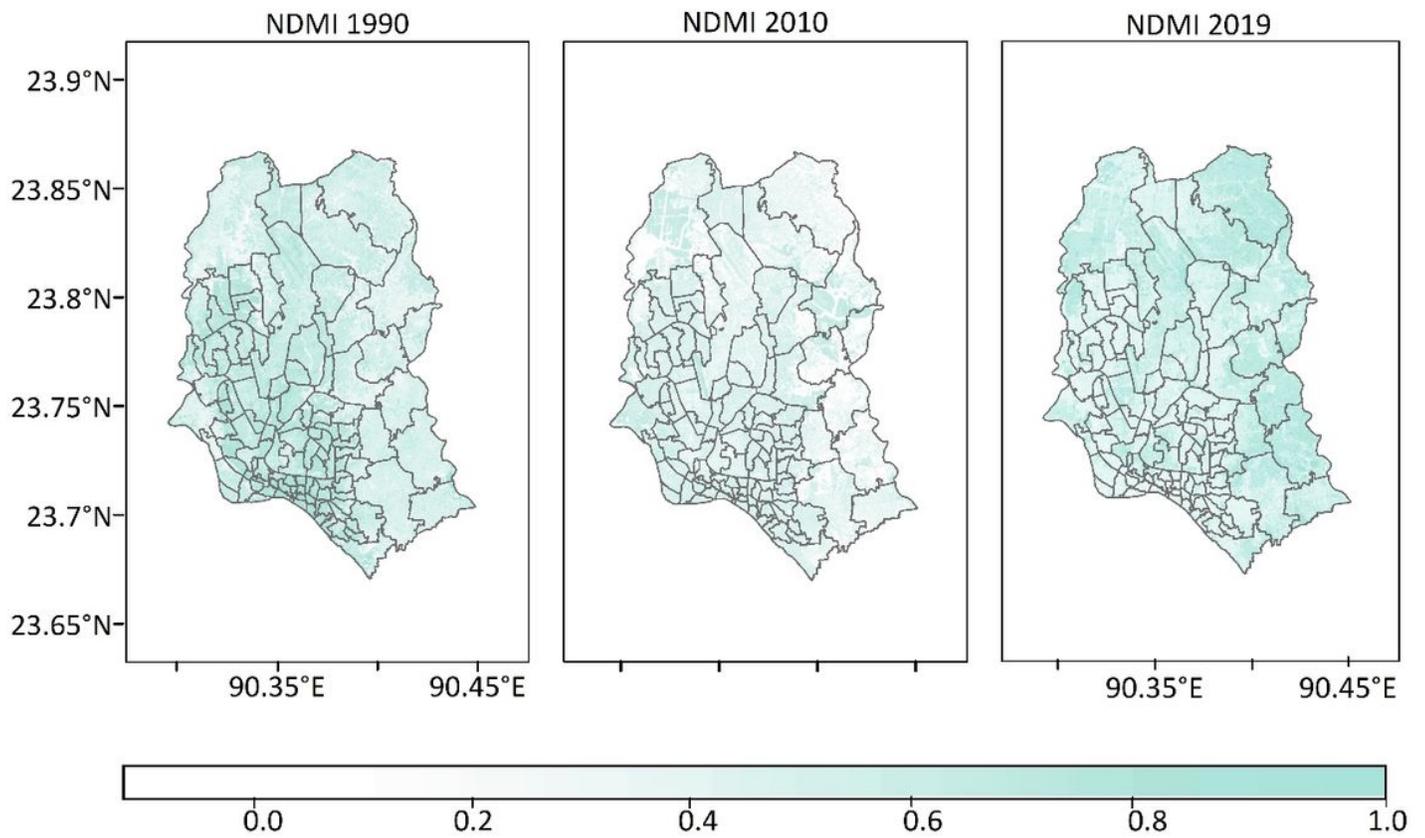
Figure 4

Temporal distribution of the NDMI map of Dhaka city in 1990, 2010 and 2019 respectively. Note: The designations employed and the presentation of the material on this map do not imply the expression of any opinion whatsoever on the part of Research Square concerning the legal status of any country, territory, city or area or of its authorities, or concerning the delimitation of its frontiers or boundaries. This map has been provided by the authors.

In NDMI, the high values indicate the existence of more soil moisture under massive water bodies and lower values of NDMI indicate low soil moisture content, as depicted in Fig. 4. It shows the temporal variation of NDMI where the value ranges of NDMI, indicating that the soil in 1990 was highly moist, which has allowed the groundwater to recharge. Besides, in 2010, value ranges of NDMI manifest the soil was comparatively dry, whereas the highest ranges of value around $+0.39$ indicate the soil had higher level of moisture in 2019 than in 2010. In the north and southeastern part of the Dhaka city, the moisture level of soil was high in the sub-urban areas and was low to moderate in the semi urbanized areas. However, the observed soil moisture in the middle part of Dhaka city reflected susceptibility to water logging.

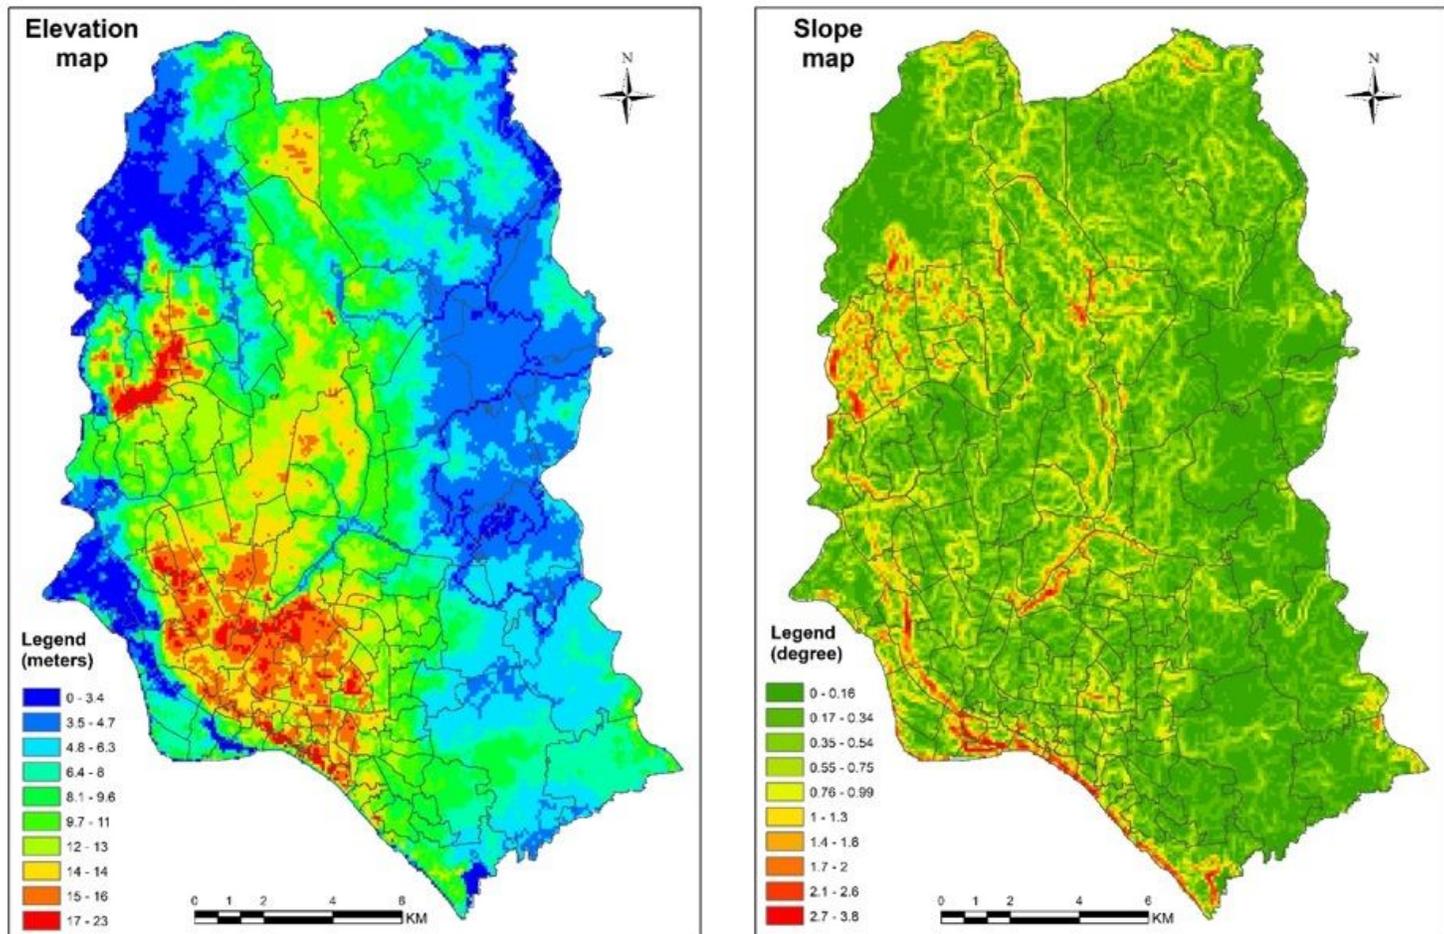
Figure 5

Elevation and slope distribution map of Dhaka city. Note: The designations employed and the presentation of the material on this map do not imply the expression of any opinion whatsoever on the part of Research Square concerning the legal status of any country, territory, city or area or of its authorities, or concerning the delimitation of its frontiers or boundaries. This map has been provided by the authors.

Topographic variation is an important factor for the waterlogged situation in flat terrain (Kaiser et al 2013). The elevation map and slope map of the study region have been generated from the Multi-Error-Removed Improved-Terrain (MERIT) DEM satellite data. The highest altitude observed from the analysis is 23 m. The lowest altitude of 0-10m indicates highest waterlogged zones in the study site which lies in the northeastern part of Dhaka city. Besides, the slope of the study area varies from 0.16 degrees to 3.8 degrees (Fig. 5). Areas with high slope and higher altitudes are affected comparatively less by water logging while areas of lower altitude are highly susceptible to the water logging phenomenon.

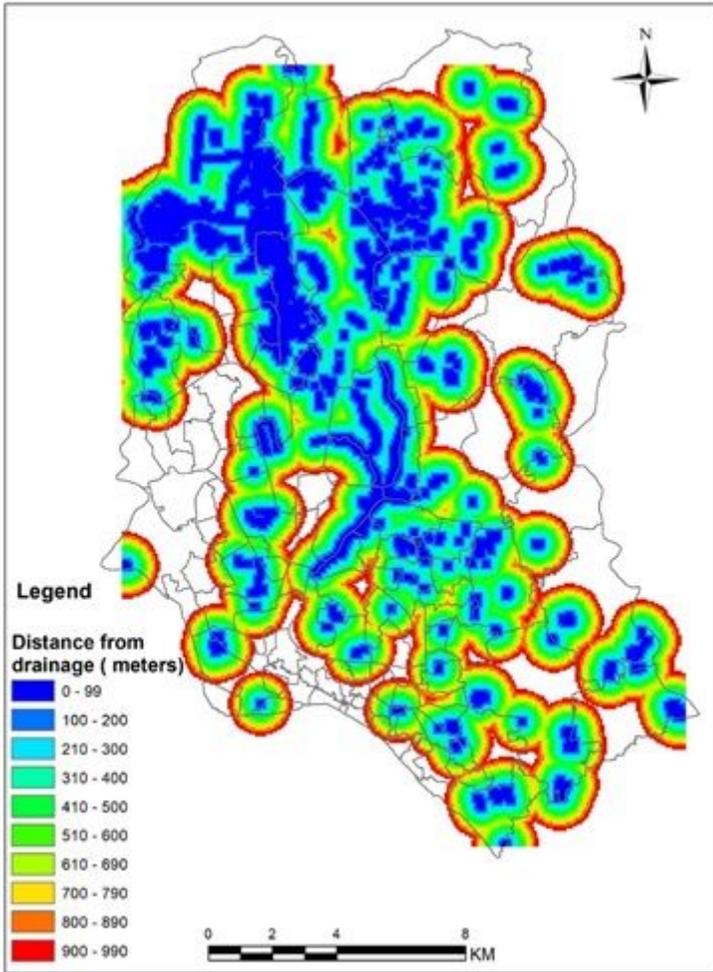
Figure 6

Distance buffer from the streams in Dhaka city. Note: The designations employed and the presentation of the material on this map do not imply the expression of any opinion whatsoever on the part of Research Square concerning the legal status of any country, territory, city or area or of its authorities, or concerning the delimitation of its frontiers or boundaries. This map has been provided by the authors.

In this study, the drainage buffer distance was used to establish the spatial relationship with the existing drainage network. In Fig. 6, the distance from drainage ranges from 0 to 990 meters. Closer proximity of area from a particular stream indicates a lower possibility of water logging as the water runs off to the nearest stream, e.g., lakes and canal, quickly.

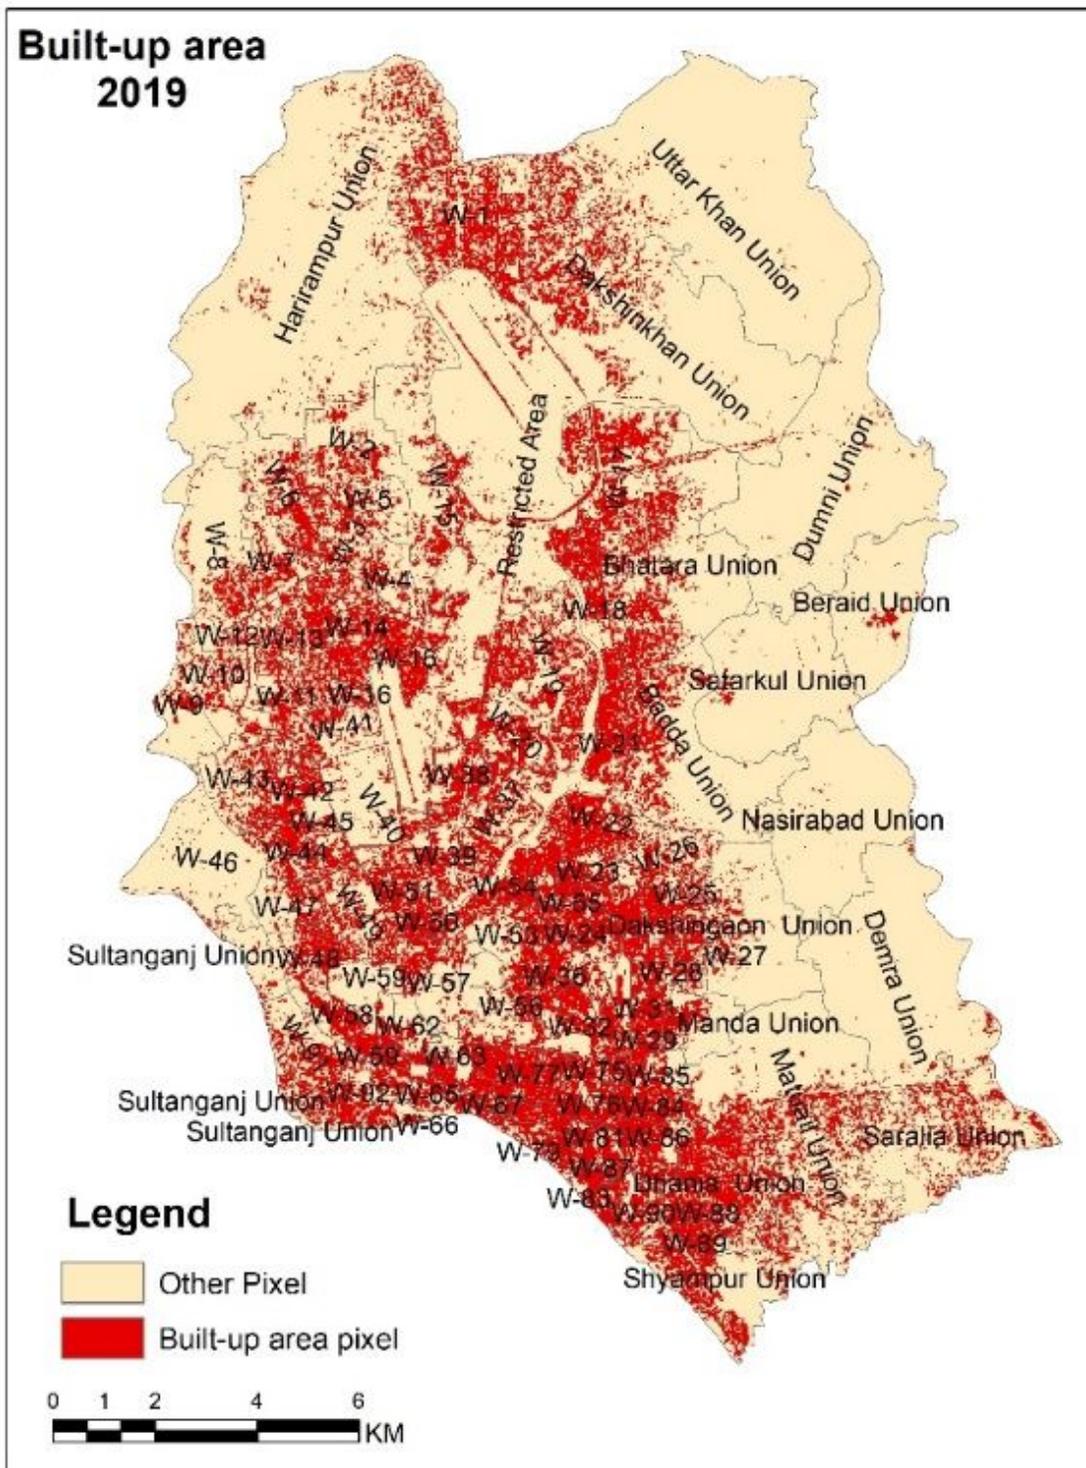
Built-up areas in Dhaka city in 2019. Note: The designations employed and the presentation of the material on this map do not imply the expression of any opinion whatsoever on the part of Research Square concerning the legal status of any country, territory, city or area or of its authorities, or concerning the delimitation of its frontiers or boundaries. This map has been provided by the authors.

Built-up areas have been increasing due to rapid urbanization of Dhaka city. In 1990, the south part of Dhaka city, currently known as Dhaka South City Corporation became more urbanized than other parts of Dhaka. Later in 2010 and 2019, the built-up areas spread over the middle and northern part of the Dhaka city. Figure 7 shows the distribution of built-up areas in the present day. In 2019, larger areas of built-up zones were observed over most of Dhaka city. Therefore, the areas became highly vulnerable to becoming clogged down by water as the drainage network has not improved proportionately. On the contrary, the eastern part of the city, much of it brought within the jurisdiction of the greater Dhaka, is yet to develop and similar levels of built-up areas cannot be observed compared to the other areas.

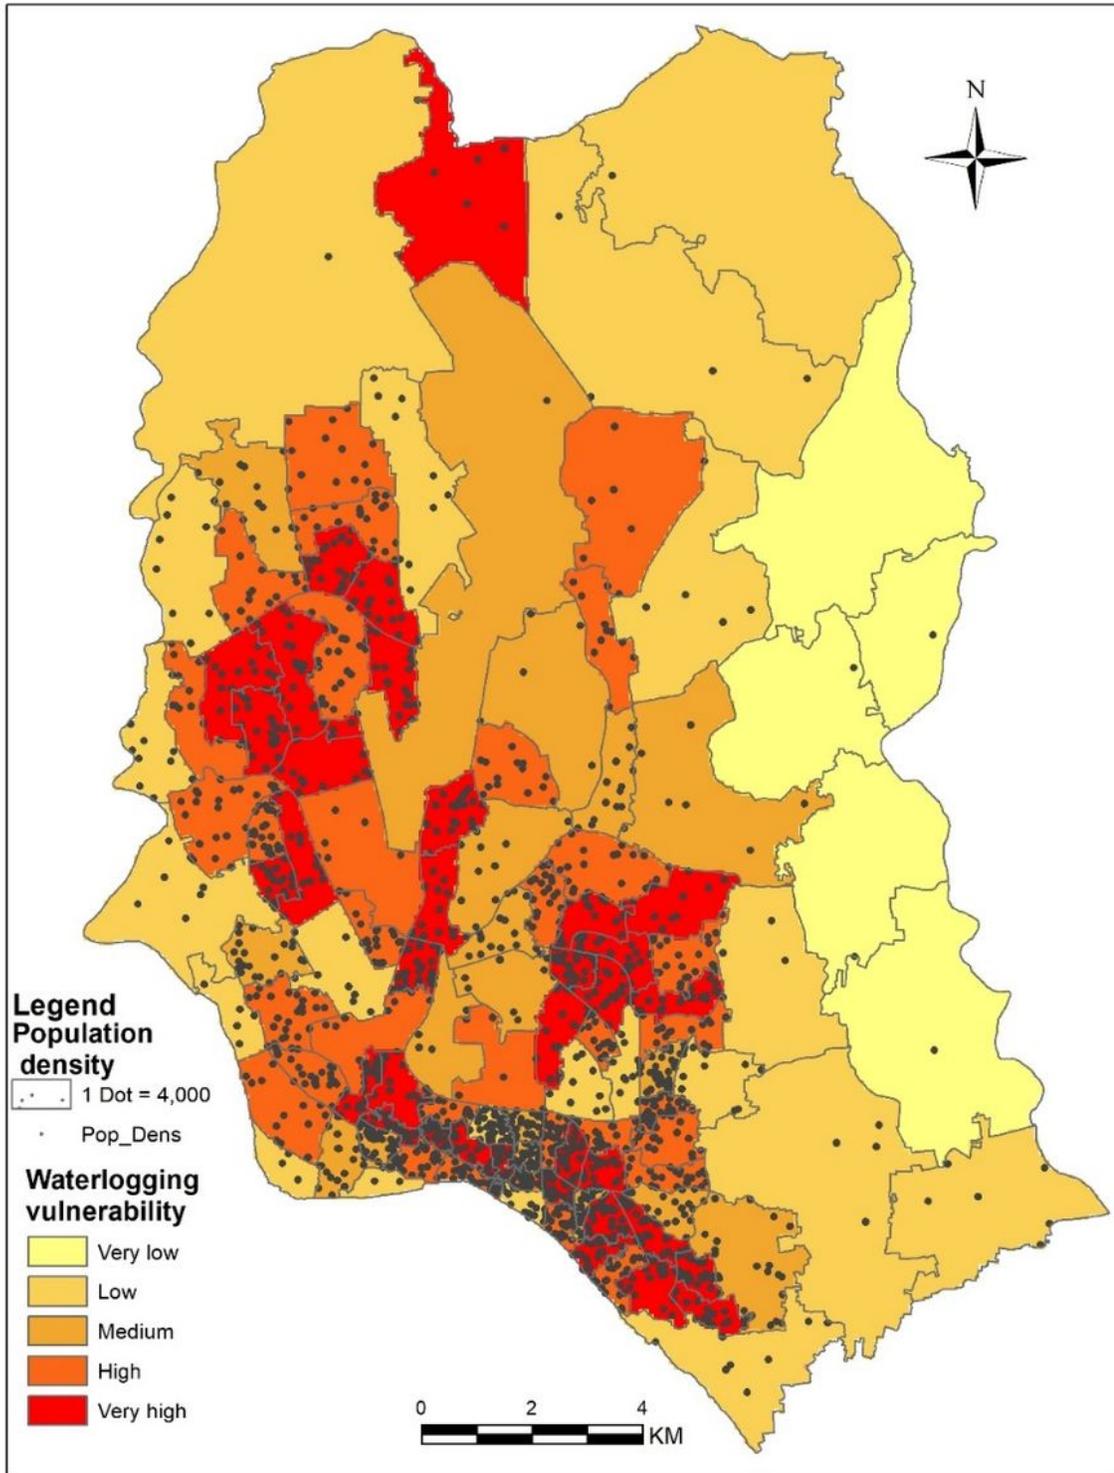
Water logging vulnerability zone and population density in Dhaka city. Note: The designations employed and the presentation of the material on this map do not imply the expression of any opinion whatsoever on the part of Research Square concerning the legal status of any country, territory, city or area or of its authorities, or concerning the delimitation of its frontiers or boundaries. This map has been provided by the authors.

The extent of calamities associated with water logging will depend on the population density of the affected area. The population density map reflects the population densification in a particular area and its association with water logging. Figure 8 shows the water logging vulnerability zone and population density. In this figure, vulnerability zones are segmented in 5 different layers as very low, low, medium, high, very high and these zones are associated with the existing population density. It was found that water logging vulnerability was very high in the wards having high population density. On the other hand, areas with medium to high water logging vulnerability also had high population density. In this map, medium vulnerable areas were found in Cantonment restricted area, Badda union and some wards that had a decent population density. The map also shows that Hariramp union, Uttar khan union, Dakshinkhan union, Bhatara union, Dakshingaon union, Manda union, Matuail union, Sarail union, Shyampur union, Sultanganj union and ward 8, 9, 33 were low water logging vulnerable areas and Dumni union, Beraid union, Satarkul union, Nasirabad union and Demra union were very low water logging vulnerable areas with very small population density. In general, more areas with high population density are found to have a higher risk of water logging, the notable exception being the eastern and north-western part of the city which are mainly suburban areas surrounded by wetlands and rivers.

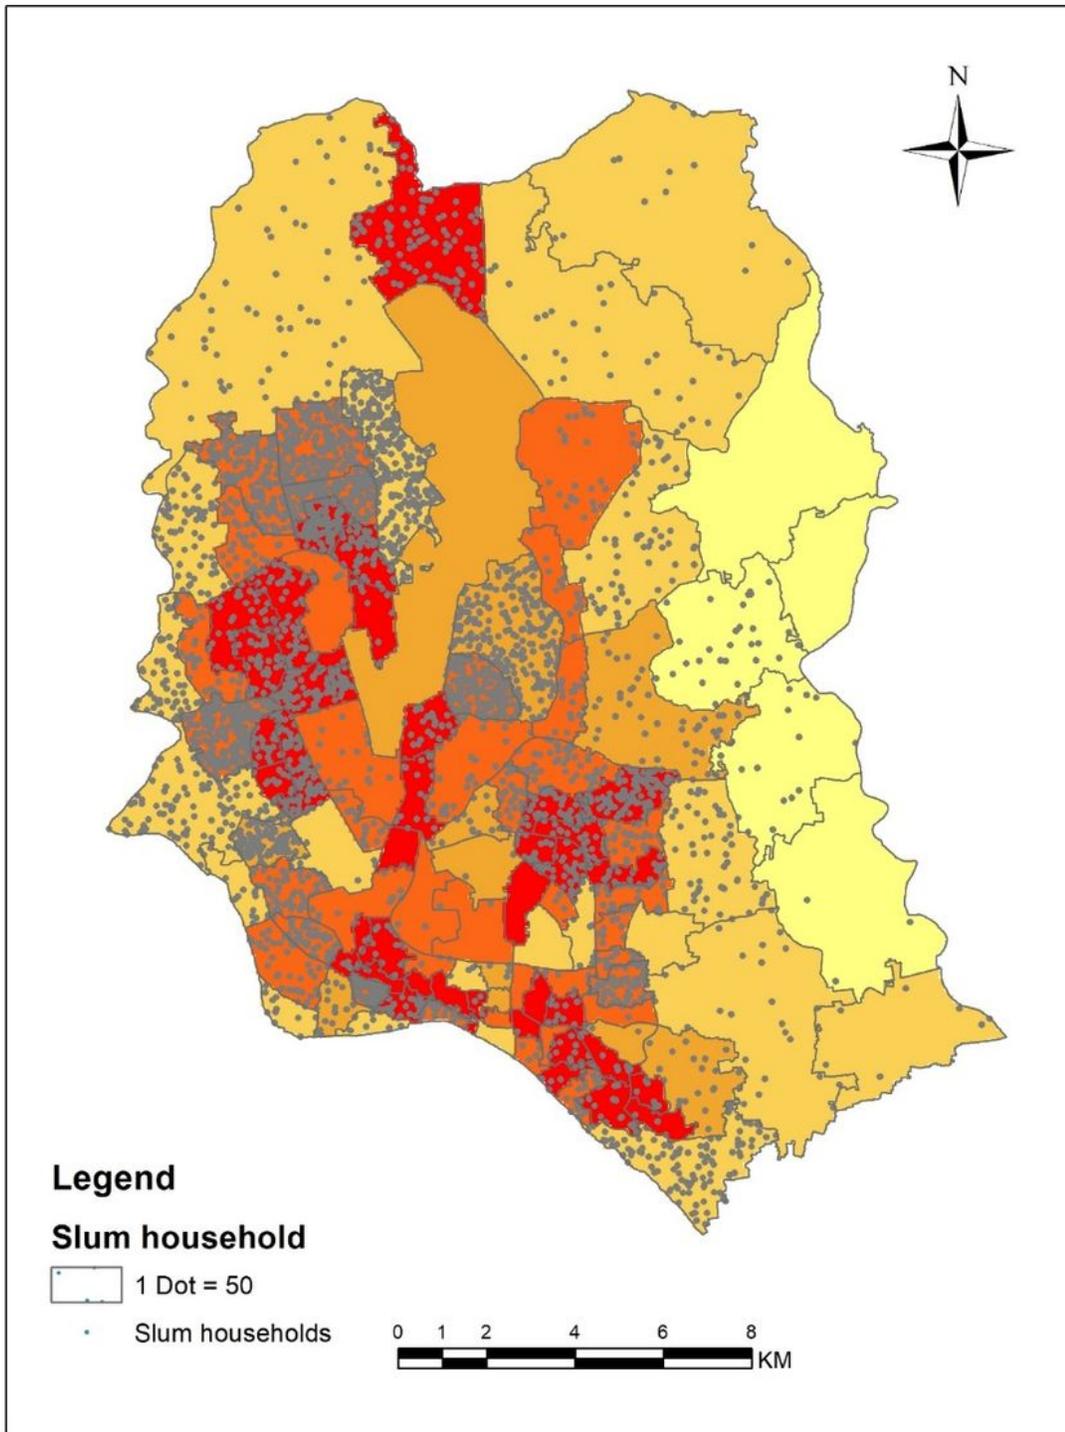
Water logging vulnerability zone and slum household's distribution in Dhaka city. Note: The designations employed and the presentation of the material on this map do not imply the expression of any opinion whatsoever on the part of Research Square concerning the legal status of any country, territory, city or area or of its authorities, or concerning the delimitation of its frontiers or boundaries. This map has been provided by the authors.

Slum population are one of the most vulnerable communities in the city living in informal settlements with poor living conditions. Their susceptibility level regarding water logging hazards are clearly depicted in the final generated map. Figure 9 depicts the dot density map of the slum households according to the Slum Census 2014 where 1 dot represents 50 households. The severity of water logging is high among the slum households because of the higher population density in slum areas, unplanned and unhygienic housing and sanitation systems, with very poor access roads and poor environment etc. The map below showing the water logging vulnerability zone and slum household distribution depicts how many slum households are vulnerable to the problems of water logging. The vulnerability of water logging was very high among the wards with the existence of slum households. Also, the existence of slum households was common among the areas of high susceptibility of water logging such as wards (2, 5, 14, 7), which reveals that most of the slum households of Dhaka city are facing serious water logging problem.

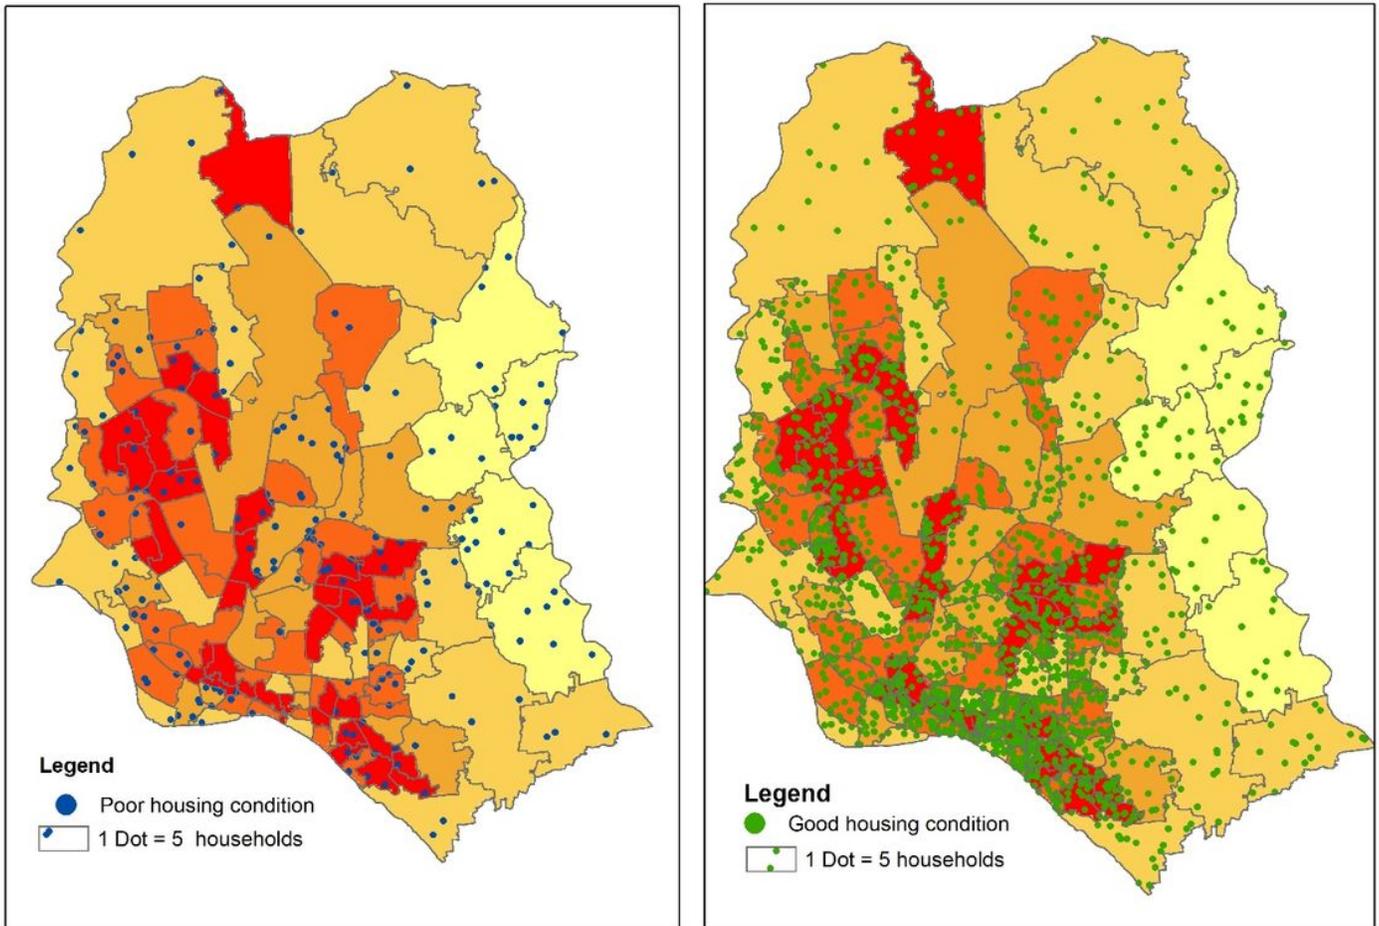
Water logging vulnerability zone and housing characteristics in Dhaka city. Note: The designations employed and the presentation of the material on this map do not imply the expression of any opinion whatsoever on the part of Research Square concerning the legal status of any country, territory, city or area or of its authorities, or concerning the delimitation of its frontiers or boundaries. This map has been provided by the authors.

Among the housing types of the dwellers in Dhaka city, good housing (Pacca and Semi pacca) and poor housing condition (Jhupri and Kacca) have been categorized from the Slum Census 2014. The consequences and severity of the problem of water logging vary based on the housing types, making it necessary to consider housing types and associate that with water logging. Figure 10 depicts the housing types in the water logging vulnerable zones. It was found that water logging susceptibility was very high within the wards with good housing (Pacca and Semi Pacca). Within same wards, the vulnerability of water logging was also very high in the households with poor housing structures. The water logging susceptibility was very high among other wards with poor housing as well. Lastly, the following analysis implies that almost 70% of poorly structured households lies within high to very high water logging vulnerable zone.

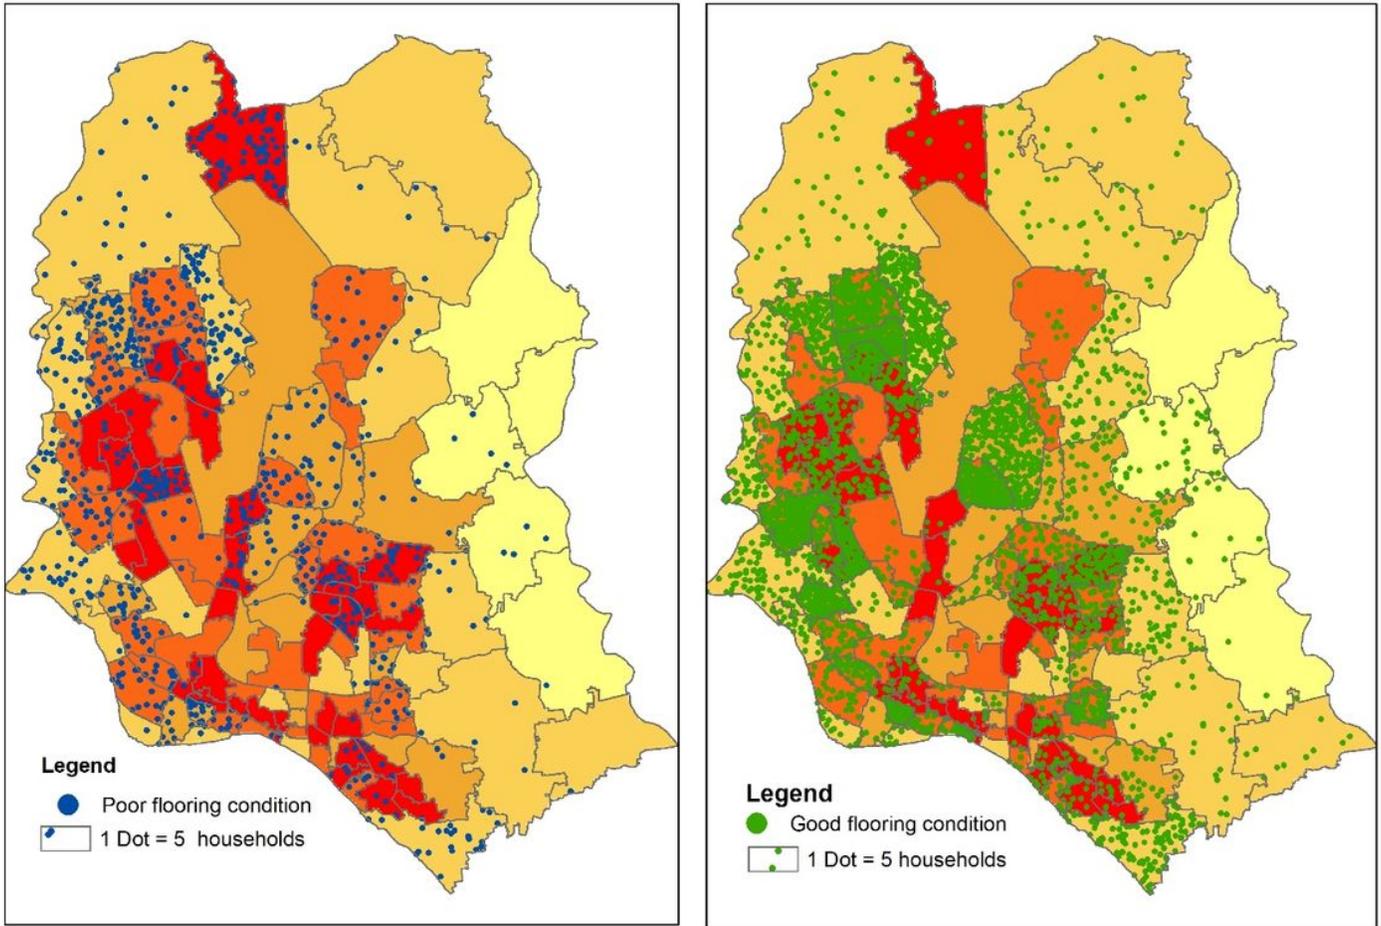
Water logging vulnerability zone and flooring condition in Dhaka city. Note: The designations employed and the presentation of the material on this map do not imply the expression of any opinion whatsoever on the part of Research Square concerning the legal status of any country, territory, city or area or of its authorities, or concerning the delimitation of its frontiers or boundaries. This map has been provided by the authors.

A study on water logging conducted in the 4 urban areas (Sylhet, Dhaka, Mymensingh and Chittagong) in Bangladesh found that 69% of houses in those areas became damaged due to water logging (Anisha & Hossain 2014). That signifies that a poor housing structure in a water logging vulnerable zone will be more prone to experience adverse consequences, especially if floor materials of houses are made from poor construction materials. It can be assumed that water logging causes dampness in some floor materials, making it remain wet for a long period (Gazi and Hossain 2019) and the issues of slipperiness or wetness occurred in the houses with mud floors. Figure 11 shows the water logging vulnerability zones and the poor and good flooring status in those areas. Bamboo and mud types floor were considered as poor floor and the floor made of brick type materials belonged to good flooring condition. The existence of a huge number of houses with poor flooring was found in north and north-western part of Dhaka where the severity of water logging is also very high. A huge number of houses with good floor materials were found throughout Dhaka city, especially in ward 11, 12, 13, where the vulnerability of water logging is also very high. As Dhaka is an urbanized city, most houses are made of brick; mud and bamboo made floor was found in the peripheral areas of north, north-western part and also in some slum areas in the middle part of Dhaka city where water logging vulnerability was also very high.
