Ancient Gypsum Mortars from Ornaments of Seyyed Shams al-Din Mausoleum(Yazd, Iran) Characterization; Identification of Technology of Making

Research article

Keywords: Structural analysis, Gypsum mortar, Mausoleum, Iran

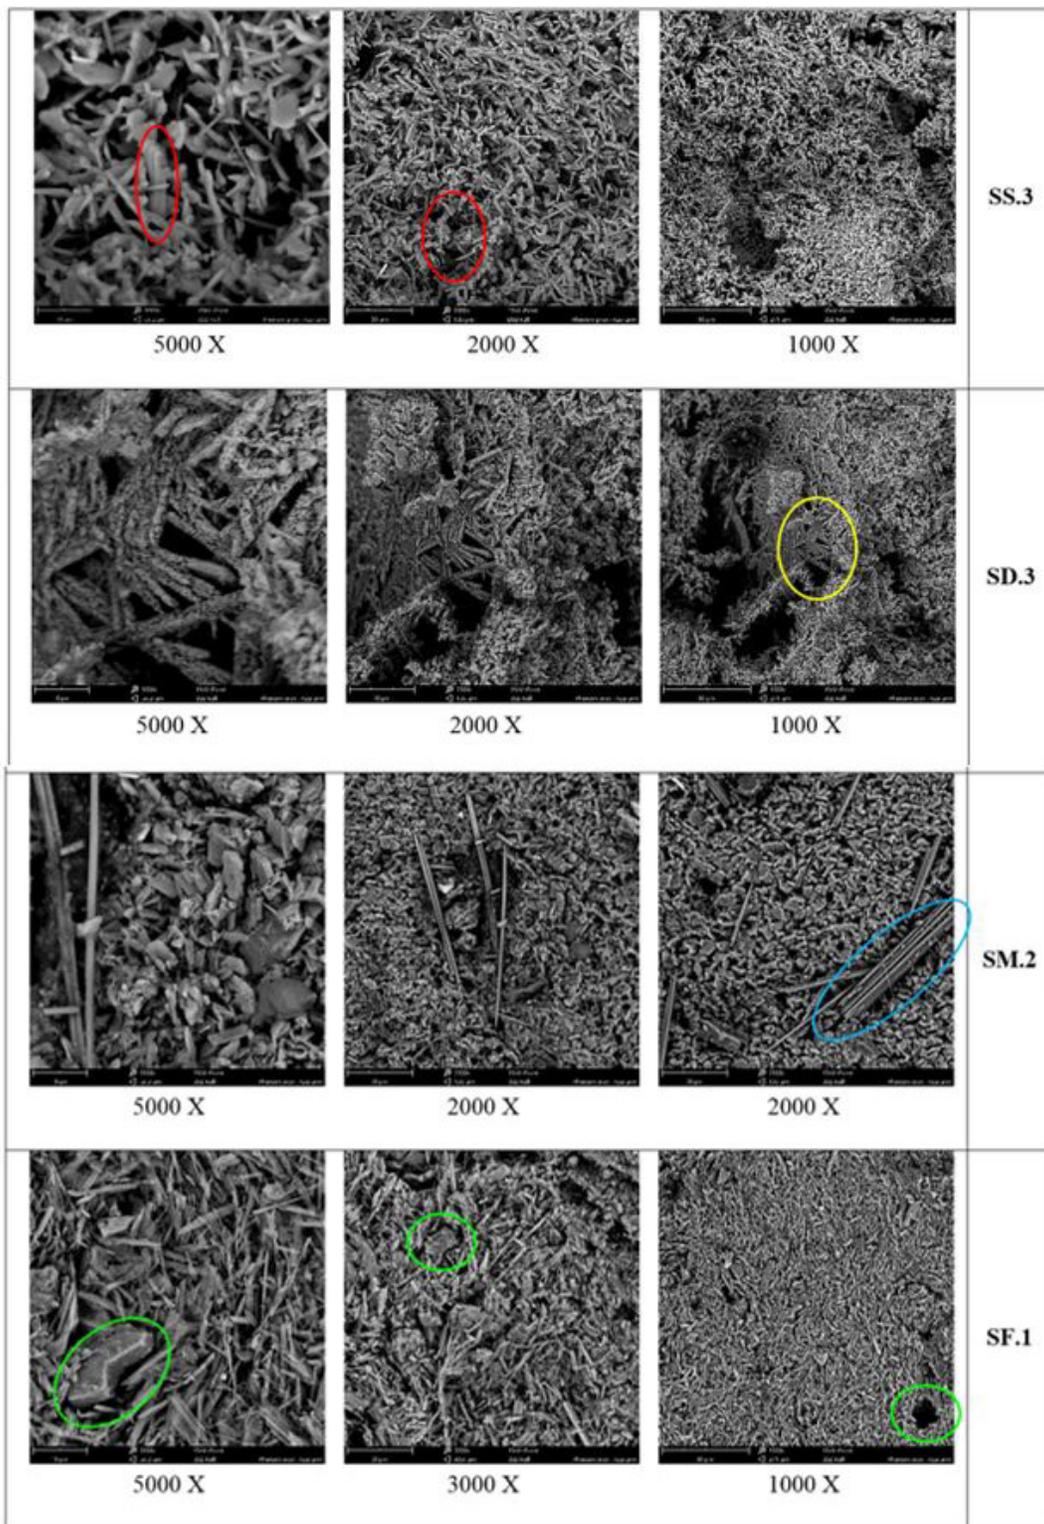
Table 5: SEM images at 1000x, 2000x and 5000x magnifications of the crystal structure of samples SS.3, SD.3, SM.2, and SF.1

SEM Imaging: Images at varying magnifications were acquired from the four samples SS.3, SD.3, SM.2, and SF.1. Given the presence of an original layer of slip and a further coating connected to later restorations on the gypsum inscription, the sampling started at depth of 0.5 cm from the surface and continued down the lower levels, and images were obtained from its crystal structure at 1000x, 2000x and 5000x. Images at similar magnifications were prepared so as to compare the crystal structures of the different levels of the gypsum inscription mortar (given its great thickness). Likewise, due to the differences in materials, processing, and manner of execution between the gypsum inscription and the molded gypsum ornament, images at 1000x and 2000x were also prepared from the latter for comparison purposes. Because of the distinctive nature of the gypsum fine coat (finishing) used in the Muzaffarid buildings in Yazd³, images were captured from the gypsum lining beneath the molded ornament at 1000x, 3000x and 5000x magnifications Table 5.

Examining crystals in images at varying magnifications revealed intertwined acicular gypsum crystals, where an aggregate of crystals in smaller dimensions. The gypsum crystals in this sample show lower growth than those of SD.3, perhaps due to the presence of calcite and salts in the deeper levels of the inscription. At times, even in the presence of acid or saline solutions in the environment, semi-hydrated gypsum is formed in the absence of pressure and at normal summer temperatures [8]; calcite also slows down setting of gypsum mortar [27], a fact that elicited the greater crystal growth.

The crystals of sample SM.2 were also subjected to SEM observation. The gypsum crystals proved to differ from those of the previous specimens in that here they lacked the acicular habit. A peculiar characteristic of an anomalous gypsum crystal structure is the formation of a network of coarse crystals instead of conventional acicular ones [28]. The squat habit exhibited by the crystals in sample SM.2 meant that they had grown excessively in the second and third dimensions. This happens when the gypsum mortar becomes slow-set. A notable fact about the SEM images is the plant fibers interspersed among the crystals Table 5.

Further, in the image at 5000x there are discernible a series of gypsum crystals with parallel, superimposed (010) planes. In this context, Mishmasht Nehi puts that: SEM images of koshteh gypsum display a large number of gypsum crystals perceptible from the (010) plane surface. In this structure, the size and shape of the crystals are similar and irregular and non-crystalline structures are absent in SEM images. The appearance of gypsum crystals from the (010) plane surface indicates that the gypsum crystals in this composition were rearranged in parallel layers and their (010) planes were placed on top of each other [3]. By juxtaposing the images at different magnifications as well as the available information, the plaster in question was apparently processed as a slow-setting gypsum mortar.

The crystals of sample SF.1 appear as intertwined needles, and this growth has occurred in different directions. The empty spaces between the crystals are infrequent, giving an expression of sufficient coherence. Twin crystals occur at one point Table 5. Whilst the most common twinning form in natural gypsum is swallowtail twin, in our specimen a different form (101) Montmartre twin or macle) is evident, and a reflection symmetry of the gypsum crystal is witnessed.

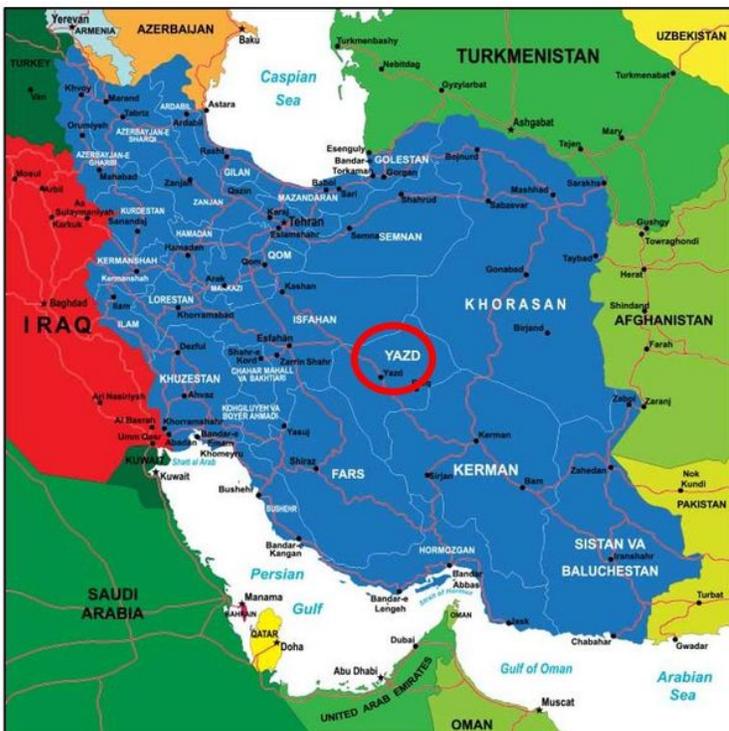
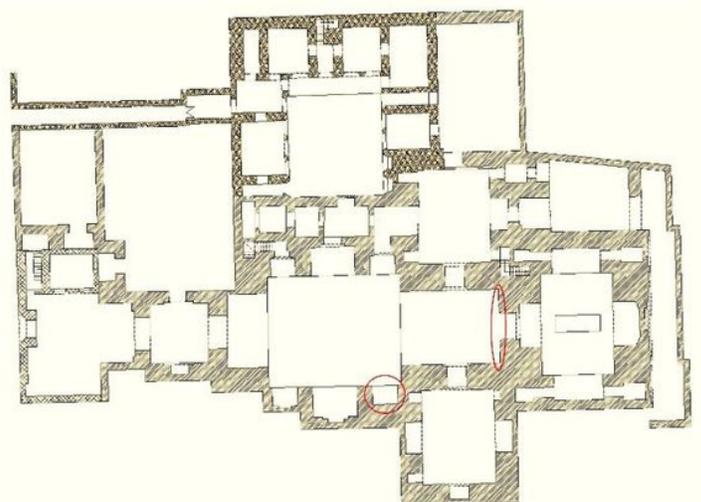
Figure 1

a. Location of Yazd city in Iran. b. Locations of the parts under study on the building's plan of Seyed Shams al-Din's mausoleum (Source: Yazd Cultural Heritage Deputy). Note: The designations employed and the presentation of the material on this map do not imply the expression of any opinion whatsoever on the part of Research Square concerning the legal status of any country, territory, city or area or of its authorities, or concerning the delimitation of its frontiers or boundaries. This map has been provided by the authors.

Seyed Shams al-Din Mohammad, the son of Seyed Rokan al-Din and the son-in-law of Rashid al-Din Fazlullah Tabib, the minister of the Ilkhanid emperors, commissioned several public buildings in Yazd [13]. Jafari informs us that Seyed Shams al-Din drew the plans of the Chahar Monar School, Dar al-Siyadat, the monastery (khangah), bazaar, and bathhouse in Tabriz and send them to Yazd, where master builds began to put up the edifice, and the edifice was fulfilled in 733 AH [15]. Yet, elsewhere he attributes the completion of the edifice to 6 years earlier: The accomplishment of his edifice was in 727 AH [15]. In the *The New History of Yazd*, Kateb points out that: When Amir Shams al-Din Mohammad gained autonomy in Tabriz, he roughed out the plans of the school, Dar al-Siyadat, Chahar Monar, monastery and bazaar, and sent to Yazd. He appointed the justices of four villages who were his trustees, and they came to Yazd and had the edifice constructed [16]. Mostowfi Bafghi likewise dates the construction of the edifice to 727 AH: "... Seyed Shams al-Din Mohammad put up that sky-scraping edifice in the months of the year 727, and was himself buried within its dome [17] Fig. 1. b.

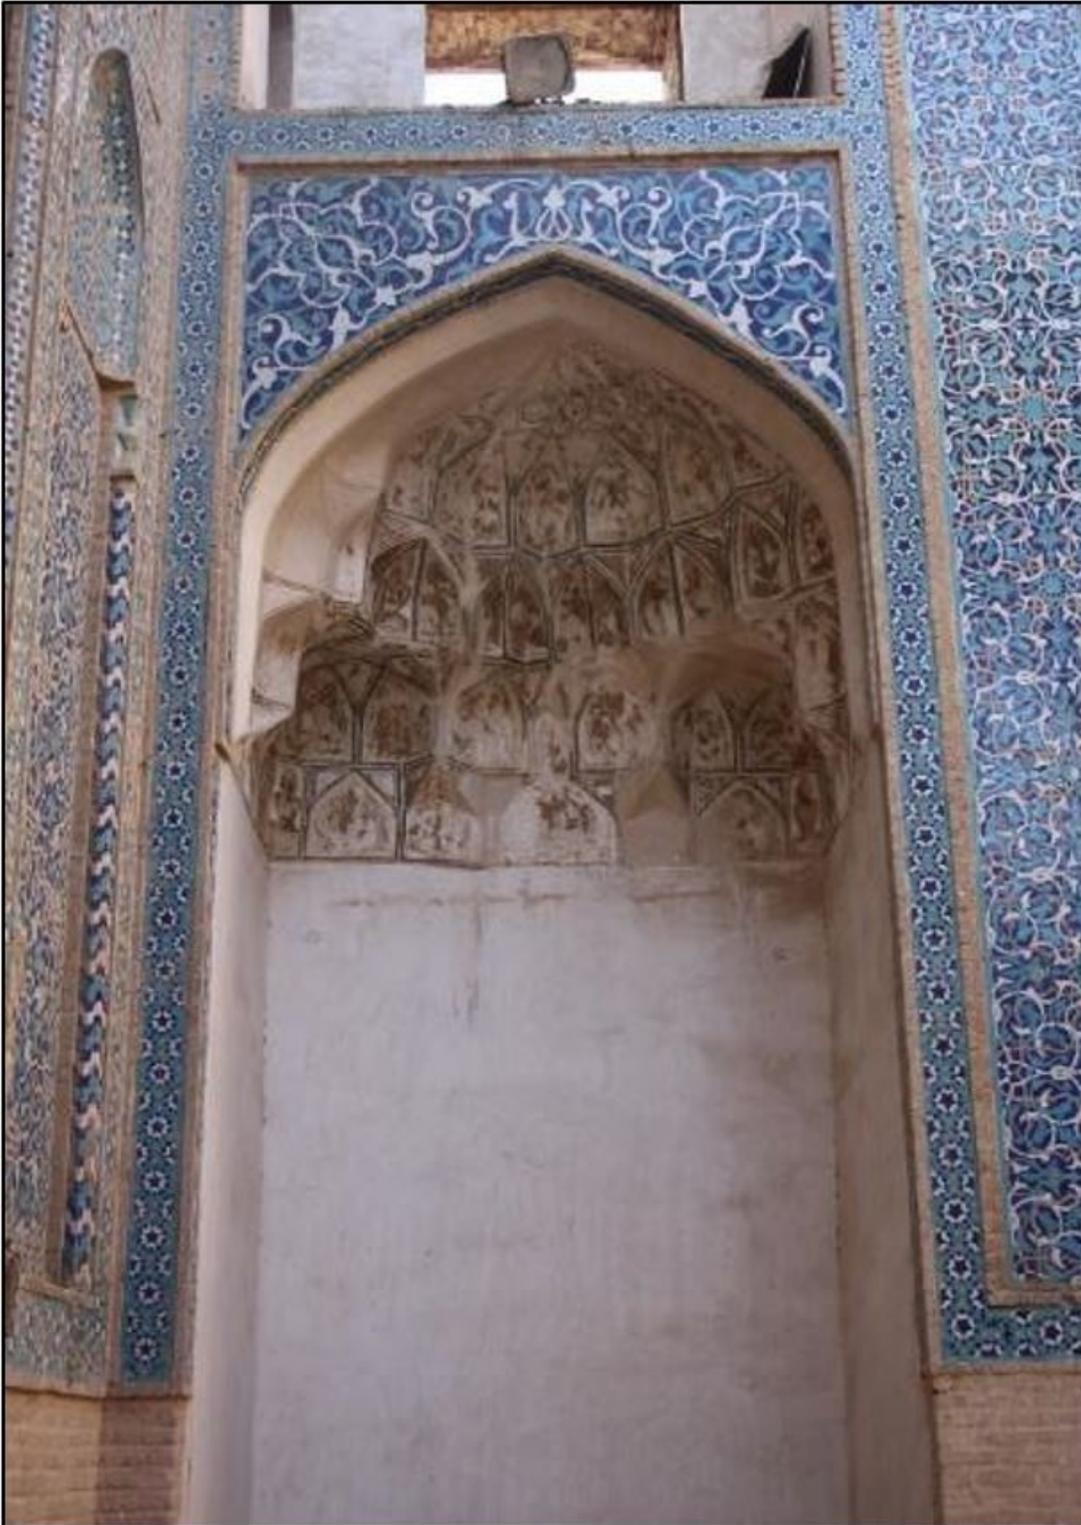
Figure 2

The iwan alcove and the molded gypsum decorations within the Moqarnas

From the whole building complex Seyed Shams al-Din commissioned in the Chahar Monar neighborhood only the iwan, parts of the dome (simply the walls), parts of the portal, and a moqarnas alcove attached to the iwan are preserved today Fig. 2.

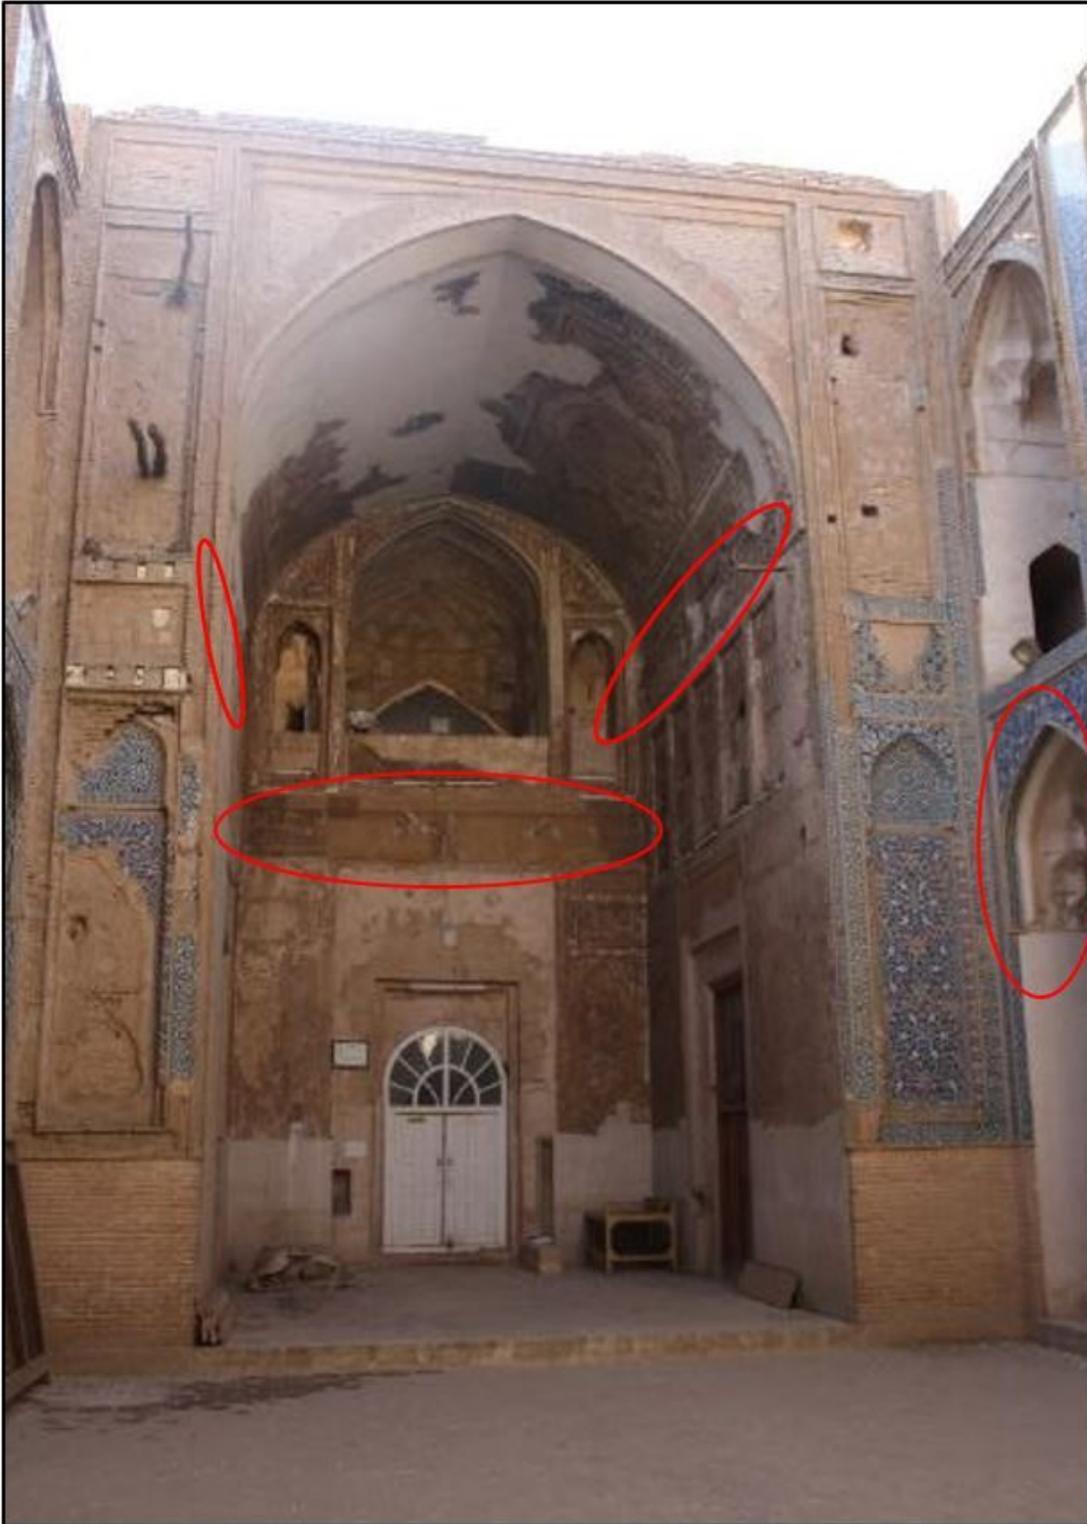
Figure 3

The iwan of the mausoleum, and the location of the gypsum inscription on the three sides

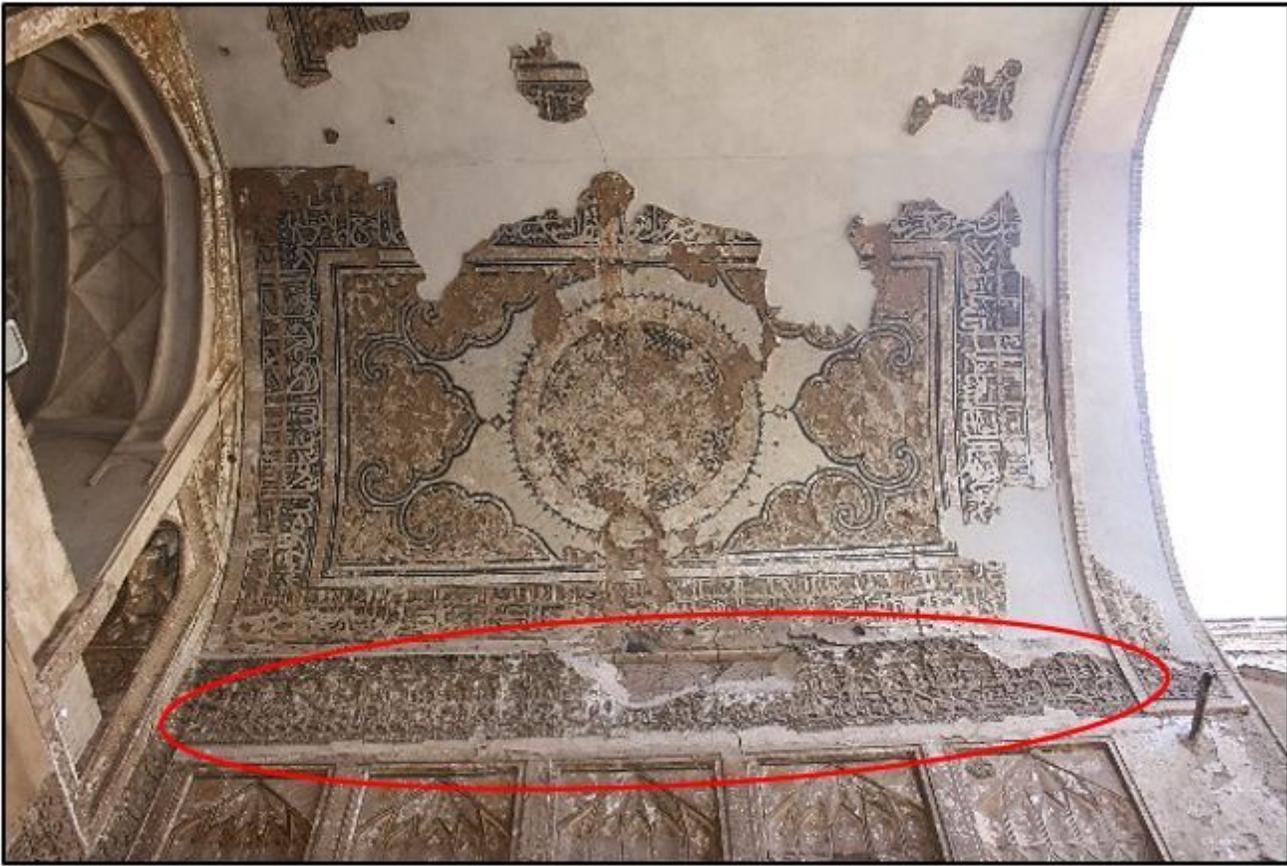
Figure 4

Seyed Shams al-Din Mausoleum: gypsum inscription on the southeast side of the iwan

The text of the gypsum inscription under study is part of surah *Al-Fath*. It starts from the beginning of verse 22 in the southeast side Fig. 4 and continues in the northeast Fig. 6 and northwest Fig. 5 sides.

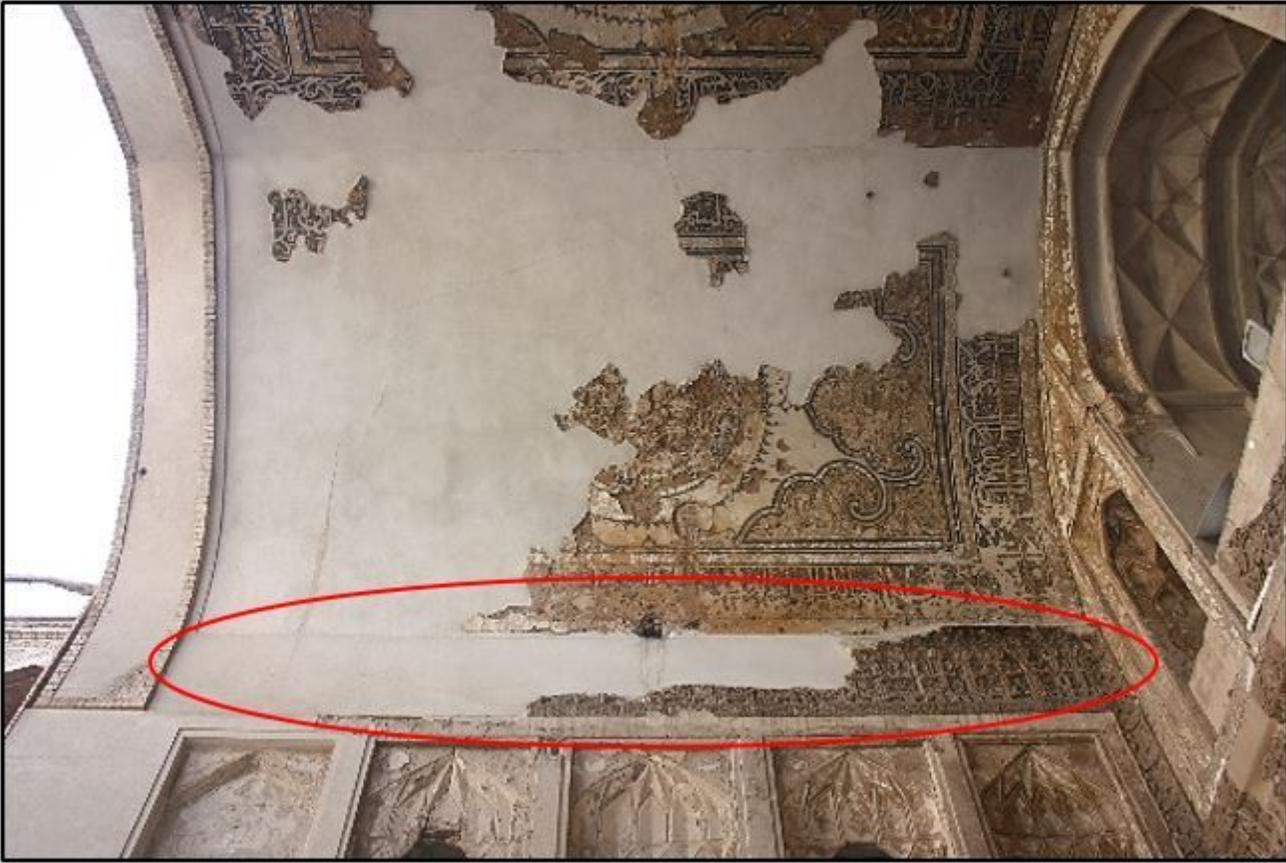
Figure 5

Seyed Shams al-Din Mausoleum: surviving parts of the gypsum inscription on the southeast side of the iwan

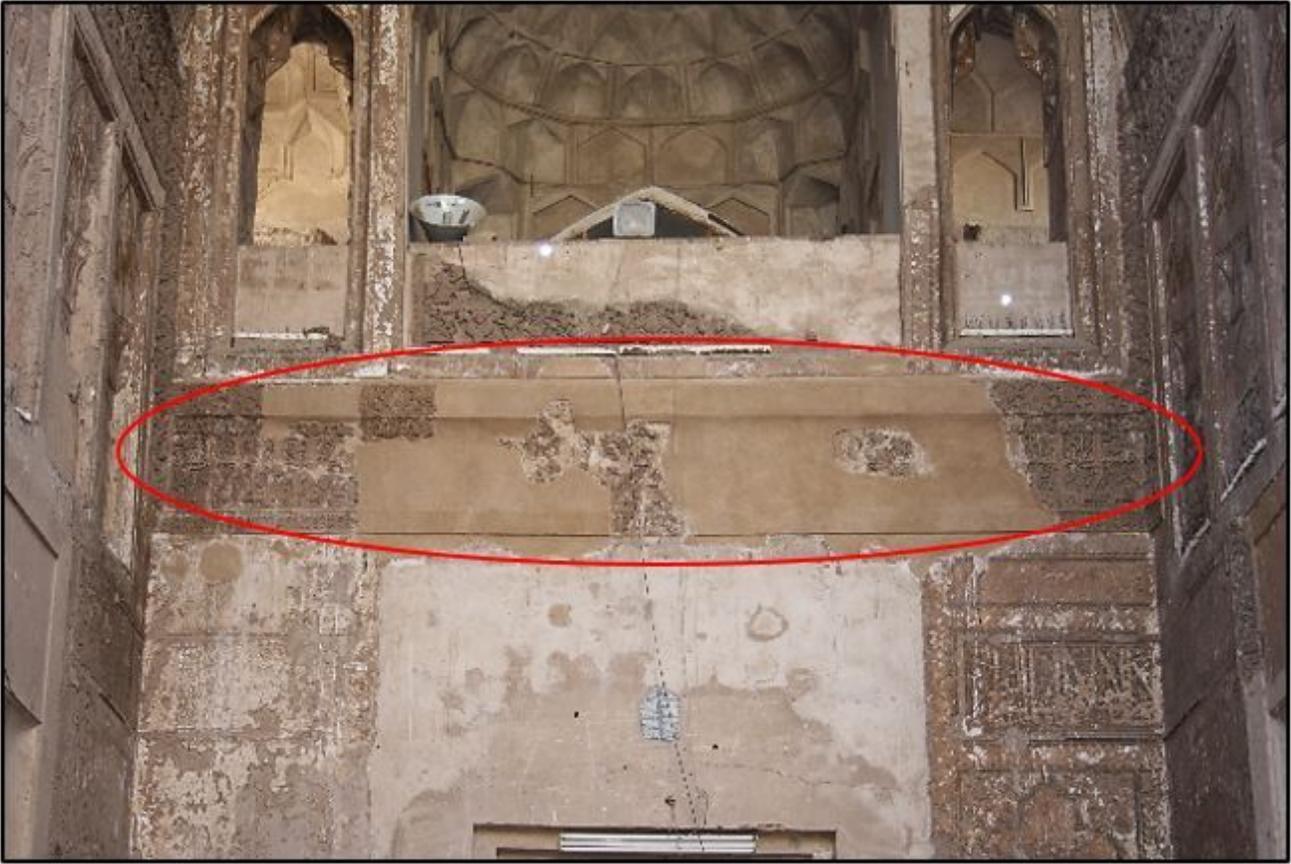
Figure 6

Seyed Shams al-Din Mausoleum: surviving parts of the gypsum inscription on the northeast side of the iwan

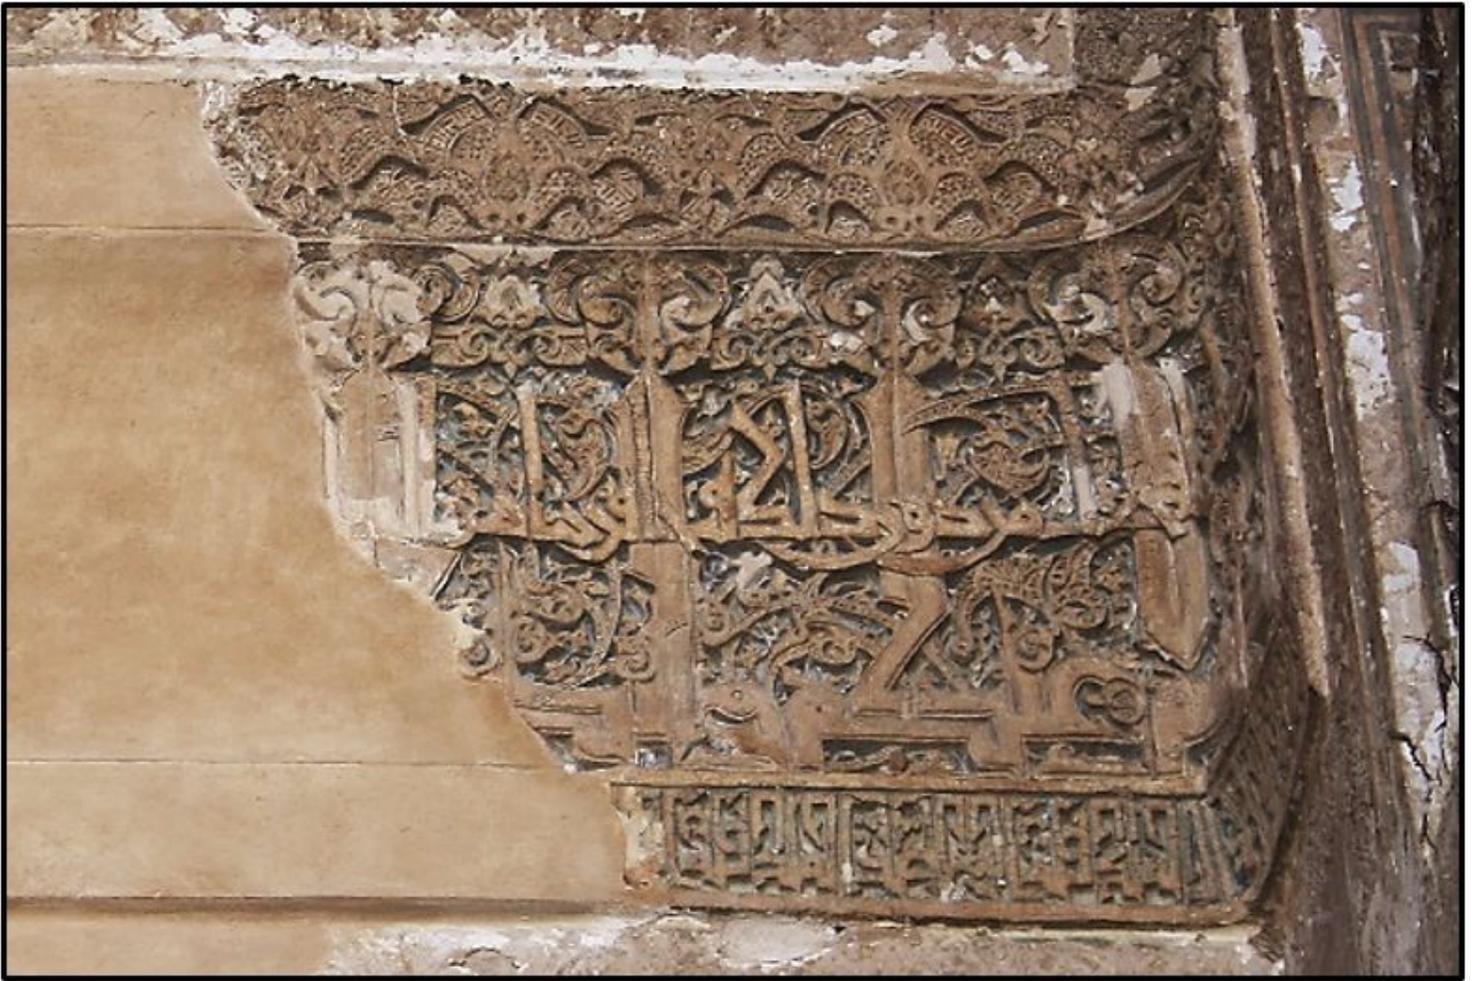
Figure 7

Seyed Shams al-Din Mausoleum: the beginning of the gypsum inscription on the northeast side of the iwan

levels in gypsum relief. The lower margin is formed by a small inscription again in gypsum relief but in a single level, and consists of the repetition of the phrase *Al Mulk li Allah* Fig. 7.

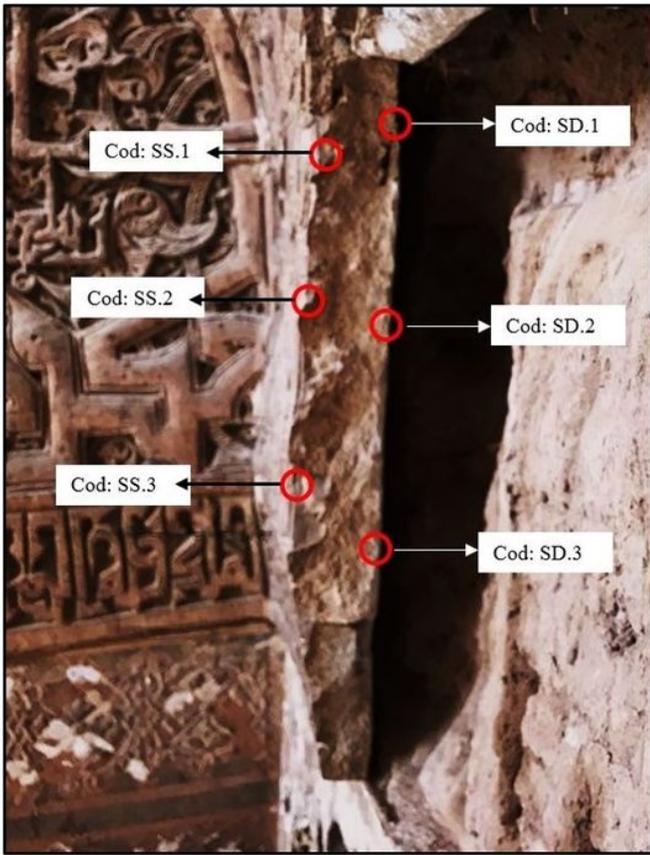
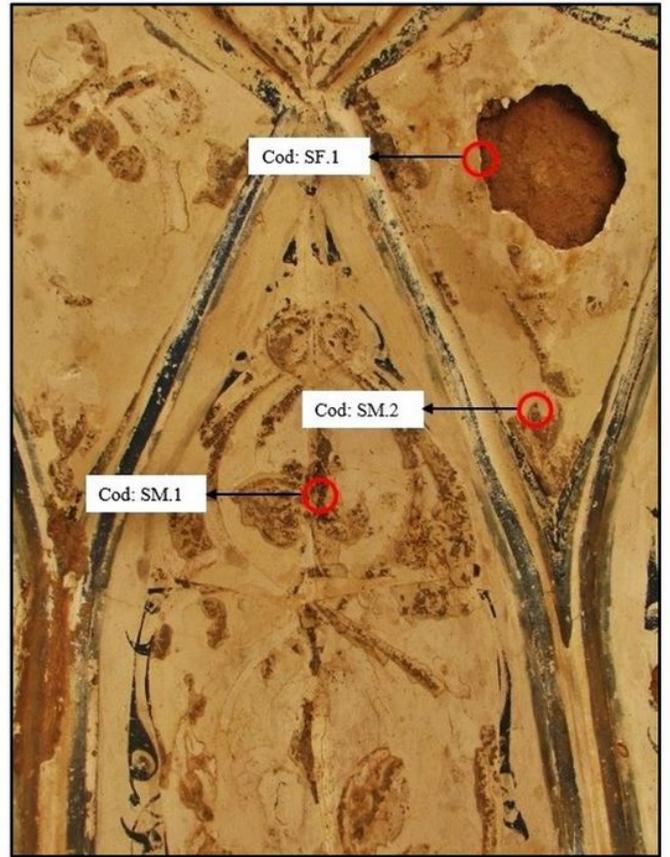
Figure 8

Sampling spots on the Moqarnas area and the gypsum inscription in the northeast side of the iwan of the mausoleum, and coding of the samples

Given the decidedly complex manner of execution (*viz.* mother and child style), the distinct stylishness, and in some parts the considerable depth (ranging between 10–20 cm) of the gypsum inscription, it was important to gain insights into the structural characteristics and compositions of the surface and deeper levels of the inscription. Of the three parts of the iwan over which the inscription extends, the extensively damaged middle part was selected for sampling as it provided easier access to the underlying layers.

Three samples were taken from the surface of the inscription and three more were obtained at 12 cm depth of it. Also, in order to compare the two types of gypsum decorations used in the building in terms of crystalline structure and mineral compositions, additional samples were collected from the molded gypsum ornaments within the Moqarnas and from the gypsum lining in the first alcove adjoining the iwan Fig. 8 gypsum was used with different percentages and methods depending on the layer, allowing surprising and varied results to be obtained, adapted to the needs of the various masters active in the period [20].

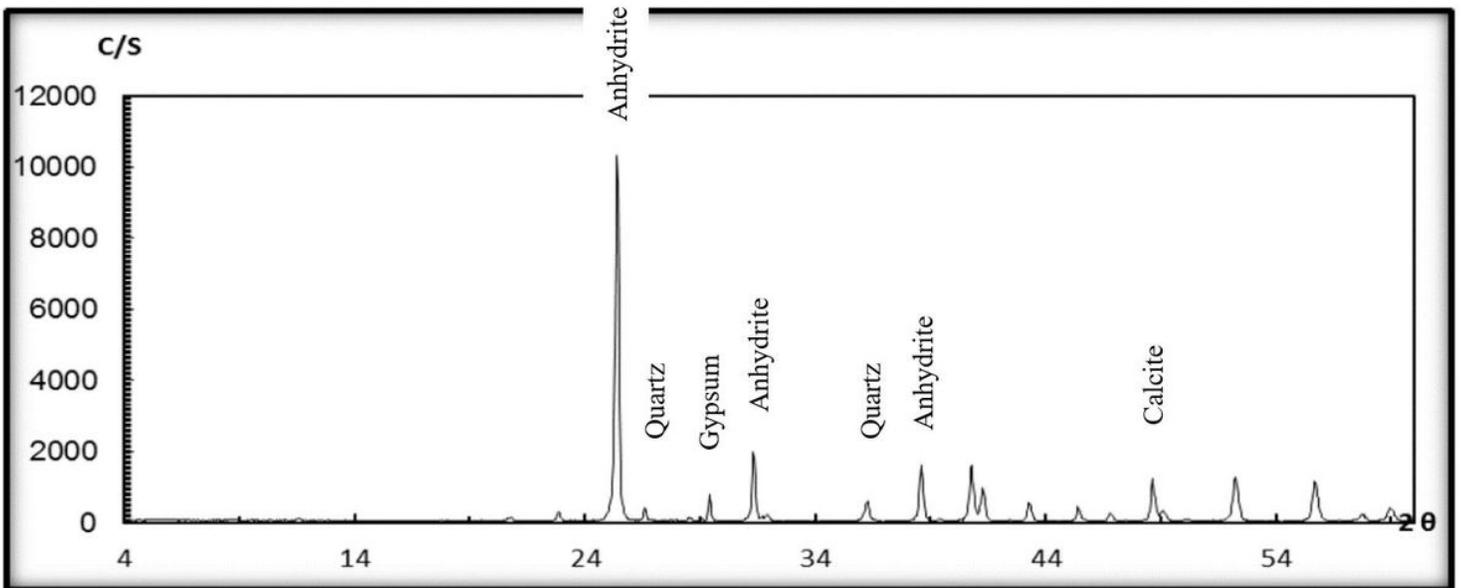
Figure 9

Diffractogram from sample SD.1

XRD analysis: A fuzzy analysis was performed on sample SD.1, whereby anhydrite was recognized as the major phase in the depth of the gypsum inscription. The identified minor and trace phases were calcite, quartz, gypsum, albite and muscovite-illite Fig. 9.

The XRD analysis of Sample SD.1 suggests the presence of the dominant anhydrite phase in this part of the inscription, an observation that in turn might point to the following two facts. First, because of the considerable thickness of the inscription, the builders had decided to work the lowest layers out of burnt gypsum (given its lower cost and inactivity in the hydration process), which is usually anhydrite [22], and the presence of an anhydrite content in the gypsum mortar was commonplace. Second, under certain conditions, e.g. at temperature range from 40 to 80 °C, under pressure, and sometimes in the presence of specific salts, gypsum phase may transform to basanite over time [23]. The loose, powdery deeper layers of the inscription further highlighted the hypothesis of fuzzy conversion in this part. Anhydrite crystals were presumed to be visible in high magnification images. The sample was first examined at 400x (SEM), which was followed by preparing 2000x and 5000x magnification images from a selected point of the crystal structure. As it is seen in the related illustration in Table 5, intertwined acicular crystals have grown together in the form of gypsum crystals, which does not correspond well to the result of fuzzy analysis. Closer analysis reveals microcrystals inside the gypsum crystals, which can be interpreted as anhydrite crystals drawing on the result of the XRD phase analysis. This crystal habit might be linked to pseudomorphism [24]. Previous studies have reported that the plastering mortars are usually composed of non-hydraulic or slightly hydraulic lime, sometimes in combination with gypsum or pozzolanic materials along with siliceous, calcareous or basaltic aggregates[25].

The minor phases attested in sample SD.1 in the XRD analysis are as follows: The first concerns calcite, which based on the elemental analyses of the same sample occurs at a very low percentage, a situation

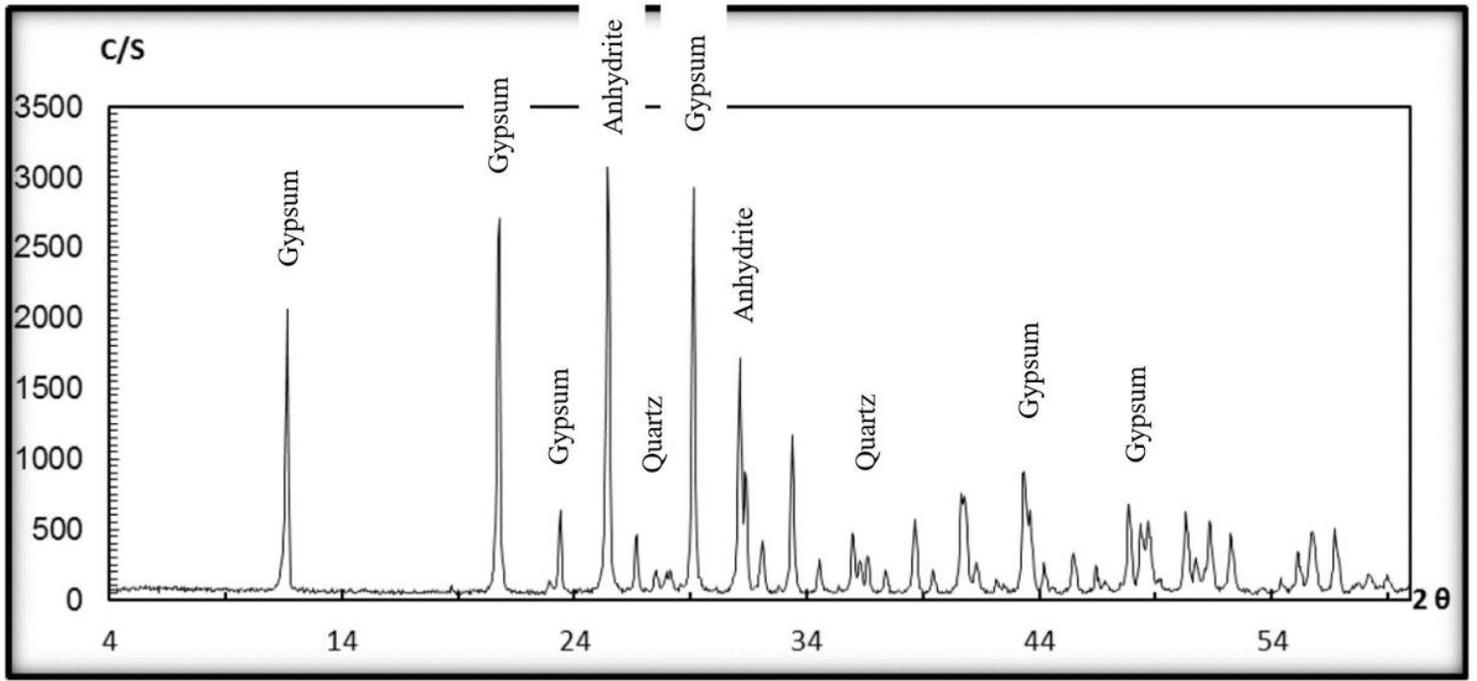
Figure 10

Diffractogram from sample SS.1

The fuzzy analysis on sample SS.1 revealed that the major phases in the surface of the gypsum inscription included anhydrite and gypsum, while minor and trace phases consisted of quartz, microcline, albite, montmorillonite and muscovite-illite Fig. 10. The same analysis on sample SM.1 showed gypsum representing the major phase for the molded gypsum ornament, and anhydrite, quartz, basanite, and montmorillonite constituting the minor and trace phases Fig. 11; Table 3.

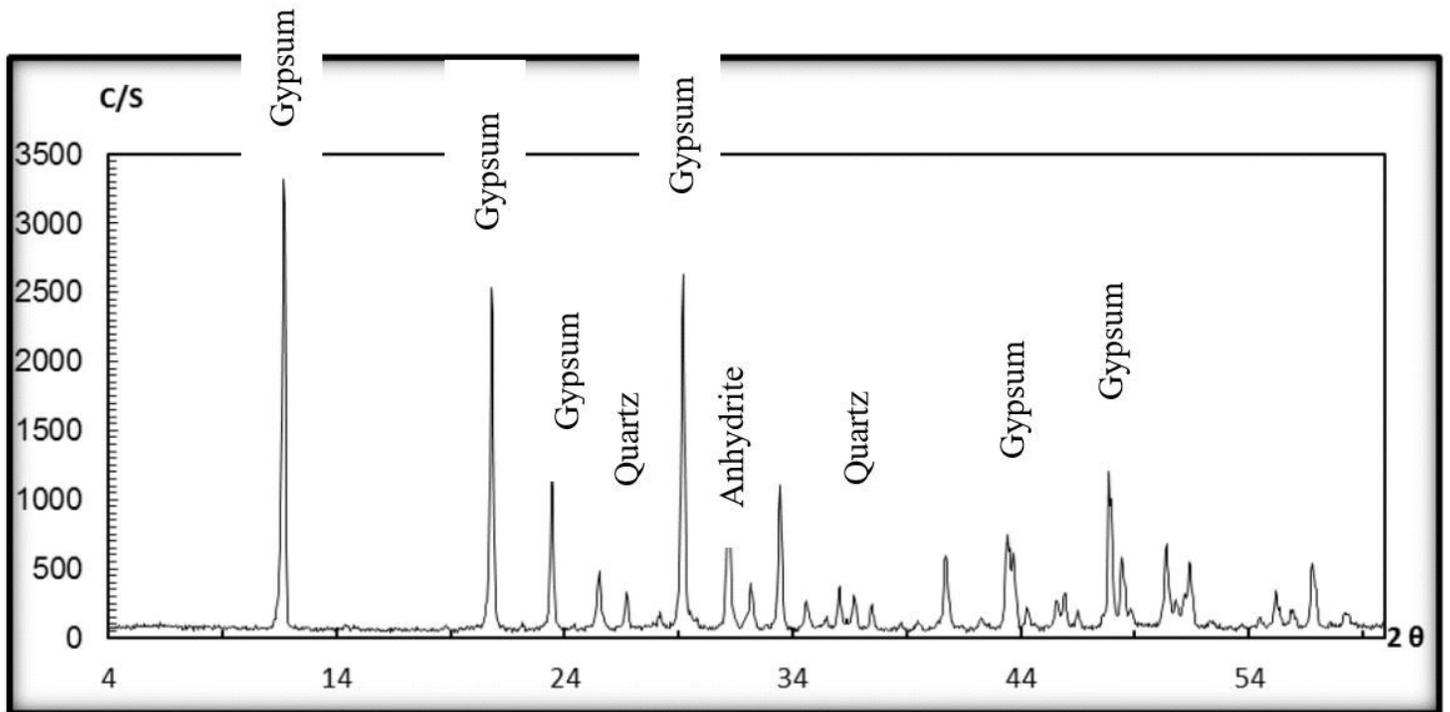
Figure 11

Diffractogram from sample SM.1

XRD analysis detected gypsum as the predominant phase in sample SM.1, where anhydrite and basanite were among the notable minor phases. In the previous two samples, no traces of basanite were identified. Quartz and montmorillonite were other minor phases in this historical sample. Other minor phases attested in the previous specimens were absent in this sample. In other words, the type of the soil that was either added intentionally or existed as impurity in the plaster mortar of the inscription differs from the one used in the specimen in question.
