Geotechnical Evaluation of Gully Erosion and Landslides Materials and their Impact in Iguosa and its Environs, Western Anambra Basin, Nigeria.

Abstract

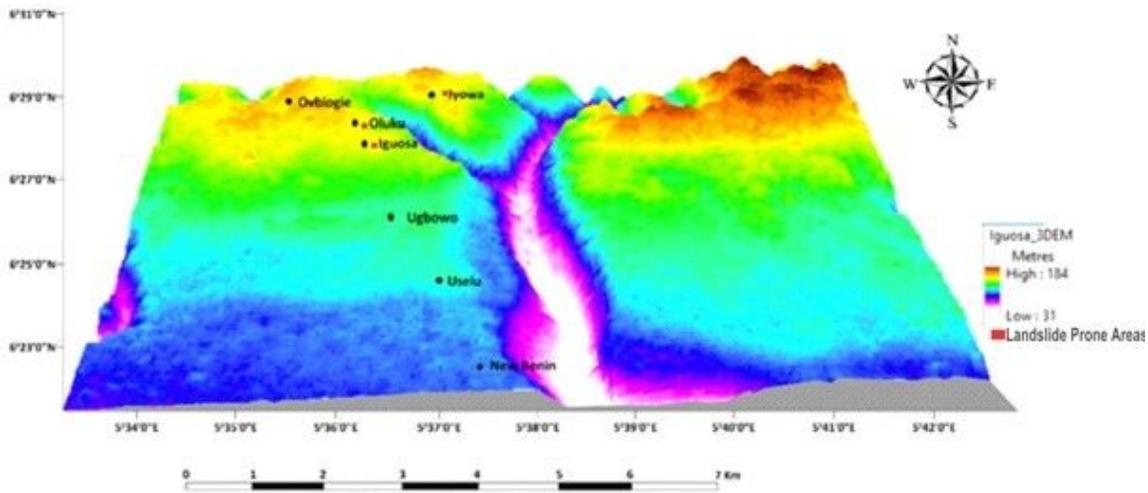
Figure 3

Digital elevation map of Iguosa and surrounding environs showing landslides prone areas.

The digital elevation model, slope map, land cover map generated from NASA SRTM 30m data shows exactly the impact of elevation, slope and vegetative/land cover on the root causes, problems and continuous

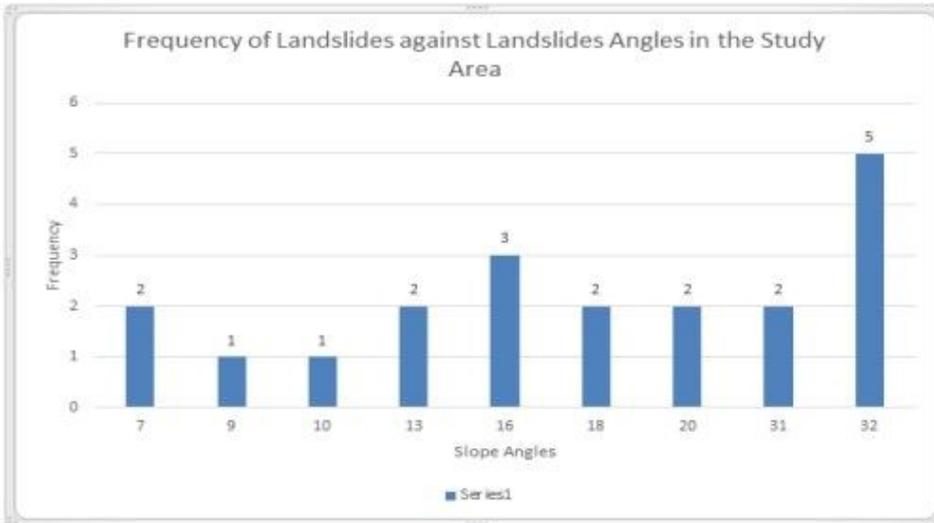
Figure 4

Graphical representation of frequency of slope angles of gullies/landslides in the study area

high slope angles of ($32^{\circ} - 42^{\circ}$). This high slope values and elevation of the landslide and gullies in (Fig. 4, Table 2) the area is the cause of the mass sliding activities that are prominently trending in the northeast direction in the study area.

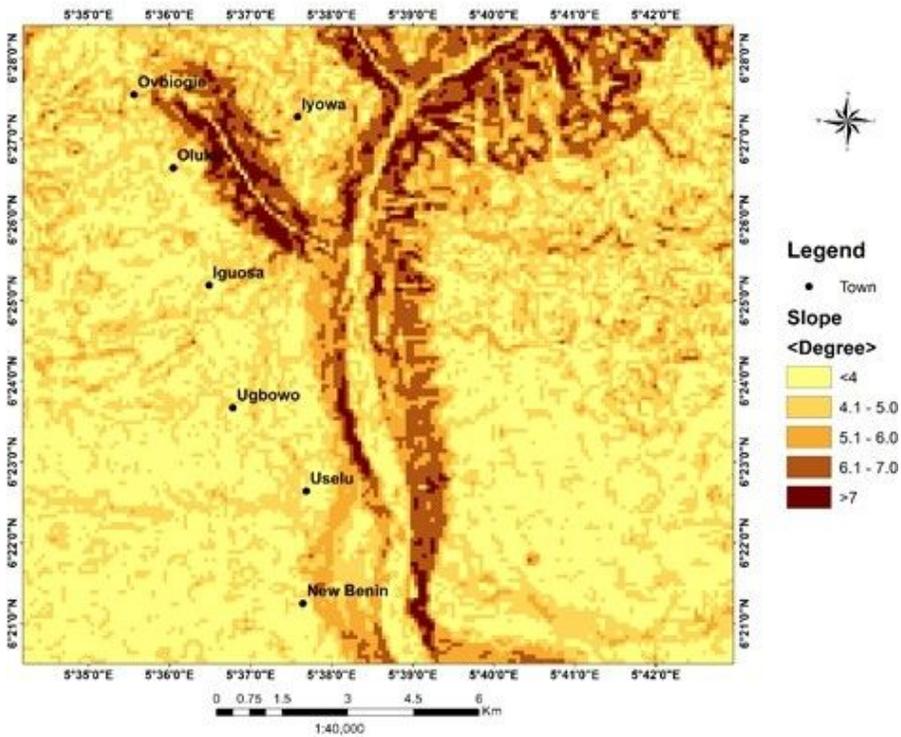
Figure 5

Slope angles of Iguosa and its surrounding environs

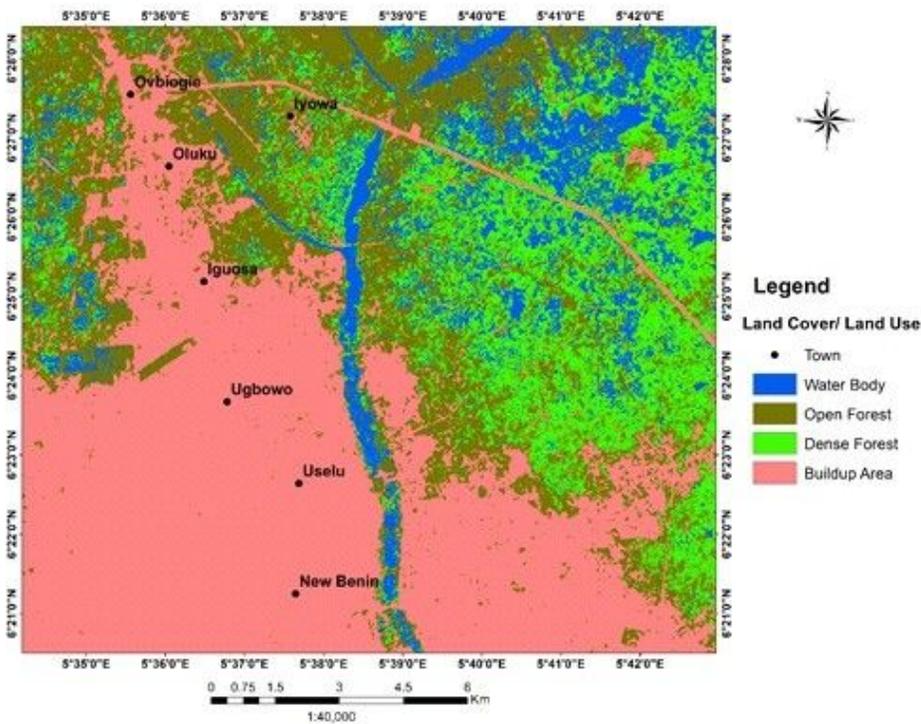
Figure 6

Land cover map of Iguosa and its environs. Note: The designations employed and the presentation of the material on this map do not imply the expression of any opinion whatsoever on the part of Research Square

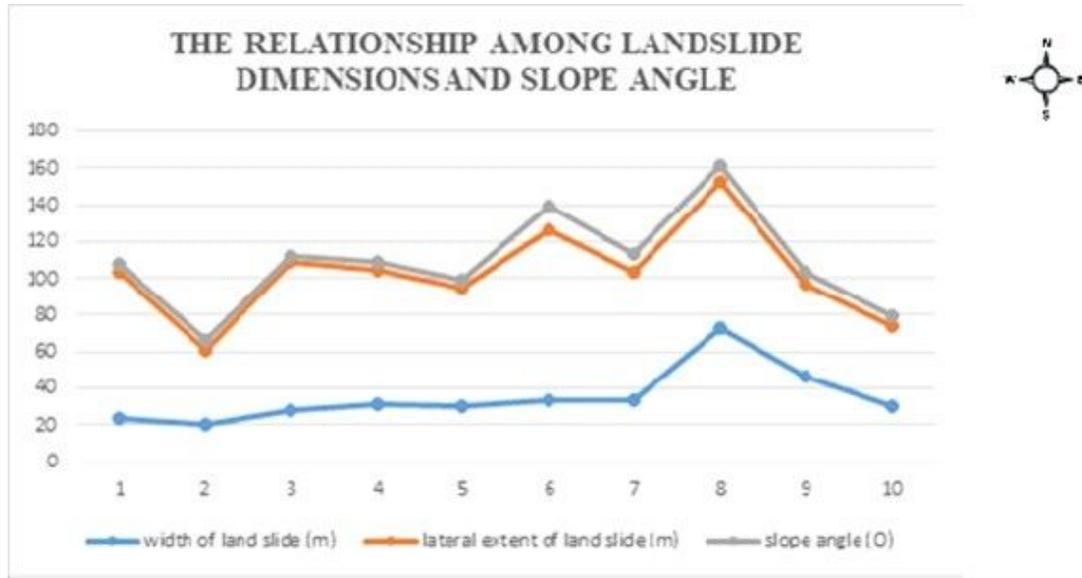
Figure 7

Plot of Dimensions of landslides (m) against slope angles of the landslide

The lateral extent ranging from 40.2 to 93.0m with mean lateral extent of 87.30m. The depth of slide ranging from 2.6m to 68.7m with mean of 57.07m and width value ranging from 20.4m to 72.6m with mean of 32.24m, indicate a high degree of erosion and sliding in the study area. The generated digital elevation model, slope map and land use map of the study area from 30m data -Spatial Resolution and Shuttle Radar Topographic Mission (SRTM) are shown (Figs. 3, 4 above and Fig. 6 below respectively). It shows that the elevation, the steepness of the slope, excess run off from heavy down pour and infiltration, deforestation, over grazing and the improper use of the land from the land cover map and poor drainage system contribute to the landslides and the exposure of the study area to other landslide related hazards in the study area. From the plot of the dimensions of the landslide against the slope angles of the landslide (Fig. 7), it shows that in this year the lateral extent and slopes angles of the landslides and gullies are sliding at almost the same rate in the north east direction in the field. During the early stage of gullying activities and sliding, the lateral extent of the slides and width of the slides were not proportionate. As the landslides and gullies become rapid this year, the lateral extent of the sliding become relatively proportional to the slope angles of the landslides (Fig. 7). The sliding in the area ranges from gentle to steep slopes at angle of 7⁰ – 32⁰ and the slides are trending in the north east direction in the study area (Figs. 8a & b). From Fig. 8b the blue colour shows initial stage of the sliding as very

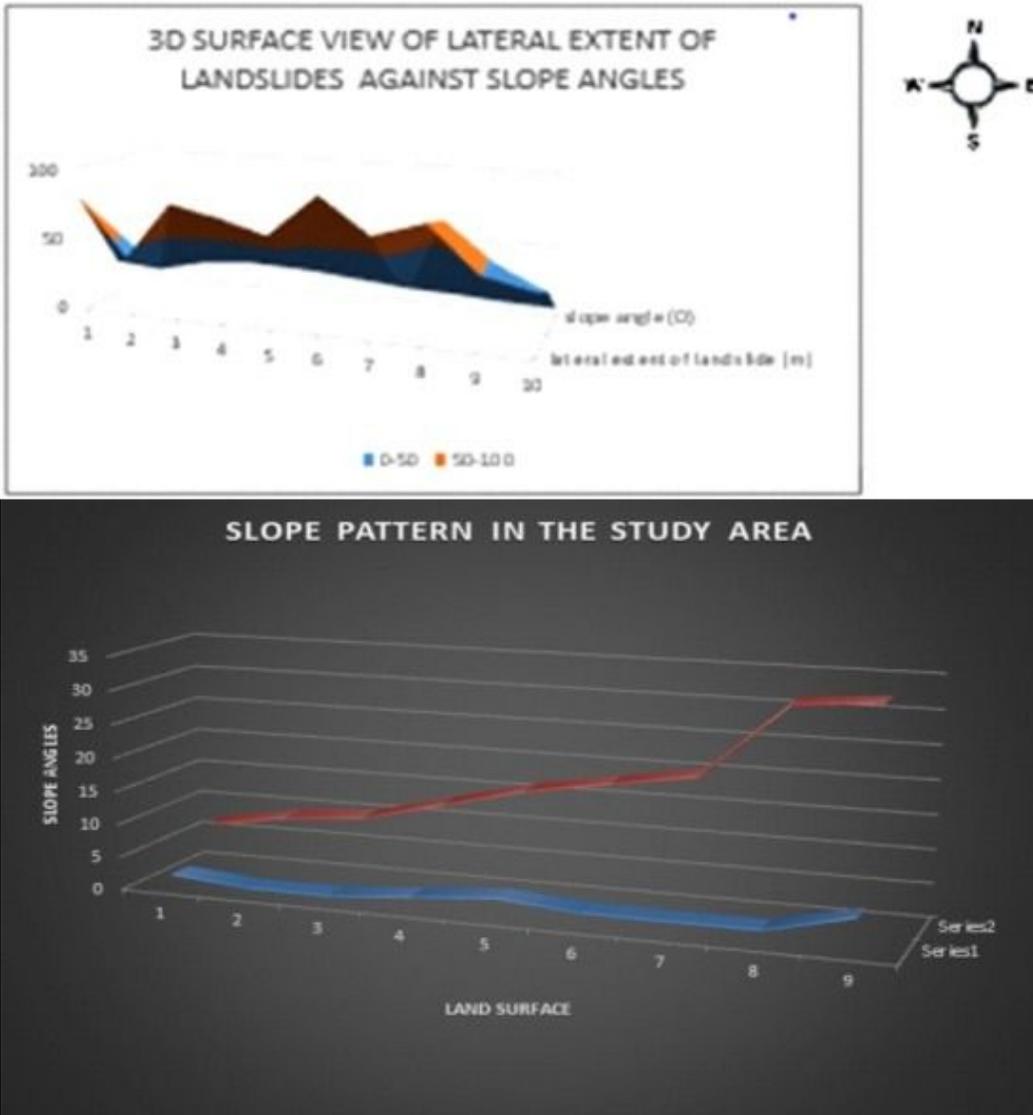
Figure 8

a: 3D surface view of lateral angles versus slope angles of the landslide in the study area. b: Slope pattern of the sliding in the affected areas

gentle to gentle slope. The red colour shows the advance stage of the sliding as moderately steep slope to steep slope in the study area. As the width of landslides increases, the lateral extent of the landslides increases relatively and these occur more on the mean slope angles of 22.5° at mean elevations of the landslides and gullies of 183.11m. The lithology investigated in the field are upper most layer (dense lateritic soil), Ajali Formation and some clay materials at the slide walls and floor of the slides/gullies. The upper most layer is mostly of red earth with little clay material present. The Ajali Formation is characterized of medium to coarse grained, friable, unconsolidated to consolidated sands of 250cm thick in the landslides area. Also, within the landslide areas the units are interbedded by clay and fine materials.

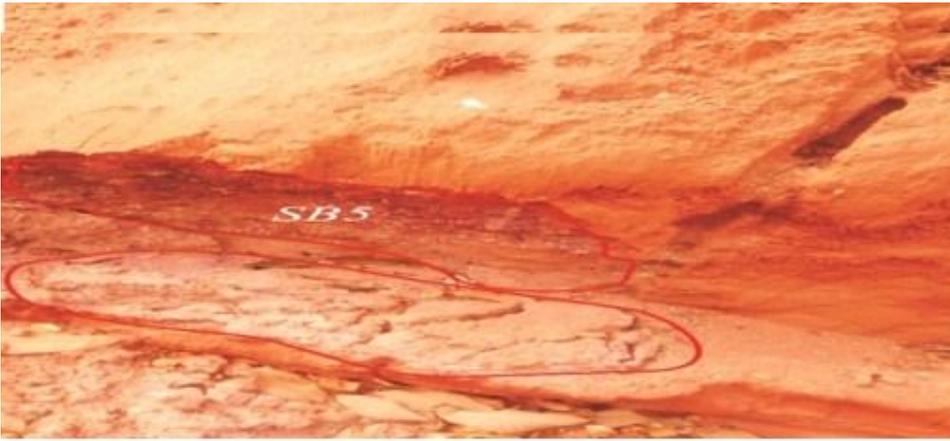
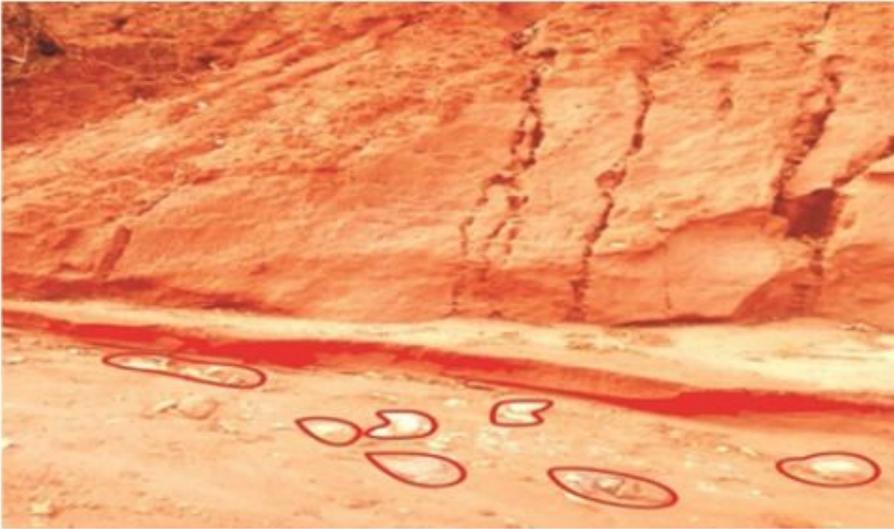
Figure 9

a: Shale/clay materials (SB5) acting as gliding surface in the study area (Photo by Aigbadon). b: Weathered Shale/clay materials on the floor in the study area which acts as sliding plane (Photo by Aigbadon)

The high plasticity values of soil sample SB5 and SB10 will result in swelling and expansion of the clay/ silt materials in the study area upon heavy precipitation and resultant runoff and infiltration. The increase in the volume will create an upward force on the overlying coarse sand and medium sand units. This alternating sequences of swelling and shrinking during wet and dry seasons will in turn give rise to the initiation of slopes failures, creating new steep slopes at the base of the Ajali sand and further landslide activities in the study area. This explains the mechanism and root causes of the problems in the affected areas. In addition the very low permeability of silty/ clay units (SB5, SB10) that separates the sand units in the area have been identified to be the gliding plane for several landslides in these areas and this corroborate the works of (Ogbukagu 1976; Okagbue 1986; Egboka and Okpoko 1984; Okagbue 1992). This may possibly explain why the clays in this area serve as gliders/gliding planes to several landslides in the area.

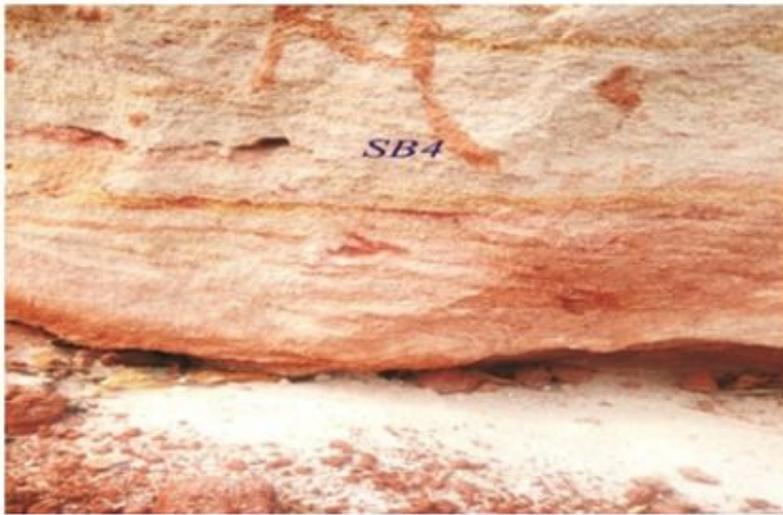
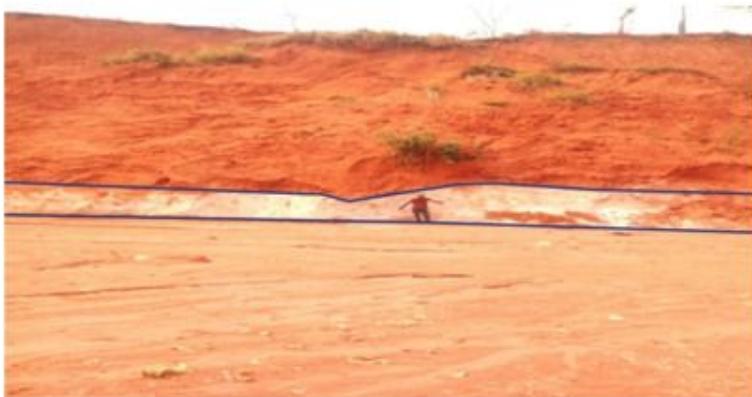
Figure 10

a: Ajali Sands (SB4) in the study area (Photo by Aigbadon). b: Ajali Sands with thickness of about 2.5m marked blue in the study area (Photo by Aigbadon)

values of cohesion and angles of internal resistances resulted to cracks, fractures and slopes of various degree in study area. The non-plastic characteristics of the Ajali sands which display a very loose to loose compaction in the study area increases its susceptibility to erosion and landslides.

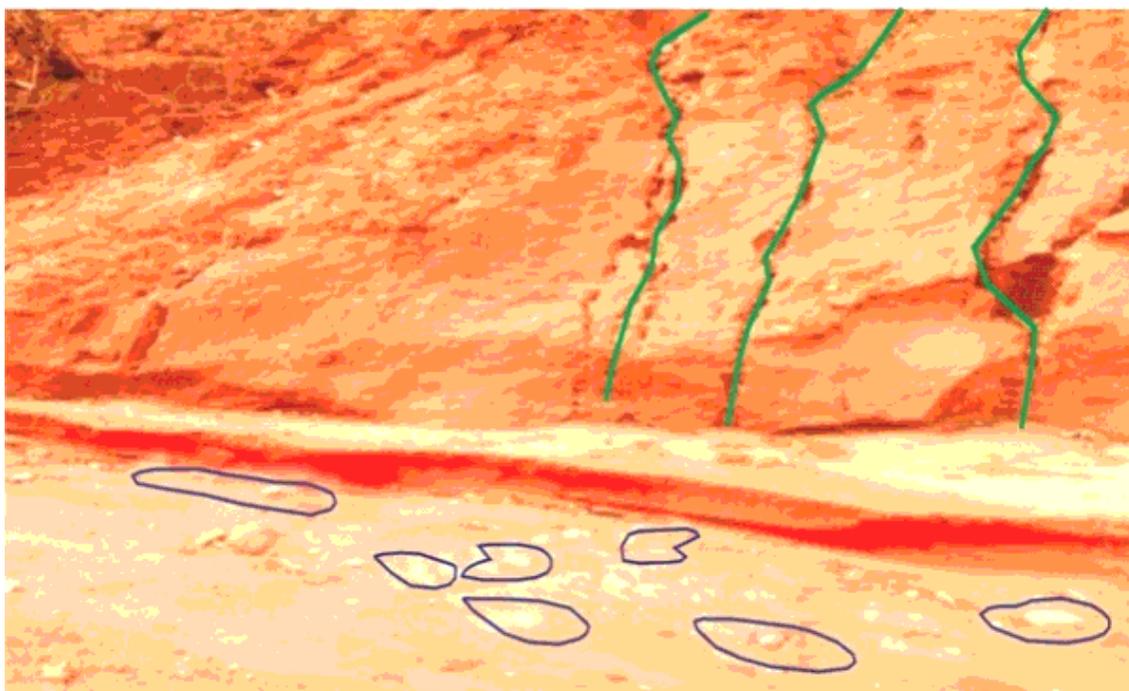
Figure 11

Cracks and fractures zones marked in green (Photo by Aigbadon)

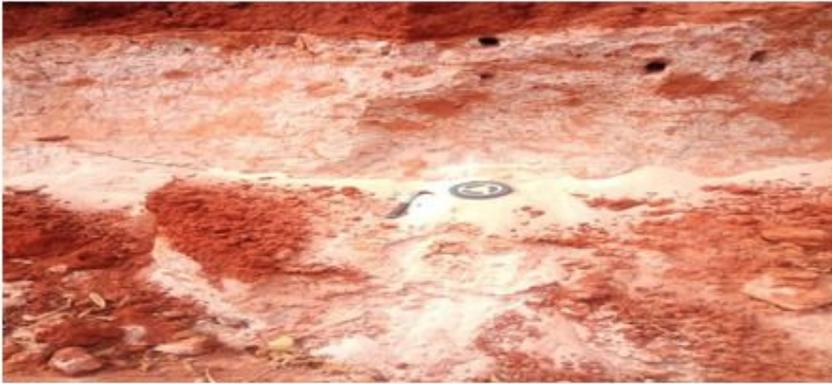
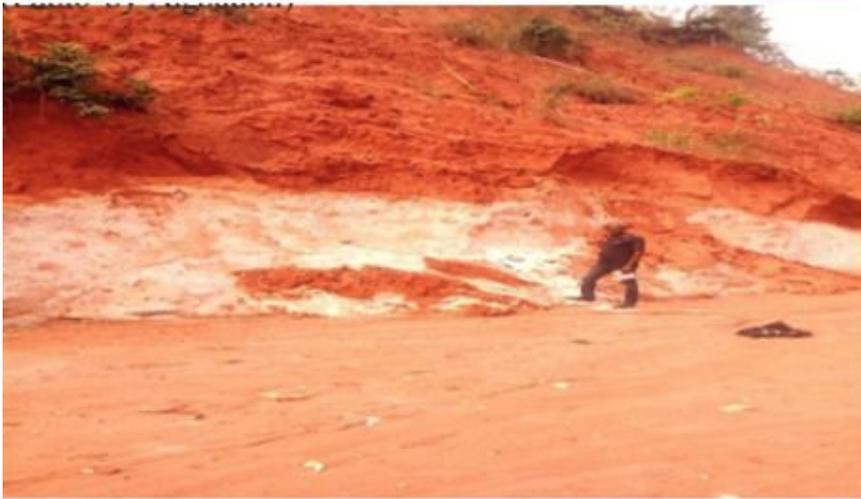
Figure 12

a: Soil debris in the study area (Photo by Aigbadon). b: lateral soil spread in the study area (Photo by Aigbadon)

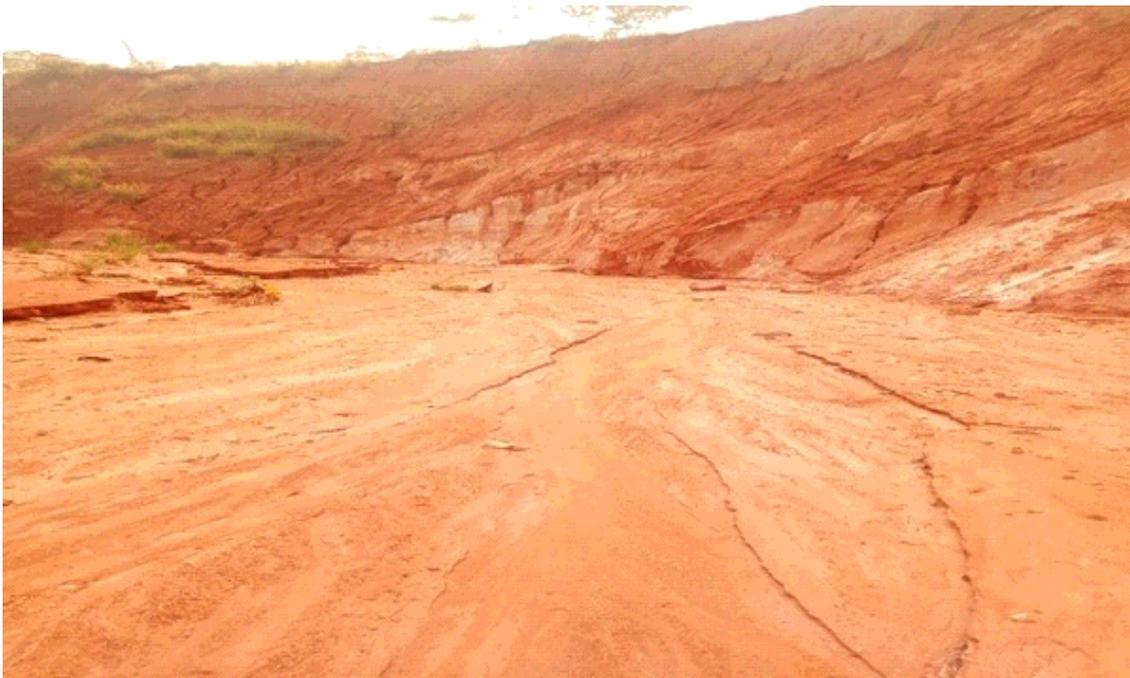
Figure 13

landslide at the study location (Photo by Aigbadon)

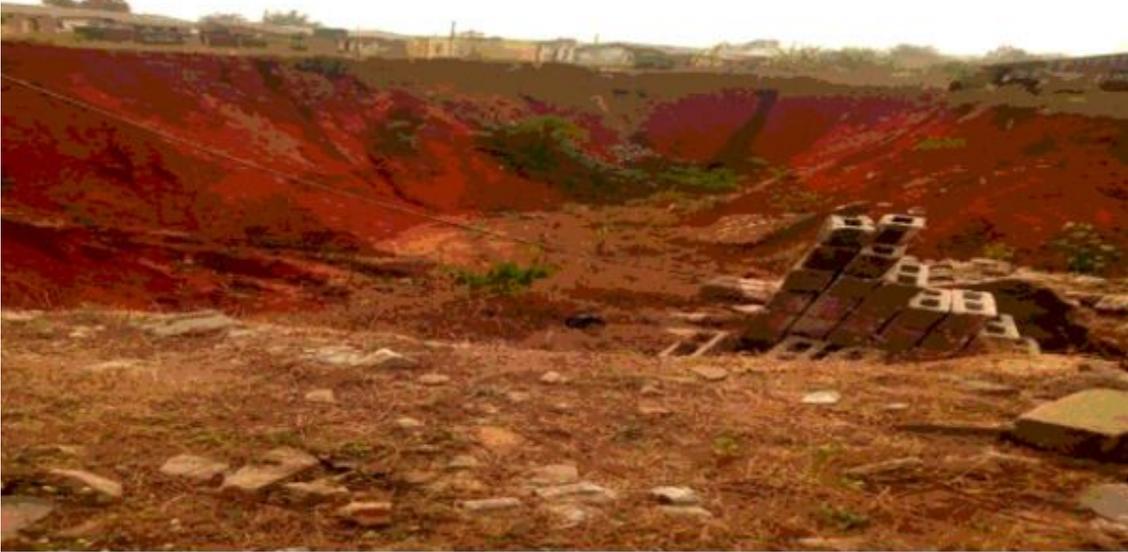
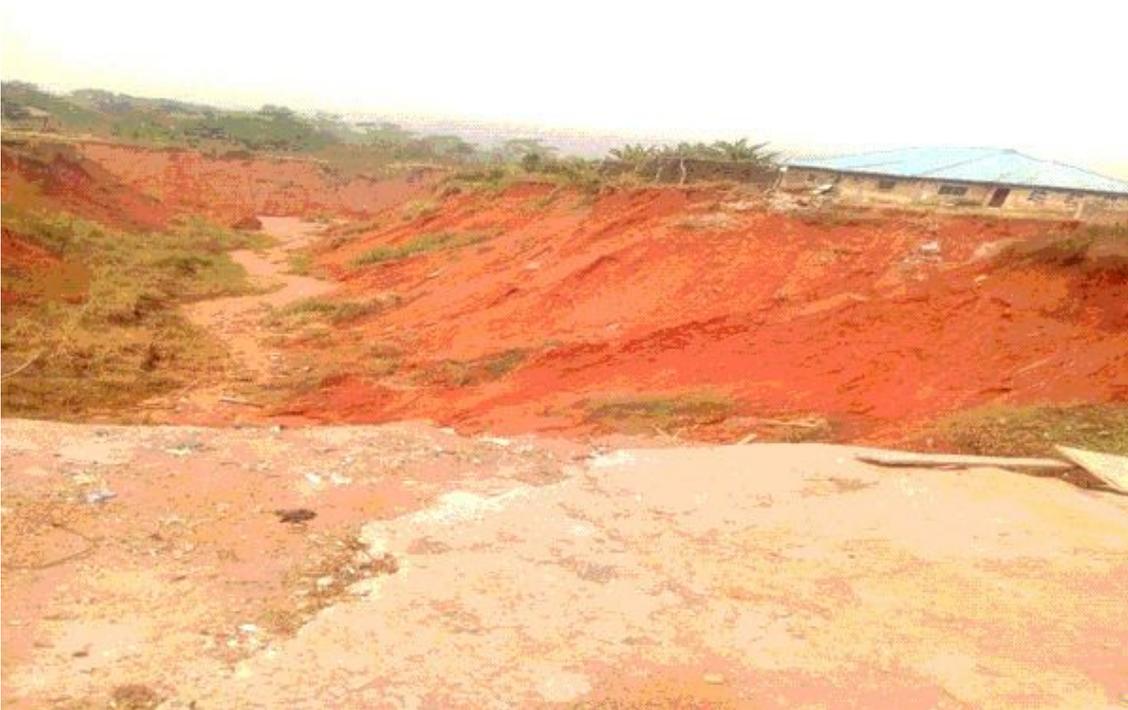
Figure 14

From the findings above, over four hundred (400) houses, farm lands, landed property have been damaged and abandoned as well as other properties worth millions to billions of dollars (Figs. 14–15). The following suggestions have been made to solve these problems:

a: Landslide on Iguosa area threatening lives and Property in the study area (photo by Aigbadon). b: The road leading to various homes in the study area has be truncated by erosion and landslides activities (photo by Aigbadon)

1. The slopes should be improved by drainage control and slope flattening. This reduces the weight of the mass tending to slide, providing a support below the toe and this support also increases the resistance to sliding and hence increases the stability (Egboka et al. 2019)

2. The landslide areas should be covered with impermeable layers/materials and also diverting of surface water away from the landslide areas.
3. Biotechnical slope method according to (Gray and Sotir 1996) should be employed to avert and stop slope failures and erosion by planting different plants on sloping landscape by government and individuals so as to stabilize the slope.

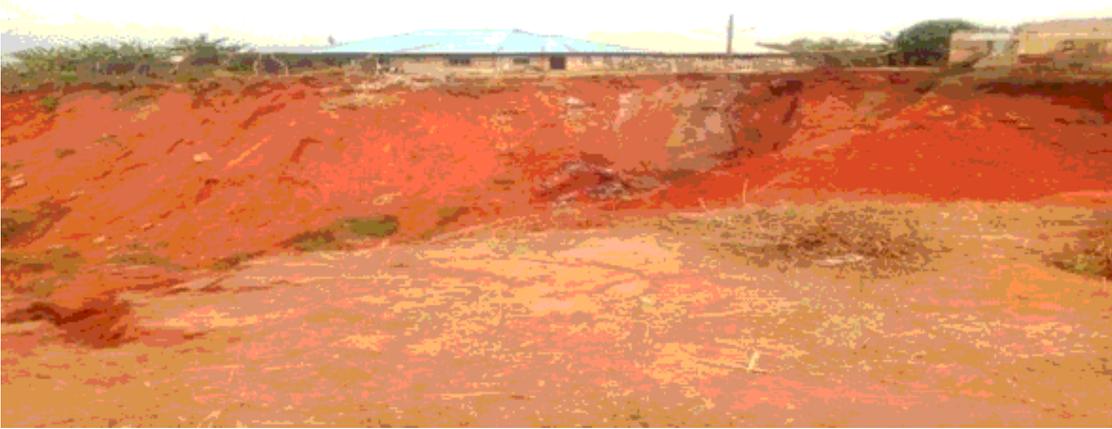
Figure 15

Surface water diverted to the landslides area couple with the poor drainage system (photo by Aigbadon)

4. There should be construction of gravity and earth dams to channel the flood and this will help to reduce the velocity of inflows and convey large inflow of water away from different catchments areas around Ovia North-East into nearby stilling basins or Neighboring Okhoro River.
