# Catastrophic Mechanism and Stability Analysis of Jiangdingya Landslide in Zhouqu County, Gansu Province, China

## Research Article

**Keywords:** Landslide, Catastrophic mechanism, Stability analysis

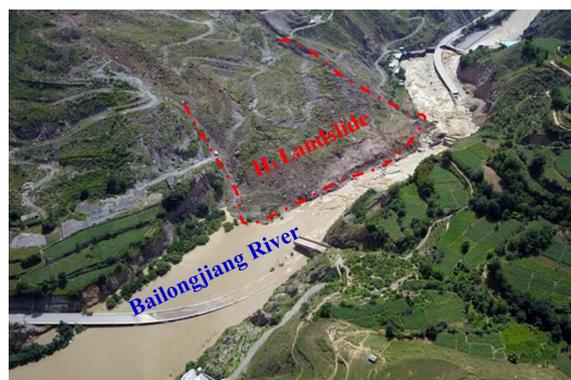
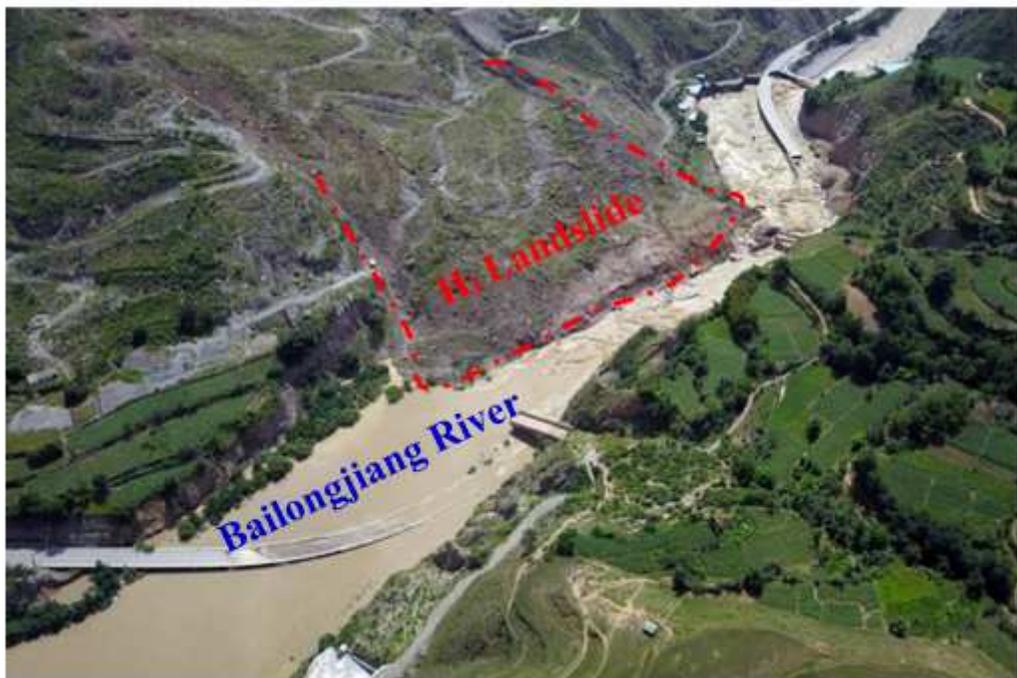
At about 17:00 on June 13, 1991, the Jiangdingya landslide of Nanyu Landslide Group in Nanyu Town, Zhouqu County, Gansu Province, China, experienced a large-scale sliding (Chen 1991; Ren 1993; Wang et al. 1994; Mu 2011). The lower part of the landslide body was firstly sheared and destroyed, then slowly declined and instantly blocked the Bailongjiang River. Then, the upper part of the landslide mass was pulled to slide rapidly. The huge thrust of landslide soil and the jacking action of the steep wall on the other side of the Bailongjiang River made the sliding tongue of the sliding body climb along the steep wall, and finally form an earth dam with a height of 20m and a width of 50m. As a result, the Bailongjiang River is cut off for up to 8 hours, the backwater in the upper reaches of Bailongjiang River is about 2.8km, and the accumulated water is  $754.9 \times 10^4 \text{ m}^3$ . Half of the Nanyu Town is submerged and the loss is serious (Huang et al.2013). In the following years, the Jiangdingya landslide was basically stable. At about 8: 00 on July 12, 2018, the Jiangdingya ancient landslide was reactivated (Fig. 2). The reactivated Jiangdingya landslide ( $H_1$  landslide) belongs to the local part of Jiangdingya ancient landslide (H landslide) The earthwork volume of landslide reached  $480 \times 10^4 - 550 \times 10^4 \text{ m}^3$ , which caused the Bailongjiang River to be blocked and the water level to rise.

**Fig. 2** The resurrected Jiangdingya landslide ( $H_1$  landslide) in 2018

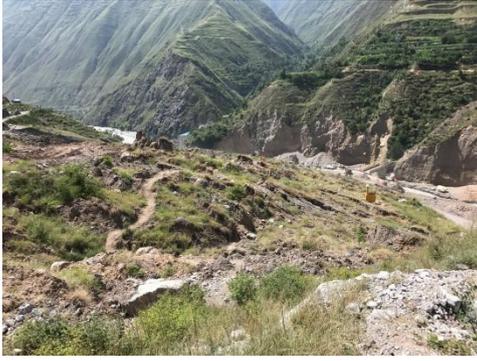
(a) Drumlin

The left bank of Bailongjiang River is an eroded structural alpine landform with a slope of about  $20^{\circ}\text{-}45^{\circ}$ . Due to the long-term spalling and accumulation of residual slope sediments, a gentle slope platform is formed in the middle of the slope. The lower slope of the slope body is relatively gentle, about  $20\text{-}25^{\circ}$  and the upper slope is steep, about  $30\text{-}45^{\circ}$ . The topography of the slope is strongly cut, forming a number of small "V" shaped gullies, which are mostly long strips. The Jiangdingya ancient landslide is located in the upper part of the slope body with a gradient of about  $20^{\circ}$ . The topography of the slope surface fluctuates greatly. The rear part of the sliding body is depression, and tensile cracks and shear cracks are developed in the middle, lower part and front edge, forming drumlins locally (Fig. 4. (a)). The leading edge has been obviously transformed by human engineering activities, and a scarp with a slope of  $45^{\circ}$  is formed by manual excavation (Fig. 4. (b)).

**Fig. 4** The eroded structural alpine landform

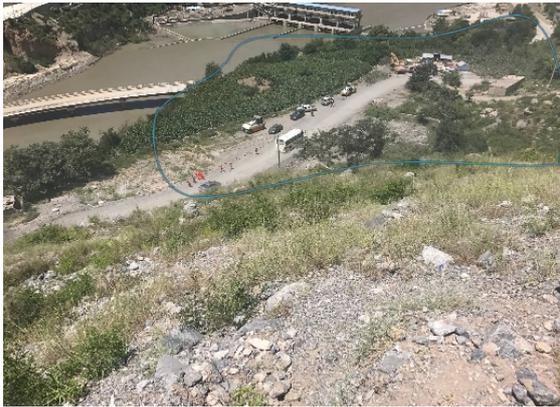
(a) The front edge of the second terrace of the valley

The front edge of the slope body is eroded accumulation valley terrace landform. The widest part is located on the west front edge of the Jiangdingya ancient landslide, which is the second terrace of the valley. It is distributed in the gentle slope form from northeast to southwest, with an average slope of about  $3^\circ$  and about 8-10 m higher than Bailongjiang River (Fig. 5. (a)). The narrowest part is located at the front edge of the landslide mass. Affected by the accumulation of landslide mass, the width of the river is only 35-40 m, the river is turbulent and the bank wall is upright (Fig. 5. (b)).

**Fig. 5** The eroded accumulation valley terrace landform

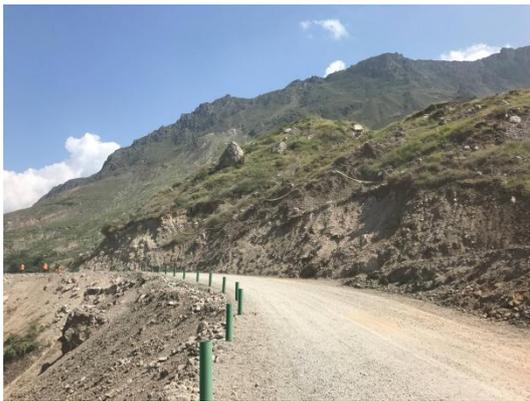
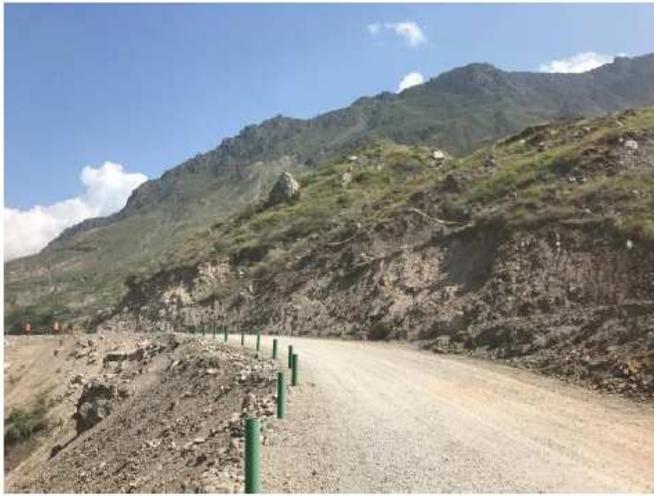
Human activities in the Jiangdingya landslide area are mainly manifested in two aspects: cutting slope to build roads and gentle slope cultivation. According to the investigation, due to the construction of national highway G345, the foot of the front edge of the Jiangdingya ancient landslide was artificially cutting and turned into a steep scarp with a height of about 9-16m, which increased the free surface at the leading edge of the ancient landslide body and reduced the stability of the leading edge slope of the landslide body (Fig. 9. (a)).

**(a) Scarp formed by road construction**

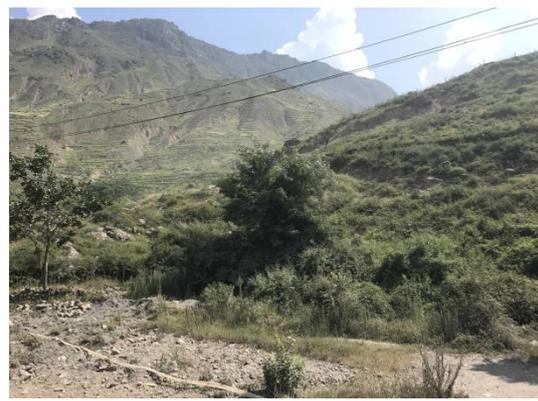
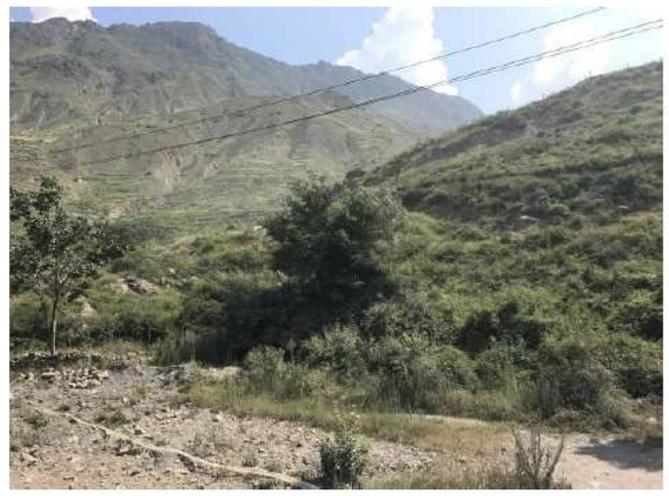
With the increasing population, the planting area of steep slope and gentle slope in Jiangdingya area is expanding, which destroys the original vegetation, makes the surface bare, reduces the water-holding capacity of soil, and forms a softening layer at the interface between soil layer and bedrock. In addition, the slope at the back and front of Jiangdingya ancient landslide is mostly cultivated artificially. Perennial irrigation increases the water content of the slope, and a large amount of water enters the landslide along the gravelly soil, which increases the water content of the soil and reduces the shear strength, resulting in a gradual decrease in the stability of the slope (Fig. 9. (b)).

**(b) Slope cultivation****Fig. 9** Human activity in Jiangdingya landslide area**2.2 Evolution history of landslide**

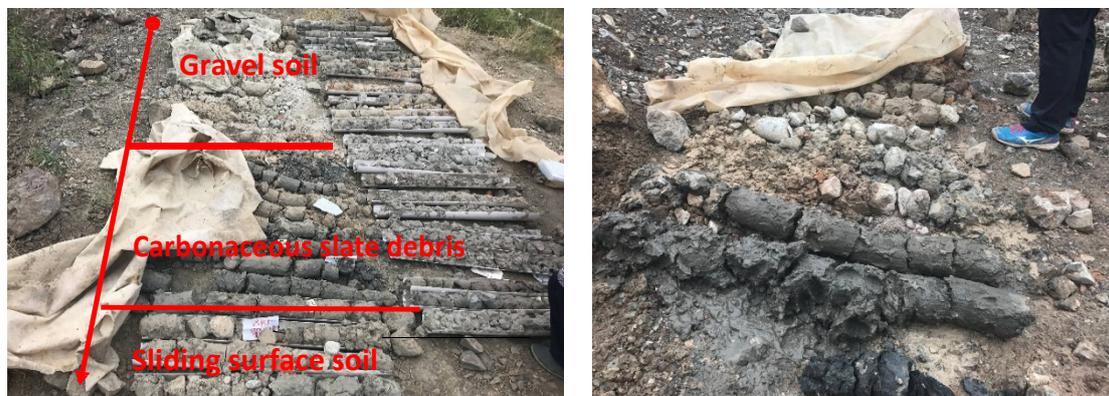
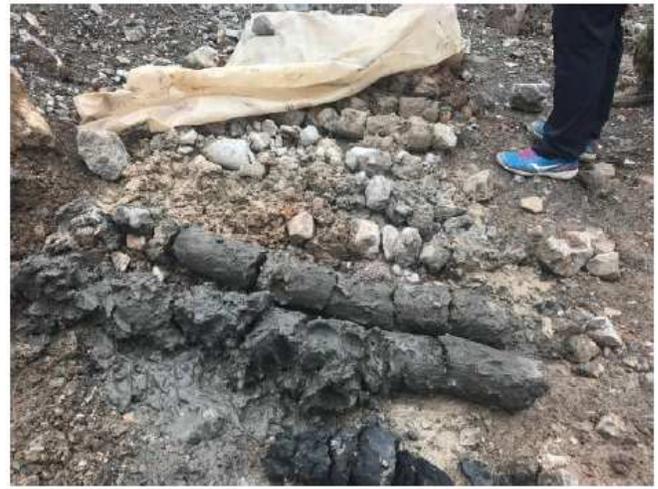
The  $H_1$  landslide belongs to accumulation landslide. In the longitudinal direction, the thickness of the landslide is thicker in the middle and upper part, followed by the rear part, and the middle and the front part is thinner. The sliding body in the middle and rear part of the landslide is mainly composed of two layers of soil (Fig. 13), the upper part is gravel soil, it is yellowish brown, the composition is mainly limestone gravels and block stones, and some parts contain large stones with a grain size of 1~2m. The lower part is mainly composed of gray black carbonaceous slate debris with high water content and low strength. The front edge of the sliding mass is gravel soil, and the soil contains large-sized block stones. The statistics of physical and mechanical index test results of the landslide body are shown in Table 2.

(a) Soil layer distribution of landslide body

(b) Gravel soil

**Fig.13** Structural and mechanical characteristics of landslide body

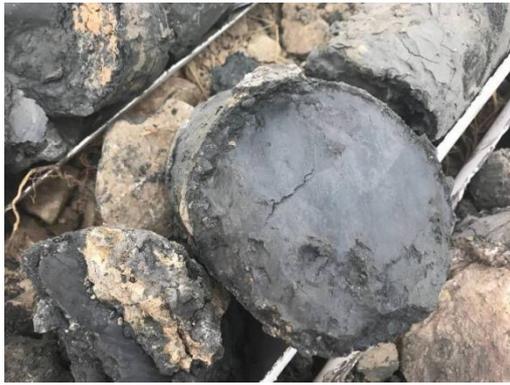
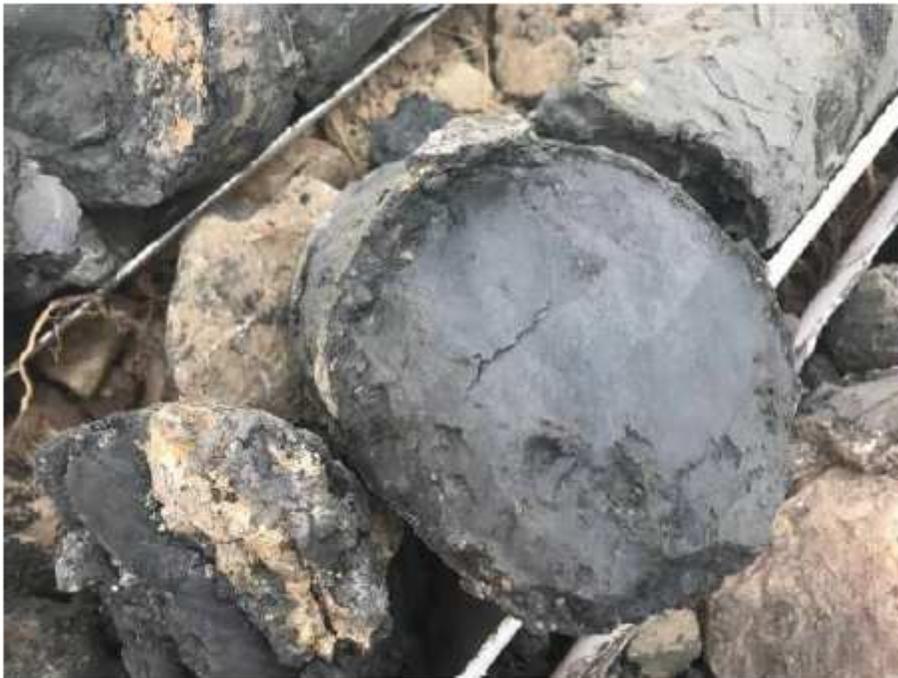
The sliding zone soil at the back of landslide is mainly gray-black gravelly clay, and the soil is soft plastic with a small amount of fine-grained breccia. The water content is high and the soil is saturated. The scratches on the surface of sliding zone soil are obvious (Fig. 14). The statistics of physical and mechanical index test results of the sliding zone soil are shown in Table 3.

**Fig.14** Scratch marks of sliding zone soil

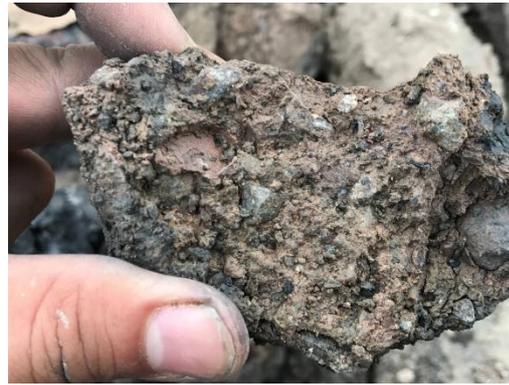
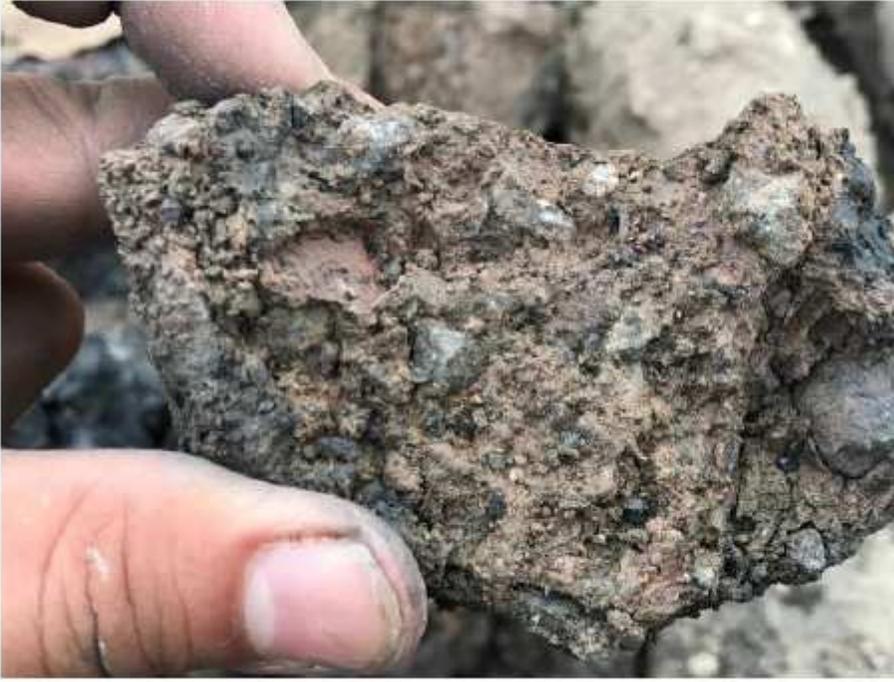
**Fig.15** Sliding bed soil

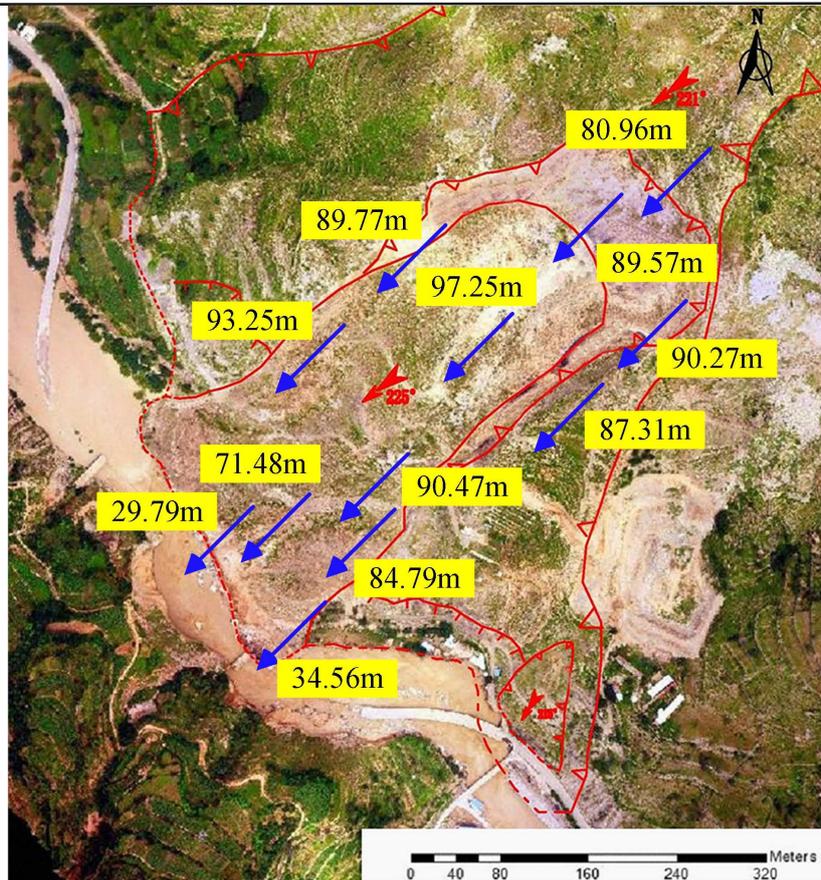
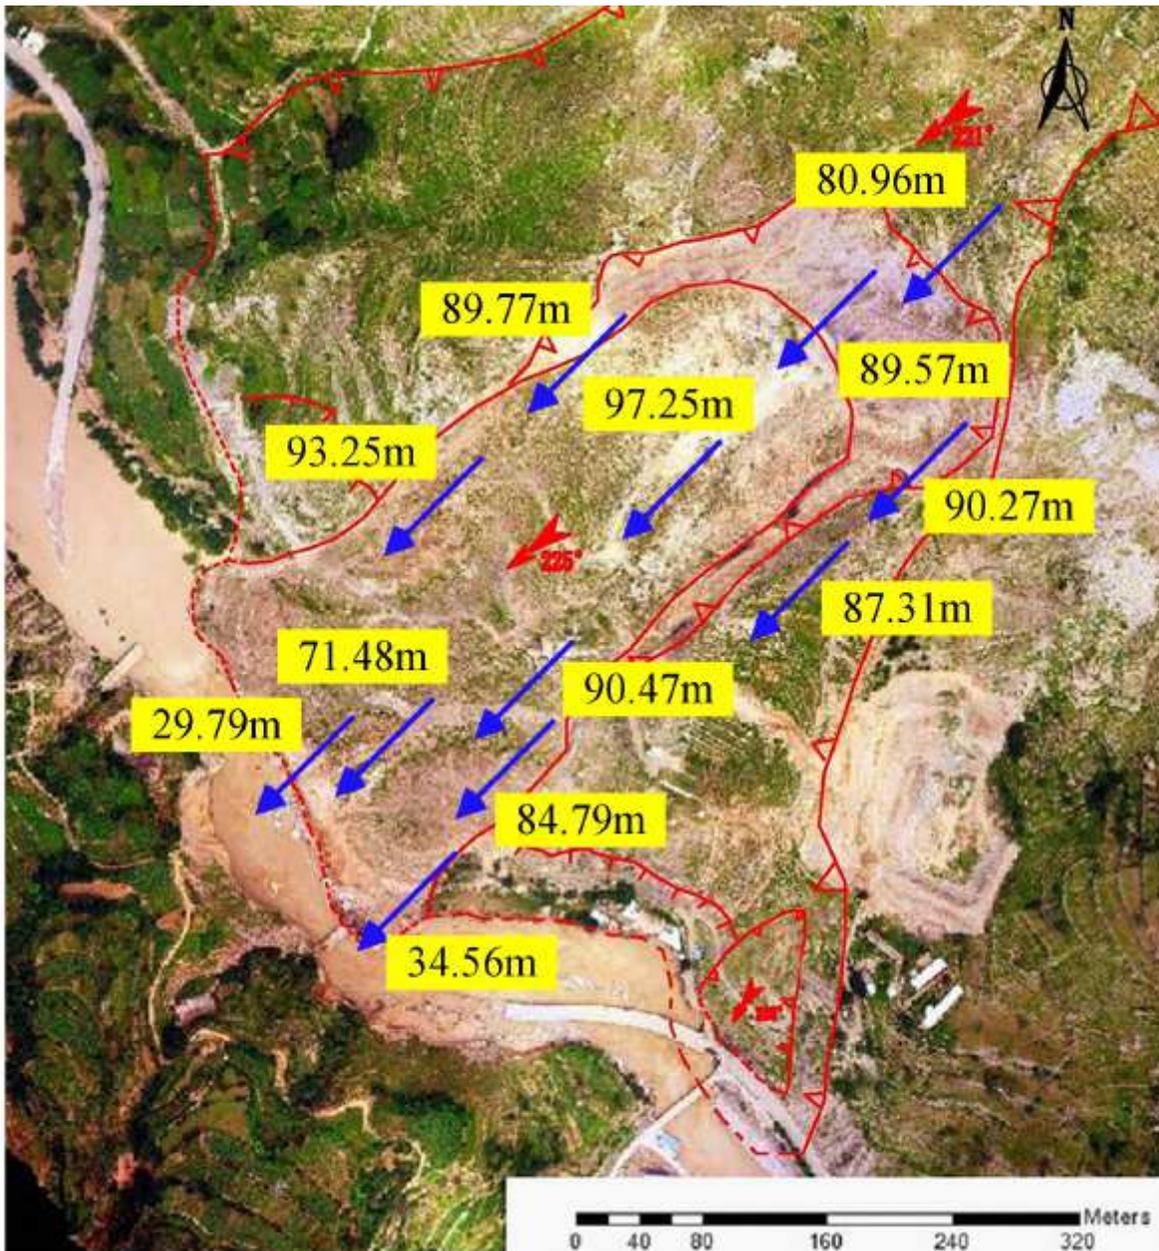
According to the remote sensing image of landslide, the sliding distance at the back of landslide is 89.57m, that in the middle is 87.31-97.25m, and that in the front is 29.79-90.47m (Fig. 16). The sliding distance decreases in turn, which indicates that when the middle-rear block slides down, it is blocked by the front block, the sliding speed slows down. The results show that the sliding mass belongs to the deep deformation of push type landslide.

According to the analysis of slip time, the landslide began to slide at 8:00 on July 12, 2018 and stopped at 9:00 on July 13, 2018, the sliding time lasted for 25 hours. The average sliding distance of the landslide mass is 65.76m, and the moving distance per hour is 2.63m/t, which indicates that the landslide is mainly characterized by push-type with slow deformation.

**Fig. 16** Sliding distance of the landslide

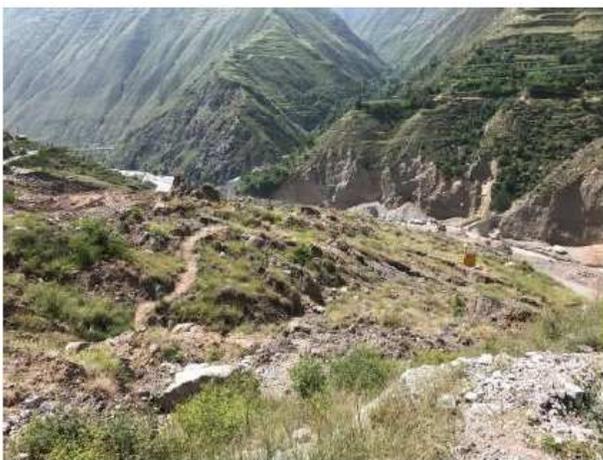
**(a) Drumlin**

The eroded structural alpine landform. Note: The designations employed and the presentation of the material on this map do not imply the expression of any opinion whatsoever on the part of Research Square concerning the legal status of any country, territory, city or area or of its authorities, or concerning the delimitation of its frontiers or boundaries. This map has been provided by the authors.
