# Multi-level and Precise Evaluation of Slope Stability in Large Open-pit Mines: a Case Study at Dexing Copper Mine, China

## Research Article

**Keywords:** mine slope, shear strength, graded analysis, stability assessment

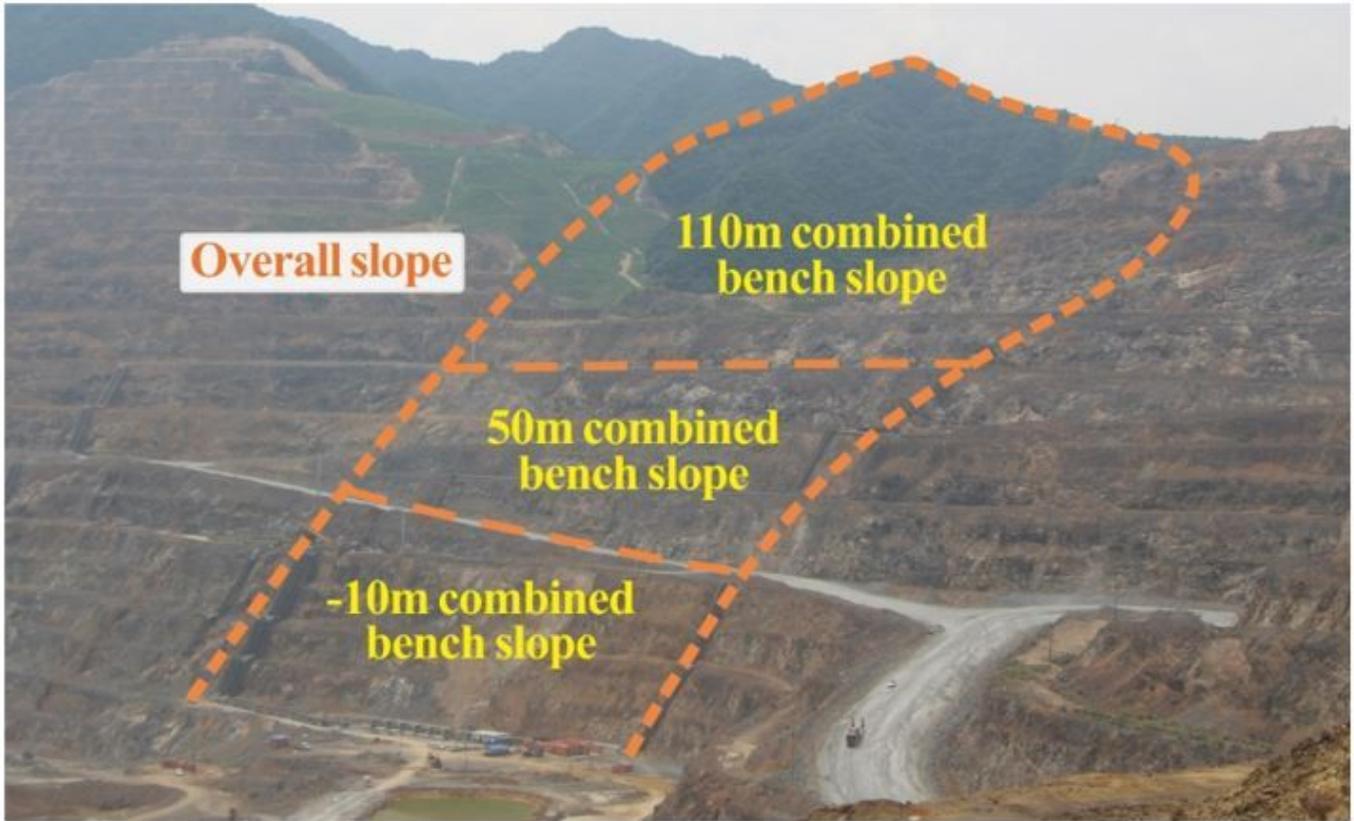
**Figure 2**

The photo of Yangtaowu slope indicating the overall slope and combined bench slopes

202 According to the parameters variation of slope engineering, Yangtaowu Slope can be  
203 divided into three main parts from bottom to top (as shown in Fig. 2): The -10 m combined  
204 bench slope (composed of three slopes of A(-10T), B (-10T) and C (-10T), which are located  
205 in the east, the middle and the west of the -10 m combined bench slope, respectively); The 50  
206 m combined bench slope (composed of two slopes of A (50T) and B (50T), which are located  
207 in the east and west of the 50 m combined bench slope, respectively); The 110 m composite  
208 bench slope. The field investigation found that 6 faults exist in the slope. The joints were  
209 extremely developed, resulting in the fractured rock mass. Additionally, the characteristics of  
210 fault and joints were listed in Table 1.

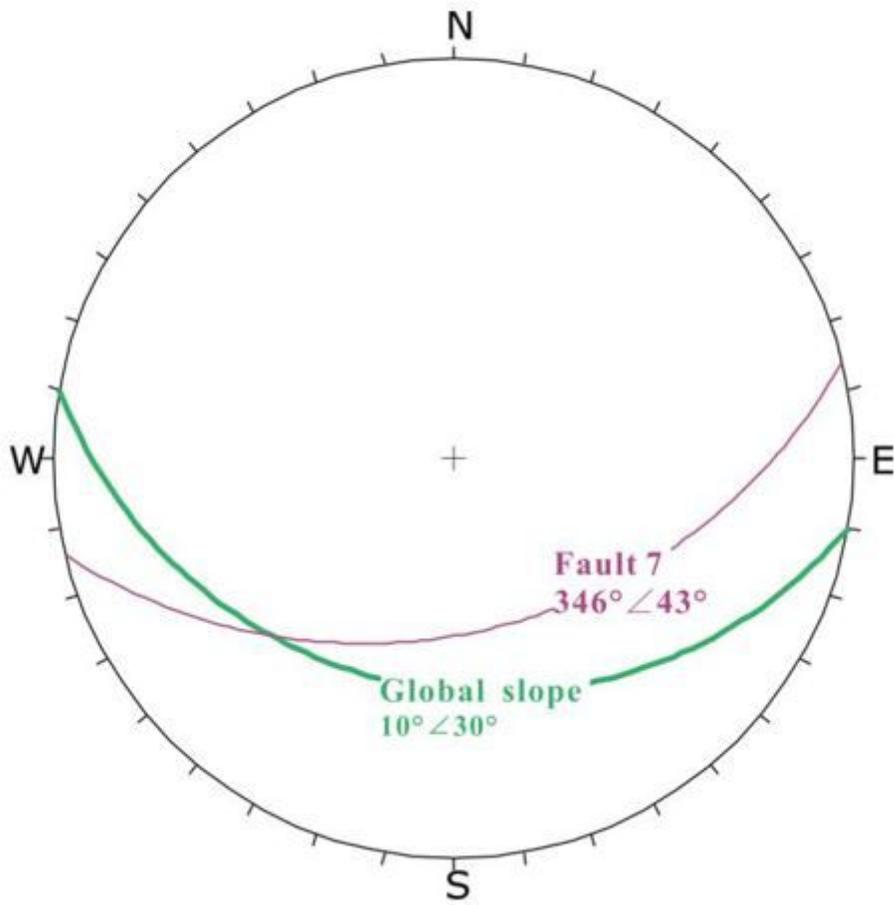
**Figure 3**

Stereonet of the Yangtaowu overall slope (global)

214 There develops a penetrating surface extending along foliation face and cleavage face  
215 within the overall slope. As shown in Fig. 3, it is found that the slope direction is  $10^\circ$  and the  
216 slope angle is  $30^\circ$ . The occurrence of fault F7 is  $346^\circ \angle 43^\circ$ , with an inclination crossing angle  
217 of  $24^\circ$  between F7 and the overall slope. The strike of F7 is consistent with the overall slope,  
218 but the dip angle of F7 is greater than that of the overall slope. As a result, the overall slope is  
219 basically stable.

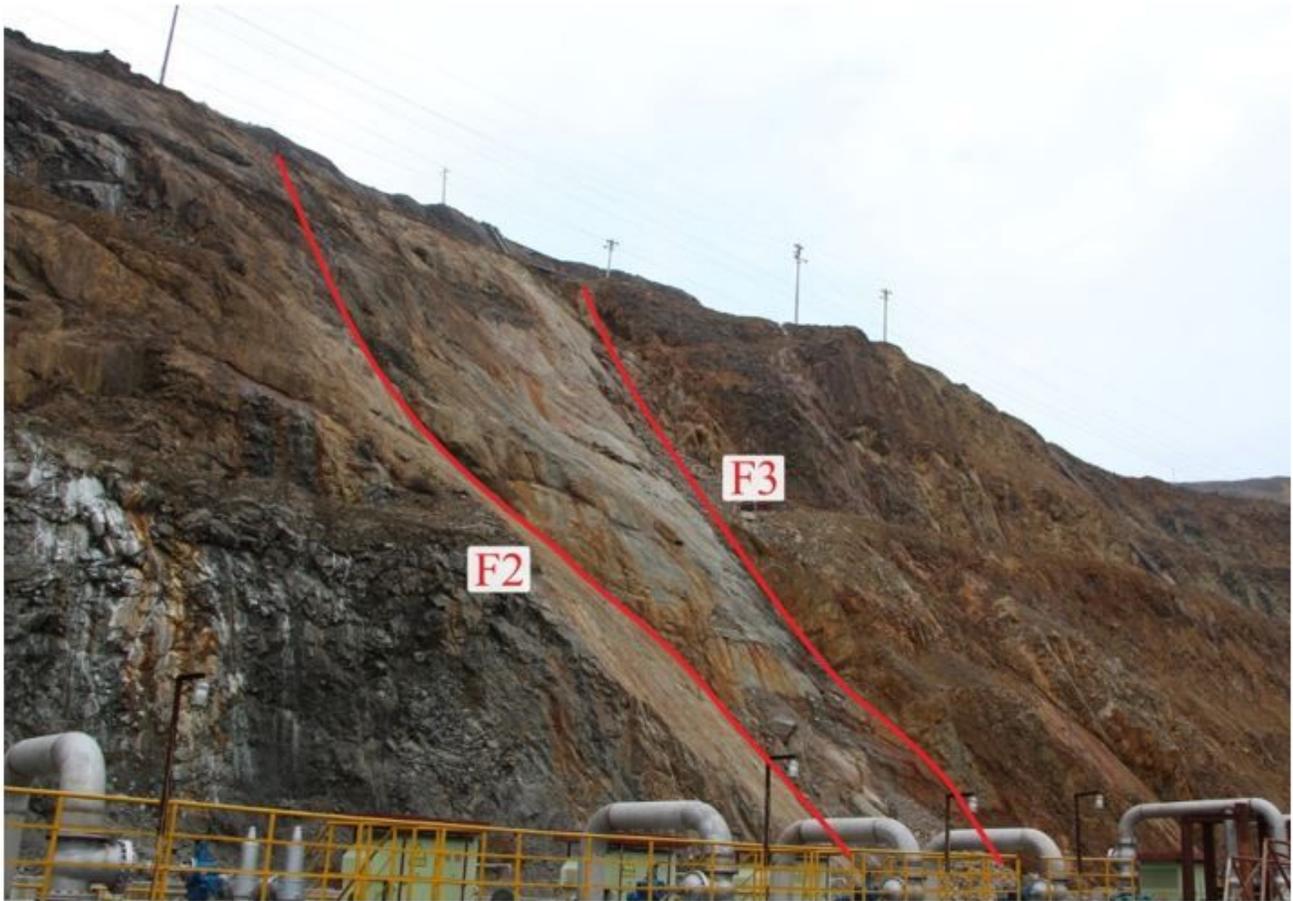
**Figure 4**

View of combined bench slope B (-10T) and the locations of F2 and F3

235 conduct stability analysis via precise evaluation in this paper. The location of B (-10T) is  
236 shown in [Fig. 4](#).

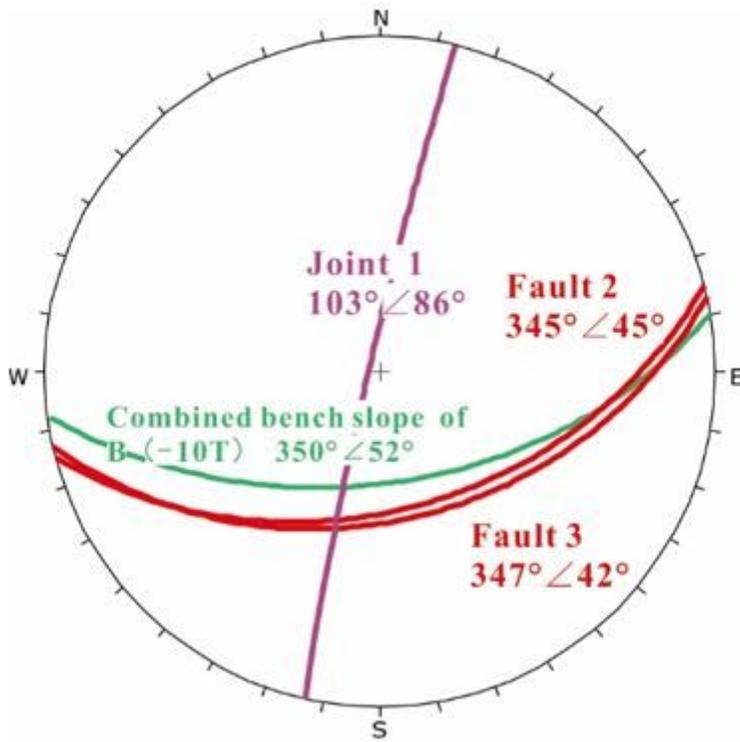
**Figure 5**

Stereonet of combined bench slope B(-10T) for global stability analysis

238 As the penetrating discontinuity of the slope, faults control the global stability of the B  
239 (-10T). It can be seen from [Fig. 5](#) that the slope direction of the B (-10T) is  $350^{\circ}$  and the slope  
240 angle is  $47^{\circ}$ . The occurrence of fault F2 is  $345^{\circ}\angle 45^{\circ}$ , with an inclination crossing angle of  $5^{\circ}$   
241 between F2 and B (-10T). The occurrence of fault F3 is  $347^{\circ}\angle 42^{\circ}$ , with an inclination  
242 crossing angle of  $3^{\circ}$  between F3 and B (-10T). The strikes of F2 and F3 are both consistent  
243 with the B (-10T), but the dip angles of F2 and F3 are smaller than that of the B (-10T).  
244 Therefore, it is likely for the B (-10T) to have single plane slip failure occurred along F2 or  
245 F3. Besides, there is also a group of penetrating joint J1 inclining to the inside of the B (-10T),  
246 with the occurrence of  $103^{\circ}\angle 86^{\circ}$  and an inclination crossing angle of  $113^{\circ}$  between J1 and B

247 (-10T). Although the B (-10T) is stable under the influence of the penetrating joint J1, it  
248 provides the cutting boundary for slope, increasing the possibility of single plane slip failure.  
249 From the above, it is highly possible for the B(-10T) to take J1 as the cutting boundary and  
250 have the single plane slip failure occurred along F2 or F3.

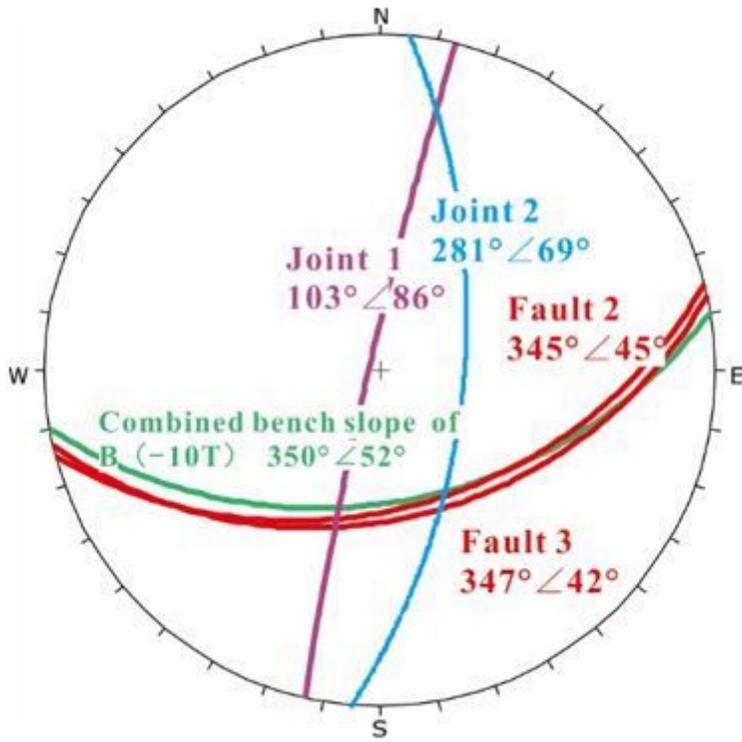
Figure 6

Stereonet of combined bench slope B(-10T) for local stability analysis

254 As shown in Fig. 6, the local stability of B (-10T) is controlled by fault F2, F3,  
255 penetrating joint J1 and non-penetrating joint J2. The slope direction is  $350^\circ$  and the slope  
256 angle is  $47^\circ$ . The B (-10T) has faults F2 and F3 developed. And the occurrence of fault F2 is  
257  $345^\circ \angle 45^\circ$ , with an inclination crossing angle of  $5^\circ$  between F2 and B (-10T). The occurrence  
258 of fault F3 is  $347^\circ \angle 42^\circ$ , with an inclination crossing angle of  $3^\circ$  between F3 and B (-10T).  
259 The strikes of F2 and F3 are both consistent with the B (-10T), but the dip angles of F2 and  
260 F3 are smaller than that of the B (-10T). As a result, it is possible for the B (-10T) to have  
261 single plane slip failure occurred along F2 or F3. There is also a group of penetrating joint J1  
262 inclining to the inside of the B (-10T), with occurrence of  $103^\circ \angle 86^\circ$  and an inclination

263 crossing angle of  $113^\circ$  between J1 and B (-10T), and a group of non-penetrating joints J2,  
264 with occurrence of  $281^\circ \angle 69^\circ$  and an inclination crossing angle of  $69^\circ$  between J2 and B  
265 (-10T). It is easy to conclude it is impossible for the local slip failure to occur along J2 for  
266 joint angle of J2 ( $69^\circ$ ) is greater than the slope angle ( $47^\circ$ ).

267 Although the B (-10T) is locally stable under the influence of the non-penetrating joint  
268 J2, it provides the cutting boundary for slope, increasing the possibility of single plane slip  
269 failure along fault F2 and F3. From the above, it is highly possible for the B(-10T) to take J2  
270 as the cutting boundary and have the single plane slip failure occurred along F2 or F3. And  
271 the local stability is similar to the global stability of B(-10T).

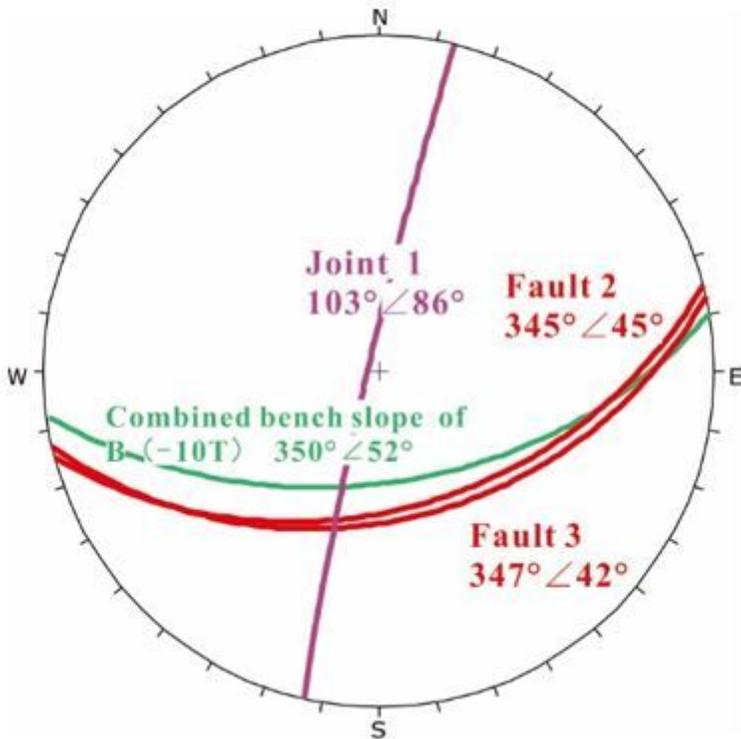
**Figure 7**

Stereonet of bench slopes B(-10T)-U and B(-10T)-D for global stability analysis

277 Foliation has developed within the B(-10T)-U and B(-10T)-D, in which there are two  
278 penetrating faults (i.e. F2 and F3) developing and extending along the foliation. F2 and F3  
279 have a similar occurrence with the foliation. From the analysis of stereographic projection

280 (Fig. 7), it is similar to the failure mode of B (-10T), B (-10T) -U and B (-10T) -D are both  
281 likely to be cut off by joint J1 and have the single plane slip failure occurred along fault F2 or  
282 F3.

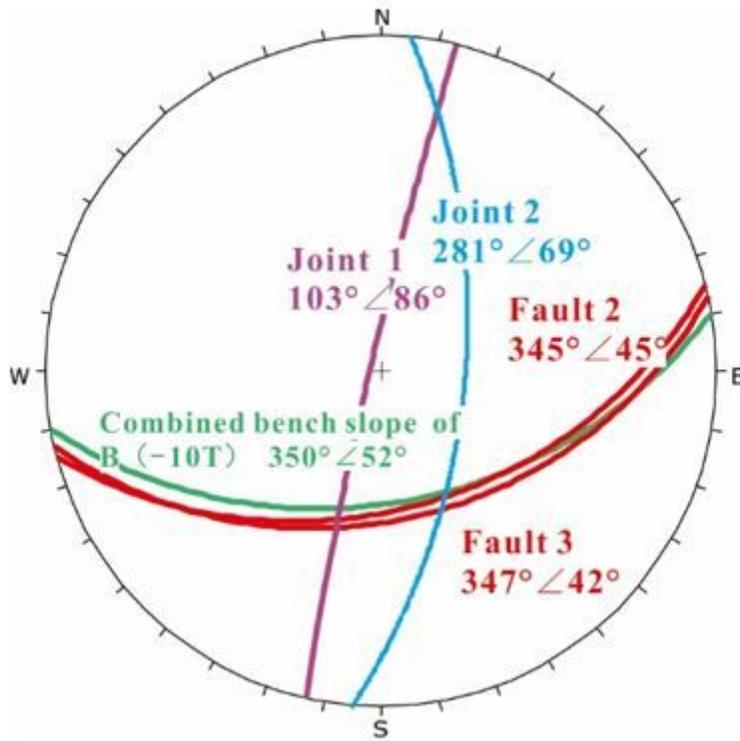
**Figure 8**

Stereonet of bench slopes B(-10T)-U and B(-10T)-D for local stability analysis

284 Fig. 8 shows the local stability of B(-10T)-U and B(-10T)-D is controlled by fault F2,  
285 fault F3, penetrating joint J1 and non-penetrating joint J2. And the local stability of bench  
286 slope is similar to that of global stability, that is, B (-10T) -U and B (-10T) -D are both likely  
287 to be cut off by joint J2 and have the single plane slip failure occurred along fault F2 or F3.

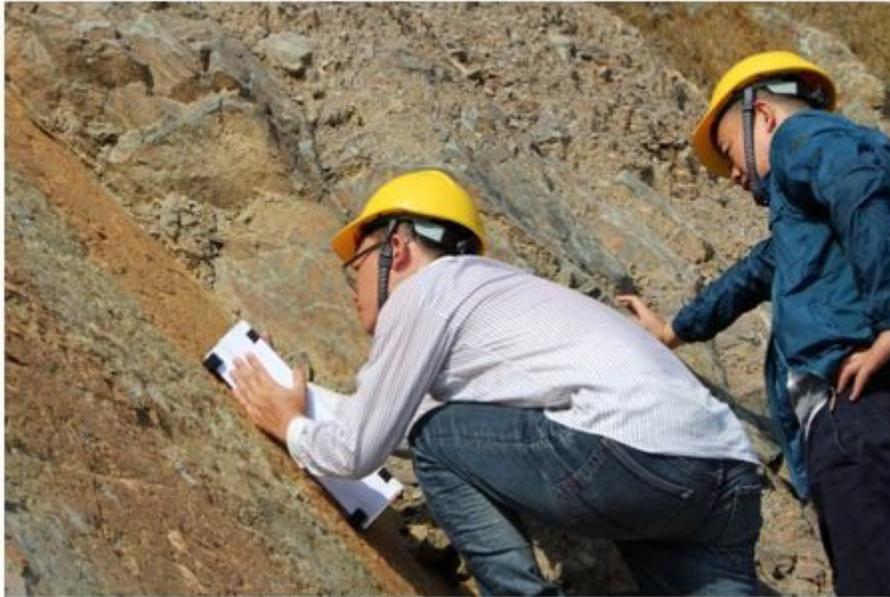
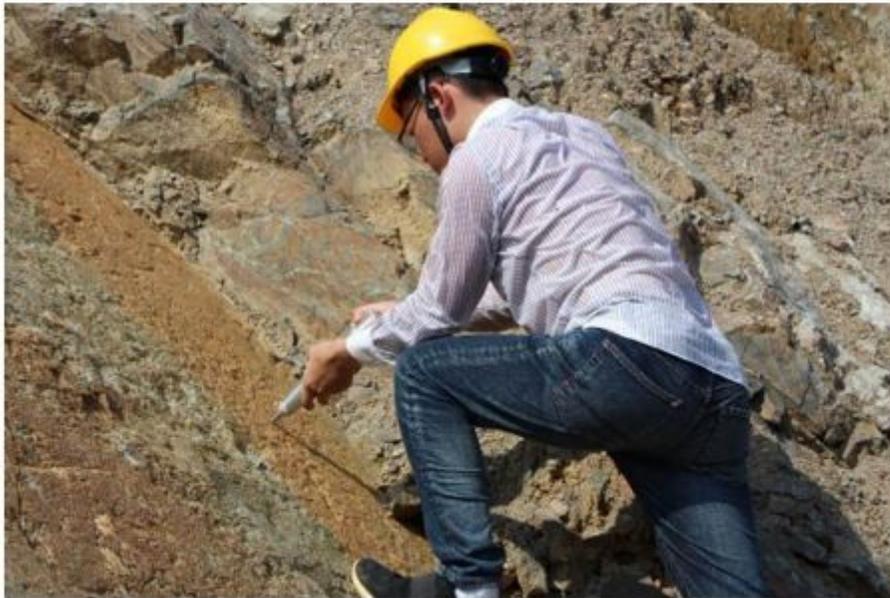
**Figure 9**

Measurement of sliding surface (a) rough joint profiles (b) rebound value

297 In the field, the measuring lines were uniformly arranged with 10cm as the interval along  
298 the inclination direction on the surfaces of fault F2, and 35 surface contour curves of 40 cm in  
299 length were plotted using the profilometer (as shown in Fig. 9a) (Yong et al., 2018b). The  
300 recorded joint profiles are tabulated in Table 2. A large-scale engineering scanner was used to  
301 scan the drawings of the contour curves of the discontinuity and convert them into picture  
302 format texts.

303 Based on the morphological filtering denoising and image normalization method (Yong  
304 et al., 2017), MATLAB was used to extract the scanning drawing of the contour curves of the  
305 discontinuity according to the gray value. Using the relationship between the actual length of  
306 the discontinuity and the size of the digitized matrix of the graph, the coordinate data of each

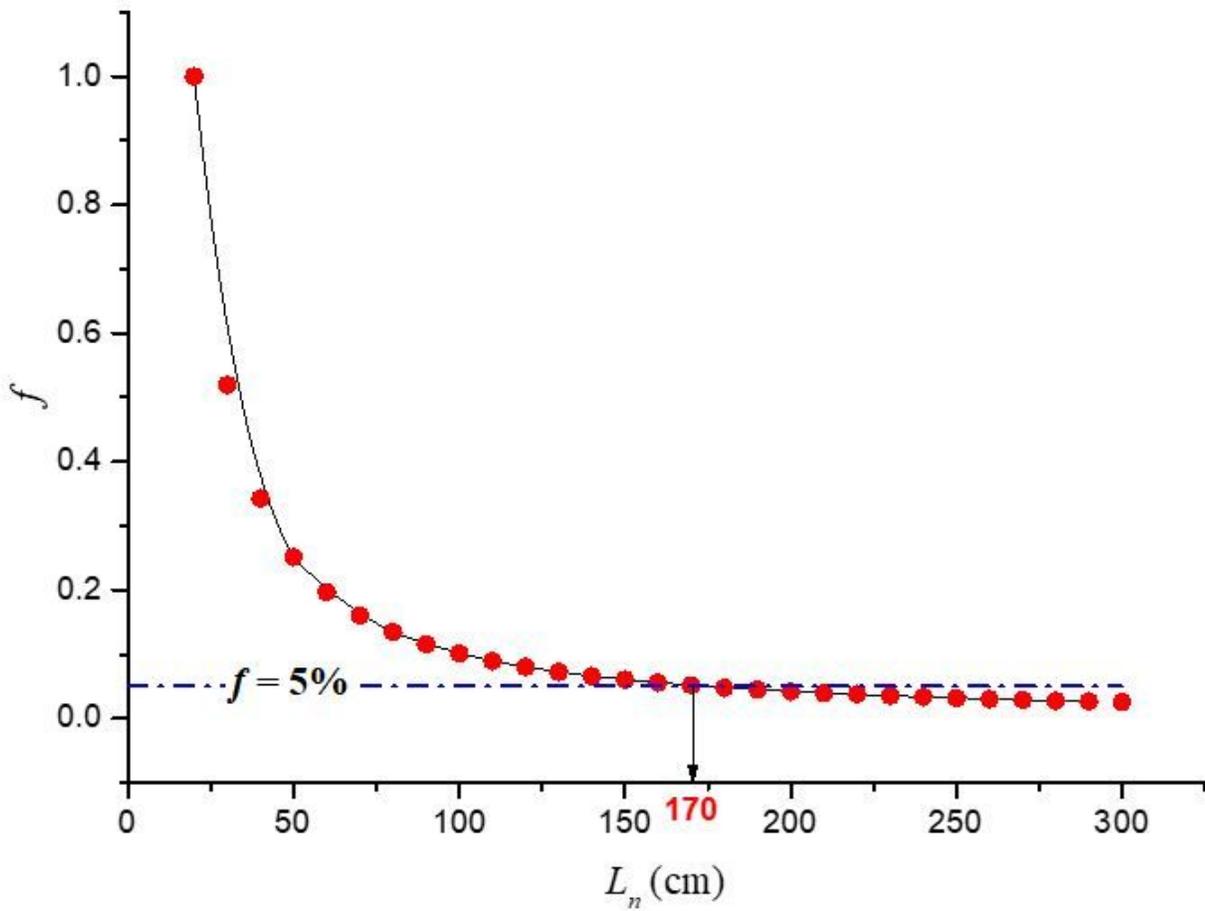
Figure 10

Ln-f relation curve of fault F2

325 In previous studies, the scale effect of joint roughness was found by many researchers.  
326 JRC generally decreases with the increase of discontinuity size, and it remains stable when  
327 the sample size exceeds a certain length (Fardin et al., 2001). The size is called the stable  
328 threshold length of JRC, which is labeled as  $L_n^*$ . Defining  $f$  as the coefficient of JRC size  
329 effect when sampling length is  $L_n$  (Du et al., 2015). The relation curves between  $f$  and  $L_n$  of  
330 fault F2 are plotted in [Fig. 10](#).

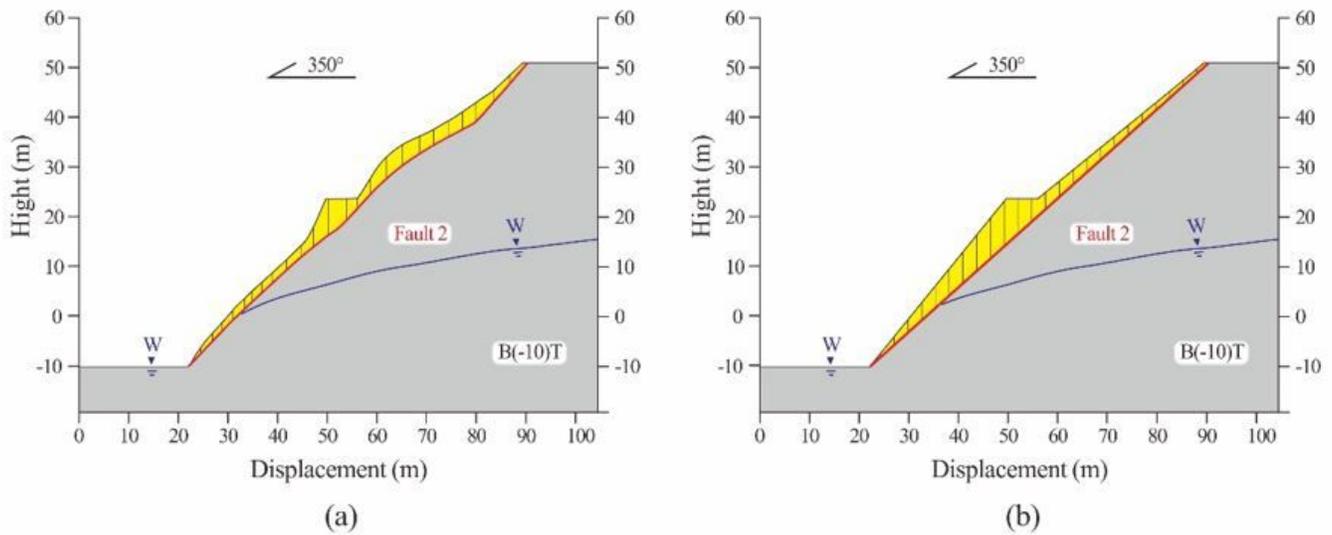
Figure 11

B (-10T) calculation models for the first evaluation (a) Precise calculation model (b) Generalization calculation model

368 The calculated results illustrate that the safety factors of B(-10T) are both less than 1.05  
369 under the most unfavorable condition, for both the precise or the traditional generalized  
370 evaluation method. The evaluation results are consistent with each other. The slope B(-10T) is  
371 unstable and will fail under the most unfavorable working conditions.

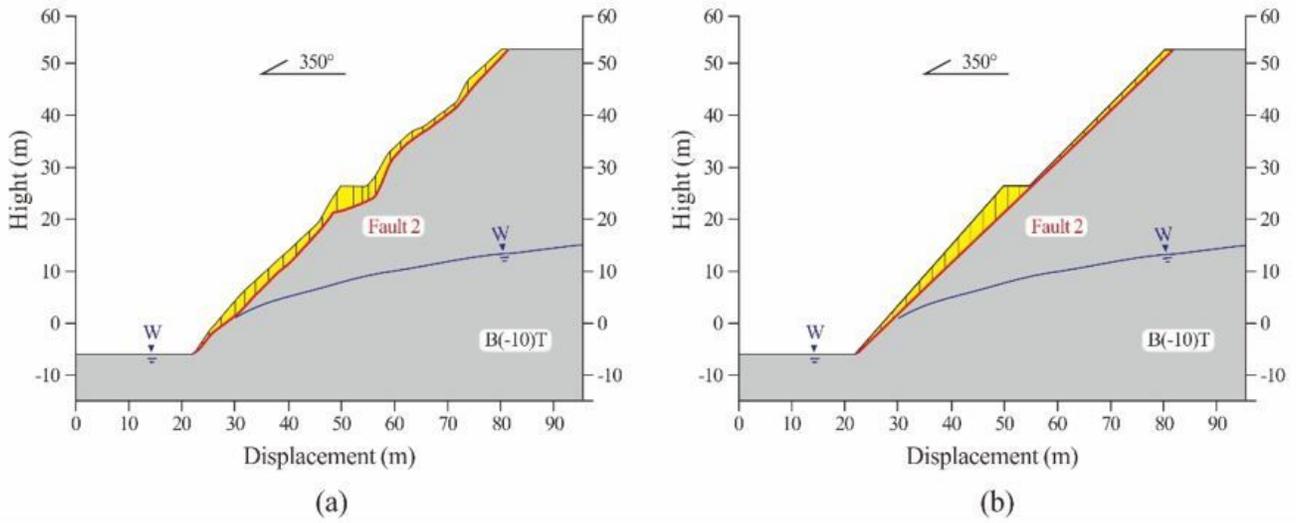
Figure 12

B (-10T) calculation models for the second evaluation (a) Precise calculation model (b) Generalization calculation model

376 After the first evaluation, the slope surface of B (-10T) had changed and the potential  
377 slip surface had turned from fault F2 to F3. In order to ensure the safety of life and property, it  
378 is necessary to evaluate the stability of B(-10T) again. The calculating geometry model was  
379 obtained as shown in [Fig. 12a](#). The generalization calculation model is shown in [Fig. 12b](#). The  
380 stability of B(-10T) was also analyzed under the most unfavorable conditions by the  
381 traditional generalized evaluation method and the precise evaluation method. The calculated  
382 safety factors are shown in [Table 7](#).

383 The results of the second stability calculation show that the calculated safety factor of the  
384 precise evaluation method is 1.061, greater than 1.05. The stability is weak, but the slope will  
385 not fail without any other influences. While the calculated safety factor of the traditional  
386 generalized evaluation method is 0.904 and the failure must occur. The evaluation results of  
387 two methods deviate from each other. Actually, the slope of B(-10T) was stable at that time,  
388 which reflected the accuracy of precise evaluation method again.

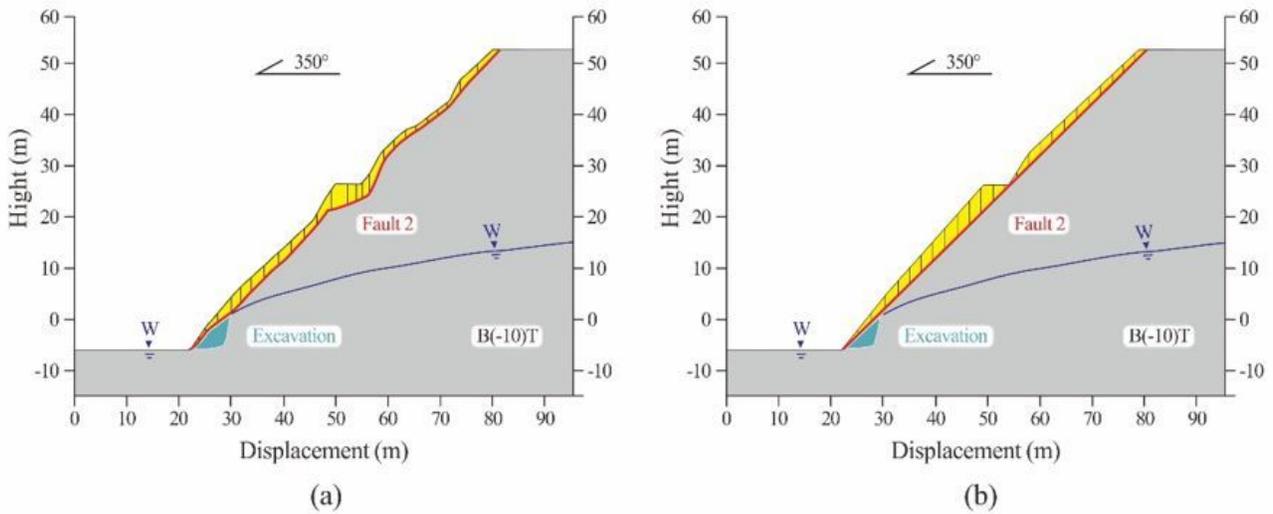
Figure 13

B (-10T) calculation models for the third evaluation (a) Precise calculation model (b) Generalization calculation model

389 However, the precise evaluation result is quite close to 1.05, which means B(-10T) is  
390 vulnerable to other influences, resulting in the slope failure. To eliminate the threat of  
391 potential sliders on the safety of construction personnel and equipment at fixed pumping  
392 stations, on March 15, 2016, slope workers planned to cut the lower part of the B(-10T) by  
393 blasting. The third stability evaluation was carried out. The geometric model, calculation  
394 parameters and calculation method adopted were same as the second evaluation. The  
395 calculation models are shown in [Fig.13](#), and the third evaluation results were shown in [Table](#)  
396 [7](#).

397 [Table 7](#) indicates that experiencing blasting cutting, the safety factor of B(-10T),  
398 calculated by the precise evaluation method, reduces to 1.026. It indicates that the slope failed  
399 after the excavation. In fact, the second large-scale slide of B(-10T) occurred after unloading  
400 (i.e. B2, in brief), the sliding area was up to 1035 m<sup>2</sup>, and the slip body was 3200 m<sup>3</sup>. The  
401 comprehensive comparison of stability calculation results of B(-10T) before and after  
402 excavation (i.e. the second and the third evaluation results) with the actual stability was made,  
403 and it can be deduced that, compared to the existing evaluation method, the precise evaluation  
404 method is more accurate in calculating the safety factor, and it is able to reflect slope stability  
405 more truthfully.

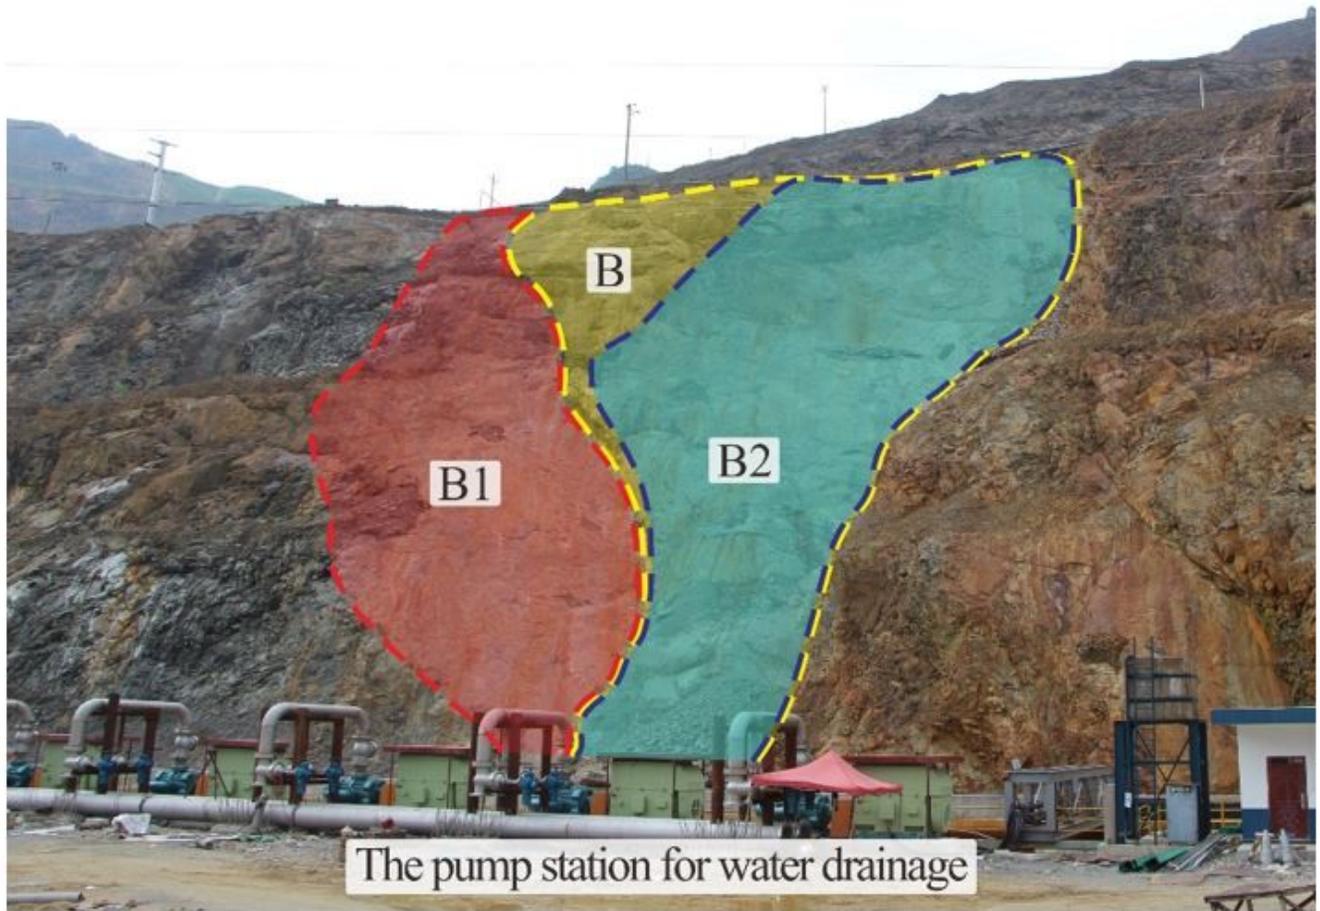
Figure 14

Locations of slopes B1, B2 and B

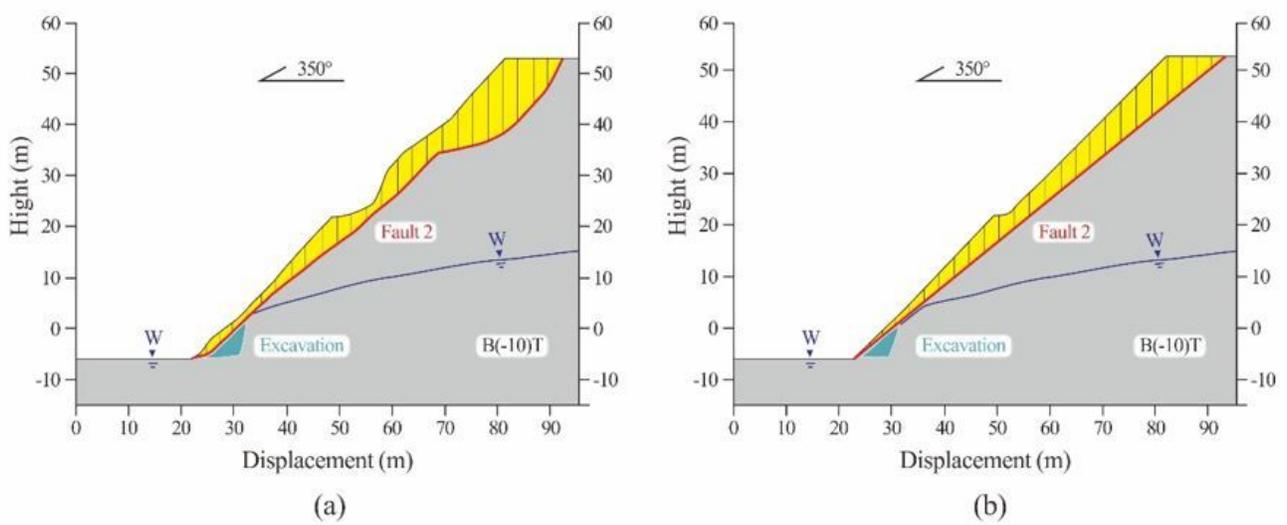
Figure 15

B (-10T) calculation models for the fourth evaluation (a) Precise calculation model (b) Generalization calculation model

414 According to the field investigations, it is very likely that the residual slope B will be cut  
415 off by J1 as the cutting boundary, and have the single plane slip failure occurred along the  
416 fault F2. The calculation model of the residual slope B is shown in Fig. 15. The results of the  
417 stability calculation are shown in Table 7.

418 As Table 7 illustrates that the safety factor of the residual slope B is greater than 1.05  
419 even under the most unfavorable working conditions, with weak stability. But it will not fail if  
420 only influenced by the current impact factors. Under the same conditions, the calculated result  
421 of the existing generalized method is 0.967, less than 1.05, which indicates that the residual  
422 slope B has already failed. In fact, the residual slope B is still in a stable state at present and  
423 there is no incident of landslide, which is consistent with the precise evaluation result and  
424 contrary to the generalization evaluation results. The comparison between the prediction and  
425 the actual situation further shows the correctness and superiority of the precise evaluation  
426 method in calculating the safety factor of slope.
