Environmentally Sustainable Wireless Track Recording Vehicle Strategy Towards Improving the Safety Standards

Research Article

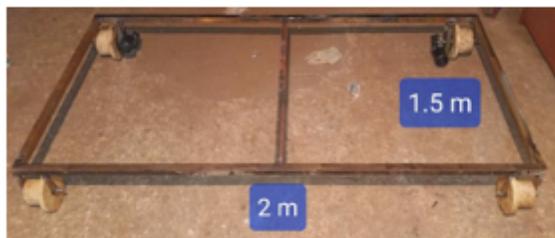
Figure 1

Metallic Frame of TRV

The developed TRV is designed on a metallic frame having length 1.5 m and width 2 m as shown in the figure 1. Such that the frame can withstand a weight of 5kg or more. The wheels of the TRV are spaced at

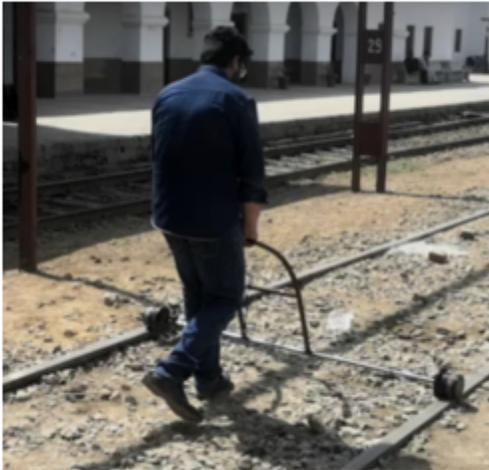
Figure 3

Handheld TRV for testing various wheelsets

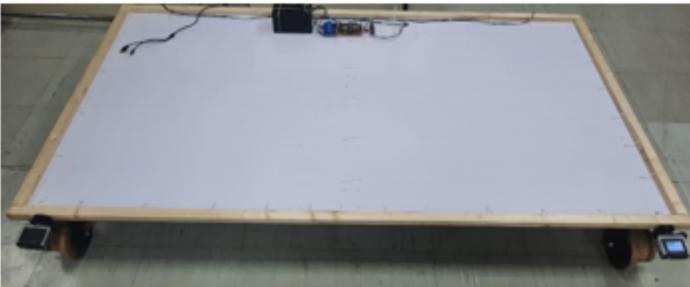
Figure 4

Wirelessly Operated TRV

The final design as shown in figure 4, had two drive wheels (that were connected with a 120 rpm, 12V and 2A DC motor) and 2 revolving wheels.

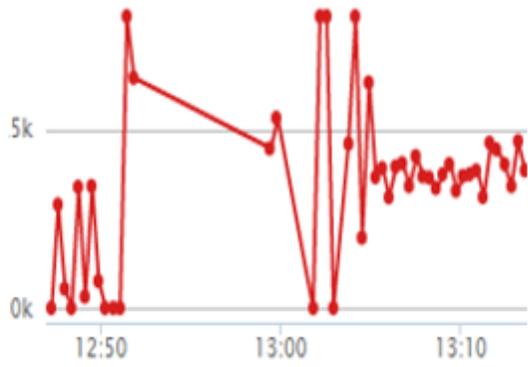
Figure 9

ADXL335's Y Axis data

Whereas the damage diagnosis is performed when the Y-axis of ADXL335 (as shown in figure 9) crosses a specific threshold, which triggers a signal to the thingspeak, specifying the damage.

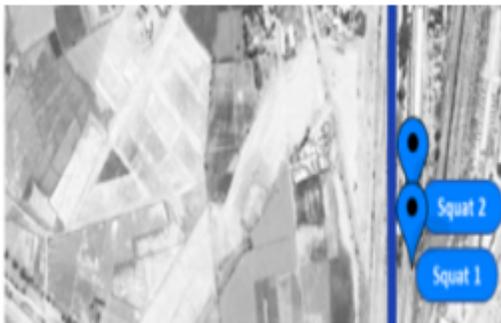
Figure 10

Google Map App Developer Platform

The trigger is sent along with the directions computed from the GPS module that is attached to the node MCU and is layered on the google maps using Google Map App Development Platform (figure 10).

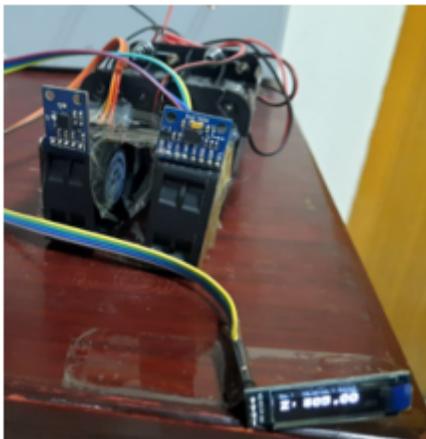
Figure 11

Accelerometer Validation Rig

The accelerometers ADXL335 and ADXL345 were mounted at an exactly same position on a working DC motor as shown in the figure 11, the comparative readings of the both sensors in table 2:

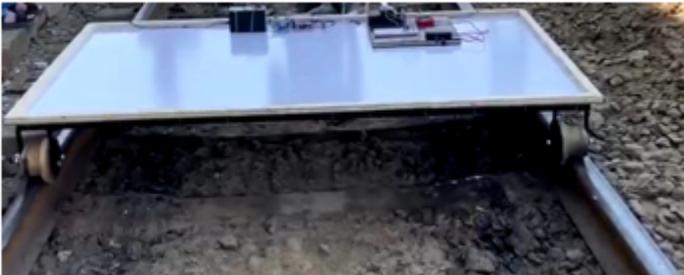
Figure 13

TRV running on an Auxiliary Track

In order to validate the ABA methodology, two ADXL335 are mounted on the developed TRV. One is mounted of the vehicle's axle and other is mounted in the center of the vehicle as shown in figure 12. The vehicle is then moved on an auxiliary track of 126 ft (as shown in the figure 13) consisting of a single squat at a speed of 5km/h.

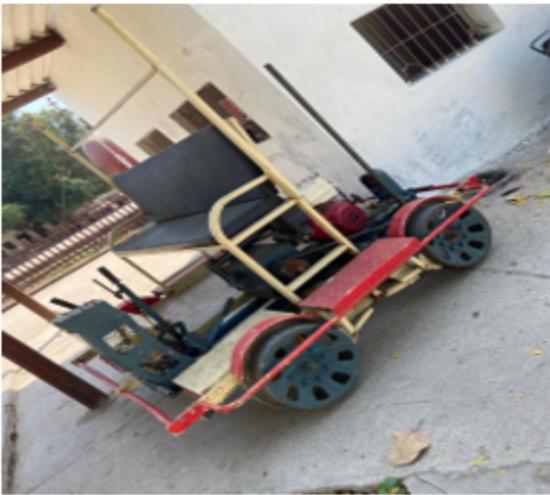
Figure 16

Motorized TRV

This vehicle is designed as per Pakistan Railways standards for substituting the motorized track recording vehicle that detects the damages using visual inspection (figure 16).
