An Investigation Into the Cause of Road Failure Along Sagamu-papalanto Highway Southwestern Nigeria

Abstract

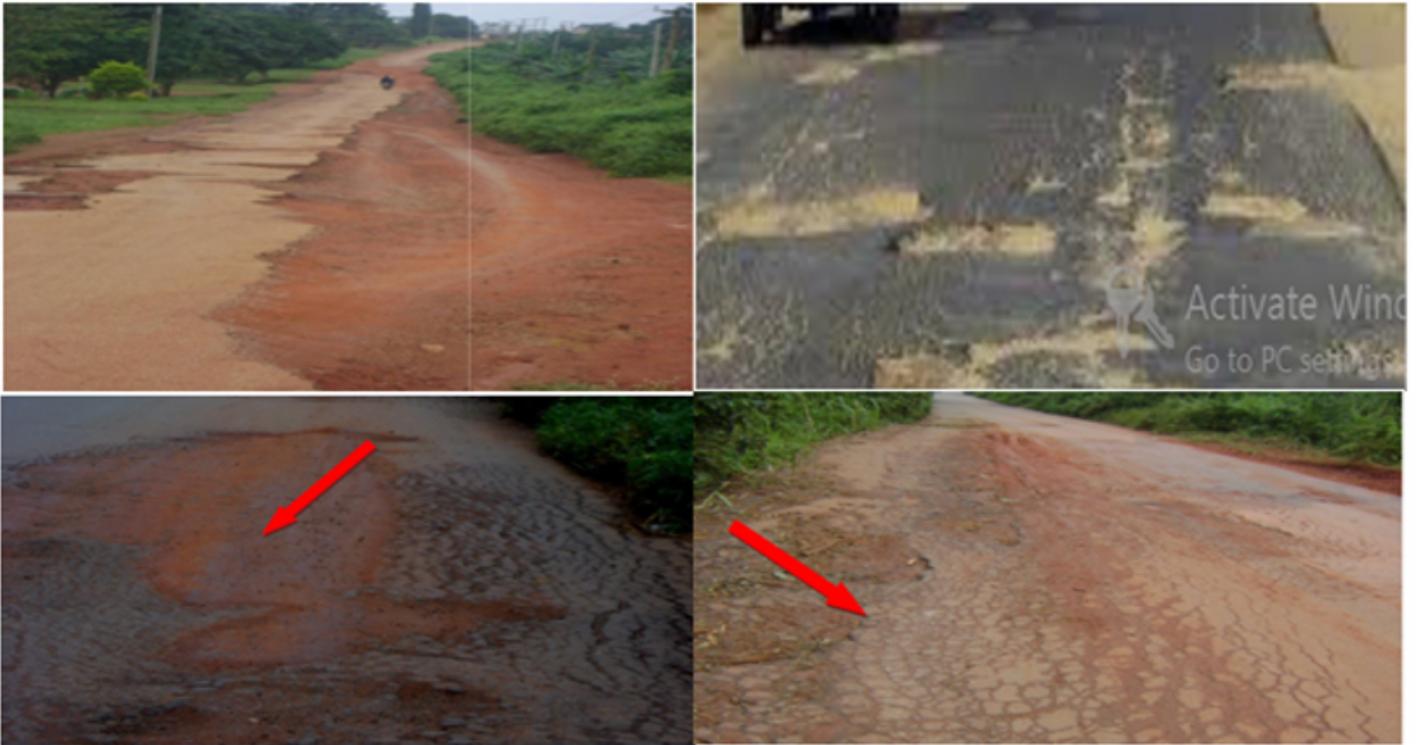
Figure 1

showing road failure in the study location

As at the time of this study, a significant portion of the road orientation and alignment has failed. The distress was obvious in different forms which include; rutting, raveling, cracks and pothole (Fig.1). In some segment of the road; corrugation, potholes and cracks are occasionally up to 1.5-2meters large and 1m deep (Fig. 1). The road under investigation is totally without drainage provision and facilities. The various types of failure encountered during investigation at different locations are outlined in Table 1. The objectives of this study is to employ the use of combined geophysical and geotechnical methods

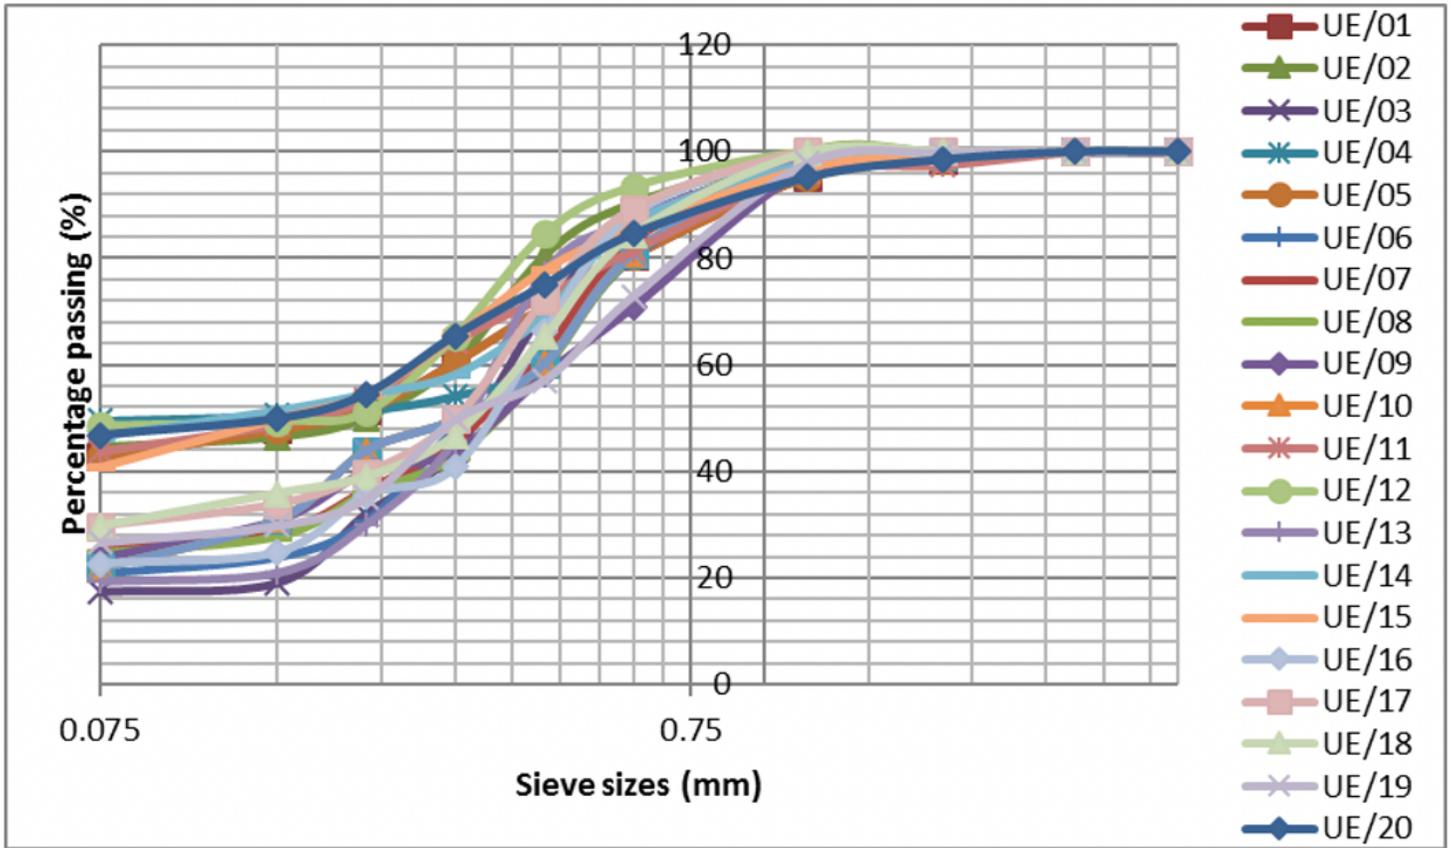
Figure 3

stacked grain size distribution for samples UE1-20.

The results of the grain size distribution are summarized in Table 2 and Fig. 3. The grain size analysis is important in determining the strength of the soil and also determine the particle size distribution of the studied soils (Naresh and Nowatzki 2006). The results show the percentage amount of clays, silts, fines, sand and gravel ranged from 12.1-27.5%, 6.1-15.8%, 12-38.5%, 49.4-80.1% and 4.7-20.2% for subgrade, 18.5-39%, 7.4-37.2%, 30.2-62.8%, 36-63.4% and 3.2-13.2 for subbase course and 26.2-48.9%, 11.2-16.4, 36.1-58.0%, 31.7-61.3% and 2.7- 25.9% for base course (Table 2 and Fig. 3). The Federal Ministry of Works and Housing (1997) recommends subgrade soils to possess less than 35% amount of fines. The results obtained in comparison with FMWH (1997) shows that four soil samples did not meet up the specification. It can be inferred from the result that the soils are susceptible to frequent shrinkage and swelling potentials during the various wet and dry seasons which are usually the characteristics of the environmental and climatic condition of the study location. The high percentage of fines had been linked to the predominance of clay which feasibly exerts a dominant control on the mass behavior of soil which makes it mechanical unfit. AASHTO (1993) classification system is based on the particle sizes, liquid limit and plasticity index. According to the grouping, soils with less than 35% pass through the No.200 sieve are classified under A-1 to A-3, typically clayey soils whereas soils with more than 35% pass through the No. 200 sieve are classified under A-4 to A-7, typically granular soils. Also, most of the soil samples had a very high percentage finer than 0.0075 fraction that is >35%, which varied between 31.7% and 61.3% for base course and 30.2% and 62.8% for sub base and 12% and 42.9% for sub grade respectively. The results from the study shows that that 60% did not meet the requirement for subgrade soil while 40% meet the condition when compared with (underwood 1967) which states that subgrade soils have less than 35% fines. The group index is the parameter that gives an indication of the load bearing capacity within the AASHTO soil group. The resulting increase in the group index will cause decrease in the load carrying capacity. The results on the studied samples (Table 2) revealed that the soils are classified as A-26, A-24, A-2 and A-7 according to (AASHTO 1993). The soils in these groups are considered as clayey soils. The soils are grouped as fair to poor materials for road construction. The soils classified as A-2-7 soil on AASHTO soil classification is regarded as poorly graded and poor graded (GP) on USCS soil classification with group index of 0 (Gopal and Rao 2011). Therefore, they are unfit for use as subgrade, subbase and base road construction materials. The clayey soils are classified as fair to poor road materials, while the granular soils are classified as excellent or good road materials.

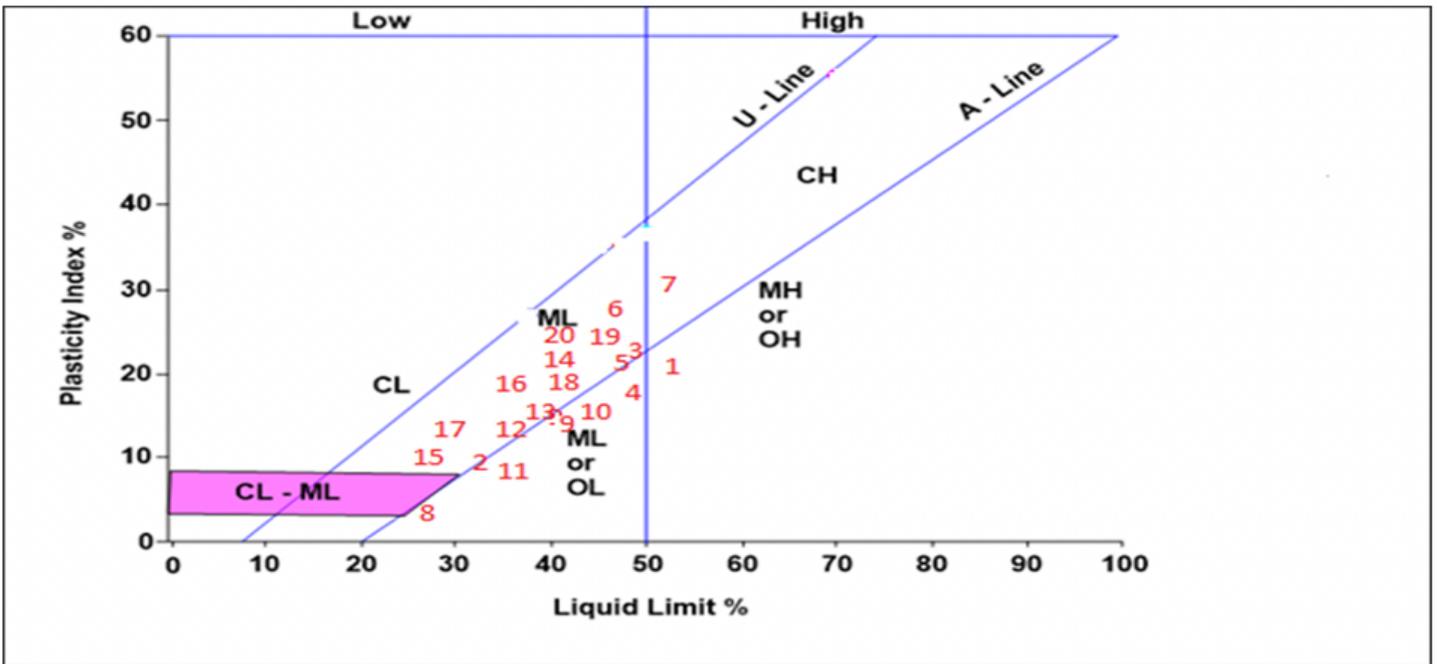
Figure 4

Plasticity chart of the studied soil samples (Casagrande 1974).

The Casagrande's plasticity chart (Fig.4) is also used soil classification (Casagrande 1947). The studied soil samples fall within the CI, CL and CH. These soils are grouped on the basis of their particle size distribution, liquid limit and plasticity index. Two of the studied soil samples are within the low plasticity (CL) whereas eighteen of the studied soil samples falls within the medium to high plasticity (CI) categories on the Casagrande's chart. The results revealed that 64% of the soils were plotted within the field of inorganic silts while 36% were plotted in the field of inorganic clays. Additionally, when the plasticity index lies between 20 and 35% then it satisfies the condition for high swelling potential and between 25 and 41% for a high degree of expansion (Gopal and Rao 2011). The plasticity index is a predominant factor used in the selection of materials for subgrade and subbase. It gives much detailed facts on the properties and behavior of clays in contrast to grain size data (Lambe 1951). Excessive plasticity often leads to fluctuations which arises from plastic flow upon the application of axle load (Adeyemi 1995; 2002). Soils with extremely high liquid limit are often prone to have low bearing capacity. Cassagrande (1947) stated that soil samples with low, medium and high plasticity will have low, medium and high compressibility respectively Table 3.

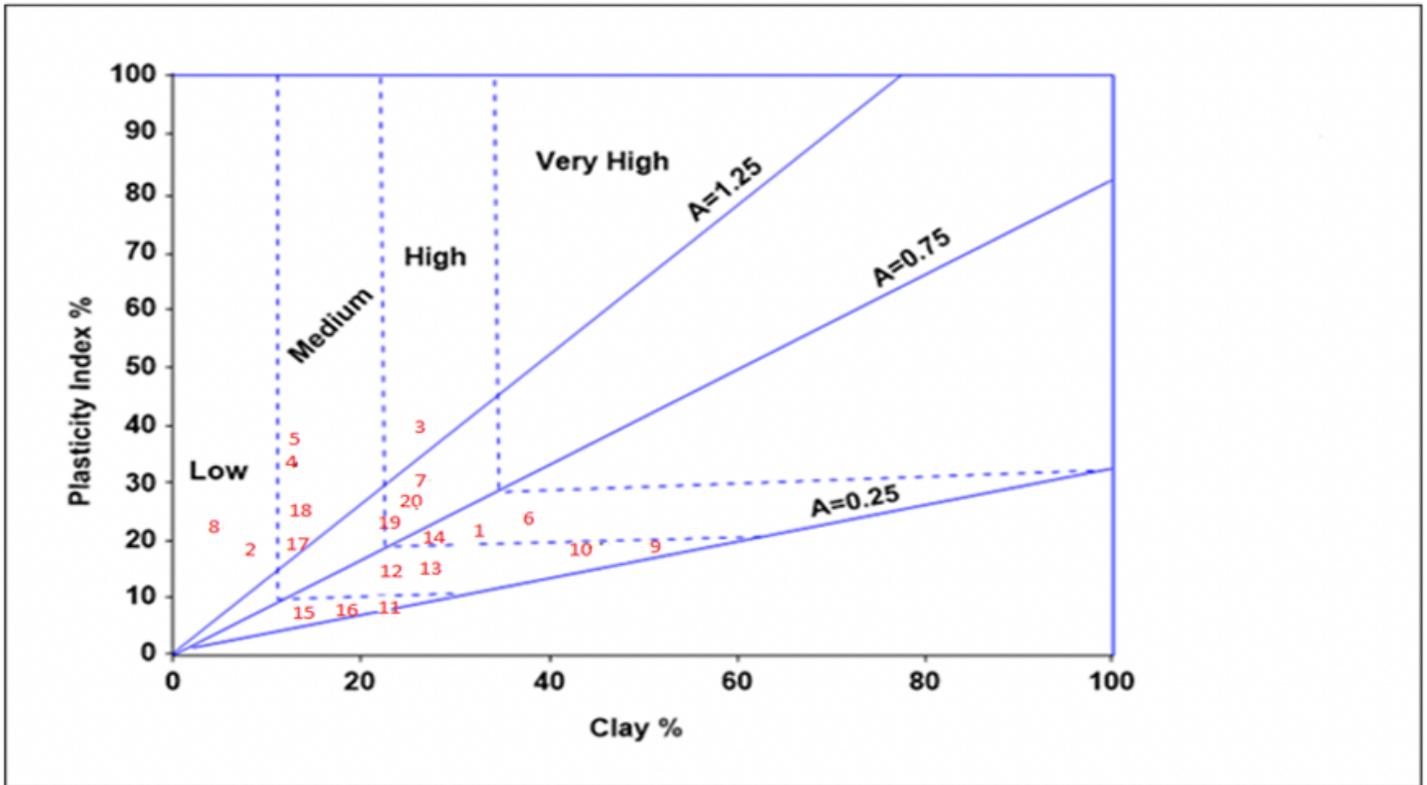
Figure 5

shows the activity chart of the studied soil (Lew 2010).

Activity of the soil results are summarized in (Table 2 Fig. 5). Clay activity of soils is obtained by integrating Atterberg limits and clay content into an exclusive parameter (Skempton 1953). The results of the percentage clay sized fraction and plasticity index were used to calculate the activity in order to determine the measure and the degree of likelihood of exhibiting colloidal behavior. This is linked to the geologic history and mineralogy of clays presents in the soils. The characteristics of clay soils are known by the physicochemical characteristics of the different constituents' minerals and by the relative

proportions of the minerals present (Olofinyo et al. 2019). The activity values from the studied soil ranges from 0.19- 2.17 (Table 2) which indicate active to inactive clays. Consequently, the studied soils have low – medium and negligible high expansion ability as derived from the activity chart (Fig. 5). Underwood (1967) proposed three classes of clay based on their activity which includes; the normal clays, active clays and inactive clays which ranges from 0.75-1.25, value greater than 1.25 and value less than 0.75. The activity less than 1 corresponds to kaolinite, while activity between 1 and 2 corresponds to illite and greater than 2 corresponds to montmorillonite (Skempton 1953). The results indicate that the predominant clay mineral present in the soil is kaolinite as eighteen samples location has clay activity values of less than one, which is inactivity and low moisture affinity.

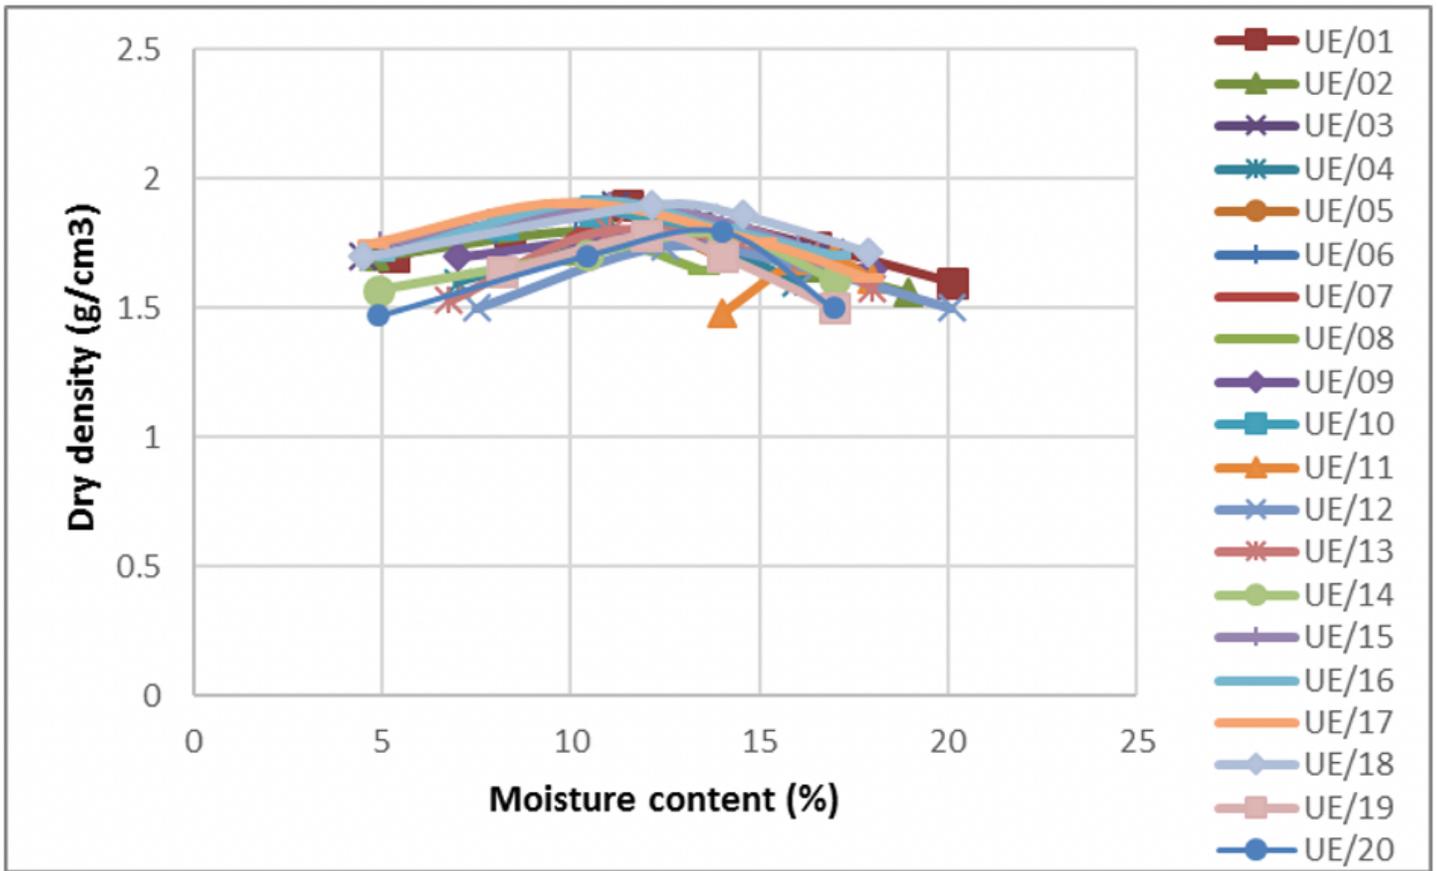
Figure 6

Stacked compaction curves for samples UE 1-20

The compaction curves for the studied soils are shown in Fig. 6. The Optimum Moisture Content varied between 12- 18%, 15- 24%, 12-17% for base course, sub base and sub grade respectively at the Maximum Dry Densities (MDD) of 1.65 -1.78g/cm³, 1.51- 1.67g/cm³ and 1.64- 1.74g/cm³ respectively Table 2. The MDD of the base course is less than the specified value (i.e.>/ 2.0g\cm³) in all the sample locations. It was revealed that five subgrade soils samples met the (FMWH 1997) specification which states that the MDD values should be above 1.70 g/cm³. The Nigeria general specification (1994) recommends that soils should be in the range of 1.50 -1.78 g/m³ for the MDD and optimum moisture content (OMC) of 8.56-12.02%. The implication is that the residual soils in the studied area have low bearing capacities due to its low OMC and MDD. The soils cannot be used as construction materials except the materials are well compacted and stabilized appropriately in order for void spaces in the soil to be removed; these will intermittently reduce the permeability and increase the strength of the soil materials. It is worthy to note that for any soils to be suitable as foundation materials such soil must be compacted above the MDD and the OMC values in order for its to give rise to the required strength that will withstand the impact of load and impede the inflow of water (Olofinyo et al. 2019). The results in comparison to Underwood (1967) revealed that the studied soil samples have fair to poor foundation attribute. This comparative low maximum dry density value is potentially responsible factor to the persistence incidence of road failure in the study area.

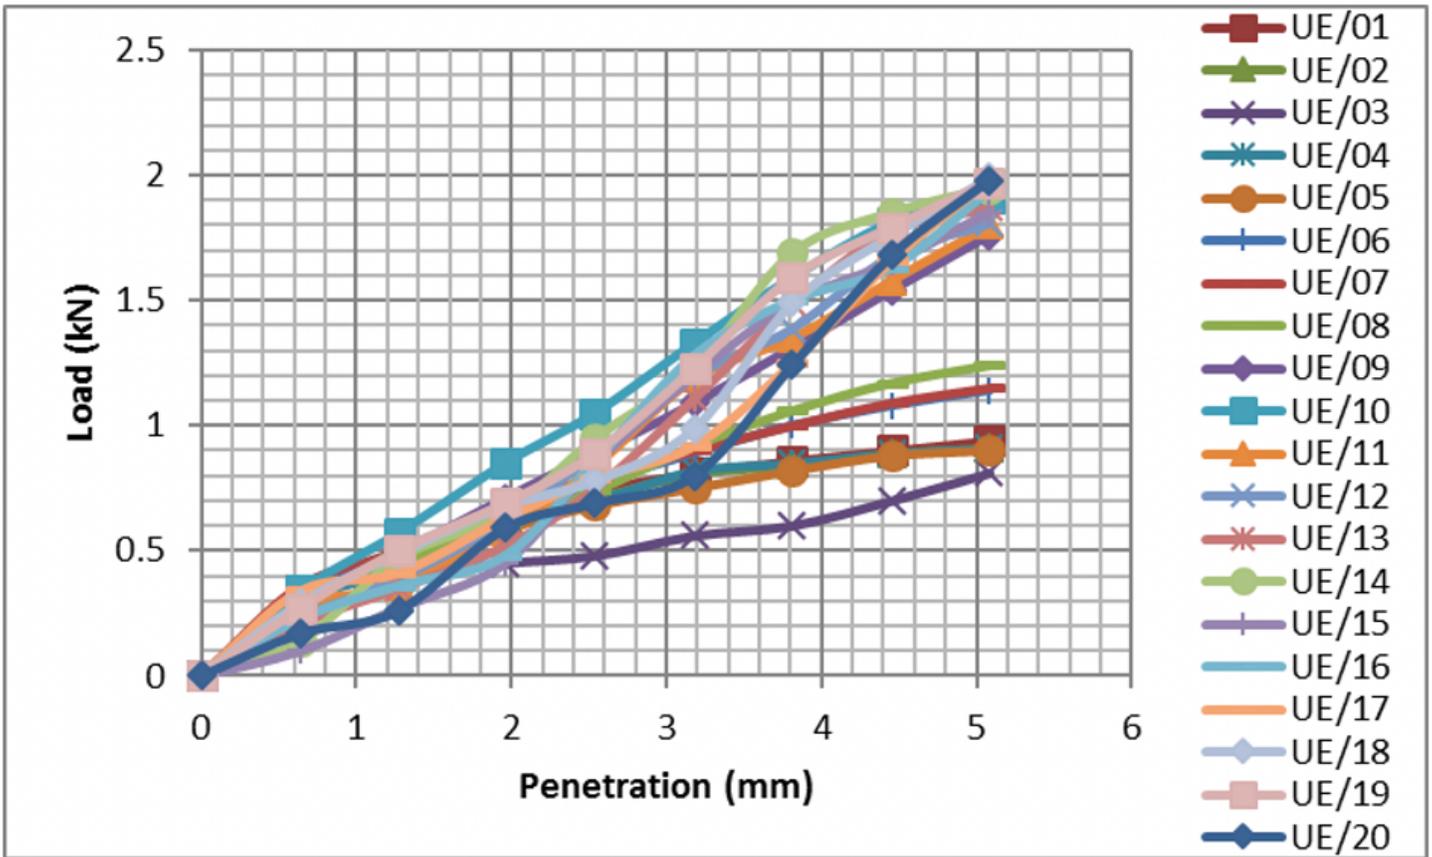
Figure 7

Stacked CBR curves for samples UE 1-20

The CBR curves for the studied soils are shown in Fig. 7. The California bearing ratio is usually used in evaluating the soils strength of subgrade, subbase and base course as road construction materials (Wignall 1999; Adeyemi 2002; Adeyemi 2013; Olofinyo et al. 2019). The CBR values for the sample locations is in the range of 3 - 5% for base course, 4- 8% for subbase course and 3-12% for subgrade (Table 2). These results fell below the maximum of 80% recommended by the (FMWH 1997). The recommended CBR value of >/5% for subgrade was met in some location. The implication of these results is that the soils are of low strength and for the strength of the soil to be increased, soil improvement methods would have to be employed before been used as road construction. (FMWH 1997) proposed that California Bearing Ratio (CBR) should be greater than 10% for subgrade materials. The results revealed that the CBR values of some soils are lower than the recommended value. The corresponding low values of CBR are partly responsible for the failure of highway pavement in the study area.

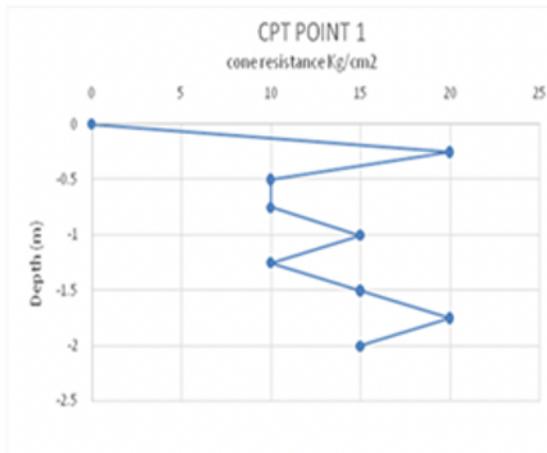
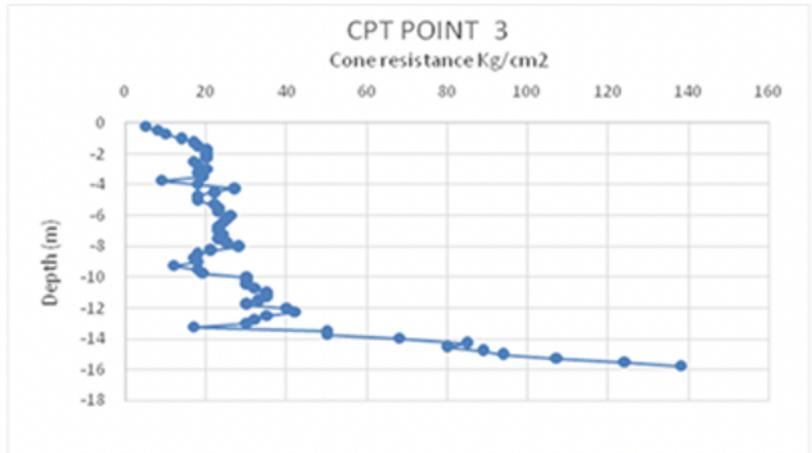
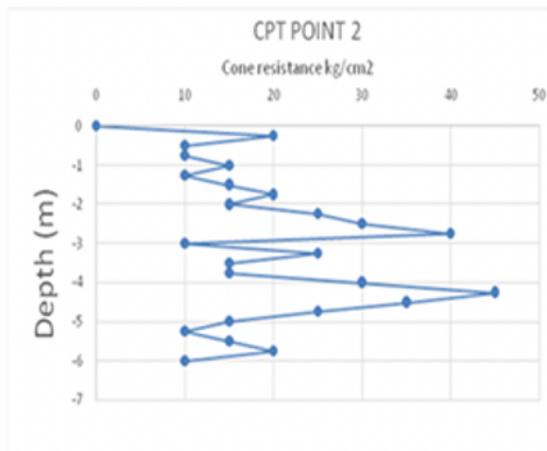
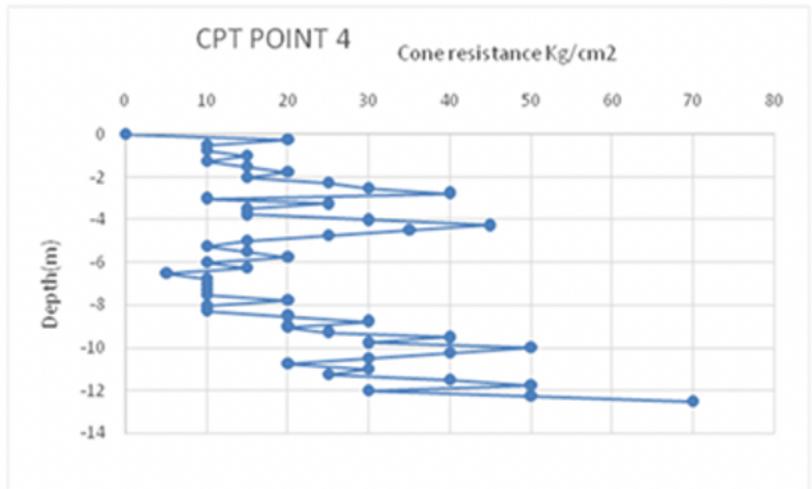
Figure 8

CPT plot for point 1 along profile 1

CPT plot for point 3 along profile 3

CPT plot for point 2 along profile 2

CPT plot for point 4 along profile 4

showing CPT plots for the studied locations.

The Cone Penetration Test (CPT) curves for the studied soils are shown (Fig.8) and the results of the CPT are shown in Table 7. The test was carried out to determine the strength of near surface materials and also access the in situ strength of the soil. The results revealed a low cone resistance value which indicates clayey sand material for sampling points 1, 2, 3 and 4. The linear natures of the curves in sample point 3 and 4 as shown in (Fig. 8) revealed that the subsurface materials offer no resistance to the driven cone when compared to the curve plotted for sample point 1. The CPT depth values for the locations are in the range of 2-16m. The depth of penetration that offers no resistance as shown in (Fig. 8) shows that the area is unfit for erecting foundation. Erecting foundation on the subgrade soil without applying the necessary treatment would result to the soil collapsing under an imposed load. The low value of the shear strength also revealed that the materials are undesirable as subgrade materials for road pavement. The implication of this is that the materials will expand and contract under diverse weather condition.

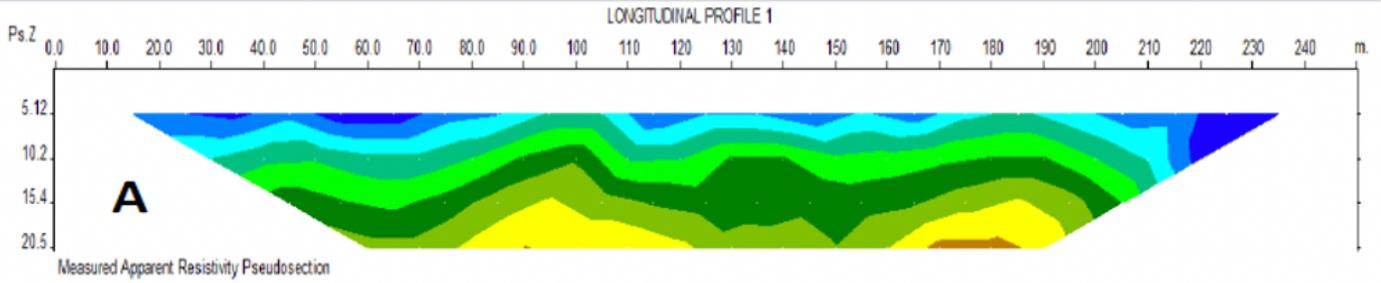
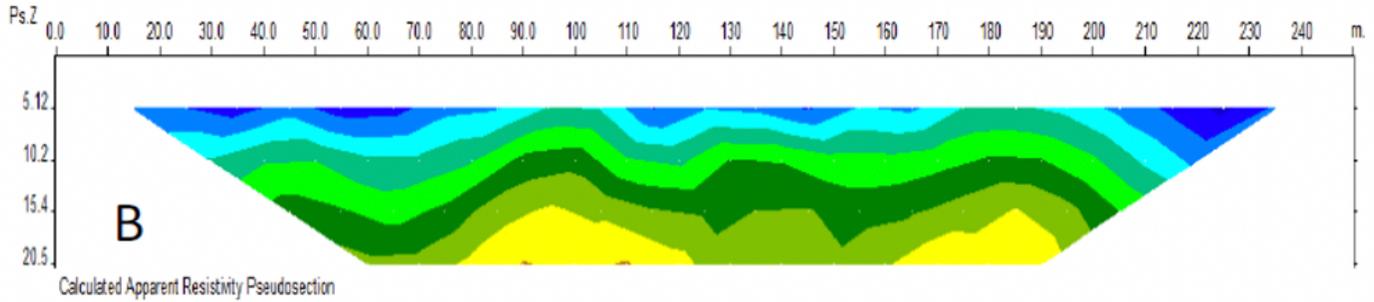
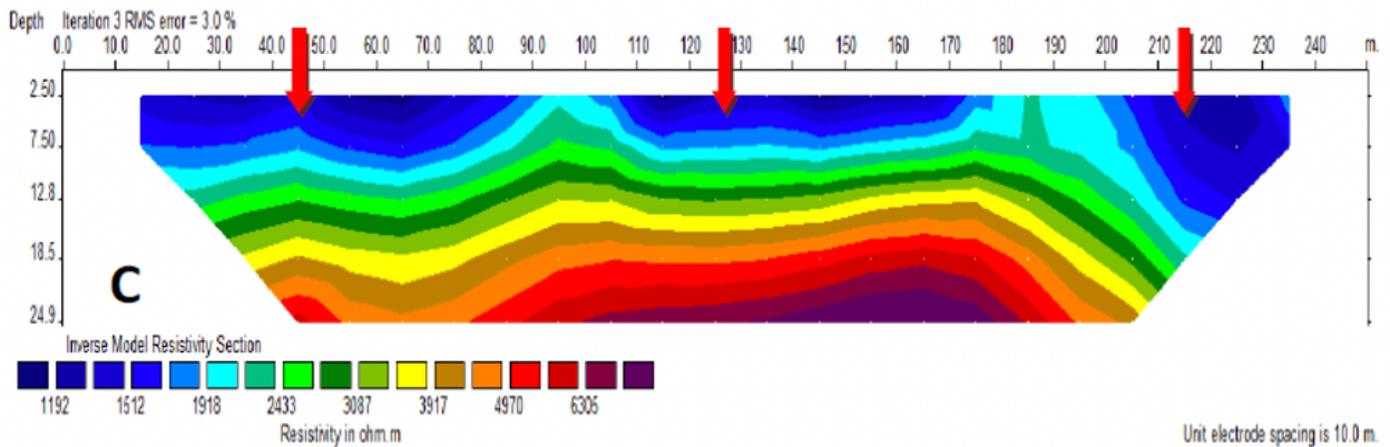
Figure 9

Figure 9a: Measured apparent resistivity of profile A.

Figure 9b: Calculated apparent resistivity of profile A

Figure 9c: Inverse model resistivity section of profile A.

Resistivity model for profile A.

Fig. 9(a) represents the Pseudo-section from the apparent resistivity measurement along profile A. The plot revealed a resistivity value in the range of 1110 Ωm – 1576Ωm, between two major segments at distances ranging from 10 – 90 m and 110 m – 170 m along the profile to a depth of 2.50m – 11.02m and 2.50 m – 15m respectively. The arrows showed sections along the profiles with low resistivity. Fig. 9(b) shows the representation of the Pseudo-section from the calculated apparent resistivity. The resistivity values are similar to the results obtained along the profile in Fig. 9(a). Fig.9(c) is the inverse model of the 2D resistivity sections along the profile. Two distinctive zones were delineated with low resistivity values along profile A. This occurred at the distance between 122.5 m – 130.0 m along the profile to a depth of 5m from the top soil. It was also revealed that at a distance of 200 m – 235m, a

moderate resistivity values in the range of 1200 Ωm – 1600 Ωm which terminate at a depth of 18m from the surface of the profile was delineated.

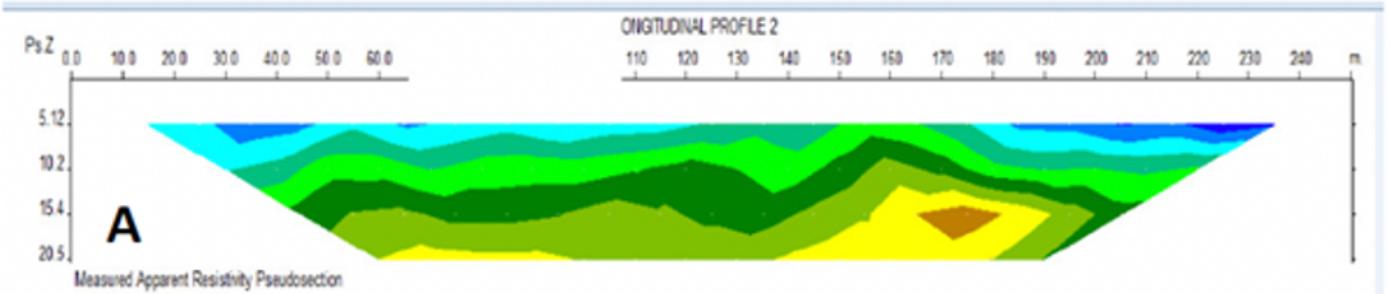
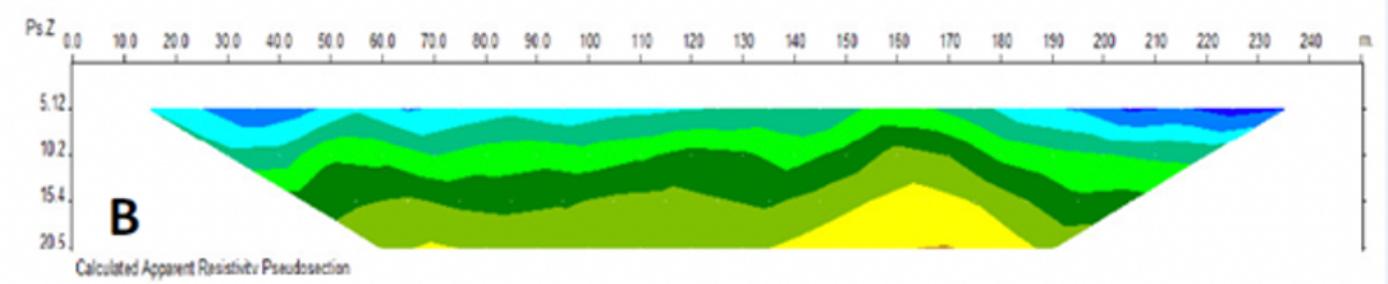
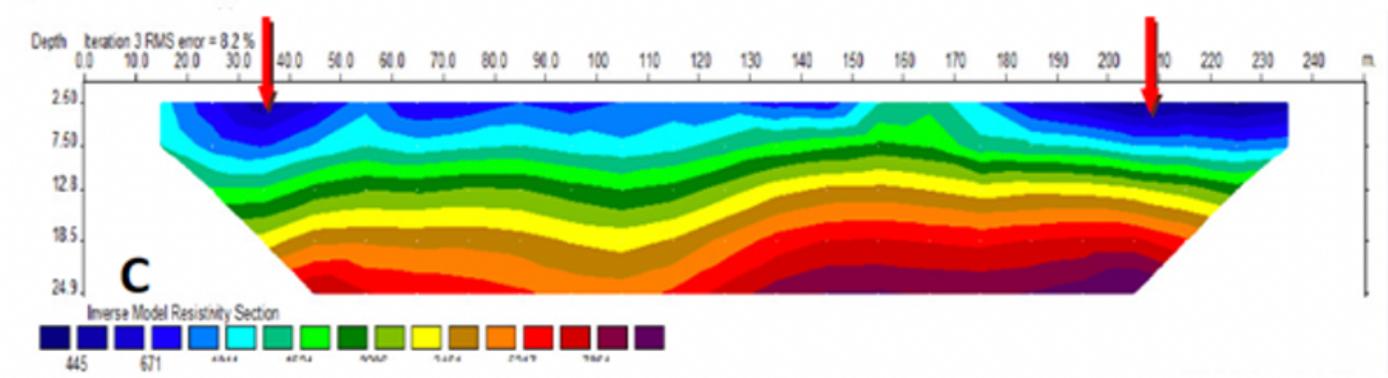
Figure 10

Figure 10a: Measured apparent resistivity of profile B

Figure 10b: Calculated apparent resistivity of profile B

Figure 10c: Inverse model resistivity section of profile B.

Resistivity model for profile B

Fig. 10(a) represents the Pseudo-section from the apparent resistivity measurement along profile B. The plot revealed a resistivity value in the range of 100 Ωm – 300 Ωm , between a distance of 20m – 240m along the profile to a depth of 7.60m from the surface of the profile. Fig. 10(b) shows the representation of the Pseudo-section from the calculated apparent resistivity. The section revealed a low resistivity values in the same section along the profile similar to that of Fig. 10(a). Fig 10(c) is the inverse model of the 2D resistivity sections along the profile. Low resistivity values were observed in different sections of the model along the profile, few sections along the profile showed a resistivity value that is greater than 200 Ωm . Two distinct sections along the profiles with very low resistivity values at a distance of 10 – 45m, 60 – 110m and 180 – 235m to a depth of 7.60m, 2.80m and 5.60m respectively were also delineated.

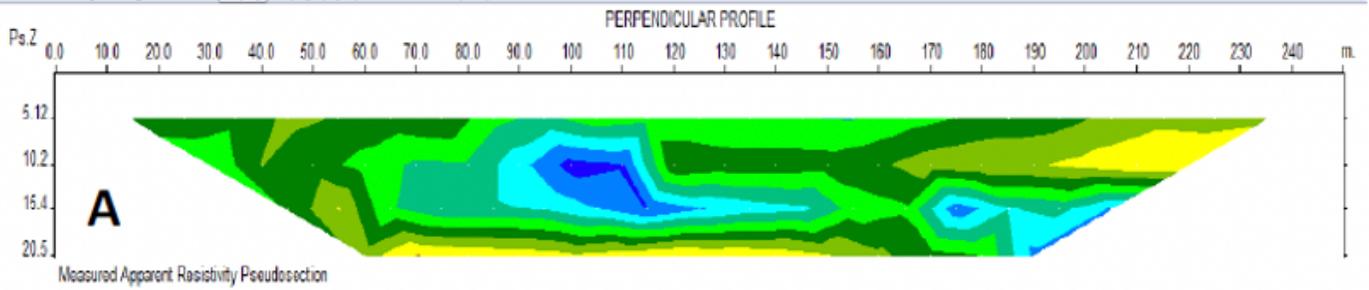
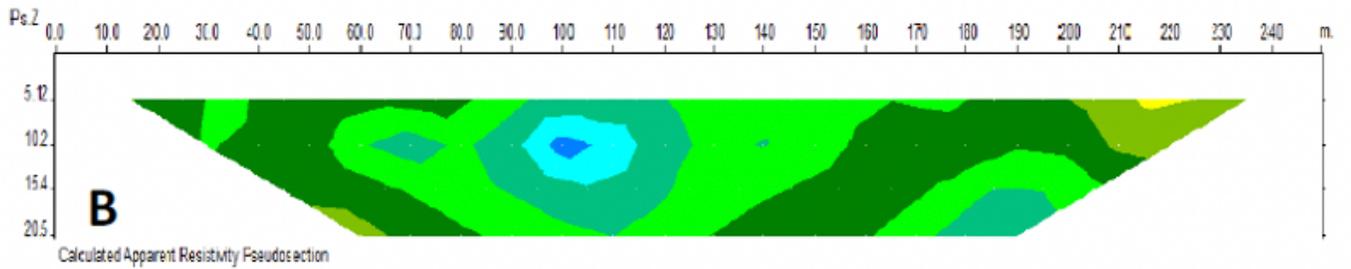
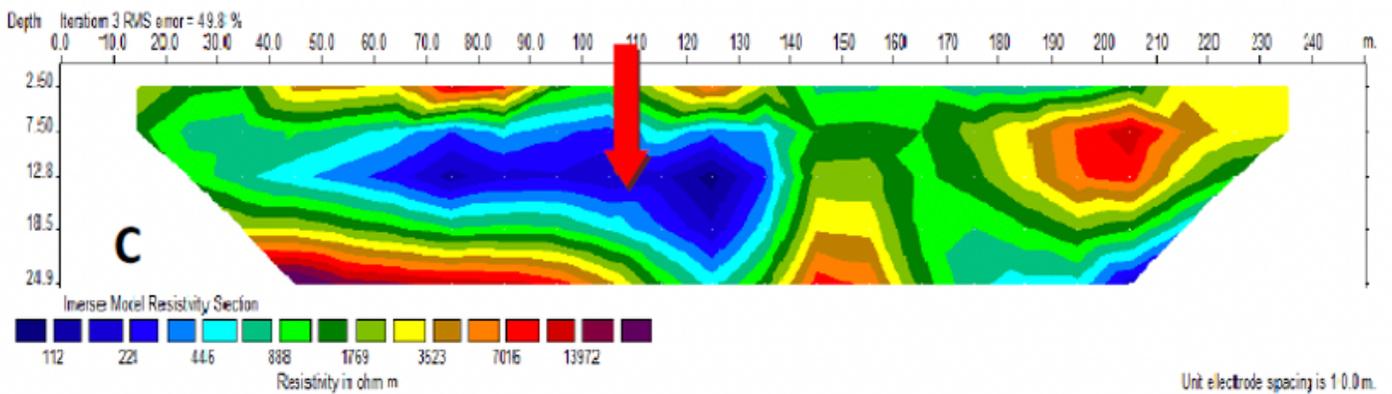
Figure 11

Figure 11a: Measured apparent resistivity of profile C

Figure 11b: Calculated apparent resistivity of profile C

Figure 11c: Inverse model resistivity section of profile C.

Unit electrode spacing is 10.0m.

Resistivity model for profile C.

Fig. 11(a) represents the Pseudo-section from the apparent resistivity measurement along profile C. The plot revealed a low resistivity value with the range of 50 Ωm – 111 Ωm , at a distance of 80m – 120 m along the profile to a depth of 15m from the surface of the profile. Fig. 11(b) shows the representation of the Pseudo-section from the calculated apparent resistivity. The section revealed a low resistivity values that is similar to what was obtained for the profile section in Fig. 11(a). Fig. 11 (c) shows the inverse model of the 2D resistivity sections along the profile. Low resistivity values were observed along the major sections. Very low resistivity values were observed at a two distinctive zone from a distance of 40.0 – 140m, 190.0 – 210.0m to a depth of 21m and 25m respectively.

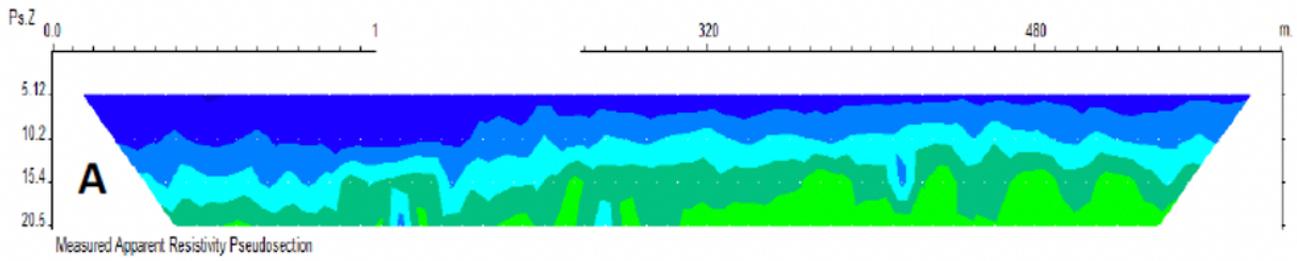
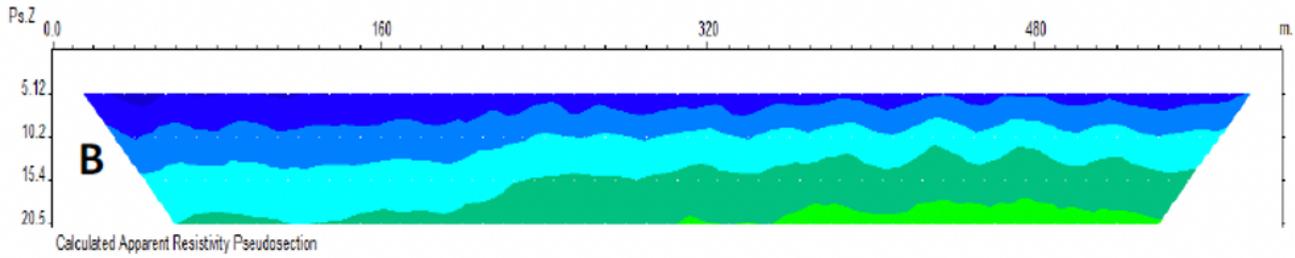
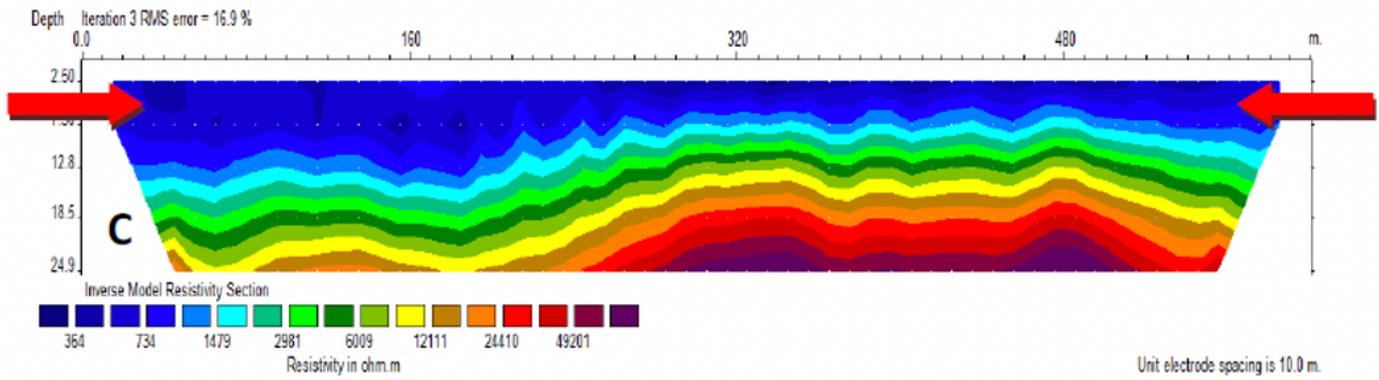
Figure 12

Figure 12a: Measured apparent resistivity of profile D

Figure 12b: Calculated apparent resistivity of profile D

Figure 12c: Inverse model resistivity section of profile D.

Resistivity model for profile D.

Fig. 12(a) represents the Pseudo-section from the apparent resistivity measurement along profile D. The plot revealed a low resistivity value in the range of 100 Ωm – 350 Ωm , at a distances of 10 m – 500 m along the profile to a depth of 13m from the surface of the profile. Fig. 12(b) shows the representation of the Pseudo-section from the calculated apparent resistivity. The section revealed a low resistivity values that is similar to what was obtained for the profile section in Fig. 12(a). Fig 12(c) shows the inverse model of the 2D resistivity sections along the profile. Low resistivity values were delineated to depth of 15m along the section. The implication of the low resistivity values as revealed from the sections signifies that the soils in the region are of poor foundation materials and not competent to withstand imposed load.
