# Geo-Environmental Monitoring and 3D Finite Elements Stability Analysis for site Investigation of Horemheb Tomb (Kv57), Luxor, Egypt

**GEO-ENVIRONMENTAL MONITORING AND 3D FINITE ELEMENTS STABILITY  
ANALYSIS FOR SITE INVESTIGATION OF HOREMHEB TOMB (KV57), LUXOR,  
EGYPT.**

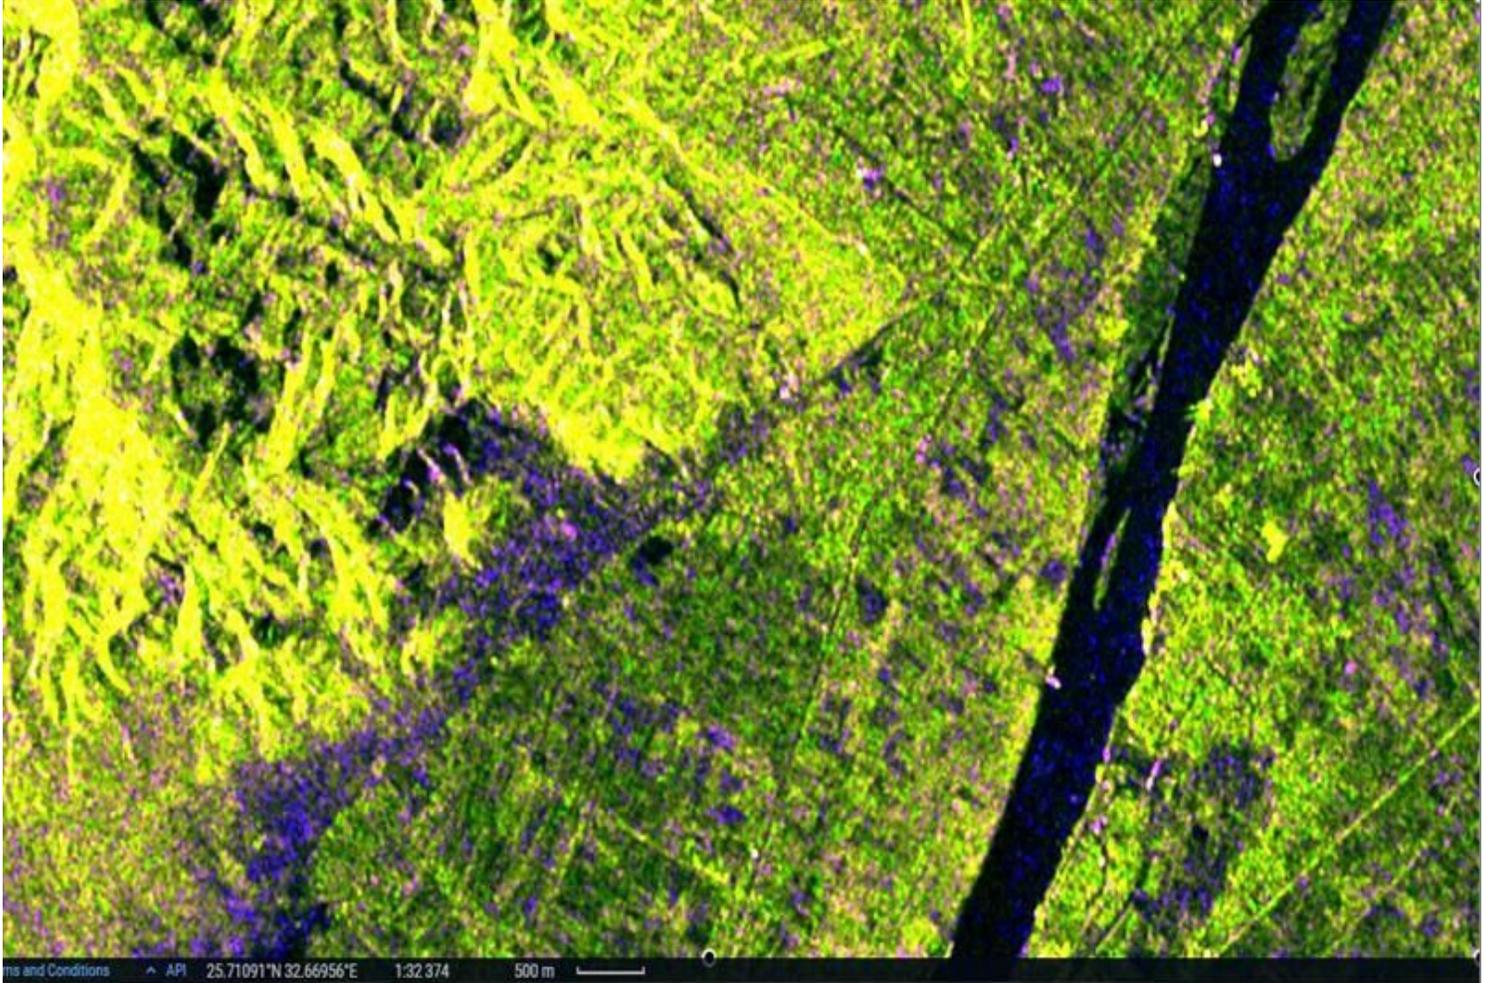
**Figure 1**

LIDAR image, The Ratio "VV, VH, VV / VH" combination works well for distinguishing water objects, open soils, moistened agricultural fields, vegetation, and urban areas. Water in lakes is shown in dark blue, bright blue or black hues with radar signal noise. Blue hues show agricultural fields with bare soil, often sufficiently waterlogged. Fields with vegetation show a green color. Buildings of a metropolis are represented by bright green-yellow shades.

Figure.1. LIDAR image, The Ratio "VV, VH, VV / VH" combination works well for distinguishing water objects, open soils, moistened agricultural fields, vegetation, and urban areas. Water in lakes is shown in dark blue, bright blue or black hues with radar signal noise. Blue hues show agricultural fields with bare soil, often sufficiently waterlogged. Fields with vegetation show a green color. Buildings of a metropolis are represented by bright green-yellow shades.

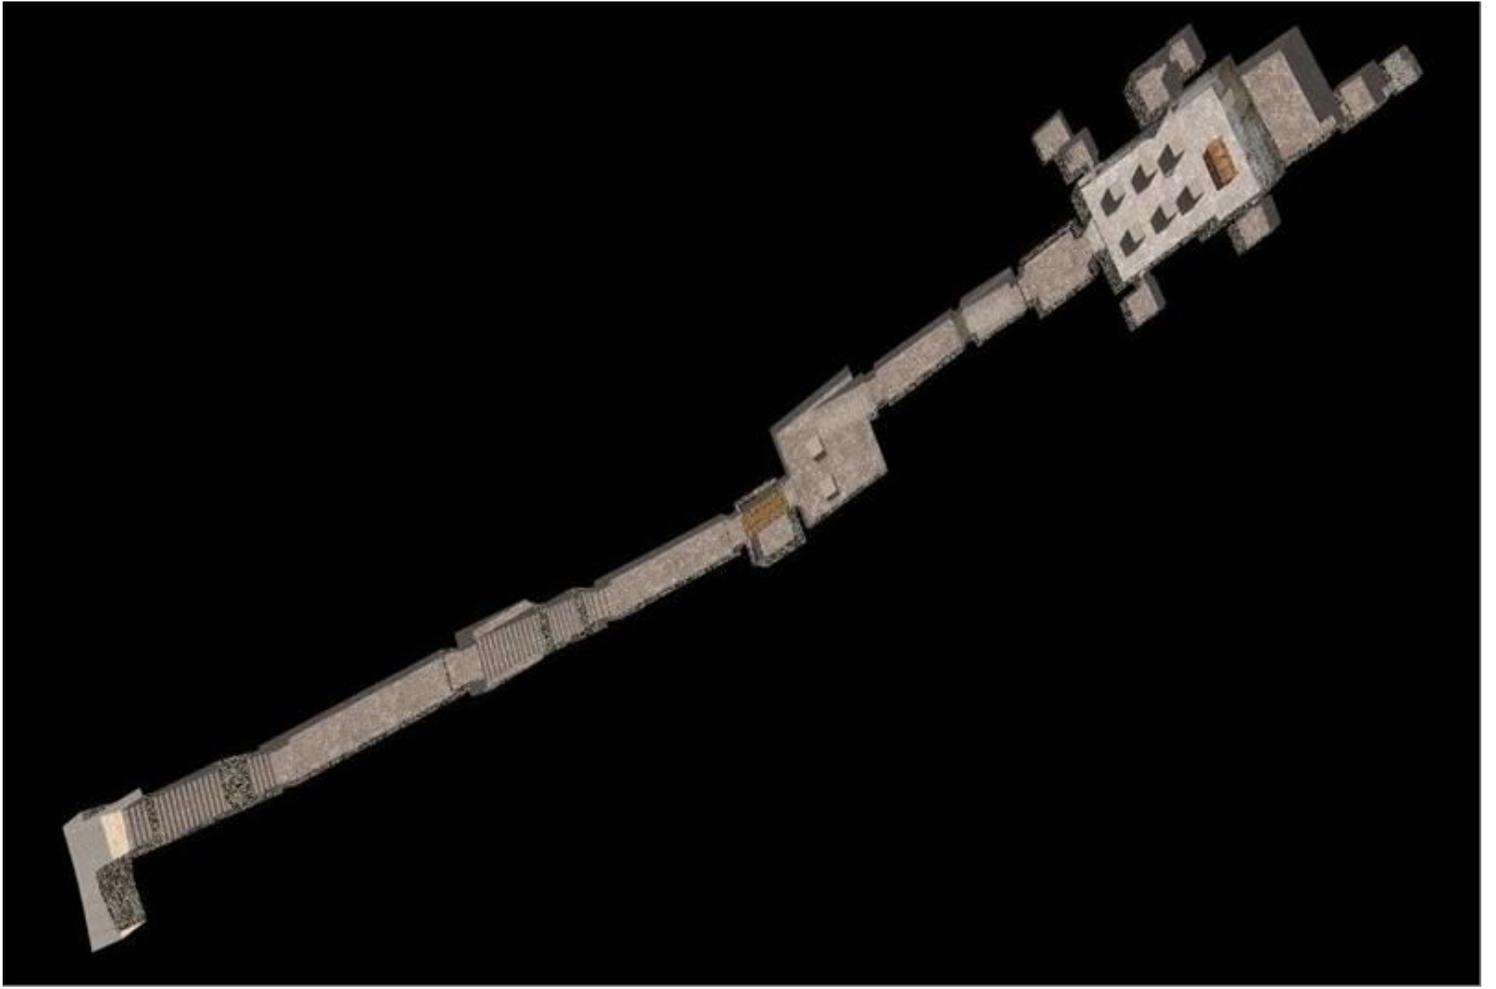
**Figure 2**

3D Sketchup model for the Horemheb tomb, Luxor, Egypt (KV57).

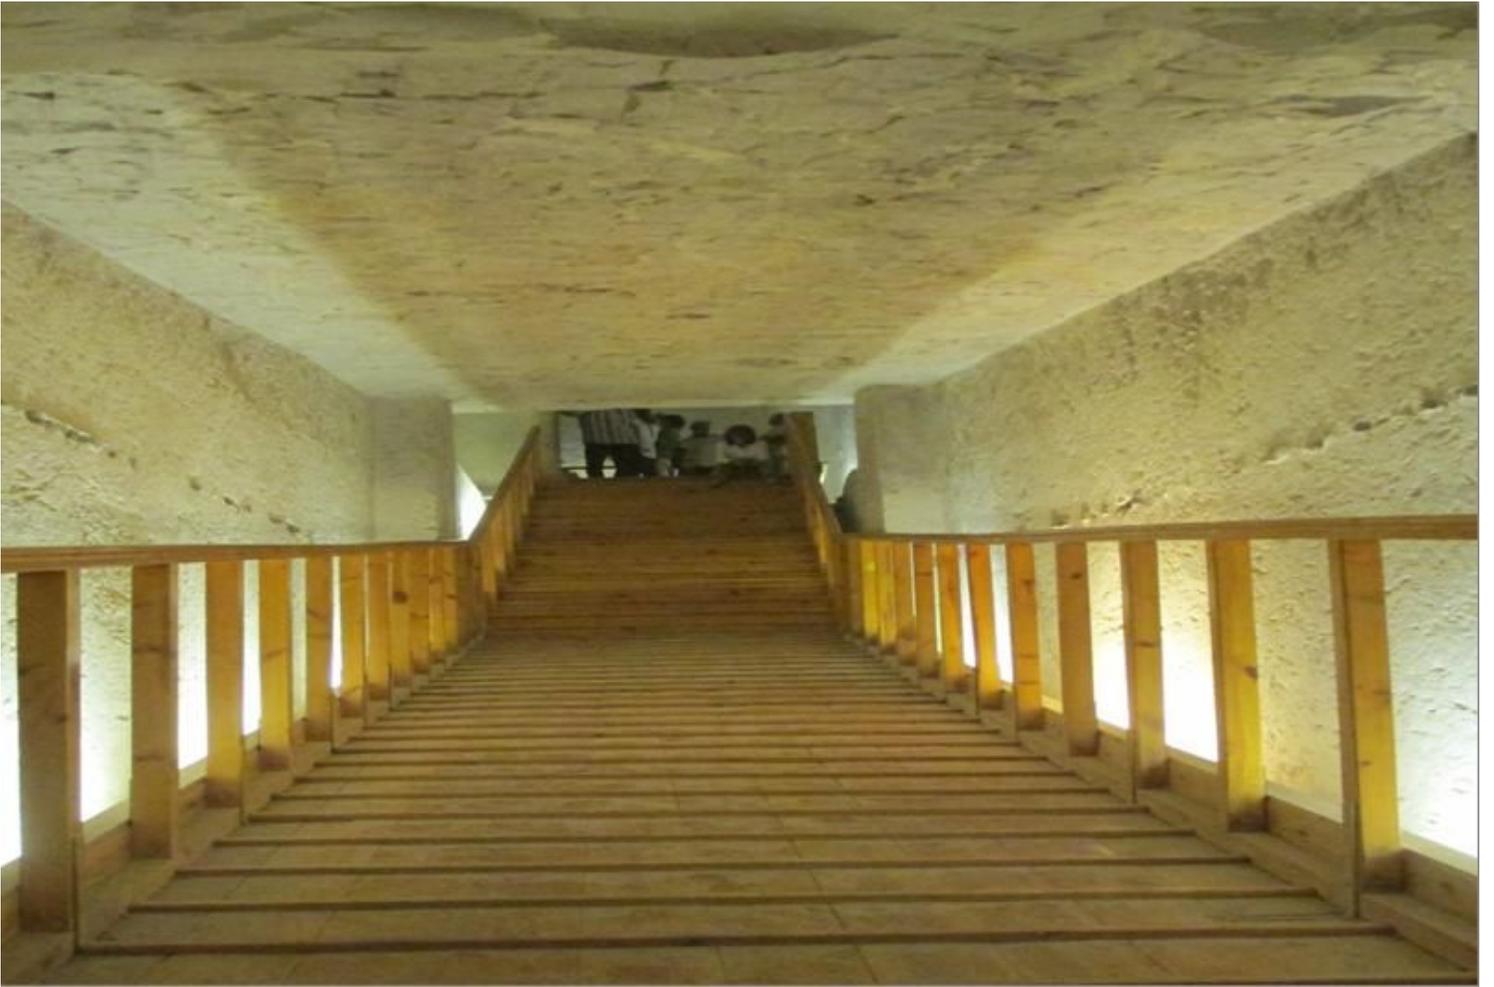
**Figure 3**

the entrance and corridor of the KV57 where it is whole excavated in the marl Shale layers, Chert lenses and nodules are abundant and obvious.

Figure (3) represents the entrance and the main corridor of the Hormoheb tom KV57 where it is whole excavated in the marl Shale layers, Chert lenses and nodules are abundant and obvious. The In-plane deformation patterns like vertical cracks and crown zone rock falling and intensive cracking of lintel due to over loading (geostatic loading) and impact of old and modern flash floods in particular the 1994 flood, as shown in figure (4). Extensive structural damage of crown ceiling zones and engineering failure of the structural pillars, sidewalls and Ceiling of the Corridors and Chambers in the KV57. Brittle rock, high stress conditions lead to rockbursting (the sudden release of stored strain energy) bursts manifest themselves through sudden. Extensive rock falls from the ceiling is obvious and cracks are active, as shown in figure (5). Carved and decorated walls in massive Esna shale Member are in advanced state of disintegration. Showing chert lenses. The ornamented plaster on top of the chert lenses and nodules was damaged during the first flash floods that entered the tomb some 3000 years ago. During several restoration projects over the past 200 years, cracks were filled with plaster for protection and stabilization of the tomb. The impact of the 1994 flash floods on the mural paintings inside the tomb are severely obvious, as shown in figure (6).

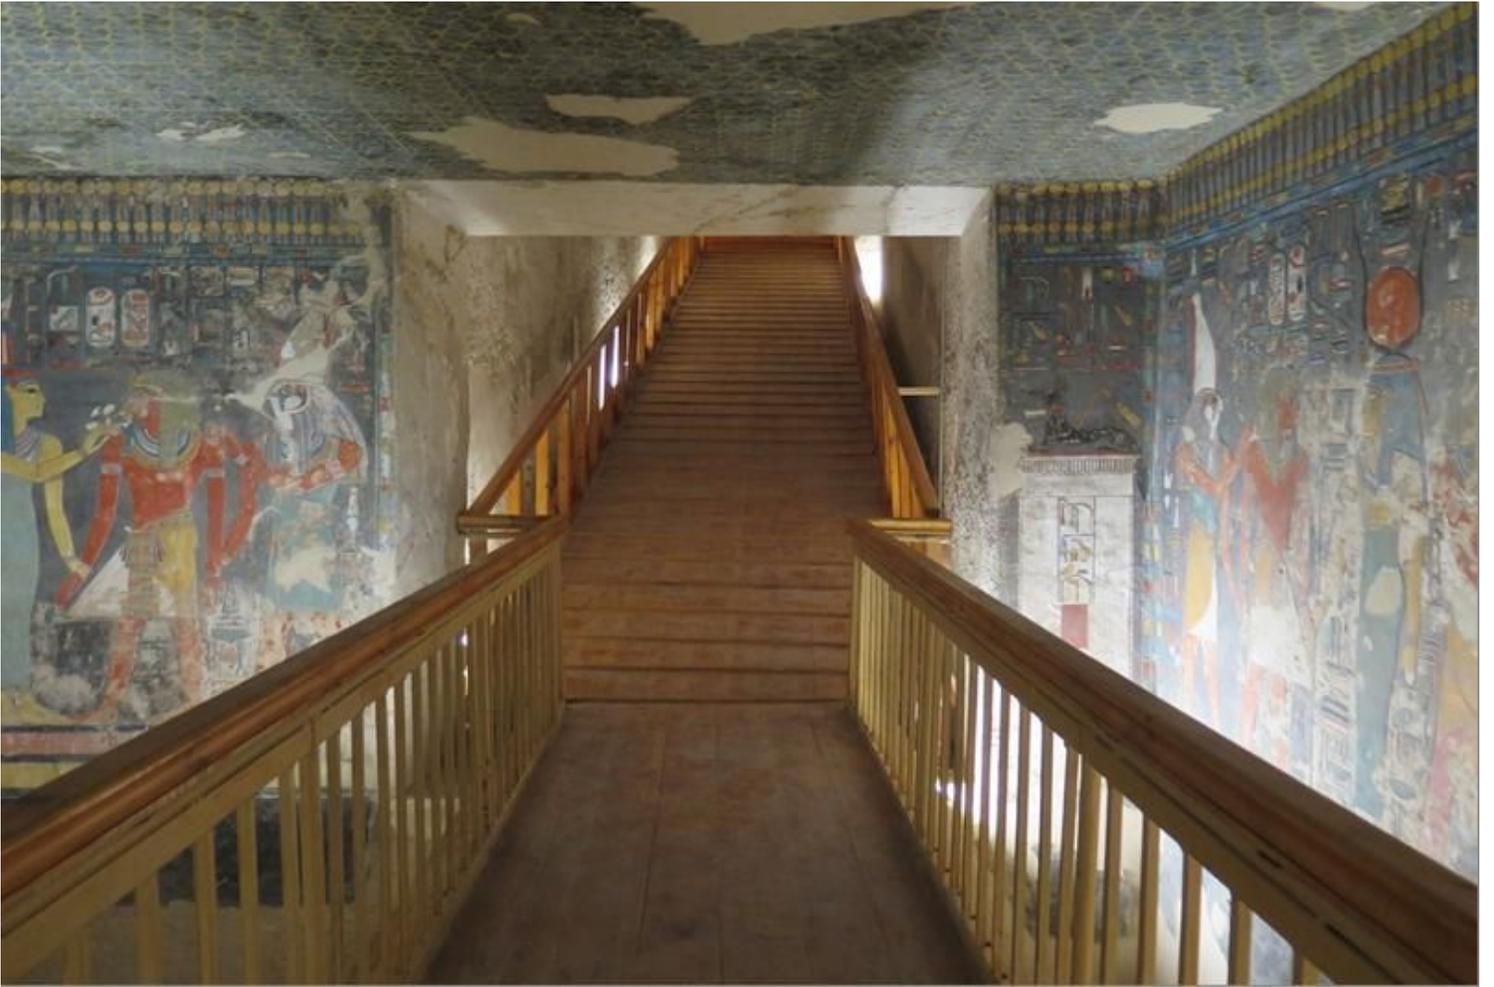
**Figure 4**

In-plane deformation patterns like vertical cracks and crown zone rock falling and intensive cracking of lintel due to over loading (geostatic loading) and impact of old and modern flash floods in particular the 1994 flood.

Fig.4. In-plane deformation patterns like vertical cracks and crown zone rock falling and intensive cracking of lintel due to over loading (geostatic loading) and impact of old and modern flash floods in particular the 1994 flood.

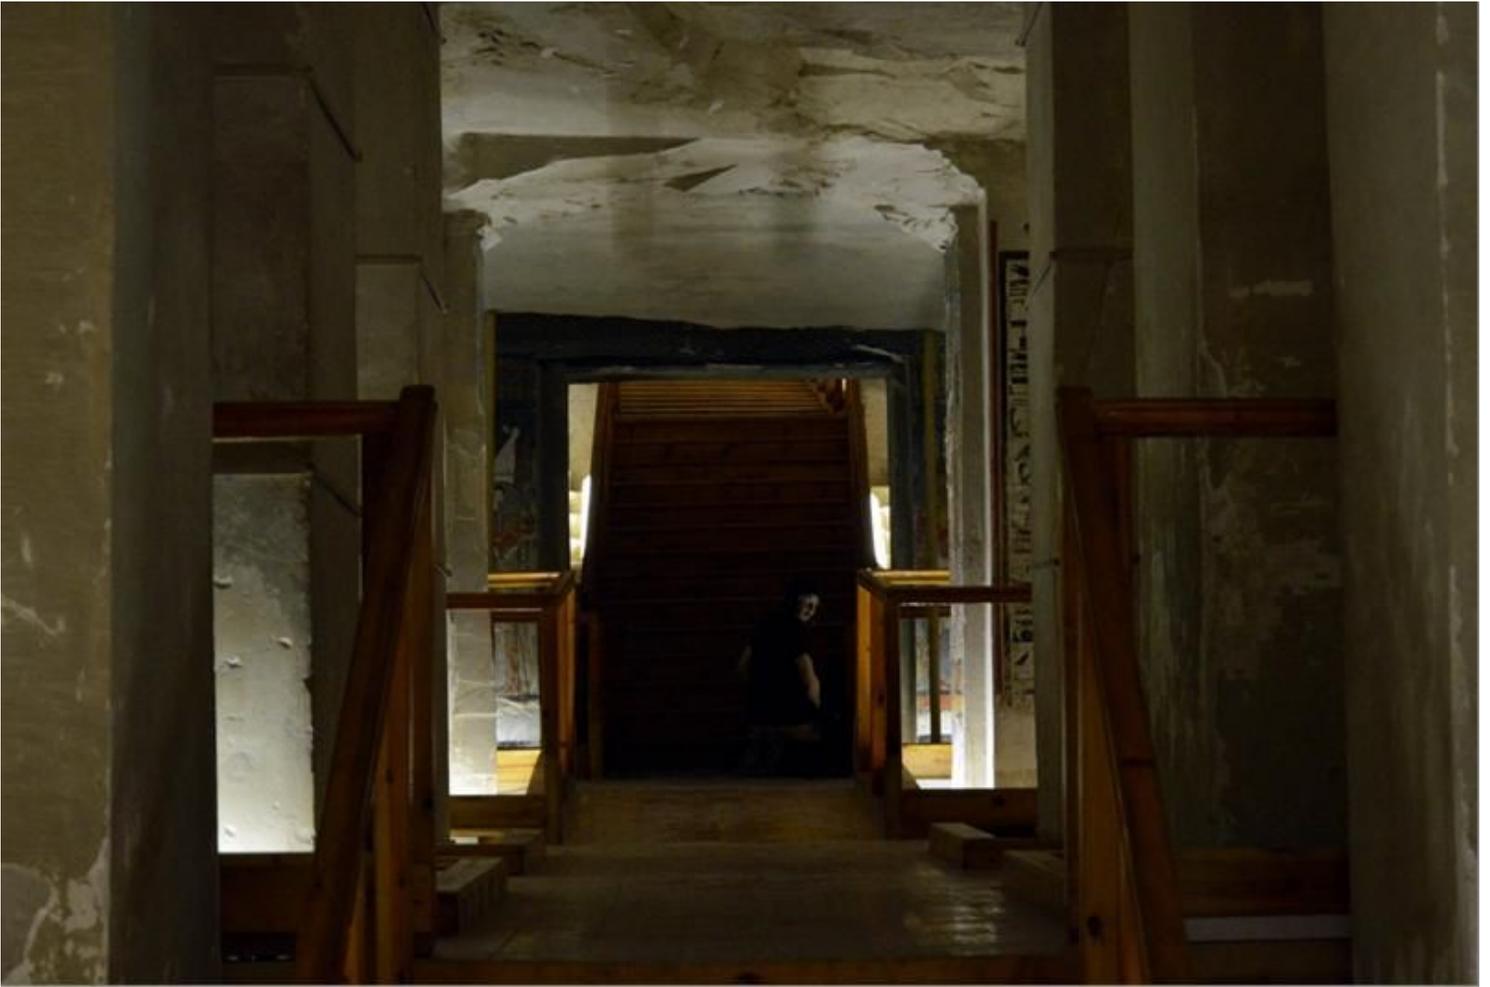
**Figure 5**

Extensive structural damage of crown ceiling zones and engineering failure of the structural pillars, sidewalls and Ceiling of the Corridors and Chambers in the KV57. Brittle rock, high stress conditions lead to rockbursting (the sudden release of stored strain energy) bursts manifest themselves through sudden. Extensive rock falls from the ceiling is obvious and cracks are active wher the gypsum Pegs are cracked and broken.

Figure.5. Extensive structural damage of crown ceiling zones and engineering failure of the structural pillars, sidewalls and Ceiling of the Corridors and Chambers in the KV57. Brittle rock, high stress conditions lead to rockbursting (the sudden release of stored strain energy) bursts manifest themselves through sudden. Extensive rock falls from the ceiling is obvious and cracks are active wher the gypsum Pegs are cracked and broken.

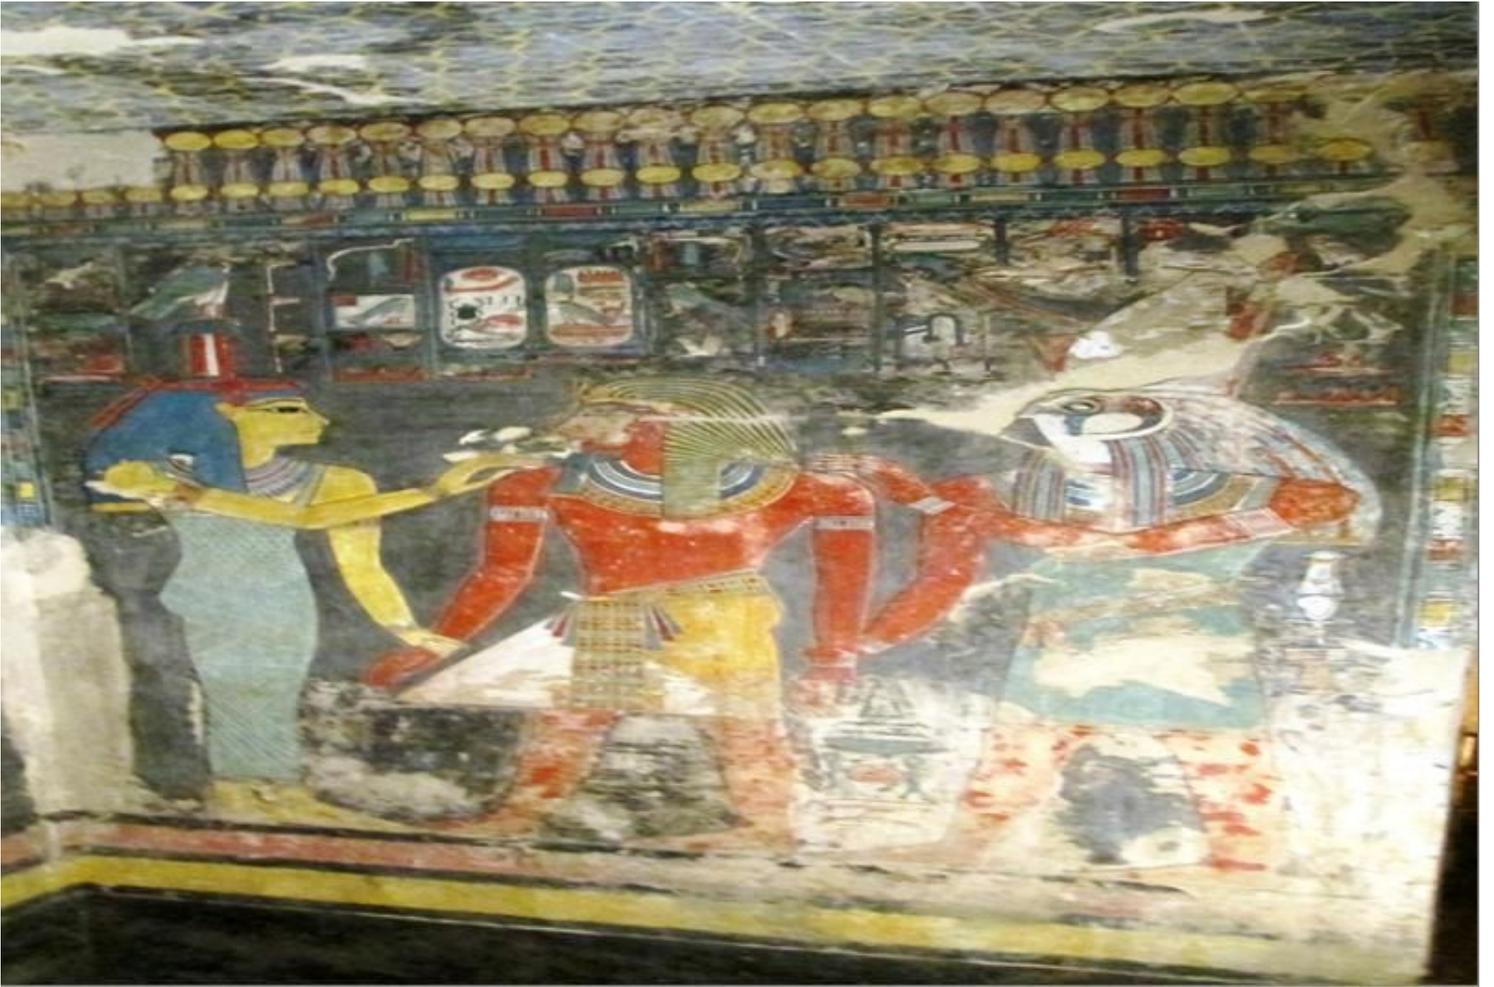
**Figure 6**

Carved and decorated walls in massive Esna shale Member are in advanced state of disintegration. Showing chert lenses. The ornamented plaster on top of the chert lenses and nodules was damaged during the first flash floods that entered the tomb some 3000 years ago. During several restoration projects over the past 200 years, cracks were filled with plaster for protection and stabilization of the tomb. The impact of the 1994 flash floods on the mural paintings inside the tomb are severely obvious.

Fig. 6. Carved and decorated walls in massive Esna shale Member are in advanced state of disintegration. Showing chert lenses. The ornamented plaster on top of the chert lenses and nodules was damaged during the first flash floods that entered the tomb some 3000 years ago. During several restoration projects over the past 200 years, cracks were filled with plaster for protection and stabilization of the tomb. The impact of the 1994 flash floods on the mural paintings inside the tomb are severely obvious.

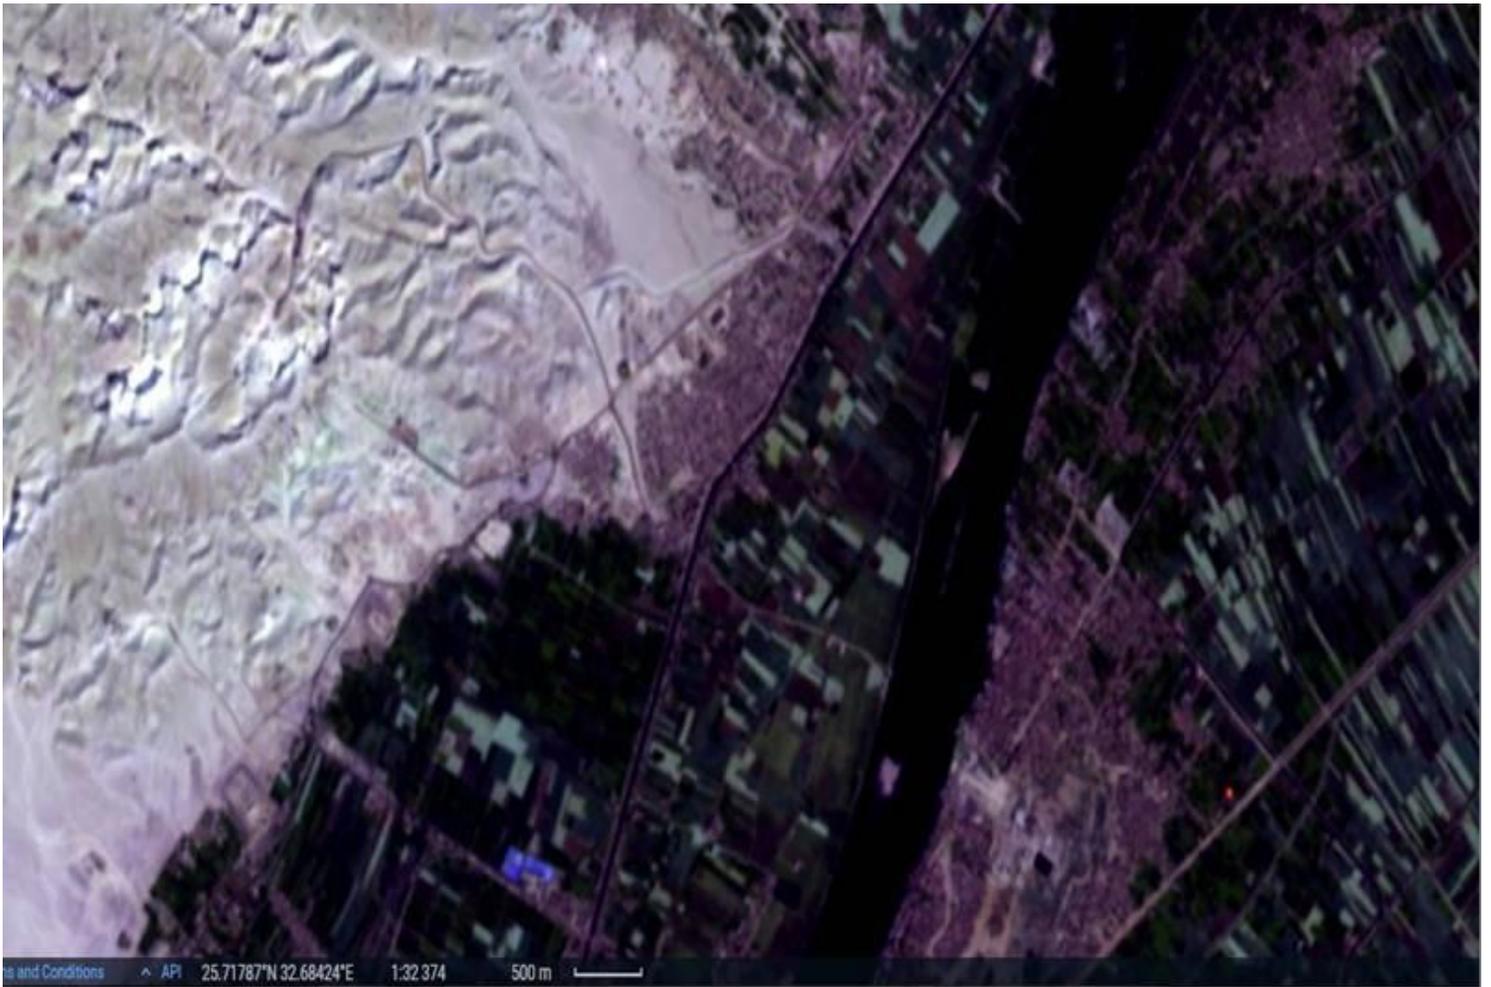
**Figure 7**

Urban Image. This band combination also provides a "natural-like" rendition while also penetrating atmospheric particles, smoke and haze. Vegetation appears in shades of dark and light green during the growing season, urban features are white, gray, cyan or purple, sands, soils and minerals appear in a variety of colors. The almost complete absorption of Mid-IR bands in water provides well defined and highlighted sources of water within the image. water is black or dark blue. Hot surfaces such as forest fires saturate the Mid-IR bands and appear in shades of red or yellow. One particular application for this combination is monitoring fires. Flooded areas should look very dark blue or black.

Figure.7. Urban Image. This band combination also provides a "natural-like" rendition while also penetrating atmospheric particles, smoke and haze. Vegetation appears in shades of dark and light green during the growing season, urban features are white, gray, cyan or purple, sands, soils and minerals appear in a variety of colors. The almost complete absorption of Mid-IR bands in water provides well defined and highlighted sources of water within the image. water is black or dark blue. Hot surfaces such as forest fires saturate the Mid-IR bands and appear in shades of red or yellow. One particular

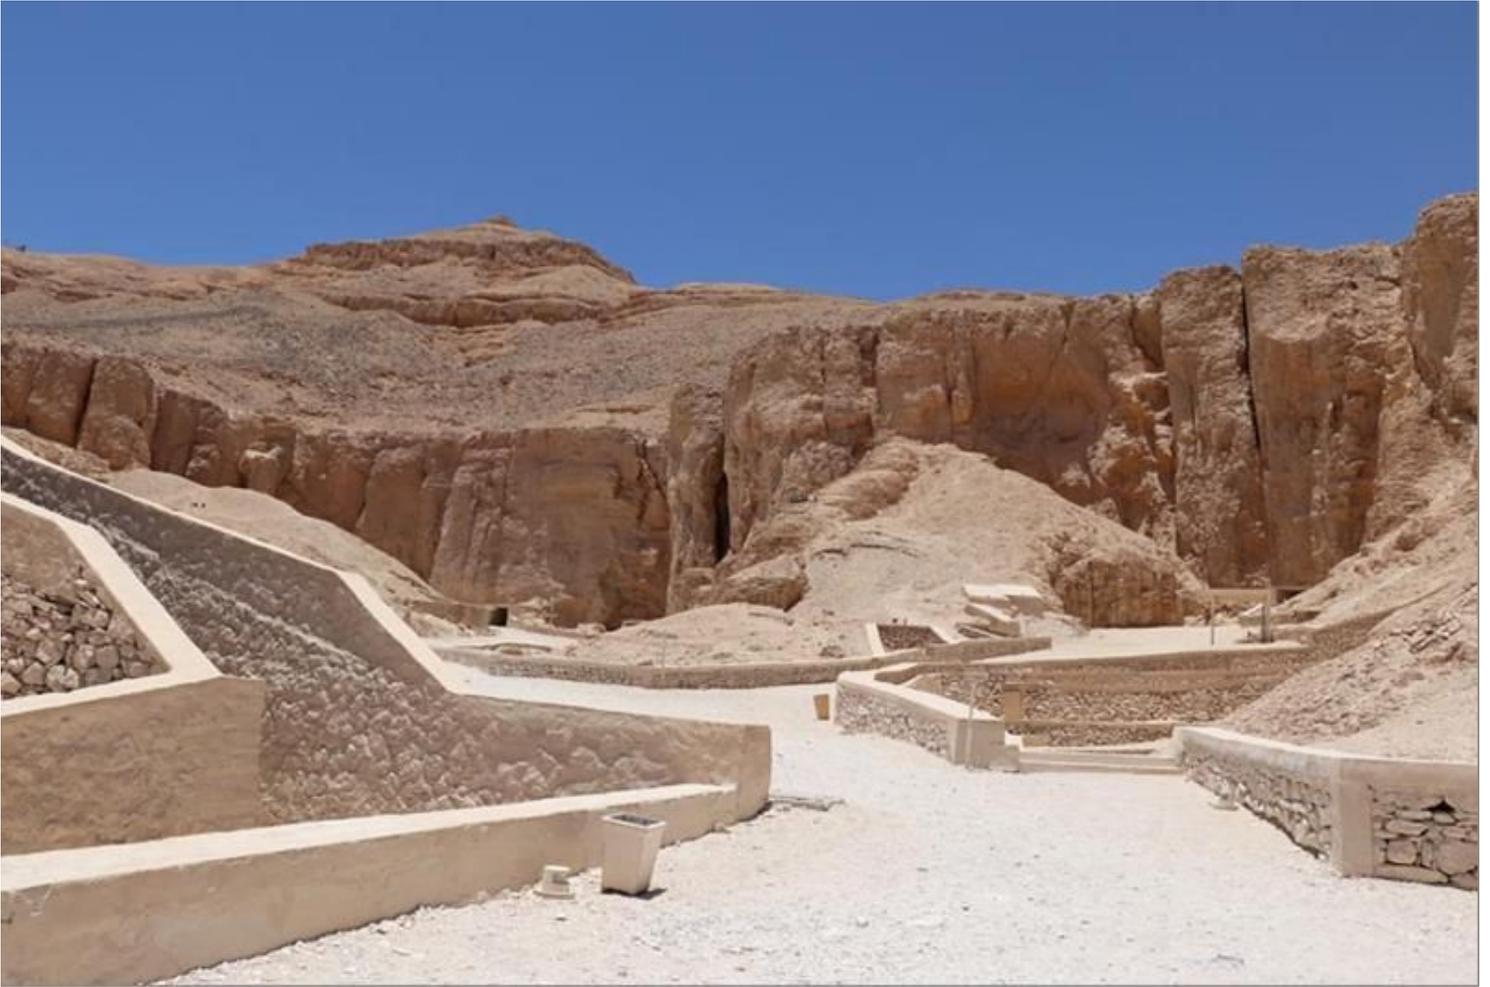
**Figure 11**

Location of the Horemheb tomb (KV57) at the east (main) Valley of the Kings (KV), Luxor Egypt. Stratigraphical succession as seen. Characteristic weathering of the Thebes Formation was used to subdivide the Thebes Formation into four units, Member I to Member IV. A 30 m displacement of Member I associated to the Kings Valley Fault is located on the right-hand side approximately 40 m from the tomb of Amenmesse (KV10).

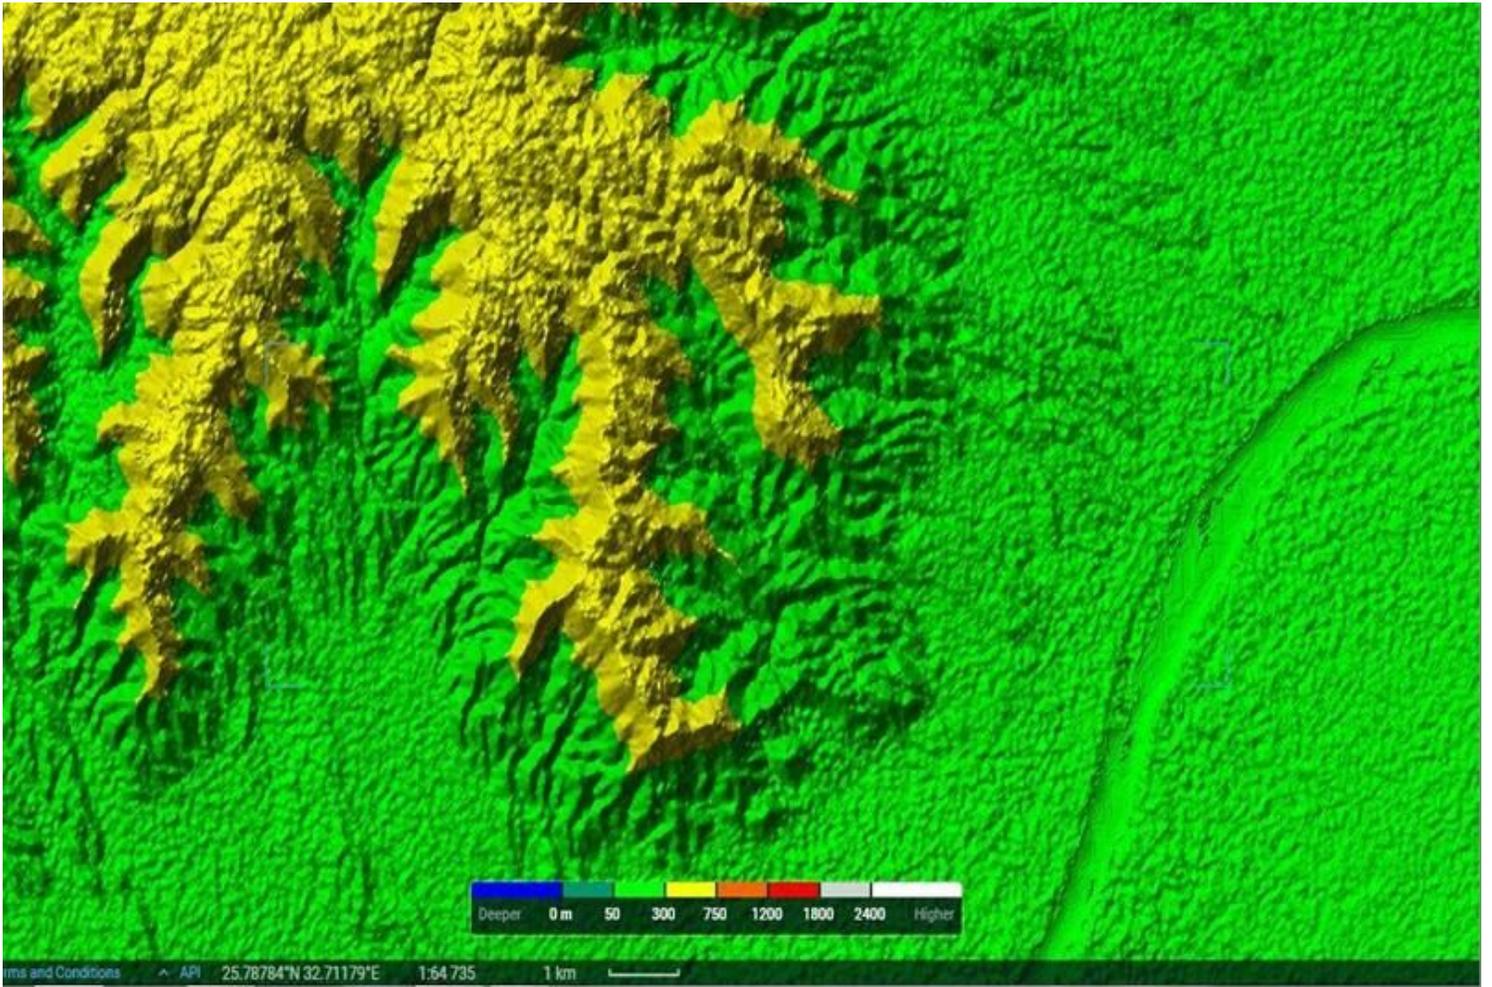
**Figure 12**

(DEM), Digital Elevation Model of the valley of kings and the Gebel Gurnah.

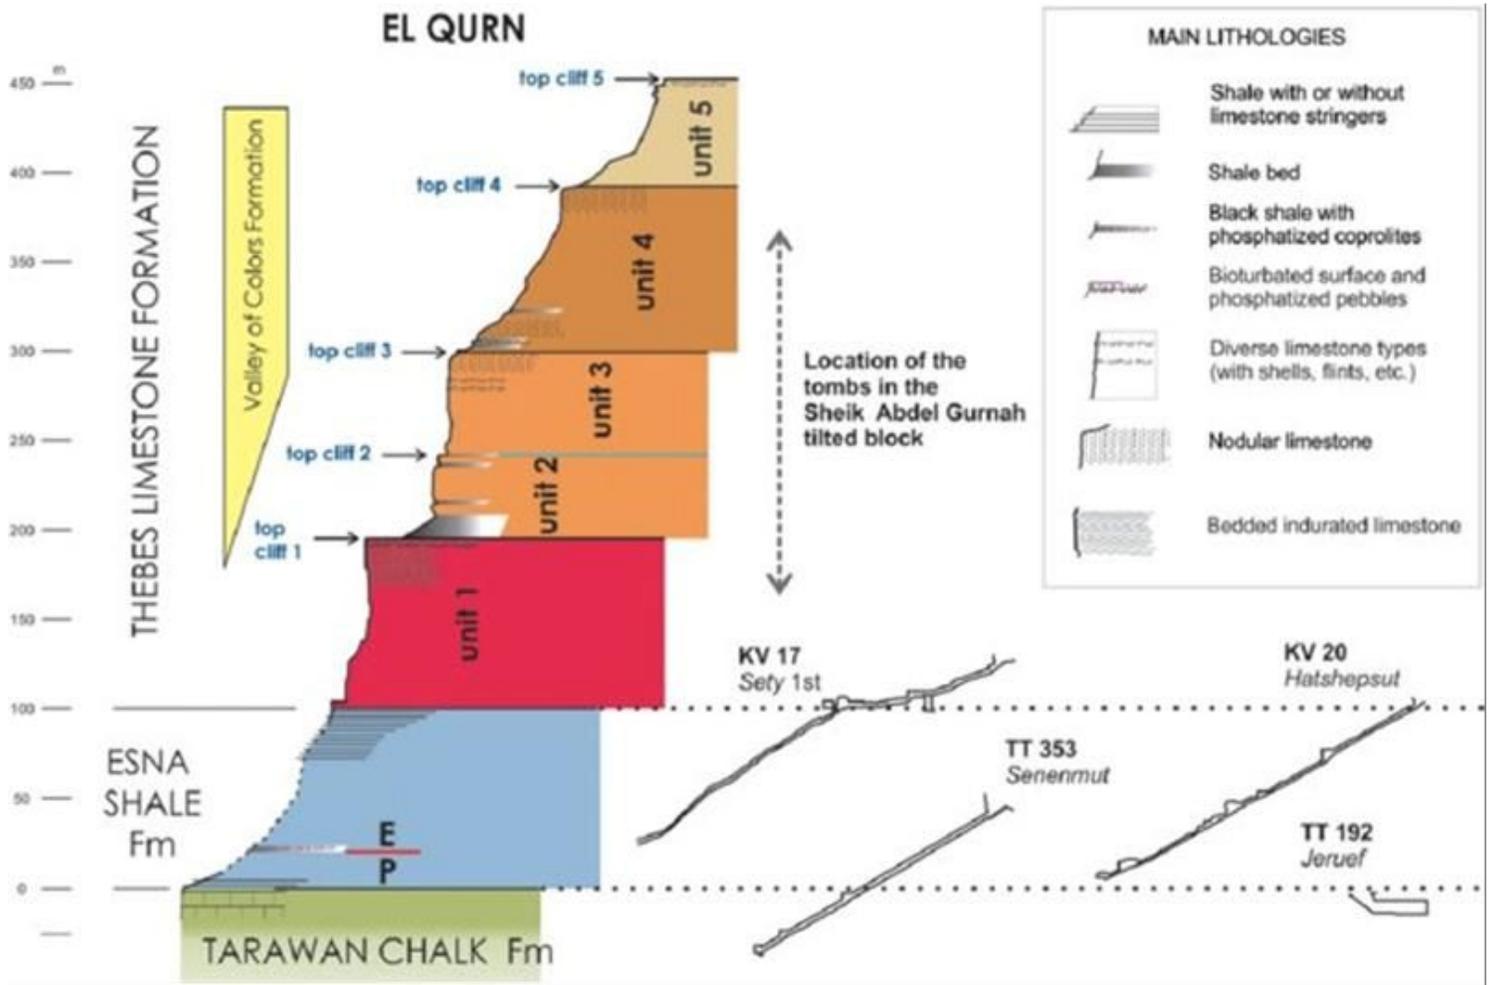
**Figure 13**

Stratigraphical succession on the West Bank. We show here the location of selected tombs in this succession. Tombs KV17, 20, TT353 and 192 are located in the sub horizontal bedrock. P, Paleocene; E, Eocene.

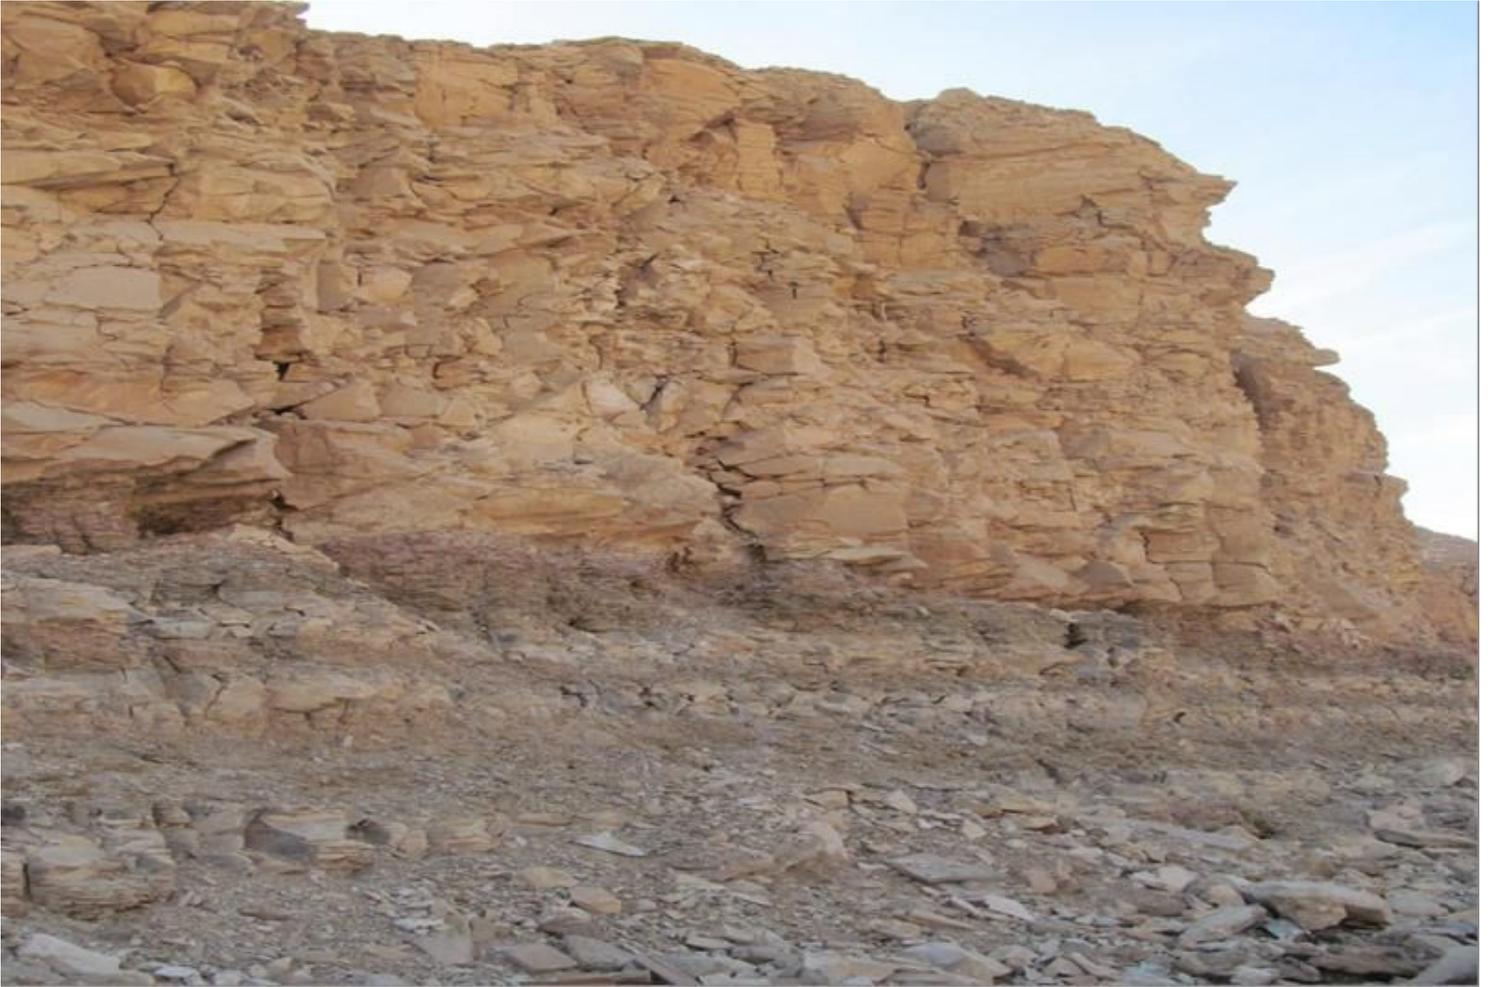
**Figure 14**

Abrupt contact of the Abu Had Member of the Esna Shale Formation with lithological unit 1 of the Thebes Limestone Formation. Photo taken just above the location of the KV57

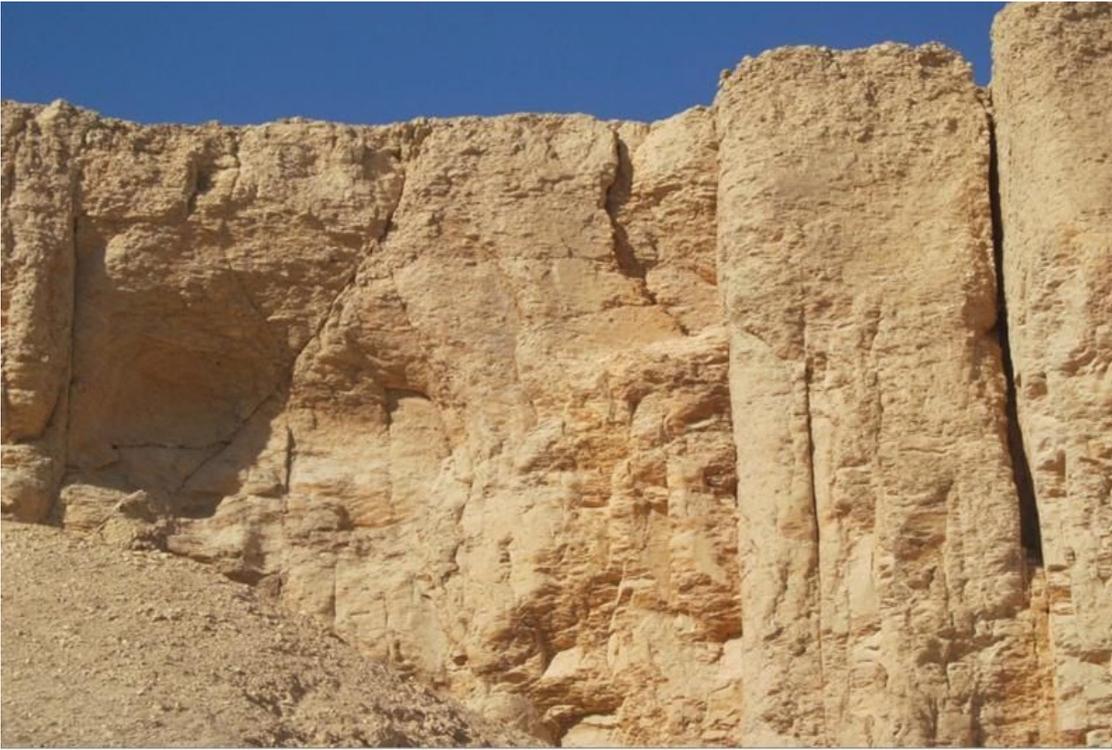
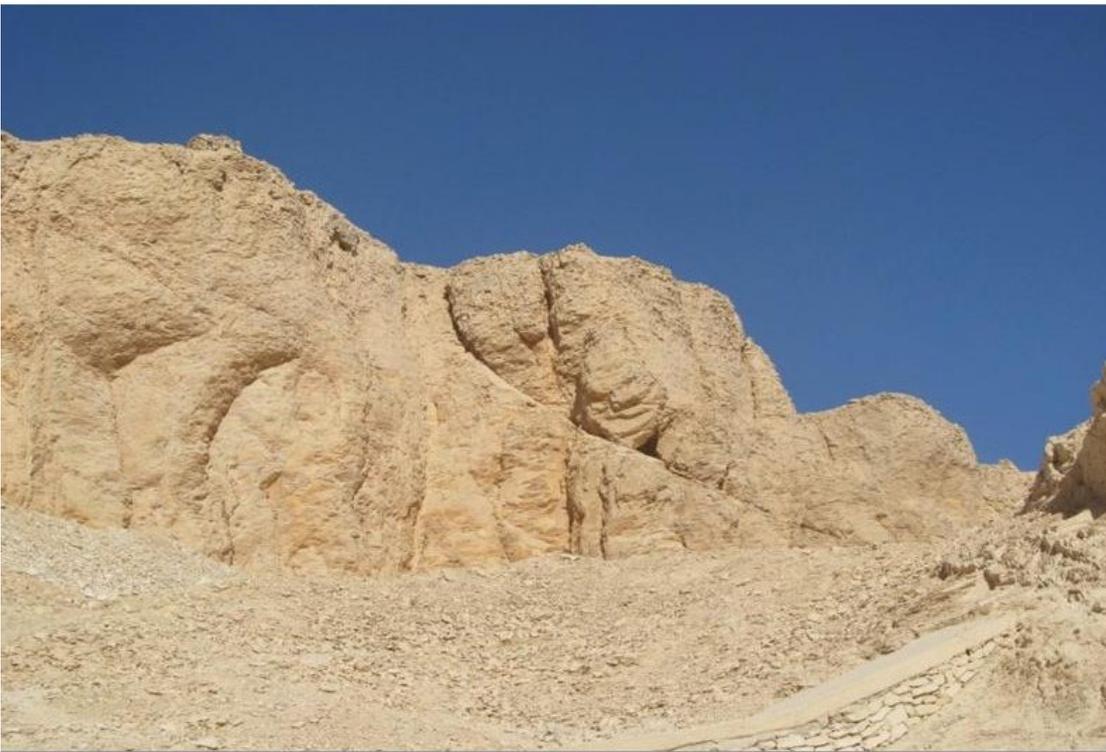
**Figure 15**

Evidence of flash flood related erosion in the Esna Shale and vertical fissures in Unit 1 of the Thebes Limestone, delineation of the abandoned Excavations and its causeway. The subvertical wall-cuts were dug in the upper part of the Esna Shale Formation and at the base of the Thebes Limestone Formation. White arrows point to erosional gullies in the lower part of unit 1 of the Thebes Formation, in the Hanadi Member (Esna Shale Formation) and in the debris that cover the Esna Formation. Note that the gullies at

the base of the Thebes Limestone and just below are commonly hollowed out, in particular on top and below the prominent base of Unit 1. These are probable evidence of flash floods. fallen blocks; unstable columnar block and open vertical fissures; screens. screens resulting from archeological excavations.

Figure (15) is an indication of the corrosion caused by the rapid flooding of marl shale and vertical cracks in Unit 1 of the limestone in Thebes, and the identification of abandoned excavations and its bridge. The sub-vertical wall pieces were drilled at the top of the shale

formation and at the base of the limestone formation in Thebes. The white arrows indicate the grooves of erosion in the lower part of Unit 1 of the formation of Thebes, in the Hanadi member (Isna rock formation) and in the debris covering the Isna composition. Note that the grooves at the base of the limestone in Thebes and slightly lower are generally cavity, especially at the top and bottom of the protruding base of Unit 1. These are potential signs of sudden flooding. Falling blocks are unstable vertical mass and open vertical fractures; degrees. The dunes resulting from archaeological excavations.

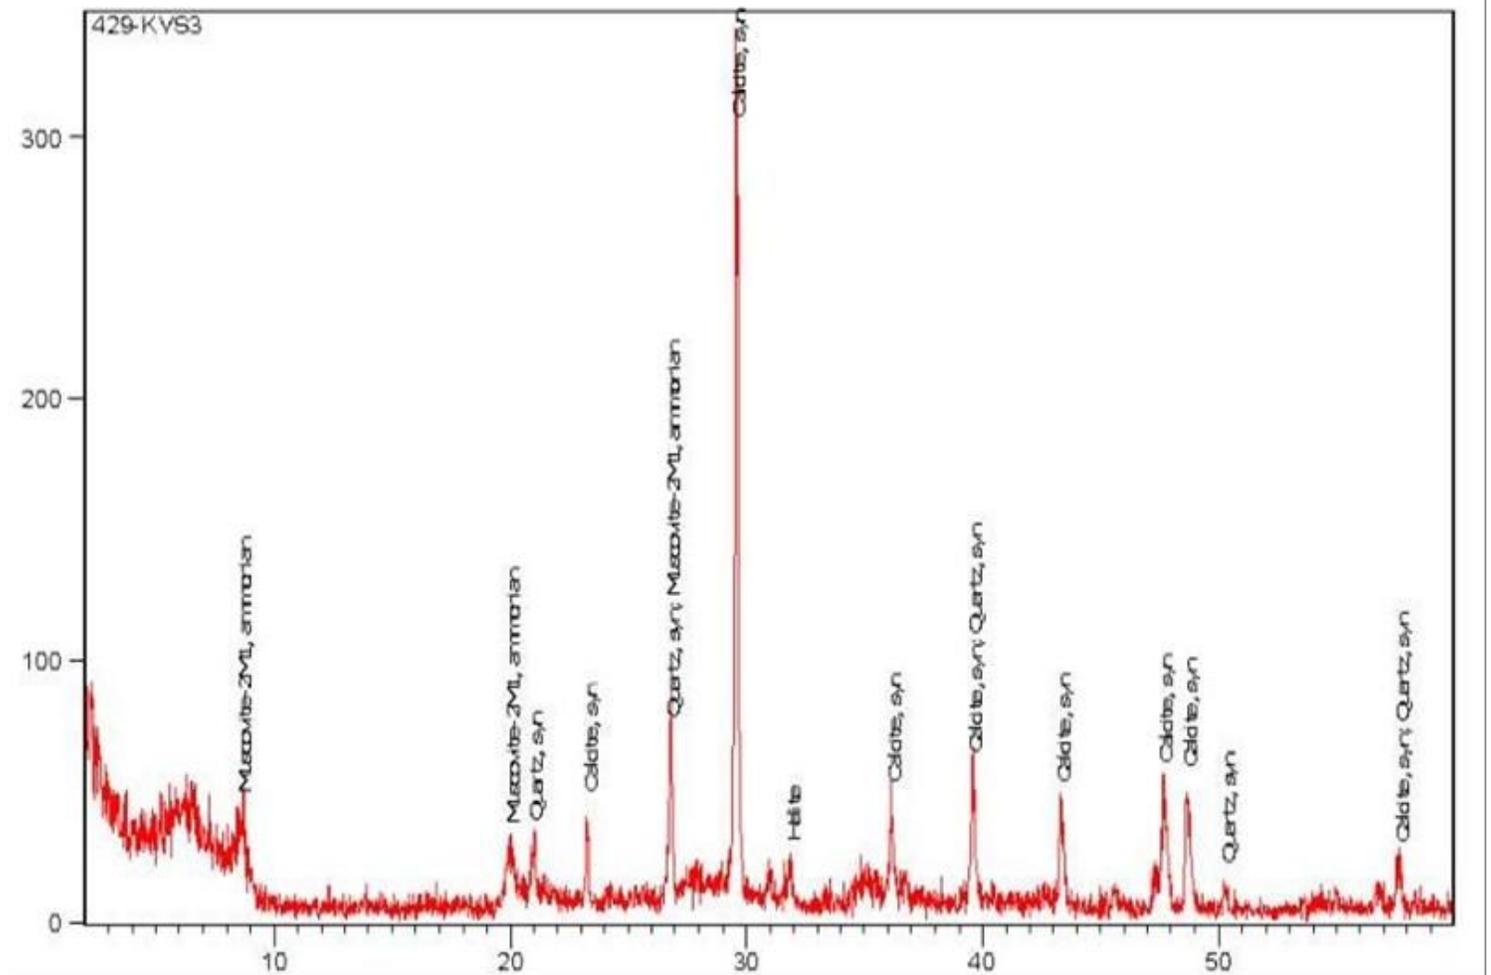
Figure 16

X-ray Diffraction results showing the bulk Mineralogy of Marl Shale (Calcite/ Smectite) where the Horemheb tomb (KV57) is excavated.
