# Geo-Environmental Monitoring and 3D Finite Elements Stability Analysis for site Investigation of Horemheb Tomb (Kv57), Luxor, Egypt

**GEO-ENVIRONMENTAL MONITORING AND 3D FINITE ELEMENTS STABILITY  
ANALYSIS FOR SITE INVESTIGATION OF HOREMHEB TOMB (KV57), LUXOR,  
EGYPT.**

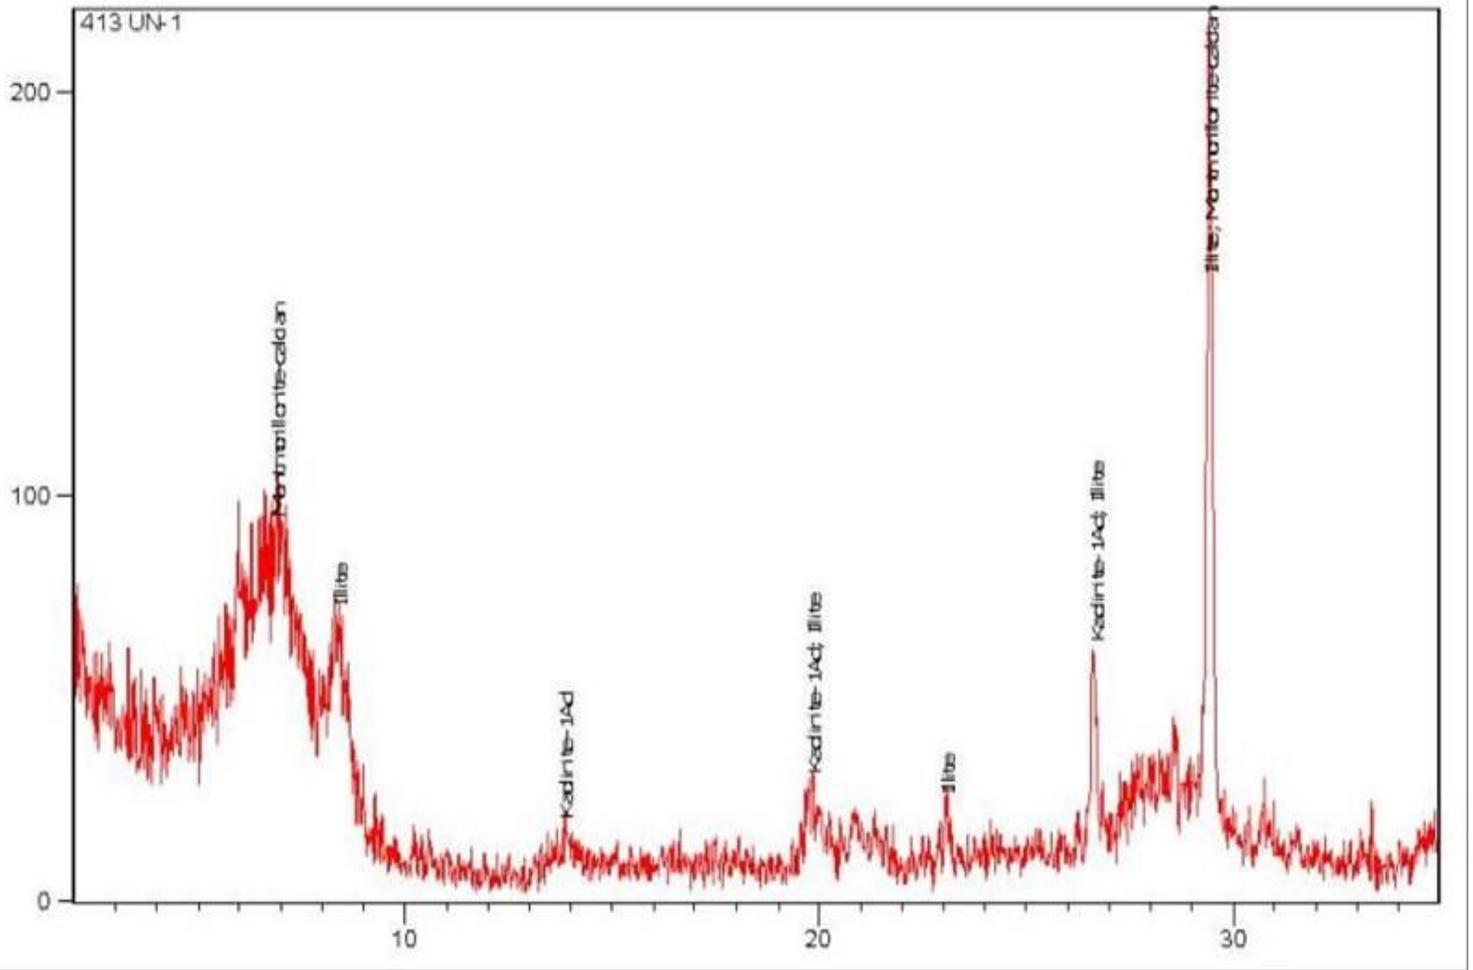
**Figure 17**

X-ray Diffraction pattern showing the clay minerals of natural or air treated untreated clay fractions sample from Esna shale Member, where the Horemheb tomb (KV57) is excavated.

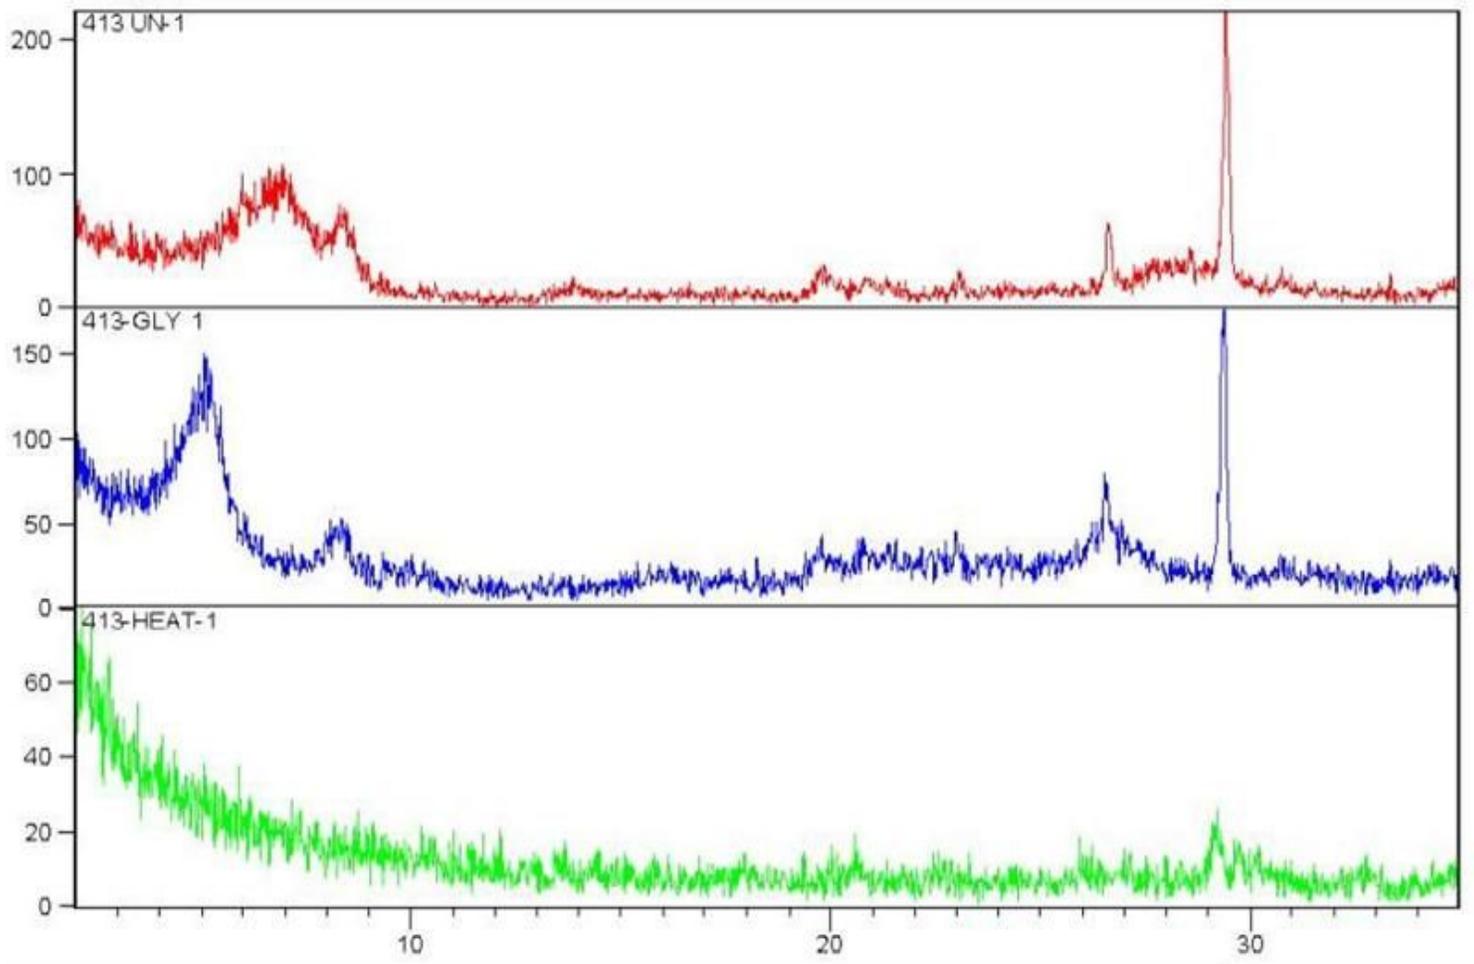
**Figure 18**

XRD for the air dried, ethylene glycol treated, and heated to 550C clay fractions from samples of Esna shale, showing decrease and disappearance of peak of Illite/Smectite (I/S) and the present of the Montmorillonite.

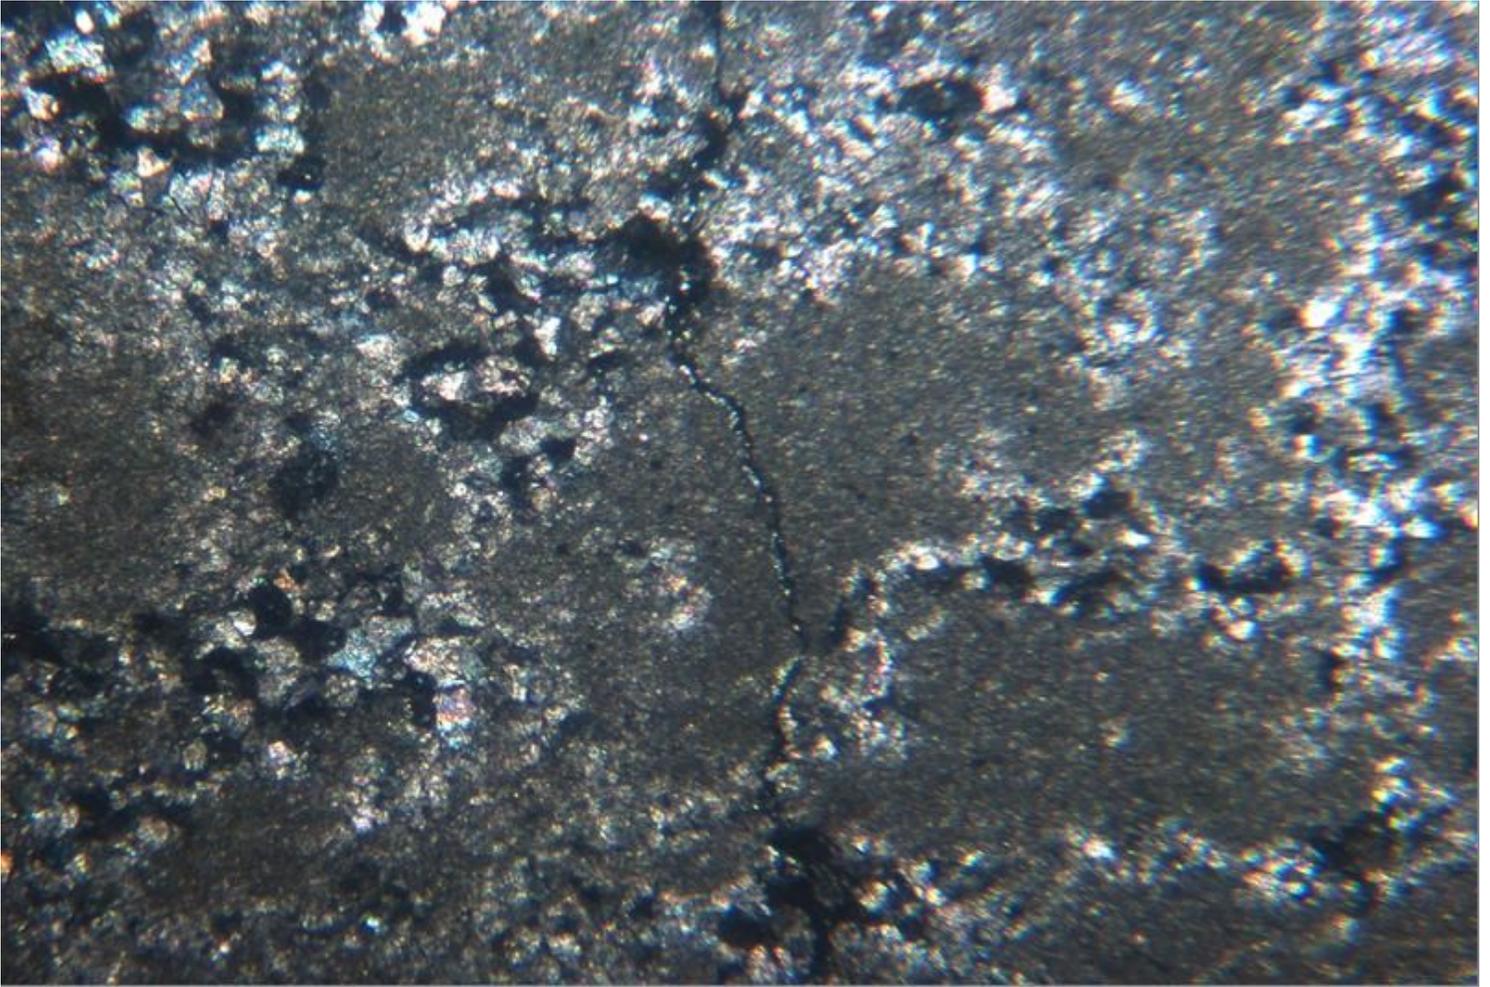
**Figure 19**

C.N. Microscopic photograph shows The marl sample from Member I is very fine-grained to fine-grained. Considerable amounts of cavities and microvioletlets filling by recrystallized dolomite are observed in the micritic calcite matrix. The rock is very to fine-grained and composed mainly of calcite and dolomite as the essential components associated with minor amount of clay minerals and rare amounts of microcrystalline quartz, iron oxides and opaques. Calcite represents the matrix of the rock and occurs as very fine-grained (micrite), anhedral to subhedral interlocked crystals. Dolomite occurs as very fine to fine-grained, euhedral to subhedral crystals and filling microvioletlets and cavities. Quartz is detected as very fine-grained crystals scattered in the matrix. Some pores of irregular shapes and various sizes are observed scattered in the rock. Some parts of the sample are stained by iron oxides

Thin-sections prepared on the marl limestone and Esna shale samples where the KV57 is excavated. C.N. Microscopic photograph shows the marl sample from Member I is very fine-grained to fine-grained. Considerable amounts of cavities and microvioletlets filling by recrystallized dolomite are observed in the micritic calcite matrix. The rock is very to fine-grained and composed mainly of calcite and dolomite as the essential components associated with minor amount of clay minerals and rare amounts of microcrystalline quartz, iron oxides and opaques. Calcite represents the matrix of the rock and occurs as very fine-grained (micrite), anhedral to subhedral interlocked crystals. Dolomite occurs as very fine to fine-grained, euhedral to subhedral crystals and filling microvioletlets and cavities. Quartz is detected as very fine-grained crystals scattered in the matrix. Some pores of irregular shapes and various sizes are observed scattered in the rock. Some parts of the sample are stained by iron oxides, as shown in Figure (19). C.N. Microscopic photograph shows the Esna shale sample is very fine to fine-grained (mainly sand size), well sorted that is cemented by minor amounts of iron oxides, clay minerals and carbonates. The sample is porous where pore spaces of different sizes are observed. The rock is composed mainly of quartz and feldspar grains cemented by minor amounts of iron oxides, clay minerals and calcite. Rare amounts of muscovite, biotite, hornblende and opaque minerals are observed in the sample. Quartz occurs as very fine to fine grains of subrounded to angular shape. Feldspars occur as fine grains that are observed in different parts of the sample. Opaque minerals occur as very fine to fine-grained crystals, scattered

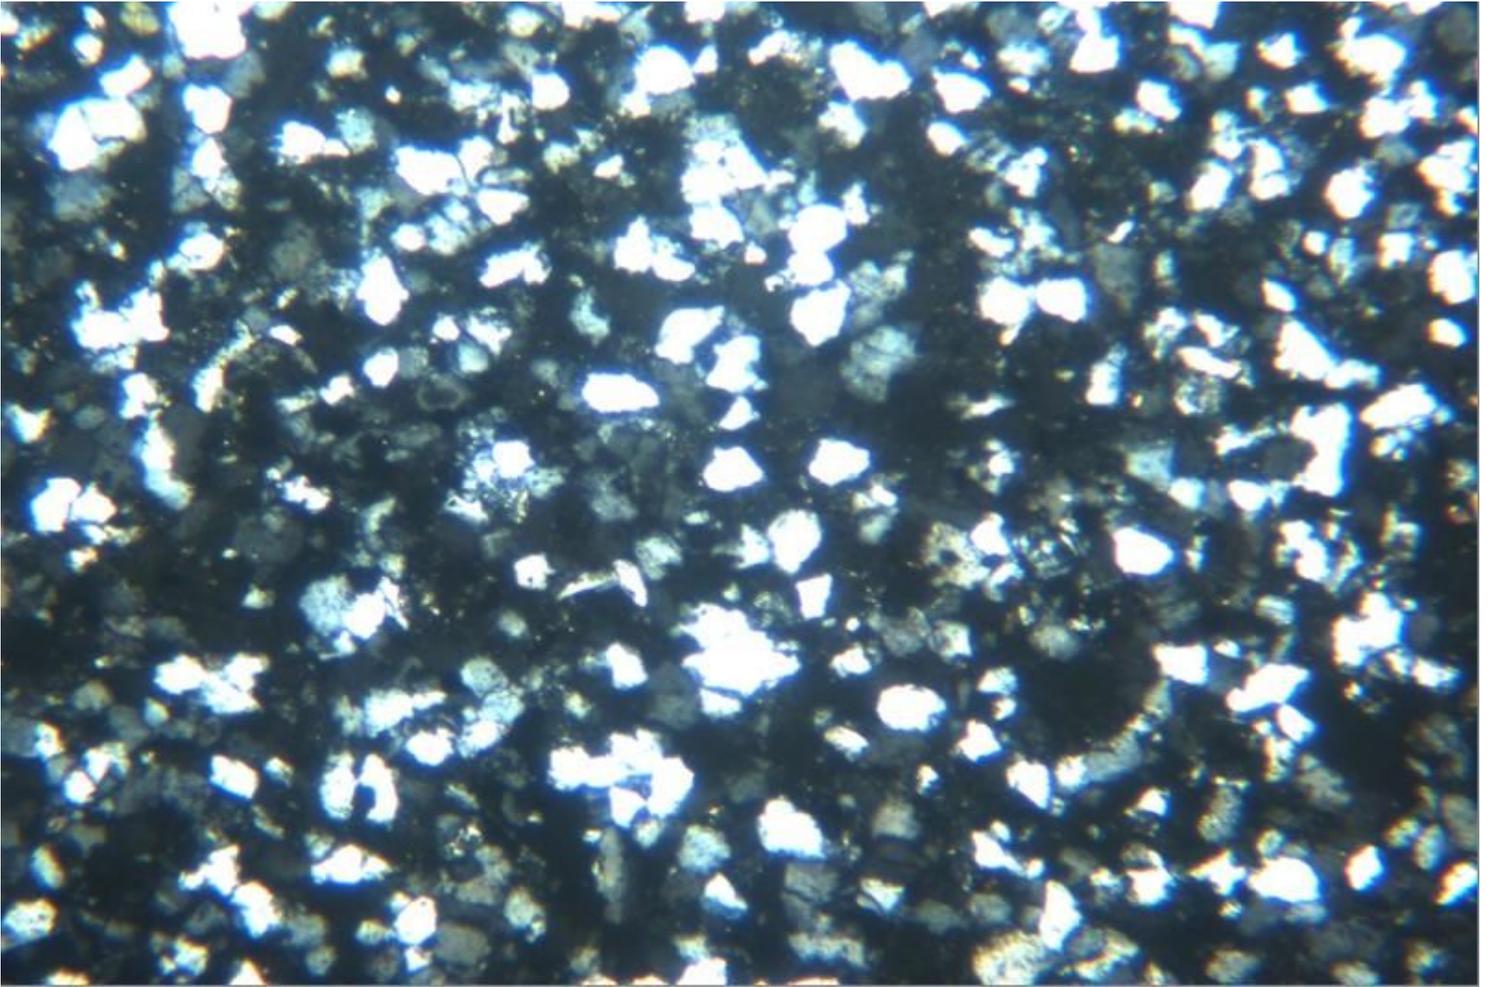
**Figure 20**

C.N. Microscopic photograph shows the Esna shale sample is very fine to fine-grained (mainly sand size), well sorted that is cemented by minor amounts of iron oxides, clay minerals and carbonates. The sample is porous where pore spaces of different sizes are observed. The rock is composed mainly of quartz and feldspar grains cemented by minor amounts of iron oxides, clay minerals and calcite. Rare amounts of muscovite, biotite, hornblende and opaque minerals are observed in the sample. Quartz occurs as very fine to fine grains of subrounded to angular shape. Feldspars occur as fine grains that are observed in different parts of the sample. Opaque minerals occur as very fine to fine-grained crystals, scattered in the sample. Some parts of the sample are stained by traces of iron oxides

in the sample. Some parts of the sample are stained by traces of iron oxides, as shown in figure (20).

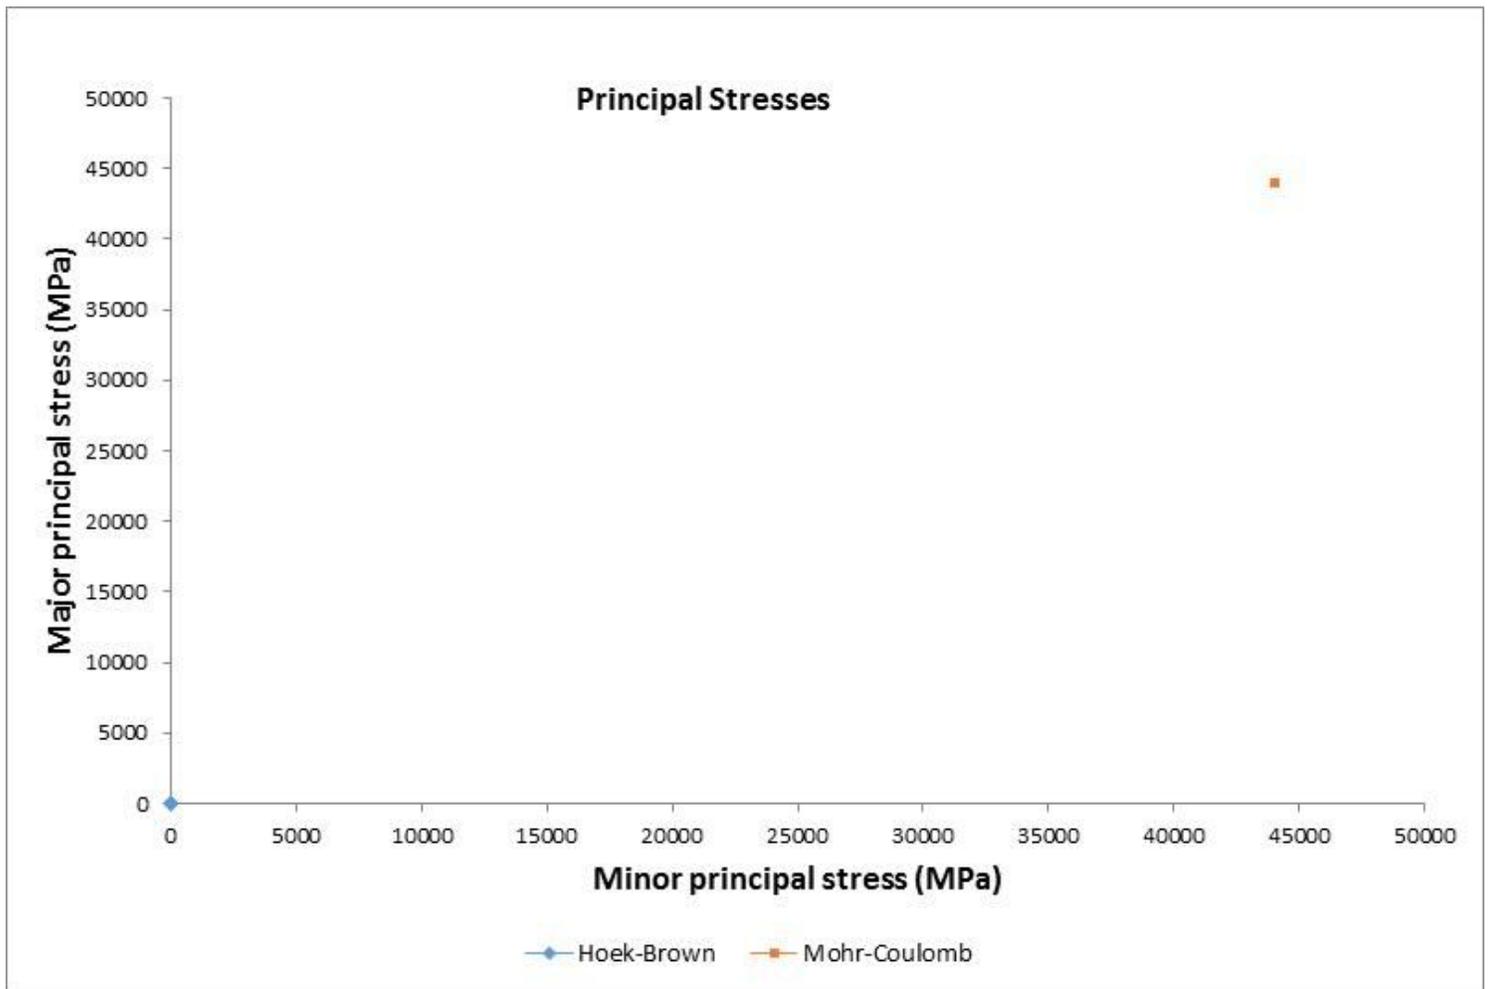
Figure 21

Major and minor principal stress curve of marl limestone (KV57) using the RocLab program.

Rock mass parameters: Tensile strength of intact rock  $\sigma_t$  = -0.016 MPa, Uniaxial compressive strength 800 kPa, as shown in Figures (21) and (22). Table (9) summarizes the Hoek Brown classification, Hoek Brown Criterion, Failure Envelope Range, Mohr-Coulomb Fit and Rock mass parameters for the marl limestone member 1 where the entrance Horemheb tomb (KV57) is excavated, using the RocLab program.

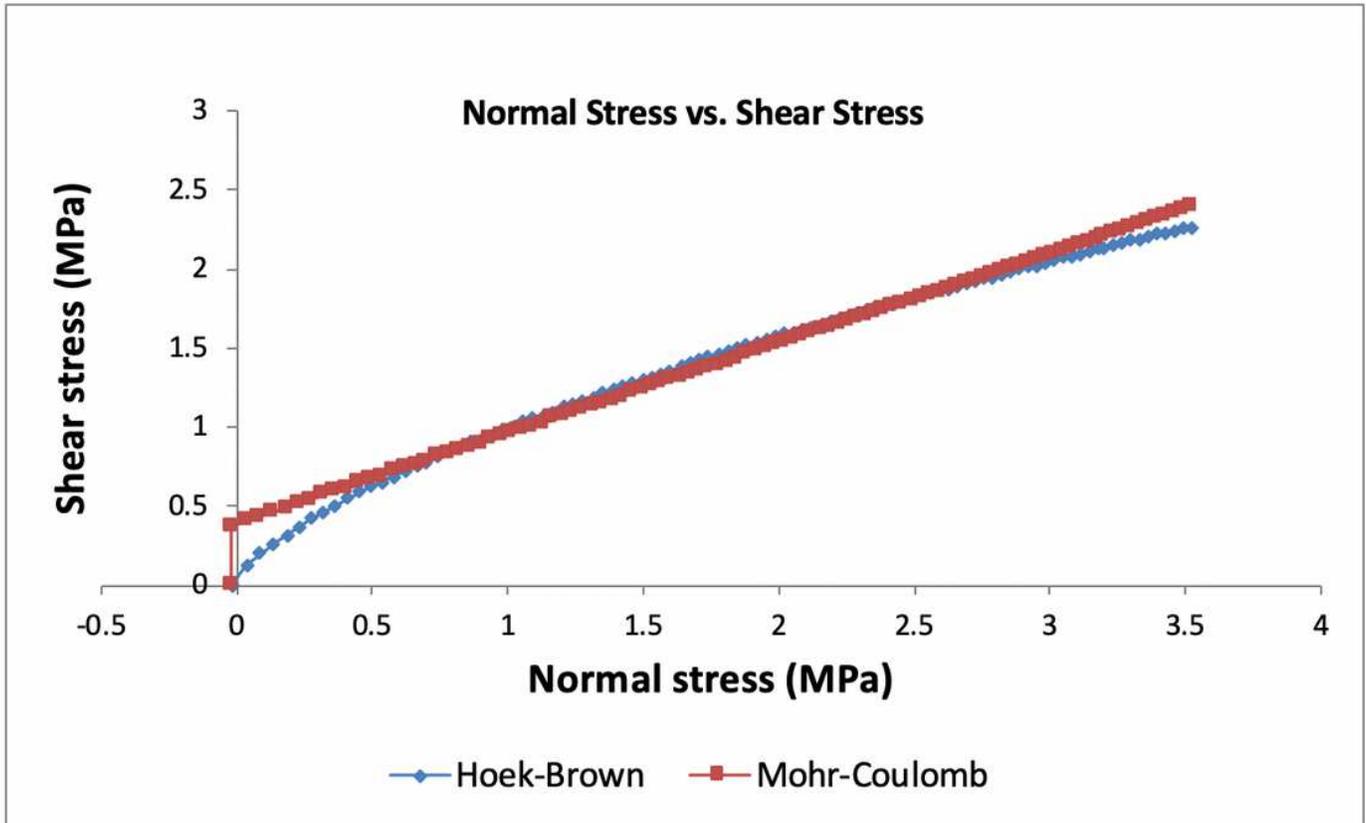
Figure 22

Shear stress-Normal stress curve of Marl limestone (KV57), using the RocLab program.

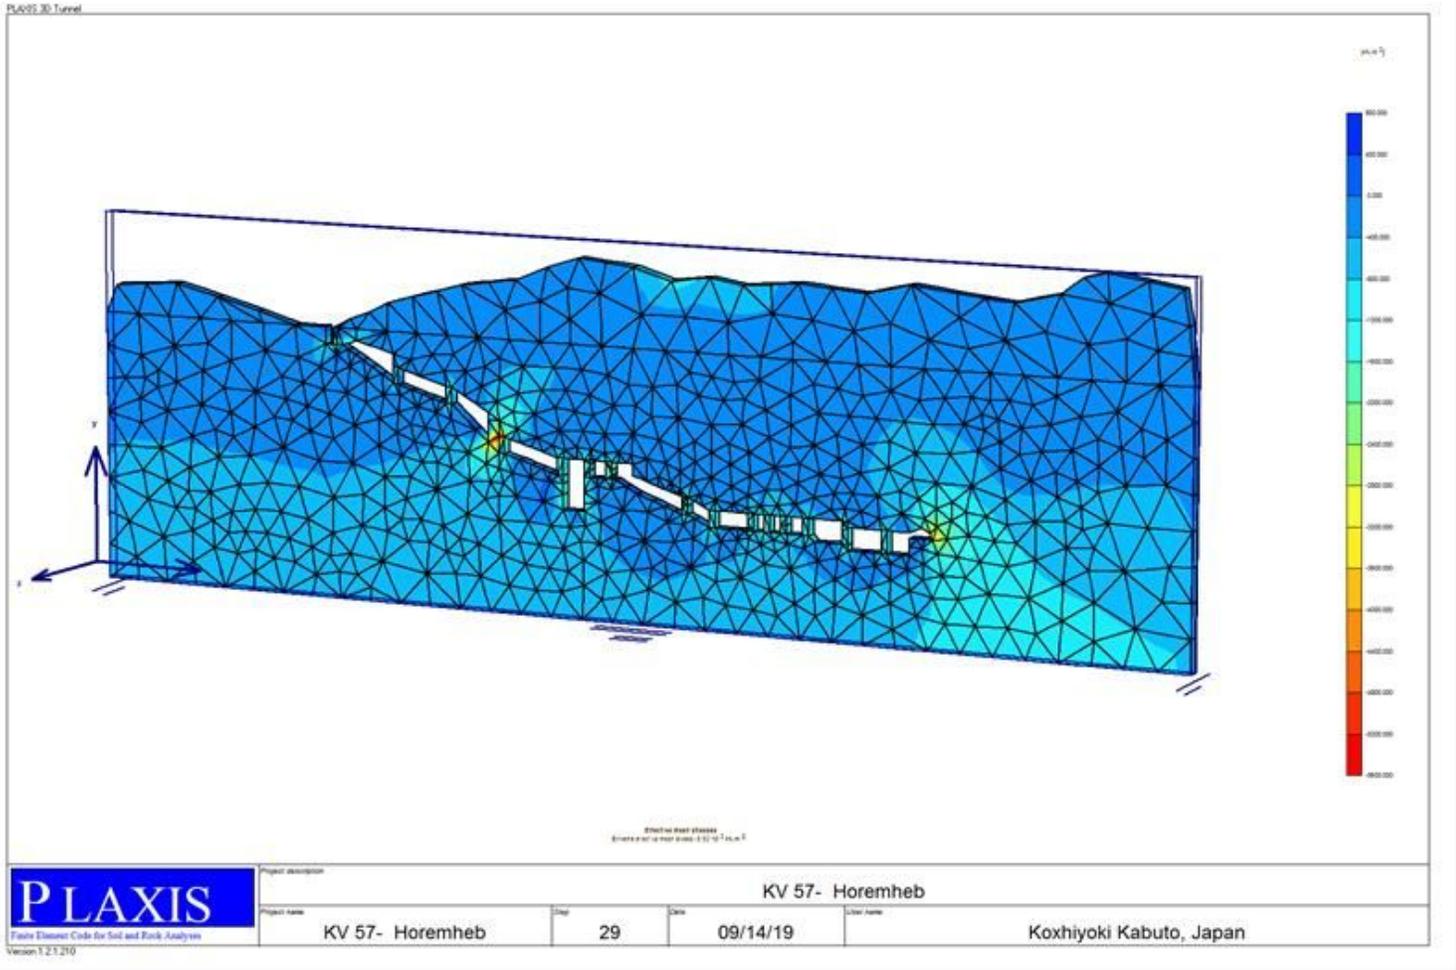
**Figure 23**

Effective mean stresses for the supported rock pillars and sidewalls in KV57, the extreme value is  $5.52 \times 10^3 \text{ kN/m}^2$ .

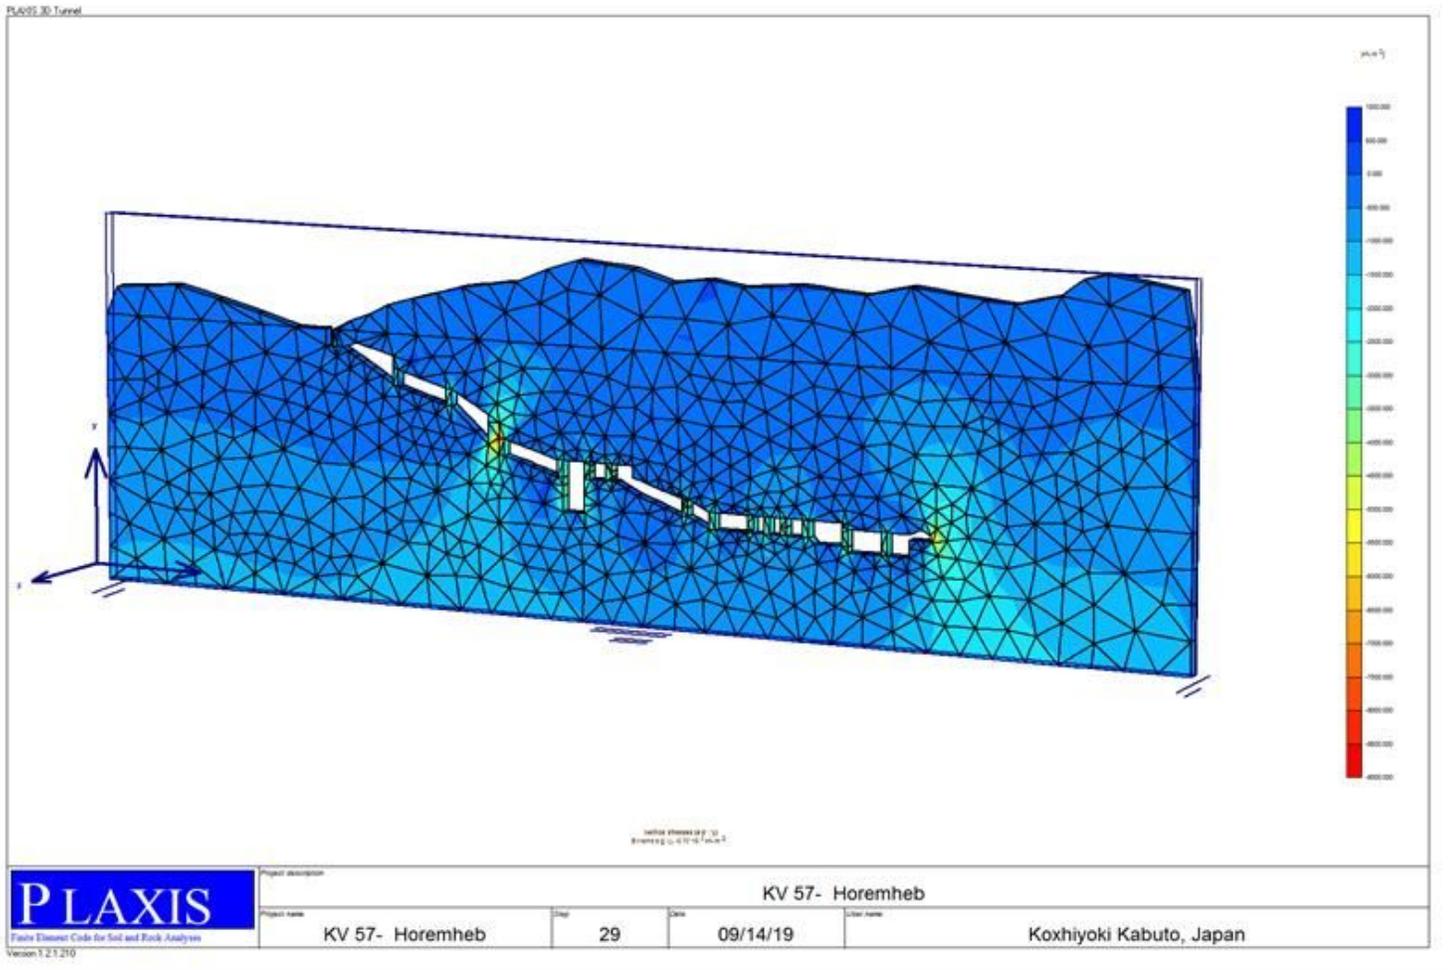
**Figure 24**

Vertical stresses ( $\sigma_{yy}$ ) for the supported rock pillars and sidewalls in KV57, the extreme value is  $8.70 \cdot 10^3 \text{ kN/m}^2$ .

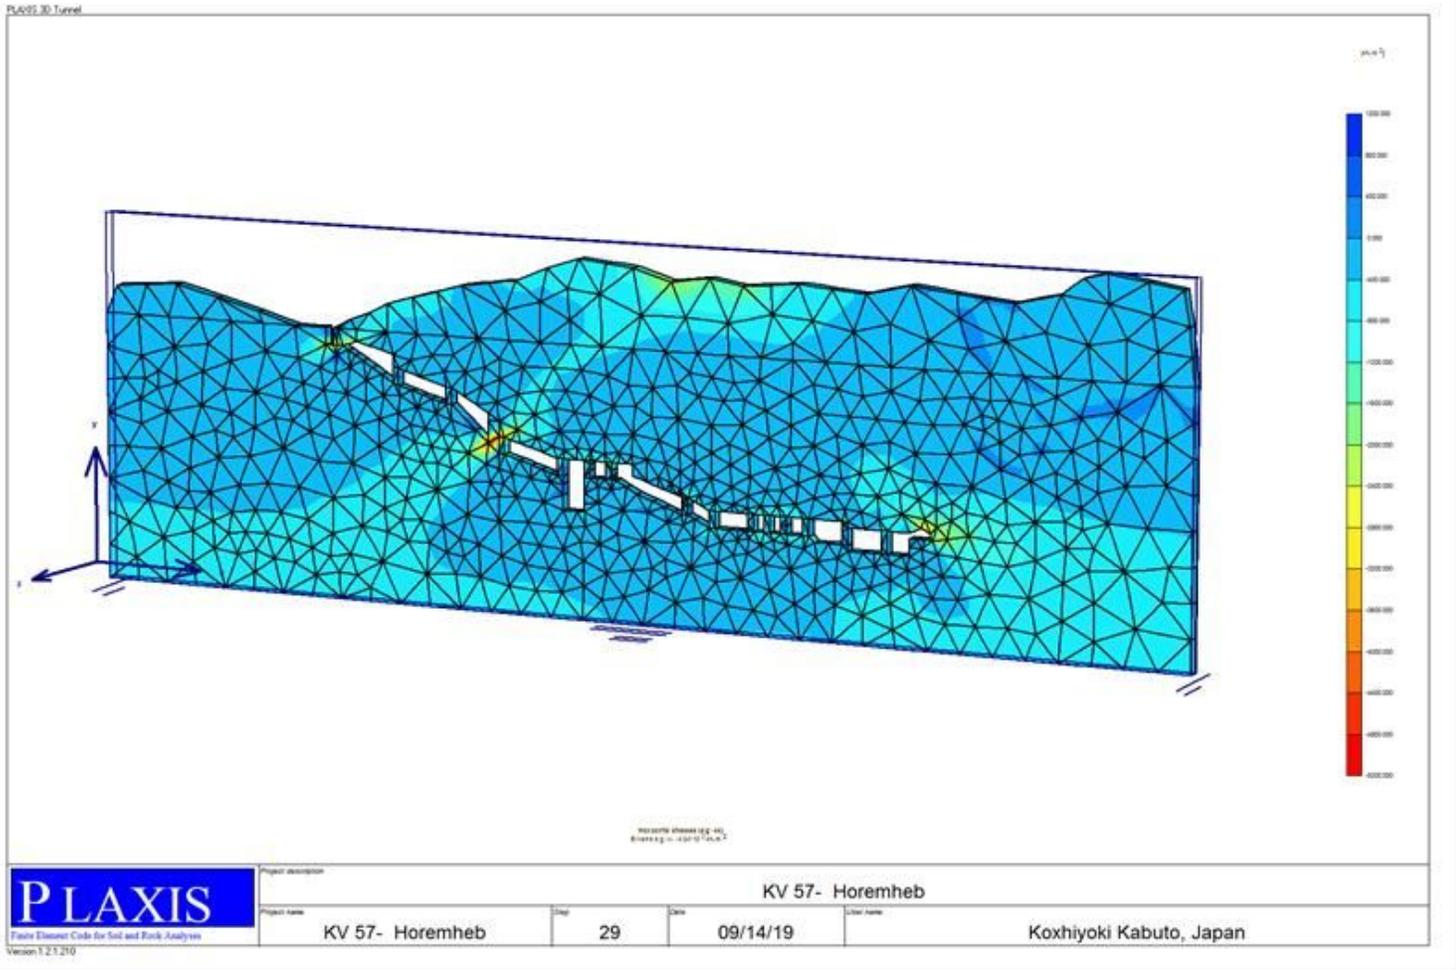
**Figure 25**

Horizontal stresses (sig xx) for the supported rock pillars and sidewalls in KV57, the extreme value is  $4.94 \cdot 10^3 \text{ kN/m}^2$ .

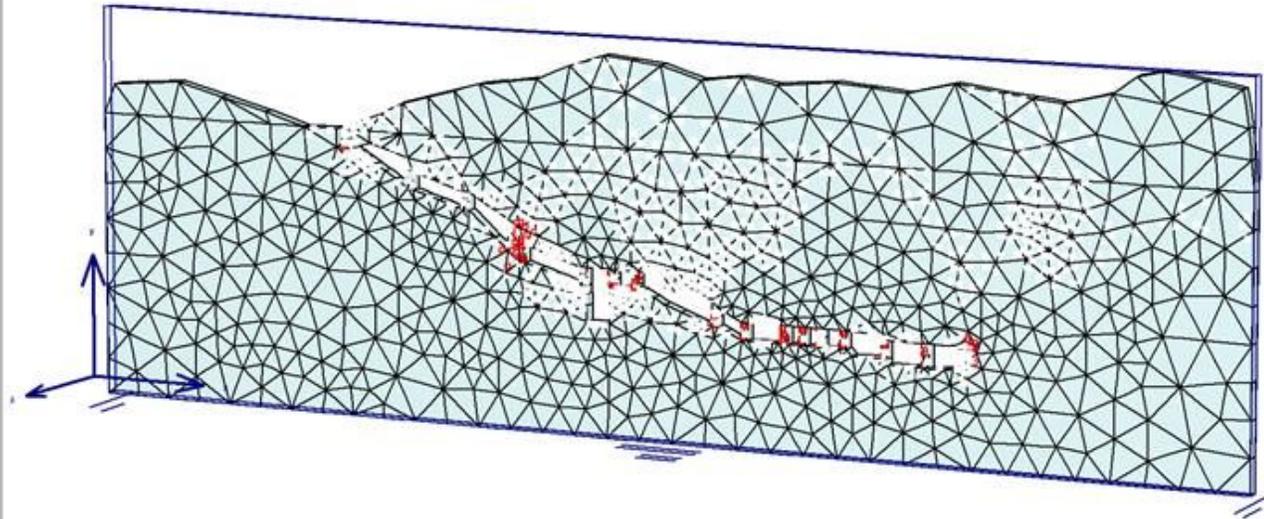
**Figure 26**

Plastic points (Mohr-Coulomb and Tension cut-off points) for the supported rock pillars and sidewalls in KV57.

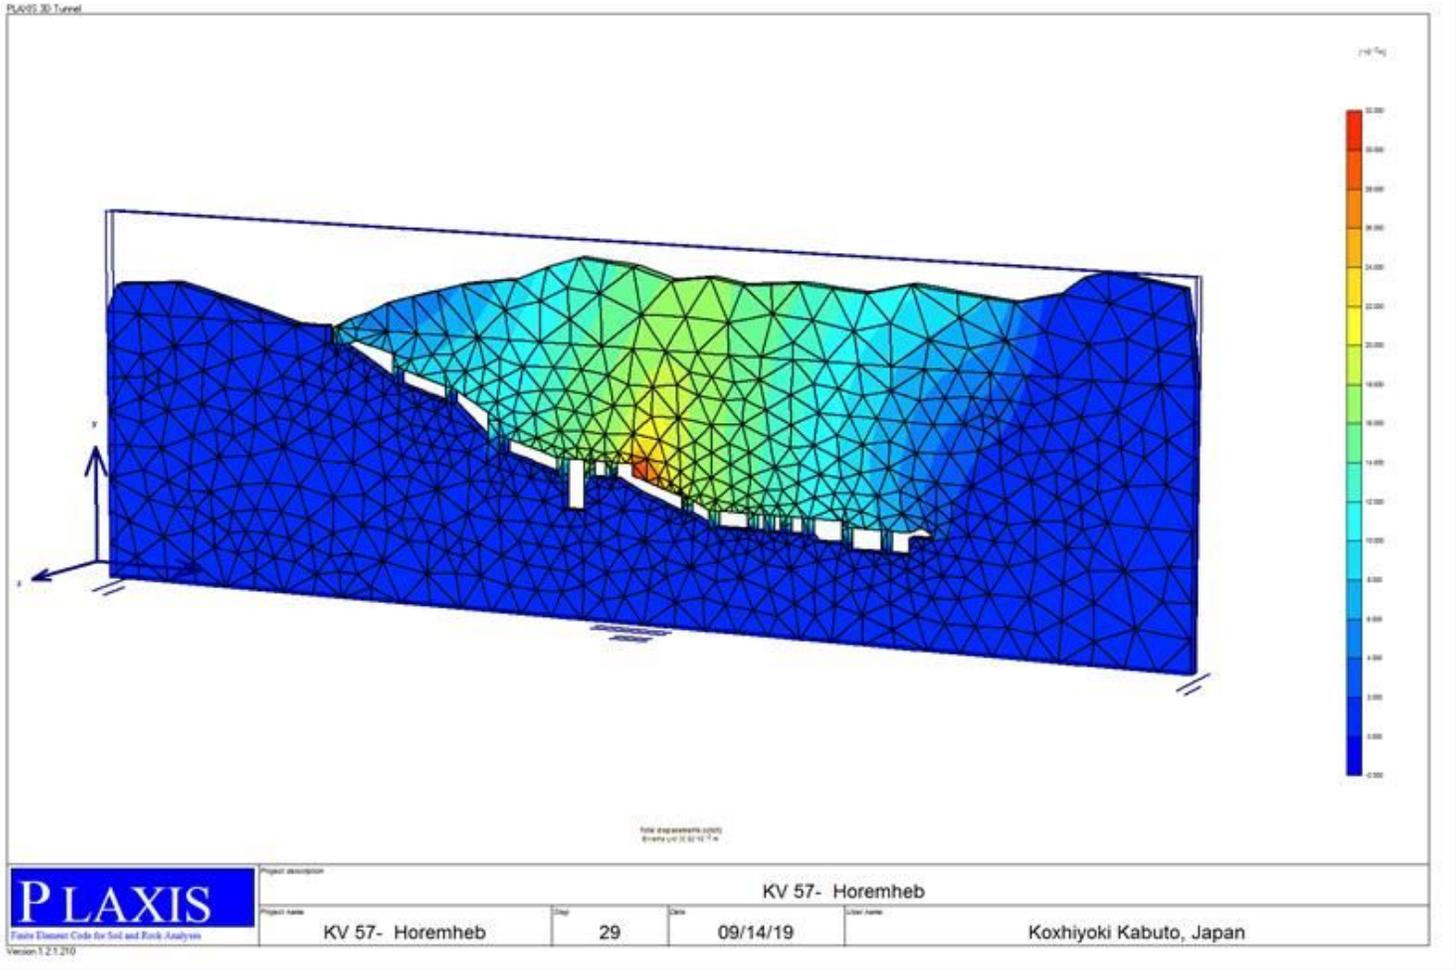
**Figure 27**

Total displacement ( $U_{tot}$ ) for the supported rock pillars and sidewalls in KV57, the extreme value is 30.92mm.

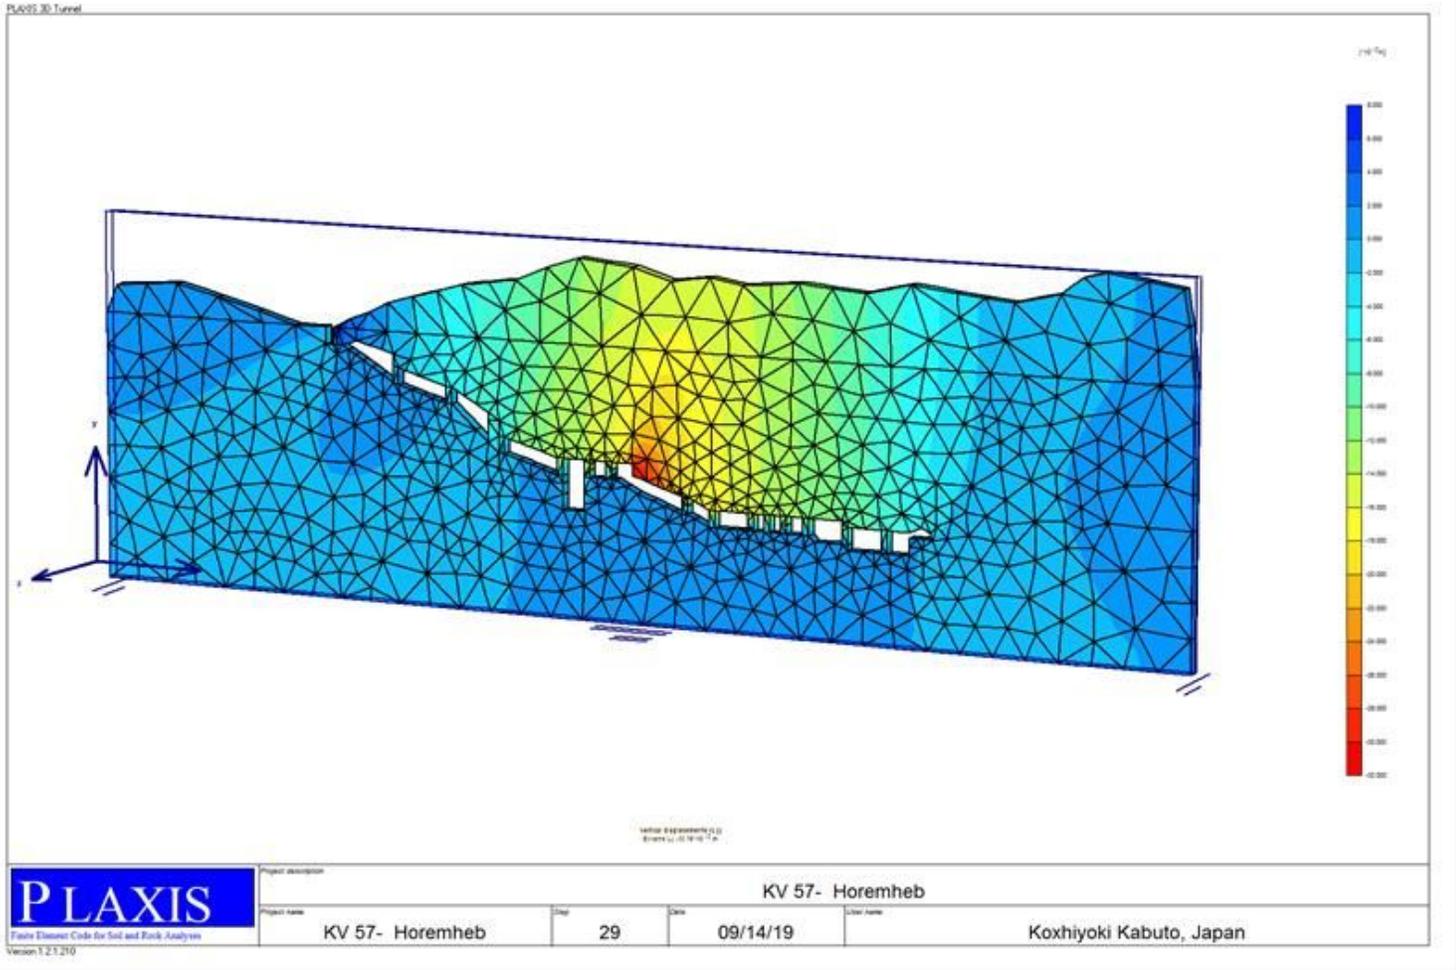
**Figure 28**

Vertical displacement ( $U_y$ ) for the supported rock pillars and sidewalls in KV57, the extreme value is 30.76mm.

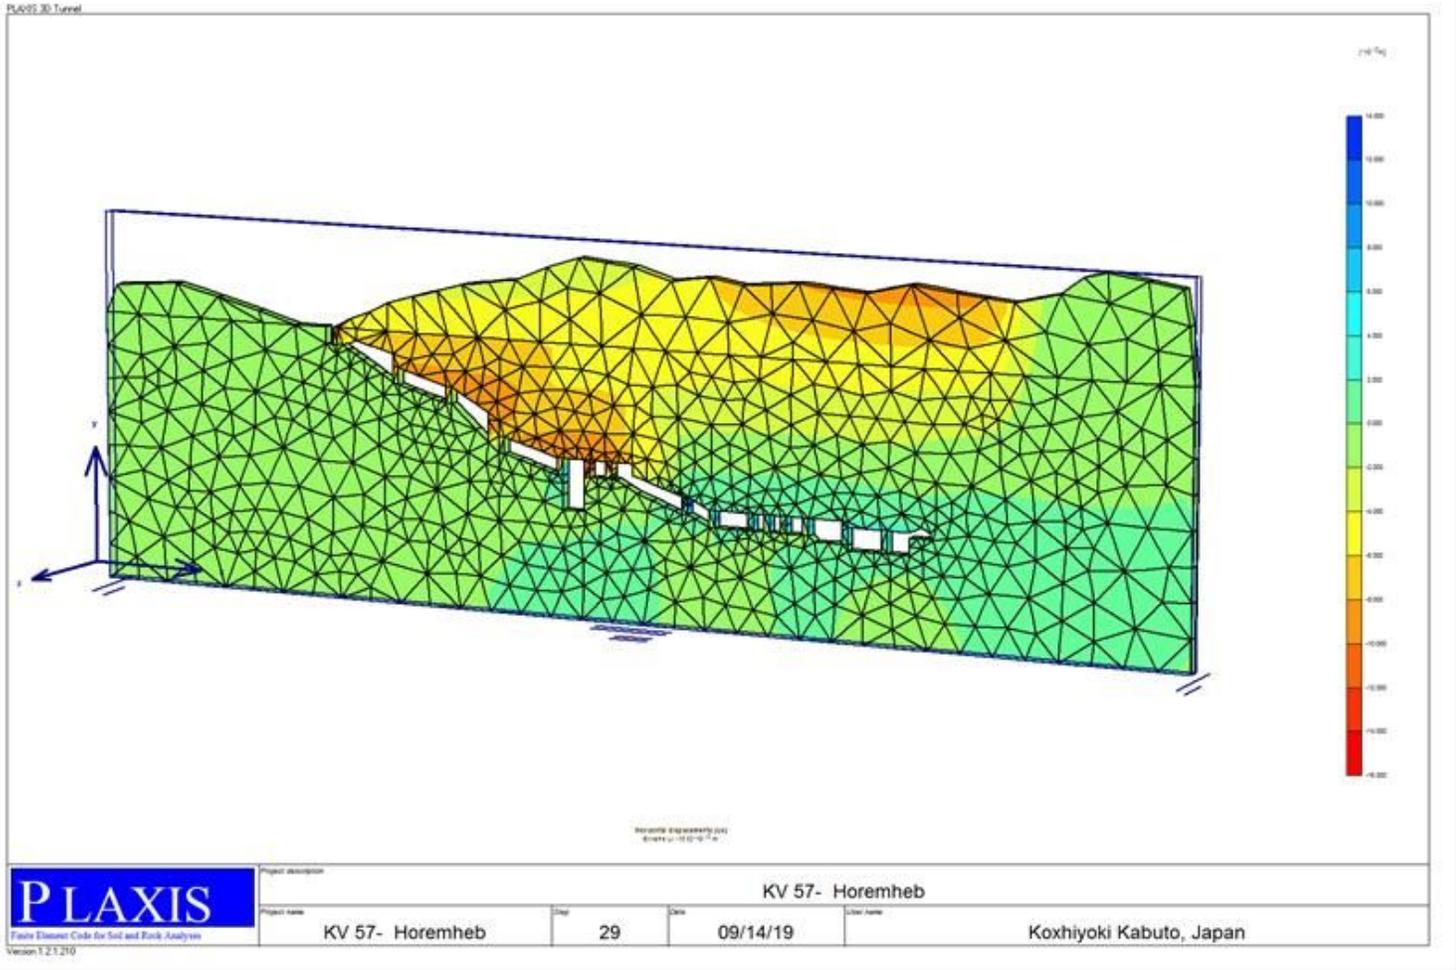
**Figure 29**

Horizontal displacement ( $U_x$ ) for the supported rock pillars and sidewalls in KV57, the extreme value is 15.52mm.

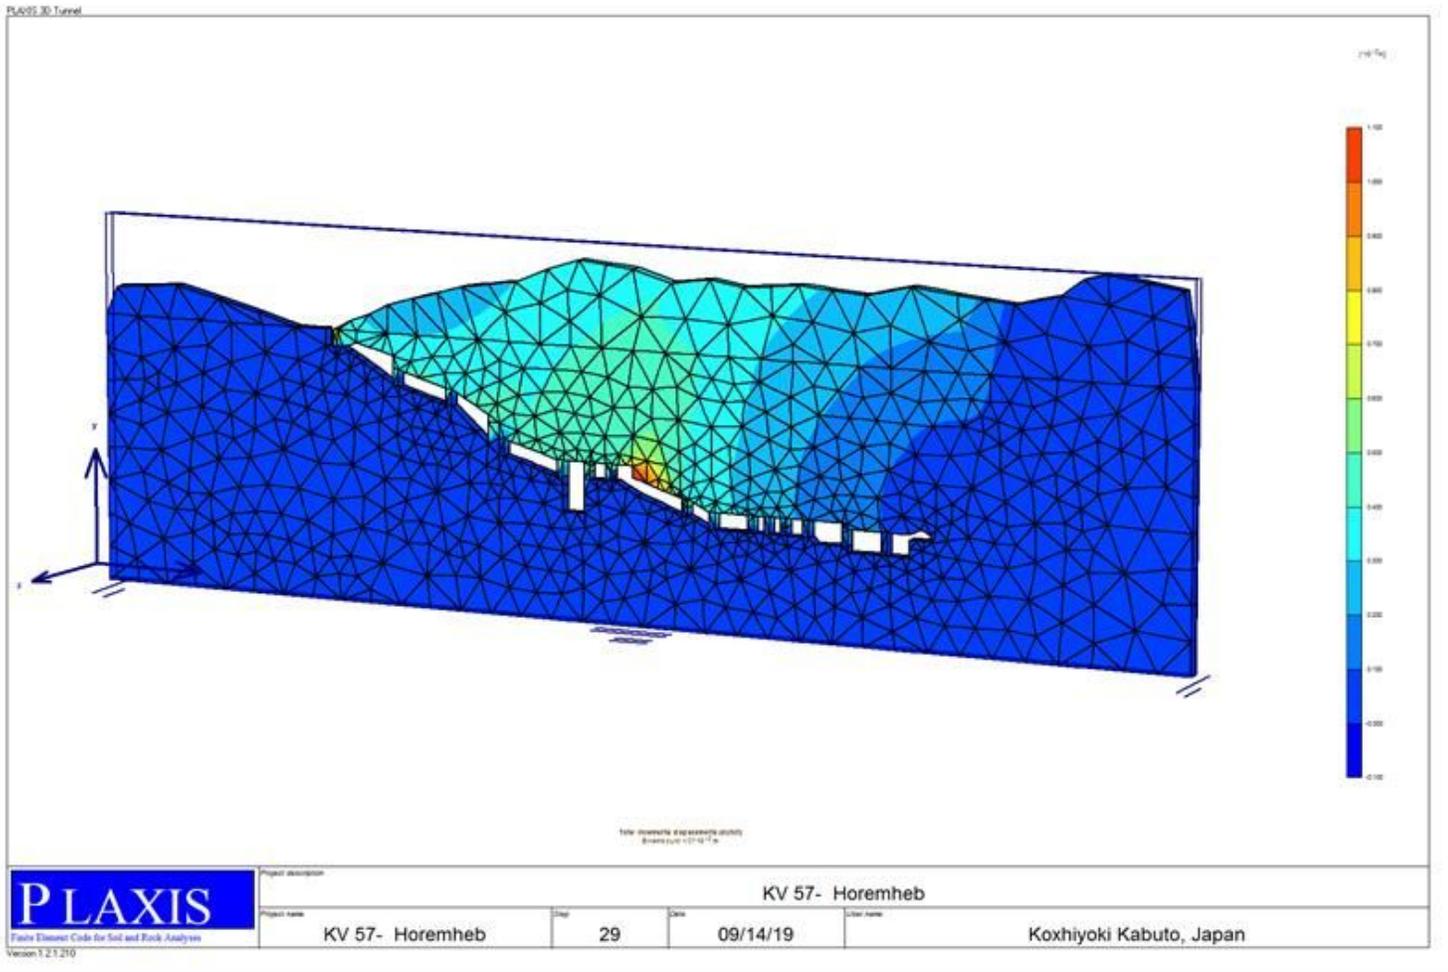
**Figure 30**

Total incremental displacement ( $dU_{tot}$ ) for the supported rock pillars and sidewalls in KV57. The extreme value 1.07mm.

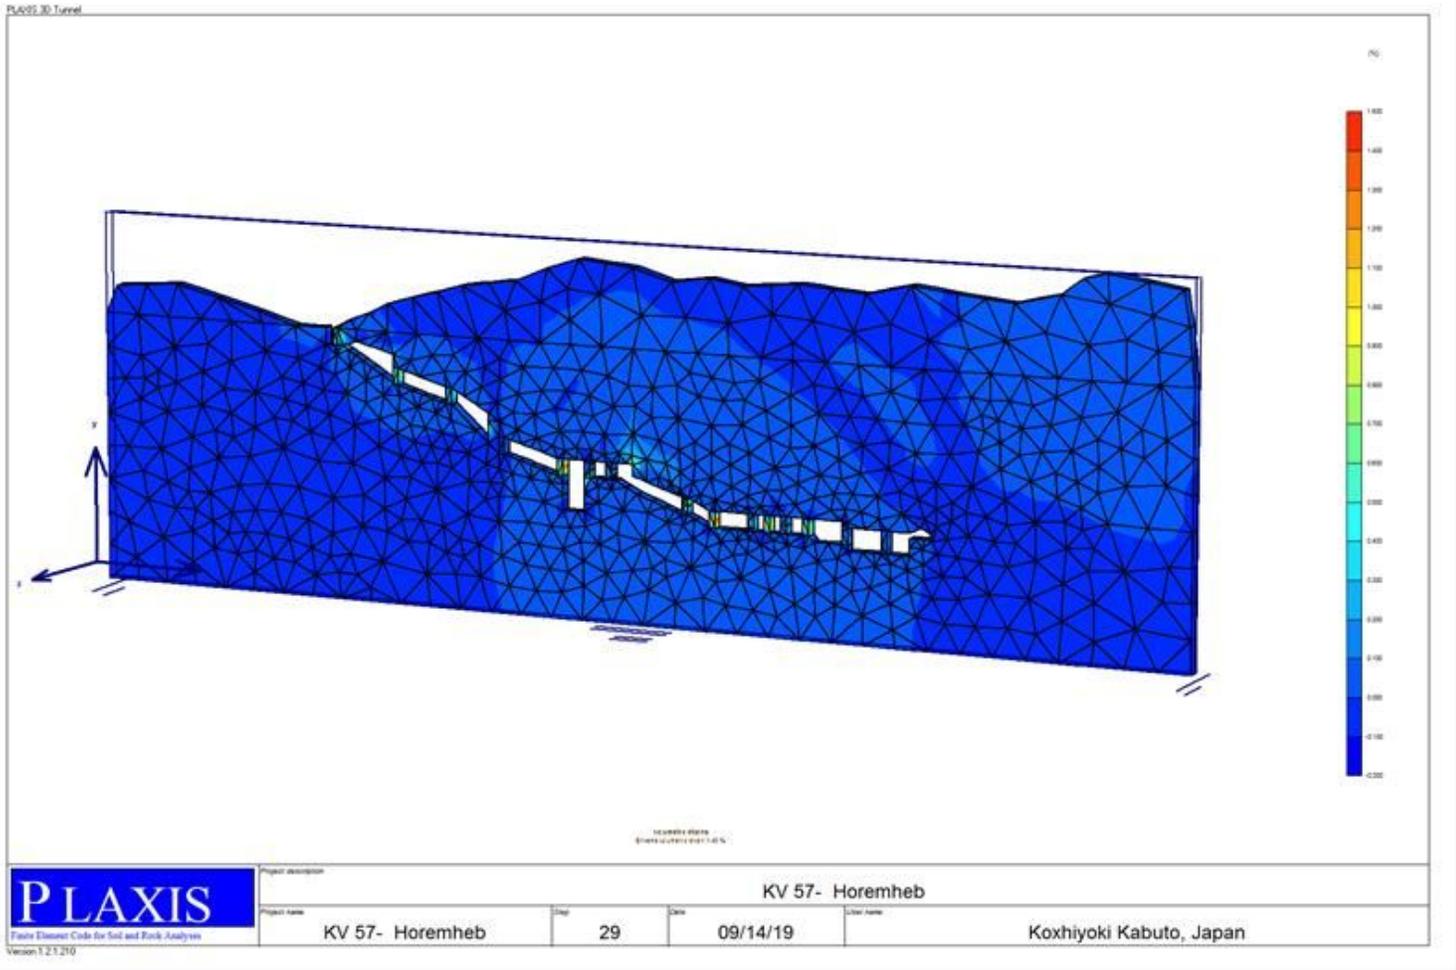
**Figure 31**

Volumetric strains for the supported rock pillars and sidewalls in KV57. The extreme value 1.45 %.
