# Corrosion Behavior and Failure Mechanism of Rock Bolt(Cable) in Underground Coal Mine

# Corrosion behavior and failure mechanism of rock bolt(cable) in underground coal mine

**Abstract** Premature failure of rock bolt (cable) due to stress corrosion cracking (SCC) is a phenomenon that has reported to occur in underground environments. In this study, the corrosion behavior and failure mechanism of rock bolt (cable) samples obtained from underground coal mine were examined and discussed. Macroscopic observation and weight loss test were carried out for the corrosion characteristics of the bolts without failure. It is found the corrosion form is uniform corrosion for the bolts with short service time (S-1, S-2). But for the bolts with longer service time (S-3, S-4 and S-5), experience different degrees of pitting corrosion and the number of corrosion spots on the surface of the sample increases with increase of the service time. The corrosion amount of different parts of the bolts shows the rule of bolt head > bolt end > free section, and the corrosion amount increases year by year with the service time, but the corrosion growth rate is fast in the early stage and slows down in th

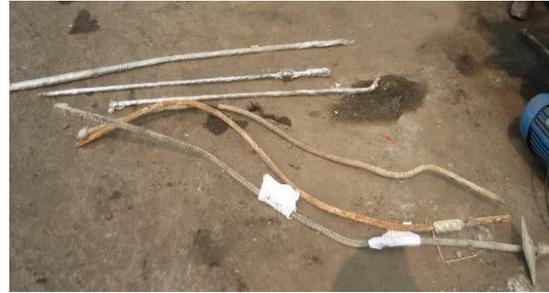
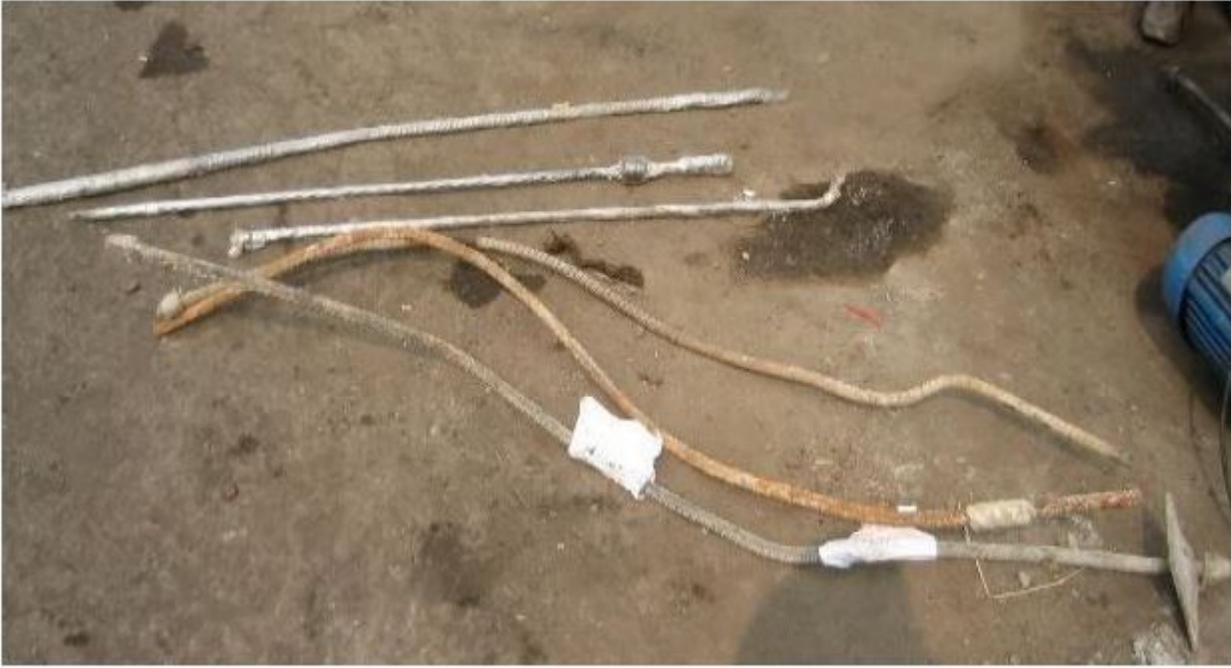
Figure 2 Bolt (cable) samples

Bolt (cable) samples

The samples were taken from Qishan Coal Mine in Xuzhou, China. Qishan Coal Mine is a typical old mine, which was put into operation in December 1959. The influencing environmental factors such as temperature and humidity, pH value of seepage water, harmful ions, stray current, residual prestress and so on were tested before examination. It is found that the surrounding rock environment of the bolts (cables) is stable in the same horizontal stratum, which provides the possibility to study the corrosion behavior of the rock bolts with different service years. Six full-length adhesive samples were drilled in the -700m East Wing return airway. Fig. 1 shows the fielding sampling diagram. After the bolt (cable) samples were taken out, they were immediately packed and sealed with the plastic wrap in order to avoid the accelerated corrosion caused by the contact with air which would otherwise affect the test results. The samples obtained from underground coal mine were shown in Fig. 2, which numbered as S-1, S-2, S-3, S-4, S-5, S-6 respectively. The details of bolt

As shown by the appearance of the bolt samples taken, all samples have slight corrosion, which can be divided into uniform corrosion and local pit corrosion. S-1 and S-2 are characterized by uniform corrosion, and pit corrosion occurs in different parts of S-3, S-4 and S-5. The number of corrosion spots on the surface of each samples increases with the increase of service time. For example, a large area of corrosion spots can be found on the surface of S-5 bolt which has been used for 8 years, and the depth of some pits reaches 0.18 mm.

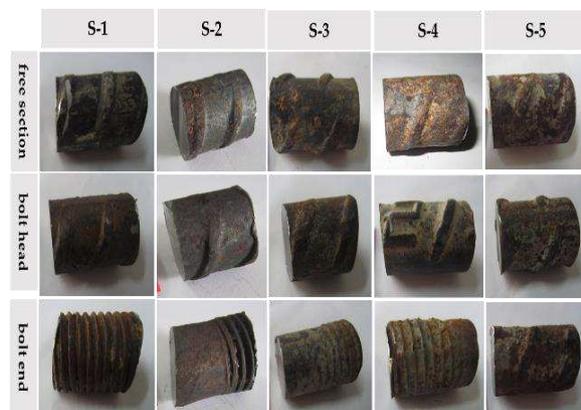
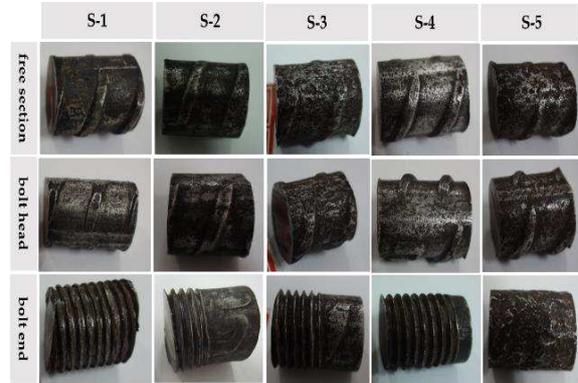
**Figure 3** Comparison of sample before and after derusting

(b) Bolt sample after derusting

(a) Bolt sample before derusting

Comparison of sample before and after derusting

The corrosion degree of five bolt samples which were not failed was analyzed, and the weight loss was measured on 2 cm samples taken respectively from the bolt head, free section and anchorage section. The bolt was derusted by acid pickling. Fig. 3 shows the schematic diagram of the bolt samples before and after derusting. The mass loss can directly and quantitatively characterize the corrosion degree of the bolt, which is calculated by Eq. (1), and the corrosion rate of the bolt is calculated by Eq. (2).

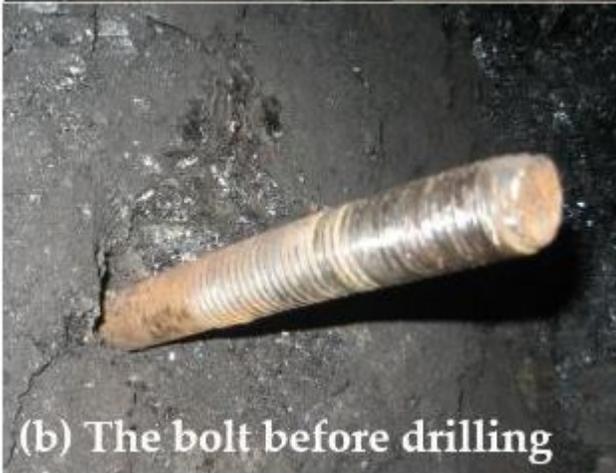
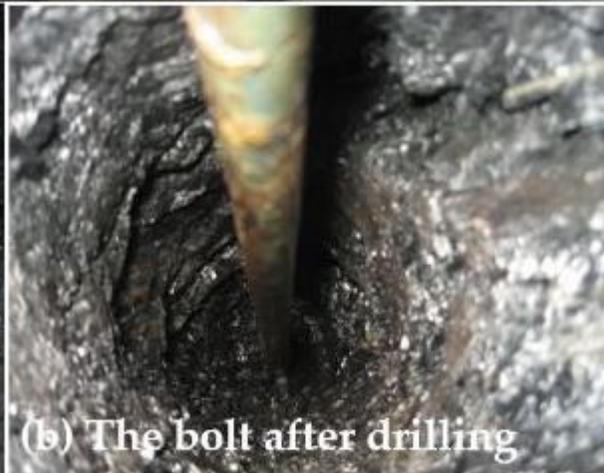
Figure 1 Field sampling diagram

Field sampling diagram

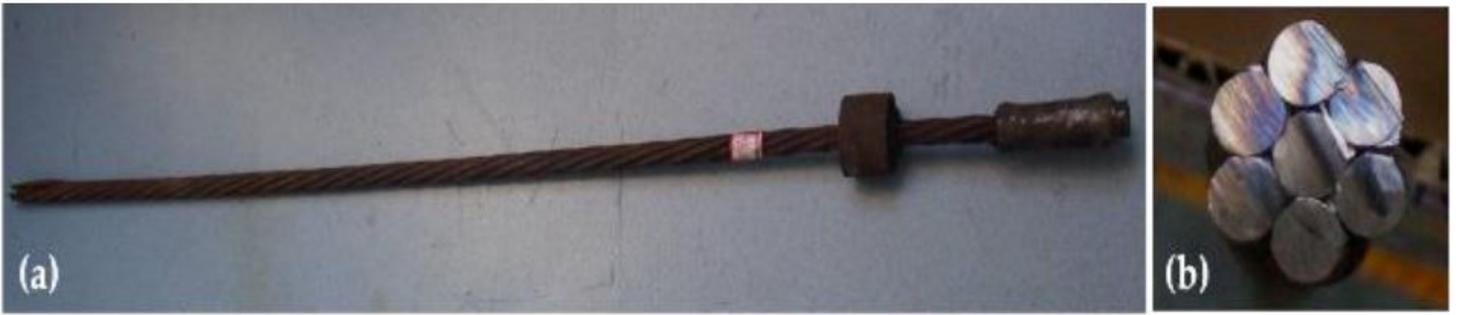
**Figure 6** morphology of the broken anchor cable: (a) Longitudinal morphology (b) Transverse section morphology

morphology of the broken anchor cable: (a) Longitudinal morphology (b) Transverse section morphology

The failure analysis of the anchor cable sample S-6 in use for six years in Qishan Coal Mine was conducted. Fig. 6 shows the overall morphology of S-6. The anchor cable has brown surface and consists of seven steel strands. The corrosion morphology of each area of the broken anchor cable sample is shown in Fig. 7. The macro analysis results show that the whole anchor cable is characterized by uniform oxidation corrosion (Fig. 7a). Pit corrosion is found in some areas of the steel strand in the region from about 900mm away from the anchorage to the fracture, as shown by the arrow in Fig. 7 (b). However, near the fracture (about 1200mm away from the anchorage), the number and degree of pit corrosion are relatively serious, and some places even have spalling (Fig. 7c). As shown in Fig. 7(c), the length of the steel strand at the breaking point of the anchor cable is different. It is an inclined fracture formed under tensile stress with a certain angle to the axial direction, and the longitudinal length of the fracture is about 25 mm. There is no obvious necking before fracture of these steel wires, and it can be observed that the steel strands crack from the outer surface with more serious oxidation and corrosion.

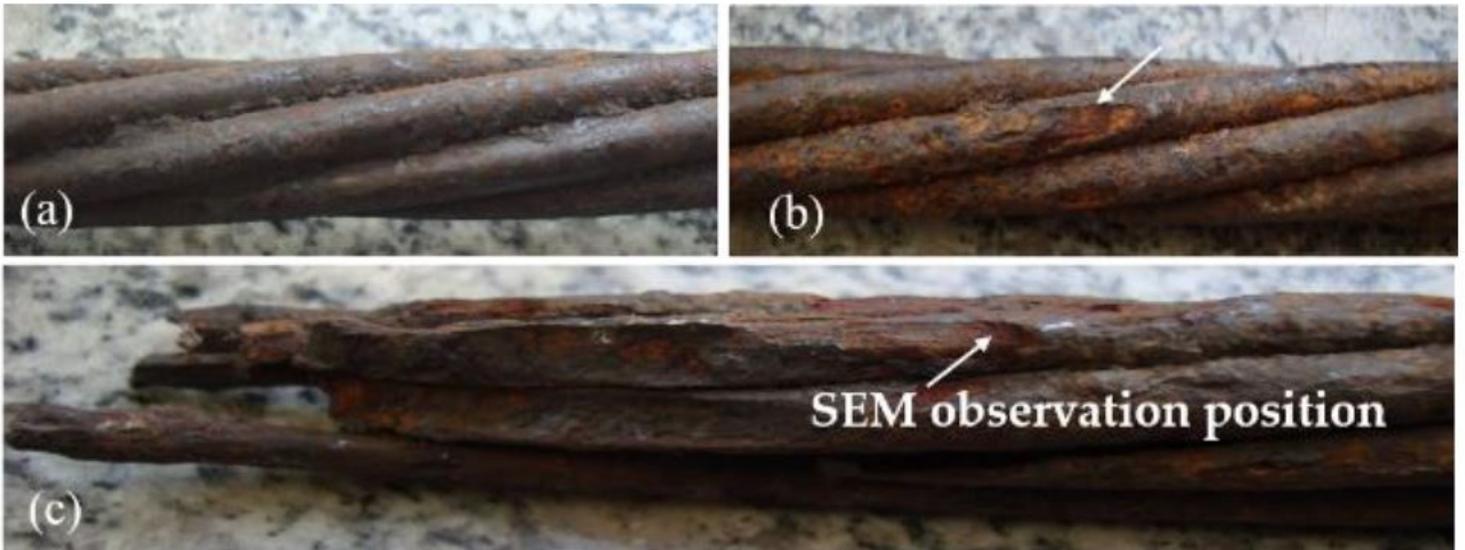
**Figure 7** Macro fracture corrosion morphology of the anchor cable: (a) the steel strand near anchorage (b) the steel strand near anchorage about 900mm away from anchorage (c) Fracture position

Macro fracture corrosion morphology of the anchor cable: (a) the steel strand near anchorage (b) the steel strand near anchorage about 900mm away from anchorage (c) Fracture position

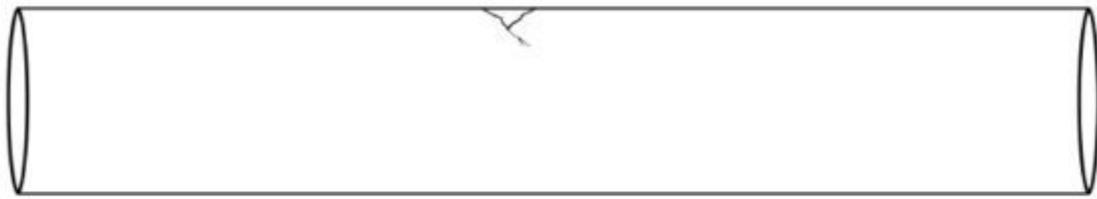
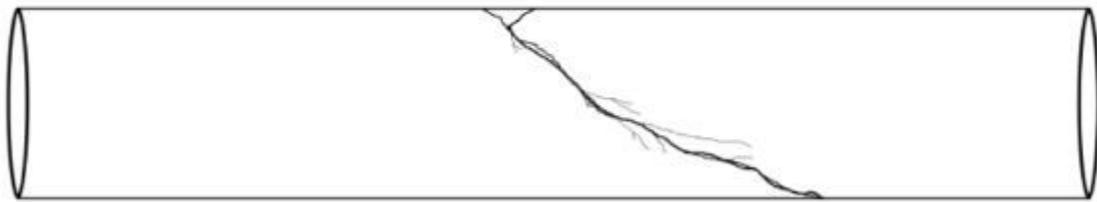
**Figure 13**

As known from the macroscopic and microscopic analysis of the samples, the failure samples are not characterized by obvious plastic deformation or necking, which indicates that the failure mode of the sample is brittle failure. The fracture path profile of the sample can be divided into three stages, as shown in Fig 13. In first stage,

there is a shallow crack perpendicular to the applied load in the fracture initiation area (Fig 13a). Then the crack deflects and propagates along the longitudinal direction in second stage (Fig 13b). Lastly, the sample was suddenly fractured with higher deviation angle in third stage (Fig 13c). This type of failure has also been observed in other research results (Proverbio et al. 2003; Toribio et al 2010; Perrin et al 2010), which is considered to be a typical feature of SCC. Therefore, to sum up, the failure samples have been in the O, Cl and S surrounding rock environment for a long time, which results in pit corrosion, causes the corrosion and spalling of surface material of the steel strand, reduces the outer diameter of the anchor cable and its bearing capacity, and leads to one-time SCC fracture of the anchor cable.

The fracture path profile of S-6

(3) The failure mechanism of sample S-6 is that it has been in the surrounding rock environment of O, Cl and S for a long time, resulting serious pitting corrosion and spalling of the surface material of the steel strand, which reduces the outer diameter of the rock cable and its bearing capacity, finally leads to the instantaneous SCC fracture of the sample S-6.
