Eliminating Delayed Cracks in Deep-Drawn SUS304 Cups Under Wider Range and Lower Magnitude of Blank Holding Forces Using Tin Coated Die

Research Article

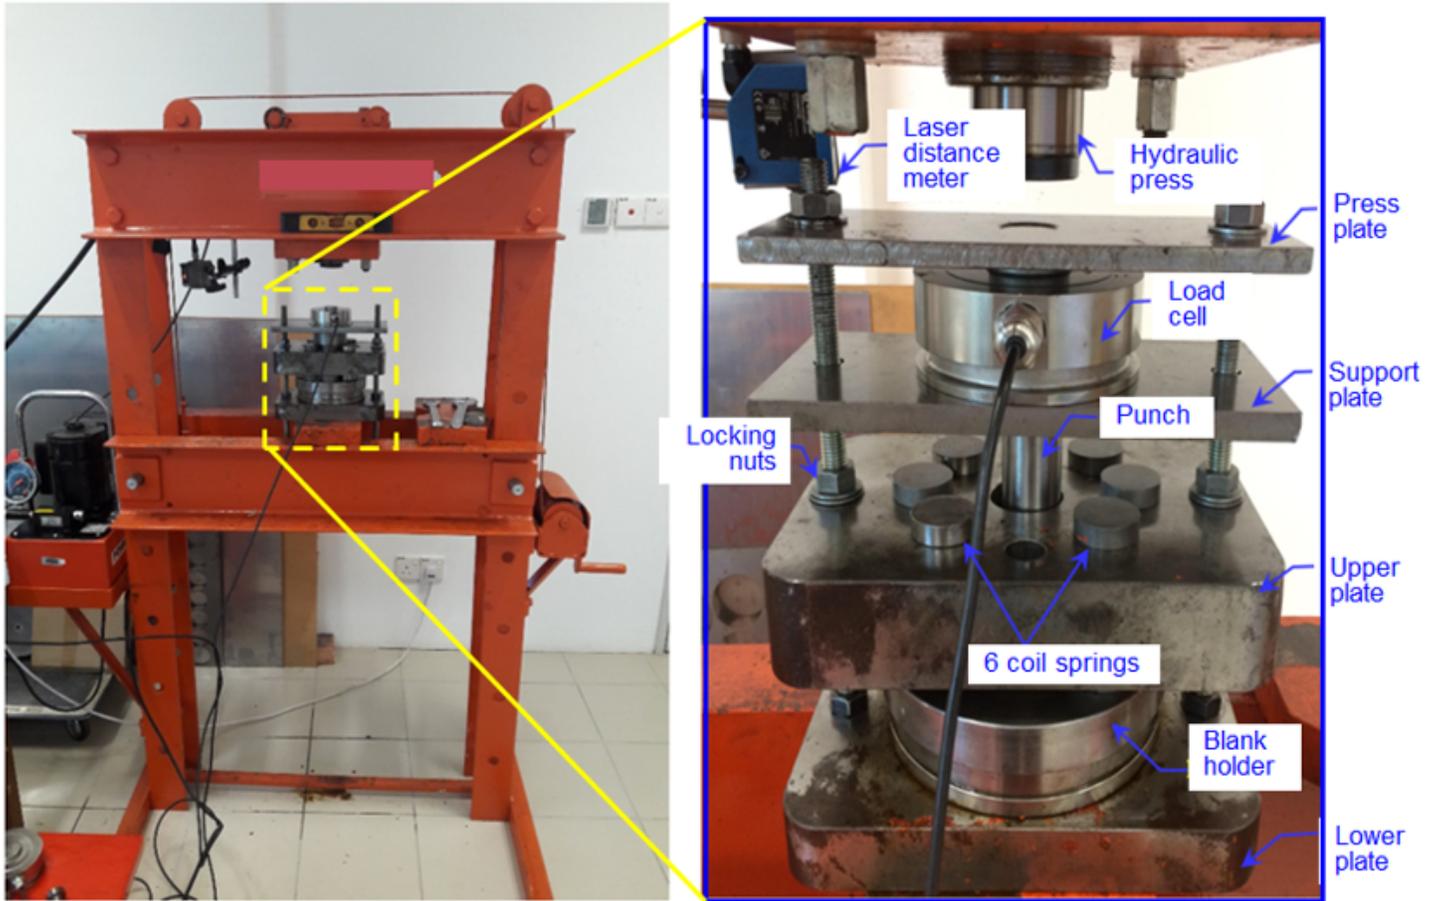
Figure 1

Experimental setup

The experimental setup of the deep drawing test is shown in Fig. 1. A 25-ton motorised hydraulic press compresses a circular blank into a fully drawn cylindrical cup at a constant speed of 1.1 mm/s. The drawing die is positioned right below the blank holder. Six Commercial JSM coil springs (Model CB 40 × 40) having a spring constant of 0.785 kN/mm are inserted into the corresponding circular holes machined inside the upper plate. The maximum deflection of the coil springs is 8 mm. Compressing the upper plate generates the BHF acting on the blank. Two locking nuts are used to prevent the return of the coil spring and to maintain a constant BHF value during the drawing test. A 30-ton load cell is placed on top of the drawing punch through a support plate. Then, the press compresses the load cell and the press plate, resulting in the movement of the punch into the die. The distance travel of the punch is recorded by a laser distance meter pointing vertically to the press plate. Since the punch and the press plate are moving together during the compression, the punch travel distance is measured. A data logger with a sampling rate of 10 Hz is used to capture the signals from both the load cell and laser distance meter. Pockets are machined onto the support and the press plates, respectively to firmly hold the load cell from falling during the test.

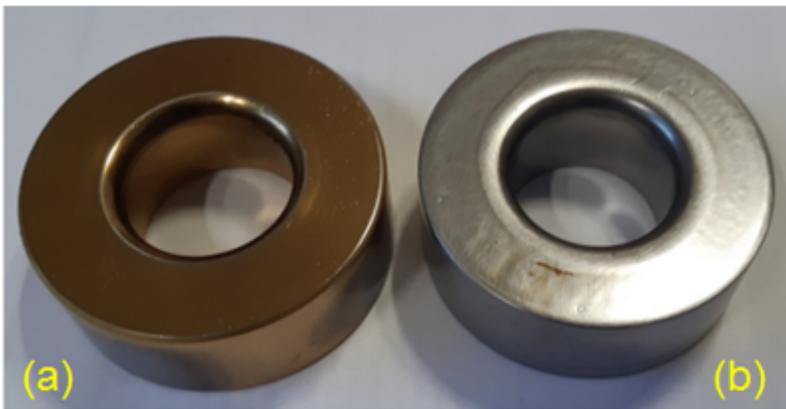
Figure 2

(a) TiN coated and (b) finely polished uncoated drawing dies

The photos of the (a) TiN coated, and (b) uncoated drawing dies are shown in Fig. 2. Both dies have the same dimensions with different surface conditions. The uncoated die is made of SKD-11 tool steel. Before each drawing test, both the uncoated die and the blank holder are polished with an orbital sander polisher machine at rotational speed of 4000 RPM using sandpapers of Grade 800 followed by Grade 1000. Finally, a solution of diamond paste with particle size ranging from 2-4 μm in a compatible diamond lubricant is used in the final stage of the polishing process. However, no polishing is applied to the TiN coated die surface at the beginning of each test. Only the blank holder is polished with the same method as mentioned above. TiN coating is applied to the drawing die made of tool steel by PVD coating process. The measured hardness of the coating is 61 ± 1 HRC, which is approximately 7.5 times higher than the SUS304 blanks. A commercial deep drawing lubricant (ACI PRESSCUT J133) with a viscosity of 285 cSt at 40 °C containing corrosive inhibitors and extreme pressure additives is applied to both drawing dies before each test.

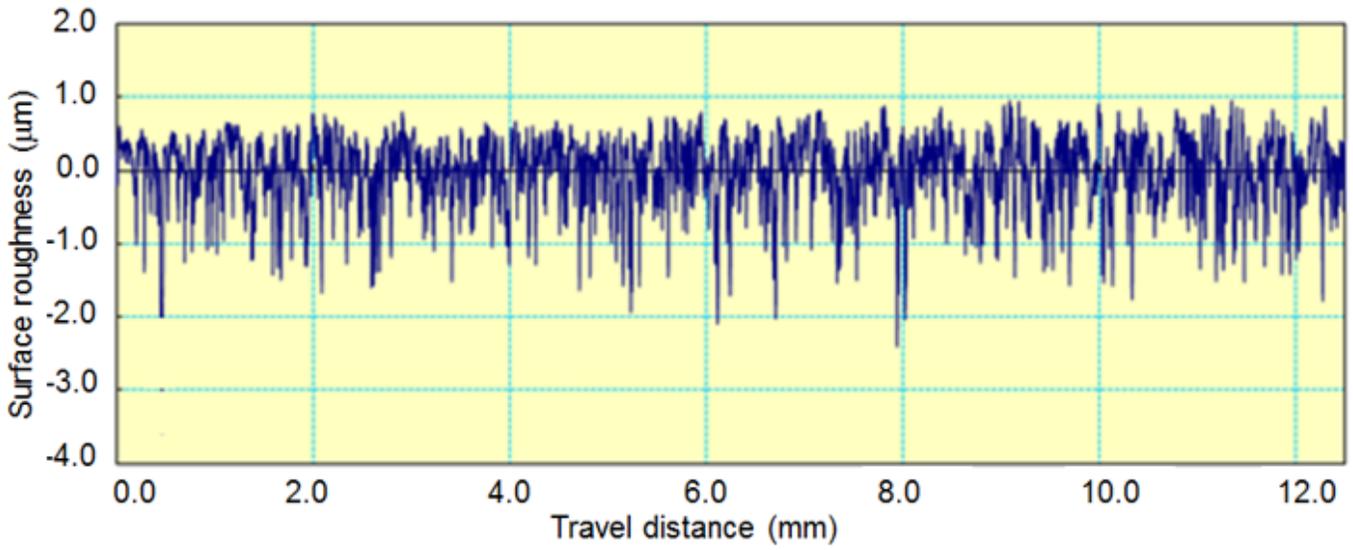
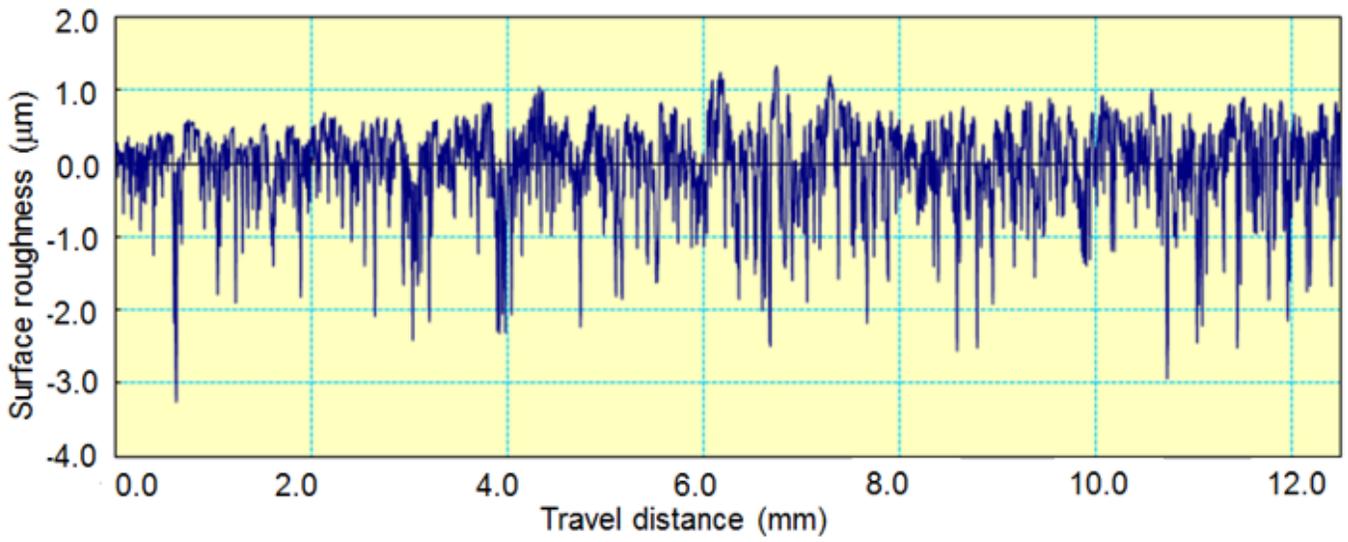
Figure 3

(a) TiN coated die

(b) Uncoated die

Surface roughness profiles for (a) TiN coated die & (b) uncoated die

The surface roughness profiles along the radial direction on the top surfaces of the TiN coated and the uncoated dies are measured using the Mitutoyo SJ-210 surface roughness tester following the ISO1997 standard. The total travel length for the stylus tip is 12.5 mm with a constant speed of 0.5 mm/s. The surface roughness profiles for both dies are shown in Fig. 3. The average surface roughness for the TiN coated and uncoated dies are 0.382 μm and 0.581 μm , respectively. TiN coated die has a smoother surface than the finely polished uncoated die.

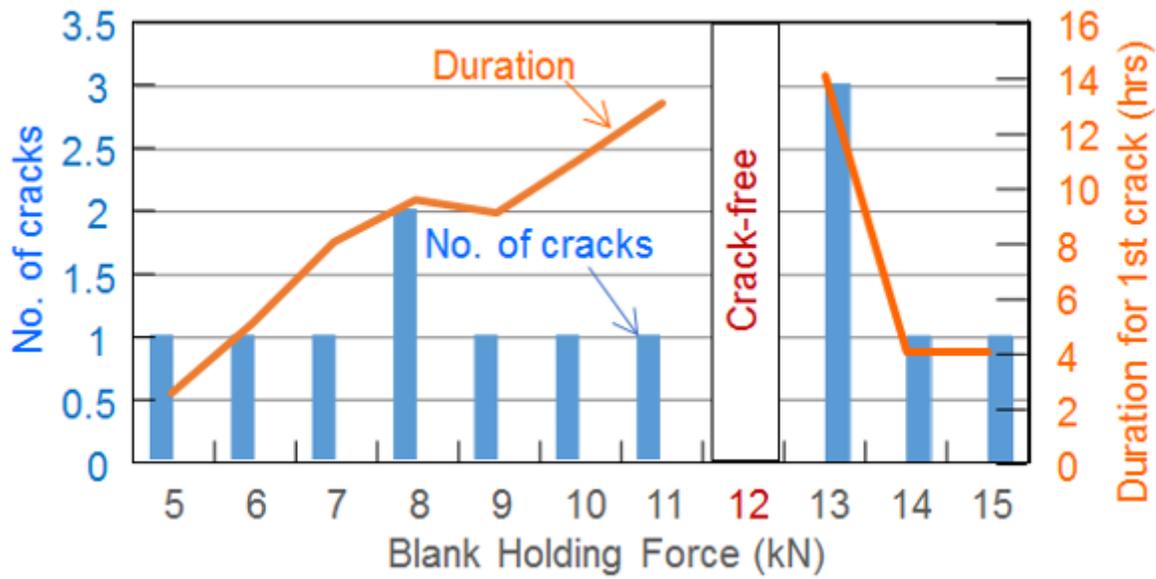
Figure 7

Number of delayed cracks and time taken for 1st appearance of crack in drawn cups formed with coated die

The data in Table 3 are summarized and presented in Fig. 7. The duration for the 1st crack increases with the increase in BHF. The crack is successfully eliminated at BHF = 12 kN. The duration and the number of cracks hit the peak values of 14 hours and 3 cracks at BHF = 13 Kn. Both values sharply reduce to 4 hours and only 1 crack for BHF from 14 ~ 15 kN.

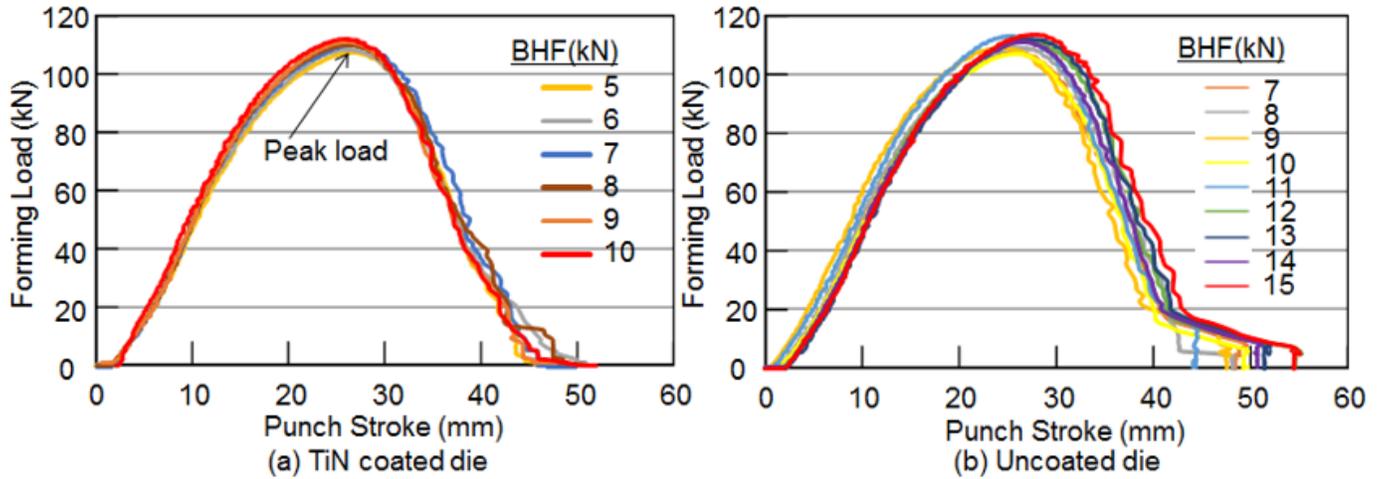
Figure 9

Comparison of forming load profiles between cups formed with (a) TiN coated die and (b) Uncoated die

The comparison of forming load profiles between cups formed with (a) TiN coated die and (b) Uncoated die is shown in Fig. 9. Since the two dies have the same dimensions, typical bell-shape drawing load profiles are obtained for both dies. The increase in drawing load is very minimum for increase in BHF values in both cases. Peak drawing loads range from 105 ~ 115 kN are obtained around 60% of the total punch travel distance for both dies.

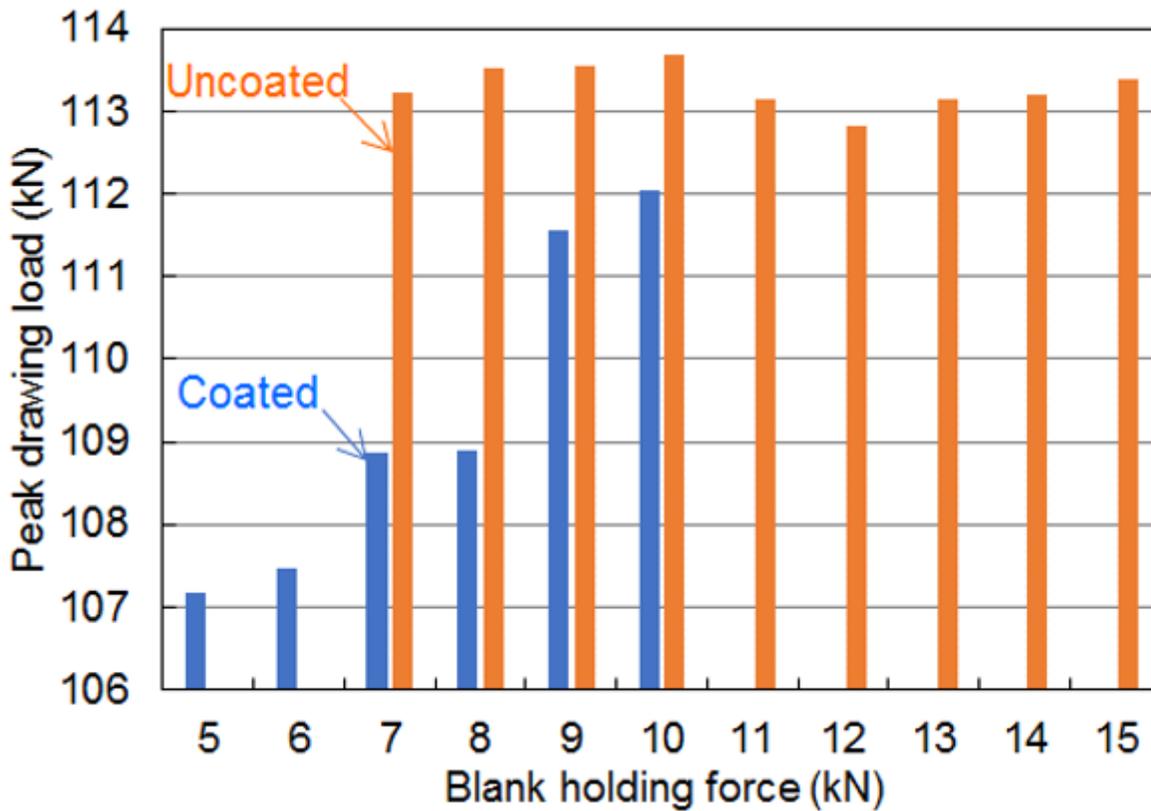
Figure 10

Comparison of peak loads between TiN coated and uncoated dies at different BHF levels

The comparison of peak drawing loads between the TiN coated and uncoated dies at different BHF levels is shown in Fig. 10. Overall, the peak loads for the TiN coated die are lower than that of the uncoated die at the same BHF levels. For coated die, the drawing loads increase with increase in BHF i.e. the frictional forces acting in the blank-die interface increases under higher holding pressure. In contrast, only slight changes in peak drawing loads are observed for uncoated die under elevated BHF. Therefore, the extreme-pressure performance of the TiN coated die is not as good as the uncoated die under the same lubrication condition. For uncoated die, galling or cold welding tends to form between the surface asperities in the interface between the SUS304 blank and the coated die surface. The galling effect or the continuous forming and breaking of the welds has produced some fine particles that facilitate the sliding motion of the tool over the blank, particularly at high BHF. However, galling is reduced with TiN coating resulting in low drawing load at low BHF. Therefore, the extreme-pressure performance of the coated die is reduced due to absence of galling at the interface.

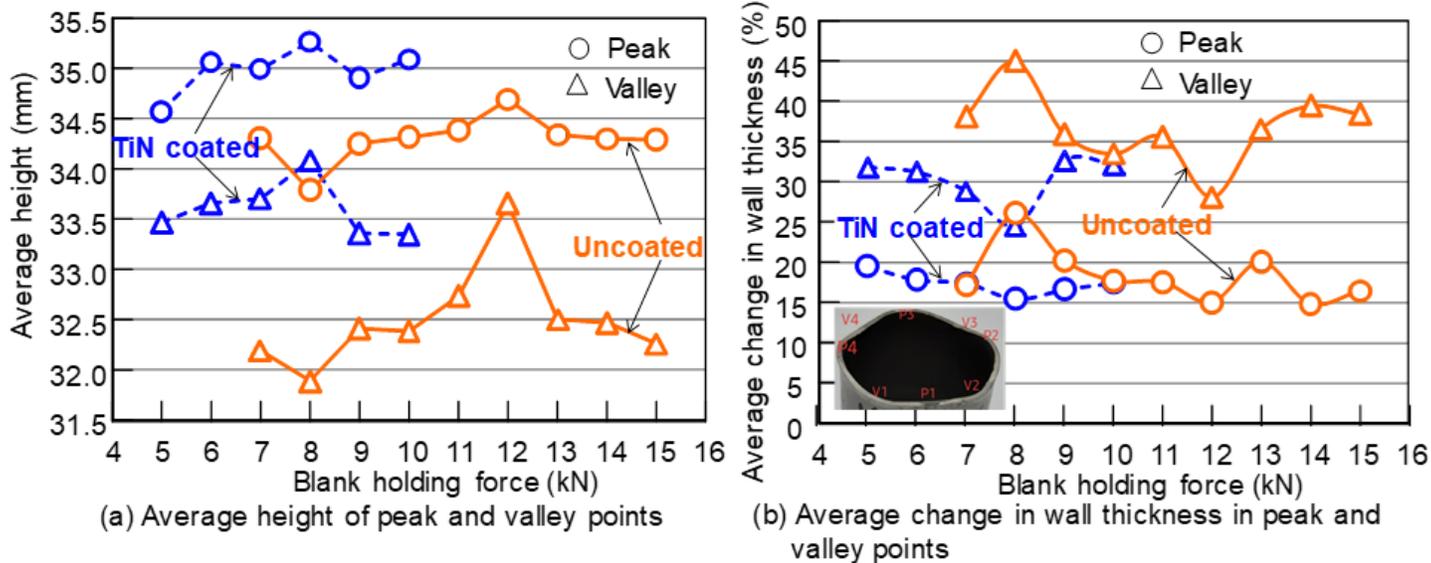
Figure 11

Comparison of average heights and average changes in wall thickness between drawn cups formed with TiN coated and uncoated dies at elevated BHF

The comparison of the average heights and the average changes in wall thickness between the drawn cups formed with the TiN coated and uncoated dies at elevated BHF is shown in Fig. 11. Overall, the average cup height formed with the coated die is larger than the uncoated die. The peak and valley heights are slightly increased with increase in BHF for both dies. The heights hit peak values at BHF of 8 kN and 12 kN for the coated and uncoated dies, respectively. Since the only crack-free cup is obtained at the peak height for uncoated die with BHF of 8 kN, increase in cup height, particularly in the valleys is favourable for eliminating the delayed crack. By applying TiN coating to the die surface, larger cup heights are obtained with lower BHF values. Overall, the wall thickness in the valleys for the cups formed with the coated die is smaller than the ones formed with the uncoated die. However, the wall thickness in the peaks for the cups formed with the coated die is at the same level with the uncoated die. Due to constant volume, the materials contributing to the elongated height is originated from the side wall below the cup edge. The average changes in wall thickness in the peaks and the valleys are slightly reduced with increase in BHF for both dies. The average thickness hit minimum percentages at BHF of 8 kN and 12 kN for the coated and uncoated dies, respectively.

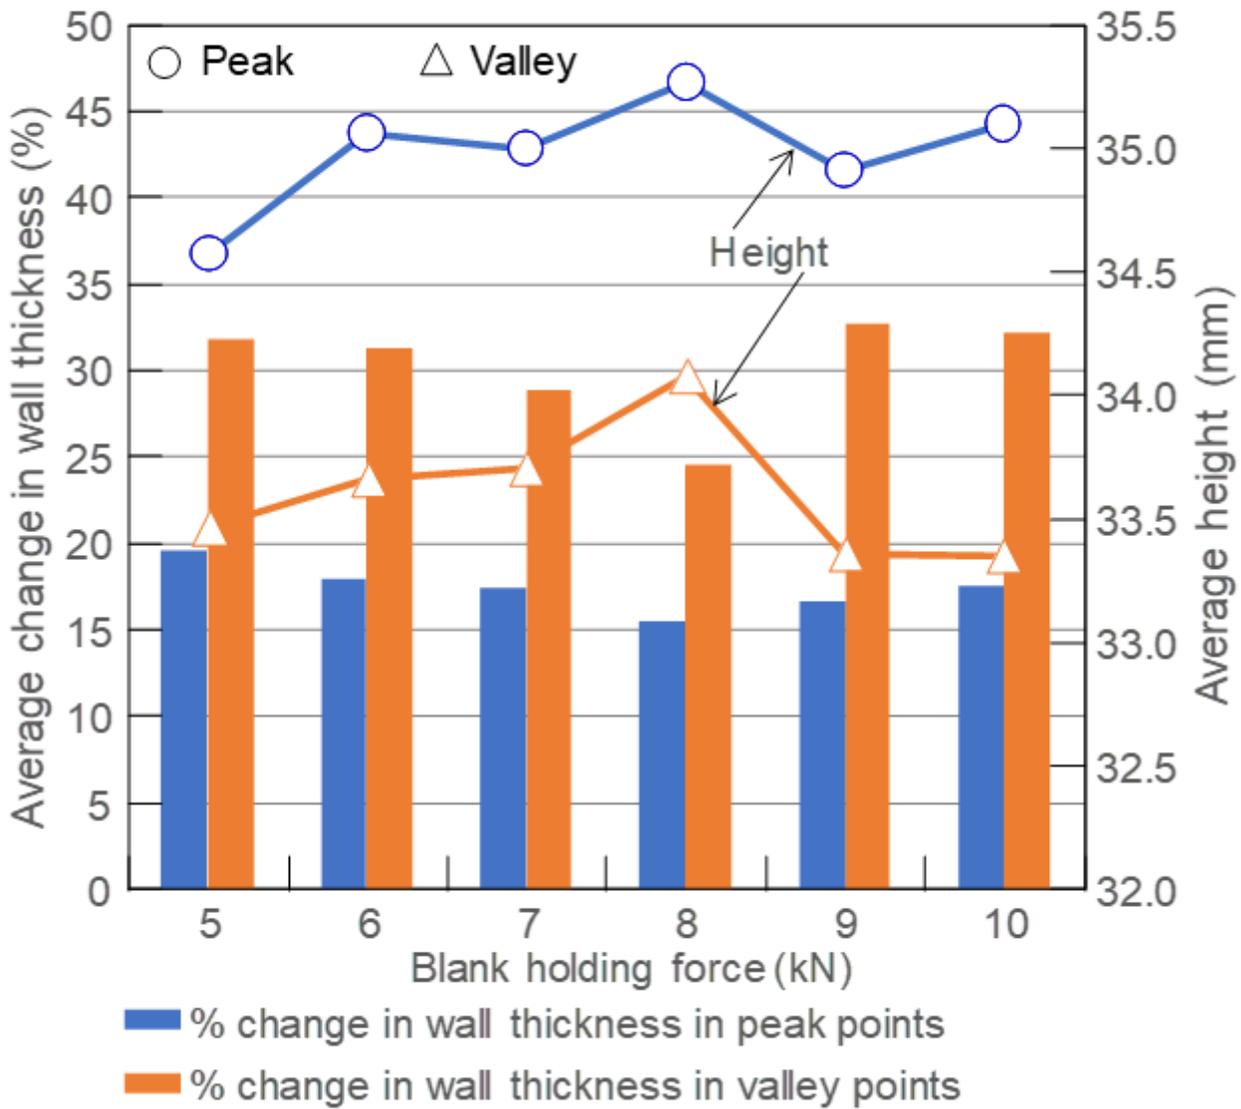
Figure 12

Average changes in wall thickness and average heights of crack-free cups formed with TiN coated die

The relationship between the average changes in wall thickness and the average heights of the peaks & valleys of the crack-free cups formed with the TiN coated die is illustrated in Fig. 12. Overall, the average wall thickness is increased, and the height is reduced with increase in BHF. The largest height and the smallest wall thickness for both points are obtained at BHF of 8 kN. Under excessive BHF i.e. greater than 8 kN, the tribological performance of the lubricant becomes poor, leading to the reverse trend of both values. However, delayed cracks are not observed in the drawn cups up to the upper BHF limit of 10 kN.

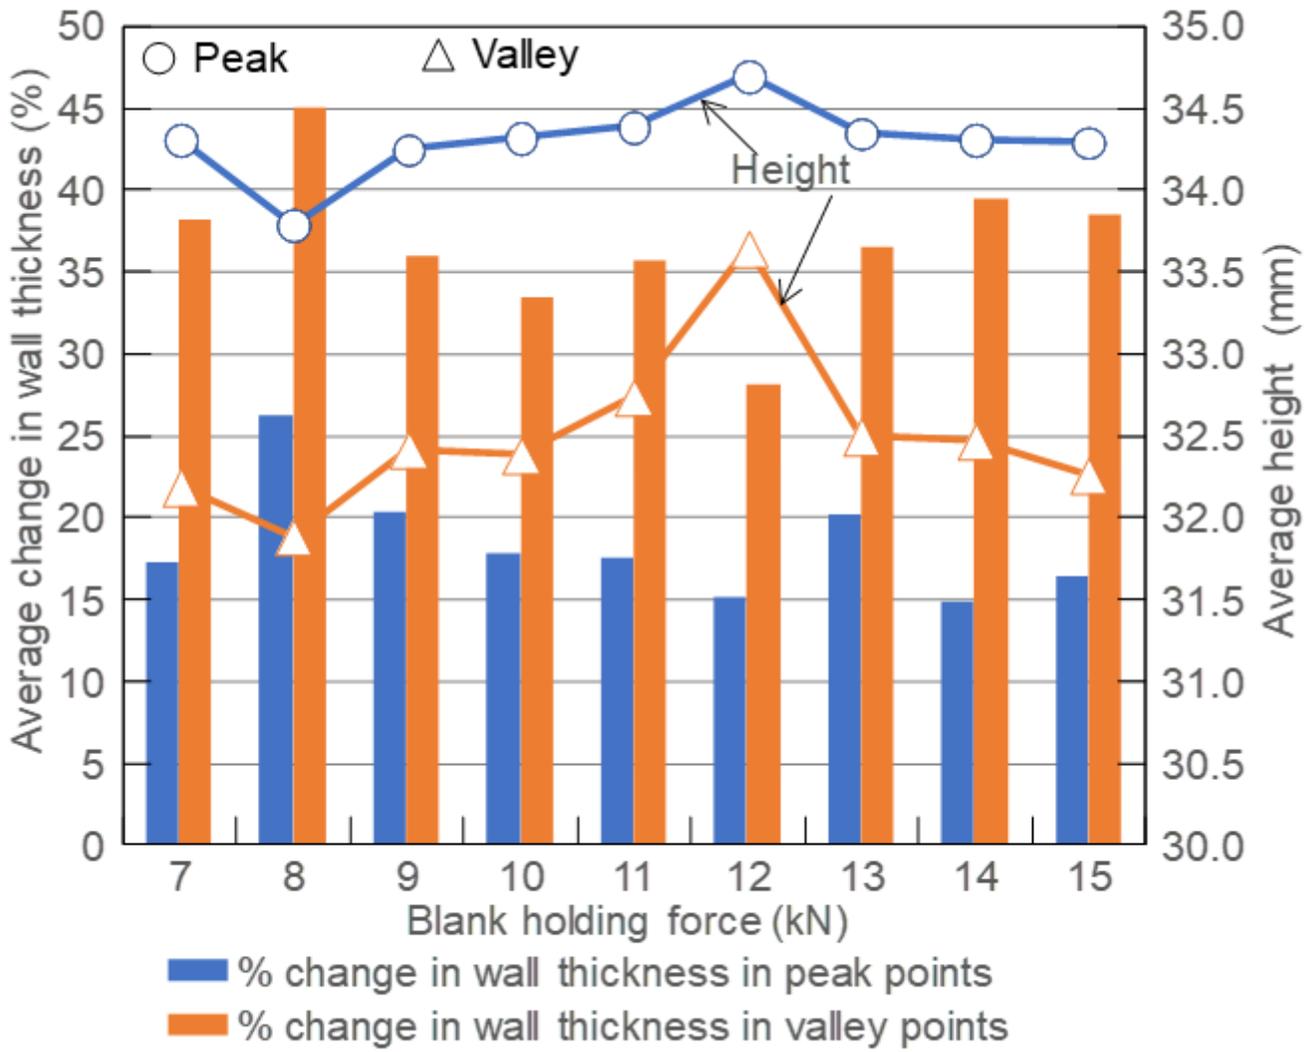
Figure 13

Average changes in wall thickness and average heights of crack-free cups formed with uncoated die

The relationship between the average changes in wall thickness and the average heights of the peaks & valleys of the cups formed with the uncoated die is illustrated in Fig. 13. A similar trend of increase in height and decrease in amount of wall thickening under elevated BHF is obtained with the uncoated die. However, the largest height and the smallest wall thickness for both points are obtained at BHF = 12 kN or 50 % higher than one with the coated die. The minimum BHF for obtaining a crack-free cup with the coated die is 140 % (i.e. reduced from 12 kN to 5 kN) less than one with the uncoated die.

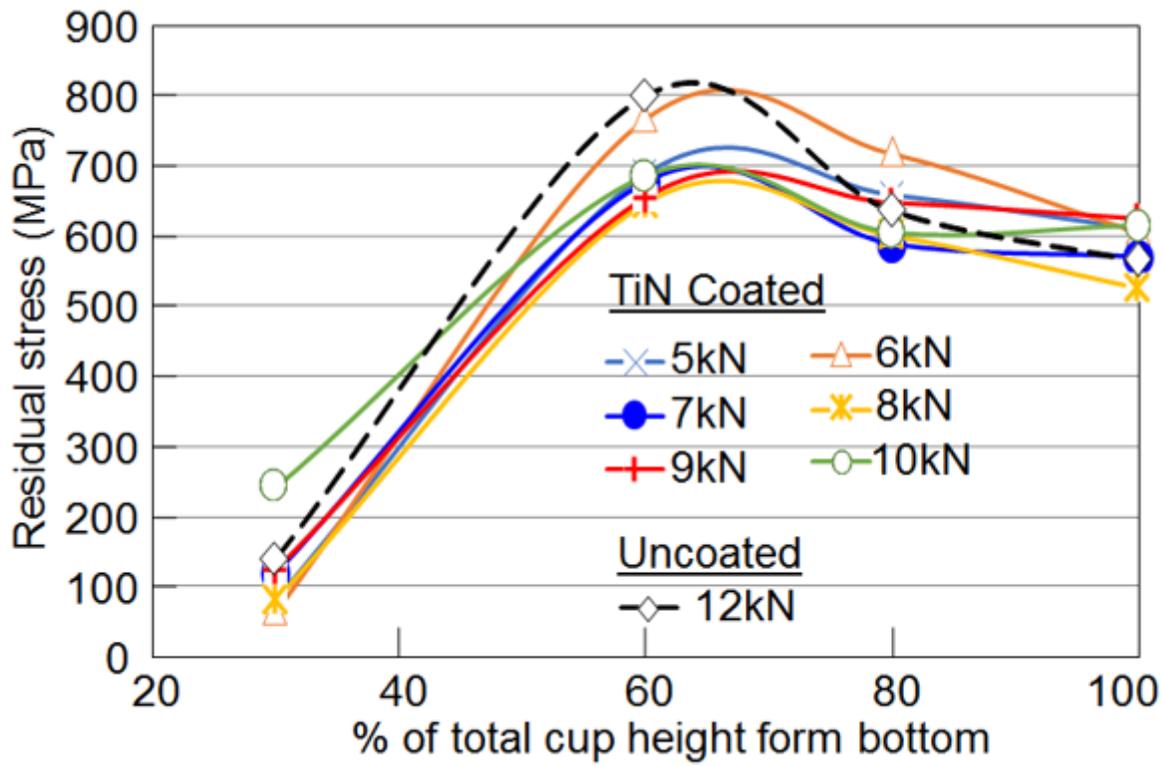
Figure 14

Longitudinal distributions of residual hoop stresses passing through valley points along the outer surfaces of the crack-free cups

The longitudinal distributions of residual hoop stresses passing through the valley points along the outer surfaces of the crack-free cups obtained from the ring-slitting test are shown in Fig. 14. Overall, the amount of tensile residual stresses of the cup formed with the uncoated die is larger than the ones formed with the coated die in the lower half of the cups due to its high BHF value. For coated die, the increase in BHF reduces both the amount of tensile stresses and the slope of the stress for greater than 80 % of its total height. Low tensile residual stress level with less gradient, particularly in the upper portion along the outer surface of cups is favourable for eliminating the delayed cracks. The favourable residual stress distribution is obtained with the TiN coated die at BHF values much lower than that with the coated die.
