Sanxicun Landslide: An Investigation of Progressive Failure of a Gentle Bedding Slope

Abstract: A gentle bedding slope (16° dip angle) failure at Sanxicun (SXC) village in Dujiangyan city was triggered by heavy rainfall in 2013. The landslide (composing of sandstone and mudstone strata) has a sliding distance of up to 1200 m and caused 166 deaths. After this failure event, a detailed field survey and a series of laboratory tests were carried out by us to investigate the progressive failure mechanism of the slope. The results revealed that the slope deformation could be traced back to the Ming Dynasty in China (400 years before) at least. A sliding block with a width of 330 m and a length of 240 m detached its original position, resulting in a depression belt with 10 m in width and 25 m in depth at the rear of the sliding block. On the scarp, a large number of cracks were widely observed not only in the sandstone but also in the mudstone. The field evidence revealed that the depression belt and cracked mudstone had provided convenience for water infiltration for a long time. The shake table test results showed that these cracks could be initiated and propagated in the slope during

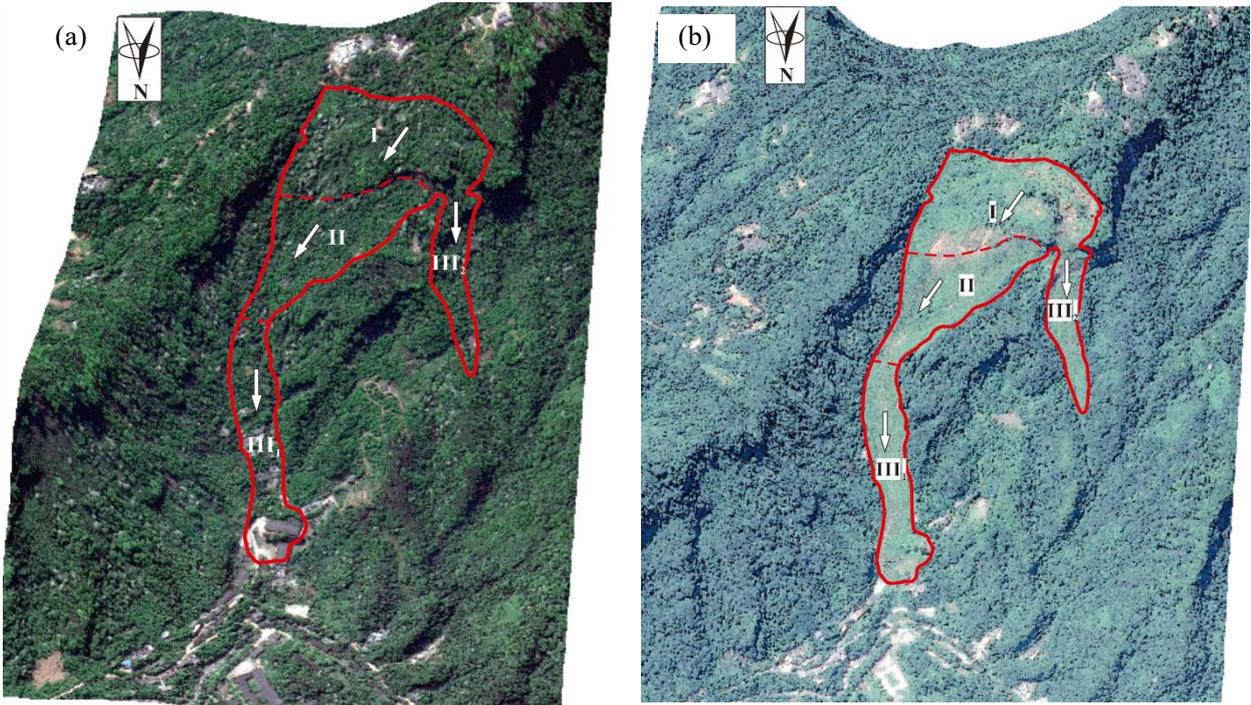
Fig. 3 Pre-sliding image on April 17th, 2013 (a) and post-sliding image on June 5th, 2016 (b)

107 to 24°. According to the remote sensing images, it can be found that the north and west sides of the landslide area are steep
108 cliffs before and after the landslide (Fig. 3), and a seasonal gully with a strike of S- N is developed on the east side of the
109 slope. The landslide area can be divided into three zones: source area (I), ploughing area (II) and accumulation area (III)
110 (Fig. 4a). The strata of the block in the source area is mainly composed of thick sandstone interbedded with thin mudstone
111 within the Guankou Formation of the Cretaceous system (K₂g) (Fig. 4b). A volume of approximately 300×10³ m³ was
112 detached from the source area. The ploughing area with an average slope angle of 27° is distributed at elevations from 850
113 to 1050 m, and the height difference is 200 m. The sliding mass continuously collides and disintegrates in the ploughing
114 area to form debris flow in the process of movement. The debris moved downslope in two directions, subsequent forming

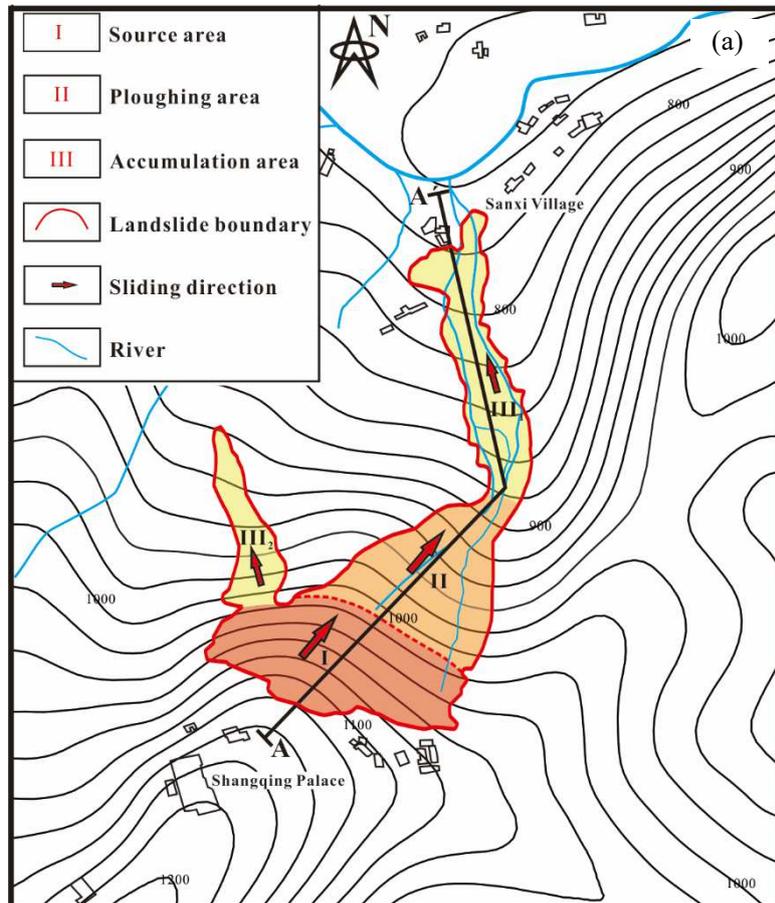
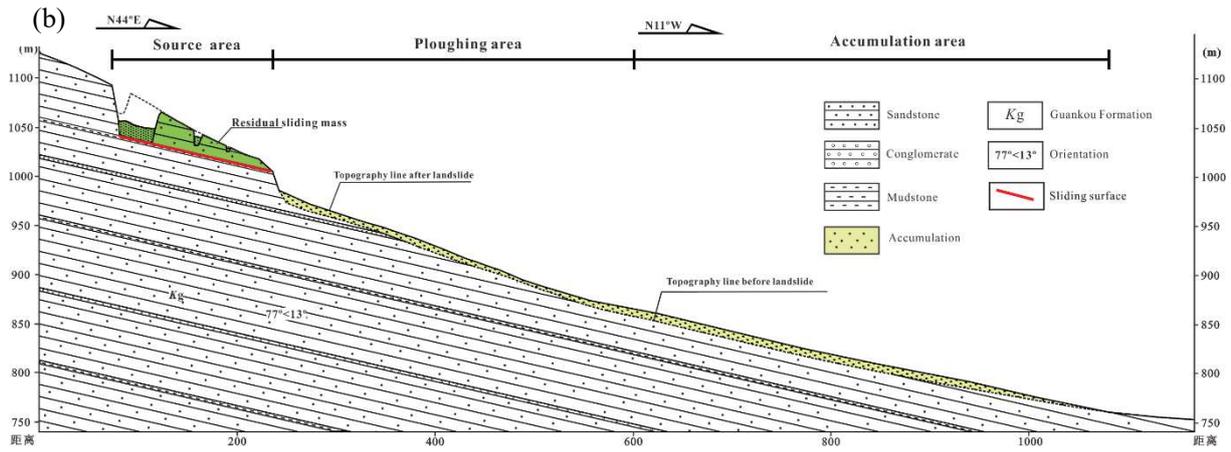
Fig. 4 SXC landslide map (a) and longitudinal profile of the landslide area (b)

115 a major slide area (III₁). A branch slide area is also can be found at the west part of the slope (III₂). III₁ subjected to direction
116 turning from the front valley, the debris flowed directly impacted the valley's right side after moving about 80 m resulting
117 in 166 deaths (Yin et al., 2016). The debris on the slope is mainly composed of rock blocks, shoveled soil and trees, and
118 the maximum diameter of the rock block is up to 5 m (Yin et al., 2016).

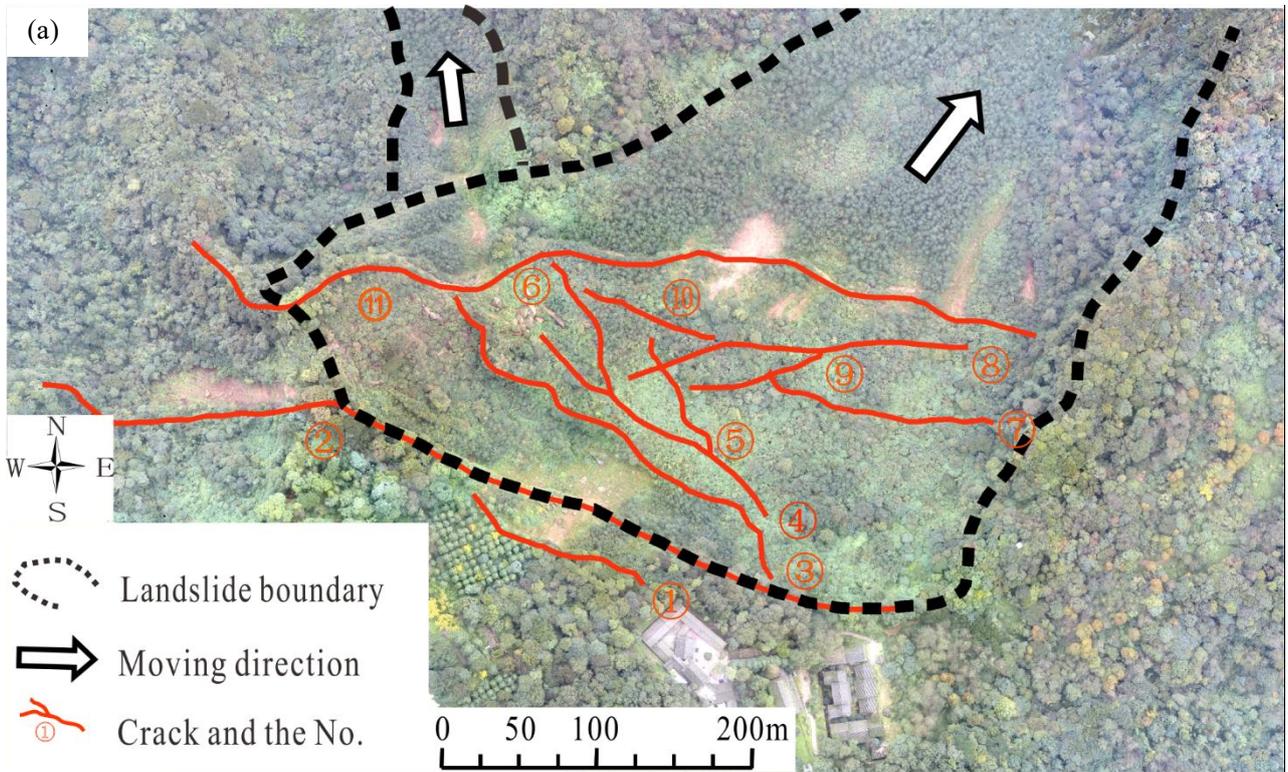
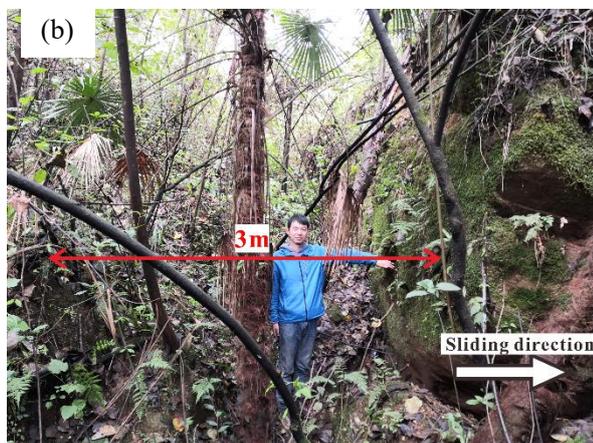
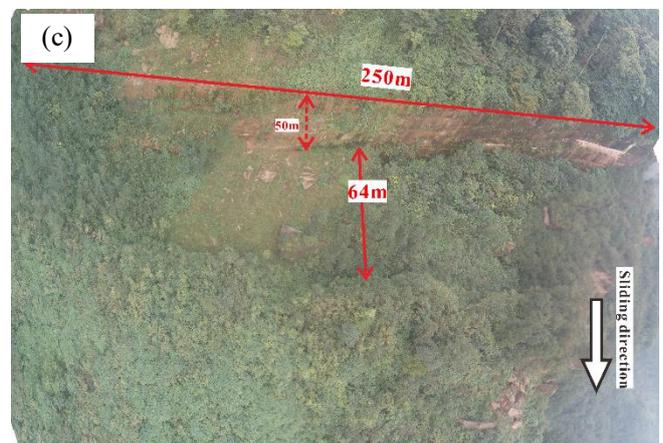
Fig. 5 The distribution of tension cracks in the source area (a), typical tension crack in the middle of residual sliding mass (b) and depression belt (c)

119 Although the residual sliding mass retained a relatively complete rock mass structure, several obvious tension cracks in
120 the residual sliding mass were developed (Fig. 5a and b). Details of these tension cracks are listed in Table. 1. A depression
121 belt with a strike of NE-SW, a depth of 30 m, a width of 64 m and a length of 250 m (Fig. 5c), which was formed by the
122 propagating and stretching during the 2013 landslide event based on a previous depression belt with a width of 10 m, a
123 depth of 25 m. The previous depression belt was formed 400 years ago.

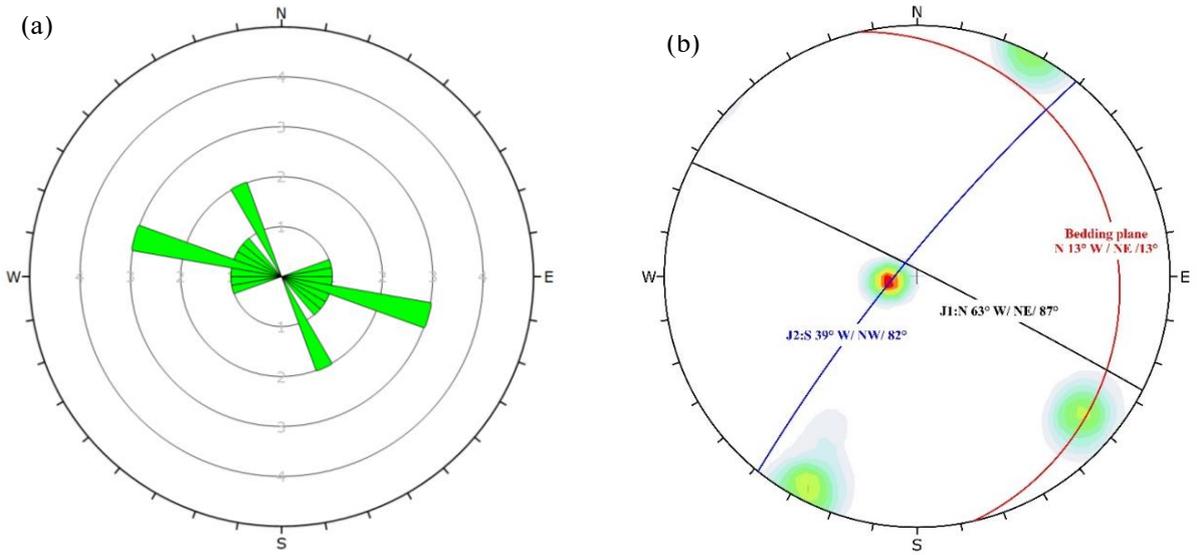
Fig. 6 Rose diagram of the tension crack strike (a) and stereographic projection of joints in the source area (b)

124 The orientation of the bedding plane is N13°W/NE/16° (strike/dip/dip angle), showing a typical gentle rock bed. Two
125 sets of joints were developed in this area. J1 shows an orientation of N 63° W/NE/87° and is in accordance with the
126 orientation of the most tension cracks on the slope, including the depression belt (Fig. 6). J2 shows an orientation of S 39°
127 W/NW/82°. Fig. 7 shows that solution traces induced by the water flow have appeared on the landslide scarp. A layer of
128 calcareous film with a thickness of 0.3-0.5 cm was found. In addition, it should be noted that the mudstone on the basal

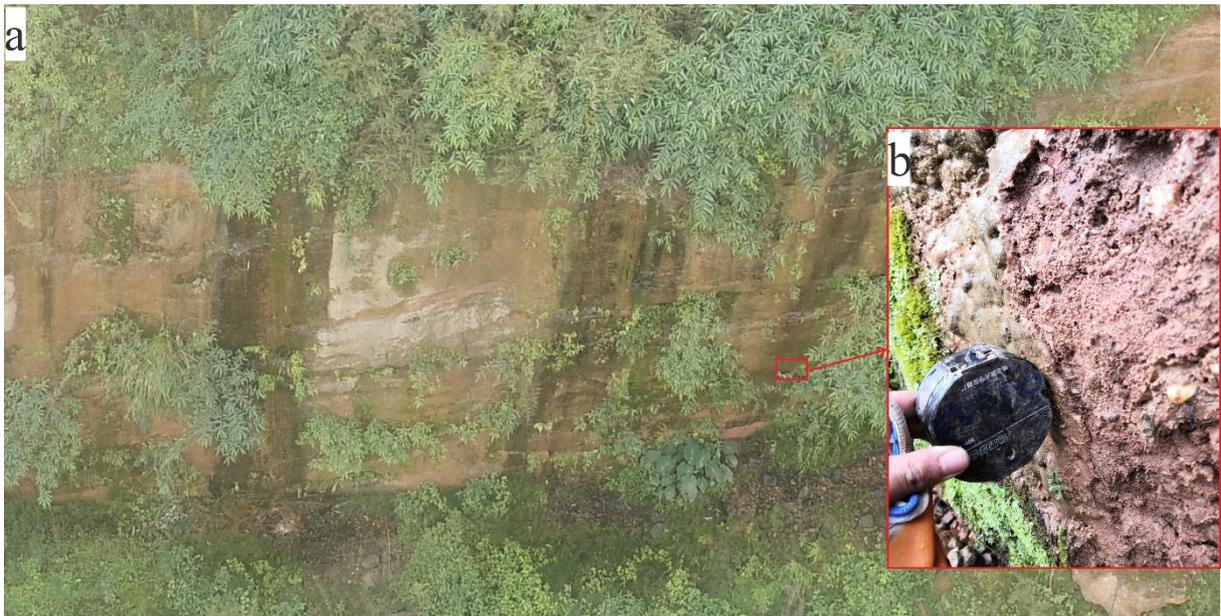
Fig. 7 Solution traces on the scarp surface (a) and a layer of calcareous film

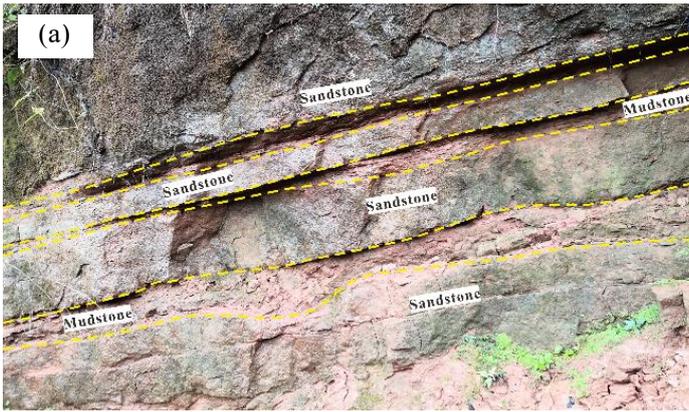
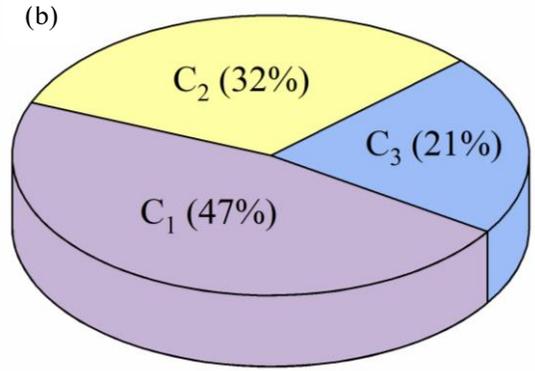
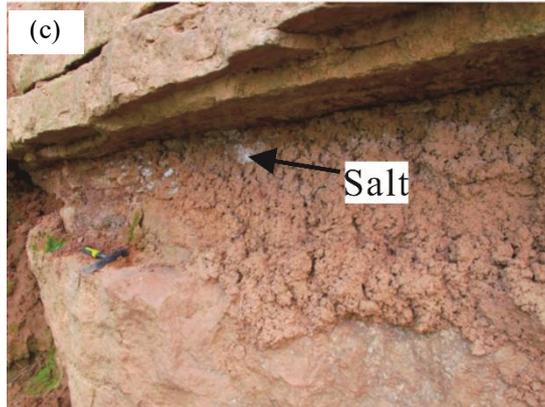
512 Fig. 8 Strata characteristic in the source area (a), the statistical results of cracks in mudstone layer (b), C₁: gently inclined cracks, C₂:
 513 moderately -gently inclined cracks, C₃: steeply inclined cracks, and salt extracted from mudstone (c) (Du et al., 2016)
 514

129 layer of the residual block is highly fragmented (Fig. 8a). According to the characteristics of crack propagation in mudstone
130 layer, it can be divided into three types of cracks: gently inclined cracks with dip angle below 30° , moderately -gently
131 inclined cracks with dip angle $30^\circ - 60^\circ$, and steeply inclined cracks with dip angle above 60° . According to the
132 statistical results of cracks in the mudstone layer, the proportion of each type of cracks is shown in Fig. 8b. From Fig. 8b,
133 the gently inclined cracks are the most, accounting for about 47%, while the steeply inclined cracks are the least, accounting
134 for about 21%. In addition, salt was extracted from the fragmented mudstone. These suggested that long- term groundwater
135 activity had been in the slope, especially on interfaces and in cracks of the mudstone on the landside's basal sliding layer
136 (Fig. 8c).

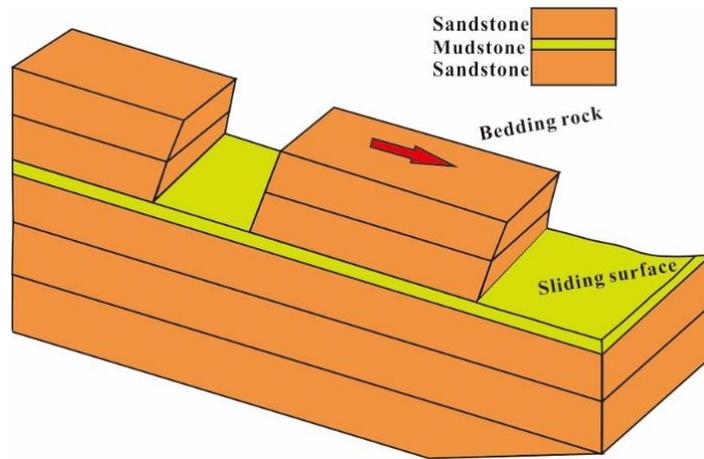
515
 516 Fig. 9 Diagram of strata, sliding surface, and slide block

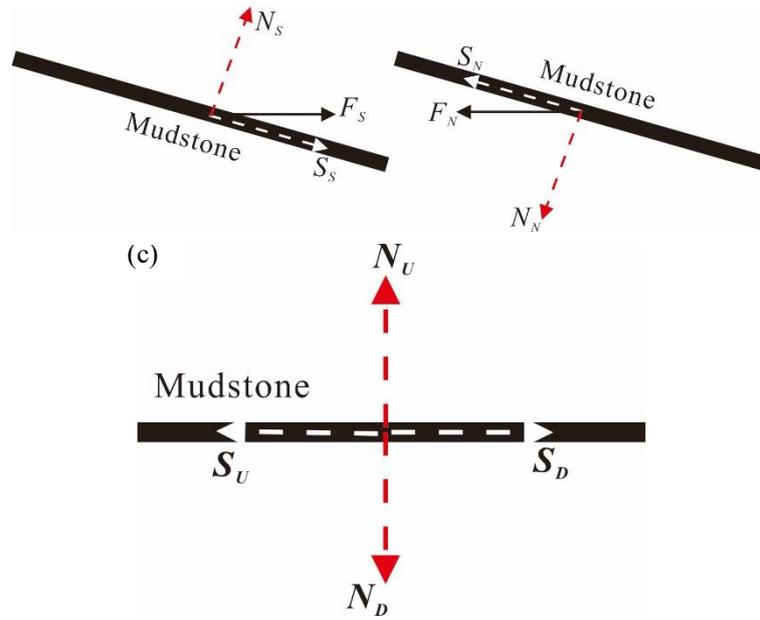
Fig. 10 Simplified mechanical mode: (a) decomposition of vertical seismic force, (b) decomposition of horizontal seismic force, and (c) seismic force composition

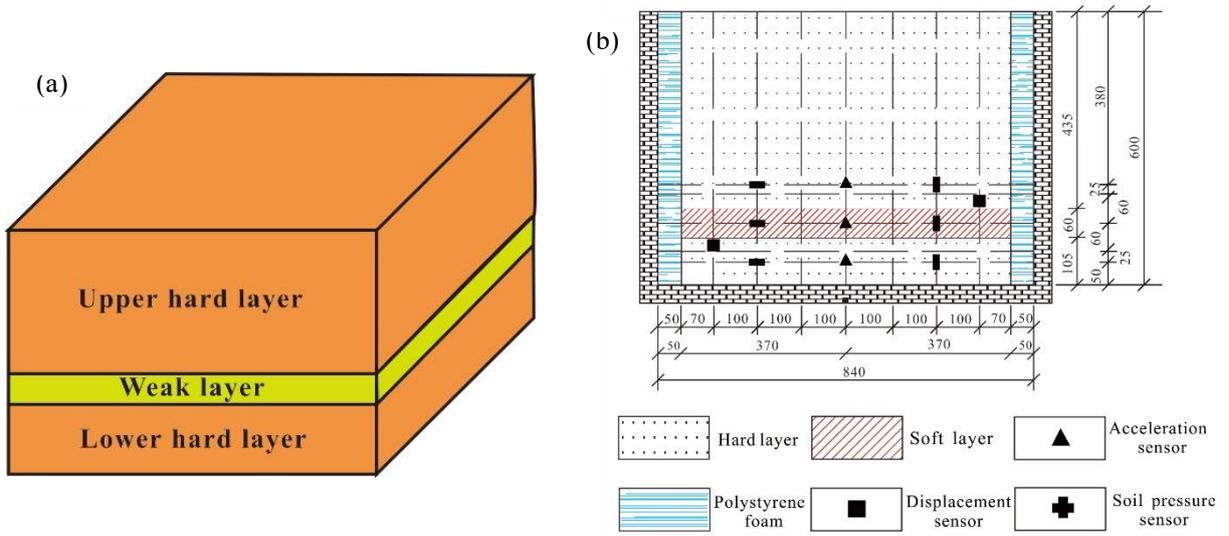
Fig. 11 A simplified model (a) and a shaking table test model and sensor placement scheme (b)

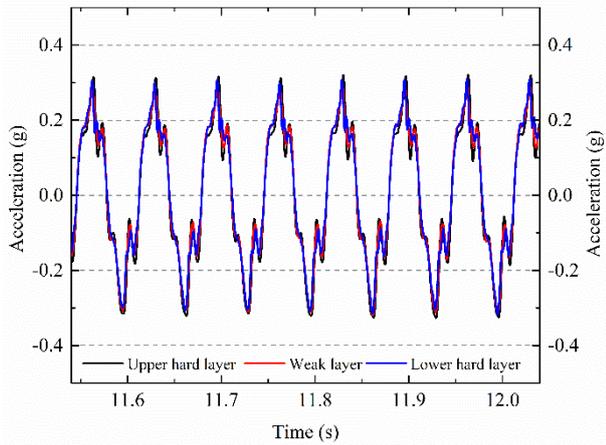
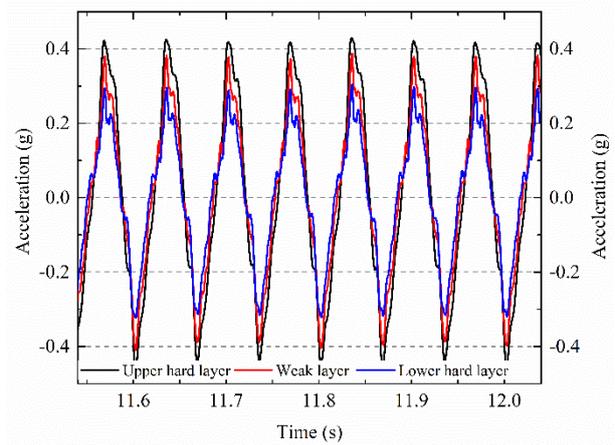
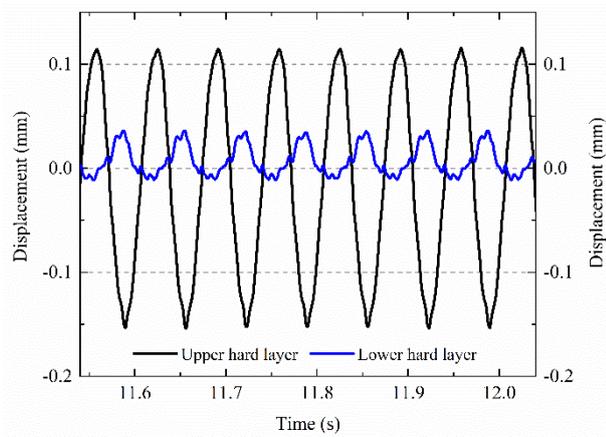
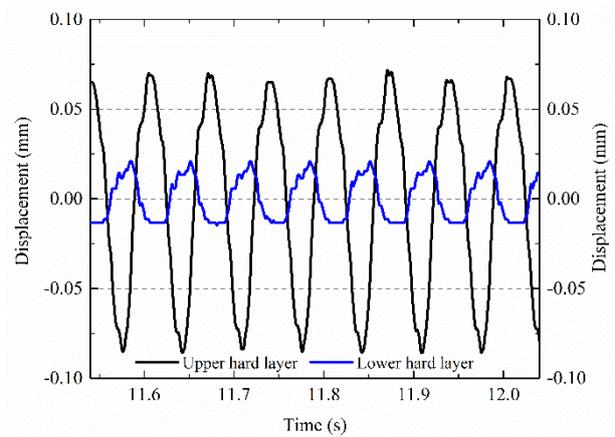
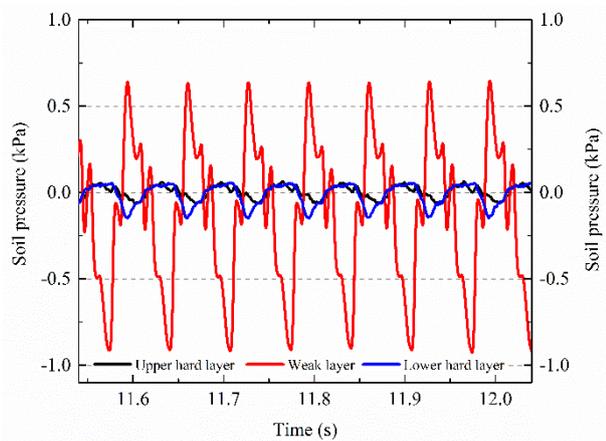
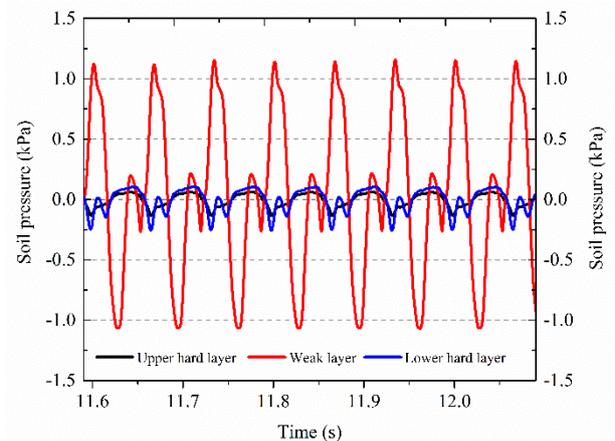
Fig. 12 Shaking table test results

167 The typical results of the shaking table test under the condition of a sine wave with 0.3 g acceleration and 15 Hz frequency
168 are shown in [Fig. 12](#). From [Fig. 12a](#) and [12b](#), the peak accelerations in the upper hard layer, weak layer and lower hard
169 layer under vertical vibration are approximately equal, about 0.31 g. However, during horizontal vibration, the peak
170 acceleration gradually increases with the height of the model. The peak accelerations in the lower hard layer, weak layer

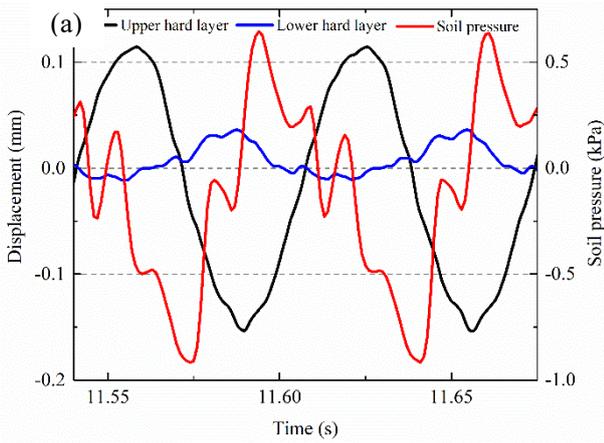
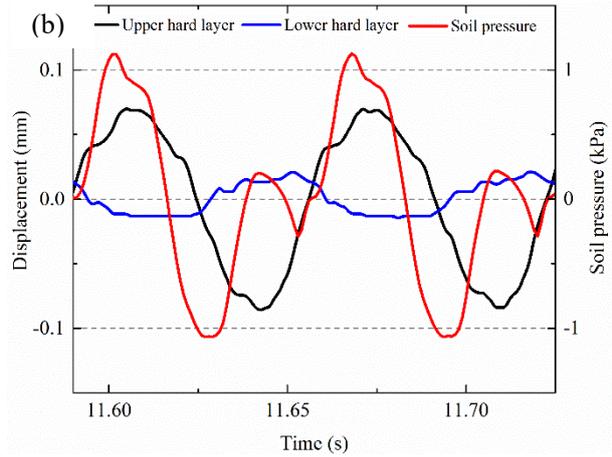
Fig. 13 Curves of displacement, soil pressure versus time: (a) vertical vibration, and (b) horizontal vibration

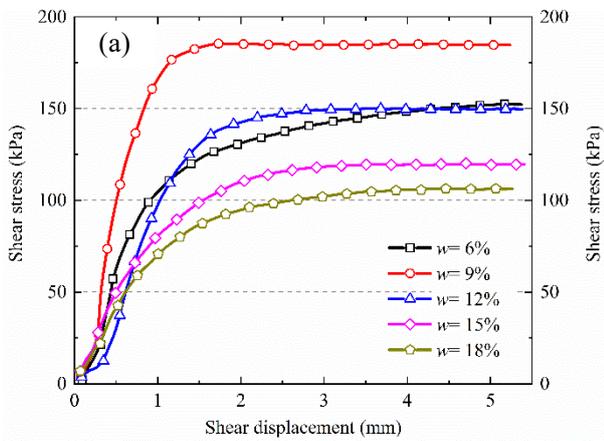
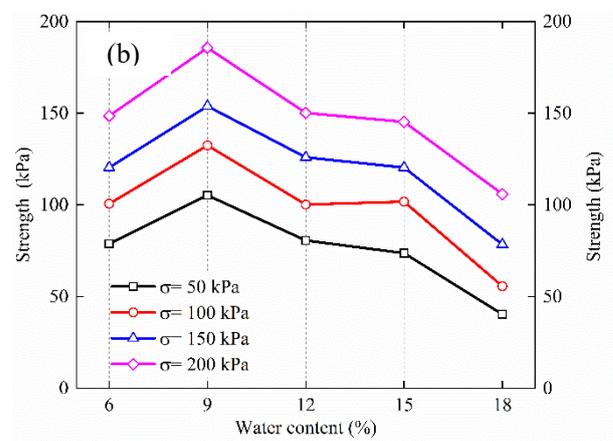
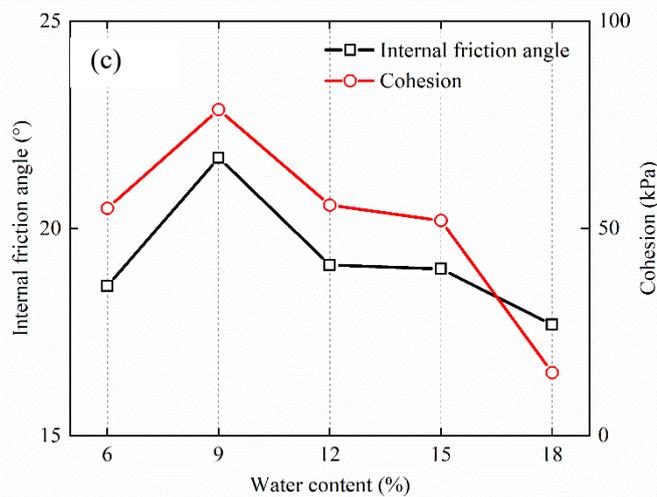
Fig. 14 Direct shear test results for samples with different water contents: (a) shear stress versus displacement curves, (b) shear strength versus water content curves, and (c) internal friction angle and cohesion versus water content curves

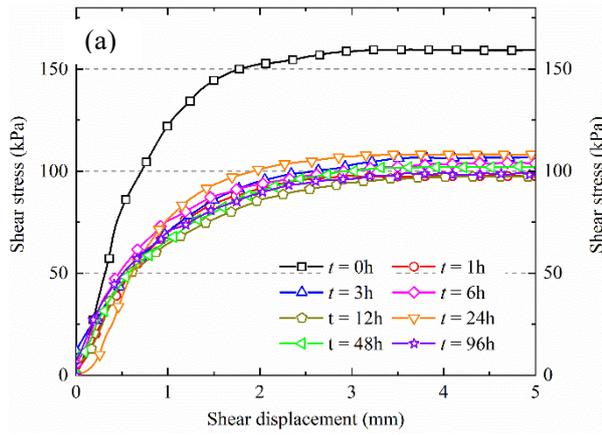
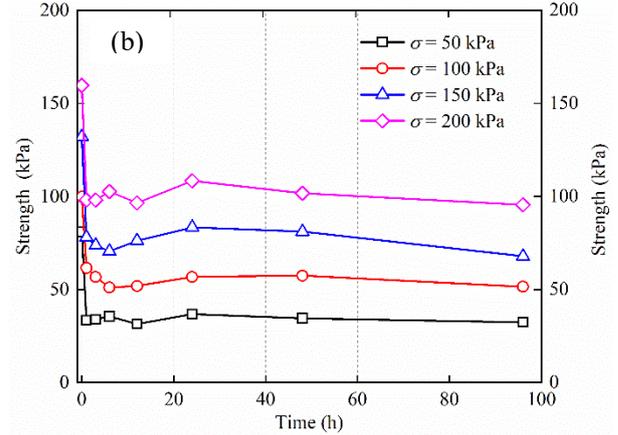
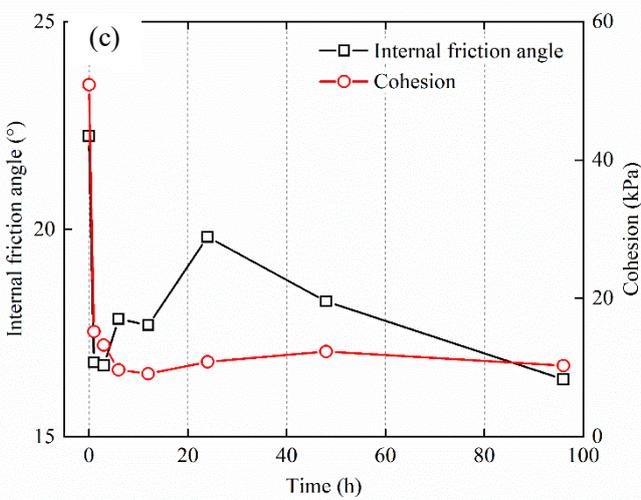
533 Fig. 15 Direct shear test results for samples with different immersion times: (a) shear stress versus displacement curves for $\sigma = 200 \text{ kPa}$,
 534 (b) shear strength versus water immersion time curves, (c) internal friction angle and cohesion versus immersion time curves

214 Our tests indicate that the immersion time has a more significant influence on the attenuation of cohesion. Zhang et
 215 al. (2016) reported that water would enter the poles between the particles and gradually undermined the cohesiveness under
 216 immersion conditions. Gradually, uneven inner-stress and many micropores in the mudstone would cause softening and
 217 degradation. The absorbed suction could resist the sliding of particles, and it increased with increasing water content.
 218 However, when the water content increased to a certain value, the pores were gradually filled with water and the area of
 219 capillary water decreased, resulting in a gradual decrease in the absorbed suction until it disappeared. Also, the water
 220 molecules in the red mudstone firstly cemented with free iron oxide to form a granular structure when the water content
 221 was low, resulting in a temporary increase in the internal friction angle of the mudstone.

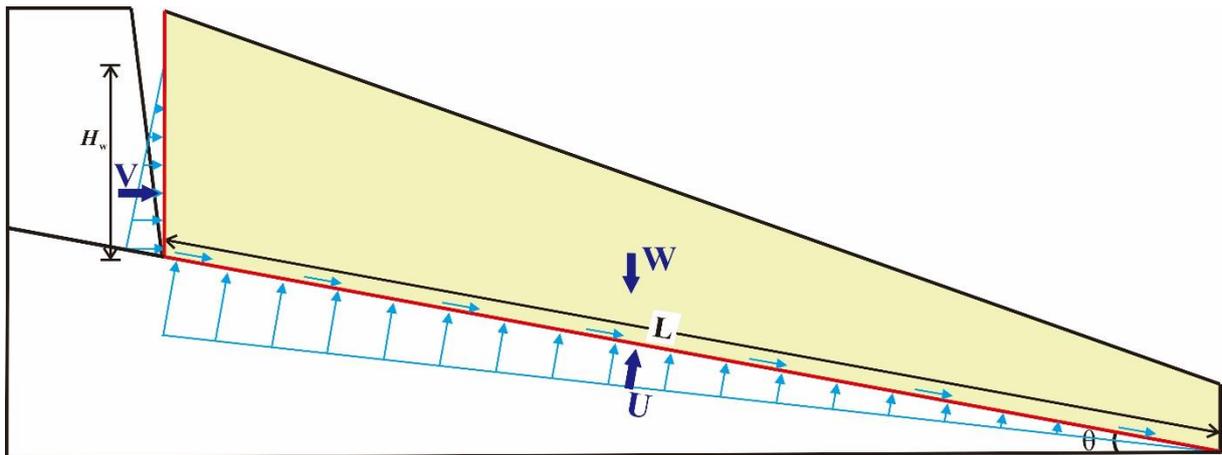
Fig. 16 Stability calculation of profile B-B'

223 The water pressure that affects cracked slope stability includes hydrostatic pressure along the depression belt, uplift
 224 pressure along the sliding surface and drag force. The water level in the depression belt of the bedding slope and the uplift
 225 pressure on the sliding surface change dynamically during rainfall. If the permeability coefficient of the sliding surface is
 226 low, it will take a long time for groundwater to flow from the rear tensile crack to the shear openings at the foot of the
 227 landslide (Wu et al., 2017). The effect of water on the tension crack and sliding surface is neglected, then the calculation
 228 formula of the safety factor of profile B-B' is given by (Fig. 16):

235 where V is the hydrostatic pressure along the depression belt, U is the uplift pressure along the sliding surface, and T is the

245 where γ is the unit weight of landslide mass; A is the area of the calculation profile; γ_w is the unit weight of water; H_w is the
246 height of water level in the depression belt; b is the width of the structural plane. So, Eq. (1) can be replaced by:

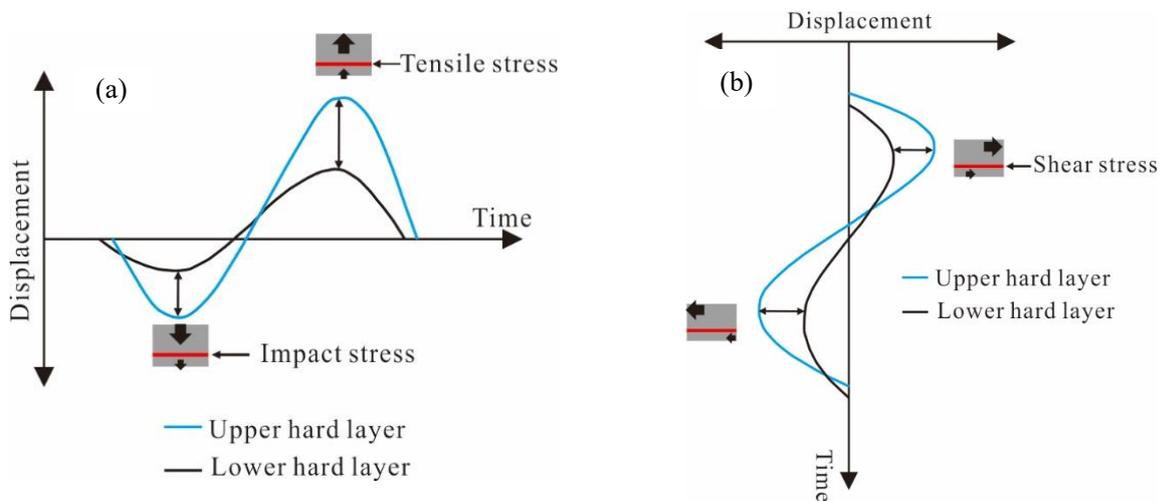
Fig. 18 Diagram of incompatible deformation in the model: (a) impact and tension stresses, (b) shear stress

291 The shaking table tests show that the weak layer is subjected to greater compressive and tensile stresses due to
292 incompatible deformation (Fig. 18). It can be reasonably proposed that the cyclic stress amplification caused the initiation
293 and propagation of fractures in the weak layer, which were confirmed by the a large number of cracks observed in the
294 mudstone on the sliding basal layer of the landslide (Pei et al., 2018).

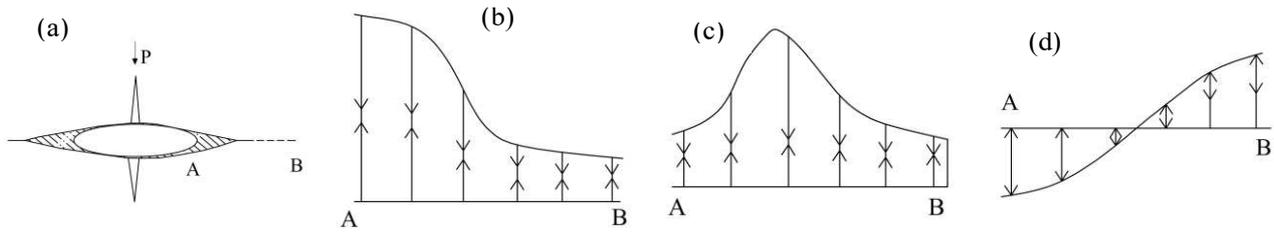
544 Fig. 19 Mechanisms of crack propagation under compression stress (modified by Lajtai 1977): (a) the tension fracture pattern of the
 545 original crack, (b) the stress concentration position at the crack tip, (c) transfer of stress concentration position, and (d) residual tension
 546 stress

295 Figs. 19 and 20 were used to shows the mechanisms of the cracks observed in the mudstone layer under compression
296 and tension stresses during the earthquake. Fig. 19 shows that compression stress will be concentrated at the tip of the
297 original joint in the rock mass. If the compression stress exceeds the strength threshold of the joint tip, the compression
298 crack will be initiated and propagated at the end of the joint. Further, the stress concentration position will be transferred
299 to the interior of the rock mass. The resilience of the crack tip is weakened in the unloading process, but the elastic modulus

300 of rock is much higher, resulting in the differential rebound, which will produce residual tension stress and compression
301 stress at the interface between the rock and the crack, causing the crack to propagate to both ends.

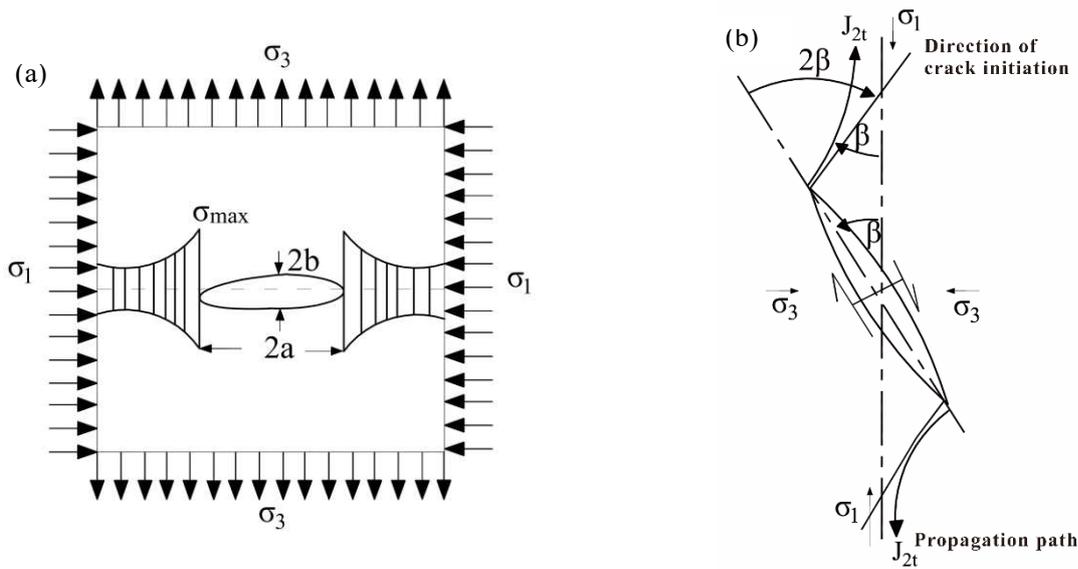
548 Fig. 20 Mechanisms of crack propagation under tension stress (a) and mechanisms of tension failure under compression stress (b)

302 [Fig. 20a](#) shows mechanisms of crack propagation under tension stress. Under the condition of tension stress, the tension
303 stress at both tips of the joint is concentrated. When it is greater than the tensile strength of the rock mass, seismic cracks
304 nearly parallel to the tensile stress are formed, and almost horizontal and gently inclined cracks are formed. Because the
305 tension strength of rock mass is far less than the compression strength, the above-mentioned tension cracks are very easy
306 to occur. In addition, under the condition of compression stress, the most concentrated tension stress is located at the end
307 of the crack with the angle of 30° - 40° with the direction of the principal compression stress. Therefore, the fracture first
308 appears at the end of some joints with favorable orientation and then develops into secondary cracks (J_{2t}). The angle
309 between the crack propagation direction and the long axis direction of the joint is about 2β , and then gradually turns parallel

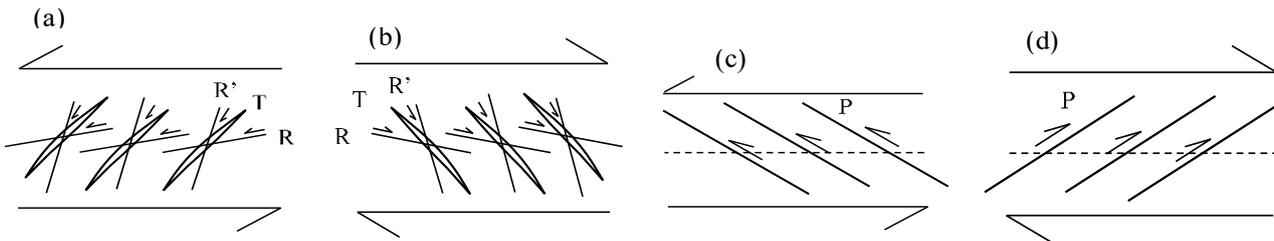
550 Fig. 21 Mechanisms of crack propagation under cyclic shear stress, a. sinistral tension cracks, b. dextral tension cracks, c sinistral
 551 compressive- torsion cracks, d dextral compressive- torsion cracks

310 to the direction of the maximum principal the most concentrated tension stress is located at the end of the crack with an
311 angle of 30° - 40° with the direction of the principal compression stress, resulting in nearly vertical cracks with high dip
312 angle ([Fig. 20b](#)). Under the condition of cyclic shear stress, tension and compression - torsion en- echelon cracks are
313 developed. The propagation direction of tension en- echelon cracks (T) is generally parallel to the maximum principal
314 compressive stress, and sometimes two groups of conjugate secondary shear cracks (R, R') can be formed. In addition, the
315 developed direction of compressive- torsion cracks (P) intersects with the shear direction at an acute angle ([Fig. 21](#)).

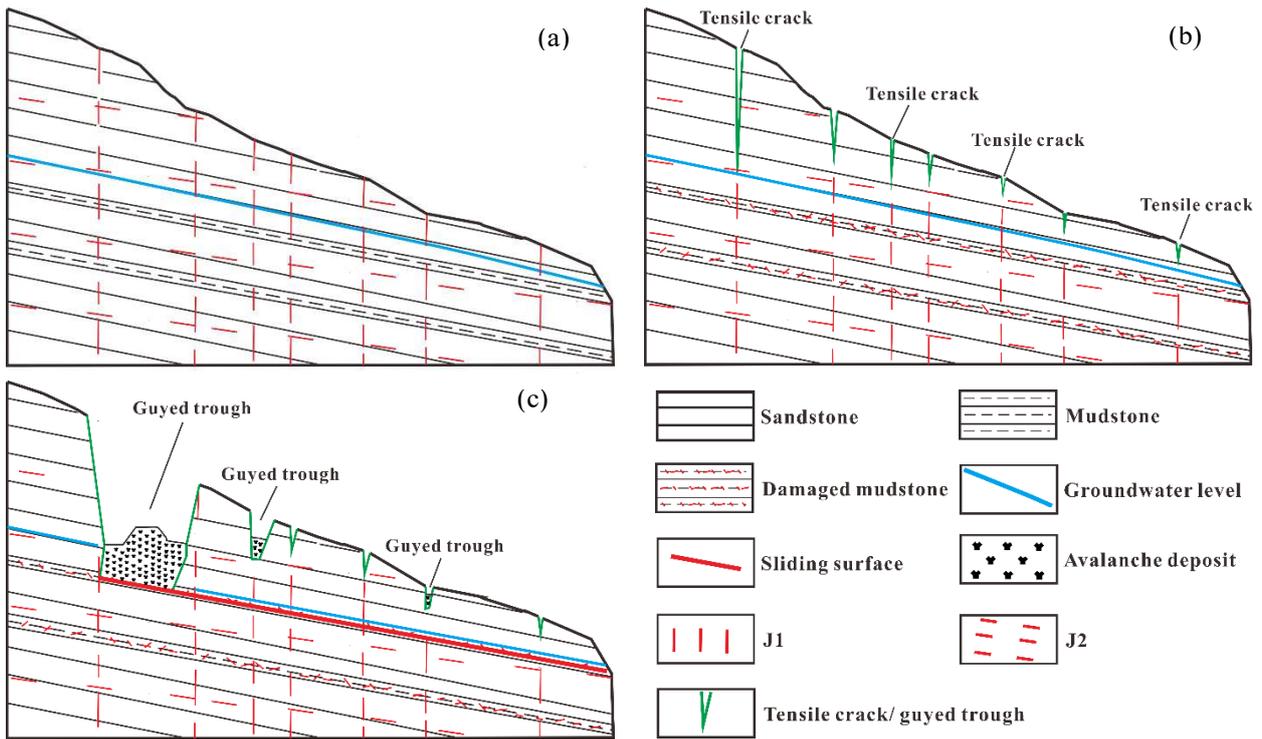
553 Fig. 22 Formation and evolution process of the cracked slope, (a) original slope with joints (b) seismic cracks formed by historical
 554 earthquakes, (c) progressive deformation of slope and the formation of tension cracks under the combined influence of earthquake,
 555 rainfall and gravity

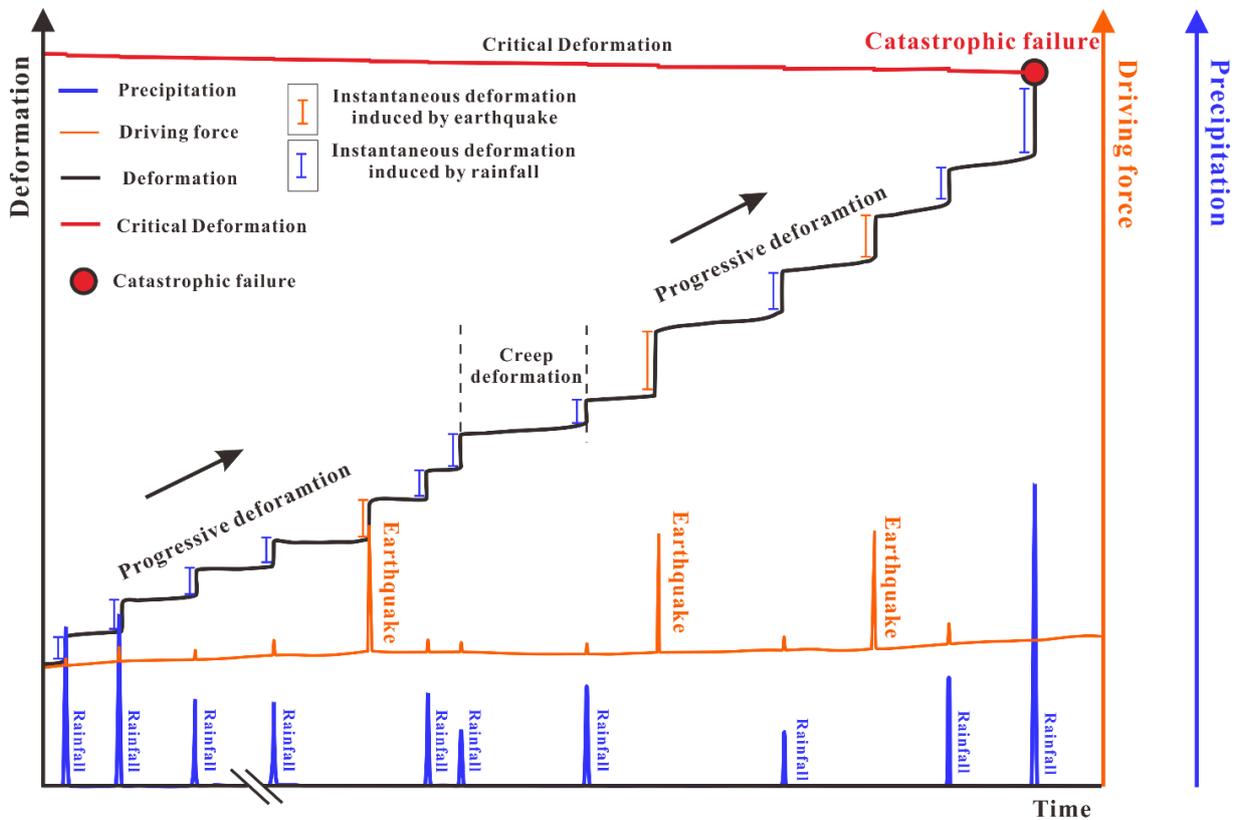
557 Fig. 23 Progressive deformation process of SXC slope under the influence of historical earthquakes, gravity and rainfall
 558

331 Similarly, rainfall plays the same role, and the hydrostatic pressure and softening on sliding surfaces induced by repeated
332 rainfall might cause instantaneous deformation of slope. Our shaking table tests, immersion tests and direct shear tests
333 simulate one earthquake, one rainfall, or one shear failure. Their results should be coupled and accumulated, which should
334 be further study. In this study, the rainstorm in 2013 accelerated the slope deformation to reach the critical state, resulting
335 in the landslide initiation. It can be inferred that the catastrophic failure of the SXC landslide triggered by the rainfall in
336 2013 strongly depends on the pre- existing deformation and damage caused by historical earthquakes, rains and gravity
337 (Fig. 23).

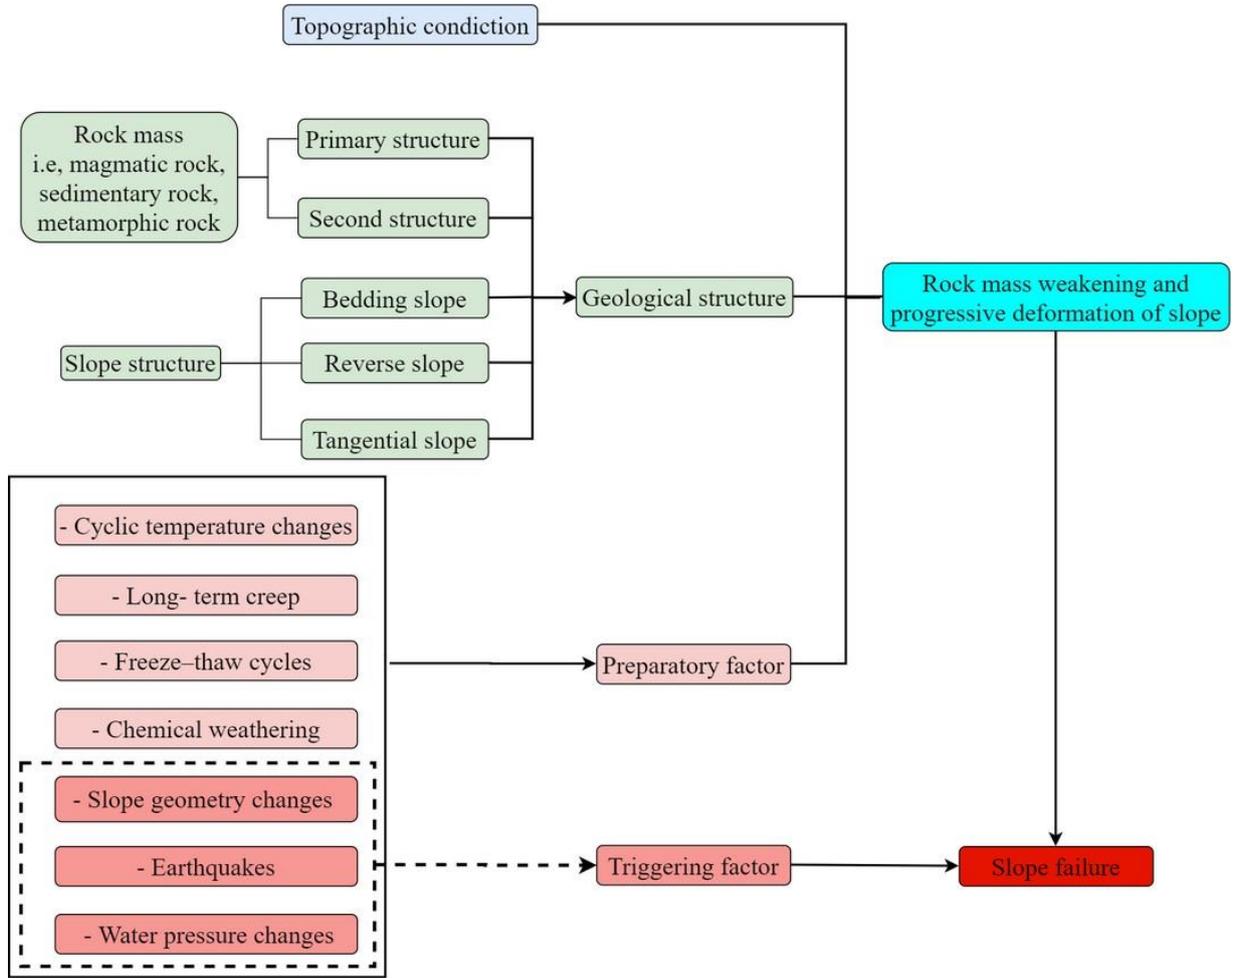
Fig. 24 Flowchart illustrating the rock mass weakening and progressive failure of slope

338 The progressive deformation and failure of slope are the results of the integrated influence of several factors, which
339 includes geological structure, preparatory factors and triggering factors (Fig. 24) (Gunzburger et al., 2005). The SXC
340 landslide with a failure history of more than 400 years is a typical example for progressive failure study. Based on our
341 understanding of its history, we made Fig. 24 to illustrate the possible effect factor of the landslide from stability to be
342 instability.
